# Mitchell Station Unit #1

## American Electric Power Company

## Westinghouse T-G Set

VHP-HP Turbine	Serial Number	13A3160-1
IP Turbine	Serial Number	13A3161-1
LP Turbine #1	Serial Number	13A3162-1
LP Turbine #2	Serial Number	13A3163-1
Turbine Instruction Book		1250-C679
Generator	Serial Number	1-S-87P0755
Brush Collector	Serial Number	1-S-94P0063
Generator Instruction Book		90P0944
Brush Collector Instruction Book		1560-0093
Boiler Feed Pump Drive Turbine		15-A-2961-1
BFP/DT Instruction Manual		1150-C129
Spring Outage		4-1-2006 to 6-18-2006

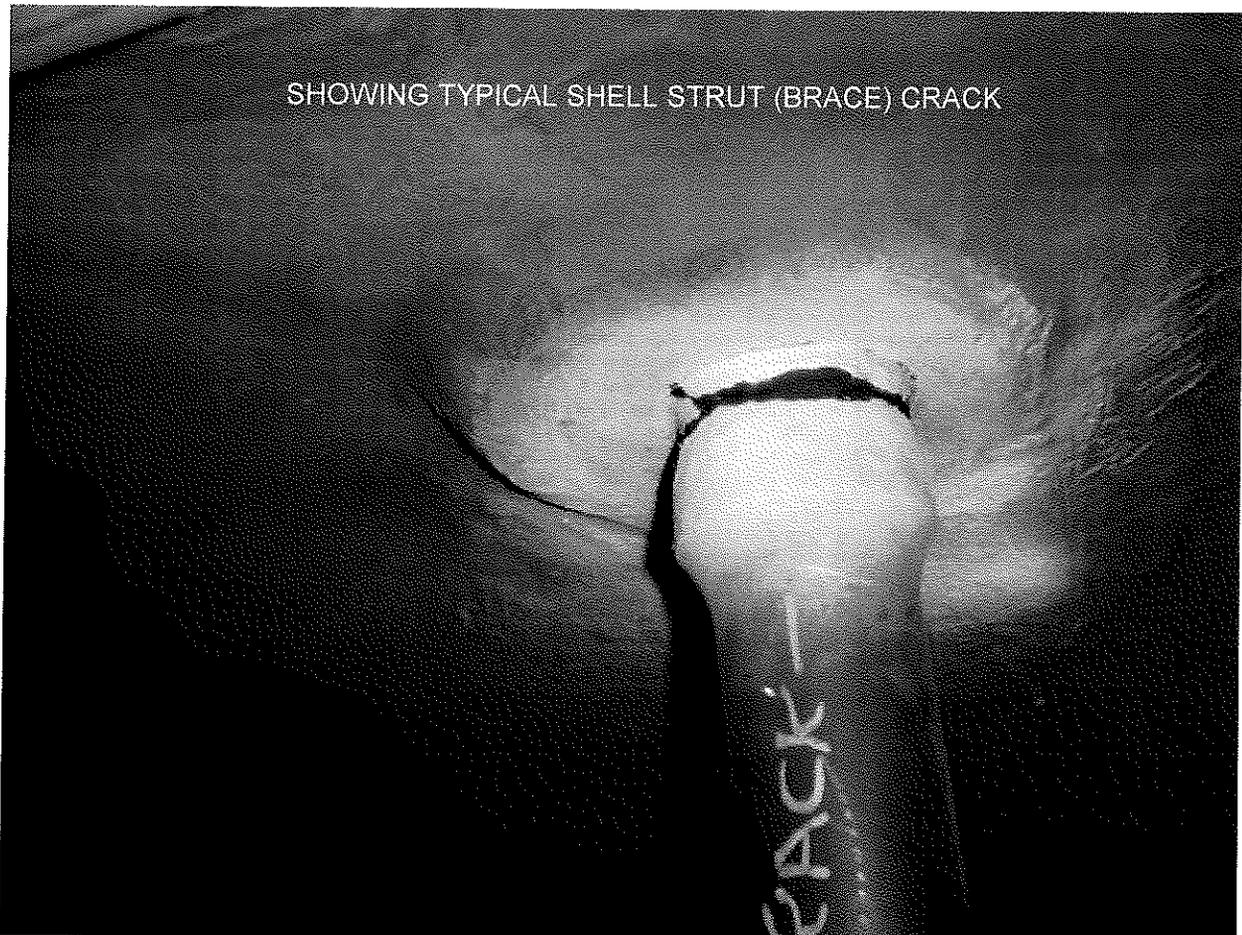
### **SECOND REHEAT TURBINE OUTER LOWER HALF SHELL**

Visible dye inspection of sixteen (16) stiffener brace welds revealed twelve (12) of the brace welds have cracks. The 1-1/4" to 1-1/2" long cracks were ground and weld repairs to the 12 cracked welds was completed. A follow up visible dye inspection revealed no defect indications (cracks) remain after weld repair.

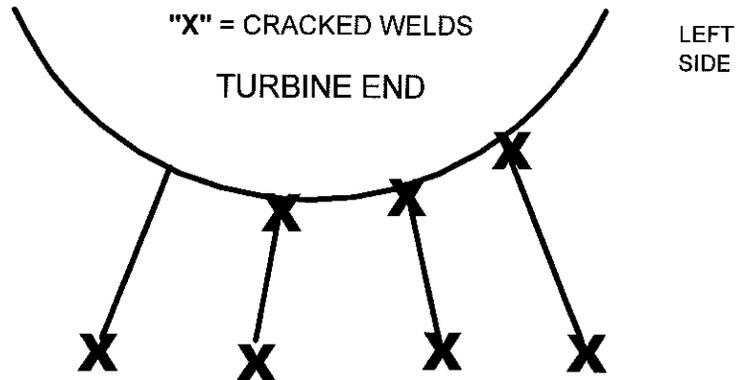
2ND REHEAT TURBINE SHELL LOWER HALF SUPPORT BRACES (STRUTS)

The outer cylinder was grit blasted and NDE inspected. The component halves were found in good condition. The lower cylinder exhaust bowl struts and their seal welds were found cracked. These were repair welded using 7018-A1 electrodes after removing the fractured inconel seal.

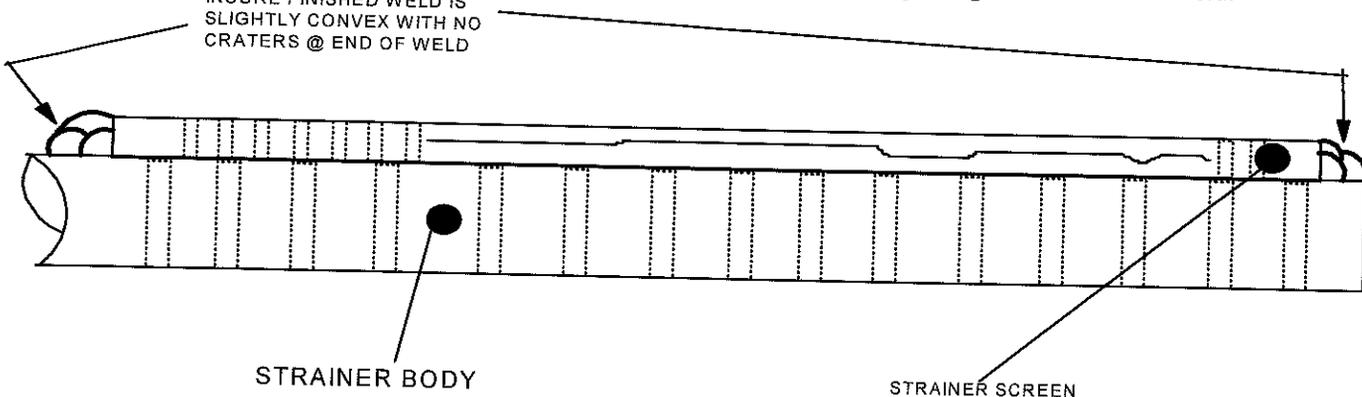
The valve bonnets were jacked out of their steam chests with difficulty due to oxide scale build up. This resulted in a number of jack bolt threads being damaged to complete the activity. The bonnets after valve plug removal were shipped to CMS to repair these threads. CMS installed double threaded sleeves as a repair. CMS at this time installed the fine mesh screens to the bonnet strainers. The fine mesh screens were stitch welded to the strainers. See CMS Shop Report.

The intercept valve bonnet jack bolt holes were drilled to a larger diameter and tapped to repair the damaged holes.

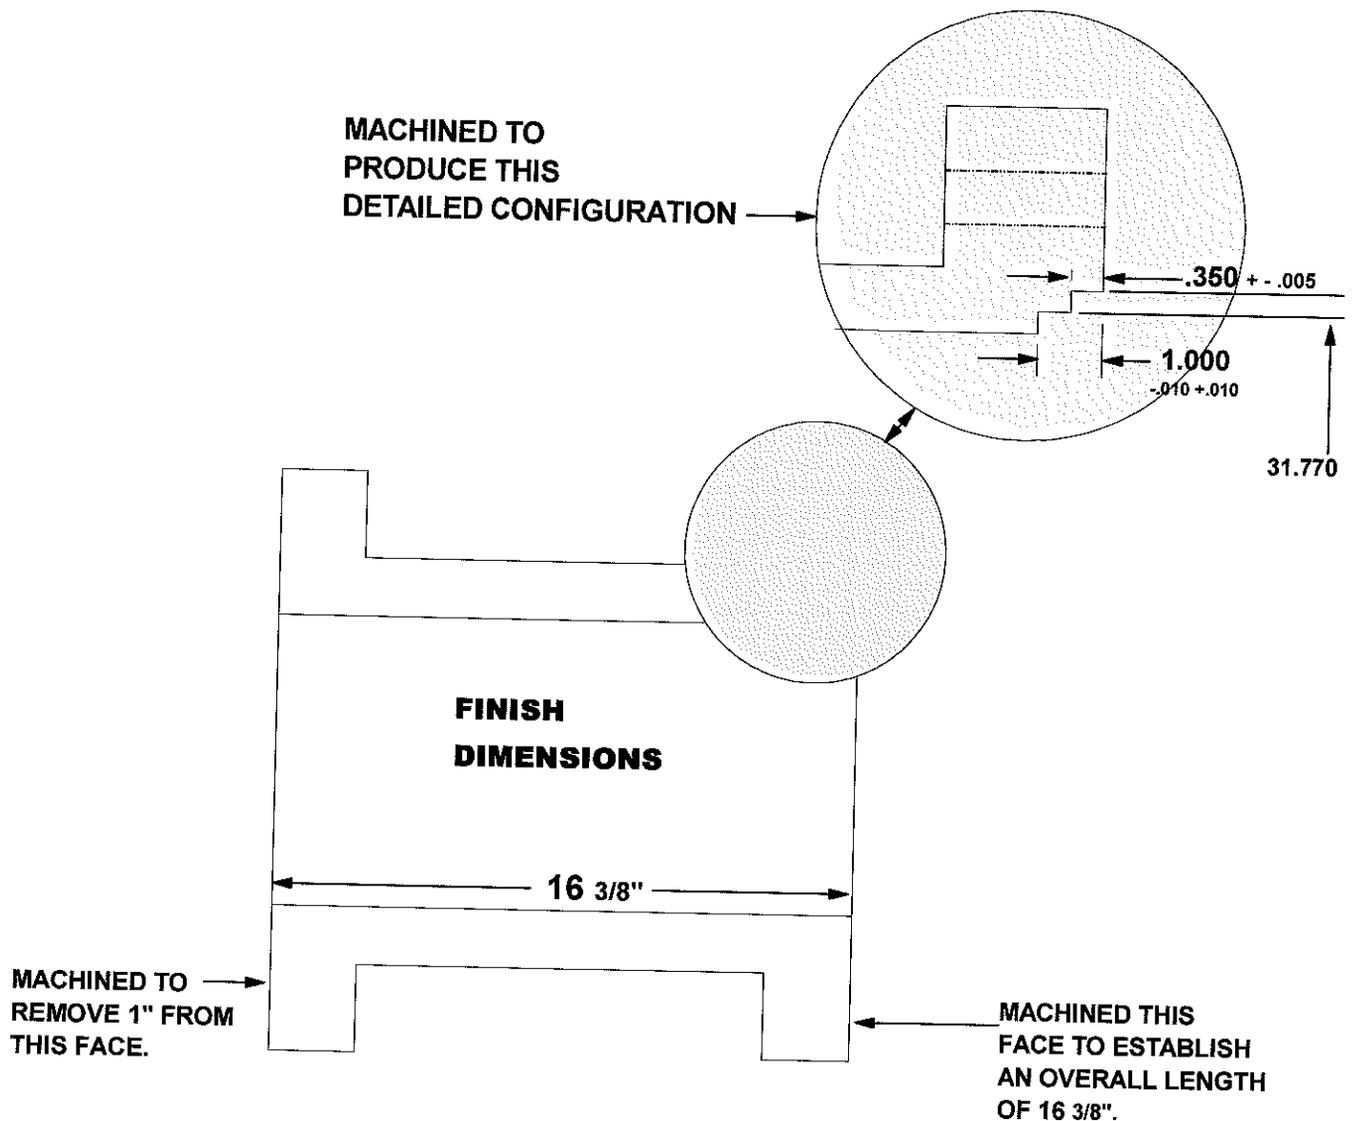
### MITCHELL U-1 OIL COOLER SPOOL PIECE LANTERN RING FIT JULY

The air side seal oil cooler(s) cooling water return loops were shipped to Shutler Machine to repair erosion damage at the lantern ring and "O" ring fit areas. These repairs (field drawings attached later) were necessary to return to the original seal techniques without use of RTV compound and other fixatives, which interfere with the movement of the cooler floating head.

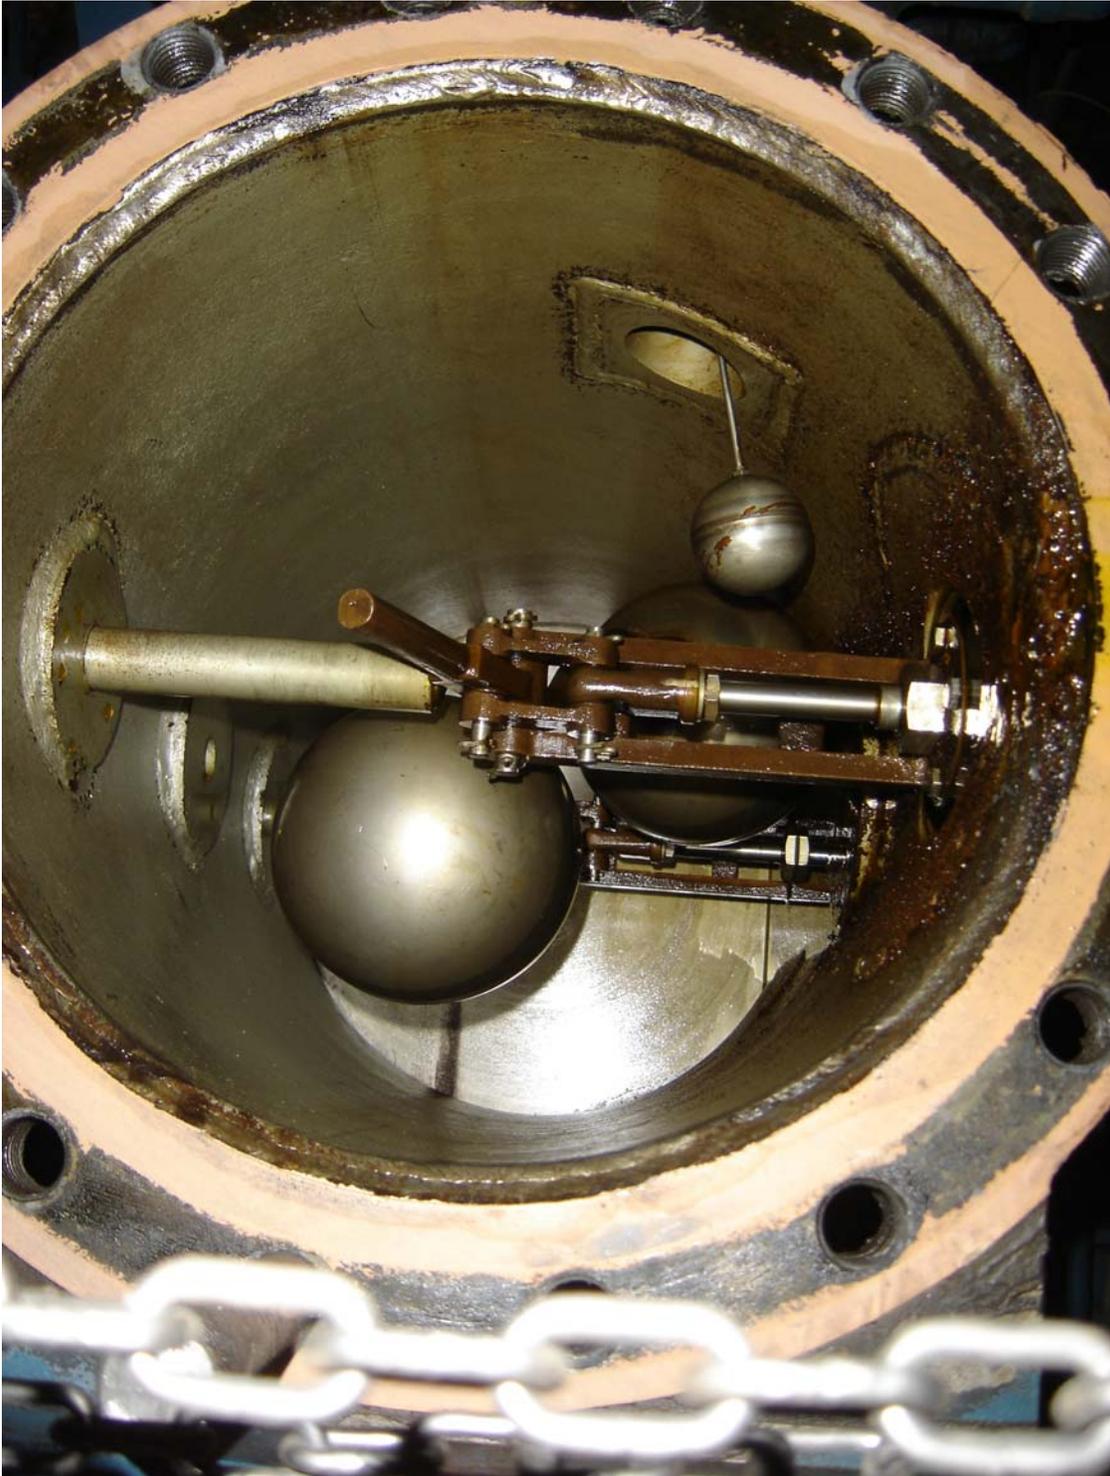
Attachment 1 - SOS Regulating Tank at Disassembly –Note fine debris and rust

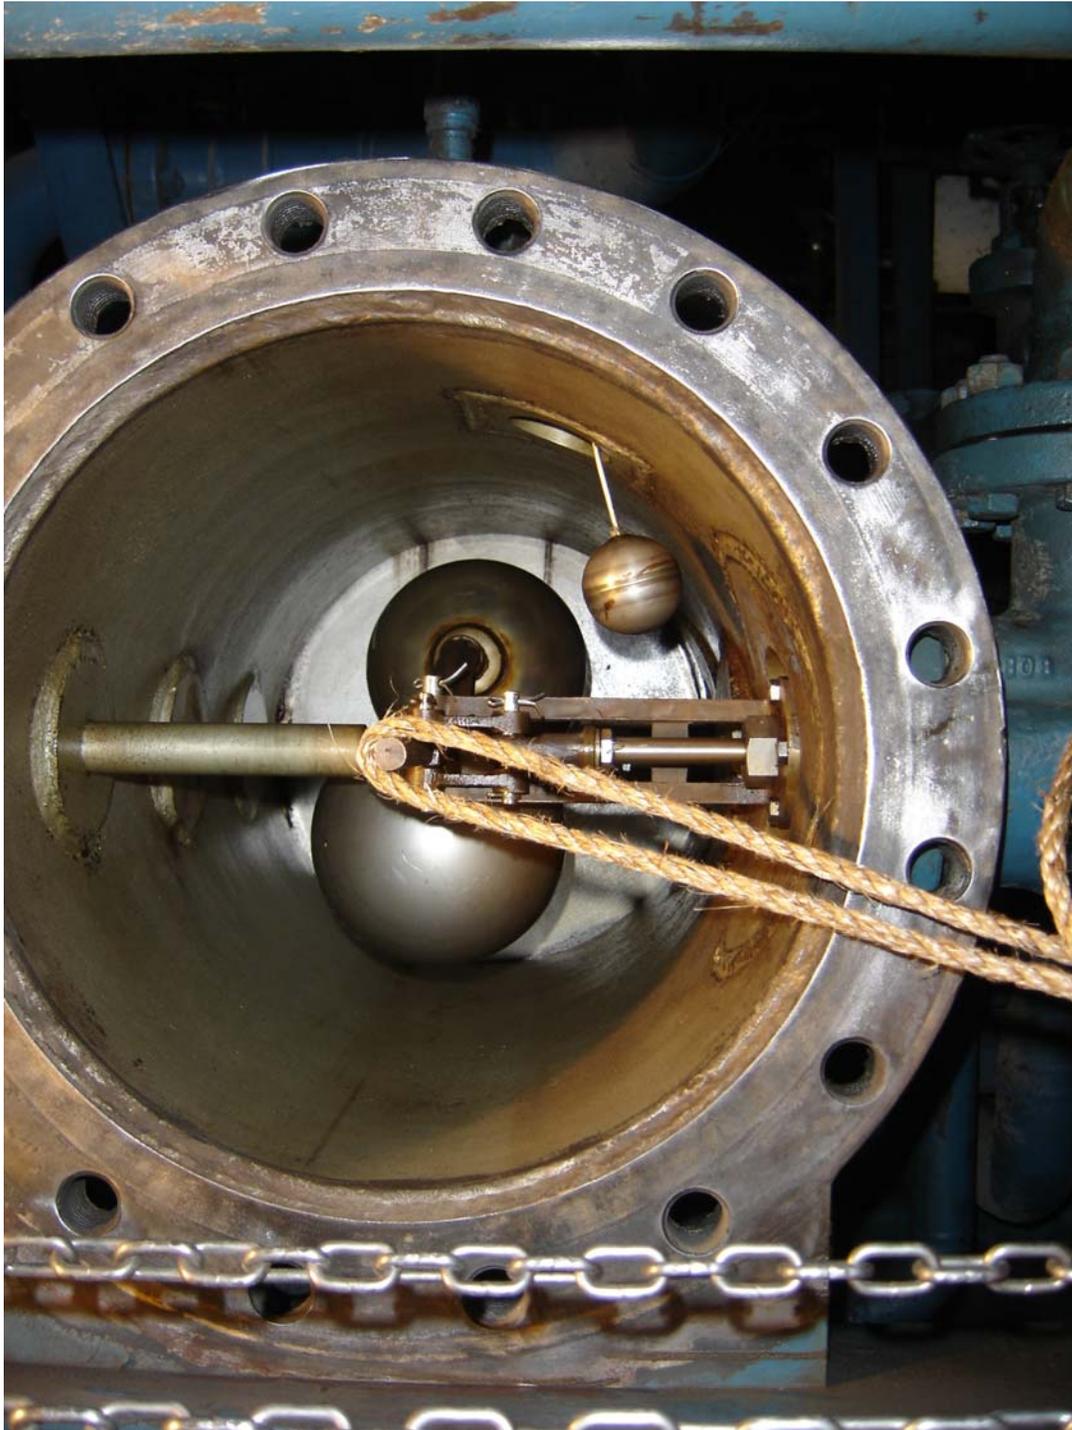
Attachment 2 - SOS Regulating Tank Floats as Restored

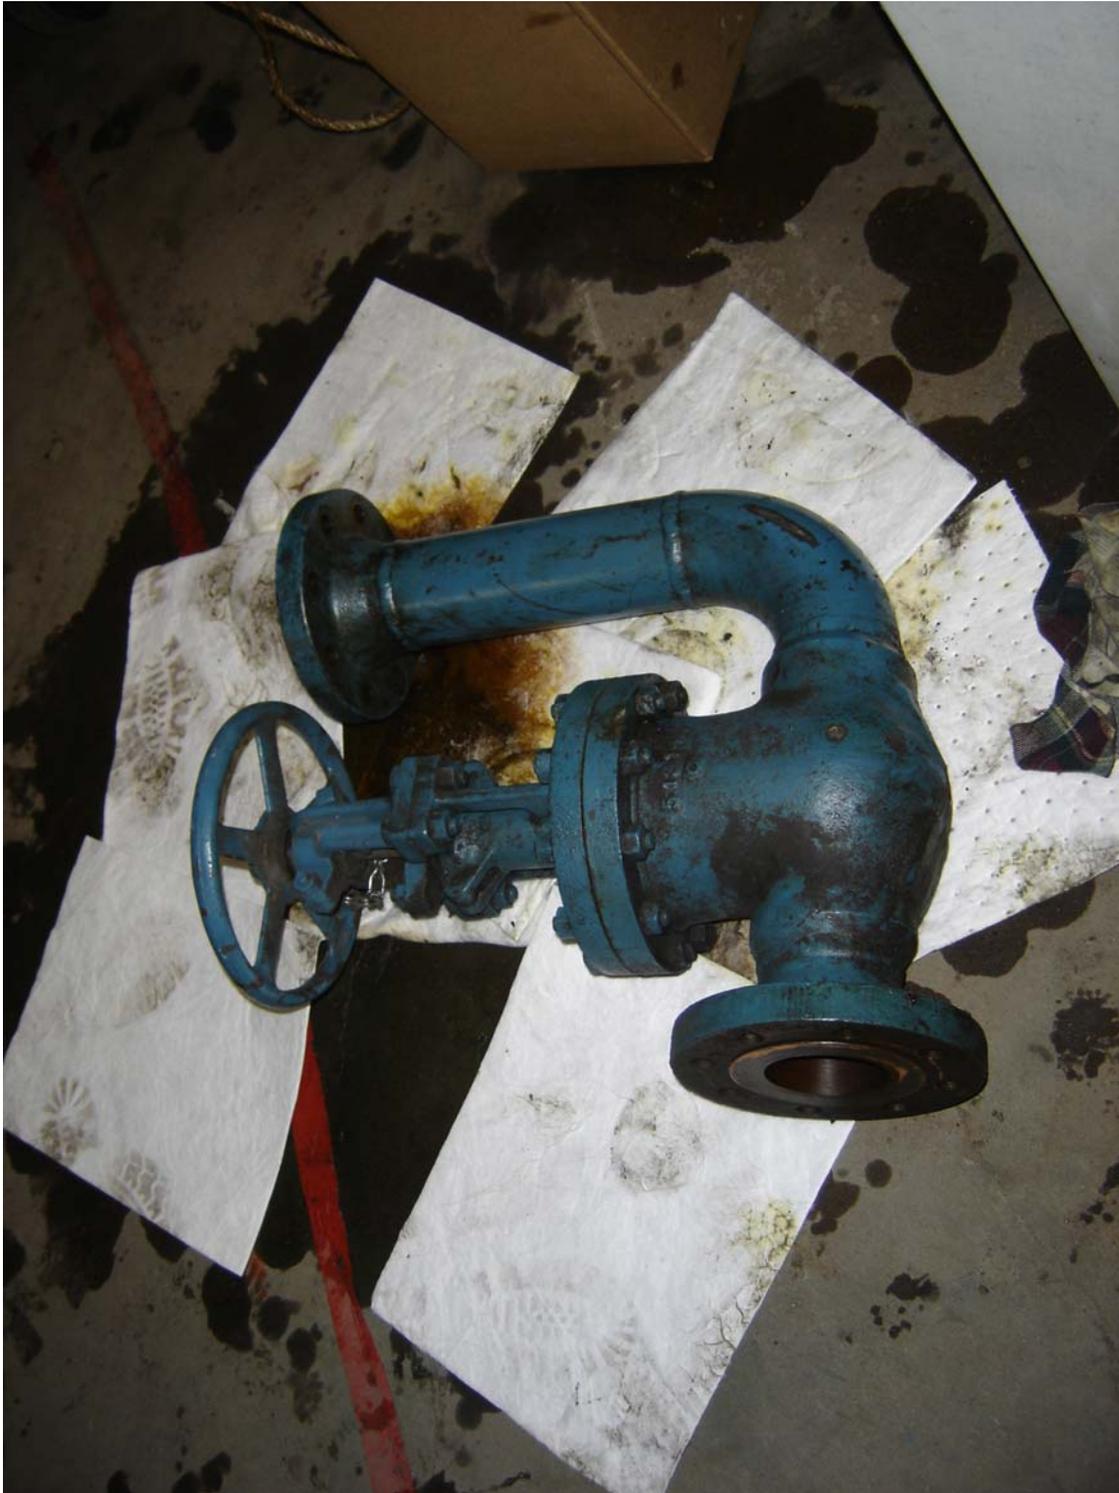
Attachment 7 - Removed Exciter H2 Drain Valve 326

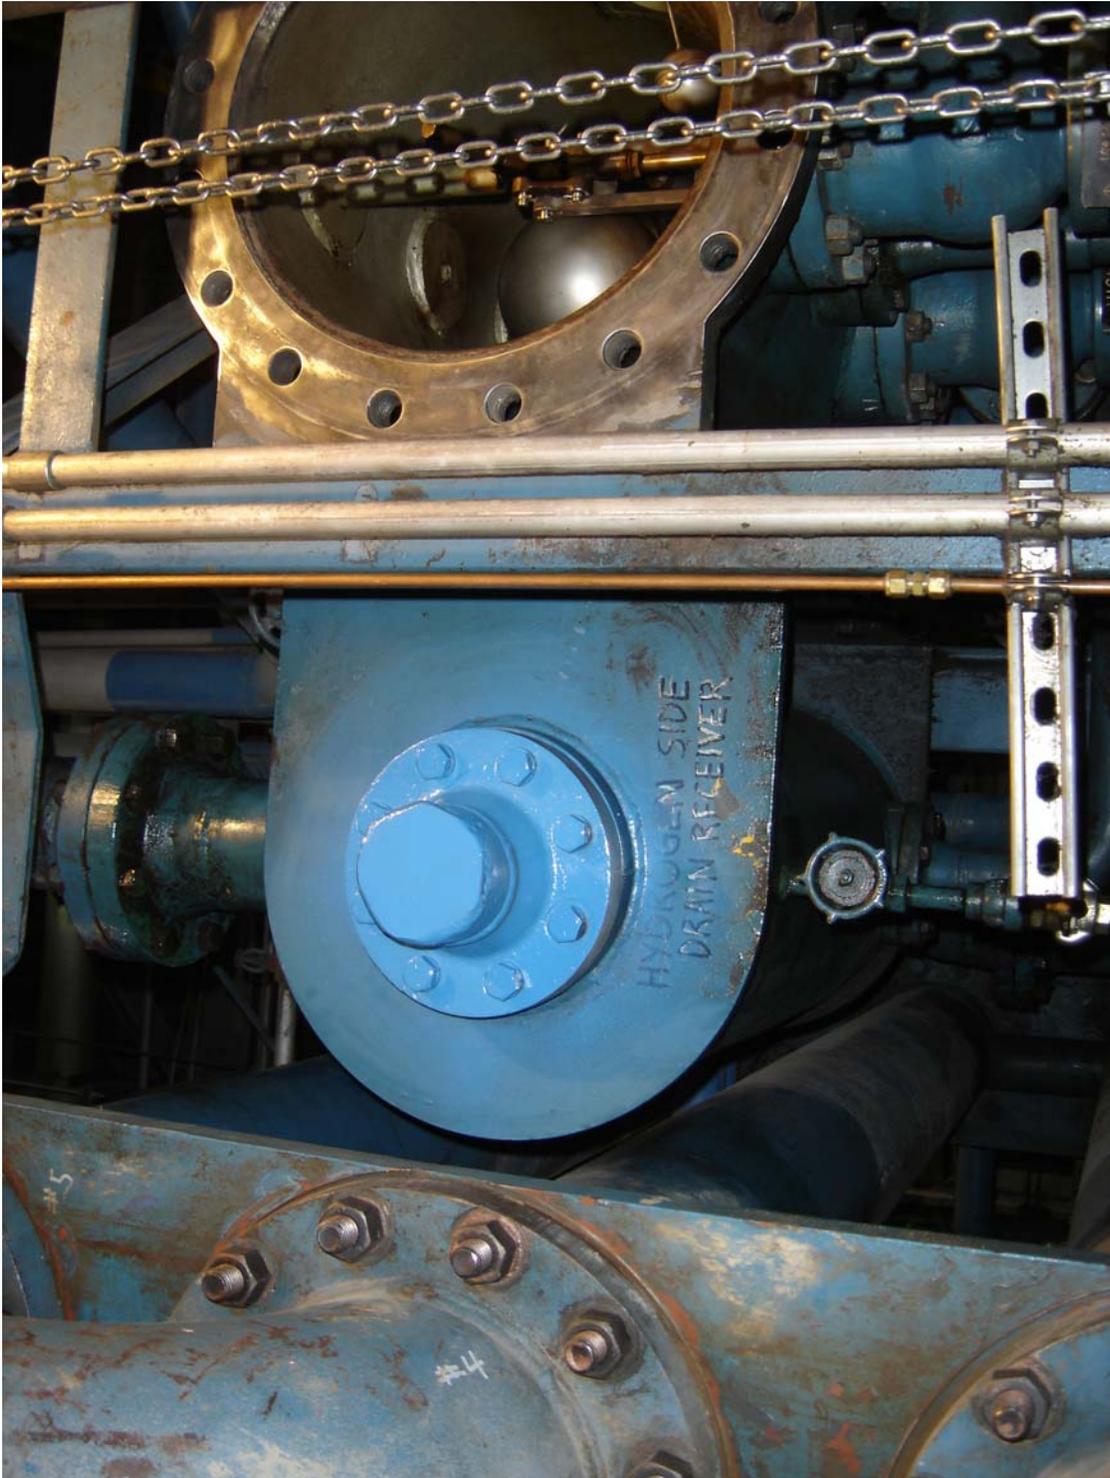
Attachment 8 - Blank Installment for Valve 326

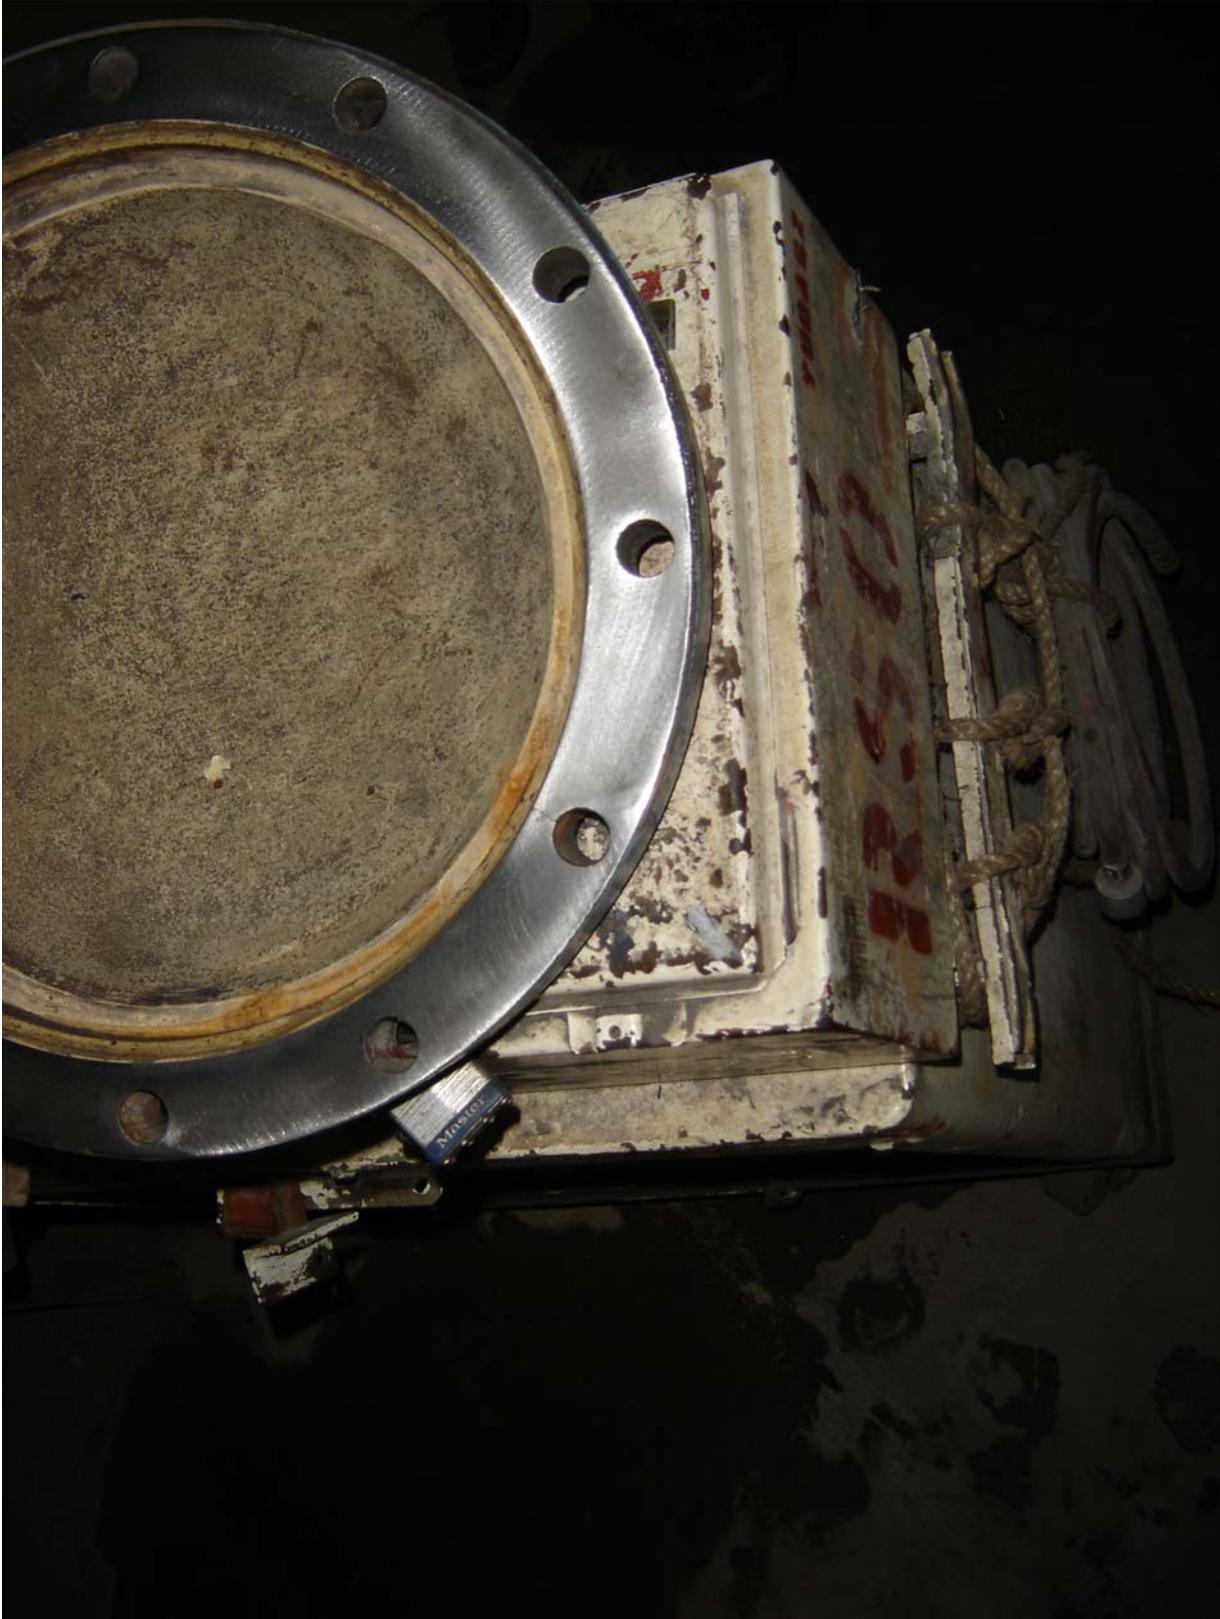
Attachment 11 - Stator Water Reversing Cover Crack

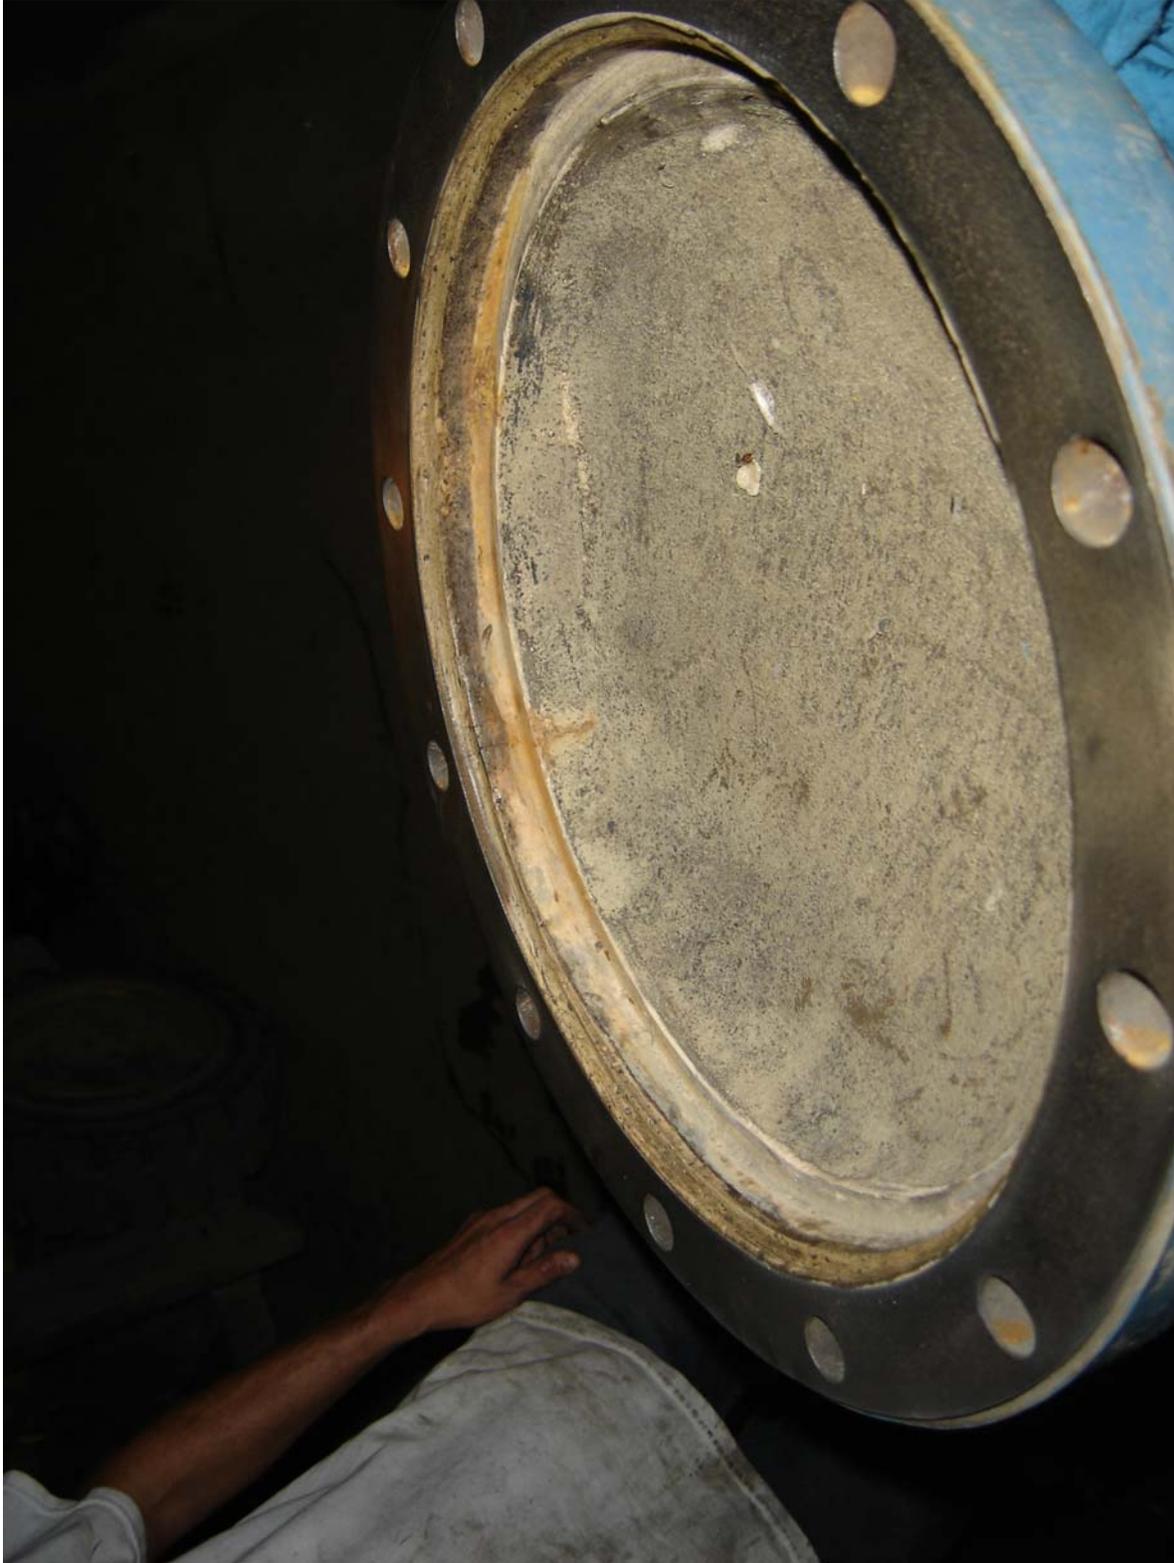
Attachment 12 - Stator Water Reversing Cover Crack

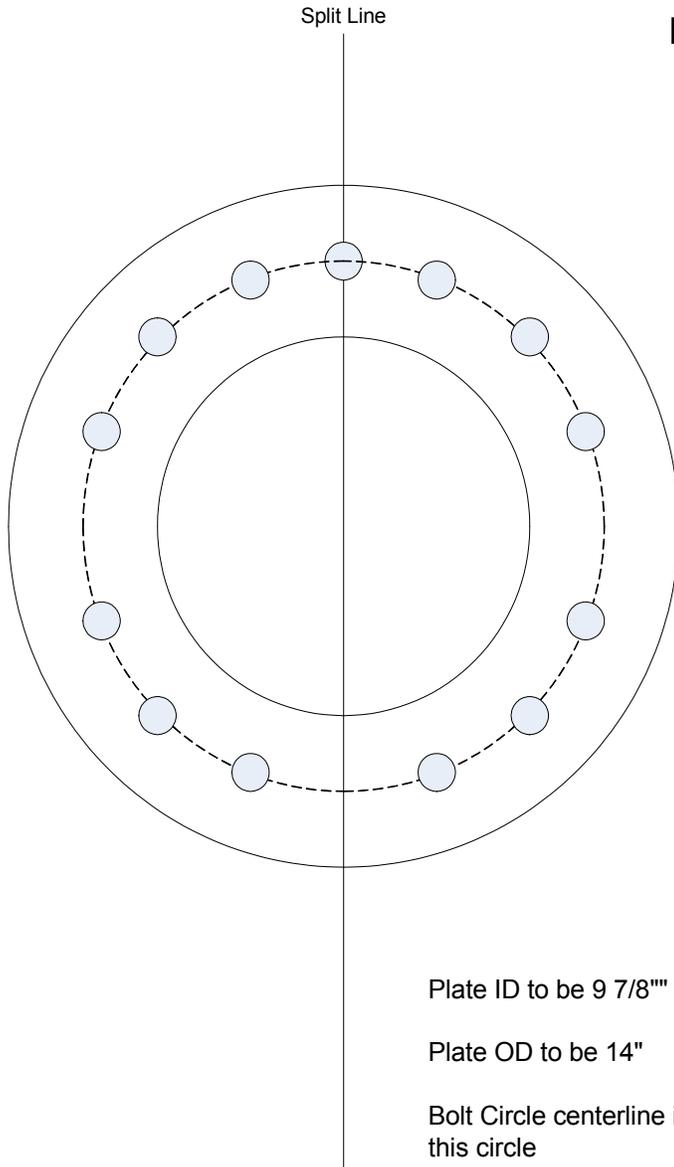
## Main Oil Pump Housing Shim Pattern

The pump housing seal grooves required weld repair and dimensional restoration. This required the parting of the suction and discharge pump lines below the concrete pier after cutting openings into the guard pipe. The removed pump housing base and cover were shipped to CMS for weld repair and machining (see CMS Shop Report). The sealing shim rings between the pump housing feet and the oil pedestal floor were replaced with split ring components to allow future elevation changes as needed without cutting supply and discharge piping. The thickness of the shim rings was cut to set the housing bore central to the pump impellor. This required lowering the pump housing 0.105” from as found. Field drawing of Shim Ring Detail attached later.
