Inspection Report

Station: Mitchell Unit: 1 Report Name: 1-WATER WALL FRONT

AREA: Water Wall Front

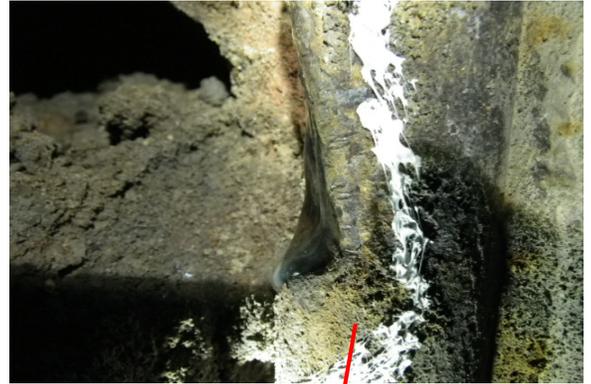
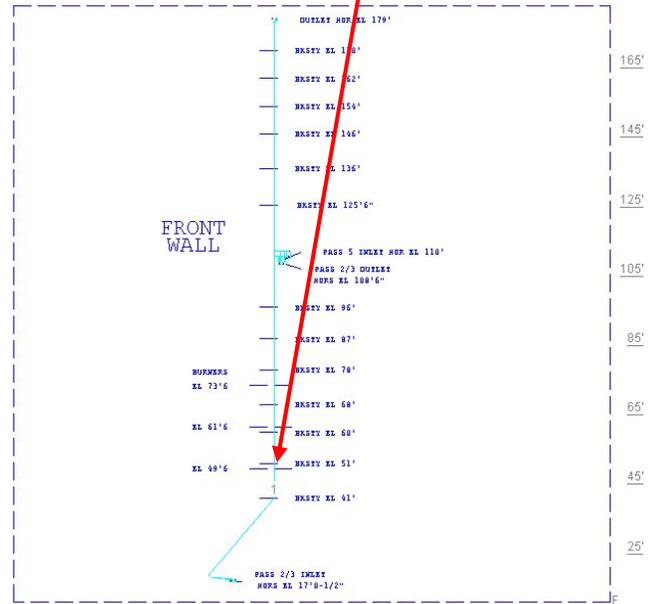
Specific location: Tube #:243

Cause: Erosion (Soot Blower)

Appearance: Eroded

The UT Data is 0.103

Replace 1' section of **Tube 243** adjacent to Burner 13C due to Soot Blower erosion and a RWT of 0.103. The area is marked with white paint stick.

If the tube is load bearing (hanger tube), temporarily support the tube before replacement is made. Verify replacement material before removing old tube section.

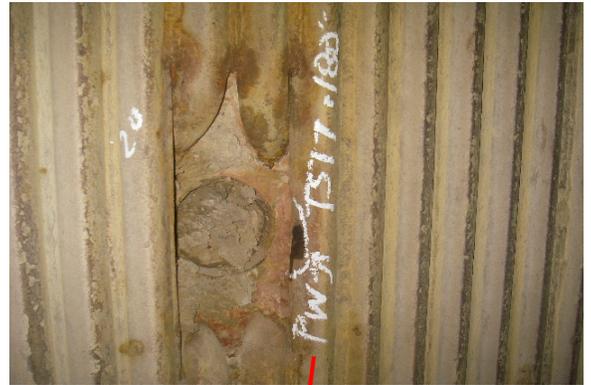
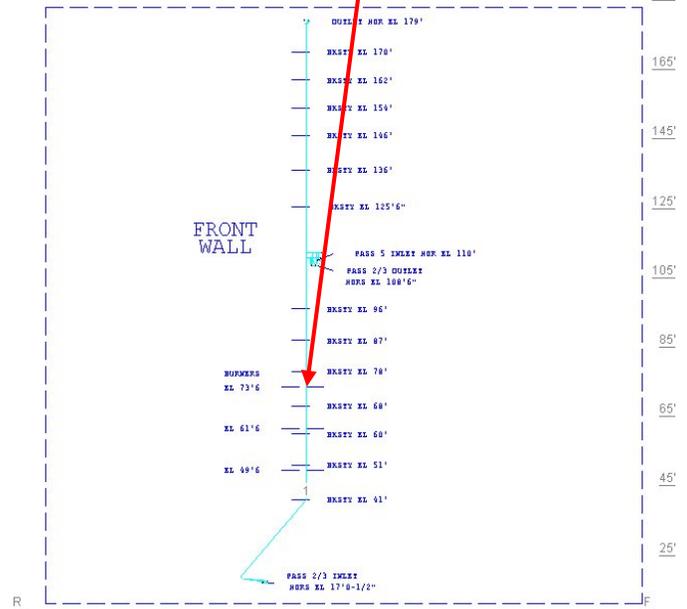
Specific location: Tube #:517

Cause: Erosion (Soot Blower)

Appearance: Eroded

The UT Data is .180

This elevation is equal to the centerline of the upper burner band.

Apply one 1"x2" pad weld to restore **Tube 517** due to erosion from a previously in-service IR. The RWT was measured at 180".

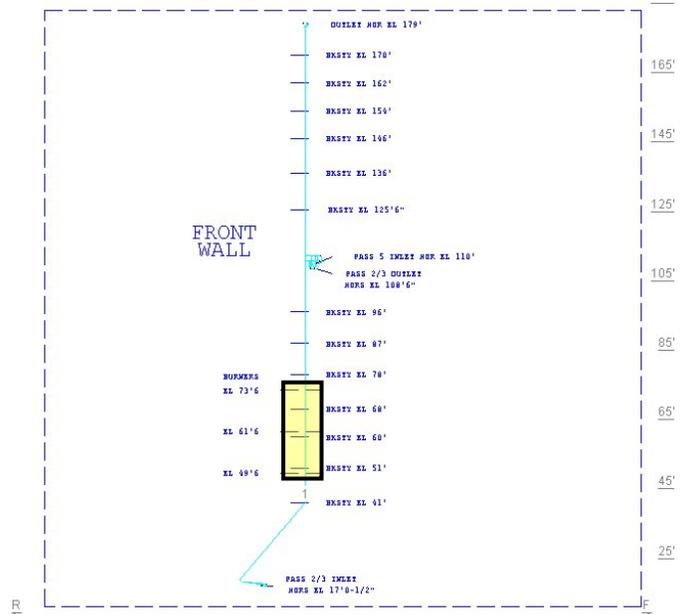
Cause: Fatigue (Thermal/ Vibration)

Appearance: Missing

The outer edge of refractory is missing and broken back on the majority of front wall burners throat tubes.

Repair/Replace the missing Refractory.

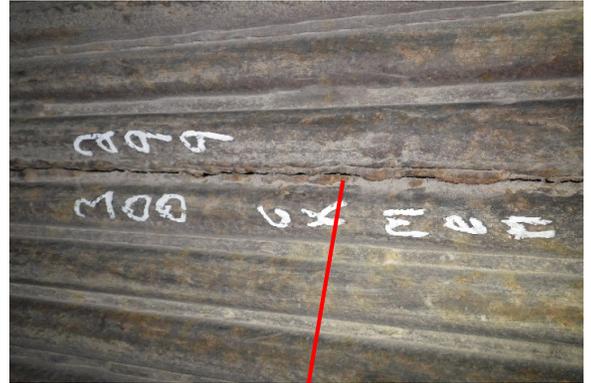
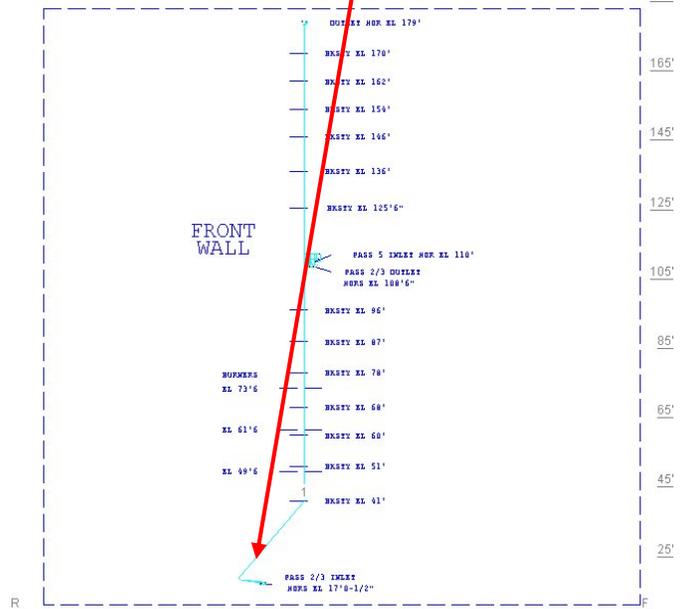
Cause: Fatigue (Thermal)

Appearance: Cracked

Re-Weld the cracked membrane in between tubes 299 & 300, 303 & 305 due to thermal fatigue. The cracks range from 1' to 5' in length.

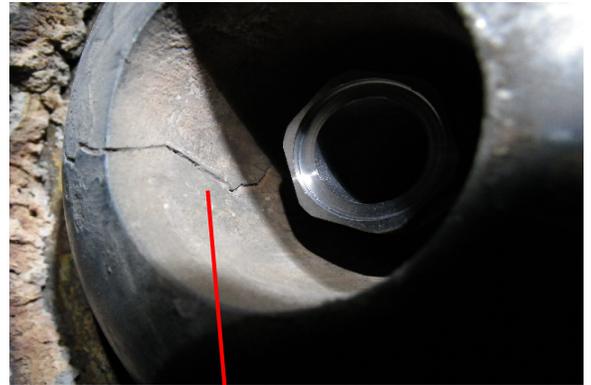
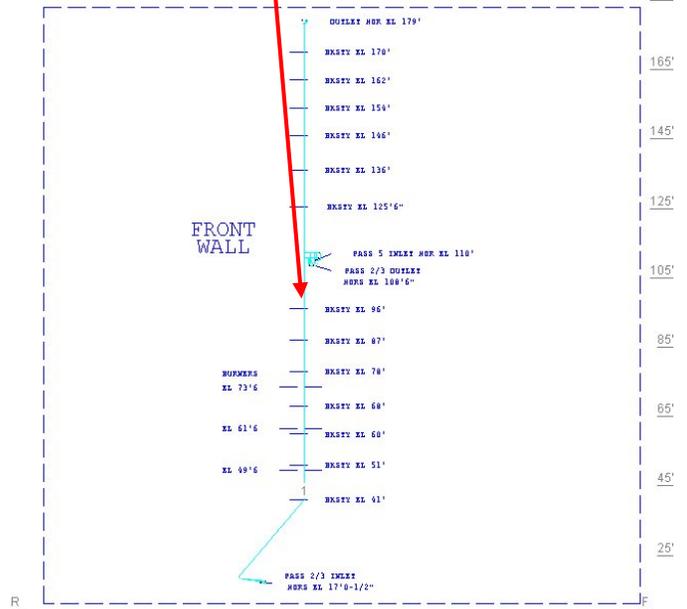
Cause: Fatigue (Thermal)
Appearance: Cracked

The Water Cannon on the left Front Wall is cracked; however, no action is needed at this time.

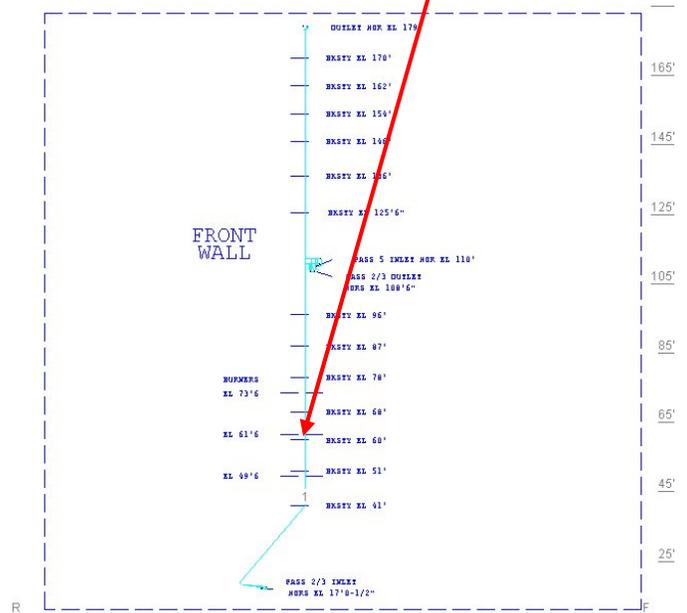
General location is Water Wall Front, Burner Coal Nozzle, 12F.

Appearance: Missing

Replace the missing ceramic liner tiles at **Burner #12F** in the 11:00-12:00 o'clock positions.

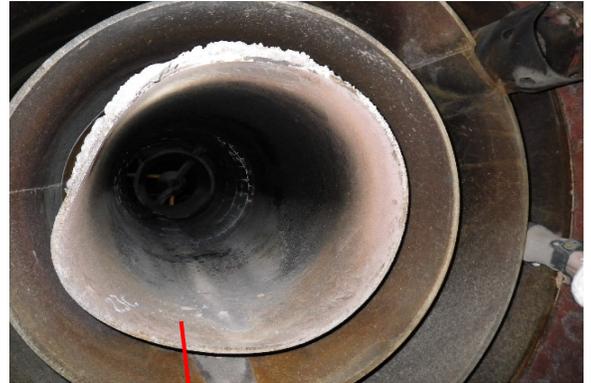
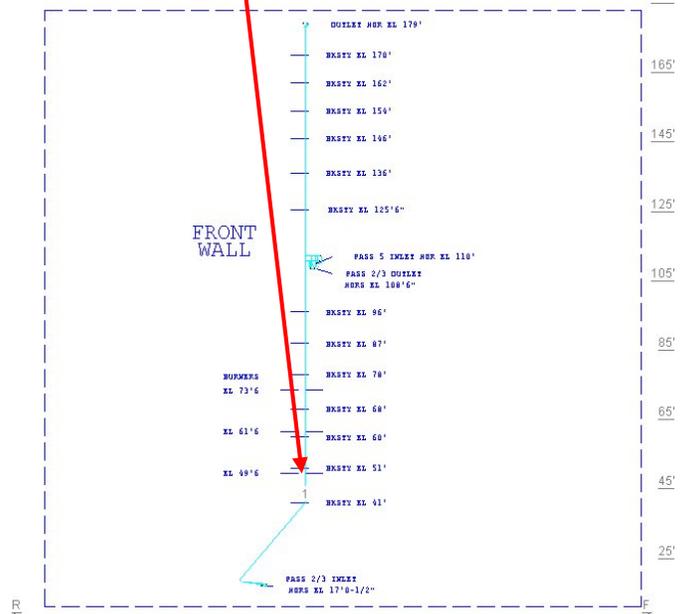
Cause: Fatigue (Thermal)

Appearance: Distorted

Replace Coal Nozzle Tip due to thermal fatigue. The Coal Nozzle Tip on Burner 13C is distorted at the 7:00 position.

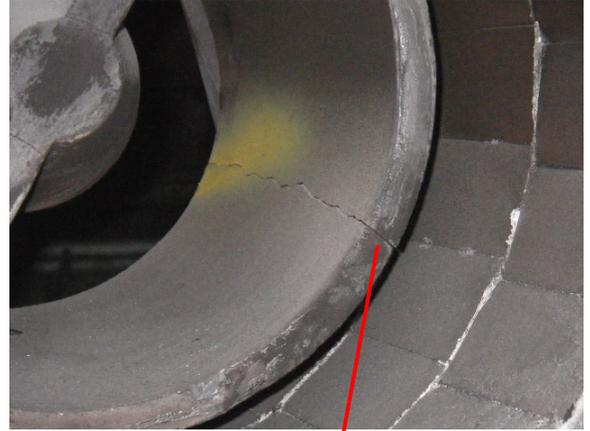
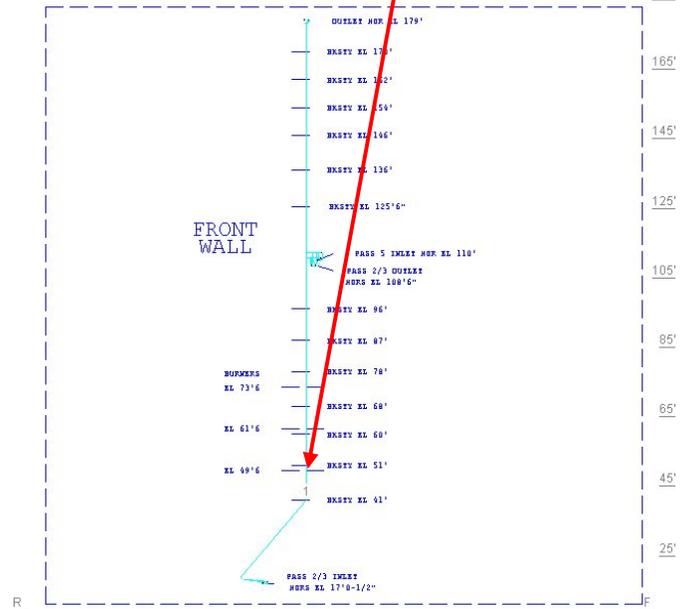
Cause: Fatigue (Thermal)

Appearance: Distorted

Replace the conical diffuser at **Burner 13C** due to thermal fatigue cracking in several locations.

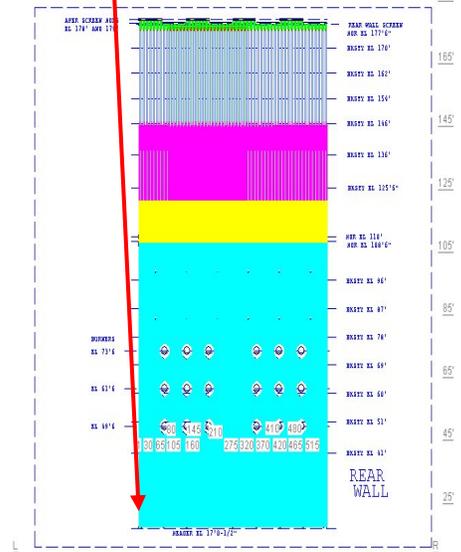
Cause: Erosion (Fly Ash)

Install approximately 2' dutchman to the eroded area on tube 1. The eroded area is located 12" above the throat of the coutant slope. The gap needs to be filled from the rear wall to the left wall the help seal up the boiler and to stop the fly ash being channeled through this area. There was no UT reading obtained due to the location of the eroded area.

If the tube is load bearing (hanger tube), temporarily support the tube before replacement is made. Verify replacement material before removing old tube section.

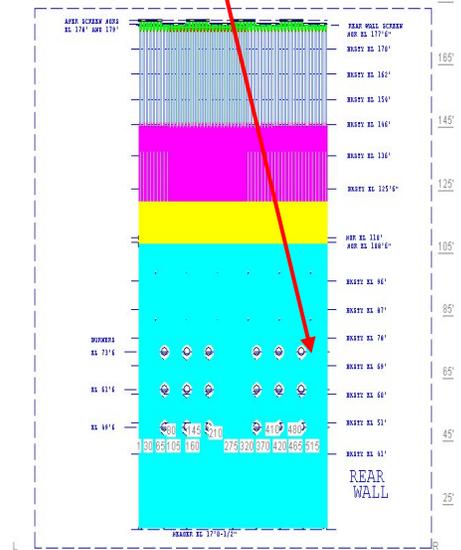
The UT Data is .183

Install 2' dutchman on tube 520 due to bulge and UT readings of 0.183". This tube is located at the top row of burners adjacent to old IR port. Bottom cutline should be approximately 10" down from IR and up 24" to remove bulge and existing pad weld.

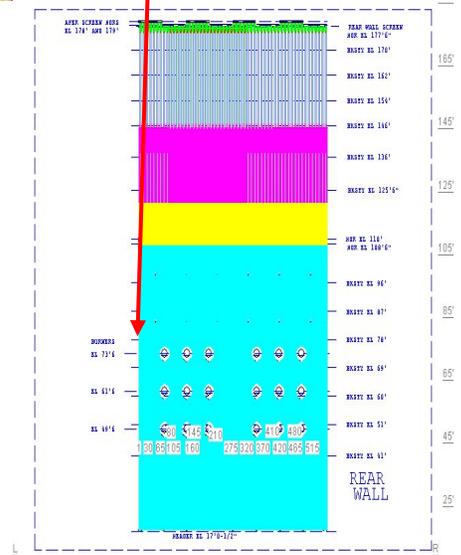
Appearance: Quench Cracked Tube

This tube appears to have been quenched from the IR that has been taken out of commission. This tube is located approximately 5' above the top row of burners.

Grind surface indications to termination and then verify that the indications are limited to the overlay material only and not the actual tube surfaces. Should indications continue beyond the overlay, determine the RWT of the underlying tube material and repair as needed.

Grind until visible defect reaches termination and call for re-inspection.

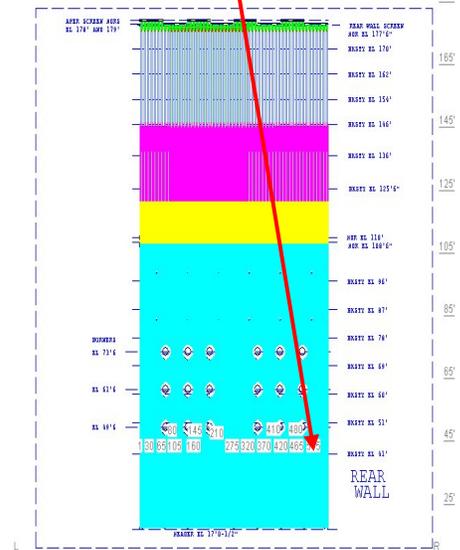
Appearance: Stress Fatigue Cracks

Further research required for tubes 557-559. These tubes appear to have stress fatigue cracks located at the rear wall right below where the rear wall transitions to the lower slope.

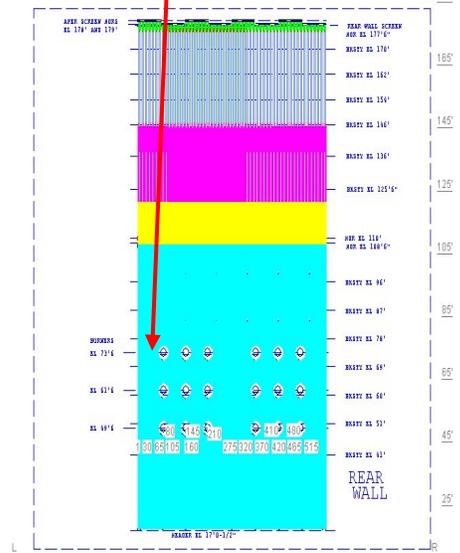
Cause: Erosion (Soot Blower)

The UT Data is .182

Apply 1" x 2" pad weld to the eroded area on tube 41 on the left side of the tube. This area appears to be at an old IR that has been taken out of commission. This eroded area is located level with the second row of burners.

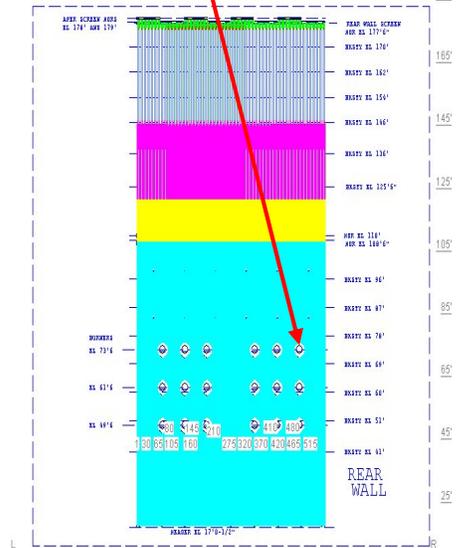
Cause: Fatigue (Thermal)

Appearance: Deteriorated

Weld repair igniter approximately 6" back from the tip at 14F.

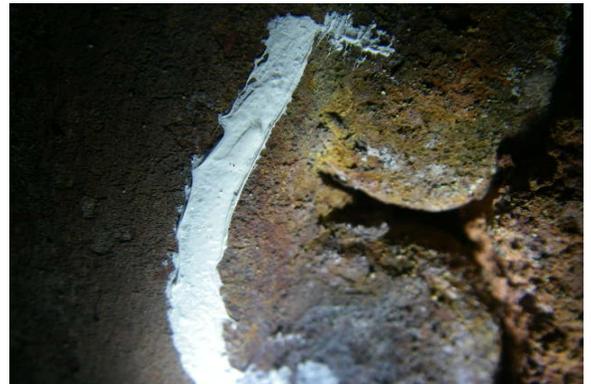
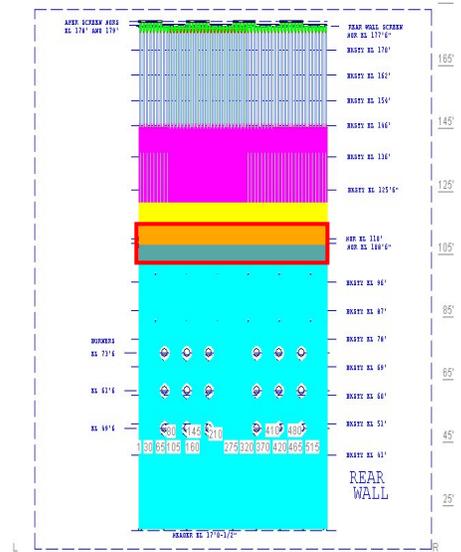
Cause: Fatigue (Thermal)

Appearance: Overheated

Replace pad fin located along the rear wall from left to right side of the furnace at the mixing header. The peg fin is being overheated and is starting to propagate into the tubes. Once the refractory is replaced in this area it will help to prevent the peg fin to propagate any further.

Remove existing peg fin remnants and replace with new like material. Install fins with non-continuous side against tube and apply >80% penetration welds not extending past each fin break. Start and stop welds on fin. Do not weld around ends of fins.

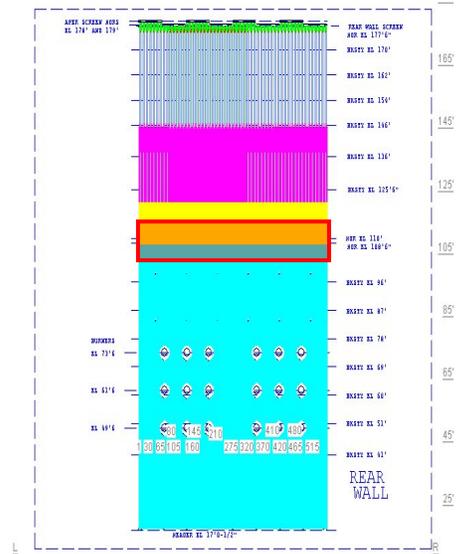
Cause: Fatigue (Thermal/ Vibration)

Appearance: Missing

Install refractory at the mixing header on the rear wall from the left to the right side of the boiler.

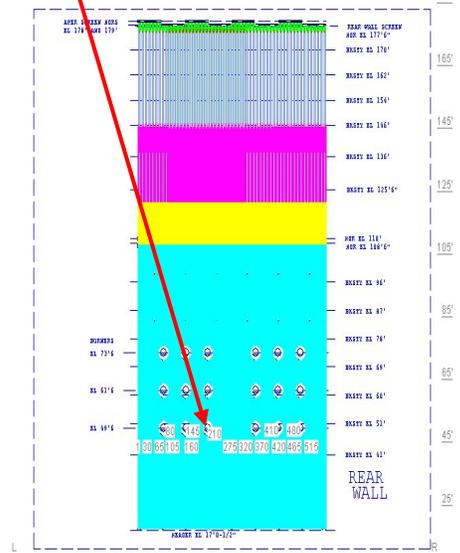
Appearance: Missing

The ceramic tiles are missing or damaged at rear wall burner 16C. The tiles to be repaired or replaced are located at the following positions:

- 11 o'clock 2' back
- 3 o'clock 2' back and 1" back
- 12 o'clock 6" back

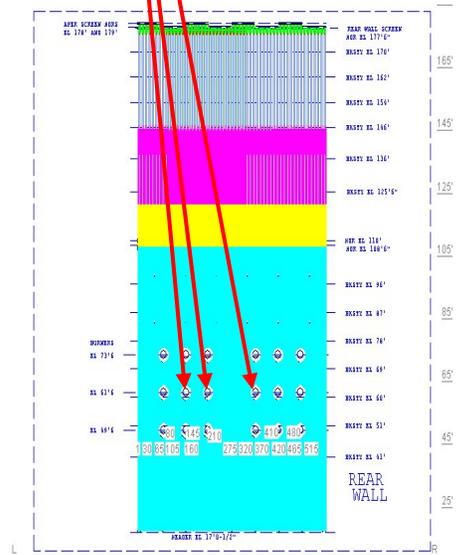
Appearance: Missing

Replace missing tiles located at burners 15B, 15C, and 15D. The tiles missing from 15B are located at the 11 o'clock position 3' back, tiles missing from 15C are located at the 12 o'clock position 2" back, and 15D at the 12 o'clock position 2.5' back.

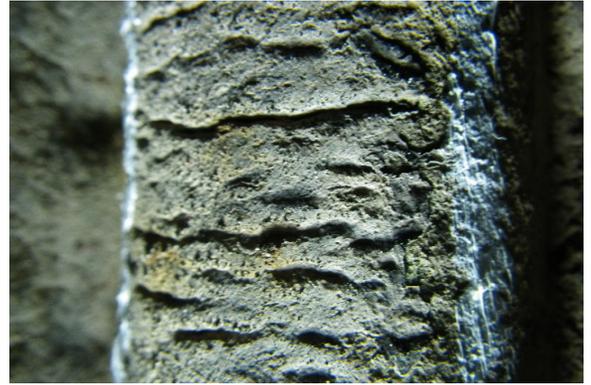
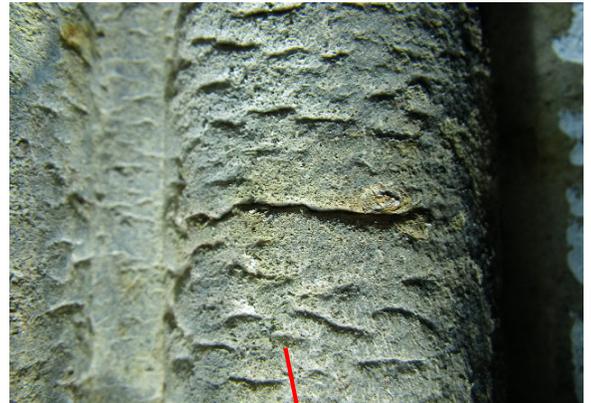
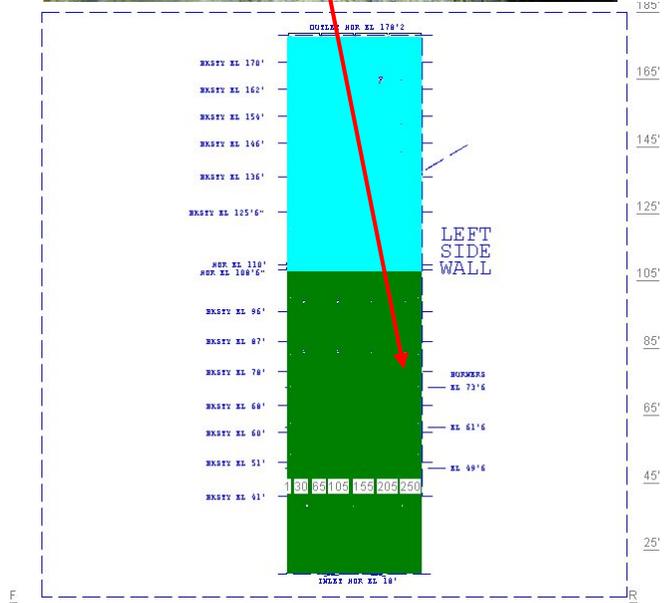
Cause: Fatigue (Thermal)

Appearance: Quench Cracked Tube

The area where the damage was located was between tubes 209 and 245 and started at the IR and extended vertically approximately 5'-6' above the IR path. The worst of the damage is located around the IR.

Should indications continue beyond the overlay, determine the RWT of the underlying tube material and repair as needed.

Grind until visible defect reaches termination and call for re-inspection.

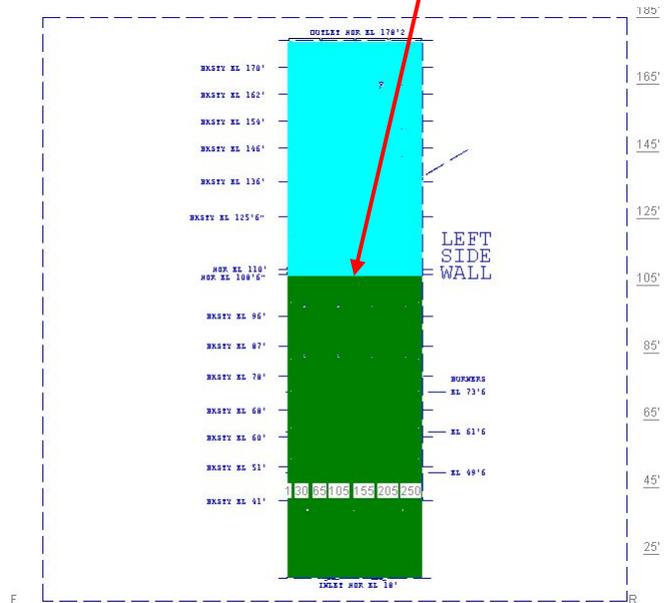
Cause: Fatigue (Thermal/ Vibration)

Appearance: Missing

Re-Install missing/broken Refractory along the tube penetrations on the Mixing Header.

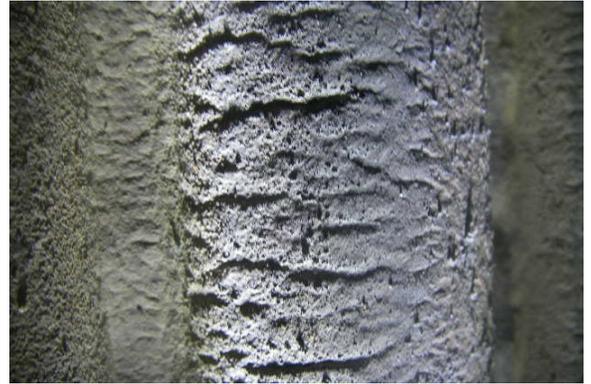
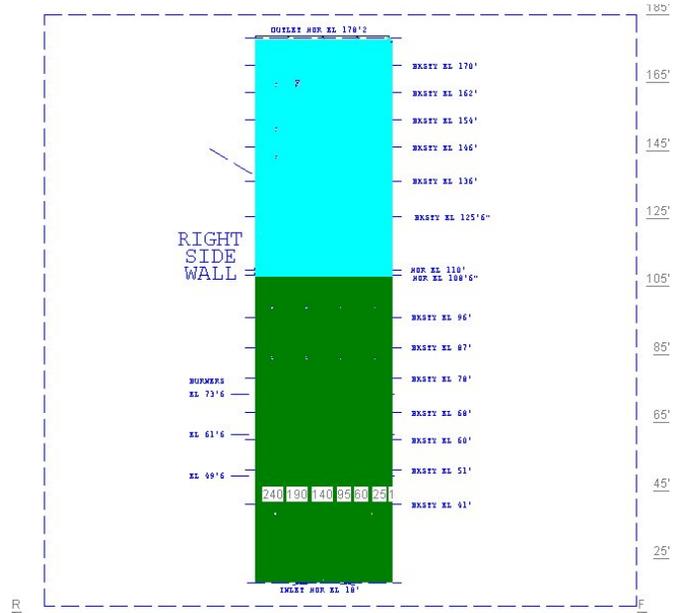
Appearance: Quench Cracked Tube

These tubes appear to have been quenched from the IR that has been taken out of commission and are located approximately 6' above the top row of burners.

Should indications continue beyond the overlay, determine the RWT of the underlying tube material and repair as needed at the following tubes:

- 19-32
- 531-543

Grind until visible defect reaches termination and call for re-inspection.

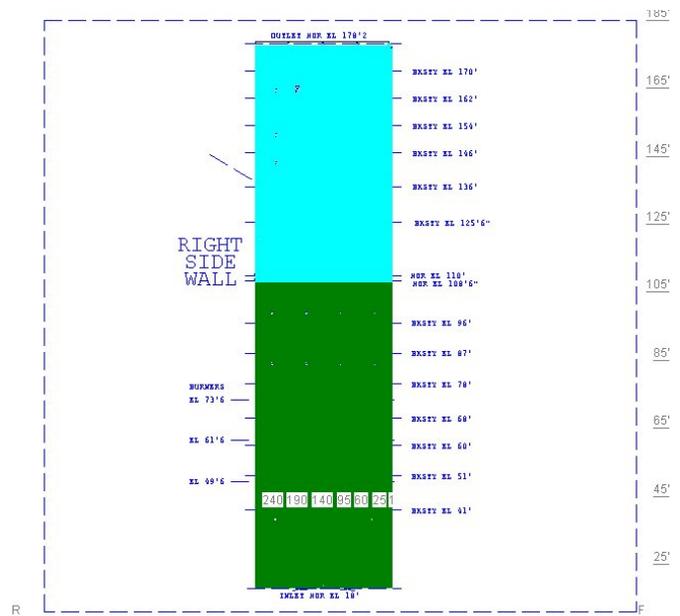
These tubes are located approximately 5' above the top row of burners.

Grind excessive weld attachment to the contour of the tube on tubes 554 and 556.

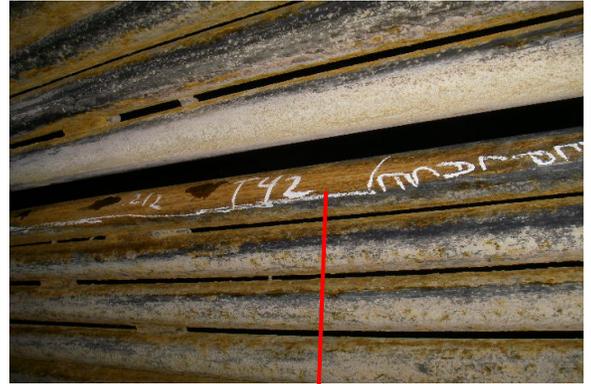
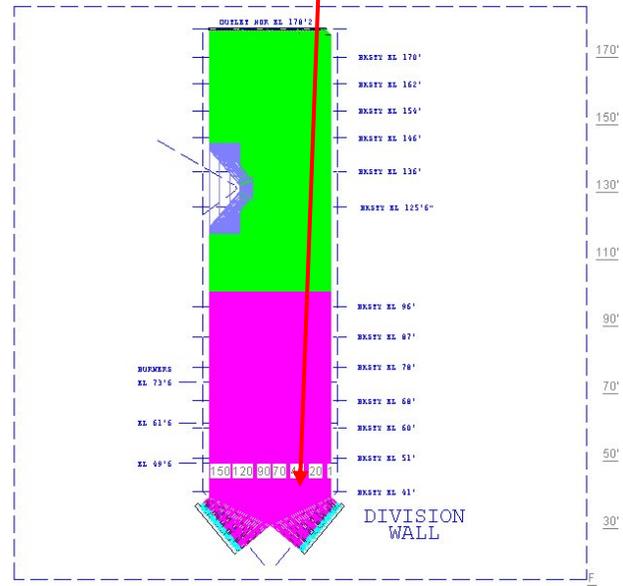
Specific location: Tube #:42

Cause: Fretting or Rubbing (Abrasion)

Appearance: Abraded

Broken tube to tube tangent welds have broken and allow rubbing in the lower wall at this location. Upper cut line is around Elevation 40' and lower should be taken down to include the 45 degree bend back towards the slope.

Replace an approximate 15'-20' section of material at **Tube 42** due to abrasion and a RWT of .212".

Area with the least thickness is marked on tube should replacement not be an option.

If the tube is load bearing (hanger tube), temporarily support the tube before replacement is made. Verify replacement material before removing old tube section.

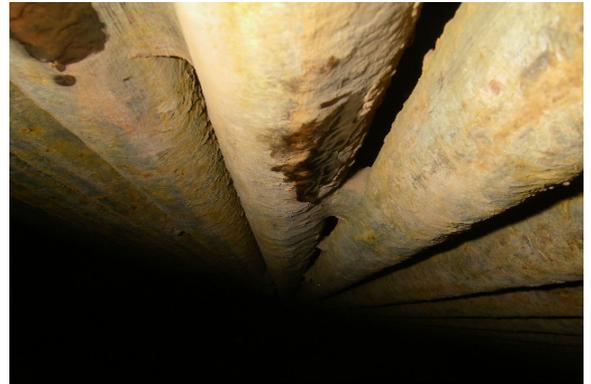
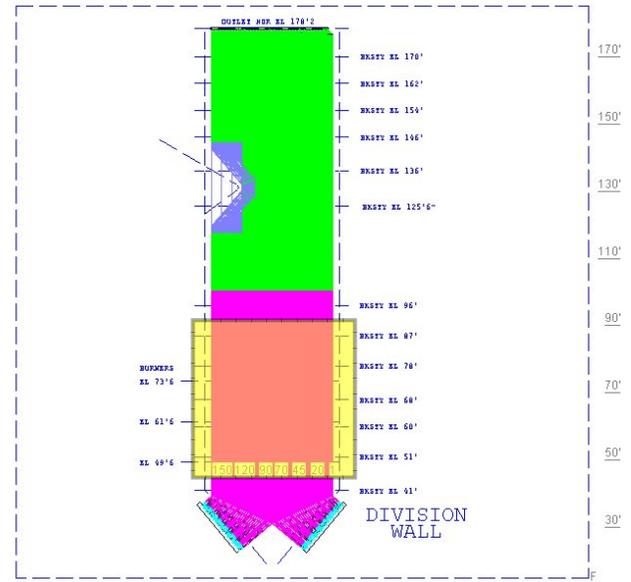
Cause: Possible Fireside Corrosion

Tube surfaces on the right side of the wall
display a general form of corrosion wastage
consistent with Fire Side Corrosion. The
total affected area begins at or about tube
50 through tubes 110 and extends up the
wall for a height of about 30-40 ft.

The worst area seems to be more
concentrated from about tubes 70-95 within
the burner zones (elev.49'-73') where
attempts at random UT readings revealed
possible RWT's of .125" or less. Confidence
of the UT readings was medium to low due to
tube surfaces and it is therefore recommended that an action plan be established
to address the need and extent of repairs by tube sampling and/or UT scanning.

Note: The left side of the wall also displays the same type of conditions;
however, it is more limited to the upper most burner elevation and up.

If UT method is chosen, it is recommended that careful surface preparation be
done in bands with-in the burner zone beginning at tube 70-95 at 3'-5'
elevations. Use a flapper wheel (tiger paw) to prep surfaces just to the point to
where the UT transducer will firmly couple to the surface. Avoid grinding wheels
as excessive material loss may occur.

Replacement would be recommended for tubes (sections) who's RWT is \leq .234" or
65% and less of the required thickness value.

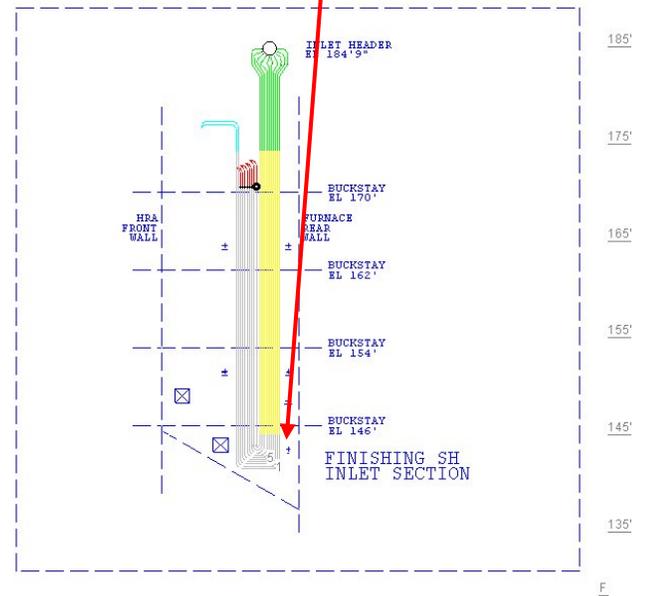
The hand cuffs are missing/broken on assembly 8, causing the tubes to be out of alignment.

Attach hand cuffs to tubes 1-20 for realignment and replace broken hand cuff on assembly 39.

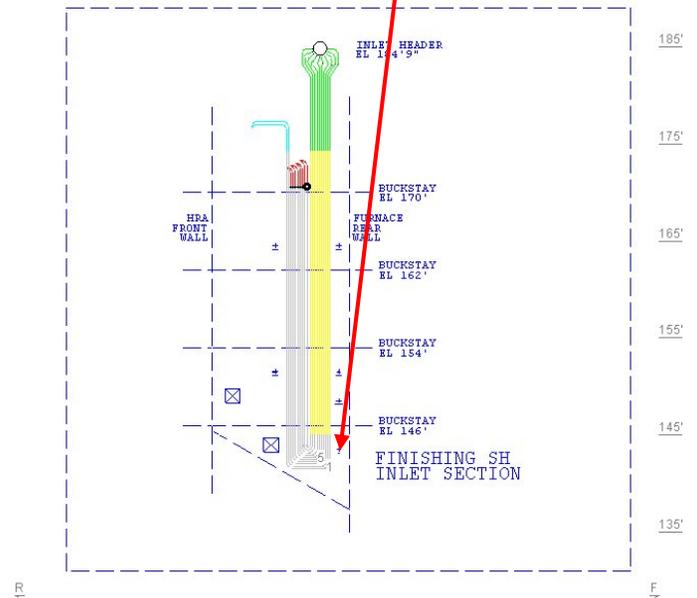
Cause: Fatigue (Thermal)

Appearance: Deteriorated

Replace Soot Blower lance sleeve due to thermal fatigue.

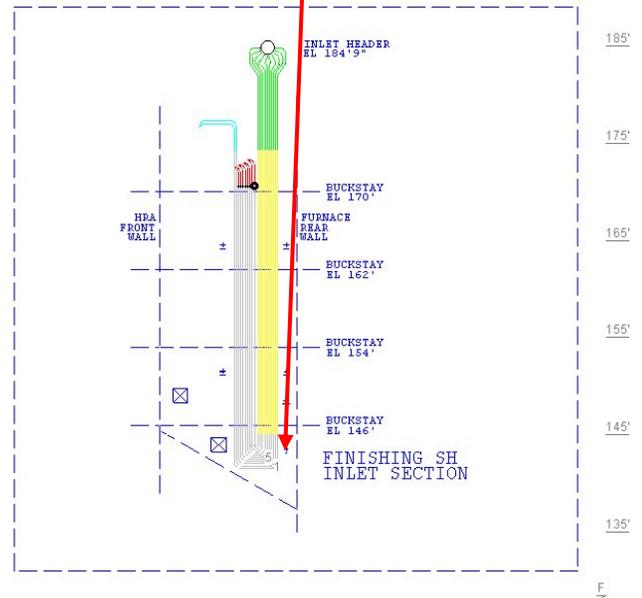
Cause: Fatigue (Thermal)

Appearance: Missing

Replace missing Refractory around IK-7/8 due to thermal fatigue.

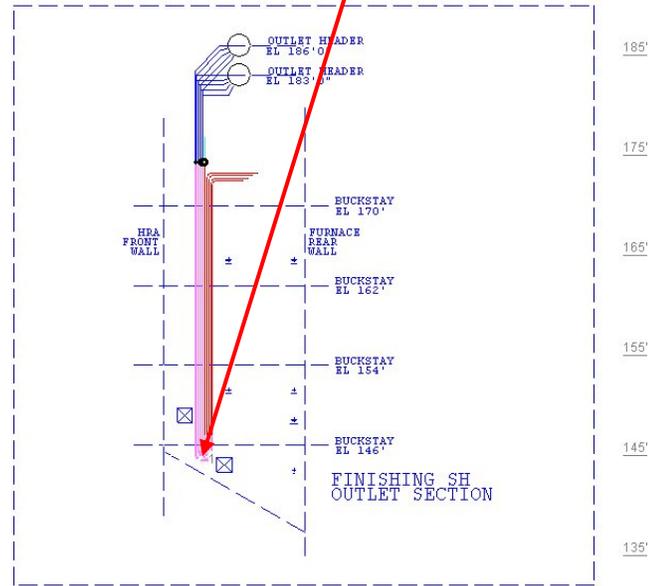
Cause: Fatigue (Thermal)
Appearance: Bowed Tubing

The same condition still exists and should be addressed in order to prevent the possibility of future boiler tube failures. The severity of the misalignment is causing the pendants to abrade one another; this abrasion appears to have caused failures in the past.

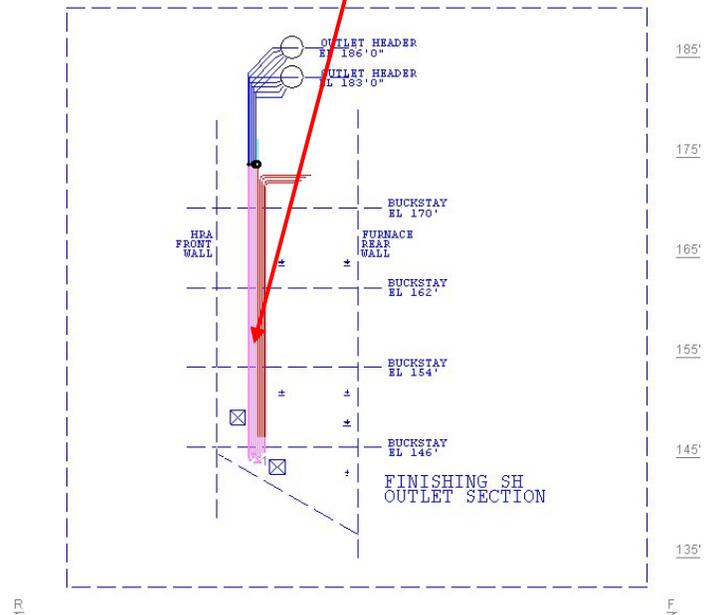
Cause: Fatigue (Thermal/ Vibration)
Appearance: Broken

Replace missing/broken Ring Castings (handcuffs). Approximately 20% of the Handcuffs are missing/broken in this area and need to be replaced to prevent from any further alignment issues in this area.

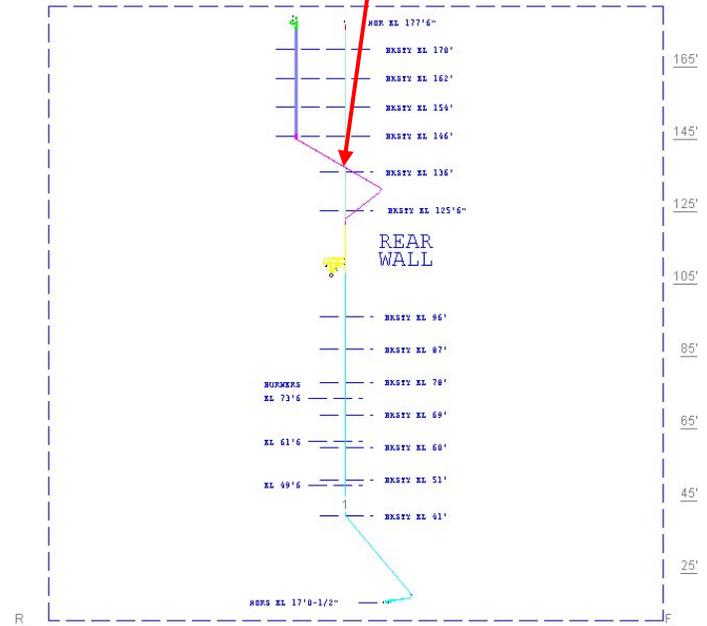
Cause: Erosion (Soot Blower)
Appearance: Eroded

246/0.171, 247/0.176", 251/0.198"

The eroded areas are located approximately 3' up from the rear wall hanger tubes.

If the tube is load bearing (hanger tube), temporarily support the tube before replacement is made. Verify replacement material before removing old tube section.

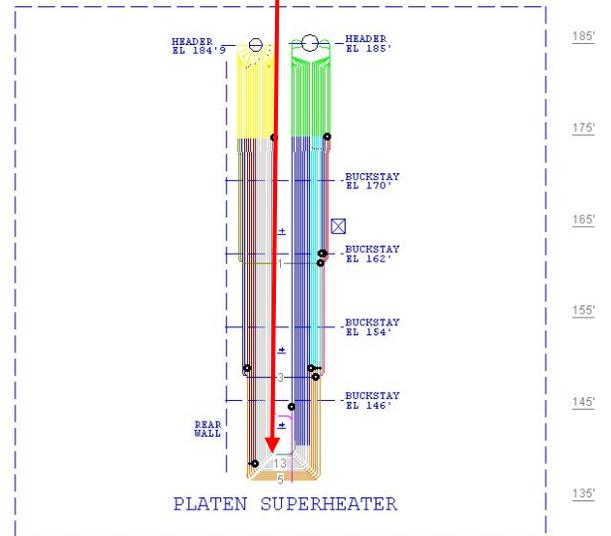
Cause: Erosion (Soot Blower)

Install approximately 10' dutchman to the eroded area. The eroded area is at the front inner radius bend on **17F**. It is recommended to replace the entire lower loop of **tube 17** approximately 4' up on either side.

If the tube is load bearing (hanger tube), temporarily support the tube before replacement is made. Verify replacement material before removing old tube section.

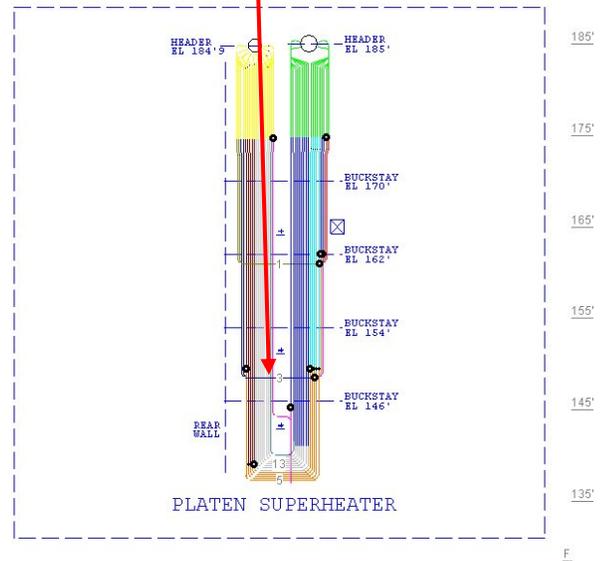
Cause: Erosion (Soot Blower)

The locations of the eroded areas are on the top side of the wrapper tube adjacent to **tube 17R**. Note: These tubes don't fall into pad weld criteria, but due to the sharp edge erosion UDC recommends pad welding.

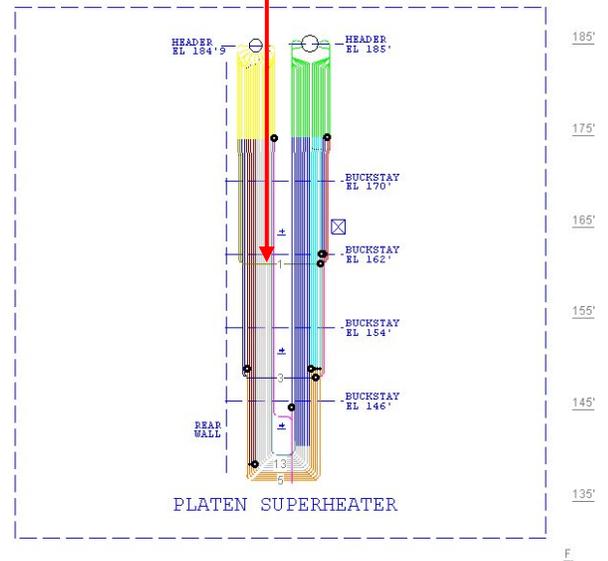
Cause: Erosion (Soot Blower)

Note: This tube doesn't fall into pad weld criteria, but due to the sharp edge erosion UDC recommends pad welding.

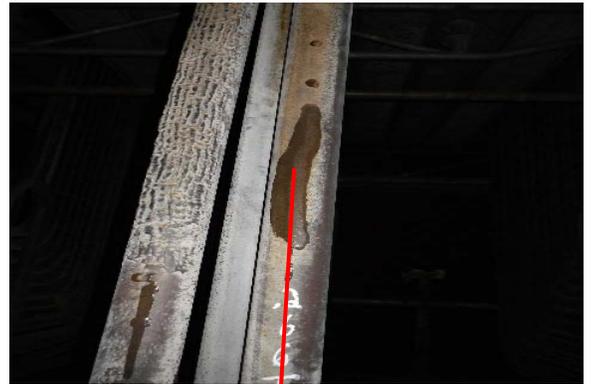
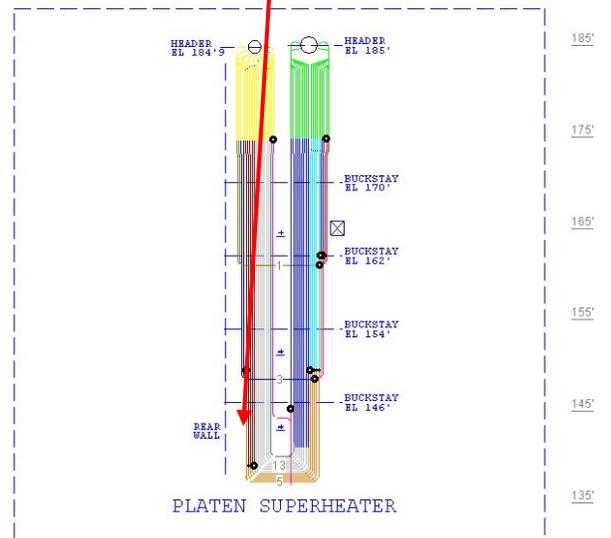
Cause: Erosion (Soot Blower)

Tube 6R of Assembly 5 in IK path 1/2 is in shield criteria, due to the location of the repair applying a 2'x3"

Pad-Weld would be a more sufficient repair.

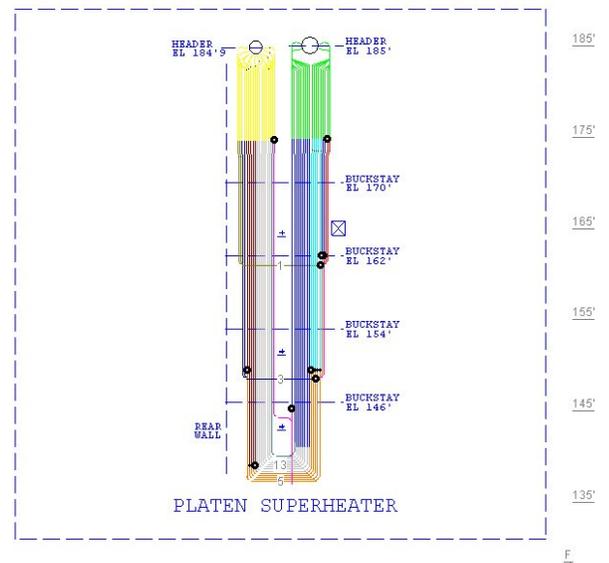
Cause: Fatigue (Thermal)

Appearance: Missing

Replace Refractory on *IK's 1-6* due to missing/broken Refractory.
