Inspection Report

Station: Mitchell Unit: 2 Report Name: 1-Reheater High Pressure

AREA: Reheater High Pressure

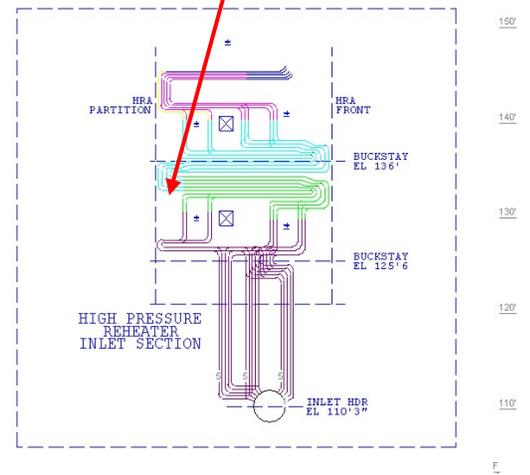
Cause: Erosion (Fly Ash)

Apply one approximate 12" pad weld to Tube 2 at Assembly 102 due to fly ash erosion on a previous weld repair. Repair is on the top side of the tube in the rear blower path.

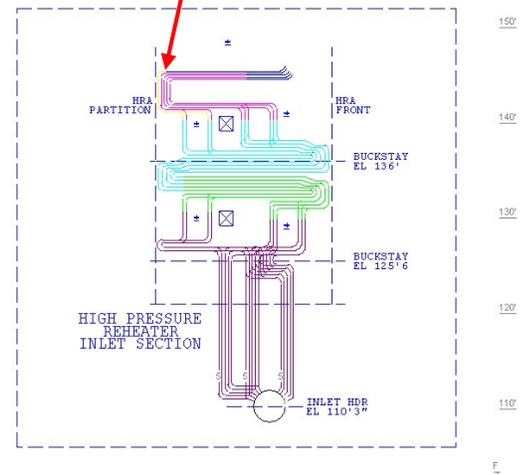
Cause: Erosion (Fly Ash)

Install one 6" shield to Tube 3 at Assembly 211 due to fly ash erosion. Repair is at the upper left side of the tube where gouging erosion is occurring. No UT was possible due to tube surface condition.

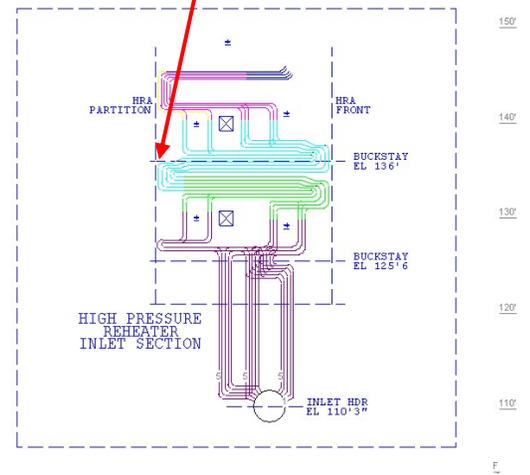
Cause: Fatigue (Thermal/ Vibration)

Reattach or replace two (2) sections of solid
baffle plate and gussets at the partition
wall roughly between assemblies 90-110.

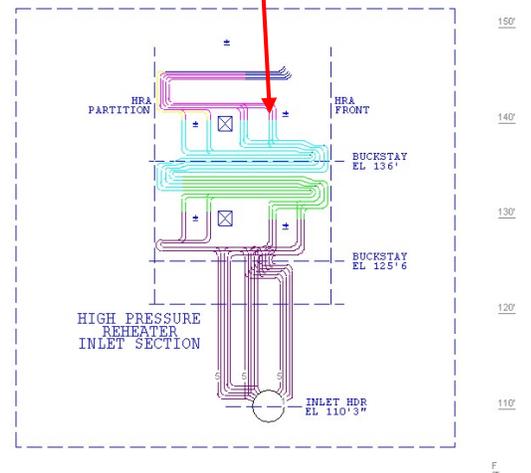
Cause: Thermal Fatigue

Appearance: Deteriorated

Numerous shields are deteriorated, damaged,
detached, or missing throughout the entire
bank. Replace or reattach shields as
needed.

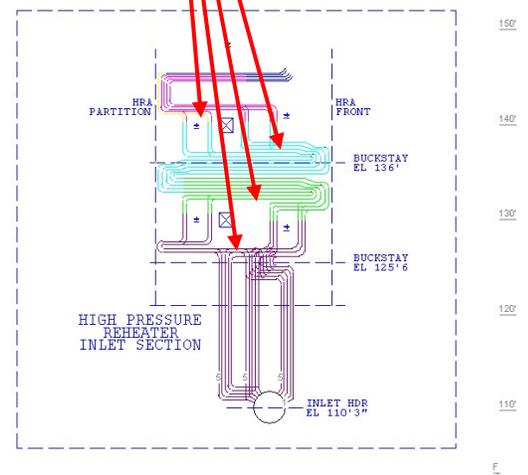
Throughout the HP Banks, the spacer canes where installed, are detached and/or loose causing abrasion potentials to occur to the adjacent tubes. It is recommended that those that are loose either be secured or removed as some do not appear to be offering any benefit to assembly spacing.

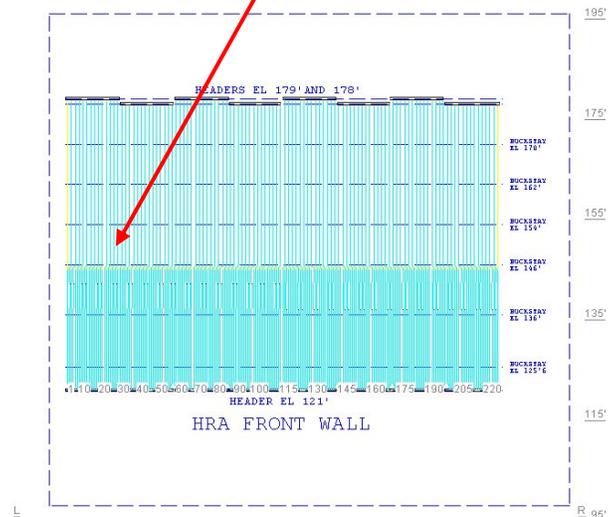
Cause: Fatigue (Thermal)

Plan for Future Replacement the following tubes of the HRA Front Wall Hangers due to bowing approximately 1 tube diameter:

The replacements would begin 12' above the refractory extending upward approximately 15' into the penthouse.

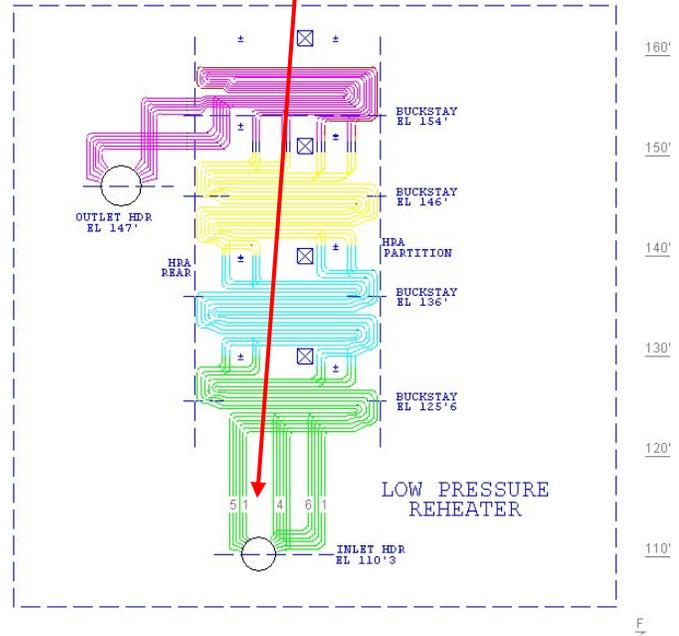
Cause: Erosion (Fly Ash)
Appearance: Eroded

Tubes are polished however no repairs are present at this time. Monitor during future outages and repair as necessary.

It is recommended that access be provided to the inlet header at the right side wall to inspect for erosion at the offset tubes. The partition baffle wall does not allow for access to this area.

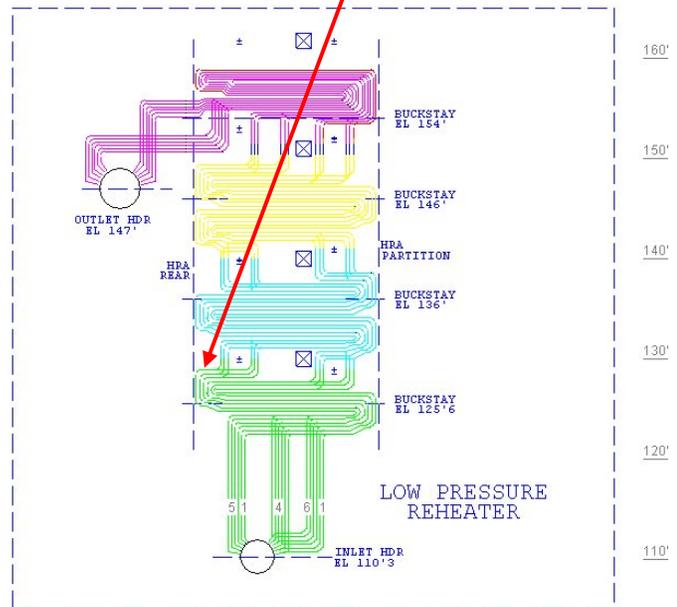
Cause: Erosion (Fly Ash)

In addition, install an approximate 2'
shield after weld repair as UT readings
of 0.123" and 0.127" were on both sides
of the existing pad weld.

The shield should begin at the
deflection plate and extend to the front
for the given length.

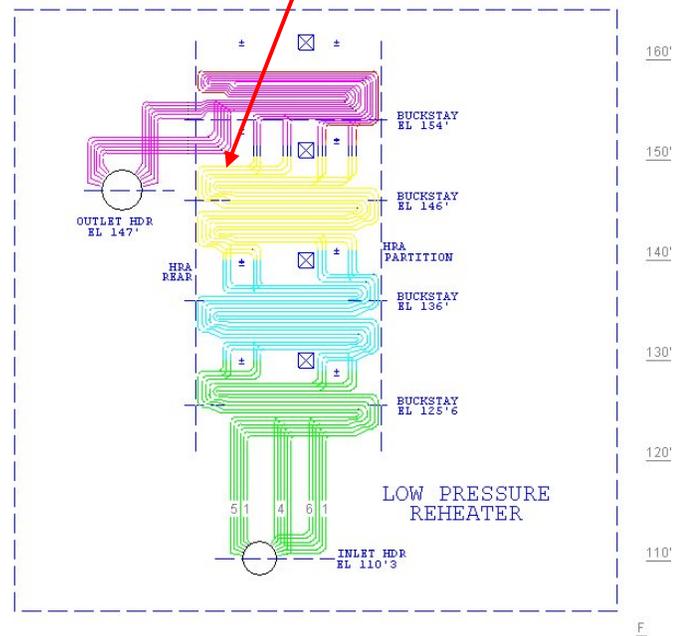
Cause: Fatigue (Thermal/ Vibration) or
Detached
Appearance: Misaligned

Numerous dropped assemblies are present
at the top rear side of the unit
indicating detachment or broken support
clips.

Per OEM dwg's, there are upper and lower
support clips for bank 2. Those involved
here are the uppers supports as no
alignment issues were observed on the
bottom side of the bank.

Further research will be required to
determine the extent of repair.

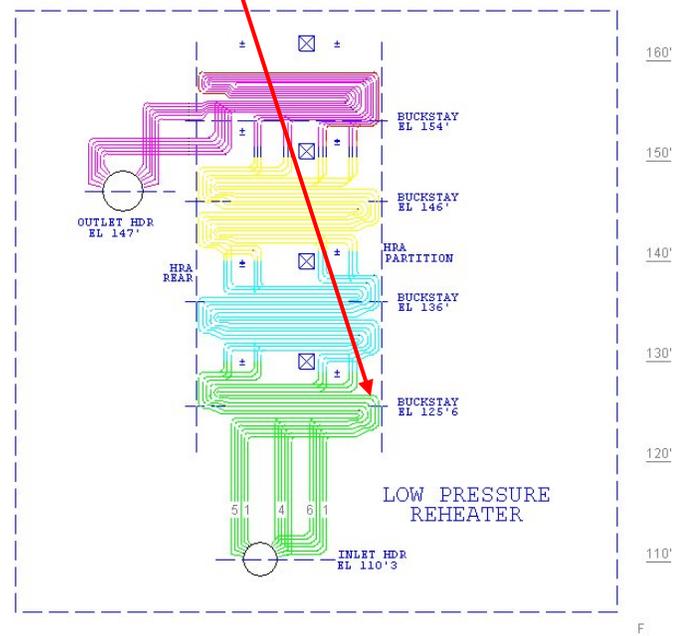
Cause: Erosion (Fly Ash)

Due to a remaining wall thickness
between 76% to 85% of MWT, the following
are recommended for shield repair for a
length of 18":

- A33/T1(0.127"), A34/T1(0.126"),
- A35/T1(0.125"), A36/T1(0.126"),
- A37/T1(0.128"), A38/T1(0.125"),
- A39/T1(0.126"), A43/T1(0.128"),
- A44/T1(0.125"), A53/T1(0.125"),
- A54/T1(0.127"), A55/T1(0.128"),
- A121/T1(0.127"), A122/T1(0.126")
- A123/T1(0.124")

The shields will begin 12" to the rear of the partition wall extending toward the front of the boiler encompassing the bends. Tube 1 of the remaining assemblies, not covered by the baffles, are at or just above shield criteria. Due to the quantity of shields needed, extending the plate baffle across the top of bank 4 at the partition wall would be an acceptable repair.

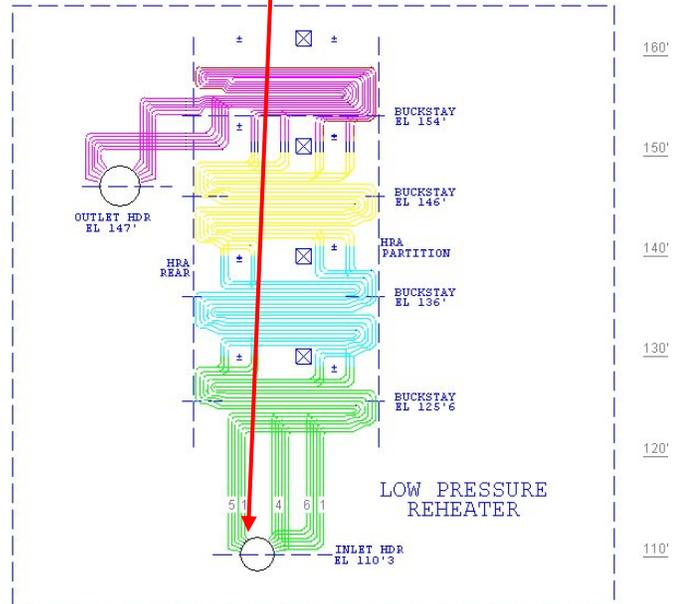
Cause: Erosion (Fly Ash)

NOTE: The tubes may not be in shield criteria at this time, however, due to the obscure location, shielding is recommended.

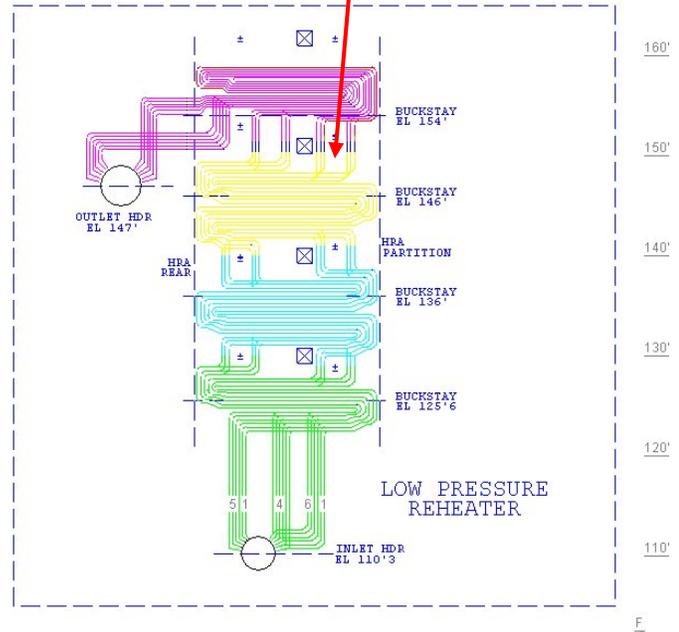
Cause: Fatigue (Vibration)

Move the loose canes and properly
reattach them back into their attachment
brackets.

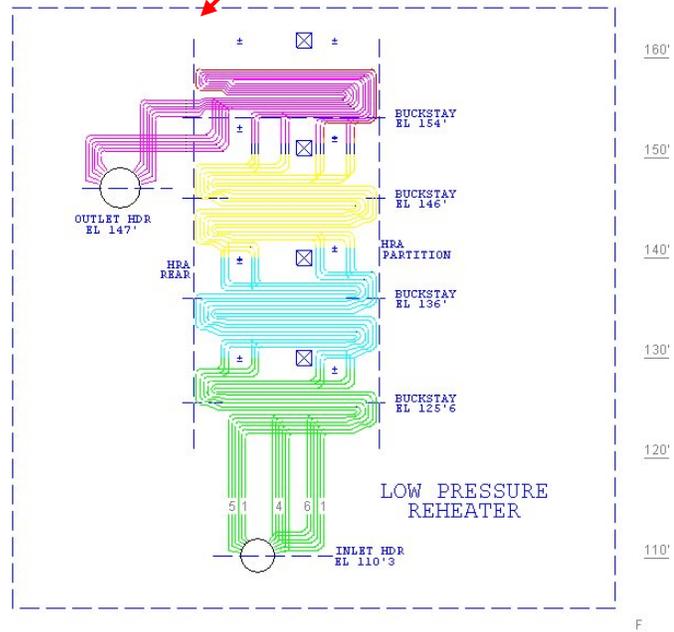
Cause: Fatigue (Thermal/ Vibration)

Appearance: Missing

Replace missing refractory where the HRA rear wall tubes meet the roof tubes.

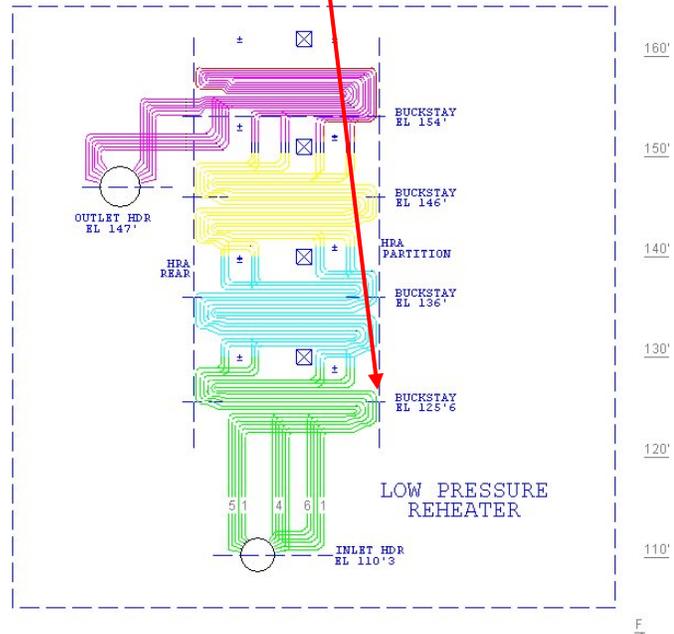
Cause: Erosion (Fly Ash)

Note: Minor erosion is apparent however
no partition wall tubes require repair
at this time.

Replace missing refractory along the
front partition wall baffle.

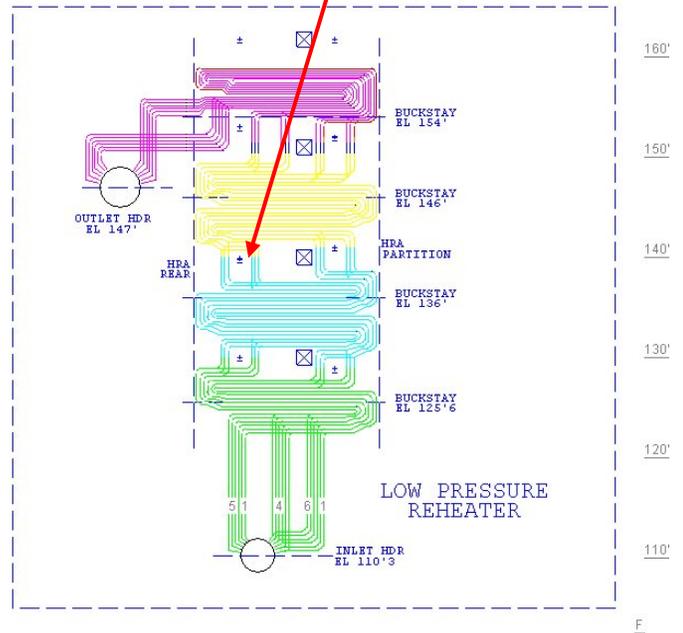
Cause: Fatigue (Thermal/ Vibration)

The shields in this area are disengaged
and trapping ash. During wash down, the
moisture and ash create conditions that
are conducive to tube corrosion.

It is recommended that any loose or
damaged shields in this area be removed.

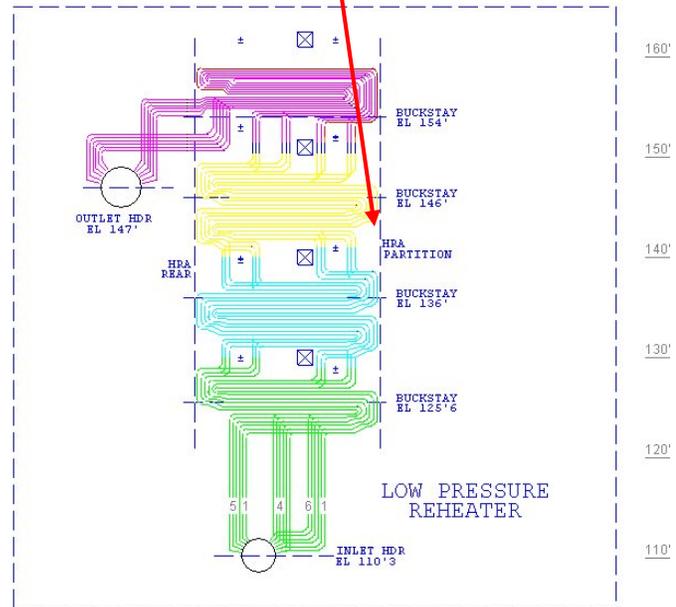
Cause: Fatigue (Stress)

Appearance: Cracked Weld

Add 3210,3208 - As noted during previous inspections, the support lugs at the bottom of the Low Pressure Reheat are beginning to fail. Some loss of tube material is present where welds are completely detached.

In addition, the supplemental "knee" supports are also failing. Continue to monitor and raise, realign and reattach supports as necessary.

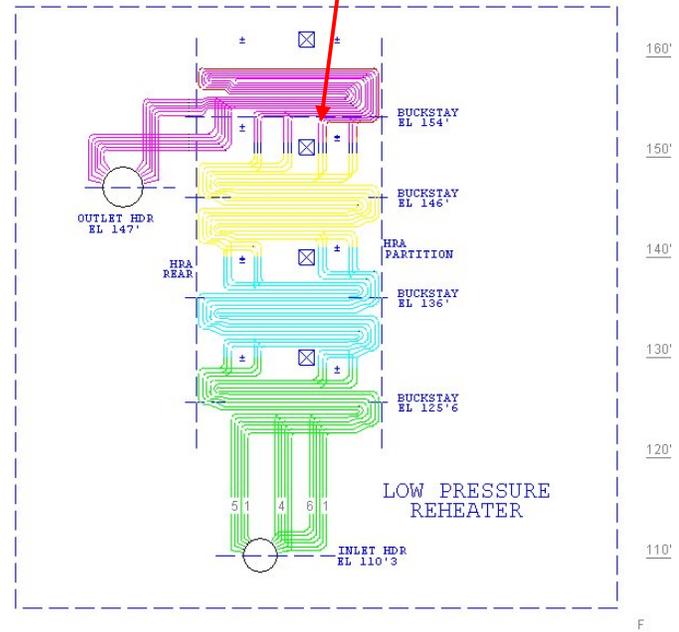
Cause: Erosion (Fly Ash)

UT measurements at this time do not
indicate the need for repair as readings
are below the nominal thickness but
still above MWT. Monitor at each outage.

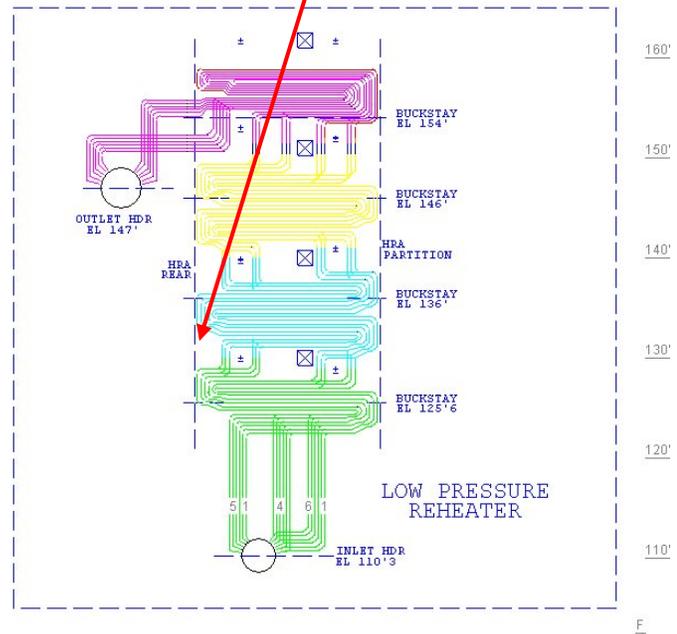
Cause: Fatigue (Thermal/ Vibration)
 Appearance: Broken and Missing

The refractory seal on the deflection plate at the rear wall is cracked, broken and missing throughout the bank. A gap is present where the plate contacts the crown of the tube.

NOTE: No erosion was observed from channeling. Monitor for erosion at each outage and replace refractory if erosion becomes evident in the future.

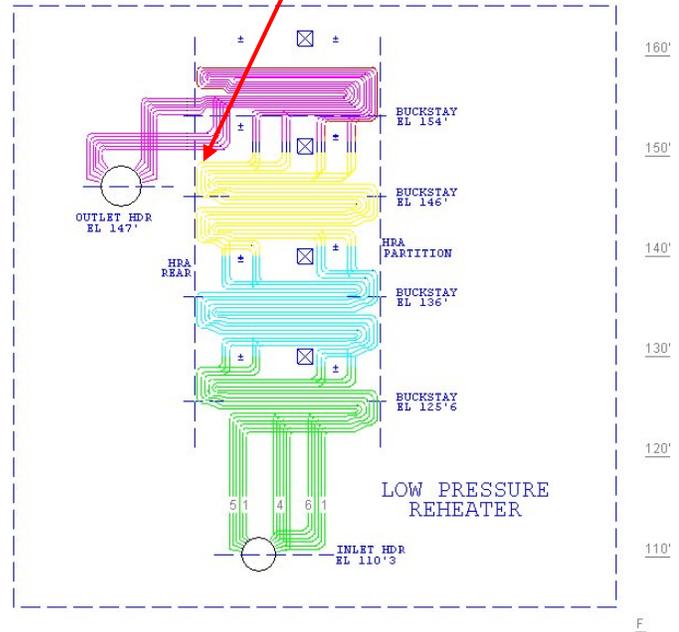
Cause: Fatigue (Thermal/ Vibration)

Appearance: Deteriorated

The plate is deflected in sections along
 its entire length, however still
 functional at this time.

Plan for the replacement of the solid
 deflection plate located on top of bank
 2 at the rear wall.

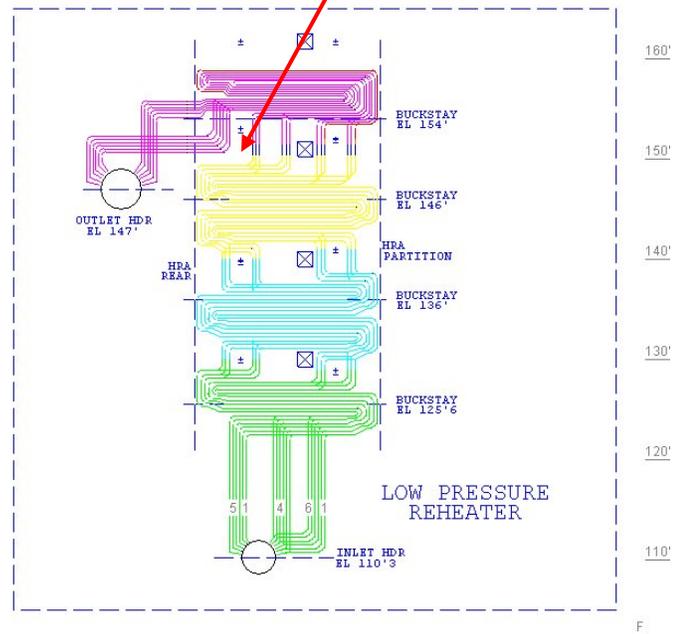
Cause: Fatigue (Thermal/ Vibration)

Appearance: Deteriorated

Remove or replace all spacer canes on
the top side of bank 2. All have become
fatigued, and deteriorated.

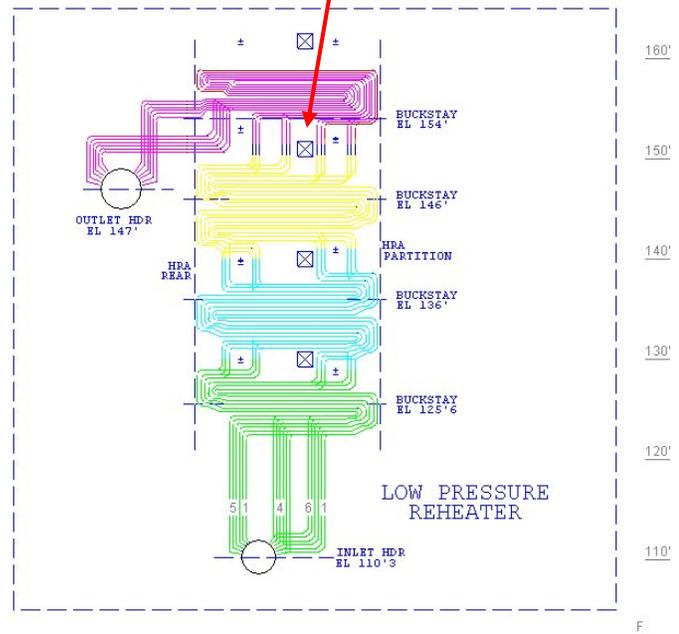
Cause: Fatigue (Thermal/ Vibration)

Appearance: Deteriorated

After the dropped assemblies have been returned to their intended positions, replace the lower deteriorated edge of the components center ladder bracket throughout the bank.

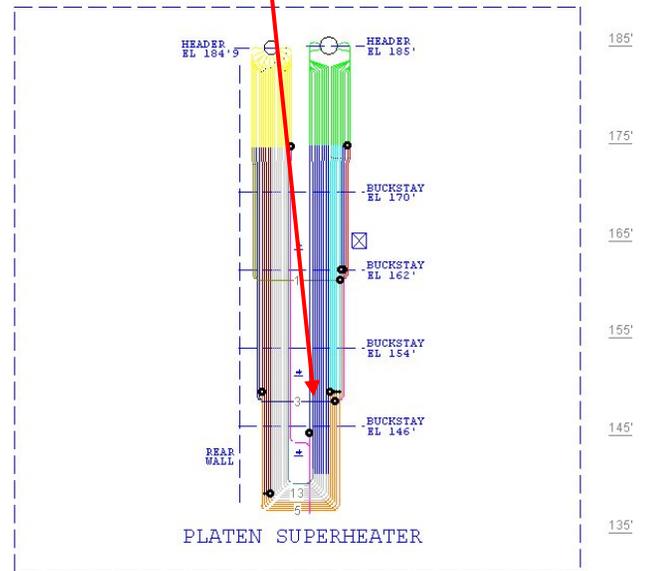
A23-T4

This area is too rough for accurate UT but depth is estimated over 0.125" up to 0.187" deep. With other pad welds in this area it is recommended to restore these areas to MWT.

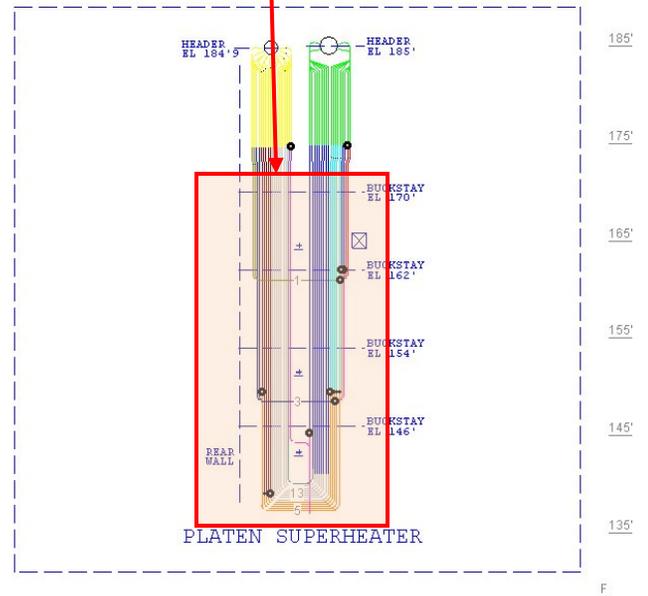
The DMWs are beginning to show signs of fatigue and possible end of life. It is recommended that further NDE testing (X-Ray, LPA) be completed to determine the severity of the fatigue and remaining life.

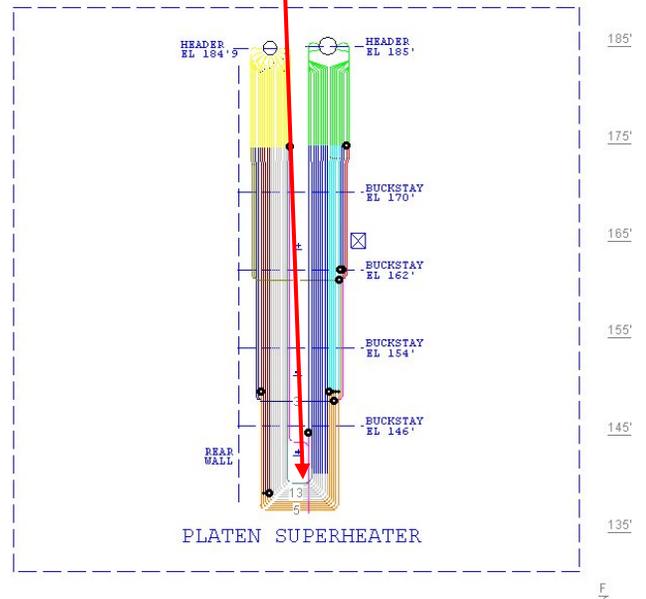
The shields on Assembly 17 T17 on the horizontal and vertical sections of tube are distorted and disengaged due to long-term overheat. It is recommended that these shields be replaced.

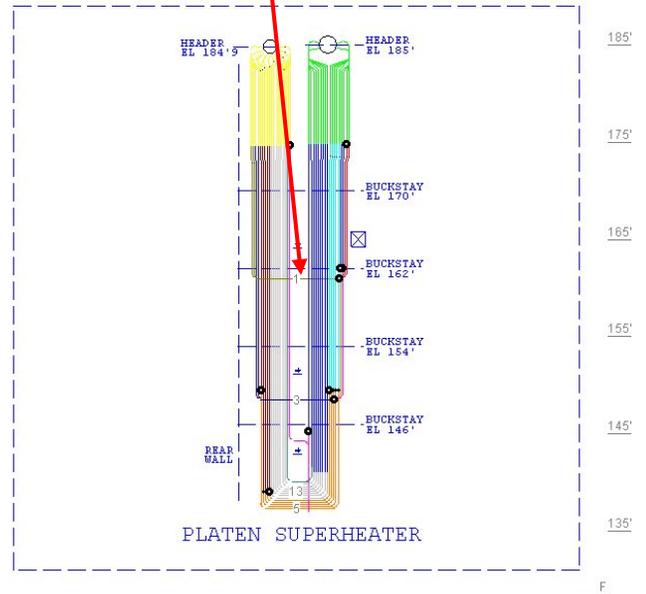
Light abrasion could be found in several locations throughout the platens where tubes are in contact with the upper wrapper. Assembly 3, Tubes 3&4F are typical of the more severe; however the tubes appear to be above any repair criteria.

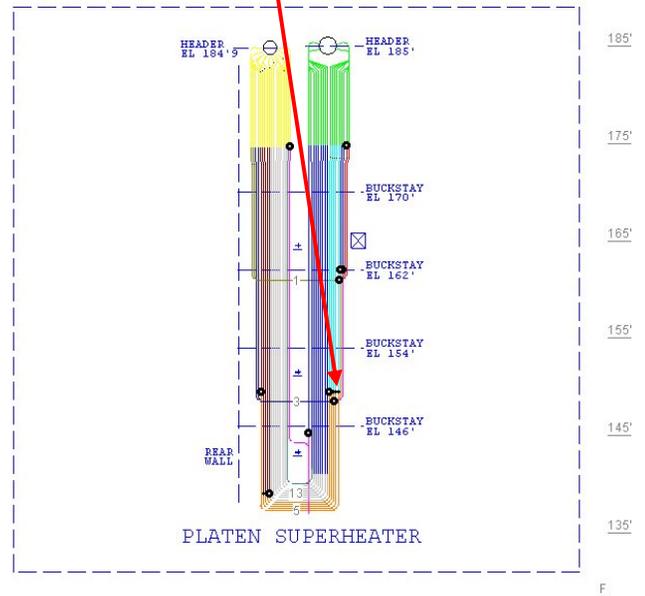
Upon inspection of the DMWs, Tube 1-Front of Assembly 16 appears to have been undercut during application. It is recommended that further NDE testing (X-Ray, LPA) be completed to determine the integrity of the weld.

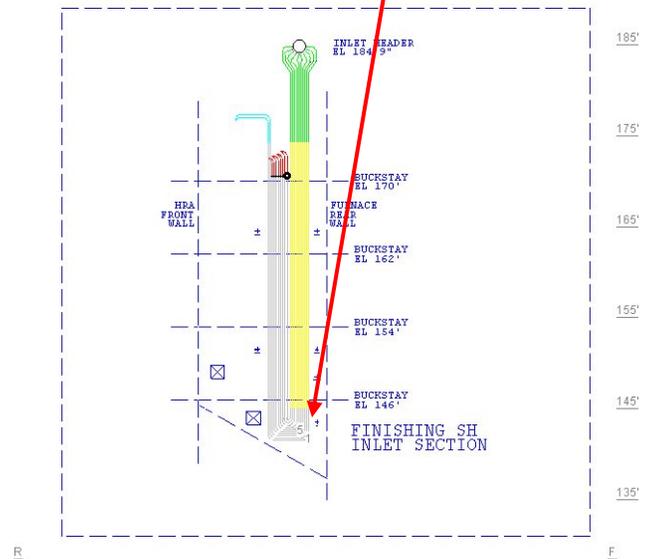
Replace an approximate 5' section of Tube 1, Assembly 56 on the lower leading edge due to apparent quenching from IK-7/8. This tube is also experiencing erosion from the soot blower. Cut-lines are marked on the tube and will involve the lower bend.

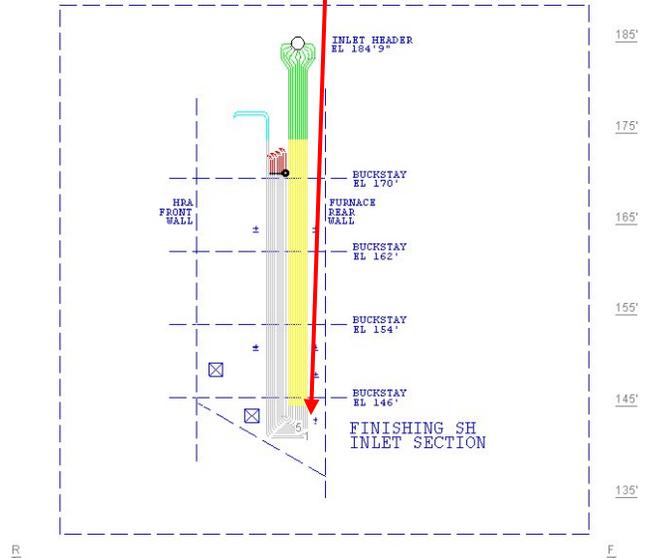
The greater majority of pendants have varying degrees of misalignment by as much as one tube diameter in the lower sections. Broken and deteriorated slip spacers and handcuffs are contributing to this condition.

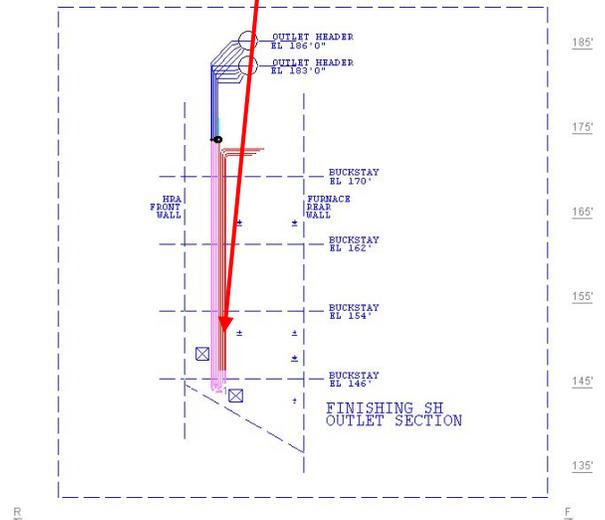
Several handcuff split ring castings are missing or broken off at over half of all assembly locations. Install new handcuff split ring castings at these locations.

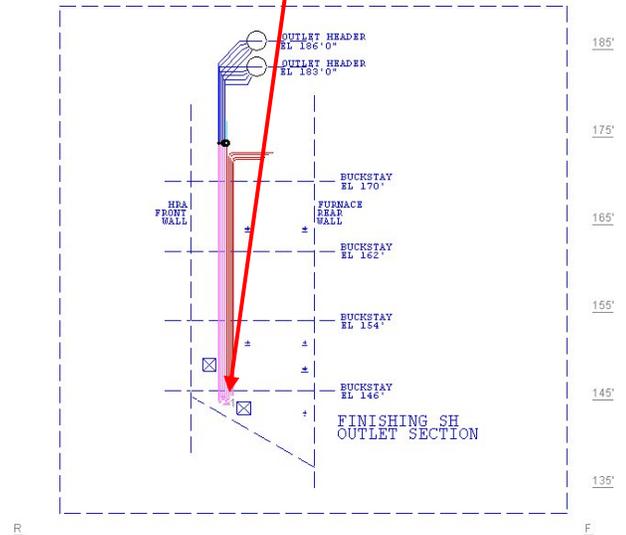
The assemblies of the Finishing Superheat Outlet pendant are severely out of alignment to where the assemblies are intertwined. It is recommended that these assemblies be realigned to where they are in plane with the leading tube.

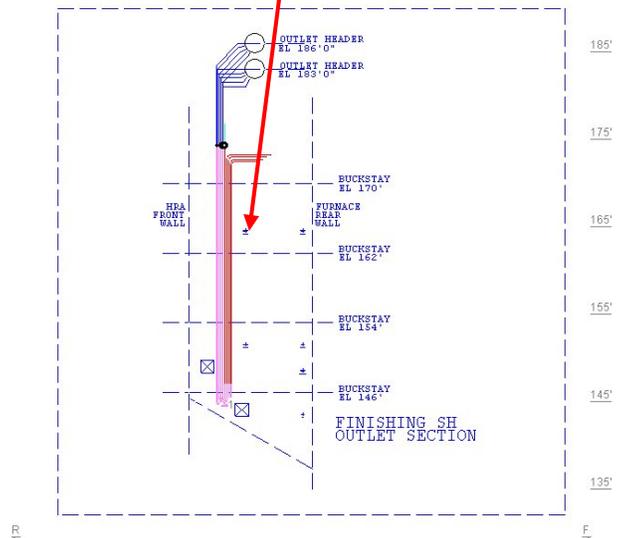
One small star-like crack was observed in the upper left side (IK-15) soot blower lance head, however it still appears to be in serviceable condition. Re-inspect at next outage.

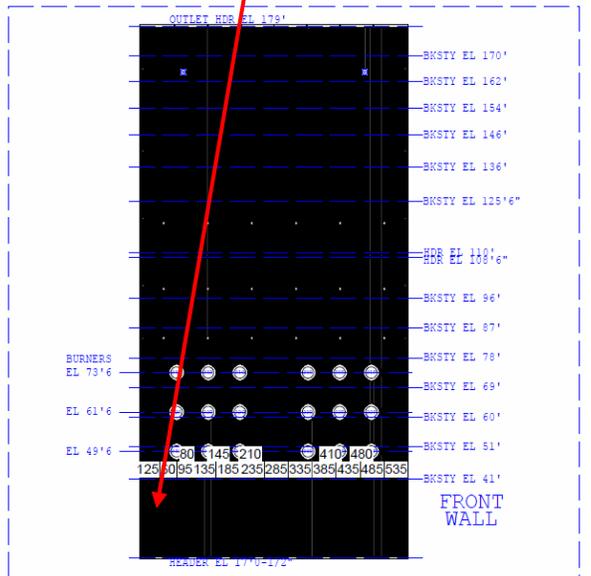
Install a 1' dutchman Tube #554 on the front wall slope 2' below the transition due to a grinder cut approximately 0.062" wide. RWT is unobtainable, however the grinder cut is into the membrane and mineral deposits around this area are indicative of a leak.

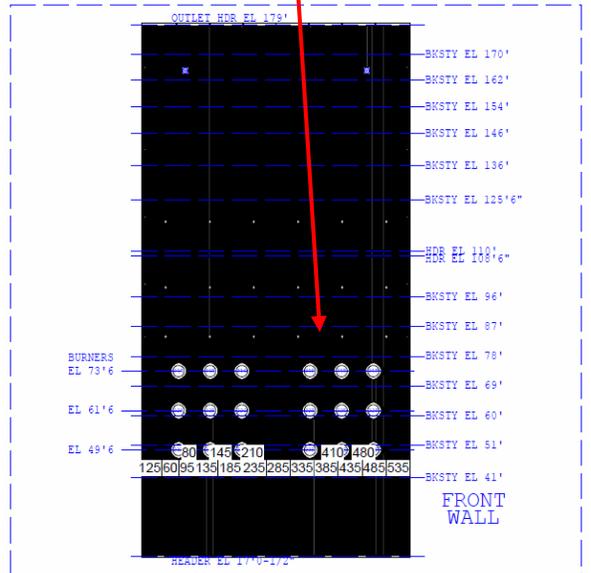
Between tubes 111 and 112 the membrane is built up higher than the rest of the area and there are **two (2) indications of a possible leak**. Recommend grinding membrane at this spot and investigating for possible holes or cracks in tube/tubes. There were mineral deposits around this area indicative of a leak.

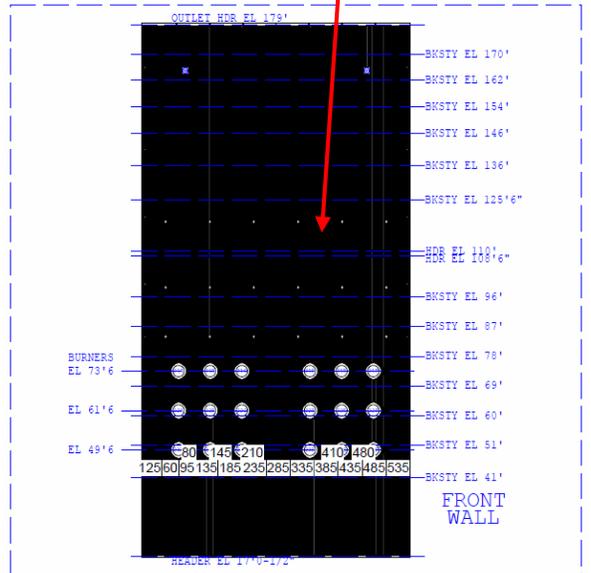
Tubes 157-159 are showing signs of quench cracking just below the left water cannon on the front wall. It is recommended that tubes be ground down to contour to determine RWT and repair as needed.

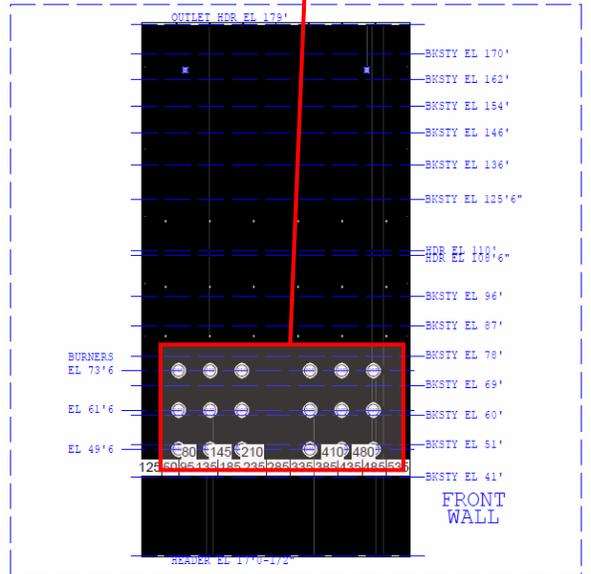
The remaining burner tiles are in good condition and no conical diffusers need repair.

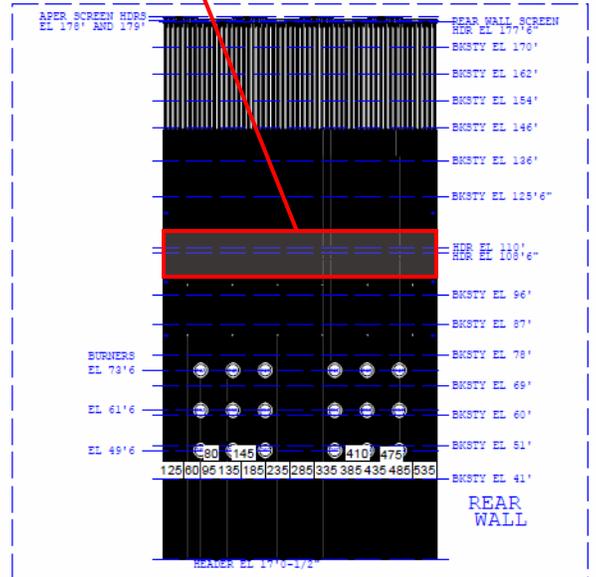
Repack the missing refractory at both header elevations on the rear wall. Missing refractory has exposed the peg fins which are becoming burnt and thermal fatigued.

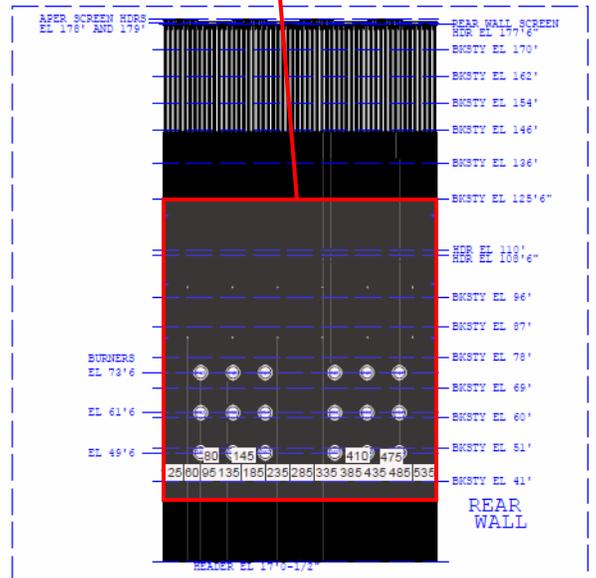
Due to expansion differentials between the tube and attachment, cracking can sometimes initiate. Best practices would indicate their complete removal after completion of their intended use.

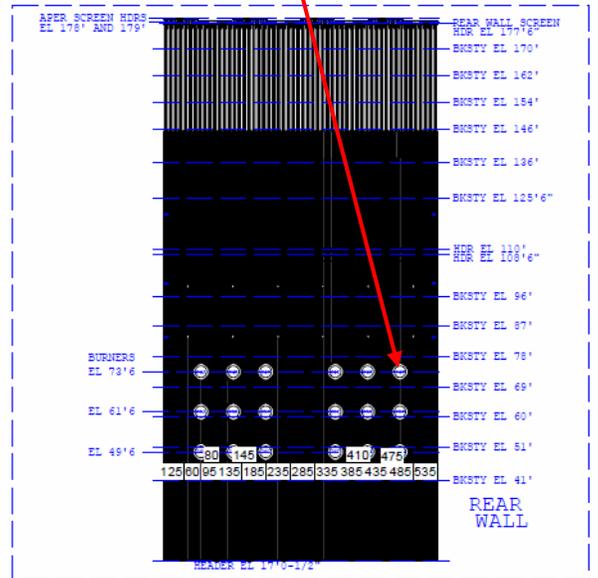
One thermocouple was observed detached at
 the top side of burner 24F coal nozzle.

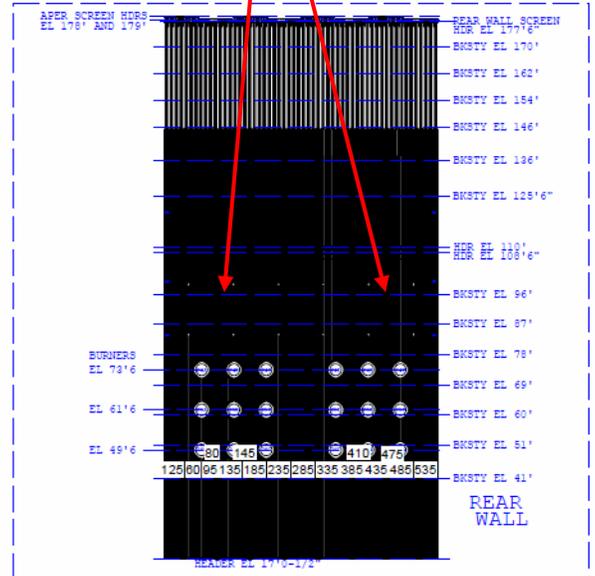
Both rear wall water cannons were inspected and found to be in acceptable condition in regard exposed wall boxes and the minimal cracking on the nozzle tips, however the left side did exhibit more cracking in the tip.

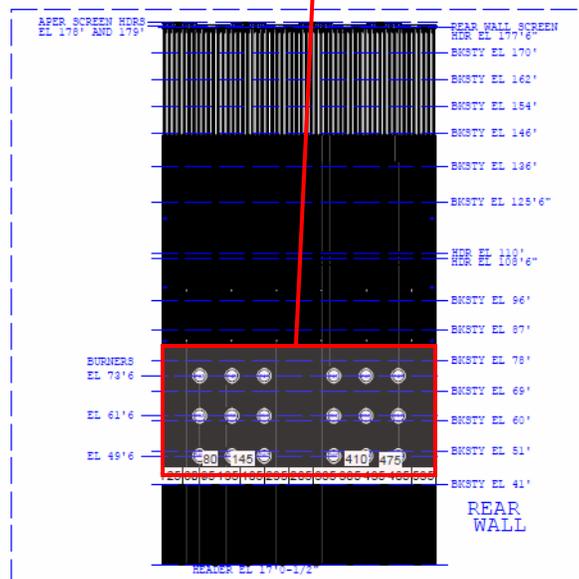
The remaining burner tiles are in good condition and no conical diffusers need repair.

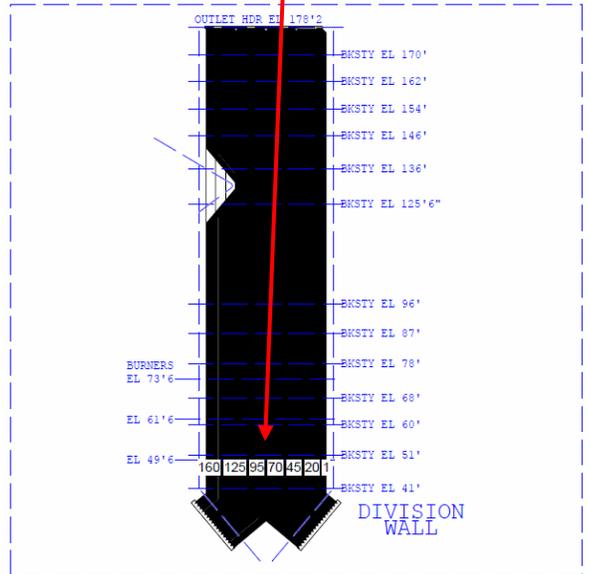
Tubes 70-82 on division wall at first burner level, right side, has fireside corrosion indications. Lowest obtainable RWT was 0.310" and does not warrant repair at this time. It is recommended these tubes be monitored during future outages.

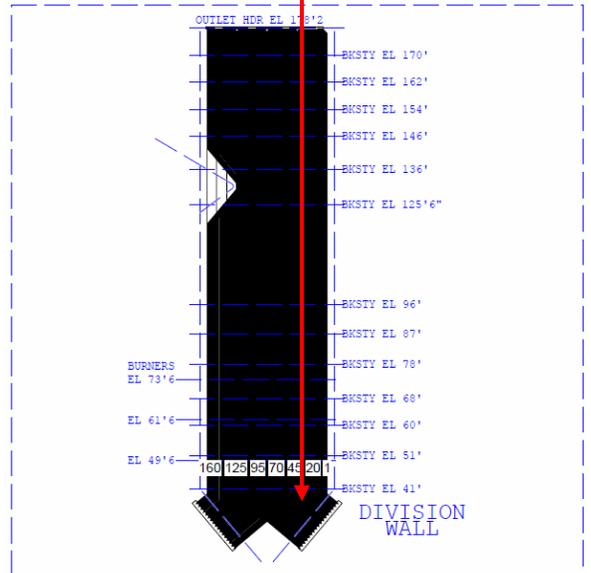
Monitor the left side of tubes 39-40 of the furnace division wall at the transition to the vertical run. Tubes are abraded but warrant no repair at this time.

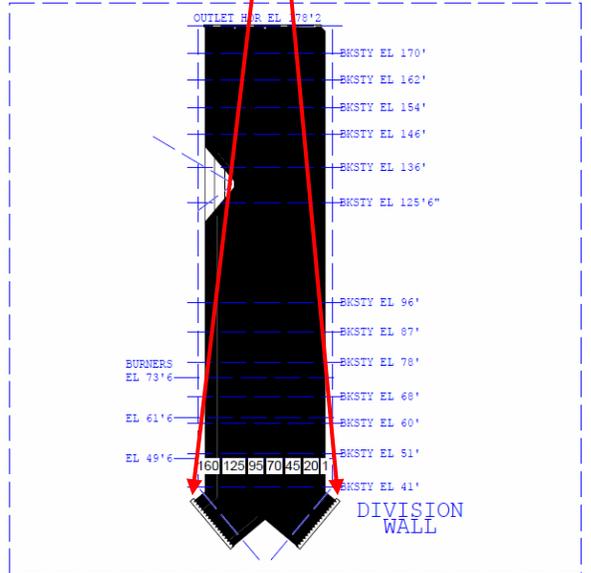
Monitor tubes 1 and 164 of the furnace
division wall where they penetrate the lower
slope. Tubes are showing signs of erosion
but warrant no repair at this time.

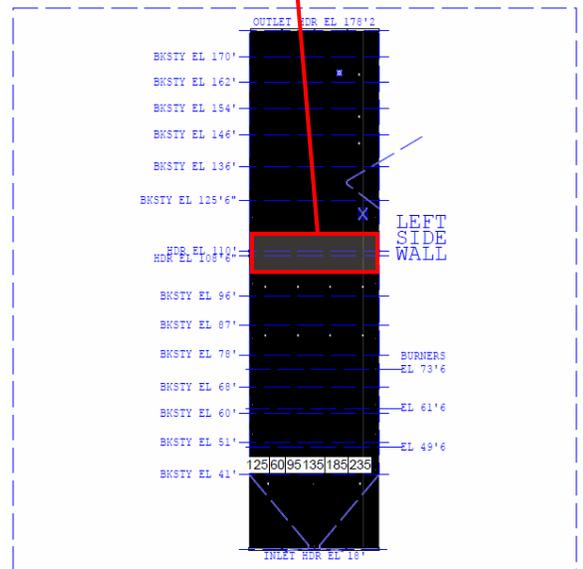
NOTE: Due to the pick arrangement, tubes near the front and rear corners could not be examined. The tube count in the field may be off by 2. All tubes are marked with an X and tube number.

Remove existing peg fin remnants and replace with new like material. Install fins with non-continuous side against tube and apply >80% penetration welds not extending past each fin break. Start and stop welds on fin. Do not weld around ends of fins.
