Subject: OST Services (OSTS) Report No. PRELIMINARY
OST Services (OSTS) Job No. 499-12
Inspections of Piping Systems, Supports, and Restraints
Mitchell Generating Station Unit No. 1 Hot inspection January 2013

During January of 2013 a hot inspection was performed at Mitchell Generating Unit No. 1. The work included a walkdown of the critical piping systems along with their supports and restraints.

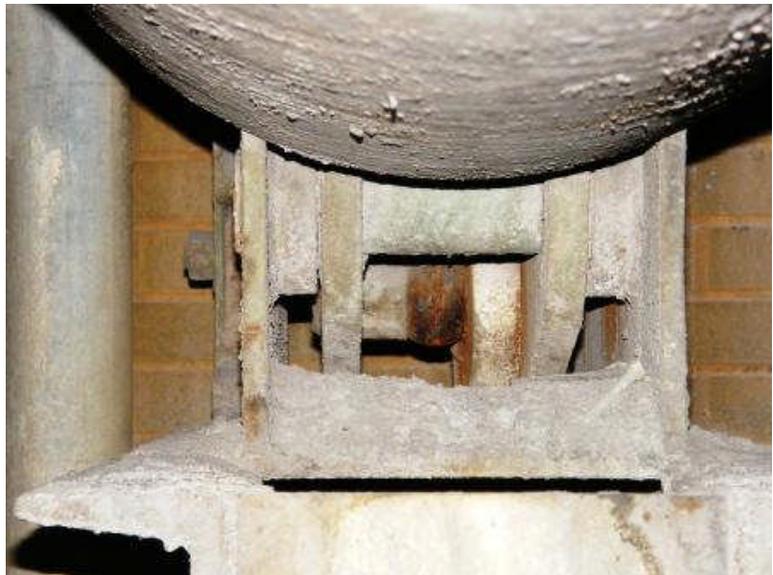
This support rod on this constant support assembly has shifted to the west and is no longer engaged on the bearing located on the load arm (Figure No. 1). It is possible to work the support rod back on the bearing. The support would have to be locked out and the load taken off prior to attempting repair. The support will require some staging prior to the repair to allow access. This condition did not exist during the 2011 inspection.

Figure No. 1
FRSH-3 support rod off bearing

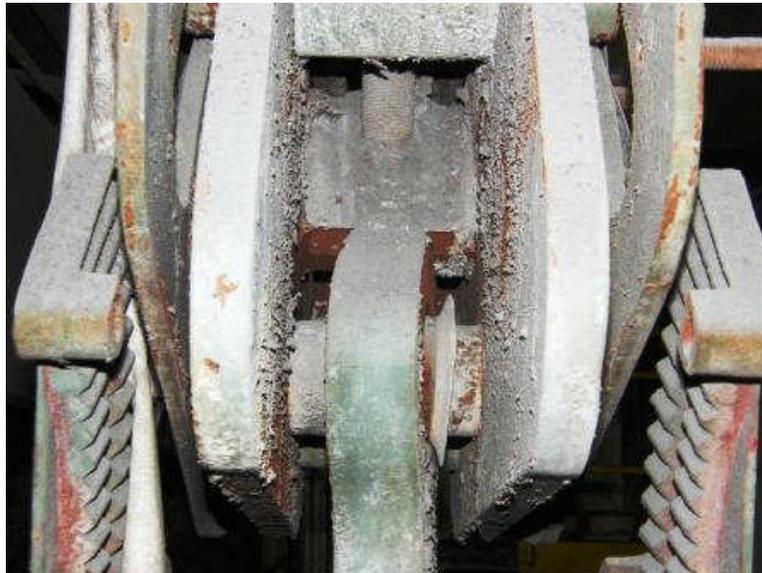
This constant support may be in the process of experiencing a bearing failure. The bearing is not in view on the support rod (Figure No. 2). We will evaluate this further during the scheduled outage.

Figure No. 2
FRSH-1 off bearing failure

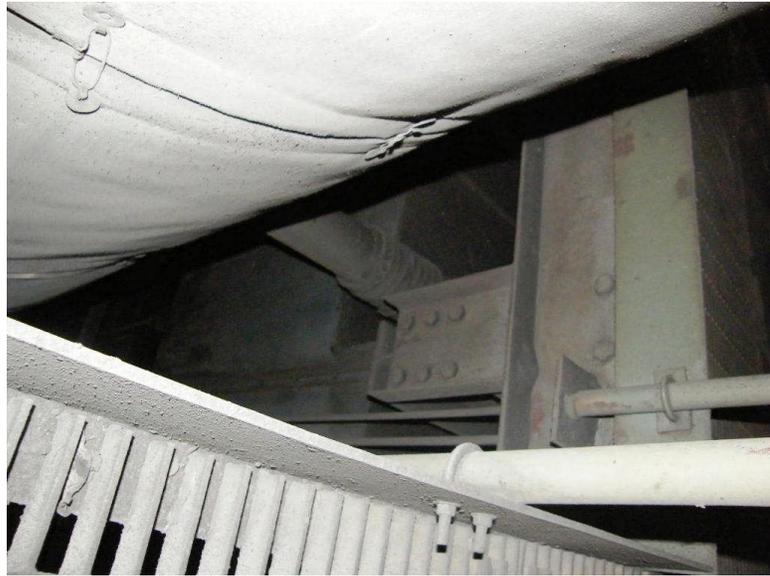
This mark number is specified to be a Figure 201 hydraulic shock and sway suppressor. The device in place is a Dyn-a-Damp mechanical device that would have been available circa 1970. There is a rubber dust boot on the piston that prevents a visual reading of the hot and cold positions (Figure No. 3). It is important to state that while popular at the time of their installation, time has

demonstrated that these devices were unreliable in dusty environments. They typically lock up when they fail. Testing can be accomplished by unpinning one end of the device and cycling the device through its travel range. We recommend that the plant replace this unit with a hydraulic snubber as was originally intended by design.

Figure No. 3
1-FRSH-16 mechanical

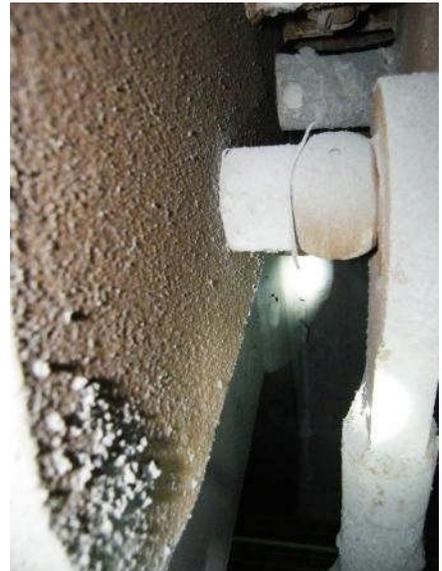
The support rod is not engaged with the bearing on the load arm of this constant support (Figure No. 4). It is possible to work the support rod back onto the bearing. The support would have to be locked out and the load taken off prior to attempting repair. The support will require some staging prior to the repair to allow access. This condition was not present during the 2011 inspection.

Figure No. 4
TEH-8 support rod off bearing

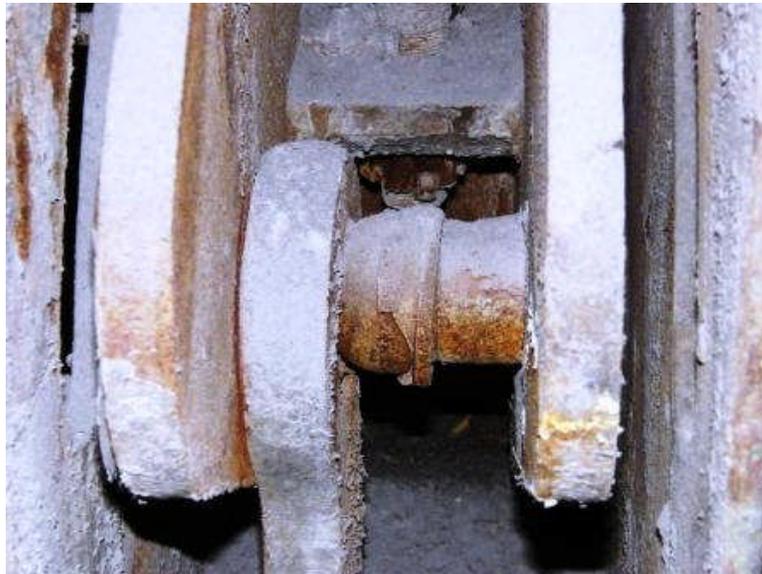
The above mark number represents a constant support hanger. The support has a broken bearing on the load arm assembly (Figure No. 5). This condition was first reported in OSTs Report No. 1160 in 2008. The support is significantly corroded due to service conditions, and exposure to water (Figure No. 6). We recommend that the plant make budgetary considerations for replacing this support during the next scheduled outage. We recommend that the replacement unit be rated for outdoor service. Such service conditions call for galvanized spring cans, and neoprene coated spring coils.

Figure No. 5
1-RSEH-7 broken bearing on load arm

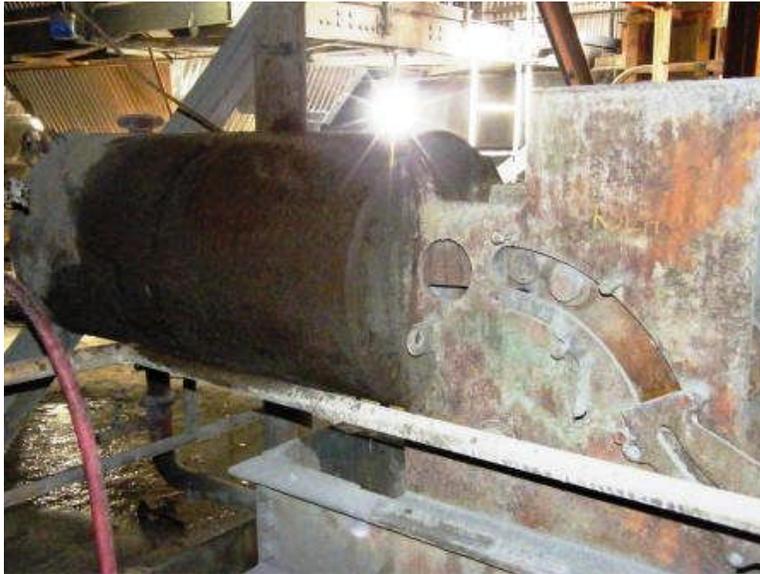
Figure No. 6
1-RSEH-7weathering

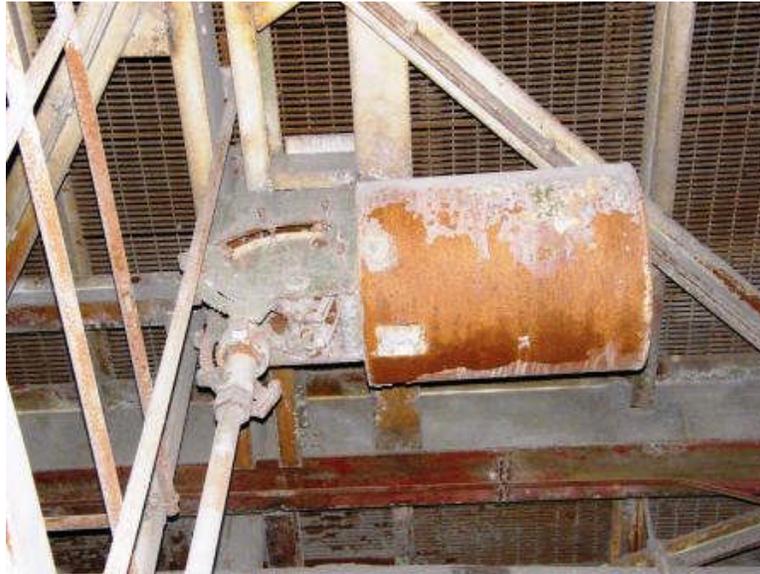
The above mark numbers represents a trapeze assembly that is rather unique. It utilizes two constant support hangers to provide support during normal operating parameters (Figure No. 7), and four variable spring cans to accommodate the increased loads seen during hydro testing and boil-off conditions. The supports are in generally poor condition due to service conditions. The constant supports are rusted, and the variable spring coils are corroded. It is advised to inspect the condition of the spring coils inside the spring can casing.

Figure No. 7
1-RSEH-8E

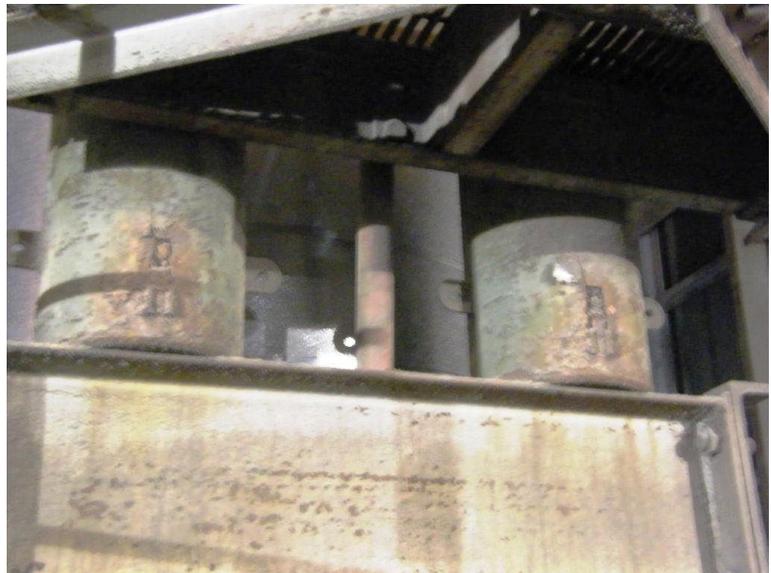
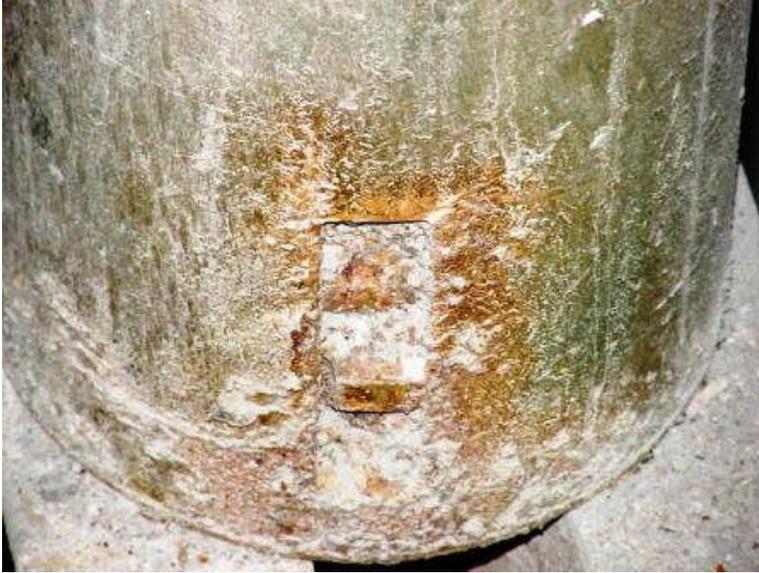
The variable springs associated with the hydro and boil off support are filled with ash and debris (Figure Nos. 8 and 9). Their effectiveness at this time is doubtful. The spring coils are in poor condition. We recommend that the plant evaluate the likelihood of this support being used again in the future before replacing it.

Figure No. 8
1-RSEH-15

Figure No. 9
1-RSEH-HBS-15 corroded
spring coils

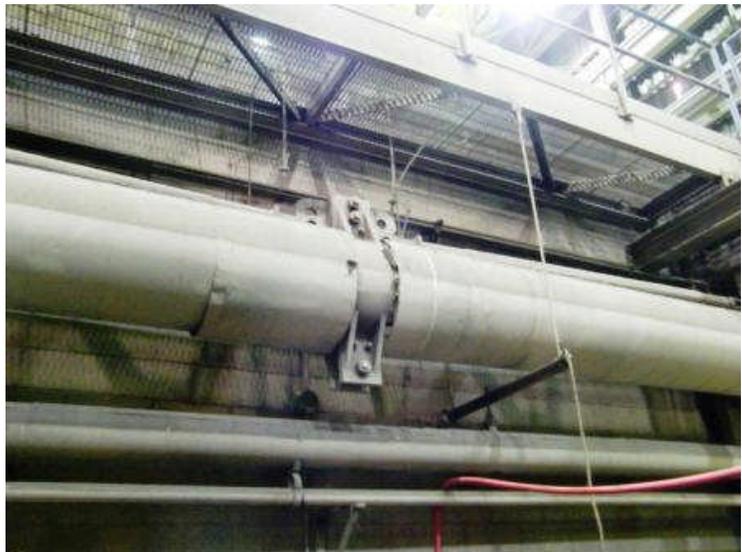
The above mark number represents a restraint that utilizes a pipe clamp with two rigid struts employed on a horizontal plane, in a north and south direction (Figure No. 10). The restraint is located between 1-FWH-19 and 1-FWH-20. The struts are currently disconnected from the pipe clamp. No design data could be located at the plant at the time of the inspection. We speculate that this device was introduced to control unwanted movement of the piping due to surges or periodic shock loading. We further speculate that after the modifications to supports 1-FWH-23 and 1-FWH-24 were made, the restraint was no longer necessary and was abandoned. In any event this should be confirmed and documented accordingly.

Figure No. 10
FWH #7 mystery restraint

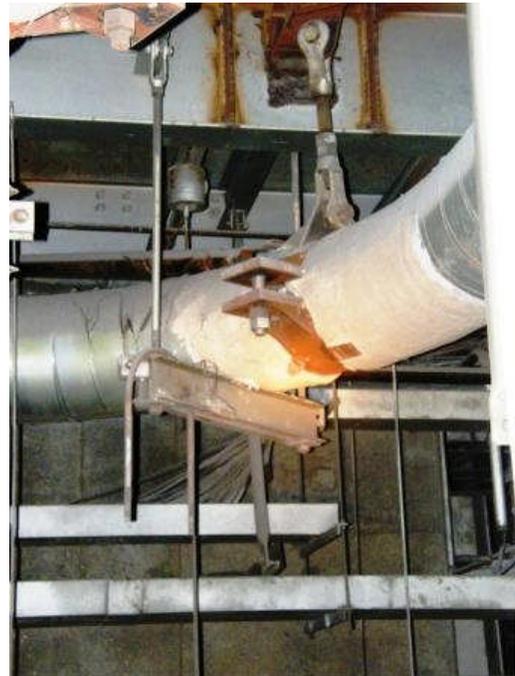
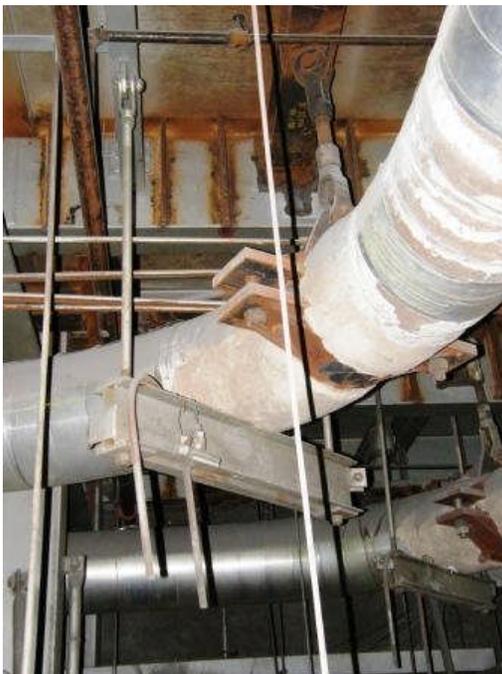
The above mark numbers represent two trapeze assemblies suspended by rigid rods (Figure Nos. 11 and 12). Originally, the piping was secured to the trapeze by U-bolts. Currently, the U-bolts have been removed and two very substantial struts have been introduced into the support scheme attached with clamps. The current hanger design sketch on file at the plant does not reflect this revision.

Figure No. 11
FWH-23 modifications

Figure No. 12
FWH-24 modifications

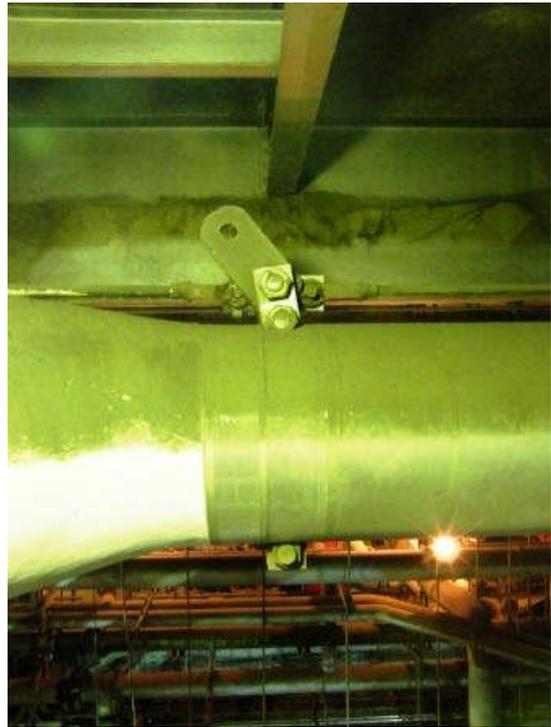
The above mark number represents a restraint that utilizes a pipe clamp with two rod assemblies employed on a horizontal plane, in a north and south direction. The upper section of the clamp at the point of the rod attachment is damaged and bent to the south (Figure No. 13). There is also a lifting lug incorporated in the clamp assembly that may have caused the damage while being used in an undisclosed way. We recommend that the plant make budgetary provisions to erect staging, strip the insulation, and inspect the clamp to determine the extent of the damage. This activity could be performed during the next outage.

Figure No. 13
1-FWH-32 distorted clamp

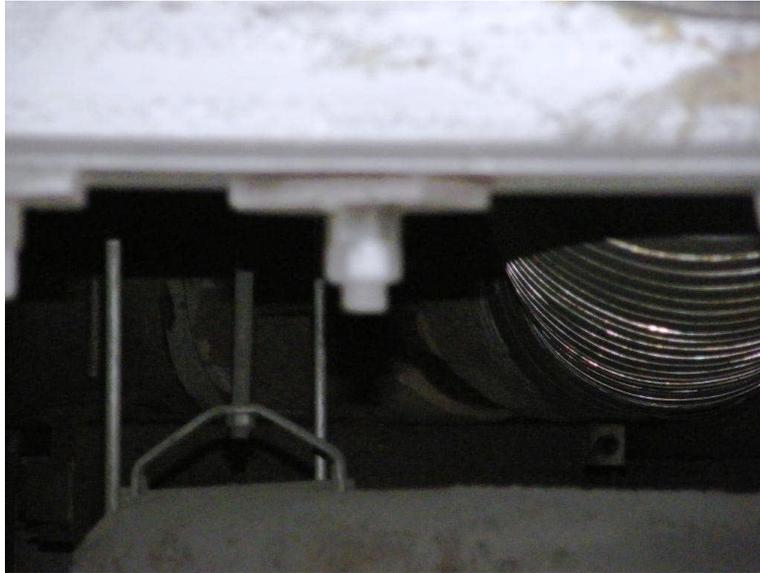
This trapeze assembly may have a loose U-bolt, due to a gap at the washer plate on the easternmost side of the U-bolt assembly (Figure No. 14). We recommend that this location be monitored for signs of unwanted lateral movement.

Figure No. 14
1-FWH-31 loose washer plate

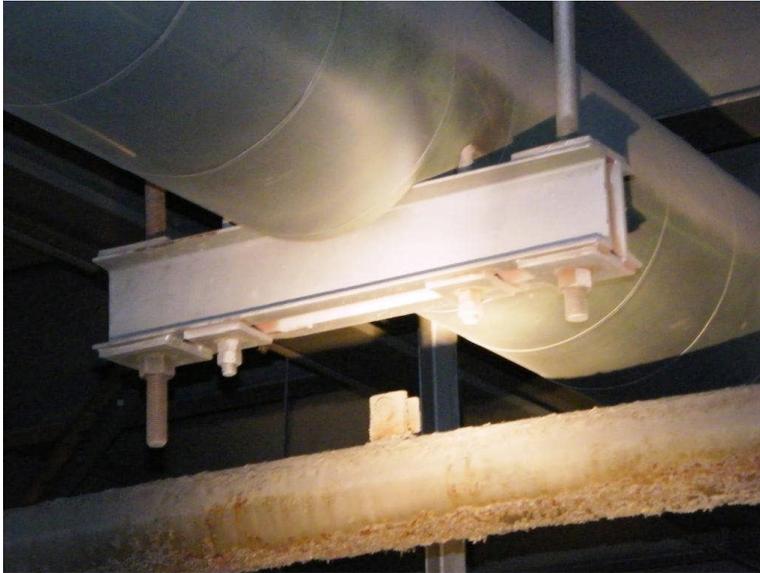
This trapeze assembly is missing the locknuts on the rod assemblies (Figure No. 15). Design sketches for the supports associated with the Feedwater supports could not be located at the plant at the time of the inspection. We will monitor this condition in the future.

Figure No. 15
1-FWH-22 single nuts on support rods

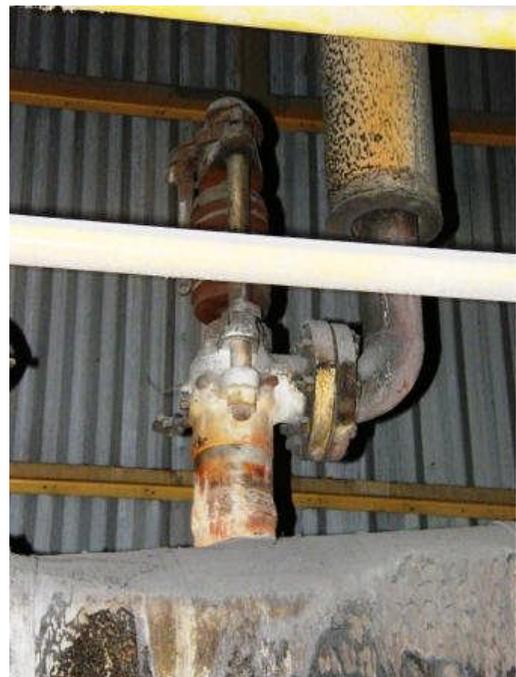
The Safety Valve discharge lines do not have support under the elbows (Figure No. 16). Without being supported from below, the elbow is driven downward when subjected to discharge conditions.

Figure No. 16
MS SV disc elbow

We recommend that the plant review the discharge piping system to ensure that the design is adequate when subjected to discharge conditions.

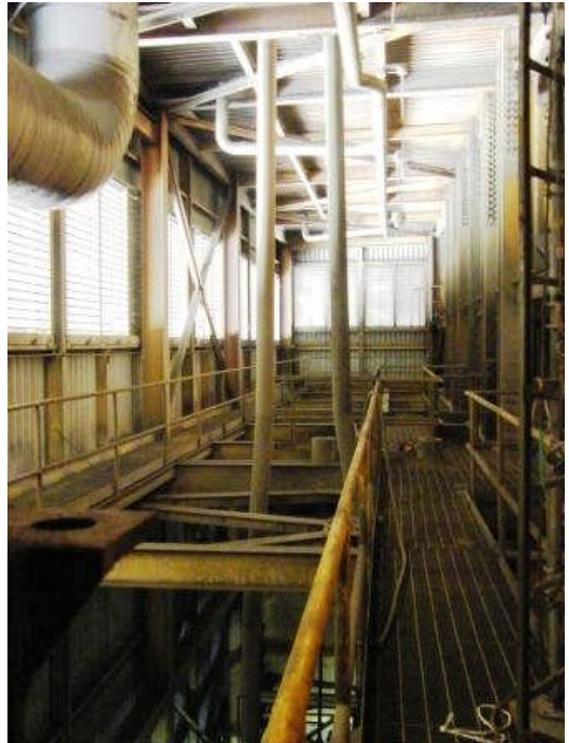
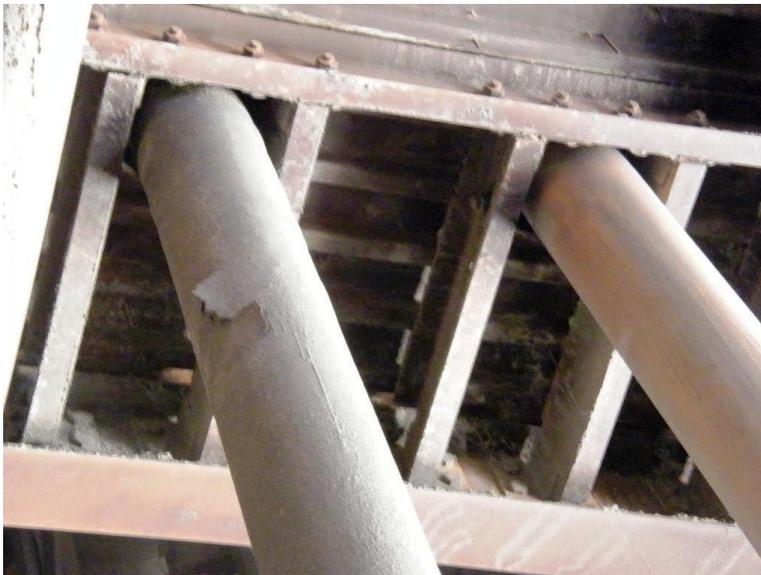
There are no visible supports on the discharge line to the roof penetration (Figure Nos. 17 and 18).

**Figure No. 17
MS SV config**

**Figure No. 18
MS SV roof**

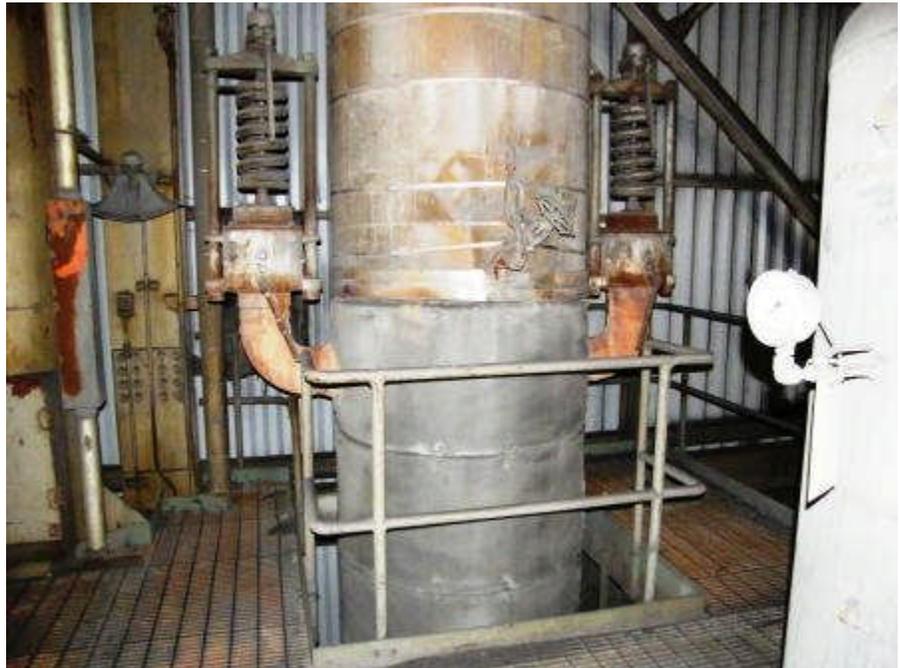
The Safety Valve discharge lines do not have support under the elbows (Figure No. 19). Without being supported from below, the elbow is driven downward when subjected to discharge conditions. We recommend that the plant review the discharge piping system to ensure that the design is adequate when subjected to discharge conditions.

Figure No. 19
Safety valve at First Reheat
Steam

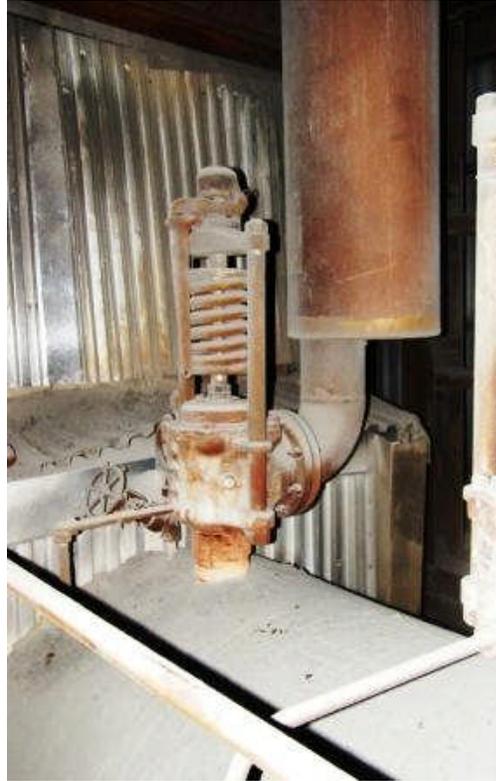
The three Safety Valve discharge lines at Elevation 147'- 0" do not have supports under the elbows (Figure No. 20). Without being supported from below, the elbow is driven downward when subjected to discharge conditions. There are no visible supports on the discharge line to the side of the building penetration. We recommend that the plant review the discharge piping system to ensure that the design is adequate when subjected to discharge conditions.

Figure No. 20
SRS safety valve

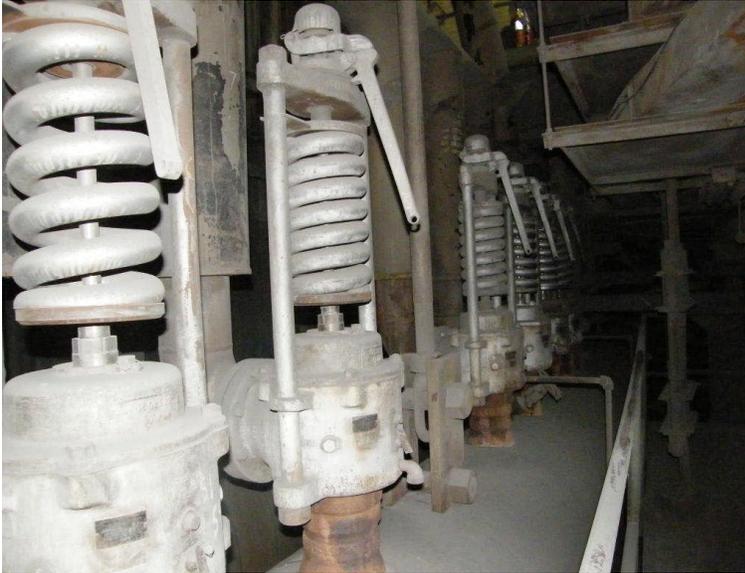
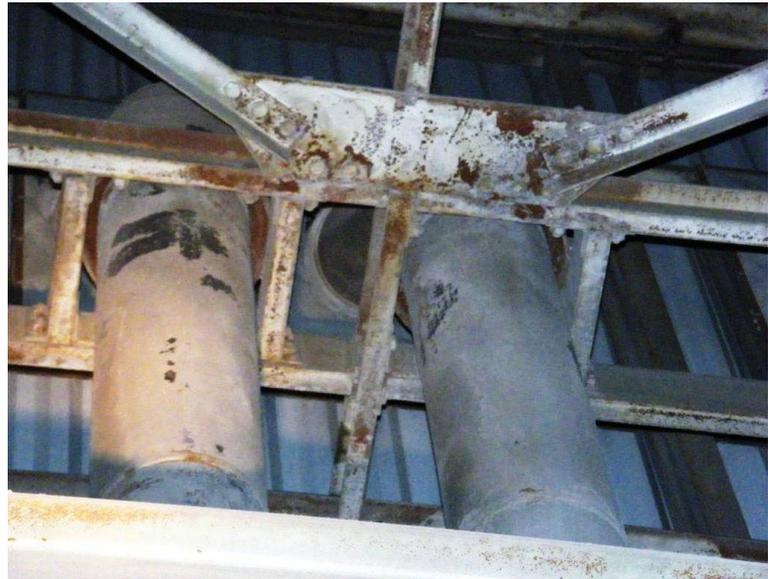
The six Safety Valve discharge lines at Elevation 25'- 8-7/8" do not have supports under the elbows (Figure No. 21). Without being supported from below, the elbow is driven downward when subjected to discharge conditions. There are no visible supports on the discharge line to the side of the building penetration (Figure No. 22). We recommend that the plant review the discharge piping system to ensure that the design is adequate when subjected to discharge conditions.

Figure No. 21
TEH SV1

Figure No. 22
TEH SV1

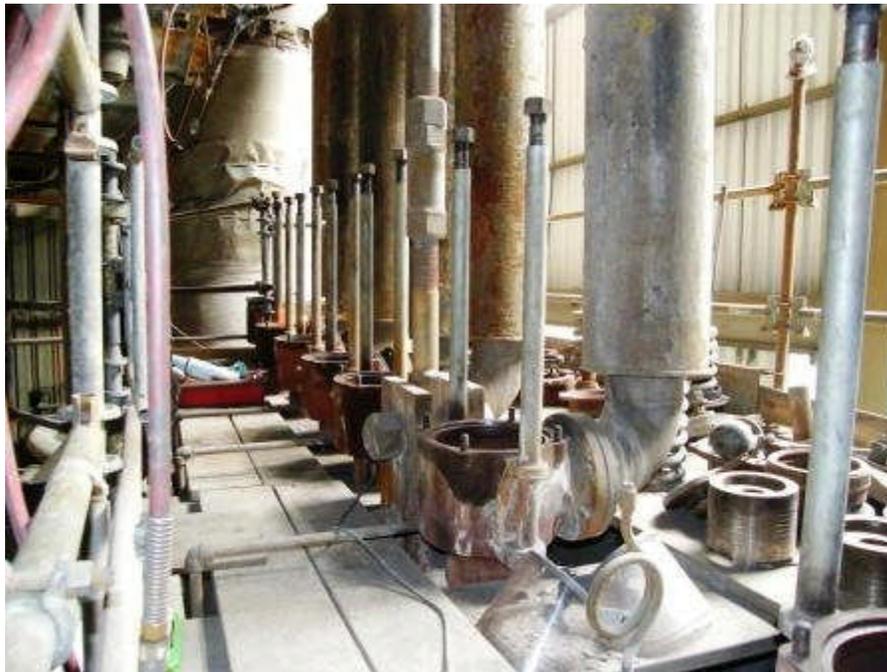
The twelve Safety Valve discharge lines at Elevation 20' 7-7/8" do not have supports under the elbows (Figure No. 23). Without being supported from below, the elbow is driven downward when subjected to discharge conditions. There are no visible supports on the discharge lines to the roof penetration (Figure No. 24). We recommend that the plant review the discharge piping system to ensure that the design is adequate when subjected to discharge conditions.

Figure No. 23
RSEH SV 2

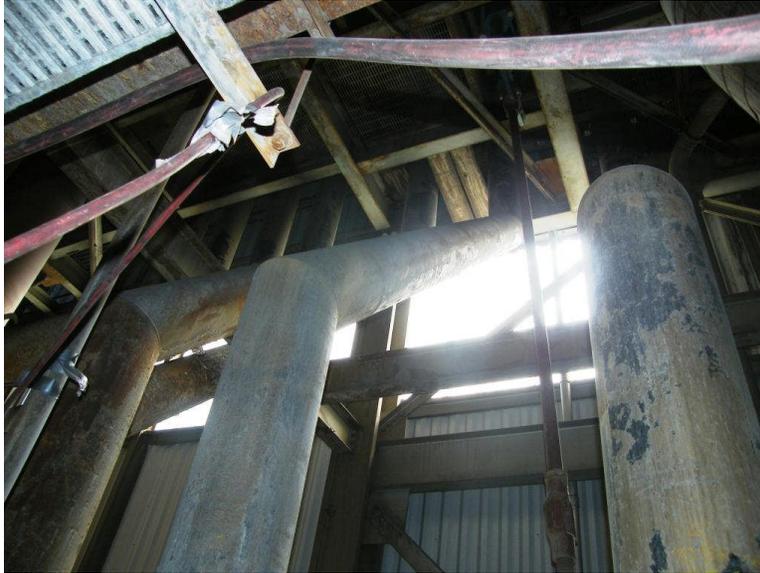
Figure No. 24
RSEH vent stack

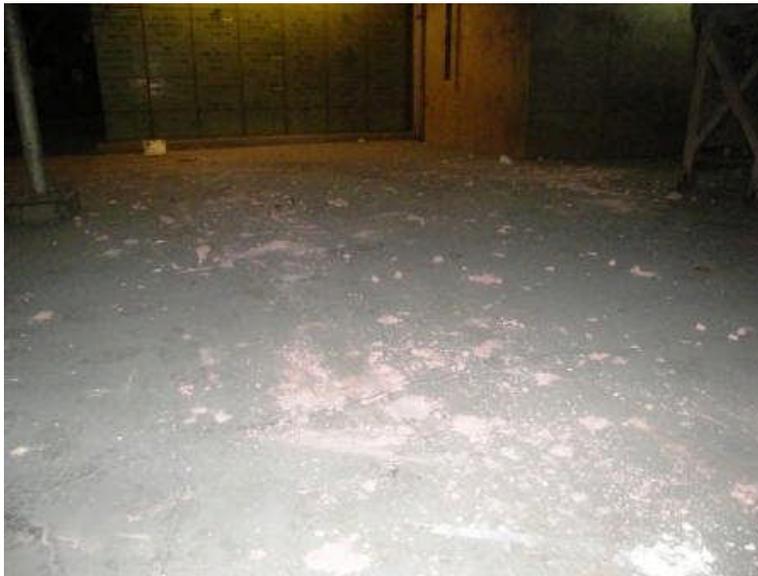
While performing the inspection broken pieces of insulation were found under the Turbine (Figure No. 25). The origin of the debris could not be determined.

**Figure No. 25
Insulation under turbine**

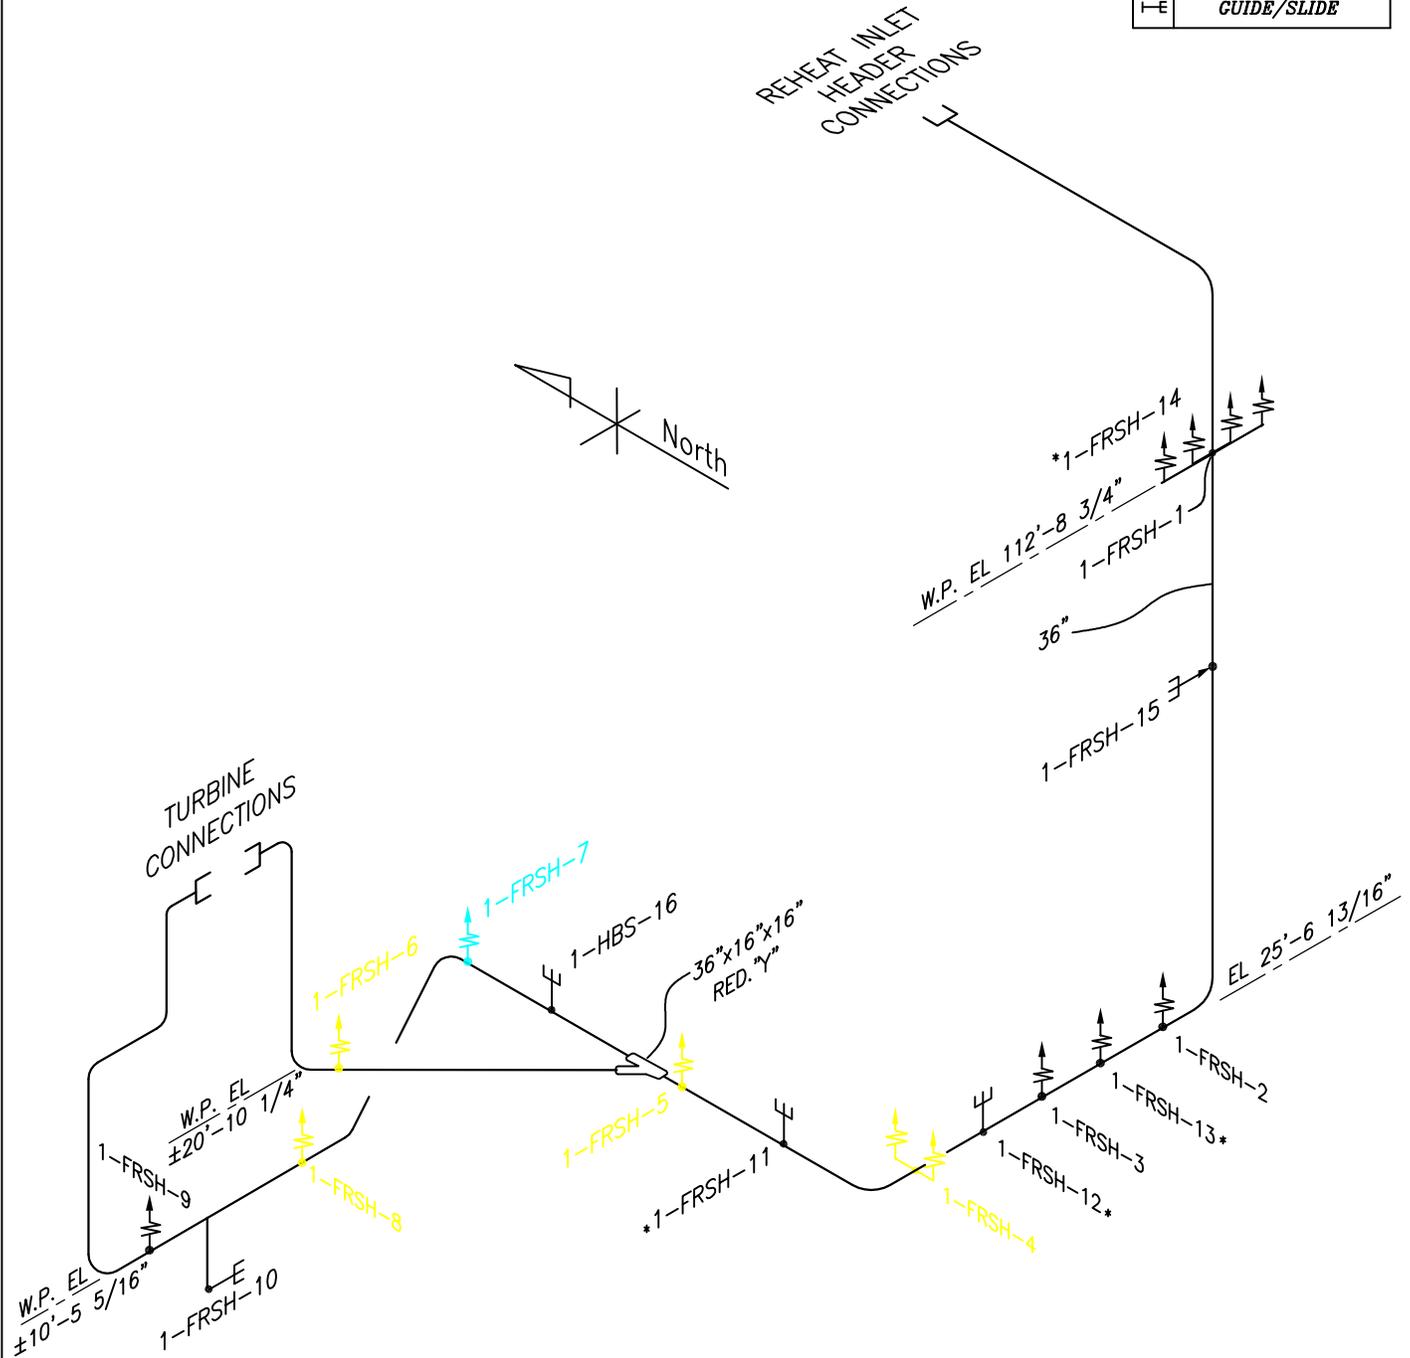
There are three constant support hangers along the bottom horizontal run of piping that are bottomed out in the hot condition. A fourth constant support, is supposed to be bottomed out in the hot condition, but is not. There are a number of factors to be considered and explored before contemplating any adjustments.

A marked up isometric of the bottomed out supports is also included.

First to be considered is the condition of the spring coils of the devices themselves. They could be at the end of their service lives and are no longer capable of supplying the rated loads. We recommend performing load testing on the affected supports during the next scheduled outage.
