Subject: OST Services' (OSTS) Report No. 1440  
OST Services' (OSTS) Job No. 005-12  
Hot and Cold Inspections of Piping and Supports  
Unit No. 2 – Spring of 2012

INSPECTION OF  
HIGH ENERGY PIPING AND SUPPORTS

MITCHELL STATION - UNIT NO. 2

DENNIS A. SCHMEDINGHOFF  
OSTS' REPORT NO. 1440  
OSTS' JOB NO. 005-12

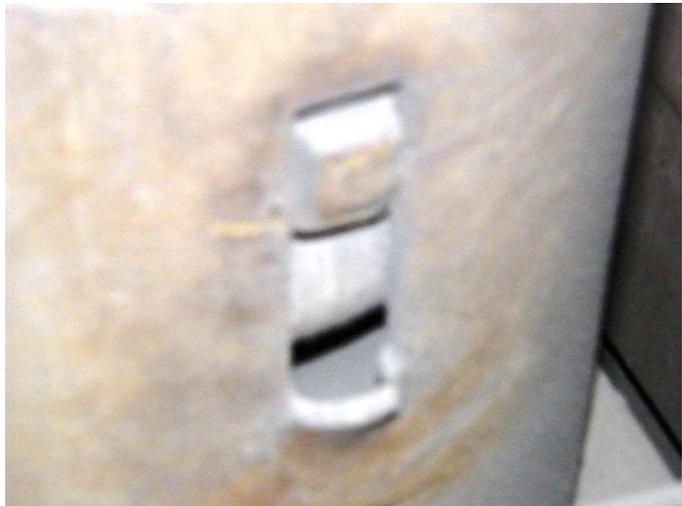
**Figure No. 1**  
**2-MS-H2 Topped Out Damaged**  
**Indicator Slot**

This variable spring support has a damaged indicator slot, indicating that the load flange was driven into the bottom of the indicator slot (Figure No. 1). Damage of this nature usually is due to shock loading; where the movement of the piping was more than the travel of the spring could accommodate. The damage appears to be old.

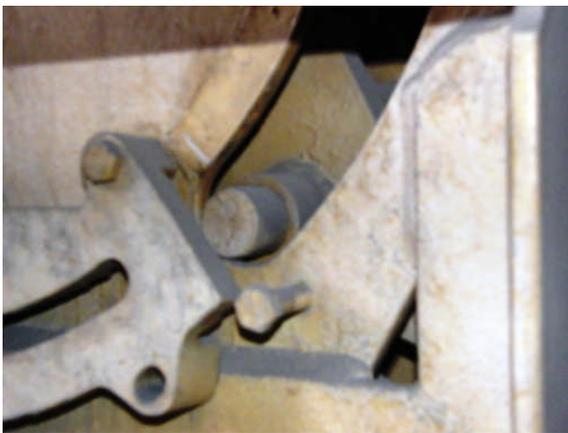
**Figure No. 2**  
**2-MS-H3 Bottomed Out Cold**

These two mark numbers represent constant support hangers. They are bottomed out in the cold condition (Figure Nos. 2 and 3). We recommend that the supports be load tested prior to making any adjustments. There is also the possibility that the piping is distorted along the upper horizontal run and this should be explored. If distortion is present, then adjustments at this time could exacerbate the condition.

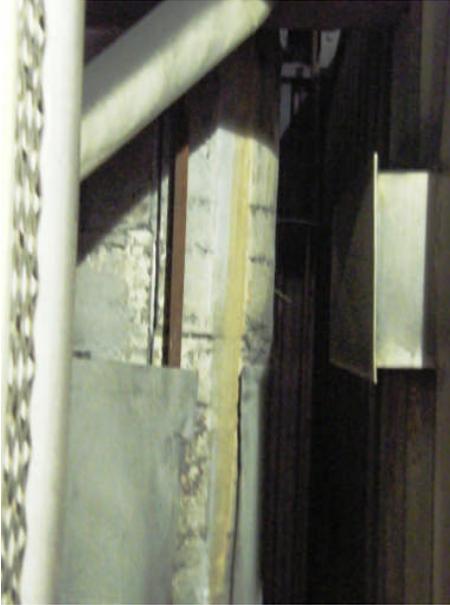
**Figure No. 4**  
**Insulation Damage at 2-MS-H17**

There is insulation damage at these locations along the vertical run of piping (Figure Nos. 4 and 5).

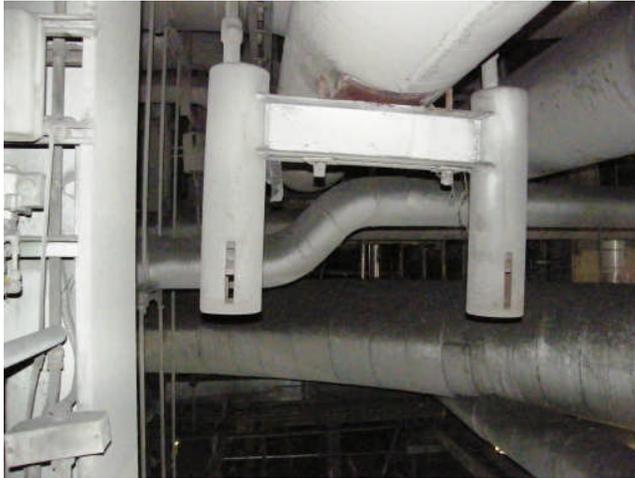
**Figure No. 6**  
**2-MS-H9 Tilted Down on South Side**

This variable spring trapeze assembly has a loose U-bolt. The southernmost support rod is slightly distorted, and the support is slightly tilted downward to the south. The U-bolt anchors the piping to the support. We recommend that the plant budget for scaffolding and allow manpower to tighten the U-bolt and adjust the support as necessary (Figure No. 6).

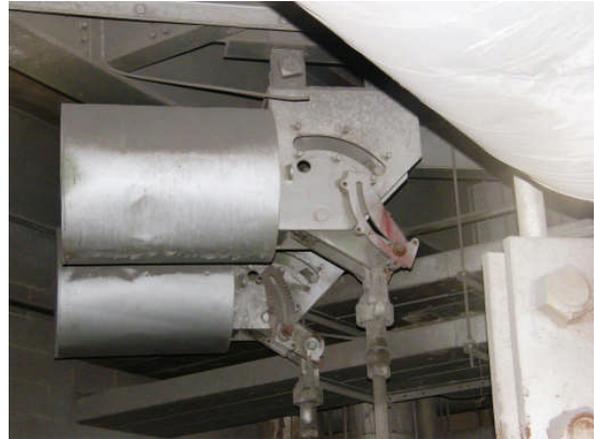
**Figure No. 7**  
**2-FRSH-4 Bottomed Out**

These two mark numbers represent constant support hangers. They are bottomed out in the hot condition (Figure No. 7). We recommend that the

supports be load tested prior to making any adjustments. There is also the possibility that the piping is distorted along the lower horizontal run and this should be explored. If distortion is present, then adjustments at this time could exacerbate the condition.

Another possibility is that the supports were adjusted improperly. During the outage of 2010 scaffolding was built to allow access to support 2-FRSH-5 to verify design information contained on the name plate. The name plate could not be found as they appear to have been removed. There was a notation written on one of the spring cans that stated the spring tension had been increased in April 2000 (Figure No. 8). There is an adjustment that allows for at least 10% adjustability. More likely, the travel was adjusted by a well intentioned, uninformed individual who thought they were adjusting the spring tension.

It appears likely, that the condition of being bottomed out in the hot condition is due to an adjustment to the travel in the cold condition in 2000.

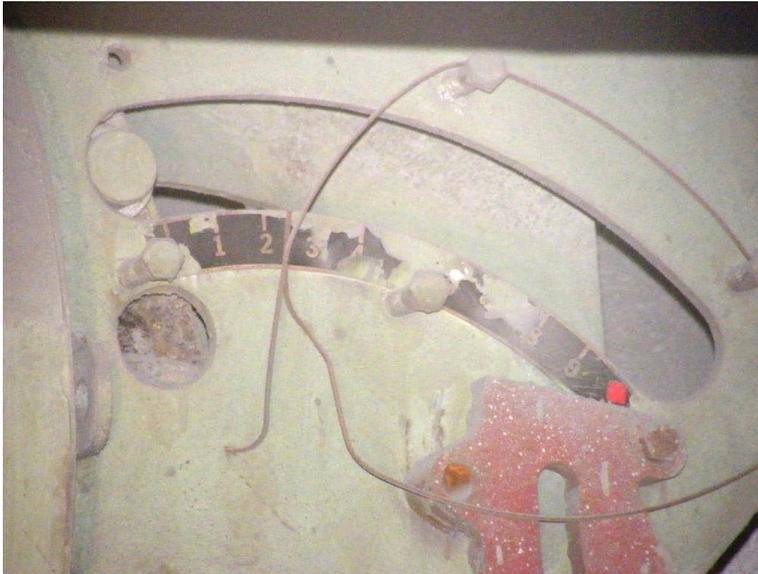
**Figure No. 9**  
**2-FRSH-7 Topped Out Cold**

This constant support designed settings were to be bottomed out hot and 6.5 cold. The support is topped out in the cold condition (Figure No. 9). This could be due to distortion of the piping if it is "humped" at this location, or someone performed adjustments without consulting the original hanger design sketches.

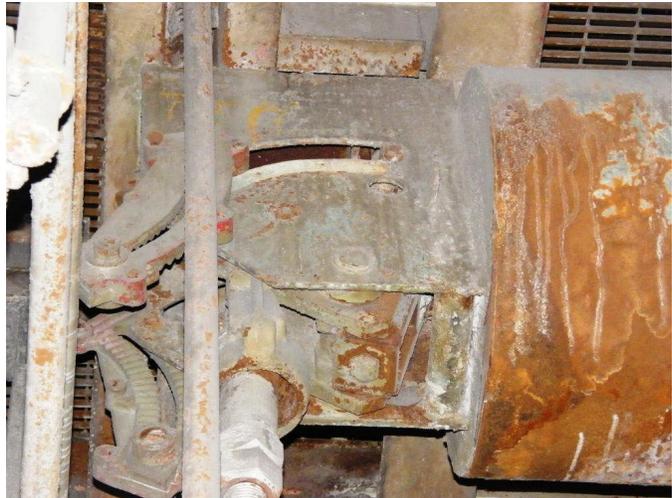
**Figure No. 10**  
**2-TEH-7 Topped Out Cold**

The above mark numbers represent a trapeze assembly that is rather unique. It utilizes two constant support hangers to provide support during normal operating parameters, and two variable spring cans to accommodate the increased loads seen during hydro testing and boil-off conditions. The easternmost constant support is topped out in the cold condition (Figure No. 10).

The supports are in generally poor condition due to service conditions. The constant supports are rusted, and the variable spring coils are significantly corroded, and the spring cans are packed with fly ash.

The combined load of the two constant support hangers is 50,746#, and is supported by two welded attachments to the pipe. We recommend that the plant inspect the lugs for indications of cracks at the welds, due to the large volume of piping that would be unsupported if a failure were to occur at this location.

It is advised to inspect the condition of the spring coils inside the spring can casings as well as those in the constant supports. The variable spring cans (used only in the hydro boil out conditions) are filled with ash. The likelihood for them to function when called upon is questionable, due to the debris in the spring can.

When the time comes to replace these supports, we would recommend that the new supports be rated for outdoor service. Such service conditions call for

galvanized spring cans and neoprene coated spring coils. Another issue for the plants consideration is whether or not support 2-TEH-13 is truly required. This support is only engaged during hydro testing and boil-off. The plant should explore the likelihood of future hydrostatic testing of this piping system in the foreseeable life of the plant, and determine if this support has to be replaced in the future.

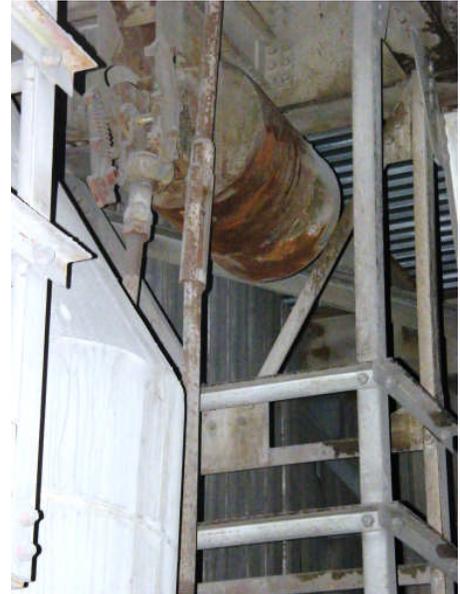
**Figure No. 11**  
**2-RSEH-7 Rusted Supports**  
**2-RSEH-13 Distorted Turnbuckle**

parameters, and four variable spring cans to accommodate the increased loads seen during hydro testing and boil-off conditions. The supports are in generally poor condition due to service conditions. The constant supports are rusted (Figure No. 11), and the variable spring coils are corroded, and the spring cans are filled with ash. The turnbuckle is distorted. It is advised to inspect the condition of the spring coils inside the spring can casing.

When the time comes to replace these supports, we would recommend that the new supports be rated for outdoor service. Such service conditions call for galvanized spring cans and neoprene coated spring coils. Another issue for the plants consideration is whether or not support 2-RSEH-13 is truly required. This

support is only engaged during hydro testing and boil-off. The plant should explore the likelihood of future hydrostatic testing of this piping system in the foreseeable life of the plant, and determine if this support has to be replaced in the future. If this approach was found to be the plants choice, we would recommend installing new constant supports to replace the current units.

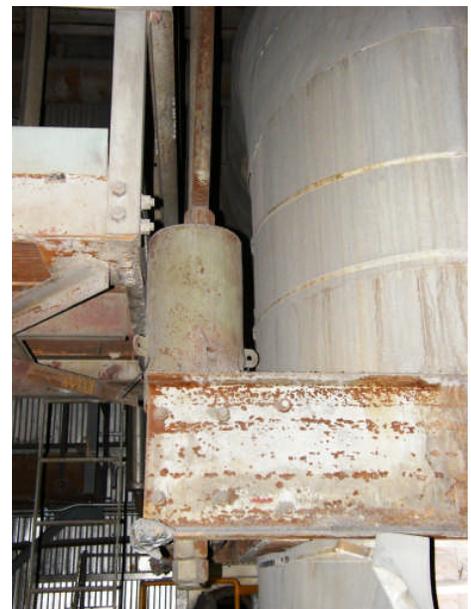
**Figure No. 12**  
**2-RSEH-13 Loaded on Access Platform**

In the cold condition the support is in contact with the access platform suspended from above (Figure No. 12). This interference has caused damage the insulation on the southern side of the piping below the clamp (Figure Nos. 13 and 14). This condition does not exist in the operating condition. The easternmost constant support is topped out in the cold condition.

We recommend continued monitoring of this support, and would advise against blindly making adjustments at this time.

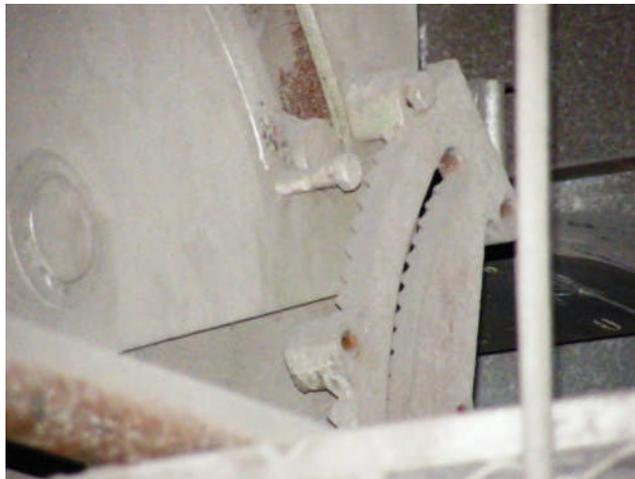
**Figure No. 15**  
**2-RSEH-5 Bottomed Out**

The above mark number represents a constant support hanger. The support is bottomed out in the hot operating condition (Figure No. 15). We recommend that this support be adjusted during the next outage.

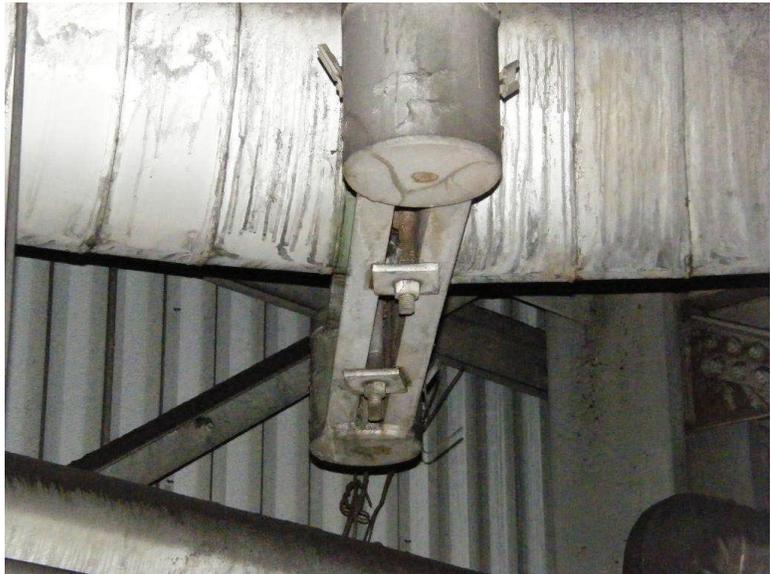
**Figure No. 16**  
**2-FWH-20 missing locknuts on U-bolt**

This variable spring trapeze assembly is missing the lock nuts on the U-bolt. The washer plates used to anchor the piping to the support have migrated (Figure No.

16). The U-bolt could be loose, damaged or elongated. Scaffolding will be required to gain access to these supports to assess the condition of the U-bolt. Insulation removal could be required, as is potential

U-bolt replacement.

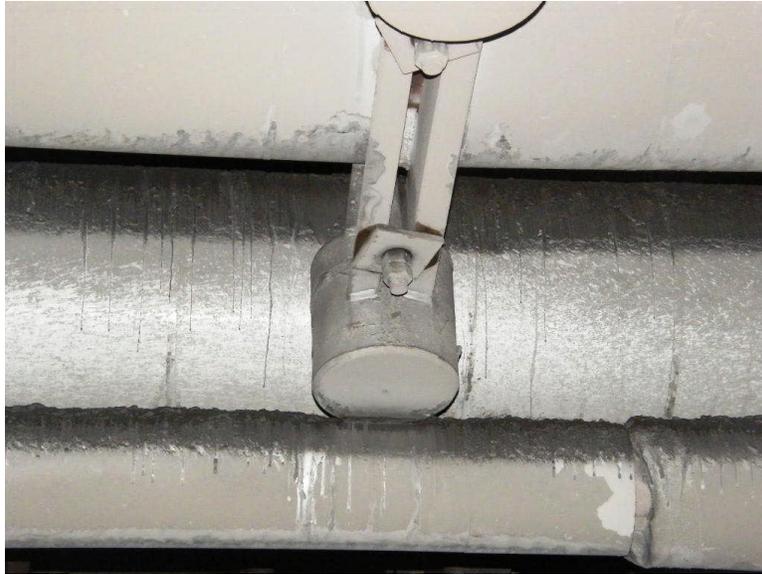
**Figure No. 17**  
**2-FWH-21 washer plate loose**

The above listed supports are all trapeze assemblies. They are exhibiting indications that the U-bolt that secures the piping to the support has shifted (Figure No. 17). The U-bolts could be loose, damaged, or elongated.

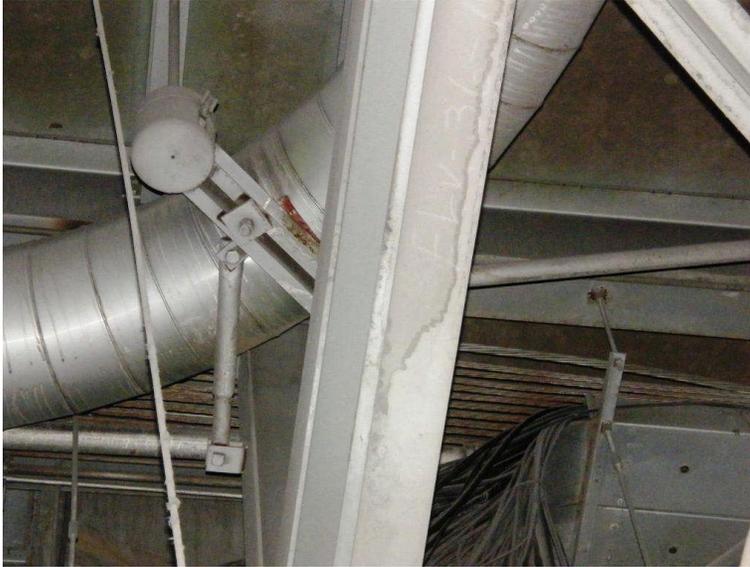
**Figure No. 18**  
**2-FWH-26A with restraints**

These two variable spring trapeze supports have been modified. They each have two rigid struts added to their design (Figure Nos. 18 & 19). It appears that the intent of the modification was to stop excessive sway at these locations. The result of the addition of the struts was essentially to turn these locations into anchors. We recommend that the plant determine what the long term effects of such a change would be.

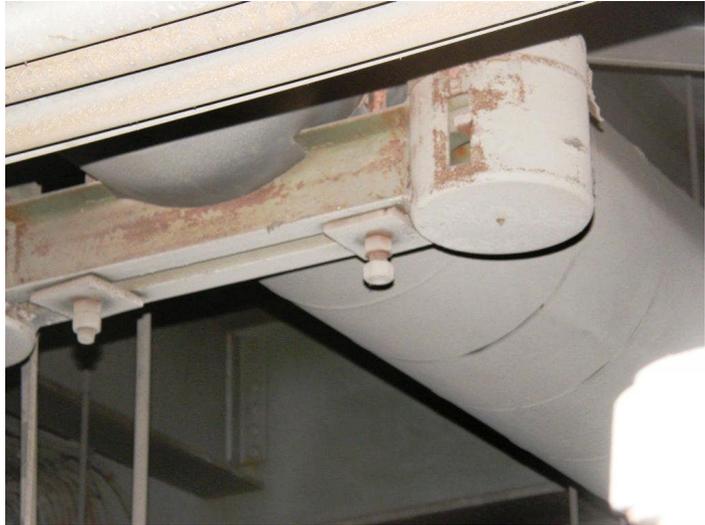
**Figure No. 20**  
2-FWH-28 loose locknut

This variable spring assembly has a loose locknut present on the U-bolt. We recommend that this be tightened during the spring outage (Figure No. 20).

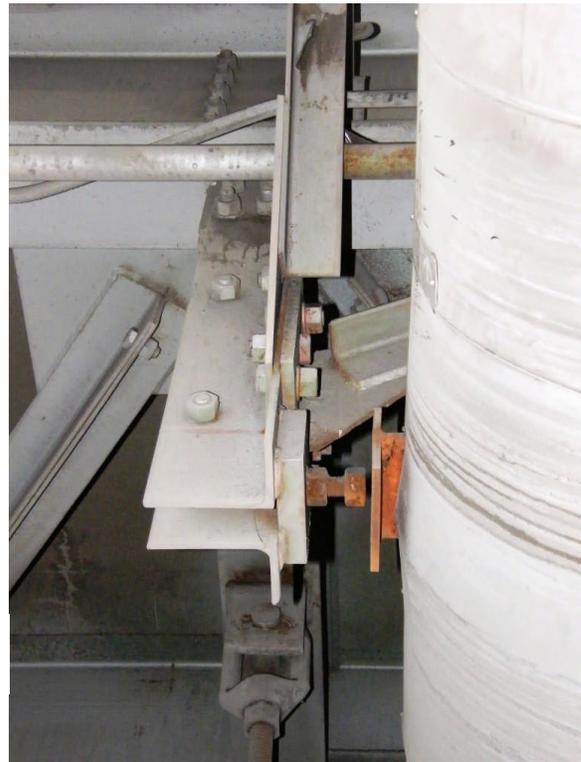
**Figure No. 21**  
2-FWH-31 added modification

This support is part of the modifications made to the piping system. It is a limit stop installed to limit lateral movement to the west (Figure No. 21). The hanger designation was added for purposes of this report, and is not on file at the plant.

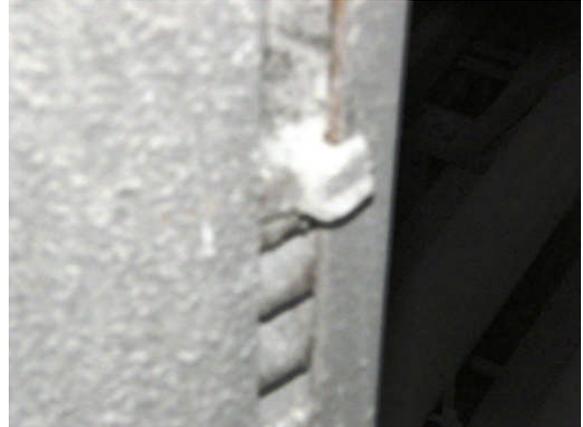
**Figure No. 22**  
**2-CH-102 Damage**

This variable spring support has a damaged position indicator. The damage is due to wear against the indicator slot (Figure No. 22).

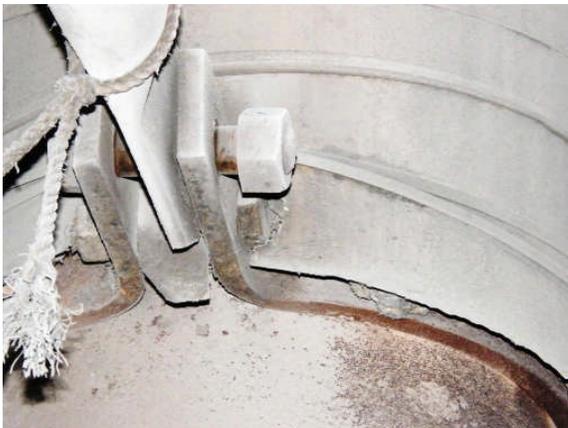
**Figure No. 23**  
**2-CH-104 Fastener Loose**

This is a strut that may have either a loose or over sized bolt in service (Figure No. 23). The other side of the attachment is inaccessible, and cannot be viewed. There is also damaged and missing insulation at this location (Figure No. 24).

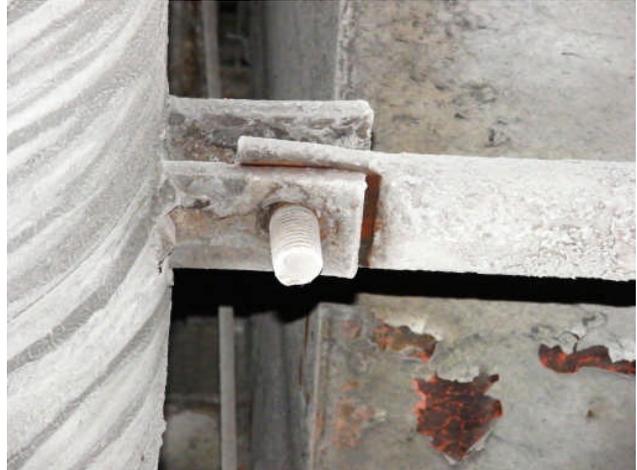
**Figure No. 25**  
**2-CH-105**

This mark number represents a rigid strut. There is a missing hex nut in the clamp assembly (Figure No. 25).

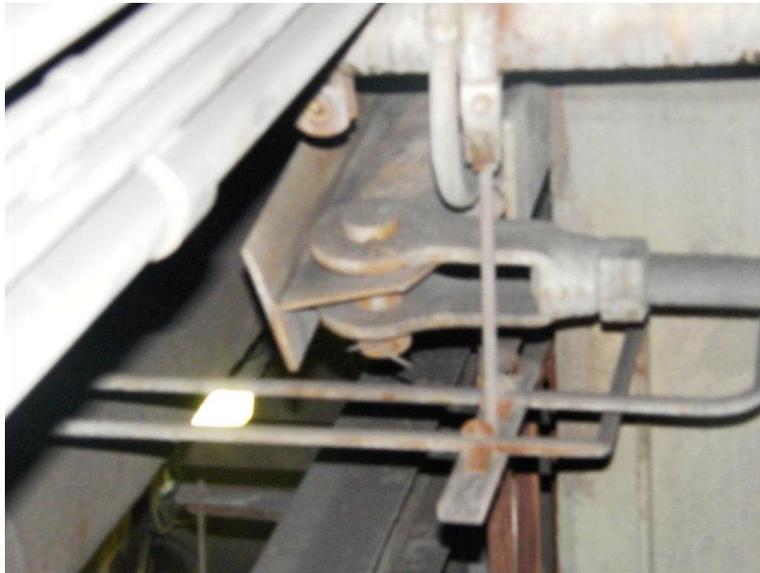
**Figure No. 26**  
**2-CH-110 North steel attachment**  
**damaged**

The northern steel attachment for this rigid support is damaged (Figure No.26). It is scheduled for repairs during the spring outage.

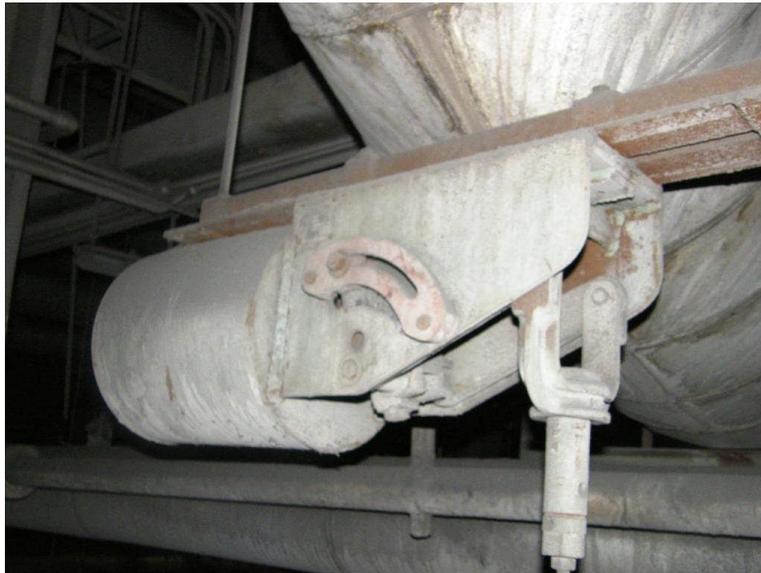
**Figure No. 27**  
**Travel stops in Alternate Steam support**

- There are no visible supports on the discharge lines to the roof or wall penetrations. We recommend that the plant review the discharge piping systems to ensure that the designs are adequate when subjected to discharge conditions.
- A constant support associated with the Alternate Steam to Turbine Room piping system was found to have its travel stops engaged (Figure No. 27). We recommend that the support be placed in travel.

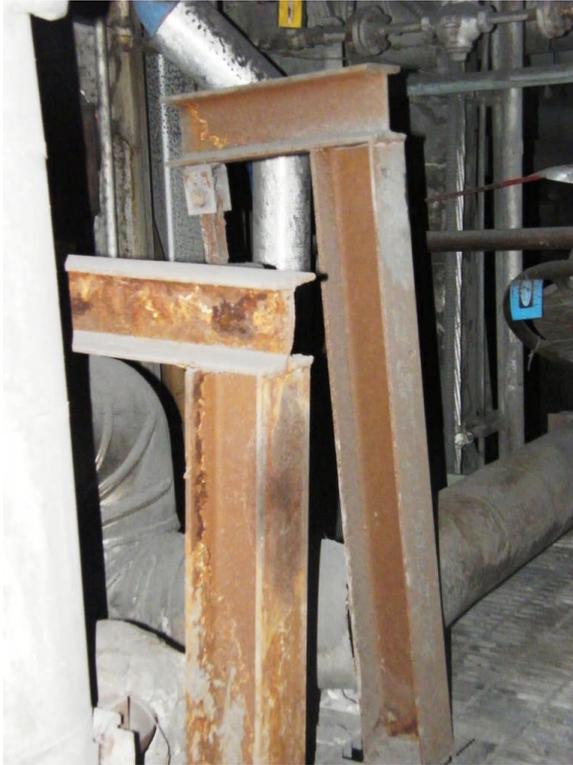
**Figure No. 28**  
**FW drain supports distorted**

- Several supports associated with the Feedwater Drains have distorted support steel (Figure Nos. 28 & 29). The damage is not recent.
