# Mitchell Unit #2 spring 2012 Turbine/Generator Outage

Turbine Serial Number	170X394
Generator Serial Number	180X394
Unit Out of Service	2/17/2012
Unit Release for Service	4/13/2012

## 1. Summary

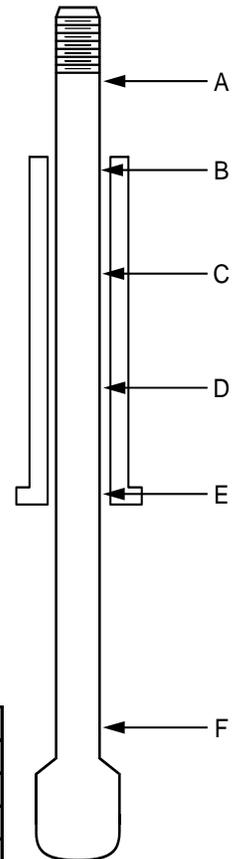
**#3 stem has a crack in the seat/pin area near the spline ( needs replaced ).**

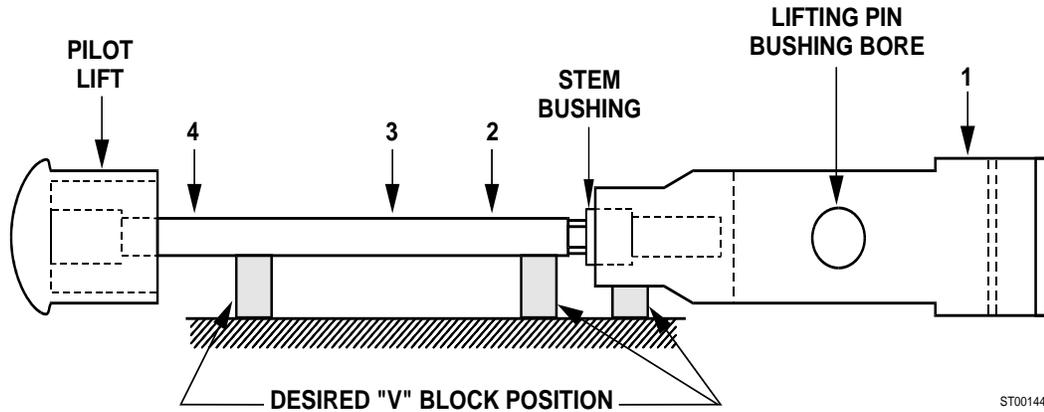
**#3 Stem has a cracked area in the seat /pin area needs replaced**
