**MPI**  
**MARTIN'S**  
PIPELINE INSPECTION  
**859-987-2529**

## Cedar Brook

Performed camera work and prepared  
this report re Cedarbrook 1-2006

# INSPECTION REPORT

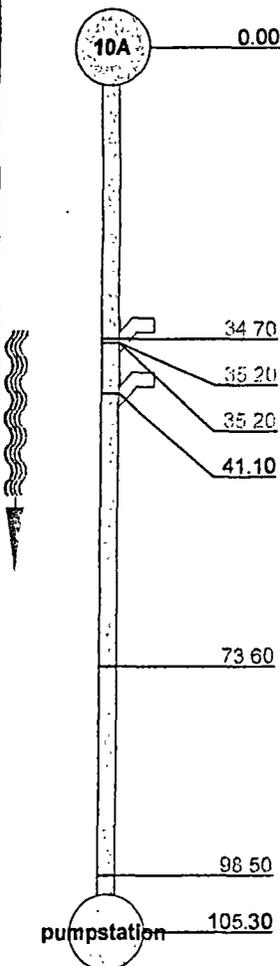
1:275	POSITION	CODE	OBSERVATION	MPEG	PH	RATE
	0.00	0	inspection begins at upstream manhole			0
	34.70	575	service connection with infiltration gushing around, at 09 o'clock	00:01:37		4
	35.20	500	pipe broken at joint at 09 o'clock	00:02:11		3
	35.20	320	Infiltration Running at joint at 09 o'clock	00:02:12		3
	41.10	0	service connection capped, at 09 o'clock	00:02:33		0
	73.60	220	Infiltration Seeping at joint at 09 o'clock	00:04:04		2
	98.50	250	separated joint medium	00:05:10		2
	105.30	0	inspection ends at pumpstation	00:05:56		0

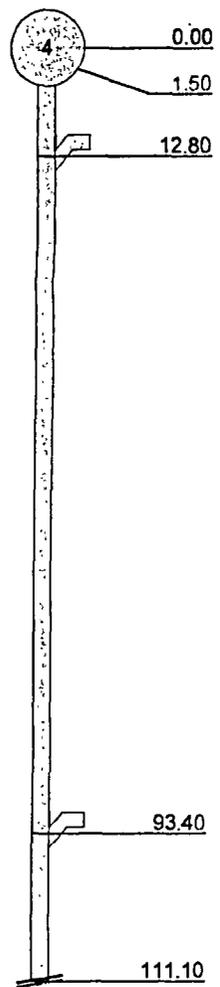
1:275	POSITION	CODE	OBSERVATION	MPEG	PH	RATE
	0.00	0	inspection begins at upstream manhole			0
	1.50	220	Infiltration Seeping at joint at 03 o'clock	00:00:57		2
	12.80	0	service connection, at 10 o'clock	00:01:43		0
	93.40	0	service connection capped, at 09 o'clock	00:04:24		0
	111.10	0	camera blocked, inspection abandoned	00:06:21		0

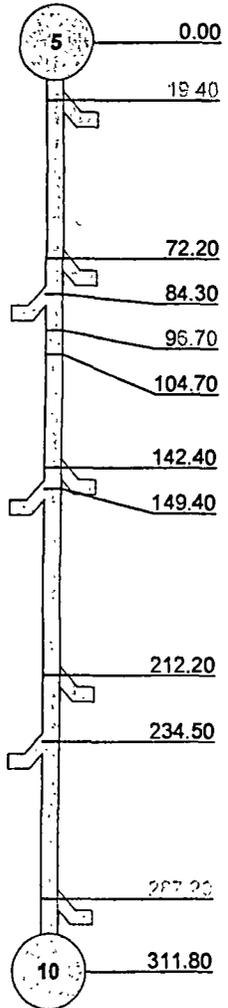
1:775	POSITION	CODE	OBSERVATION	MPEG	PH	RATE
	0.00	0	inspection begins at downstream manhole			0
	19.40	350	service connection with roots heavy, at 09 o'clock	00:01:09		3
	72.20	0	service connection, at 09 o'clock	00:03:08		0
	84.30	0	service connection, at 03 o'clock	00:03:45		0
	95.70	230	roots medium	00:04:23		2
	104.70	130	roots light	00:04:48		1
	142.40	0	service connection, at 09 o'clock	00:06:10		0
	149.40	0	service connection, at 03 o'clock	00:06:40		0
	212.20	0	service connection, at 09 o'clock	00:08:59		0
	234.50	0	service connection, at 03 o'clock	00:09:58		0
	267.20	350	service connection with roots heavy, at 03 o'clock	00:12:00		3
	311.80	0	inspection ends at upstream manhole	00:13:37		0
