RE: **Case No. 2025-00027**

Larry and Debra Peterman)	
)	
Complainants)	
v.)	
)	Case No. 2025-00027
Kentucky Power Company)	
)	
Defendant)

Kentucky Power Company's Notice of Filing

Summary of Neutral-to-Earth Voltage and Testing Results

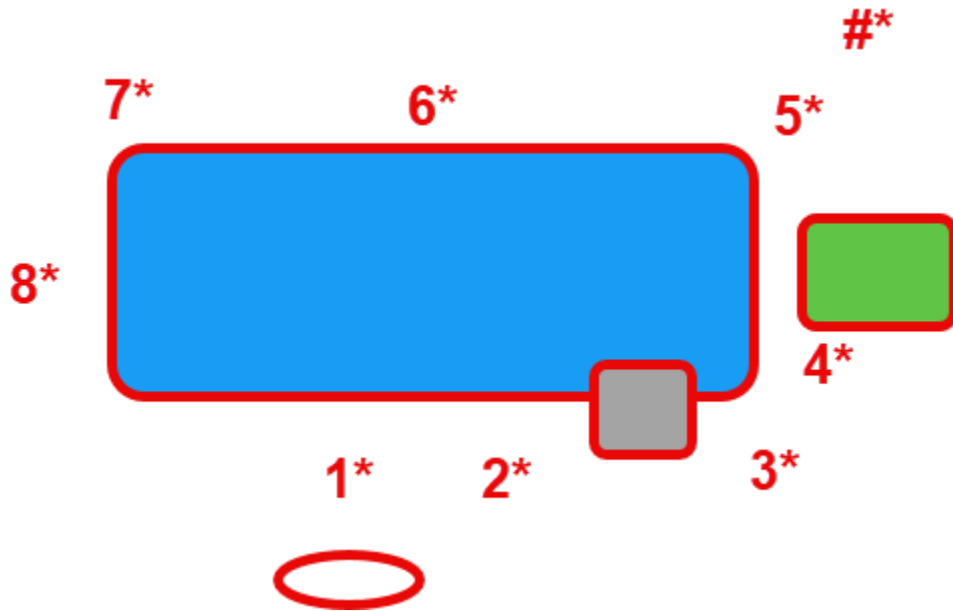
Below is a general layout of the pool and will be used in reference to various test points around the pool.

= The slide location

= The ladder (rail) to enter/exit the pool

= is the meter base location

= various locations around the pool where a metal structure was driven into the concrete

1. **Bonding Issues:** The voltage variations observed suggest that the pool is not properly bonded, as a well-bonded pool would show consistent voltage readings across all test points relative to a static reference.

4. **Ladder Readings:** Consistently showing **0V** may indicate a poor continuity path between the railing and the bus bar, rather than an absolute absence of voltage.

The readings taken at the Peterman residence on 9/10/2024, 08/27/2025, as well as the readings taken from 09/12/2025 indicates that the stray voltages present are minimal. On 9/12/2025 efforts to reduce the stray voltage by driving ground rods at various locations had little to no effect on the stray voltage present. Given the potential risks associated with ground faults near the pool, it is strongly recommended that the pool be properly bonded in accordance with NEC standards to ensure safety. The tests conducted by AEP indicate a lack of proper bonding, which could lead to significant injury or worse.

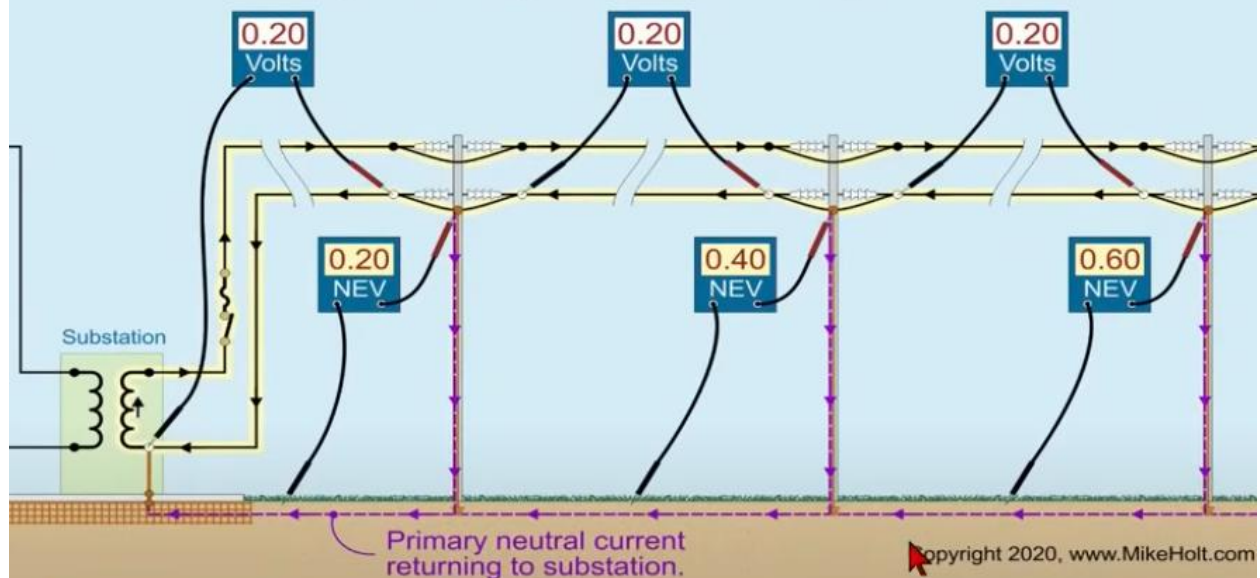
Neutral-to-Earth Voltage (NEV) Utility Primary Neutral Voltage Drop

The voltage drop of the primary neutral conductor is dependant on the impedance of the neutral return path and the magnitude of the return current; $E = I \times R$.
