# RussMar Logistics, LLC.

Case No. 2012-00361<sup>362</sup>

The following documentation is being submitted by RussMar Logistics, LLC. on behalf of the Tompkinsville Natural Gas System.

1. Leak Survey(City): (24 pages)
2. Visual Inspection of Main: (1 page)
3. Leak Repairs: (26 pages)
4. Office Chart Clock: (18 pages)
5. Public Awareness Meeting(s): (Oct 1 & Oct 24)

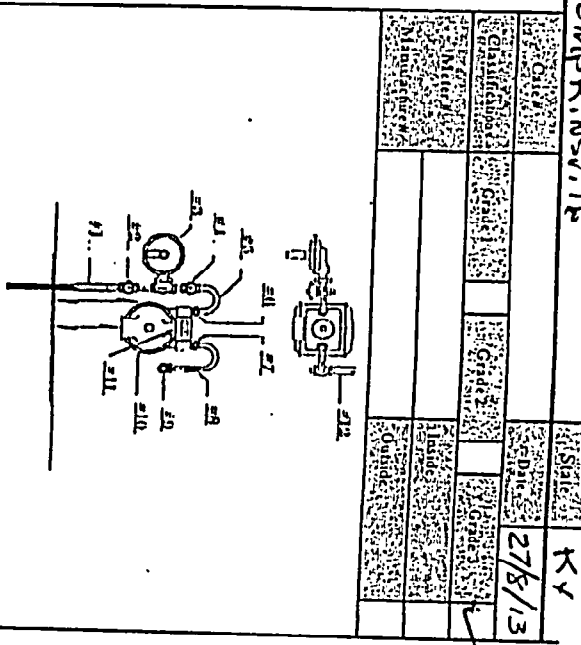
LEAK ON BOTTOM OF LOCK VALVE

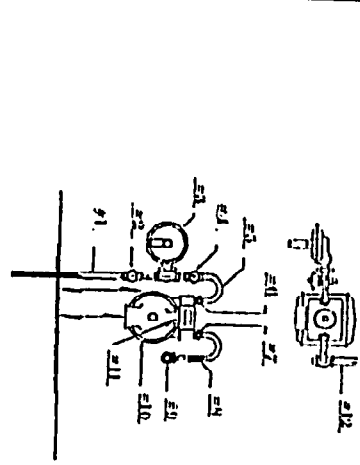
**LEAK ON 90' VAD TO STEPS INVERT SIDE**

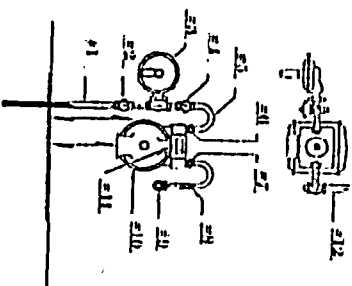
LEAK ON UNION AT RISER

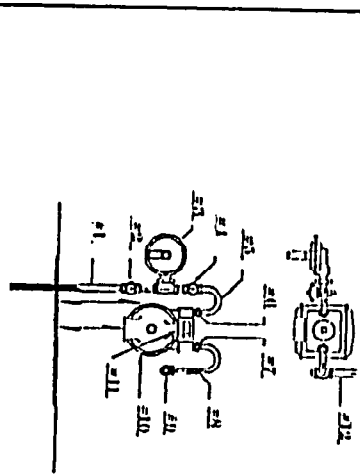
LENK ON TOP OF REDUCER ON INVERT SIDE

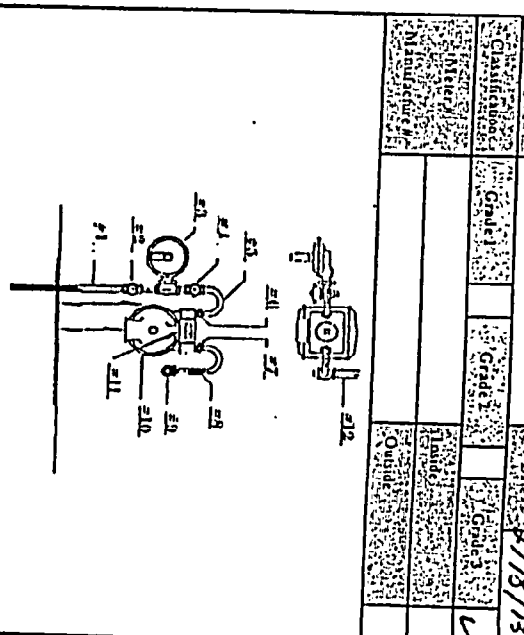
LEAK ON TOP OF LOCK VALVE

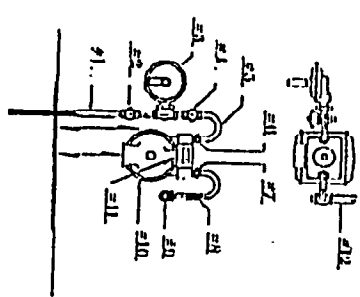
**LEAK ON BOTTOM OF REGULATOR**

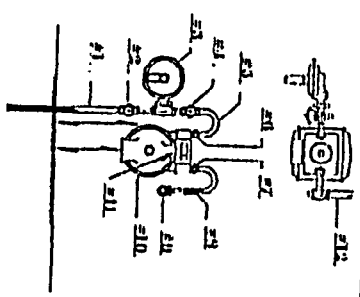
LEAK AT BOTTOM OF REGULATOR

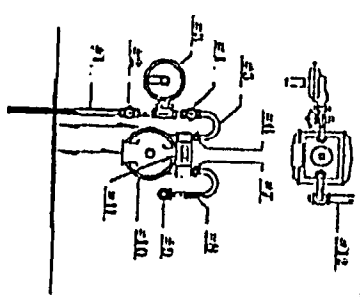
LEAK ON SPUD INLET

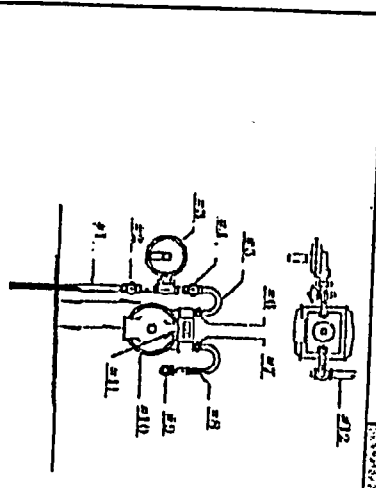
LEAK ON TOP OF LOCK VALVE

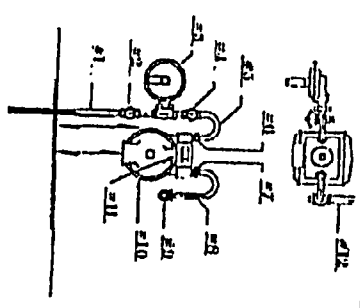
LEAK ON TOP OF LOCK VALVE

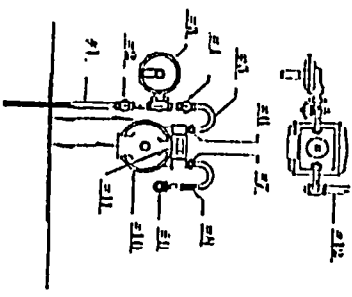
CLAMP ON RISER

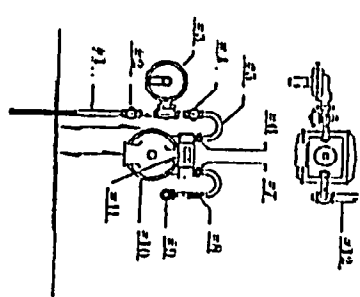
LEAK TOP OF LOCK VALVE  
AND TOP OF REGULATOR

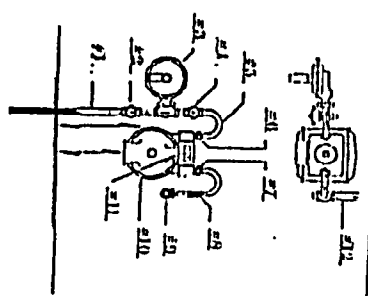
IN Ground LEAK AT RISER

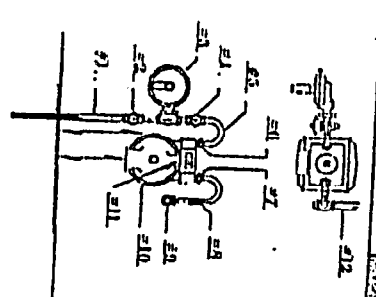
Lock valve was leaking through on an old service with no meter. We broke down the service & replaced the faulty lock valve. We then locked off the service & tested for leaks.

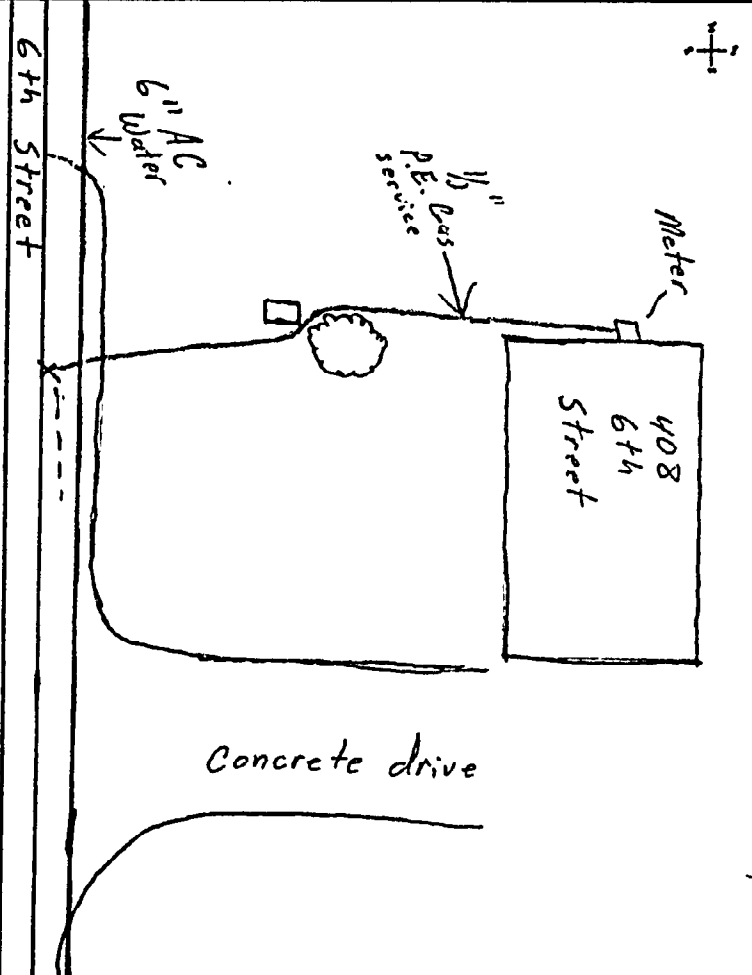
Leak found on compression tee. We cut it out + fused a PE tee back in place.

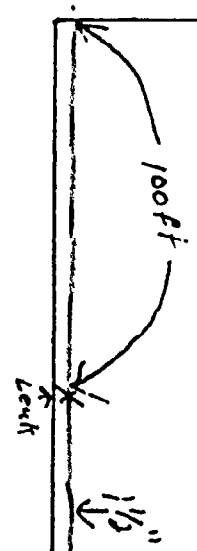
Castle Heights Rd

Found leak on 1/2" line.  
 A weld was leaking from corrosion.  
 We put a repair clamp on to temporarily repair it.
