Case No. 2012-00362

The following documentation is being submitted by RussMar Utility Management, LLC. on behalf of the Tompkinsville Natural Gas System.

1. Leak Survey (Business District)- June/July, 2014
2. Odorometer Readings- June & September, 2014
3. Patrolling- a. Business District- March, 2014
b. Outside Business District- June, 2014
4. Third Party Excavation Inspection- June 23, July 1 & 11
5. Natural Gas Main & Service Installation Records- May 21, June 16, July 21
6. Visual Inspections of Mains & Service Pipelines-May 29, June 11 & 18-24, August 8 & 20, September 17.
7. Main * Service Abandonment Report- June 4, 11, 24, September 18
8. Leak Repair- August 13
9. Office Chart Clock

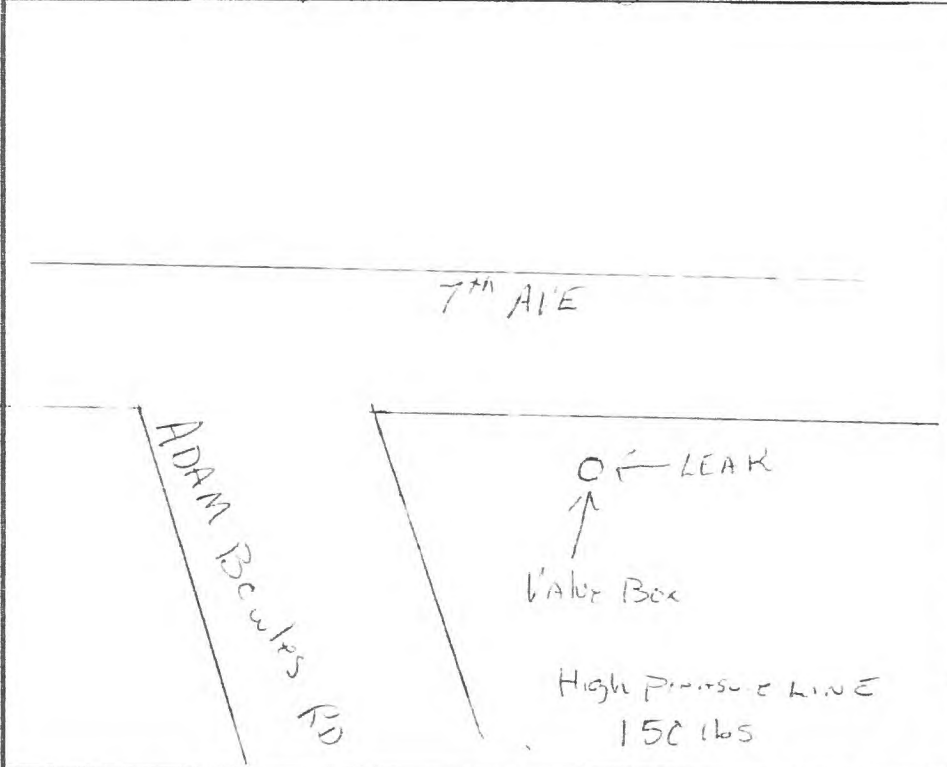
LEAK ON INLET SP-d

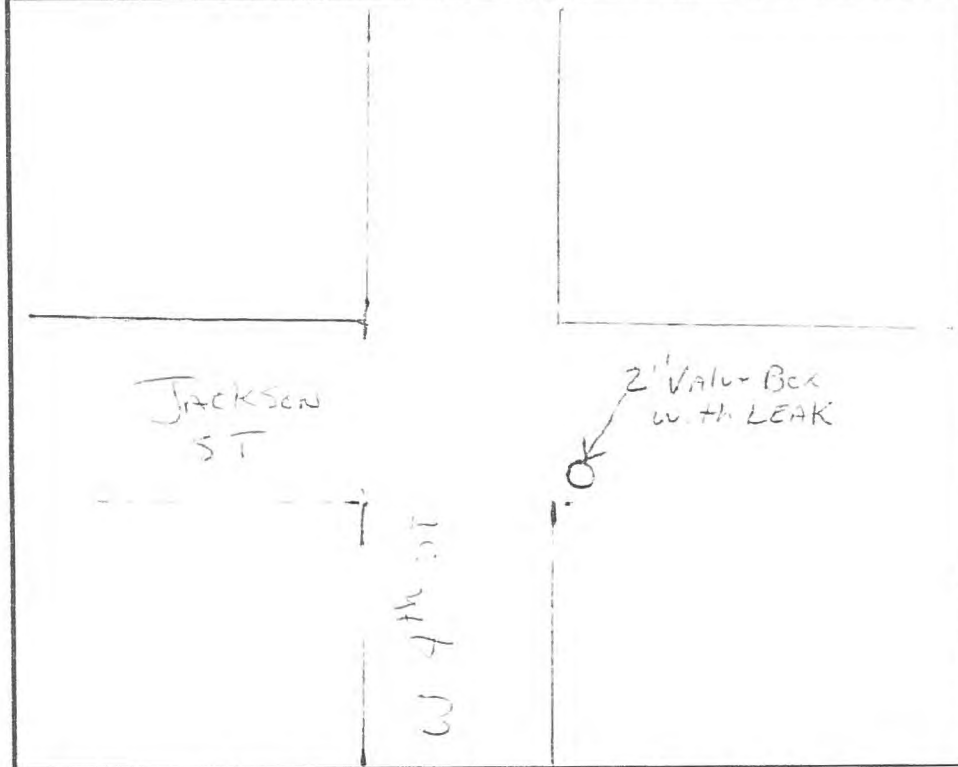
LEAK IN INLET SWIVEL

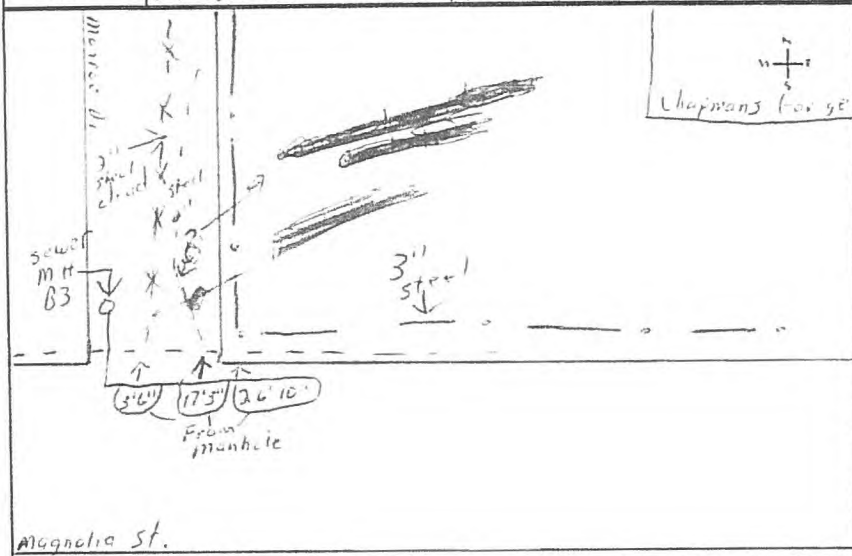
Sewer main replacement

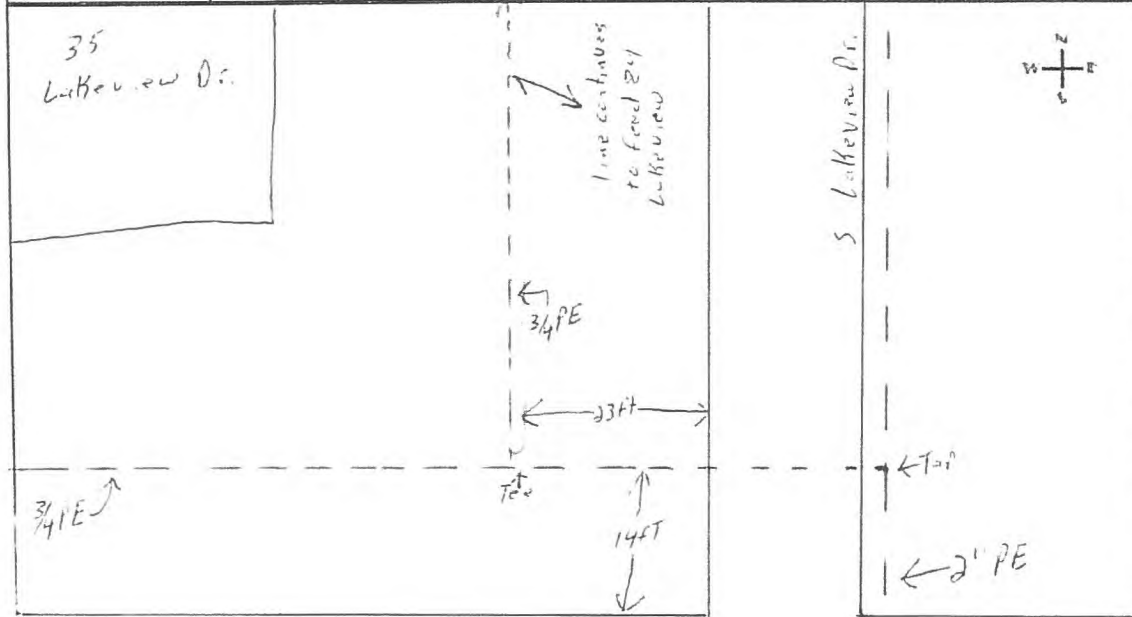
Meter Locked	Yes	No	Card Left	Yes	No
LOCATION					
Gas Main Location					
Mainline Valve Installed	Yes	No			
Service Location					
Service Valve		Tapping Tee			
REMARKS					
The 3/4" PE circled in red was believed to be capped off & not in use. The homeowner at 35 Lakeview was going to do ground work in the location. We cut & capped the line back out of the way for him to work. We later found that the service continued down the street & crossed the road to feed another home. We had to put it back together & restore service. We had no way to trace the line.

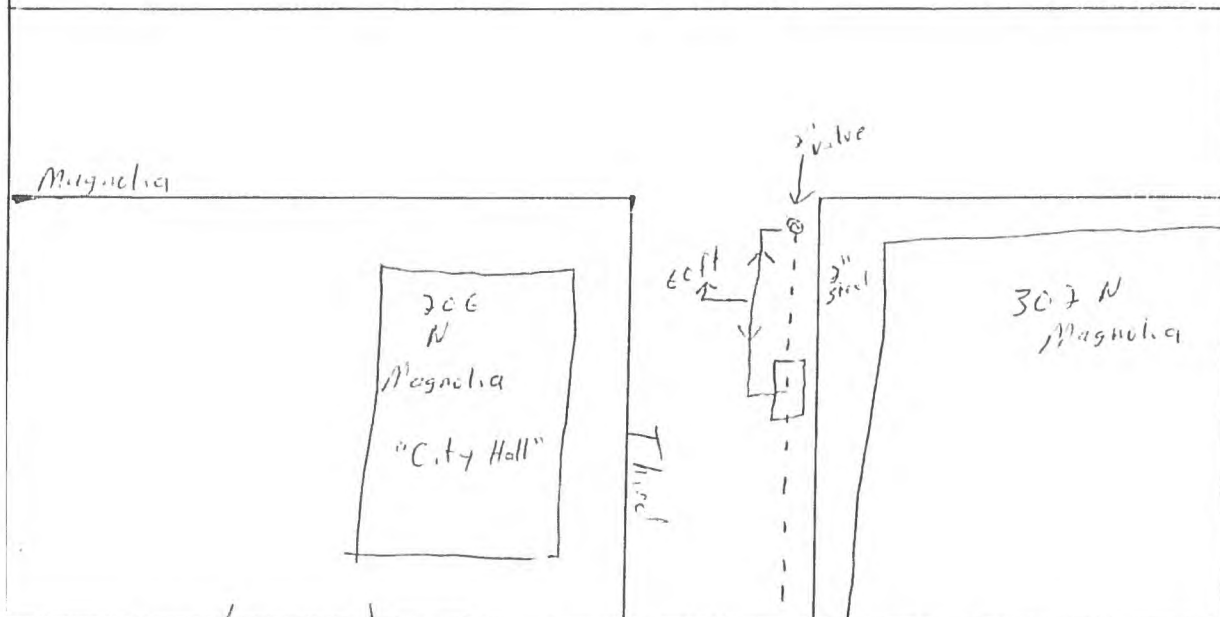
Description/Comments: Day out for gas leak repair. Found no leak in area after digging w/ll continue to search. 6-11-14

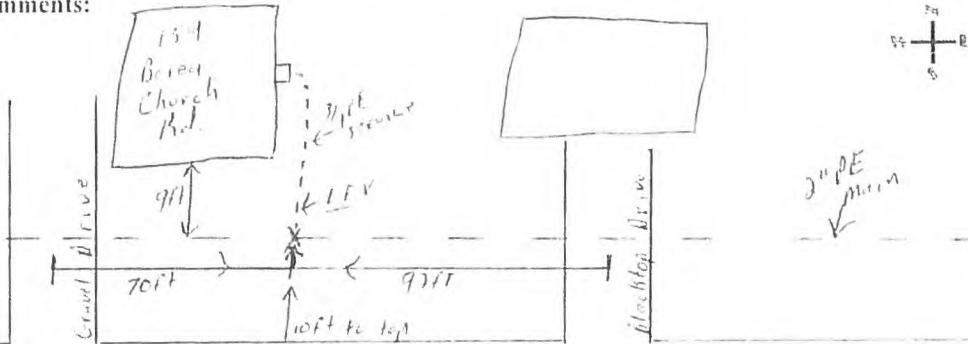
2" PE is approx 10ft off road edge at the top

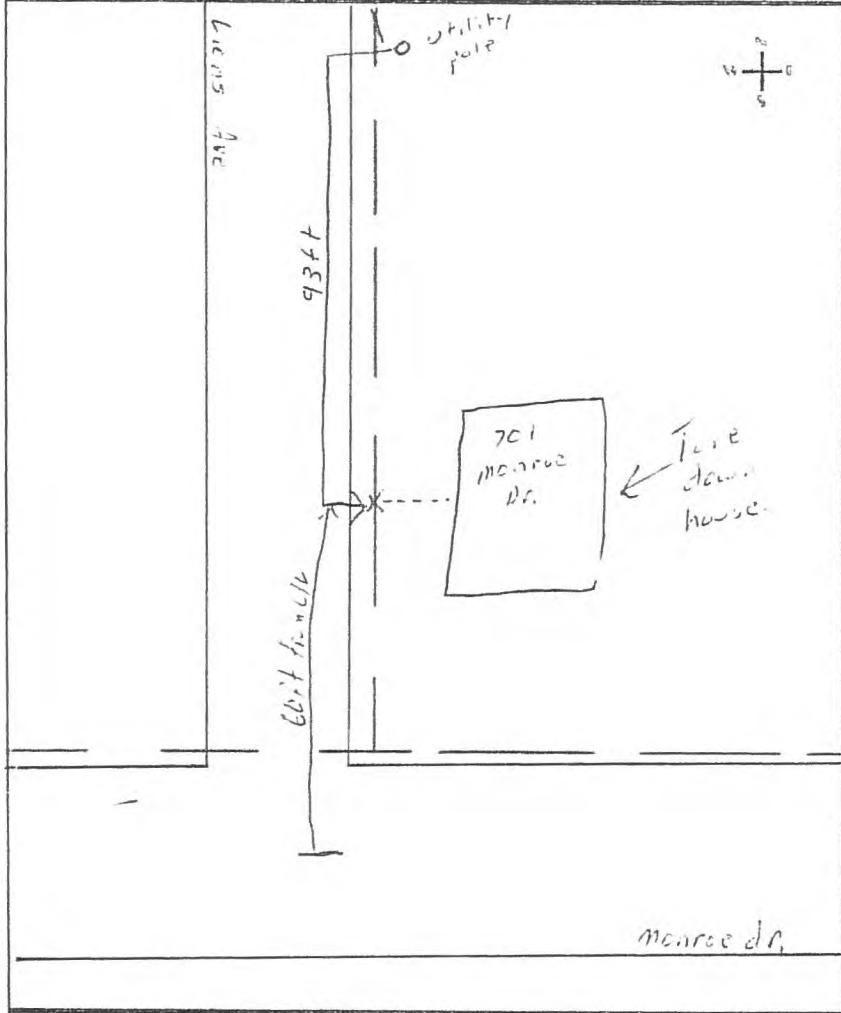
REMARKS					
This tap was completely removed except for a 2ft stub coming off the main. We welded a 3/4" cap on the end & removed the rest including the riser. The main is 40" deep. The house has been tore down.
