FIELD VISIT REPORT

KENTUCKY PUBLIC SERVICE COMMISSION (KPSC)

Evaluation of Kentucky Power's (Ky. Power) performance during the December 2009 snow storm.

KPSC Photographs of Affected Area

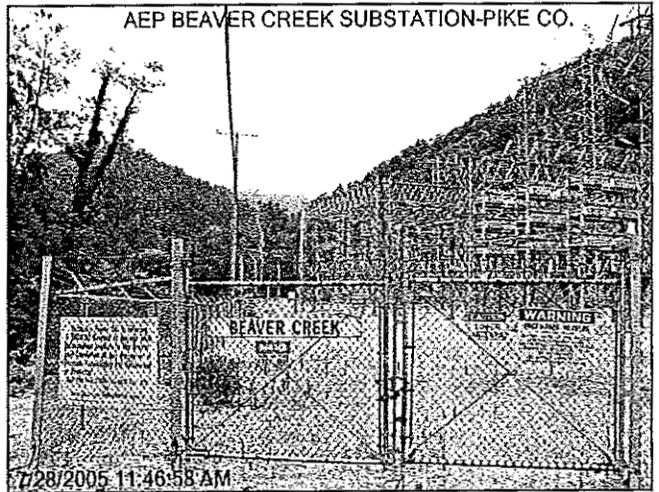
AEP BEAVER CREEK SUBSTATION-PIKE CO.

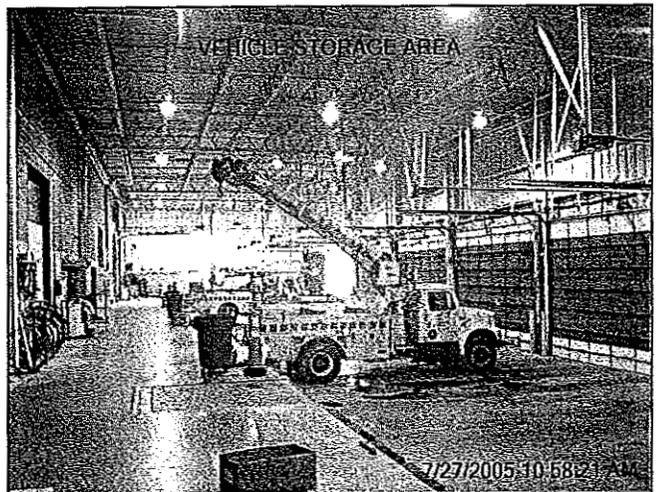
VEHICLE STORAGE AREA
