KY PSC & PHMSA Pipeline Safety Seminar 2010

Lessons Learned and Other Safety Related Topics

Ronald Six
Senior Utility Consultant
Loss Control Division
AEGIS Insurance Services, Inc.
201/417-2487
RonaldSix@aegislimited.com

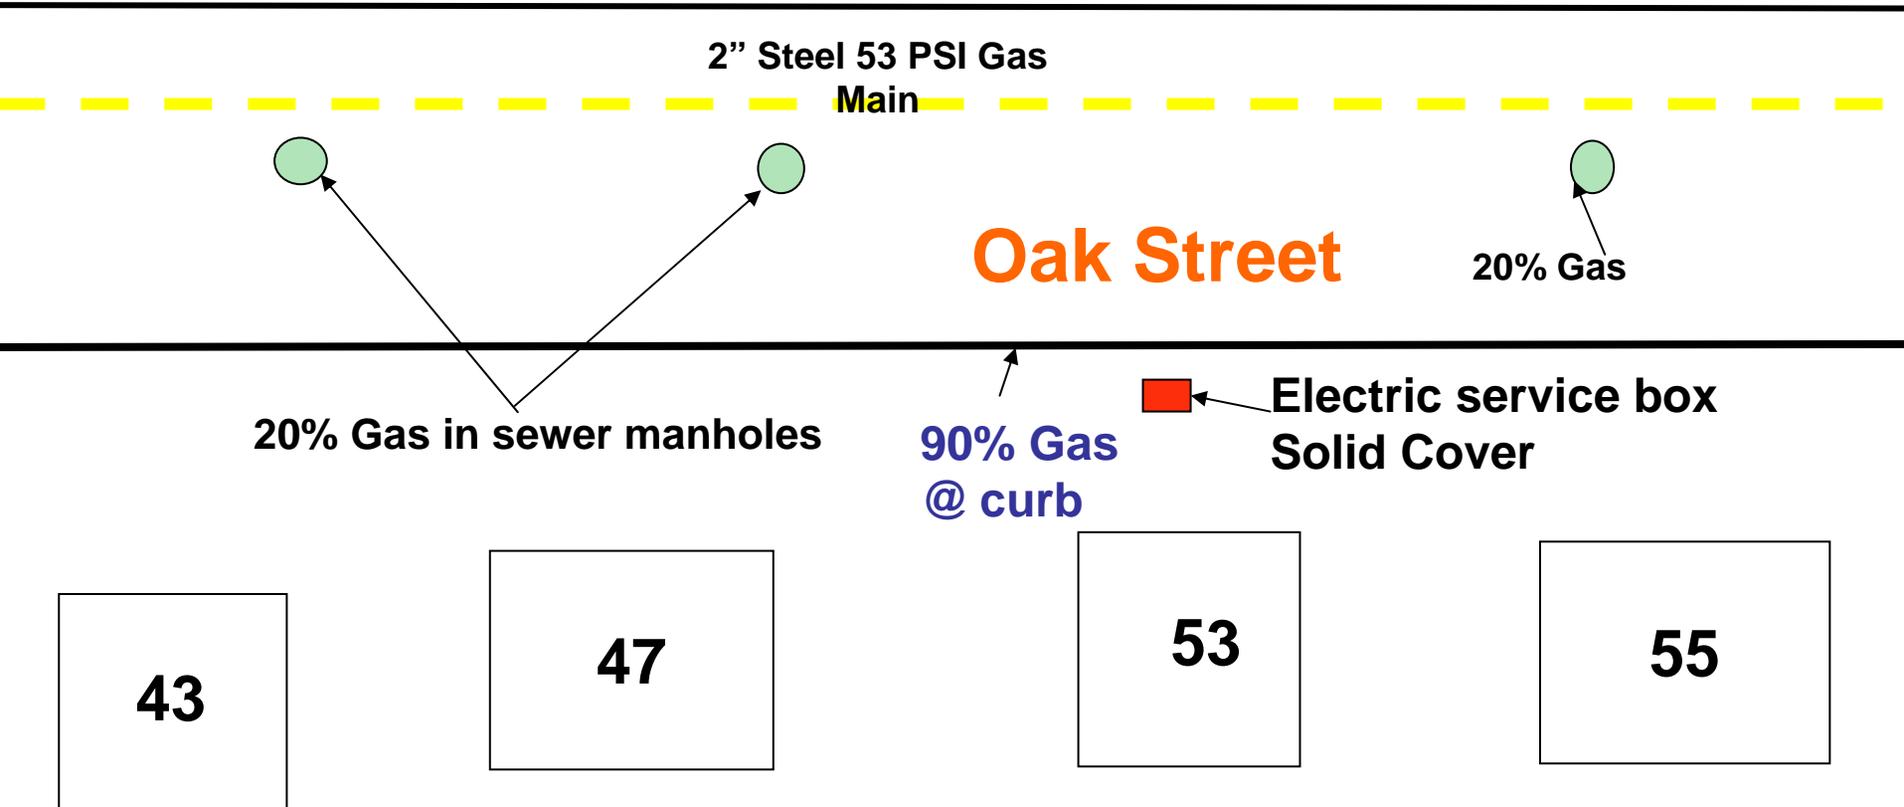
Gas mechanics arrive and they lift the cover on the electric service box and They get a 80% gas in air reading.

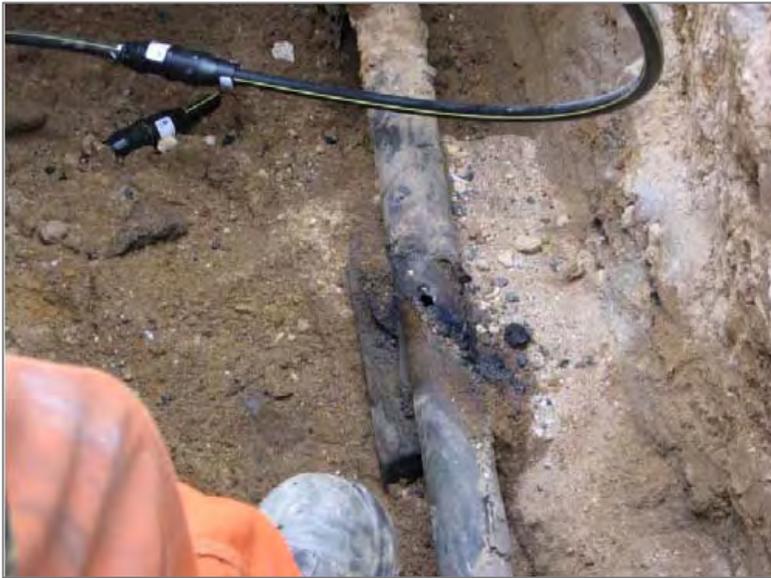
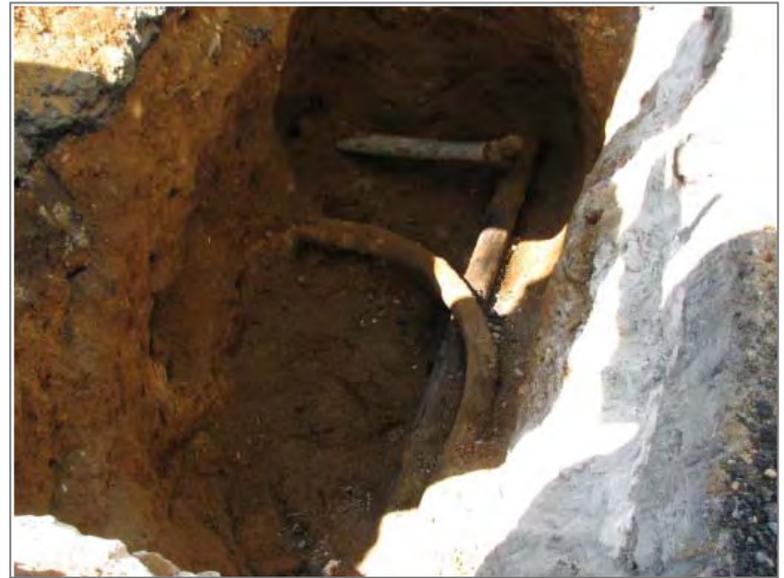
Cause of the leak attributed to a short in electric service cables caused current to flow onto the steel gas main where they crossed. Arcing created holes in both the electric conduit and the gas main.

Hole Made When Shorted Electric Cable Arced Over To Gas Main

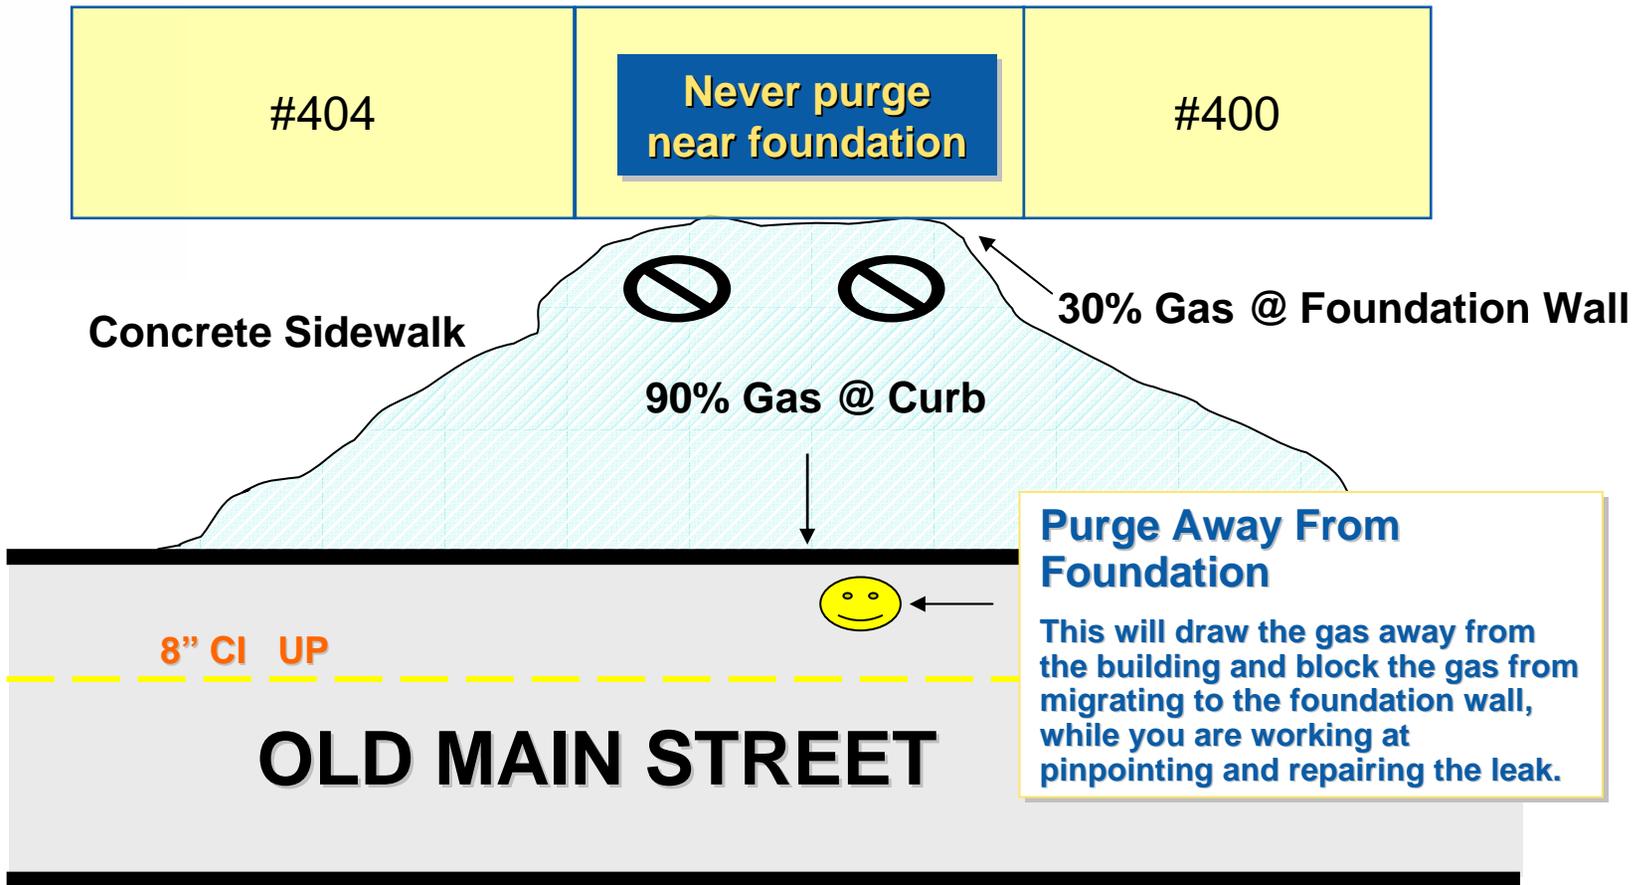
90% Gas @ Curb

30% Gas @ Foundation Wall

Never purge near foundation

Purge Away From Foundation

This will draw the gas away from the building and block the gas from migrating to the foundation wall, while you are working at pinpointing and repairing the leak.

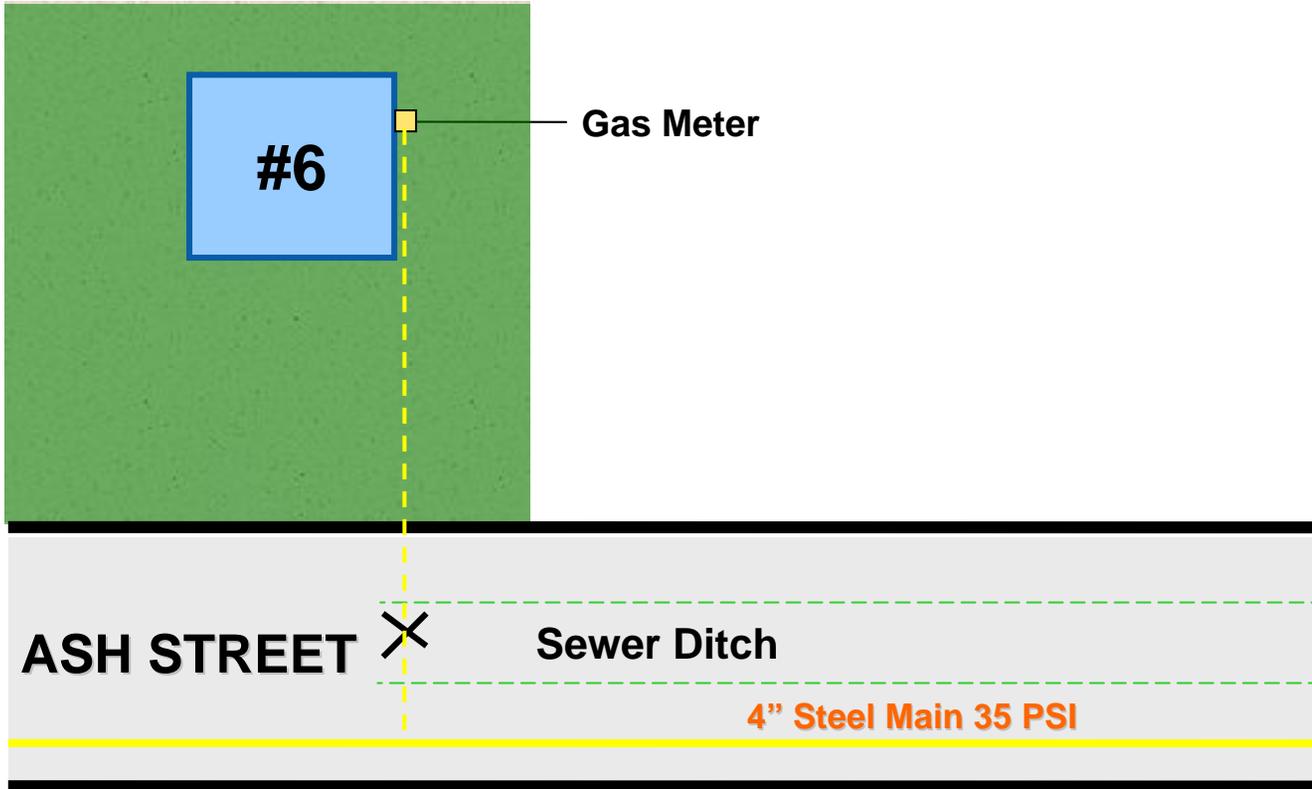
Figure # 1

A contractor has snagged the 1" steel service and bowed it in the ditch. A small hole was made in the line and gas is blowing in the ditch.
