Commonwealth of Kentucky  
Public Service Commission

REPORT ON THE COLLAPSE OF A  
HARDIN COUNTY WATER DISTRICT #1 STANDPIPE

February 7, 1986

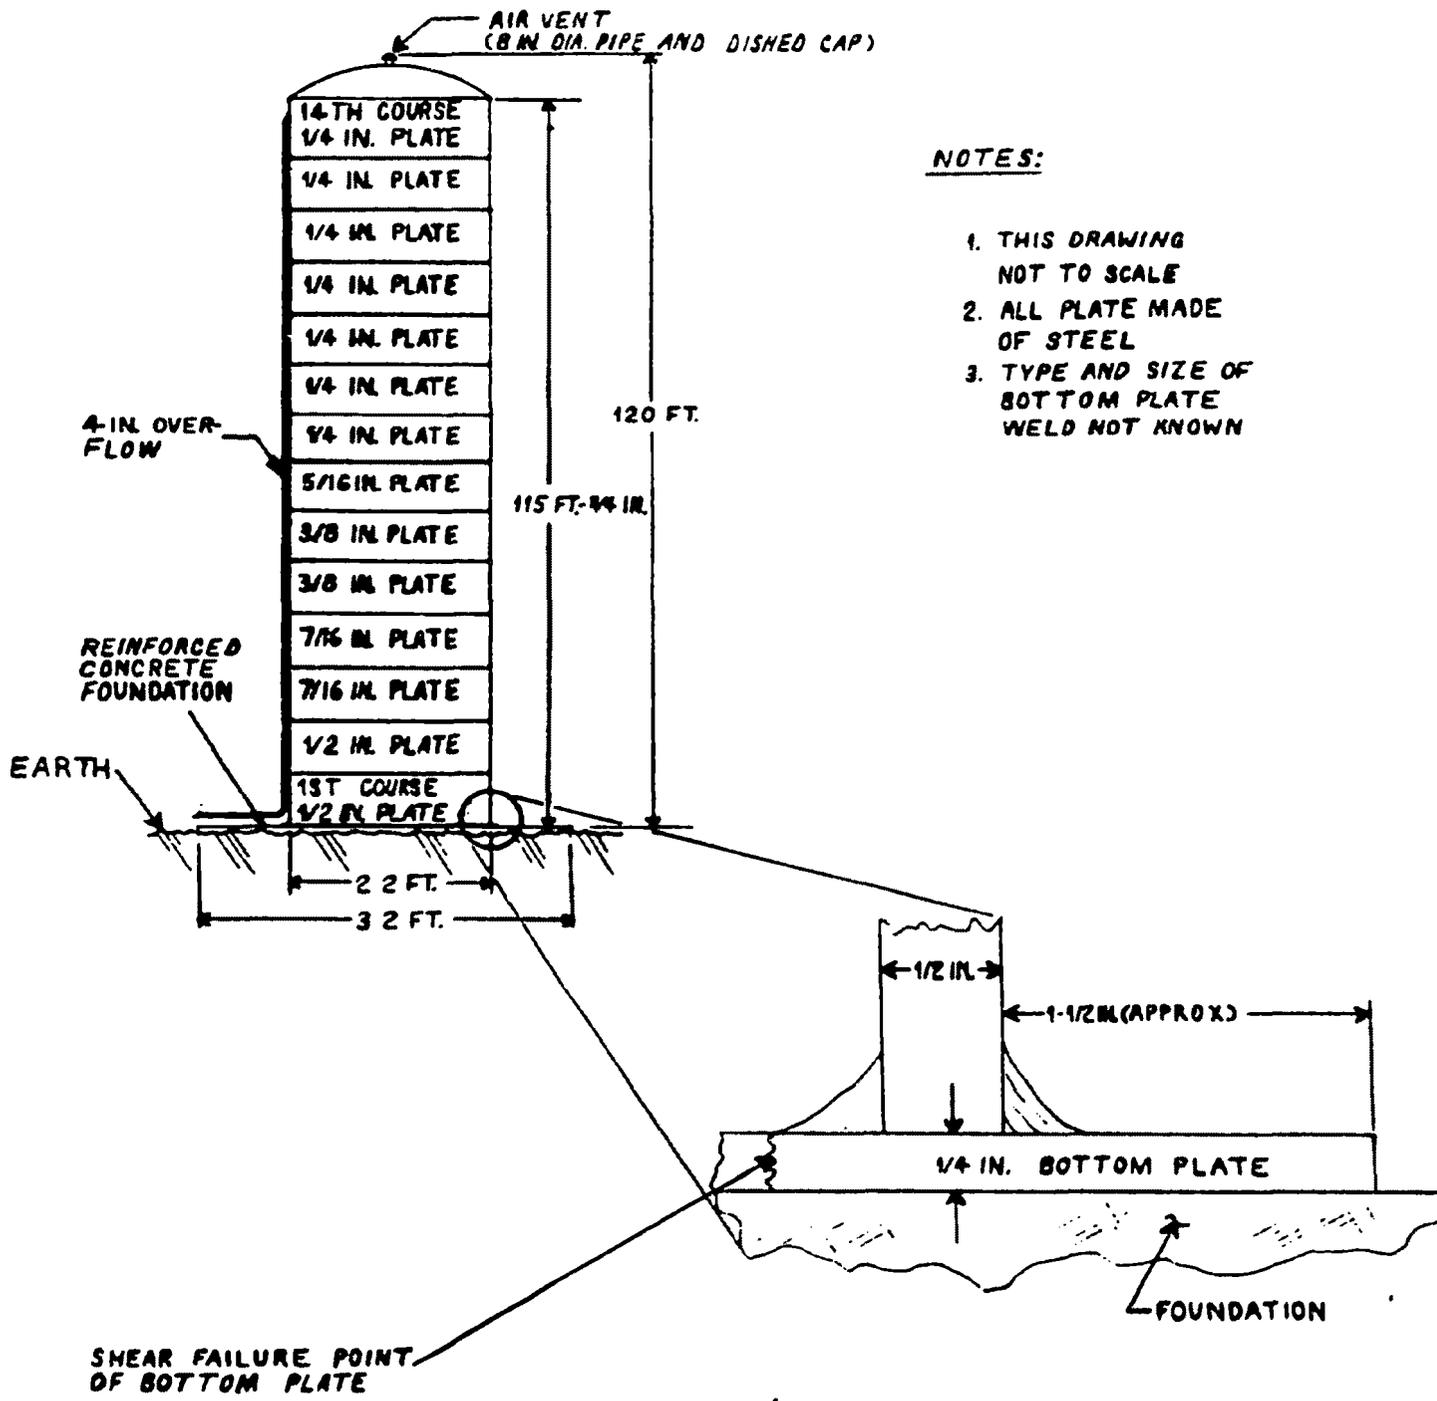
**FIGURE 2. STANDPIPE CONSTRUCTION DETAILS**

The walls of the standpipe had stood on a 1/4-inch thick bottom plate, and were welded to the plate to prevent leakage. This plate was previously mentioned and appears on the circular foundation in the photo. Figure 2, along with providing some detail of the overall structure, includes a cross-sectional view of the wall to bottom plate weld. As seen in the drawing, the tank wall was sealed to the bottom plate with welds on both sides. When the failure occurred, the bottom plate broke from the inside of the interior weld, as the drawing indicates. The circular part of the plate inside the tank stayed on the foundation, while the ring of plate outside the weld went with the rest of the tank. The part of the plate that stayed on the foundation was dished up along its southern edge, and flat along the northern edge. The wreckage of the tank shows that a rupture occurred at the base, and that another occurred midway up the tank.

Under a condition of sufficient internal pressure, the tank structure would begin to lift off its base by deforming the attached bottom plate. The bottom plate would tend to take on a dish-shaped contour by stretching, and bending at the weld connection to the wall of the tank. Evidence of this stretching appeared along the southern edge of the bottom plate, which was dished up off the foundation. Edward Bedell, the metallurgical consultant of the insurer, commented that the metal in the base plate, to which the walls were attached, was brittle. This means the metal in that area would tend to break while undergoing stretching or bending. It appears likely that failure occurred when this deformation took place. When the base ruptured, water

mid-height rupture was 1/4" thick. The corresponding welds should have been fabricated by an edge to edge, or butt, weld. Such a joint would require full penetration of the weld, meaning there would be solid weld metal equal to the thickness of the original steel plates at each joint. After the collapse both the insurer's metallurgist and the Commission staff observed that ruptured joint contained far less weld metal than the fabrication drawings called for. Stress calculations by the staff indicate that the poorly made joint may have been only marginally adequate to handle the normal pressure in that area of the tank. When the poorly made joint ruptured, a fairly uniform width of metal ripped open in the side of the tank, and spread horizontally in both directions. This meant there was no longer any support for the top of the tank, which proceeded to collapse onto the overturning lower section of the silo-like structure.
