COMMONWEALTH OF KENTUCKY
BEFORE THE PUBLIC SERVICE COMMISSION

SHOW CAUSE ORDER

ELECTRICAL UTILITY ACCIDENT INVESTIGATION

INVESTIGATION OF AN ACCIDENT IN
BIG RIVERS ELECTRIC CORPORATION, COLEMAN PLANT

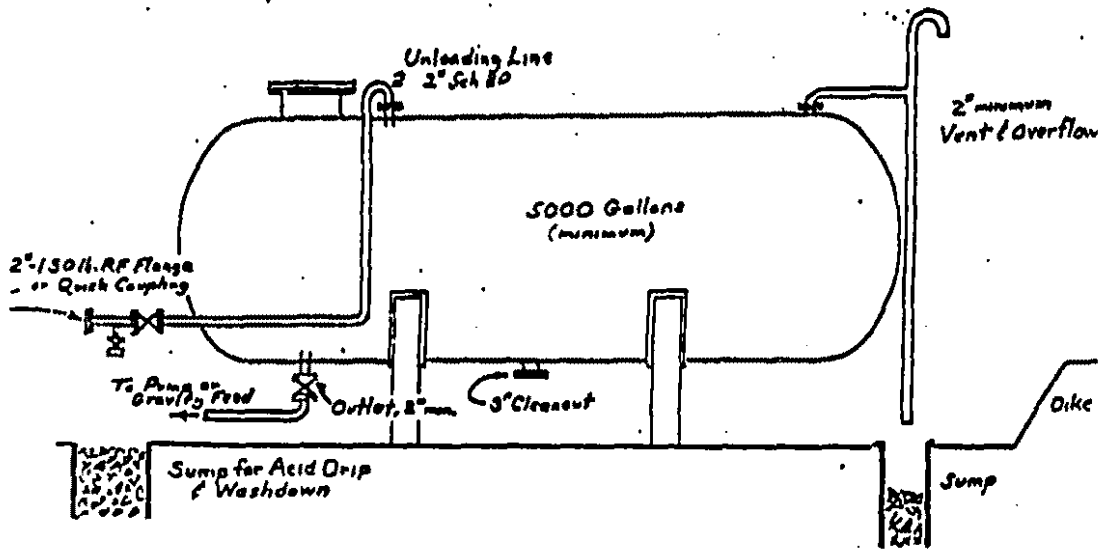
Figure 1

The tank was constructed with a vent. The purpose of the vent connection is to release the vapor mixture from the top of the tank. An overflow line is used to drain the excess acid in case of overloading the tank. The overflow line and the vent line may jointly be connected to the vent nozzle as shown in Figure 1, page 6.

4. A vent and overflow is shown in a typical tank's drawing as shown in Figure 1.

Typical Sulfuric Acid Storage Tank Arrangement

Tank 1 was not appropriately vented. There was no vent line connected to the outside of the tank's vicinity. The 2-inch overflow line, which was found broken, was inappropriately considered a vent line. The overflow line is used in case acid Tank 1 is overfilled during loading. A vent is recommended for a sulfuric acid tank because of formation of hydrogen gas in the vapor phase. Since hydrogen and air make an explosive mixture (4 to 74.2 volume percent hydrogen), it is essential to connect a tank vent to a point outside the basement and preferably with a flame trap and/or a desiccant dryer. If the tank was idle for most of the days, the condition would be even more hazardous.

2. A proper vent should be installed on the tank to release the hydrogen into a safe area outside the vicinity of the tank.
