COMMONWEALTH OF KENTUCKY  
BEFORE THE PUBLIC SERVICE COMMISSION

SOUTH KENTUCKY RURAL ELECTRIC COOPERATIVE )  
CORPORATION )  
 )  
\_\_\_\_\_ ) CASE NO. 94-518  
 )  
ALLEGED VIOLATIONS OF COMMISSION )  
REGULATION 807 KAR 5:041 )

ELECTRICAL UTILITY ACCIDENT INVESTIGATION

INVESTIGATIVE REPORT  
PUBLIC ACCIDENT  
ELECTRICAL CONTACT

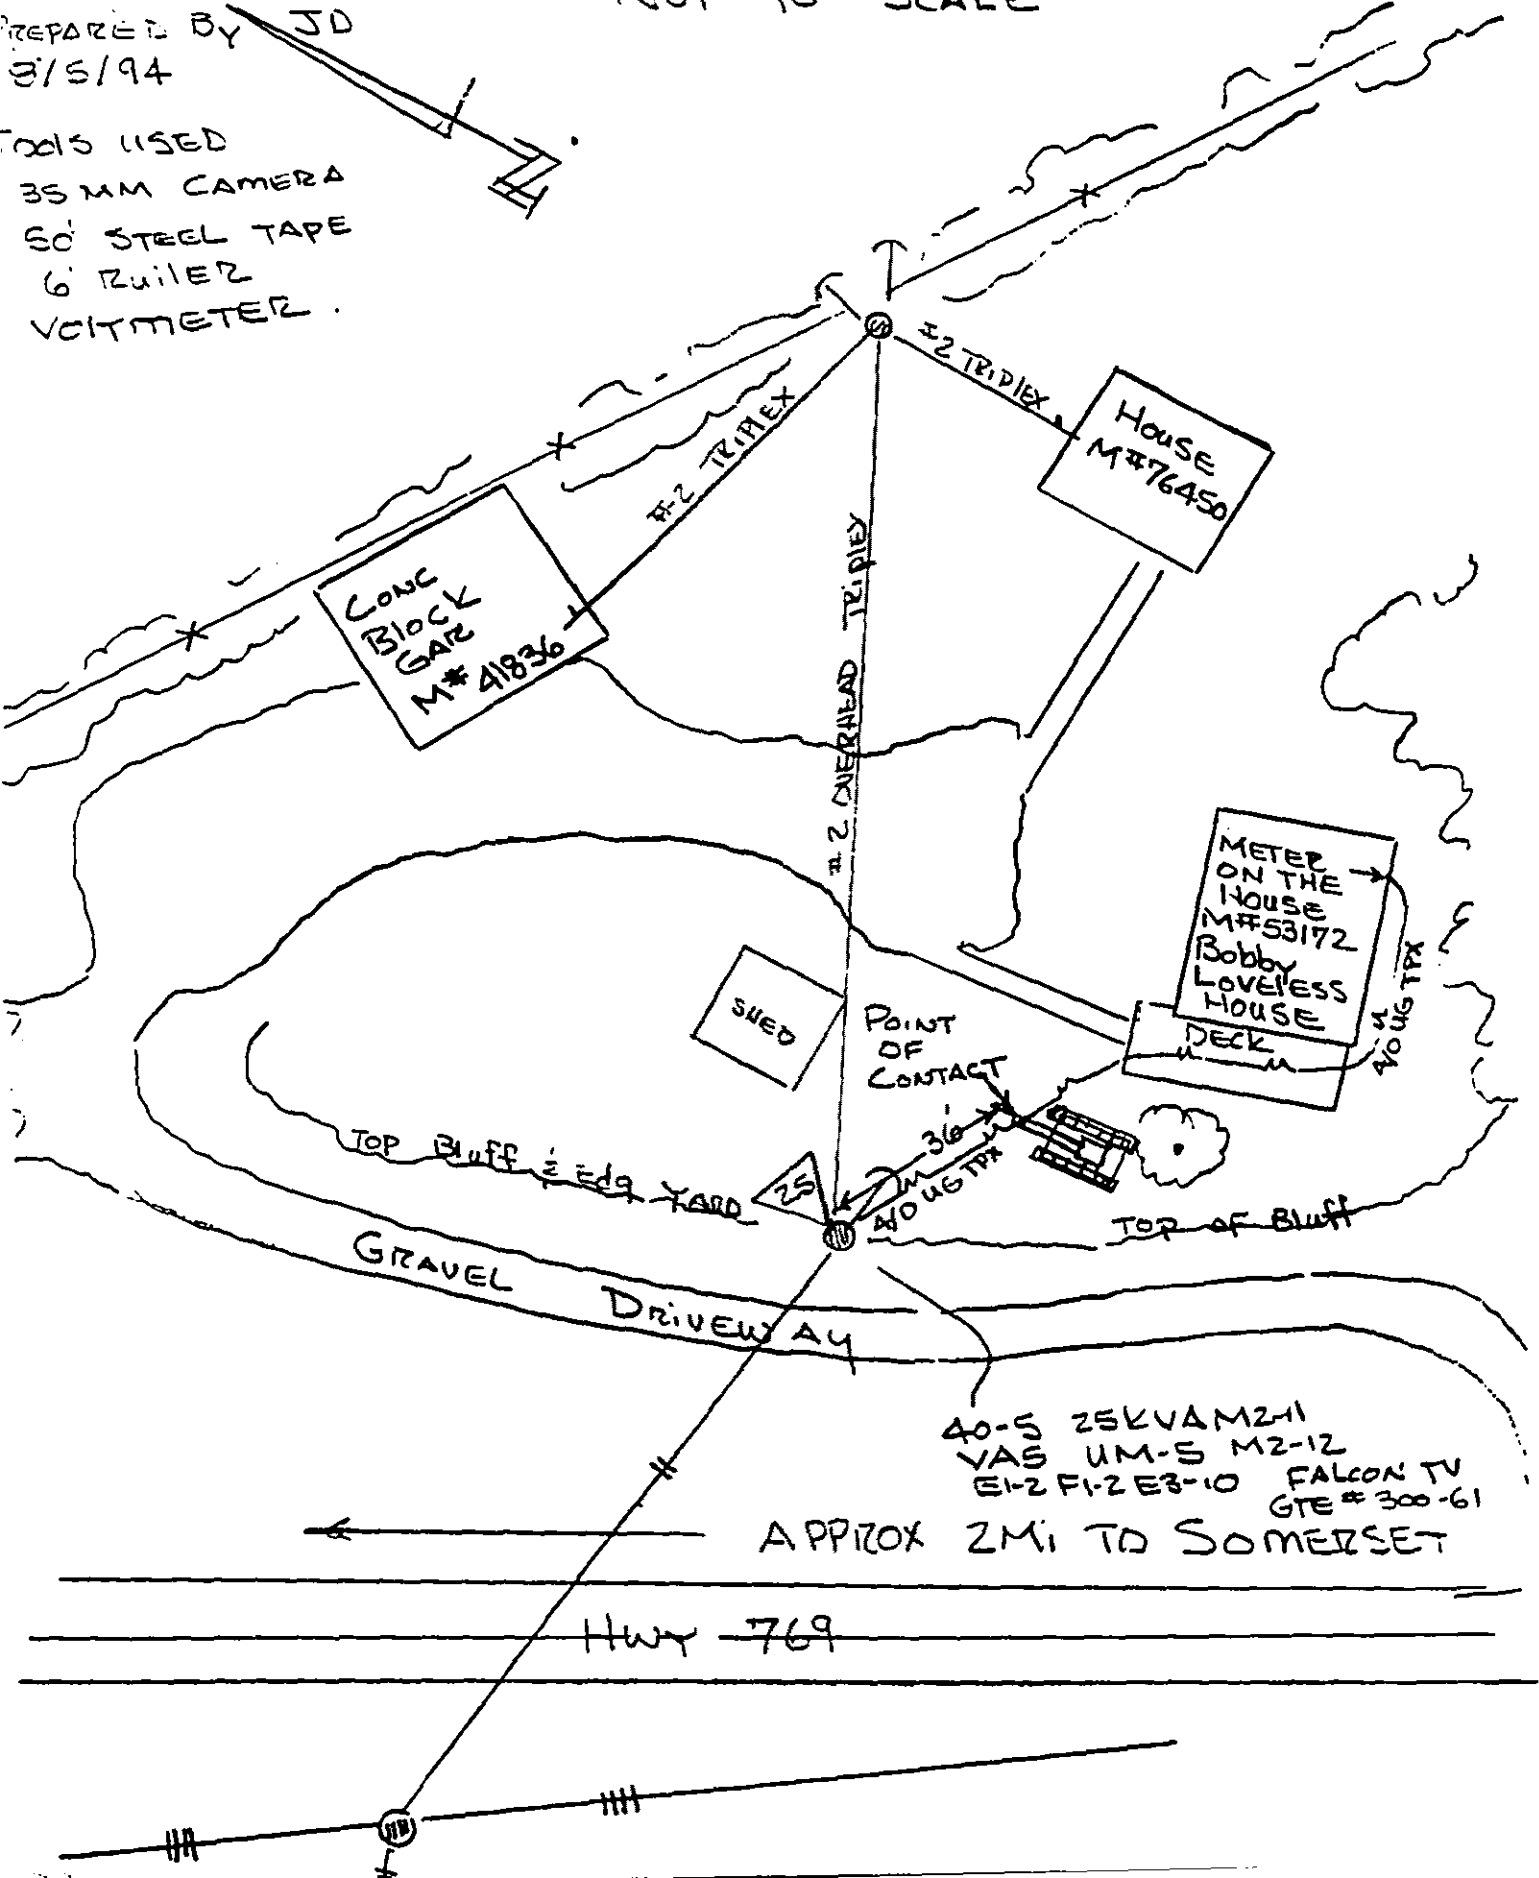
- NOT TO SCALE -

DESCRIPTION OF ACCIDENT Mr. Jeff Belcher was drilling holes with  
a track drill to blast a ditch for water lines. The drill bit  
contacted the underground 120V electric line. He received an  
electrical shock and was taken to the hospital. No request was  
made to South Kentucky RECC to locate the underground electric  
lines prior to the drilling. At the point of the accident, the  
buried underground electric line was 20 inches deep and at other

points the depth ranged from 15 inches to 26 inches; however, the majority of the line was less than 20 inches deep.

POINT  
OF  
CONTACT

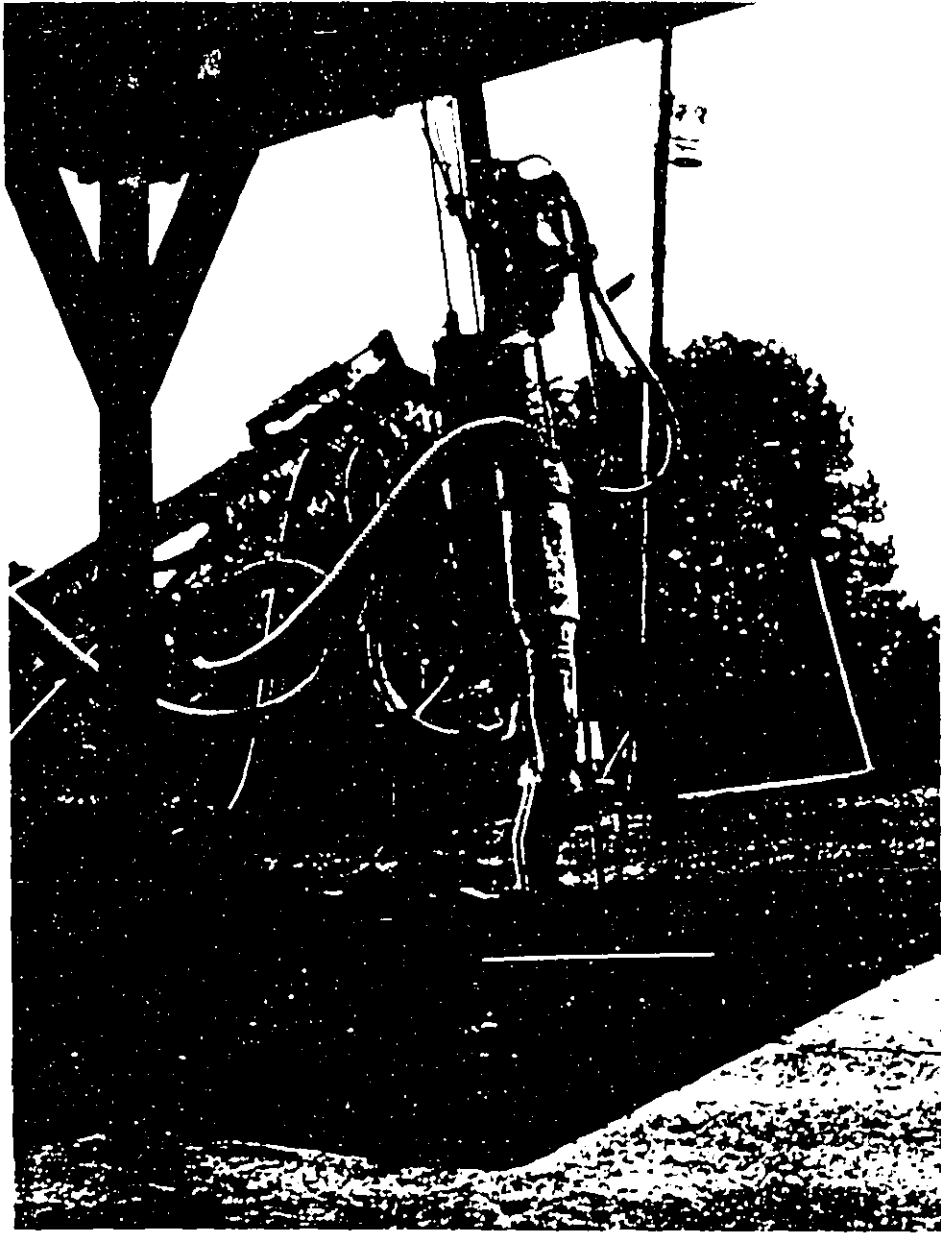
PICTURES TAKEN AT THE ACCIDENT SITE

PROBABLE VIOLATIONS There was one probable violation of Commission Regulations involved in this accident. The burial depth of the conductor was 20 inches, resulting in probable violation of 807 KAR 5:041, Section 3(1), Acceptable Standards, which requires compliance with the NESC. The 1990 NESC, Section 353(D2), requires burial depth of underground conductors with less than 600V phase-to-phase to be 24 inches. It should be noted that this violation didn't contribute to the accident.

SYSTEM Voltage-type & size conductor-type pole structures-etc.  
PROFILE: 120 Volt Underground Service Wire - Direct Burial Triplex Wire. The wire was installed in a 4-inch black plastic drain pipe. This is the service wire that runs from the transformer pole to the meter on the house.

CORRECTIVE ACTION South Kentucky RECC indicated that the underground electric conductor is scheduled to be relocated along with some overhead electric conductors due to the construction of new roads in the area. The relocation of the electric lines is expected to be completed within 60 days from the date of the accident. South Kentucky should insure that the burial depth of the new underground conductors meet the 1990 NESC requirements.
