COMMONWEALTH OF KENTUCKY  
BEFORE THE PUBLIC SERVICE COMMISSION

KENTUCKY POWER COMPANY D/B/A )  
AMERICAN ELECTRIC POWER )  
 )  
\_\_\_\_\_ ) CASE NO. 96-446  
 )  
ALLEGED FAILURE TO COMPLY WITH )  
COMMISSION REGULATION 807 KAR )  
5:006, SECTION 25(4)(d) )

UTILITY ACCIDENT  
 INVESTIGATION REPORT

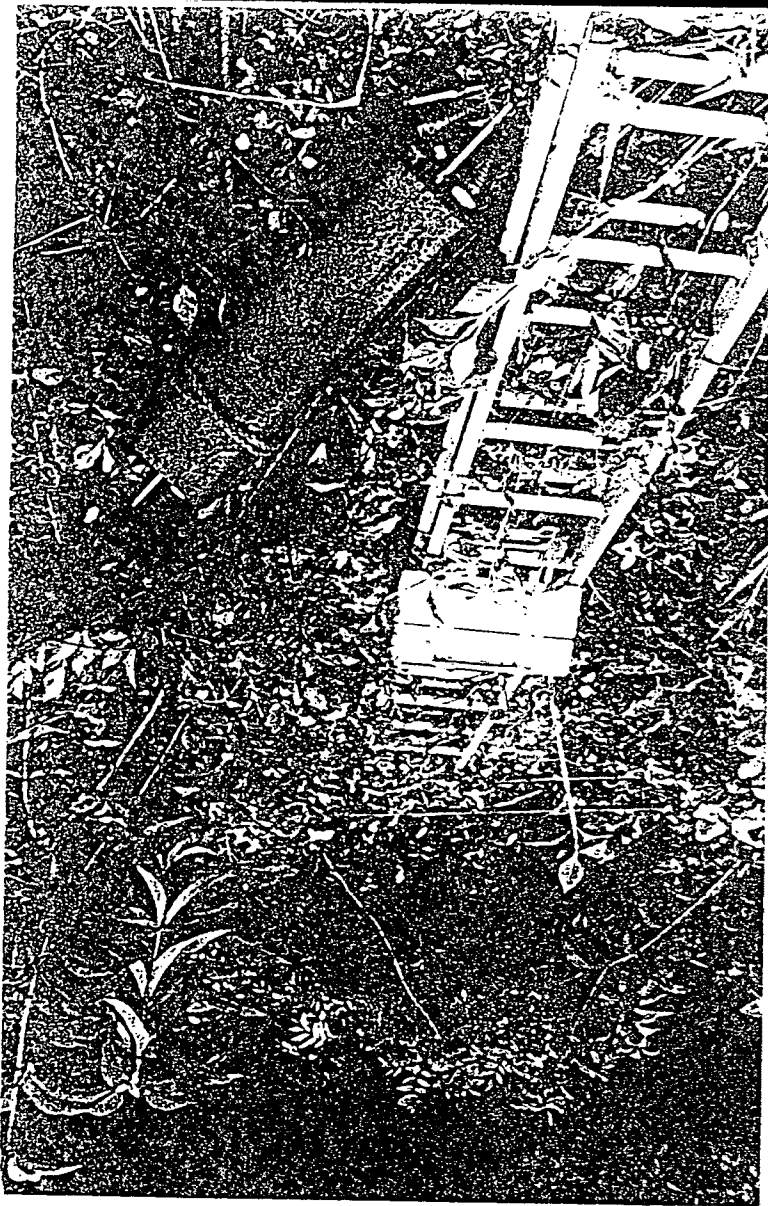
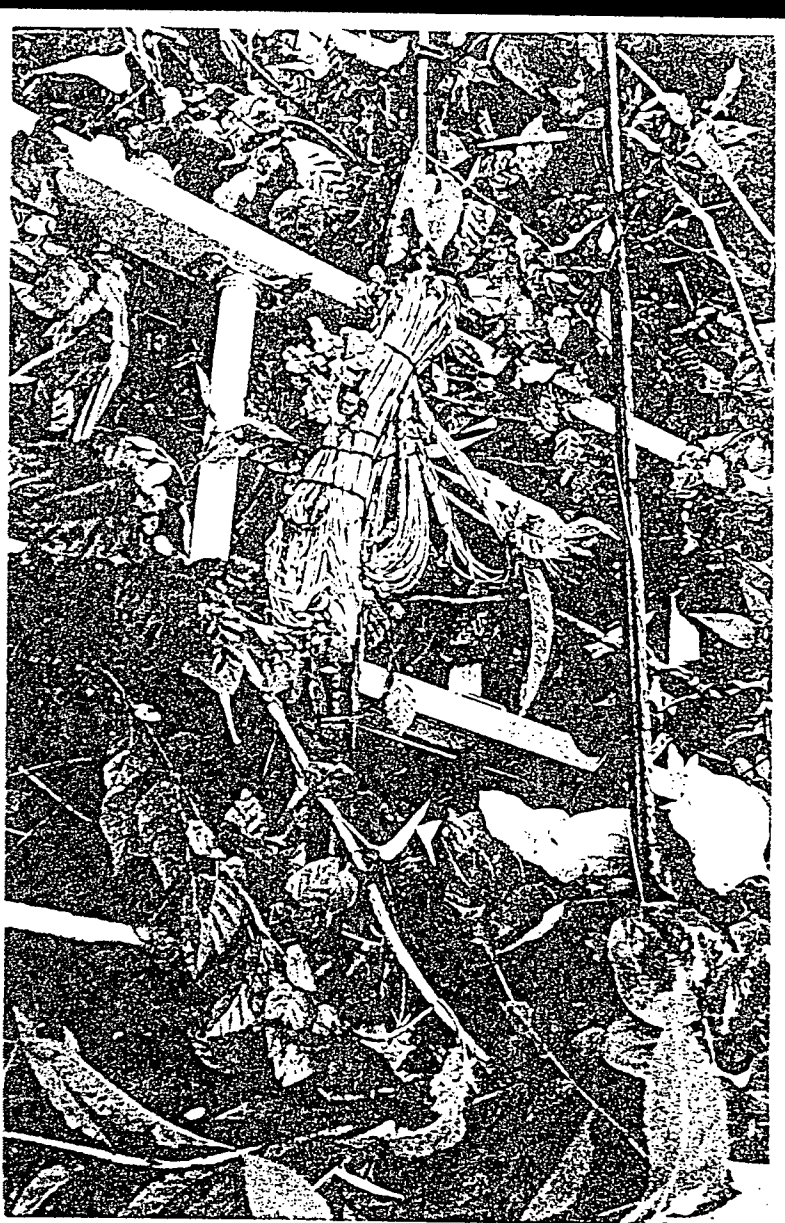
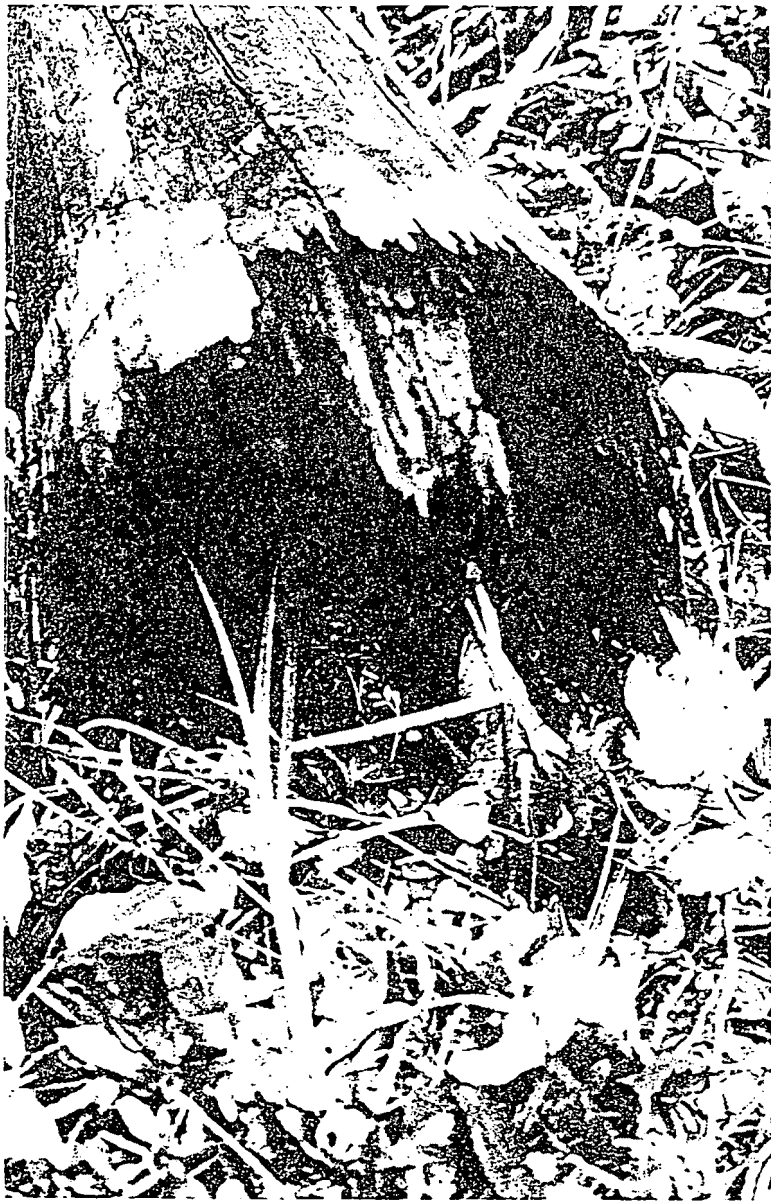
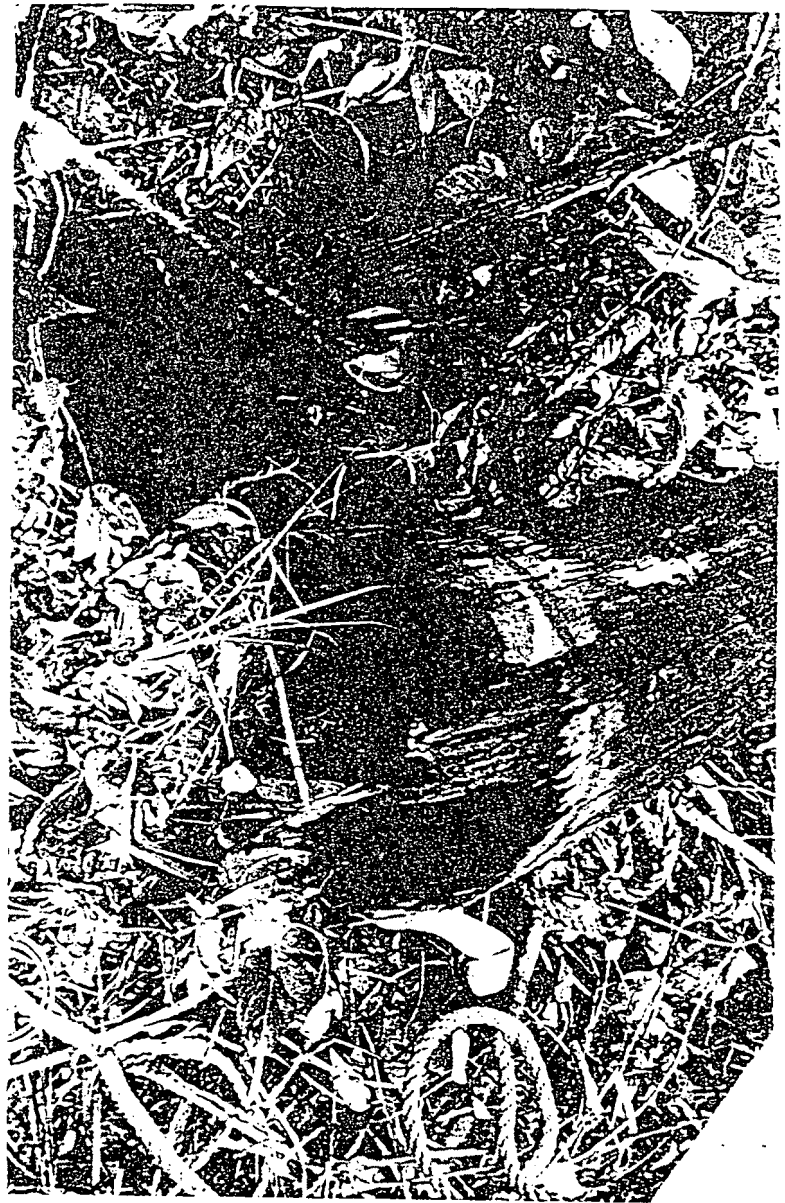
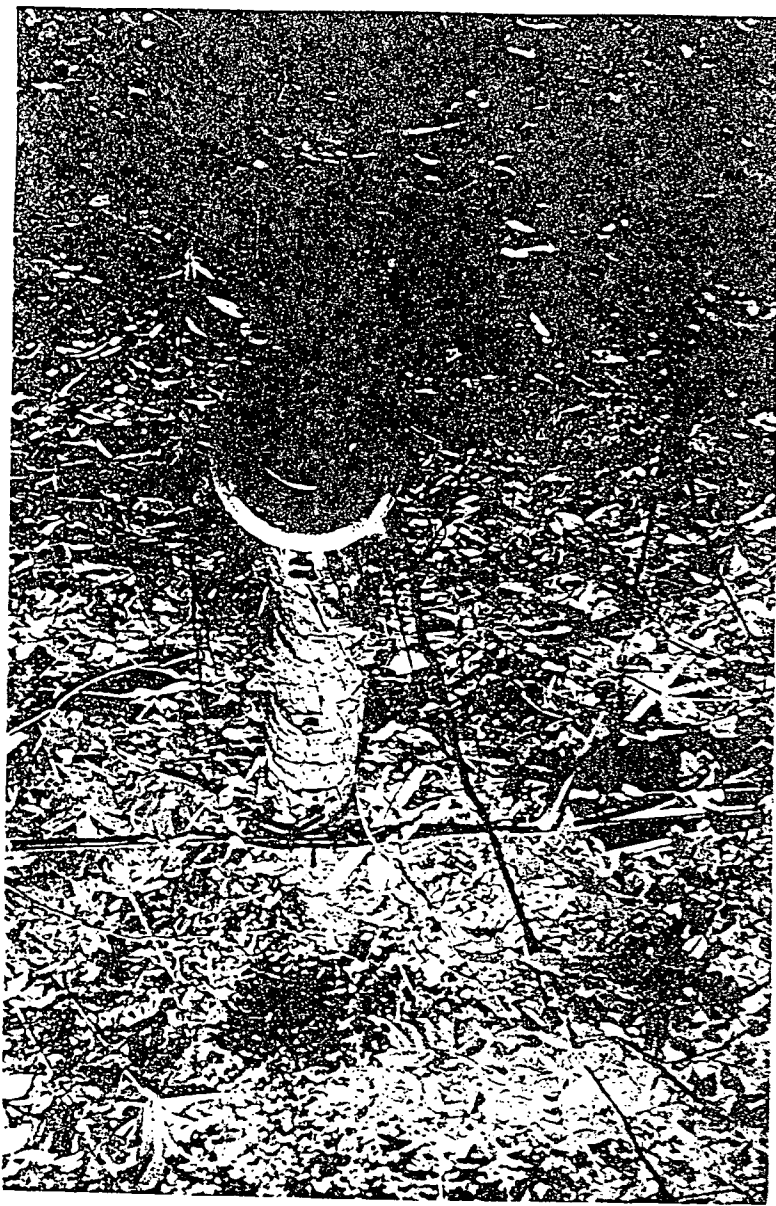
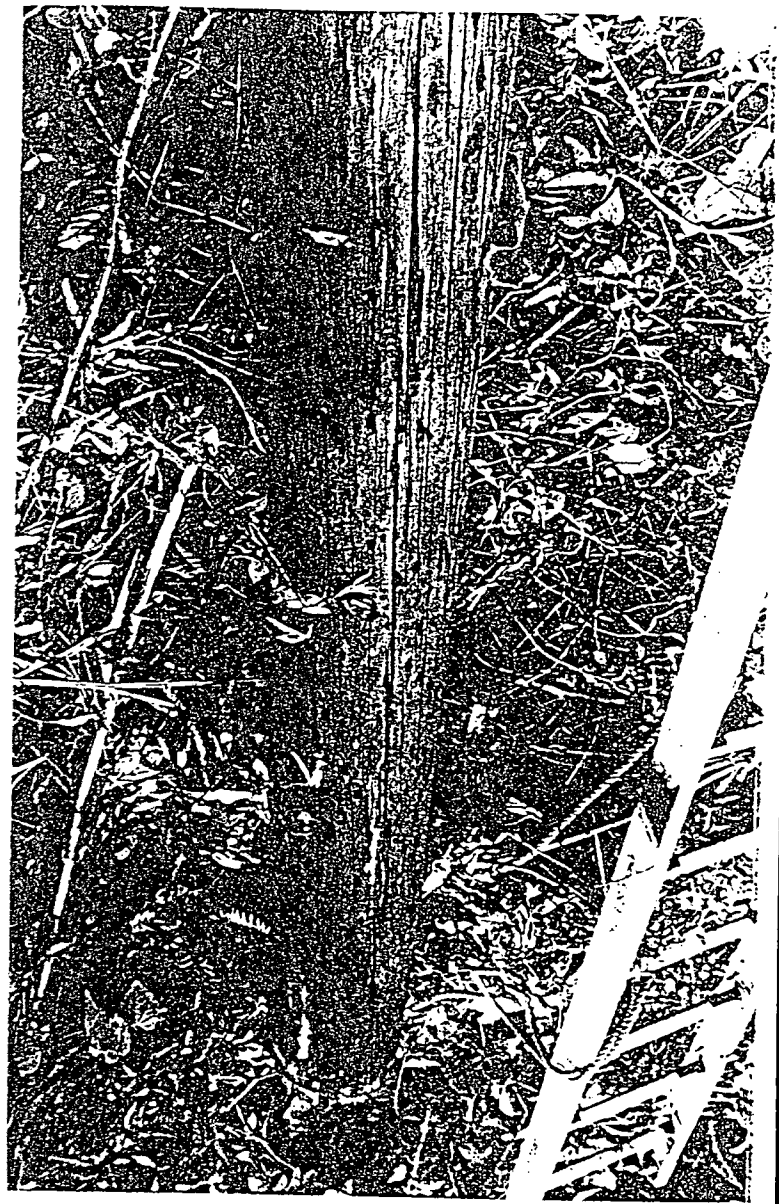
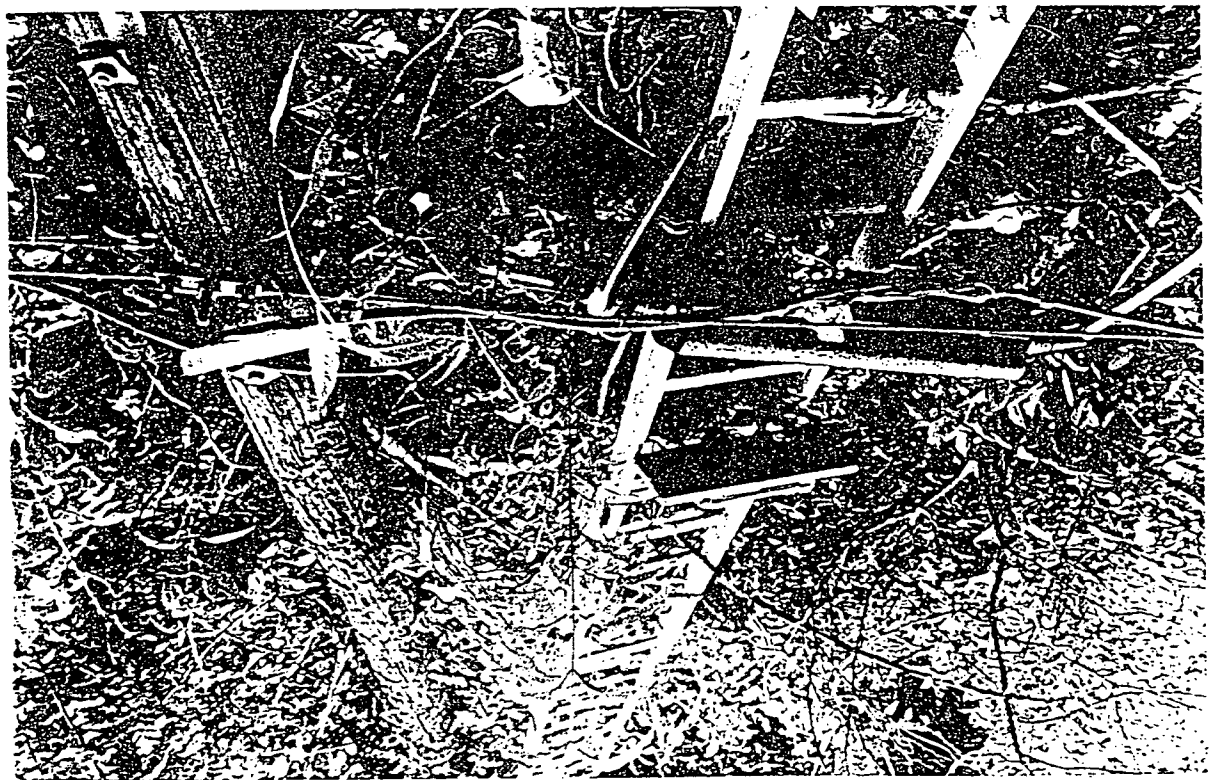
**Attachment C**  
**Photographs of Accident Site**

The pole was a 35' class 6 installed in June 1945 with a single phase #4 cu. primary and neutral conductors. The pole also had two telephone cables attached. The pole appeared to be 6' 3" in the ground. Last pole inspection was on 10/11/93. The pole was rotten at the ground line and was covered with red ants. The pole appeared to be hollow at least four feet up from the ground line.

It appeared the primary conductor was broken loose from the insulator when the pole fell and contacted a pine tree approximately twelve feet away. The conductor fell striking Ellis or the ladder he was standing on.
