COMMONWEALTH OF KENTUCKY  
BEFORE THE PUBLIC SERVICE COMMISSION

WESTERN KENTUCKY GAS	)	
_____	)	
	)	CASE NO. 97-289
ALLEGED VIOLATIONS OF 807 KAR	)	
5:022	)

O R D E R

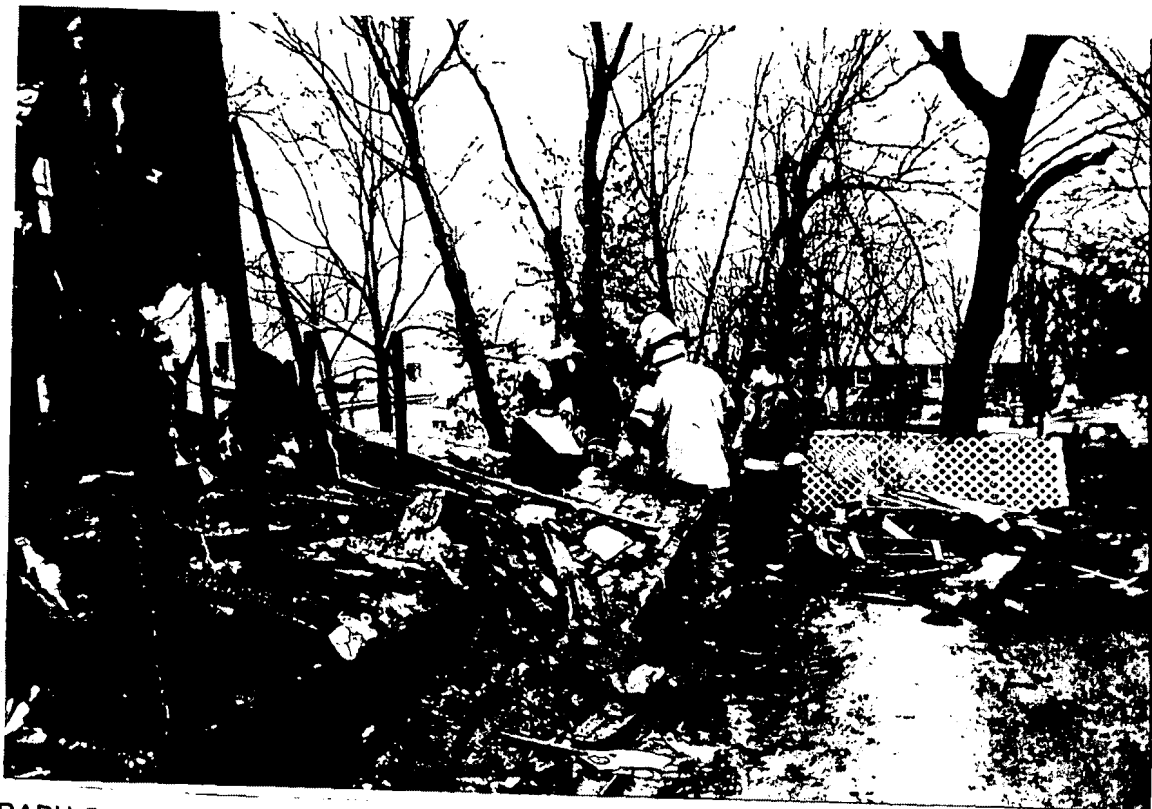
PHOTOGRAPH 5 - Fire department representative sawing opening in floor. Taken looking north from northeast corner of drive between 511 & 509 Smith Street (3/5/97).

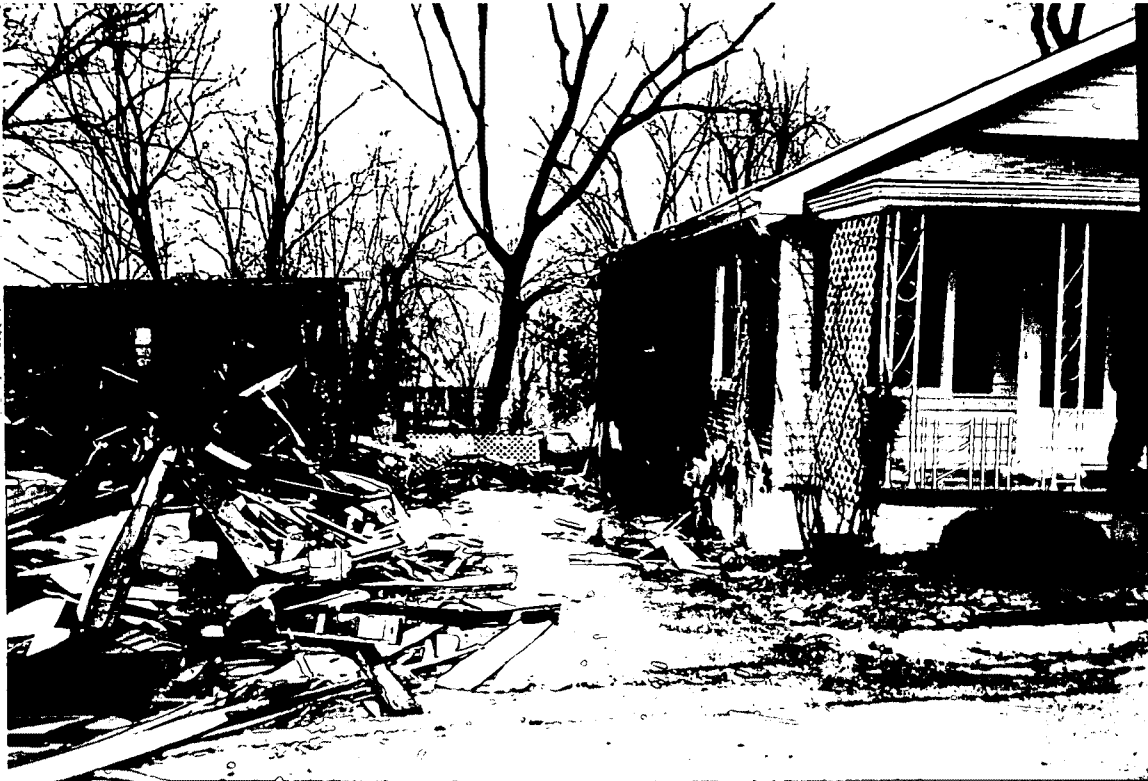
igniting when the wall blew out and fell on the gas meter, regulator, and piping (Attachment 1, Photograph 7). The house at 509 Smith Street suffered severe fire damage (Attachment 1, Photographs 1 & 2) as well as two automobiles in driveways on both sides of the house. The house on the west side suffered debris damage (Attachment 1, Photograph 4).

PHOTOGRAPH 1 - Front and east side of house. Debris covering area of curb valve location. West side of 509 Smith Street also shown. (3/5/97)

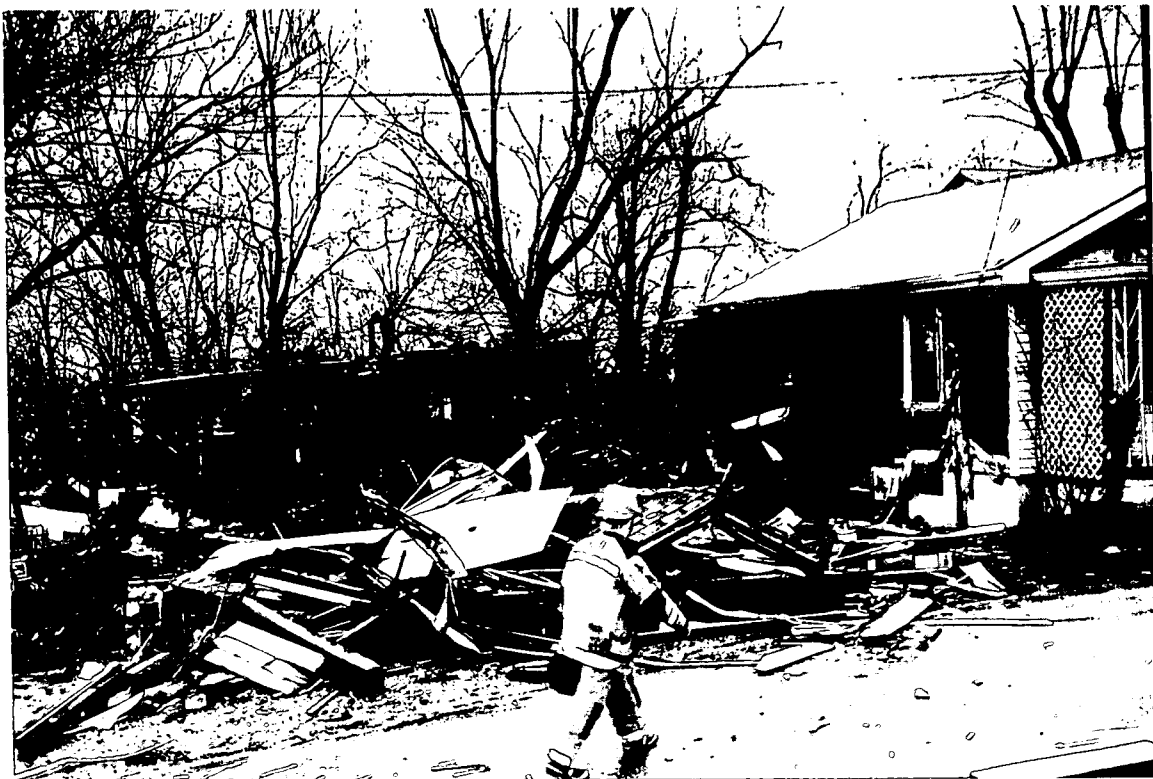
PHOTOGRAPH 2 - Front of house and west side of 509 Smith Street also shown. (3/5/97).

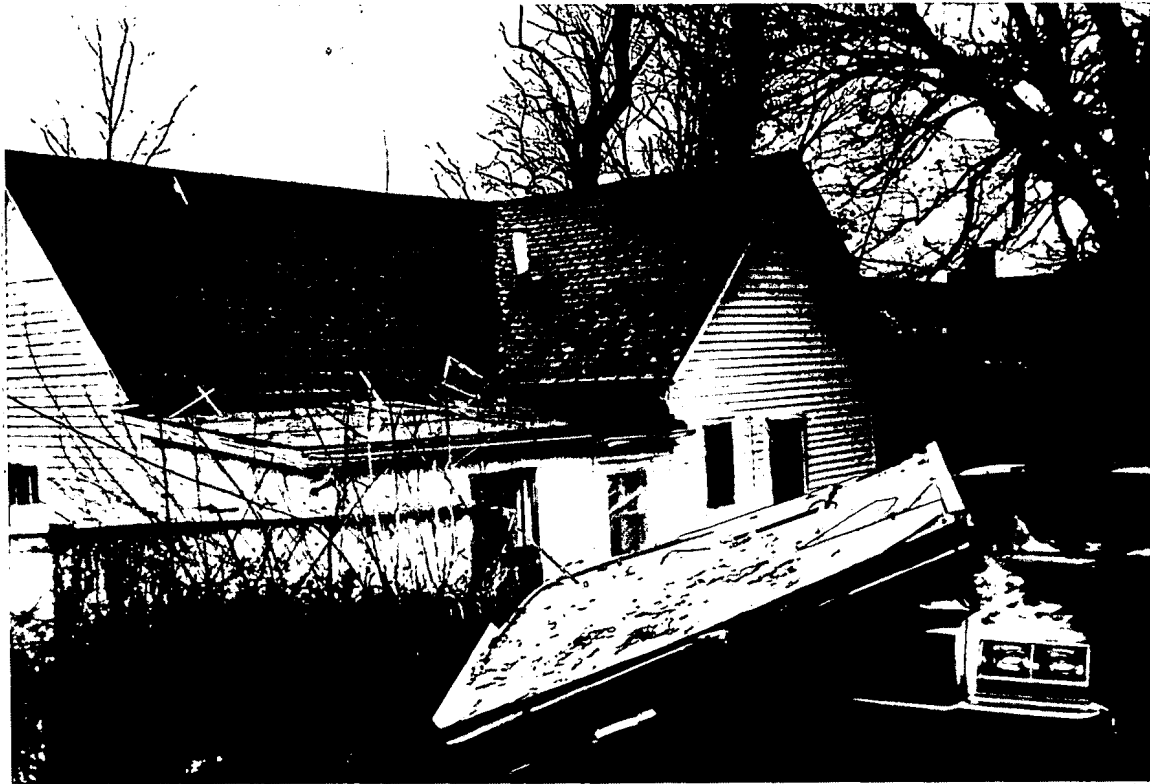
PHOTOGRAPH 4 - Portion of wall of house looking northwest from front. Also shown is east side of 402 6th Street with debris and explosion damage. (3/5/97).

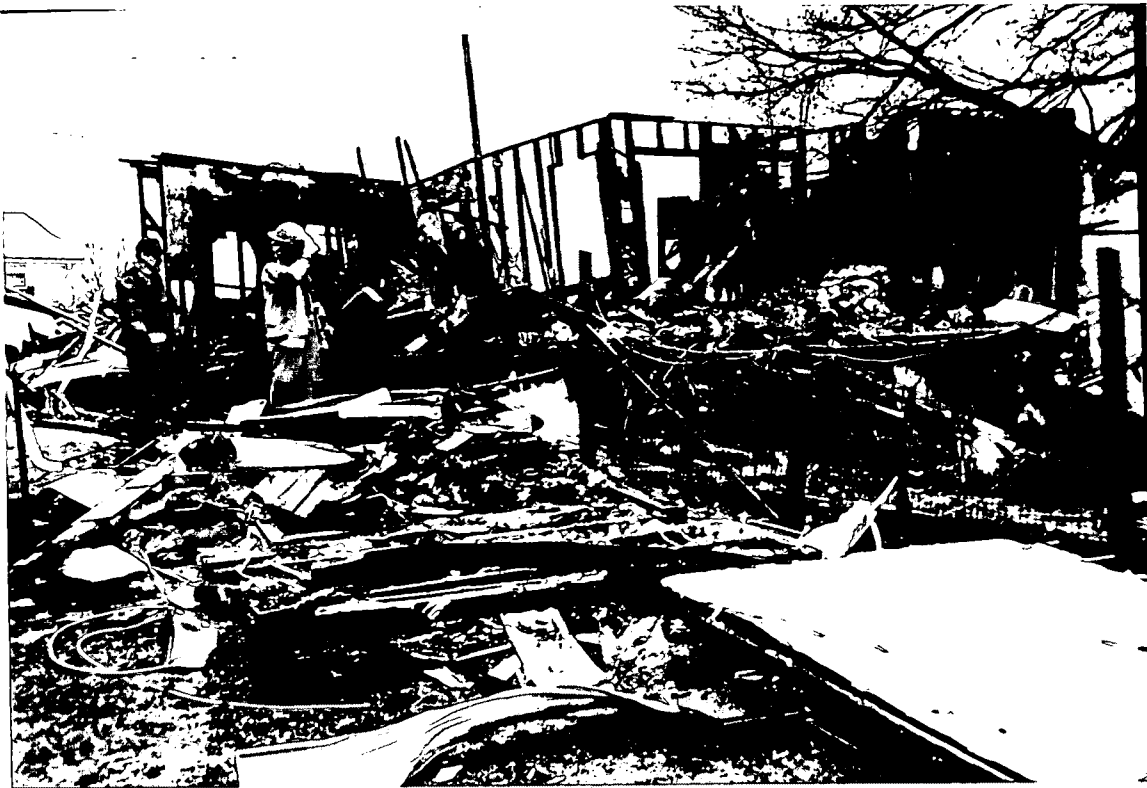
PHOTOGRAPH 6 - Fire department representative sawing opening in floor to provide access to basement. Photograph taken looking south from rear of house. (3/5/97).

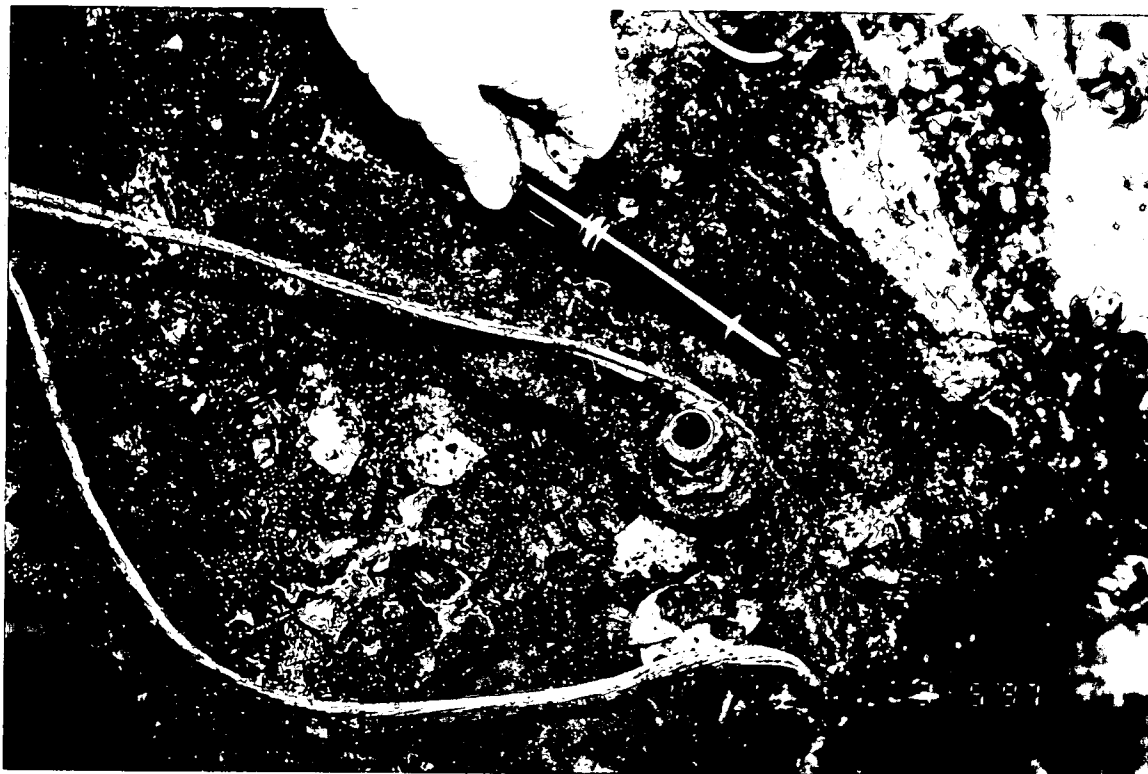
PHOTOGRAPH 18W - 1/2-inch gas line behind range showing 1/2-inch bronze range connector. (3/5/97).

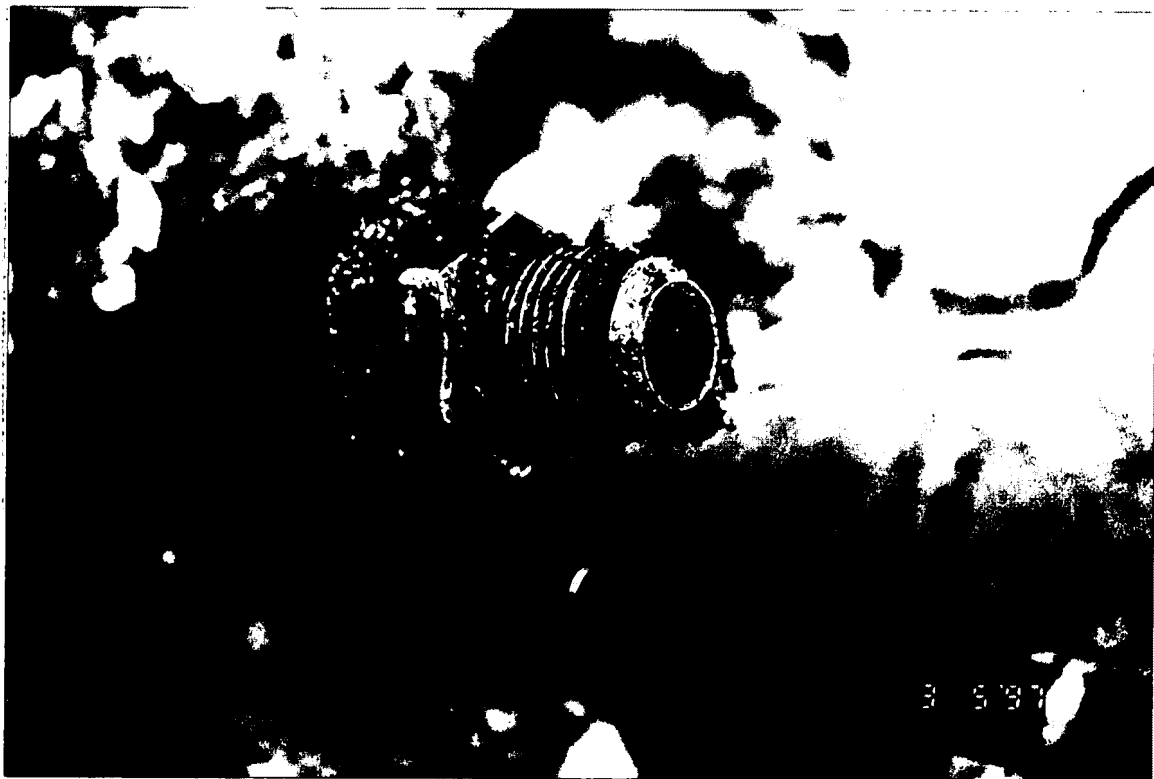
PHOTOGRAPH 19W - Same as 18W. Closeup of range connector. (3/5/97).

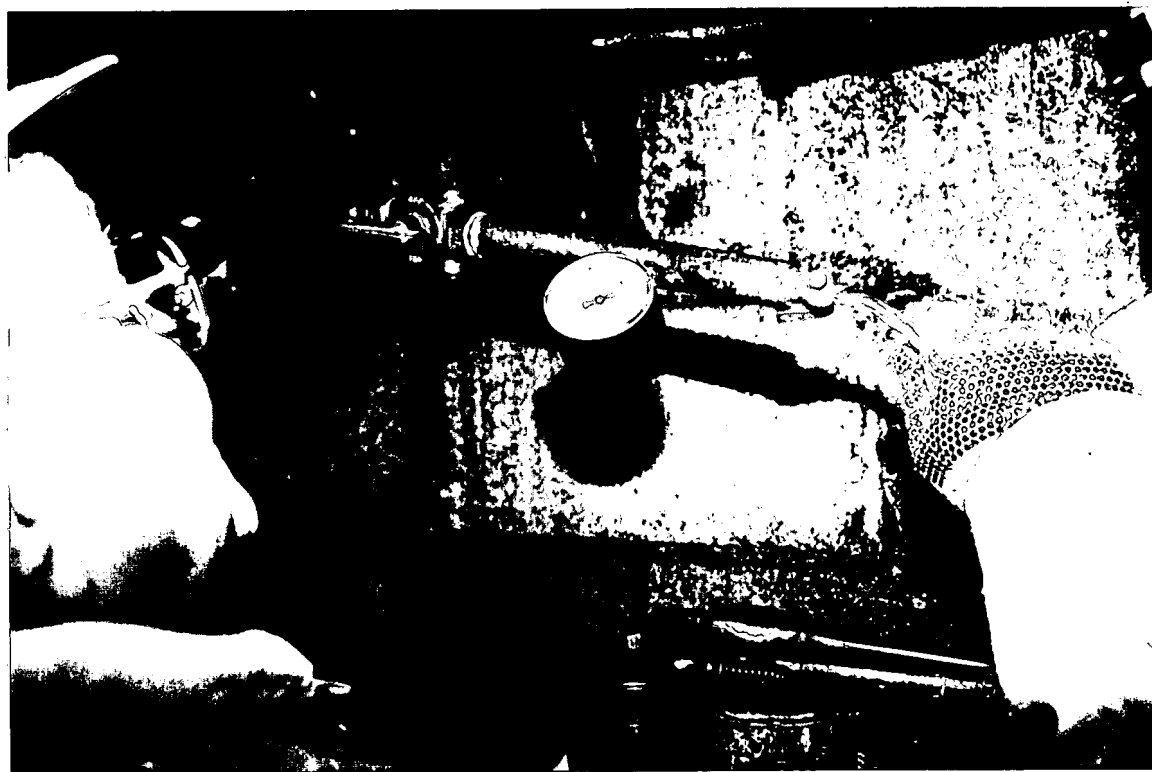
PHOTOGRAPH 15W - Test gage and hand ball pump connected to 1/2-inch brass valve pumped by Mr. Teter. (3/5/97).
