COMMONWEALTH OF KENTUCKY
BEFORE THE PUBLIC SERVICE COMMISSION

KENTUCKY UTILITIES COMPANY)
_____))
ALLEGED FAILURE TO COMPLY WITH) CASE NO. 98-275
ADMINISTRATIVE REGULATION)
807 KAR 5:041, SECTION 3)

**UTILITY ACCIDENT
 INVESTIGATION REPORT**

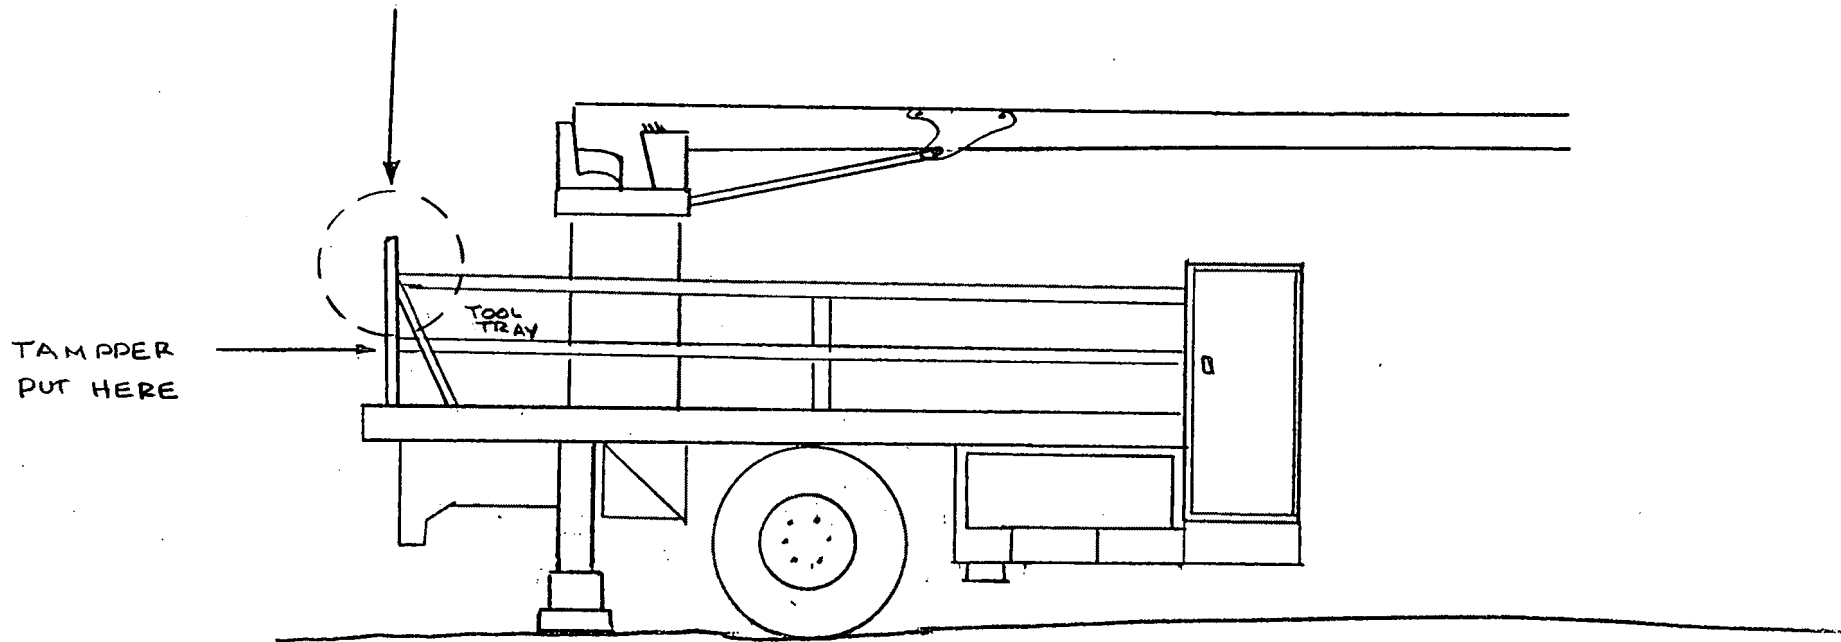
APPROXIMATE LOCATION OF
WHERE HAND CAME INTO CONTACT
WITH TRUCK.

TAMPER
PUT HERE

POINT OF CONTACT WITH LINE
ON BACK SIDE.

POLE
GRABBER

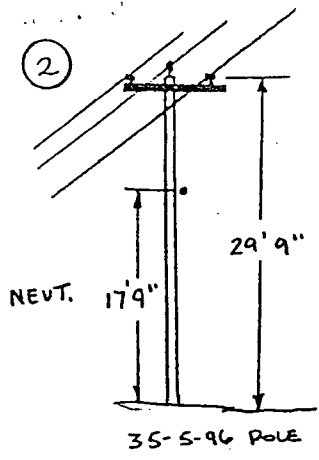
2

NOTE: NEUTRAL NOT ATTACHED TO POLE

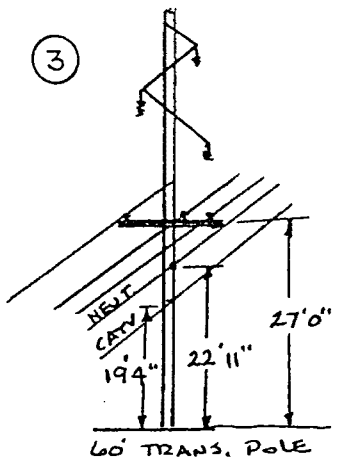
NOTE: POLE WAS BEING SET IN HOT 3 ϕ LINE WITH LINE HOSE ON CONDUCTORS

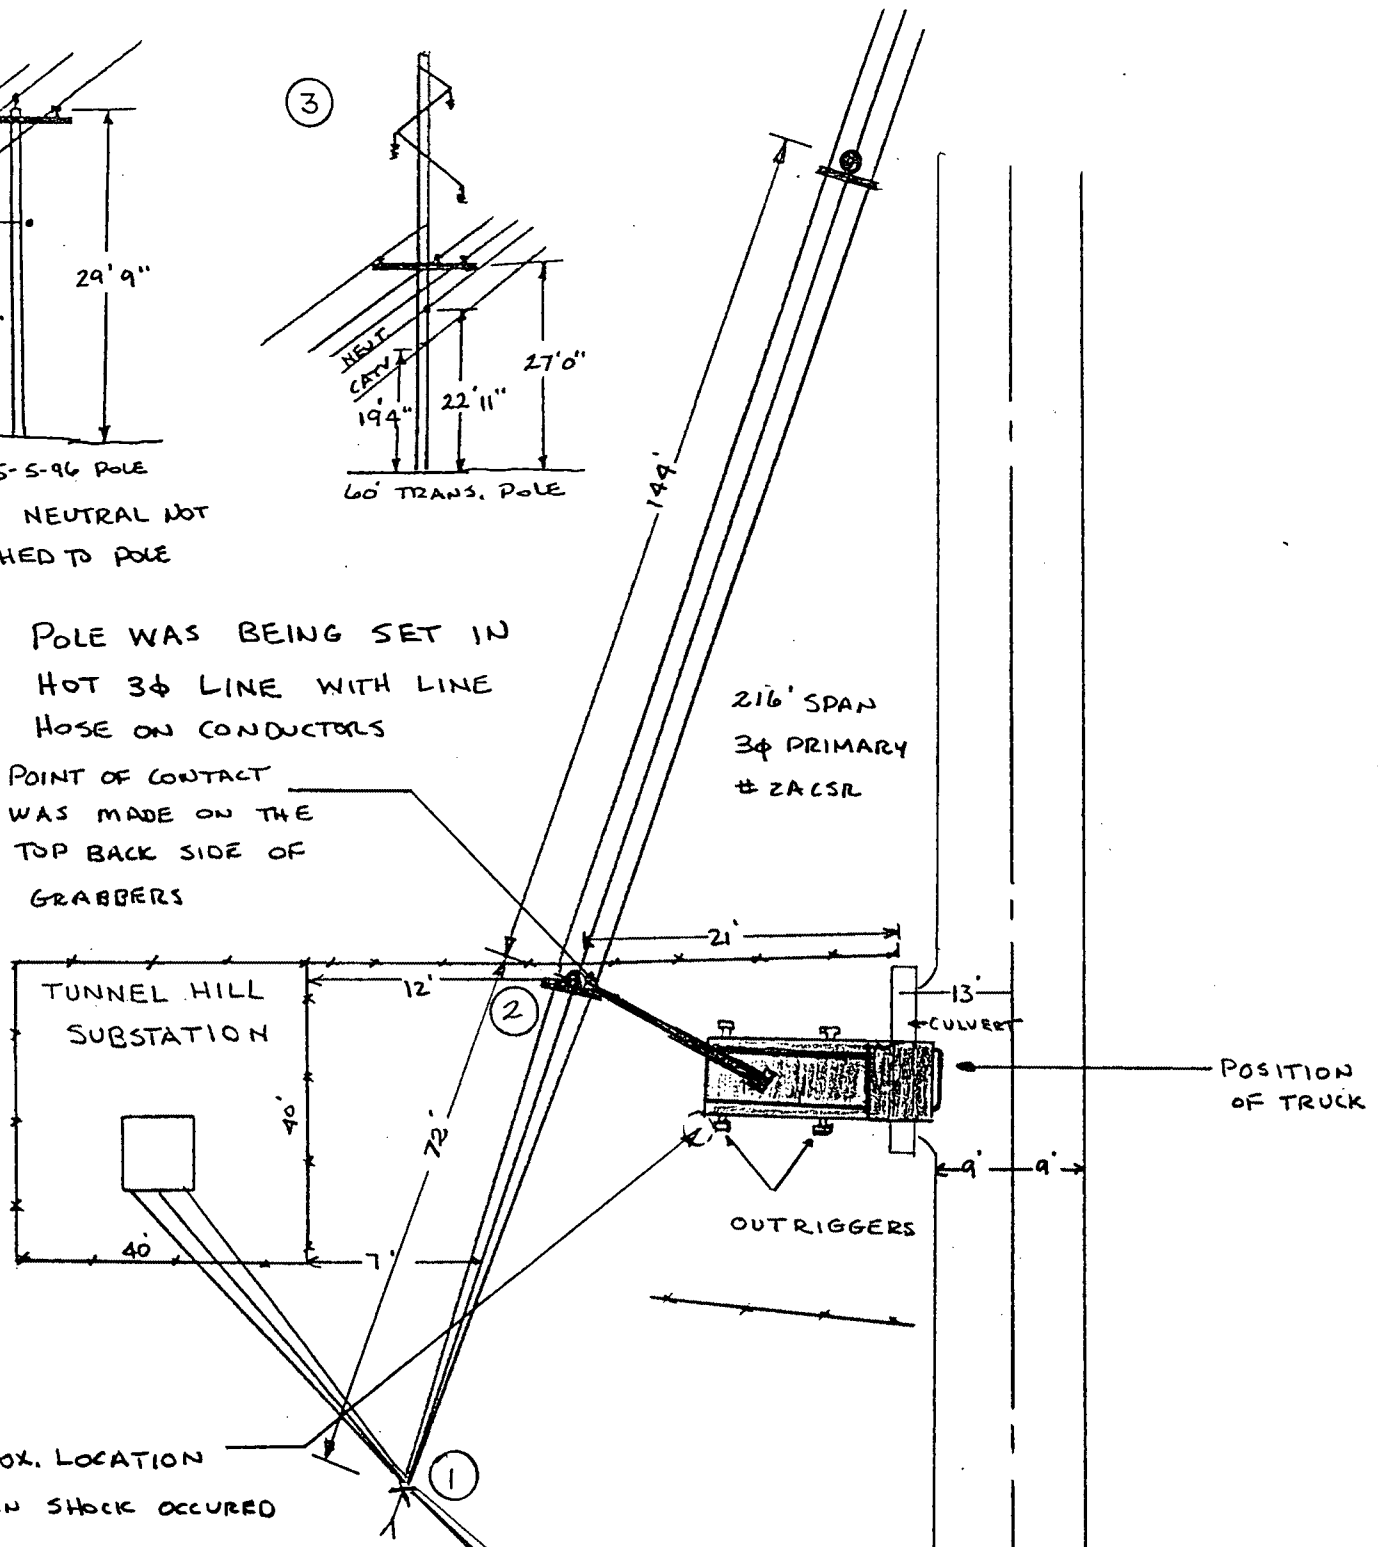
NOTE: POINT OF CONTACT WAS MADE ON THE TOP BACK SIDE OF GRABBERS
