COMMONWEALTH OF KENTUCKY
BEFORE THE PUBLIC SERVICE COMMISSION

GRAYSON RURAL ELECTRIC)	
COOPERATIVE CORPORATION)	
_____)	CASE NO. 98-590
)	
ALLEGED VIOLATION OF COMMISSION)	
REGULATION 807 KAR 5:041)

**UTILITY ACCIDENT
INVESTIGATION REPORT**

Utility:	Grayson Rural Electric Cooperative Corporation			
Reported By:	Carol Hall Fraley – President and CEO			
Dates & Times	Accident Occurred:	02/07/98 – Approximately 12:20 p.m.		
	Utility Notified:	02/07/98 – Approximately 1:45 p.m.		
	PSC Notified:	02/07/98 – Approximately 3:38 p.m.		
	Investigated:	02/10/98		
	Written Report Rcvd:	02/12/98 .		
Location of Accident:	Iron Hill, on Route 7 in Carter County, Kentucky			
Description of Accident:	Mr. Hosack was connecting a jumper to a 7200 Volt primary line. Mr. Hosack made contact with the energized line and was shocked and burned. Mr. Hosack was not wearing rubber gloves.			
Victims:	Name:	Harry Hosack, Jr.	Fatal:	No
	Addr./Empl.:	EZ Electric, Inc., 4812 W. Pea Ridge Road, Huntington, West Virginia 25707		
	Injuries:	Entry wounds, left hand, index and middle finger, blister in palm of hand, flash burns on the knuckles and there is an exit wound in the top of the left foot. Also, there are

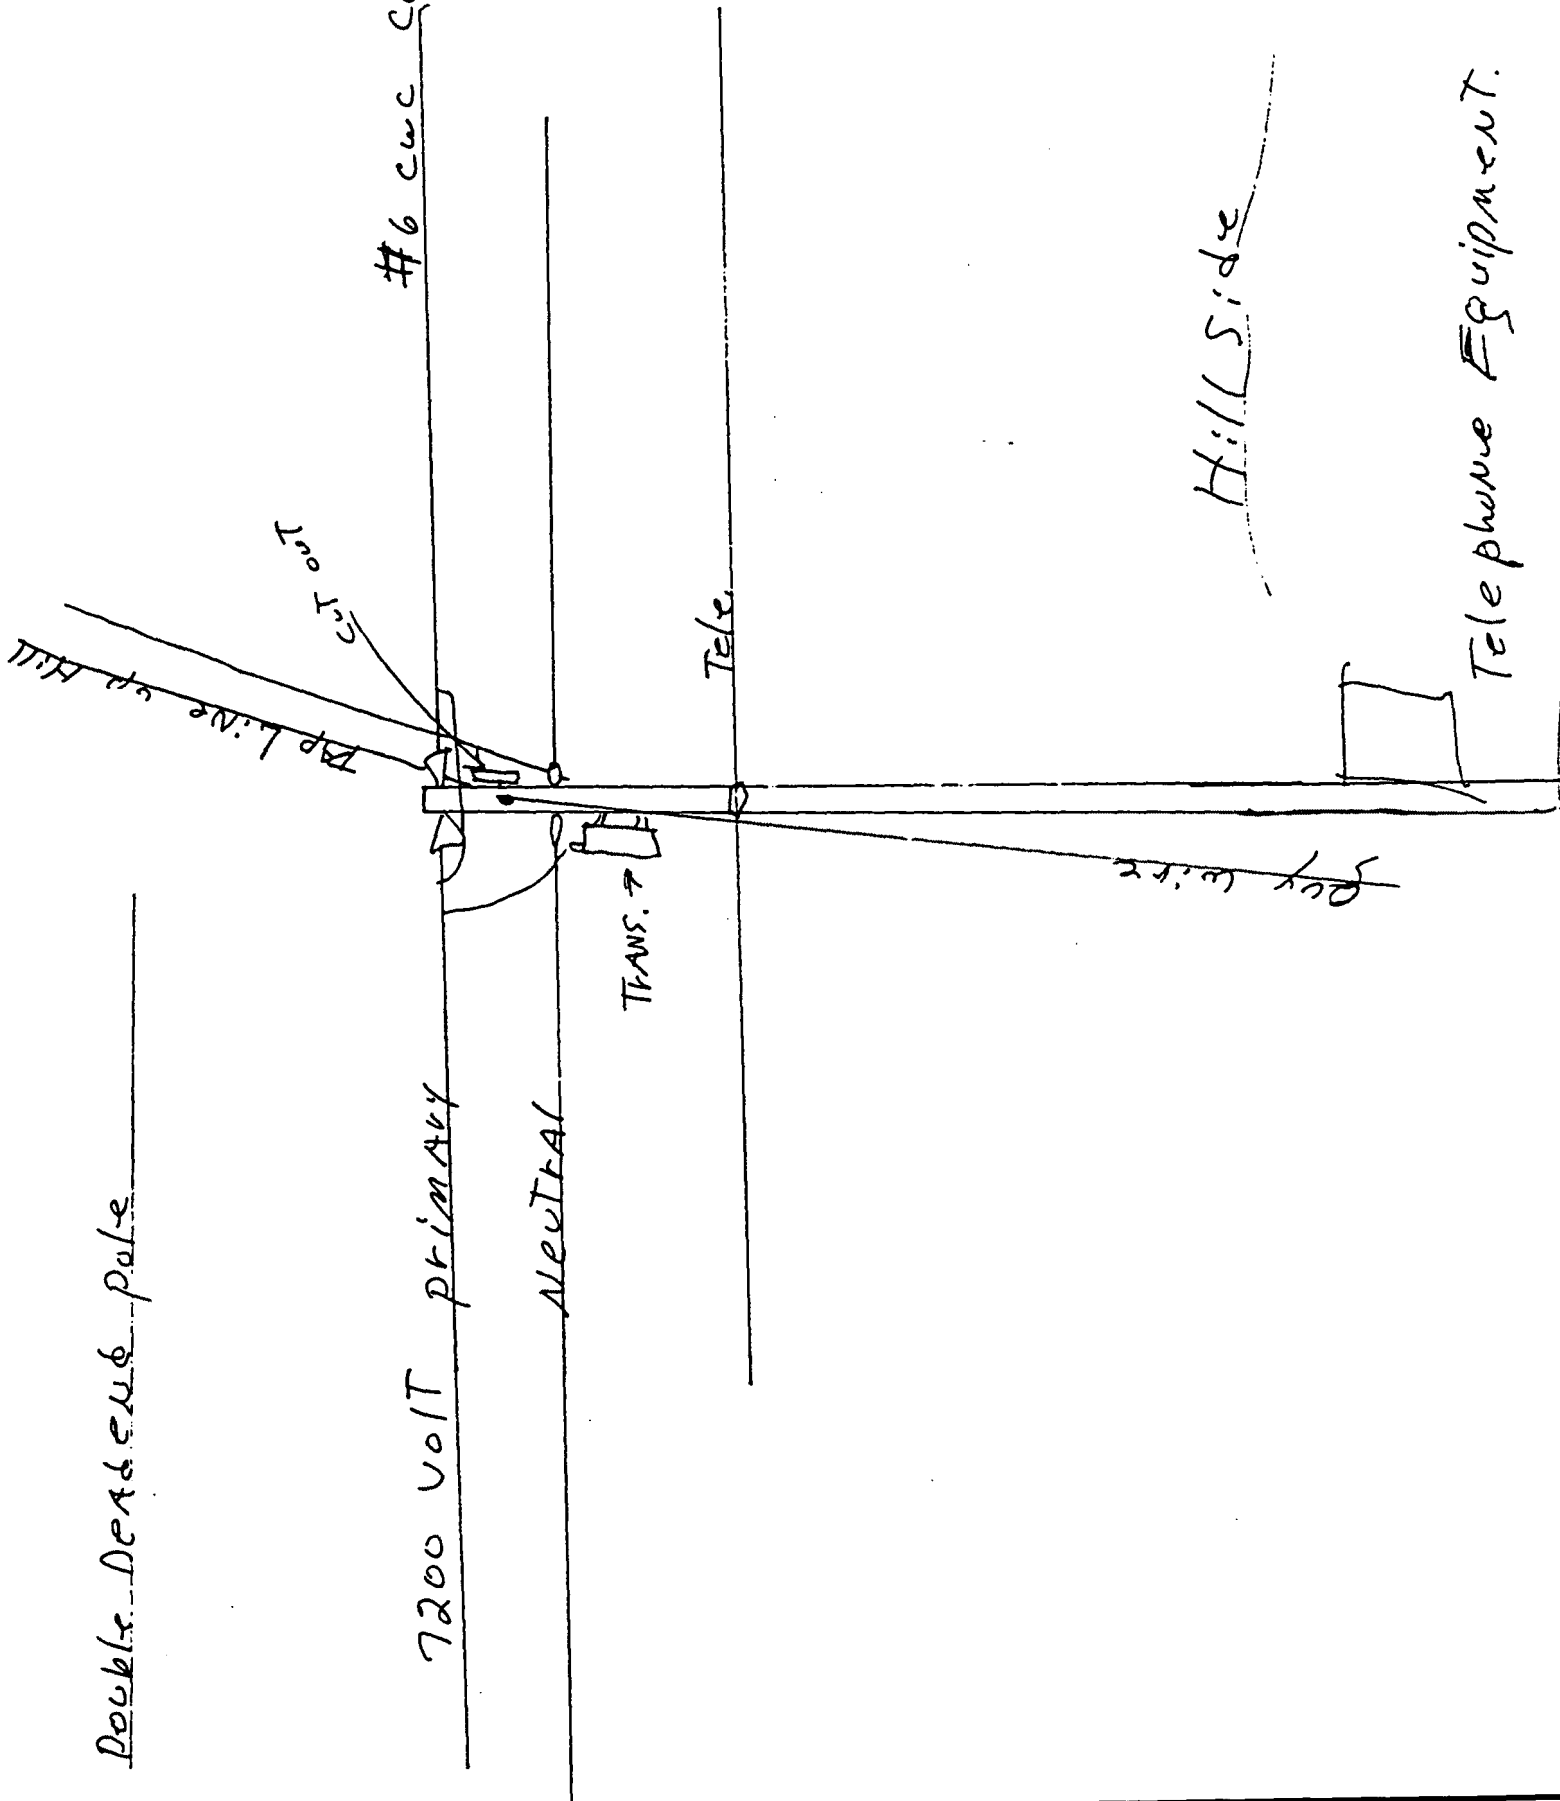
DESCRIPTION OF ACCIDENT: Mr. Hosack was connecting a jumper on an A6, double dead-end and made contact with an energized line.

7200 volts single phase, double dead-end with tap, cutout, guy wire, telephone and transformer

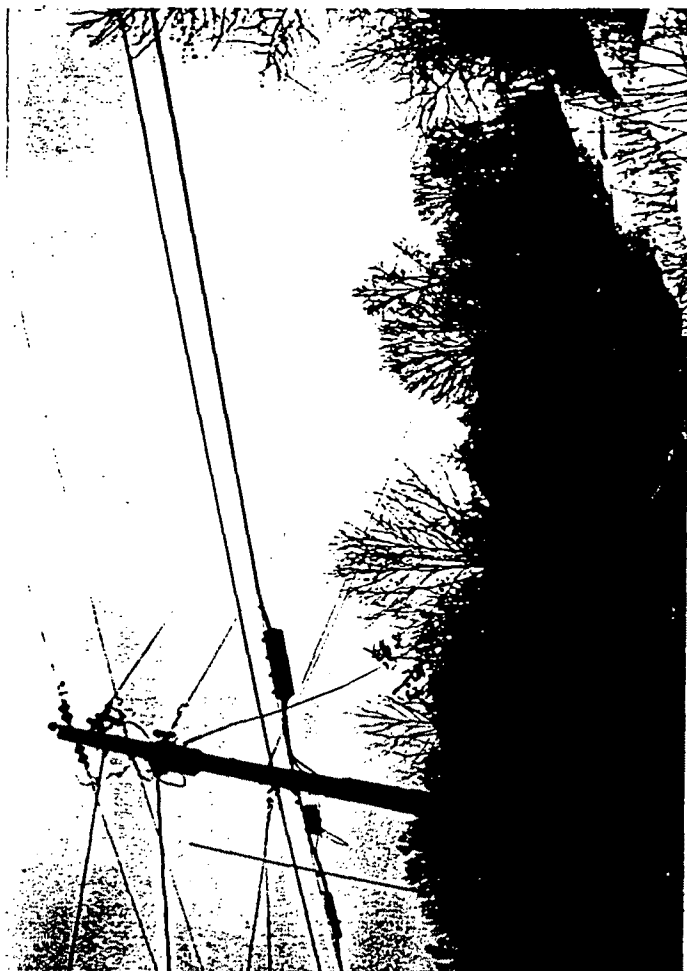
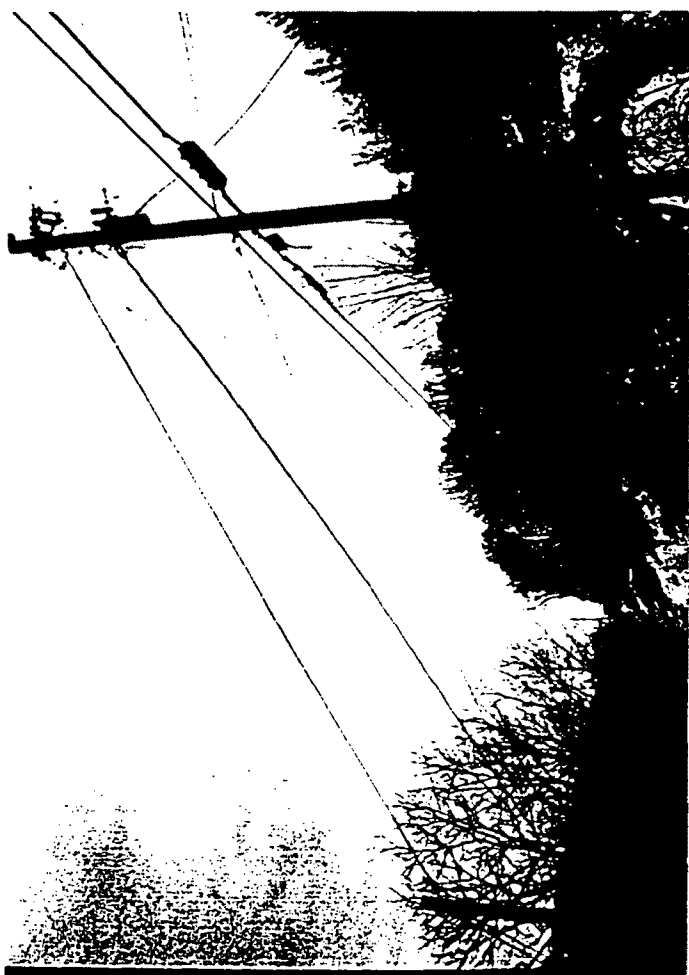
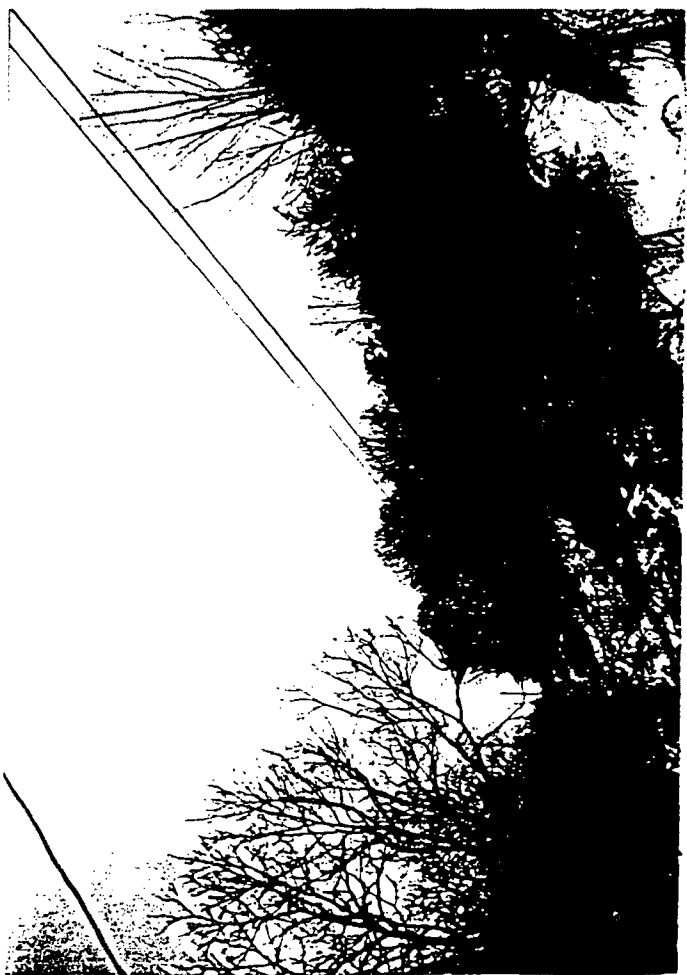
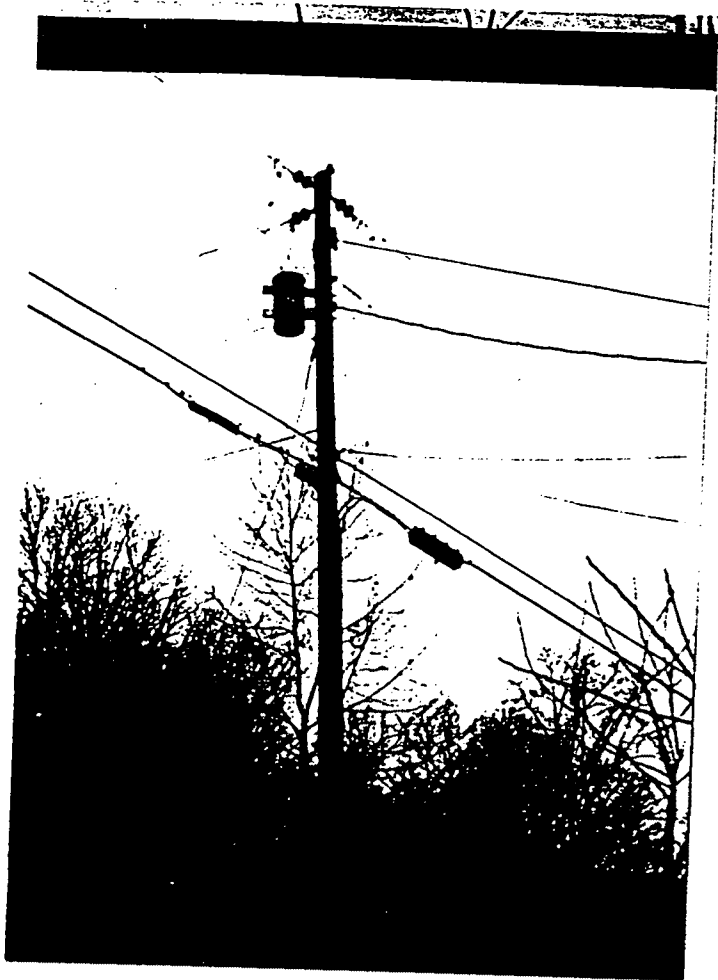
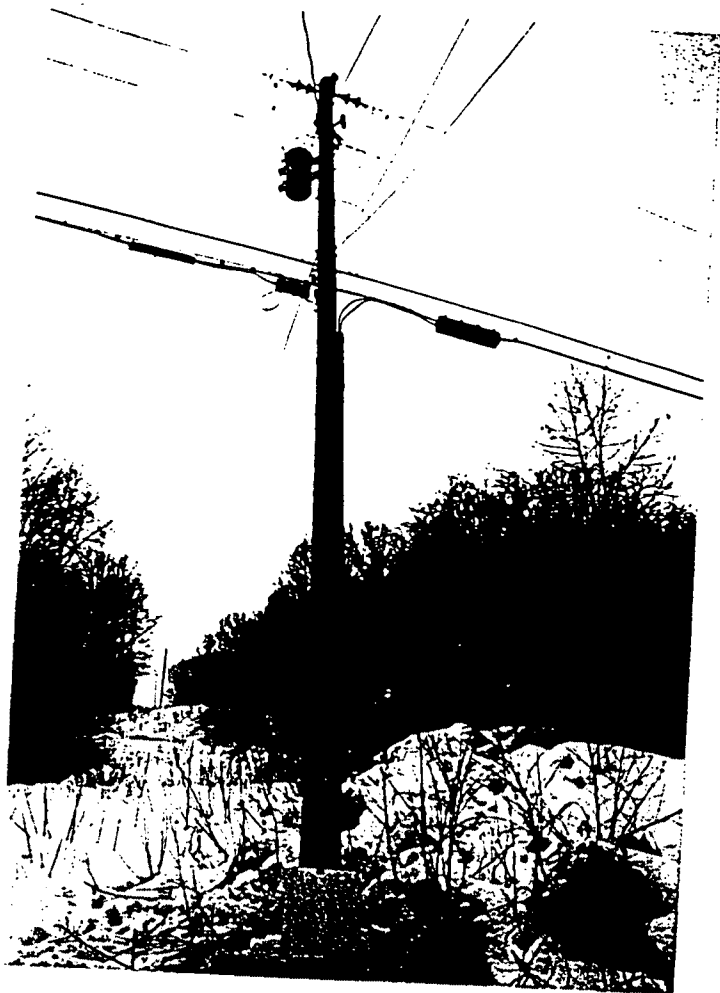
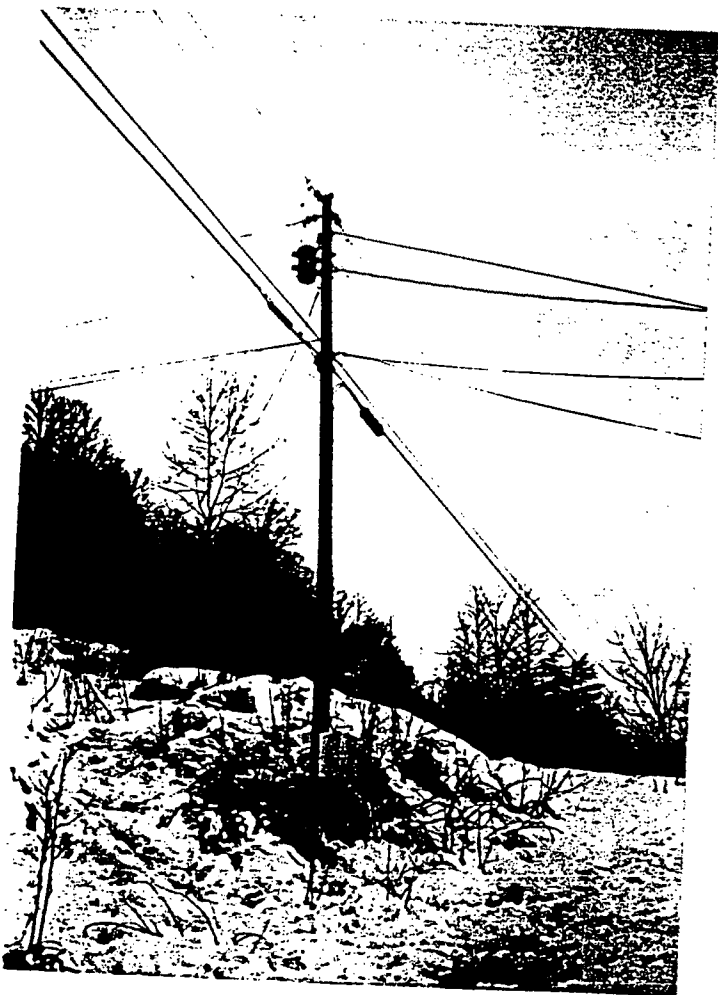
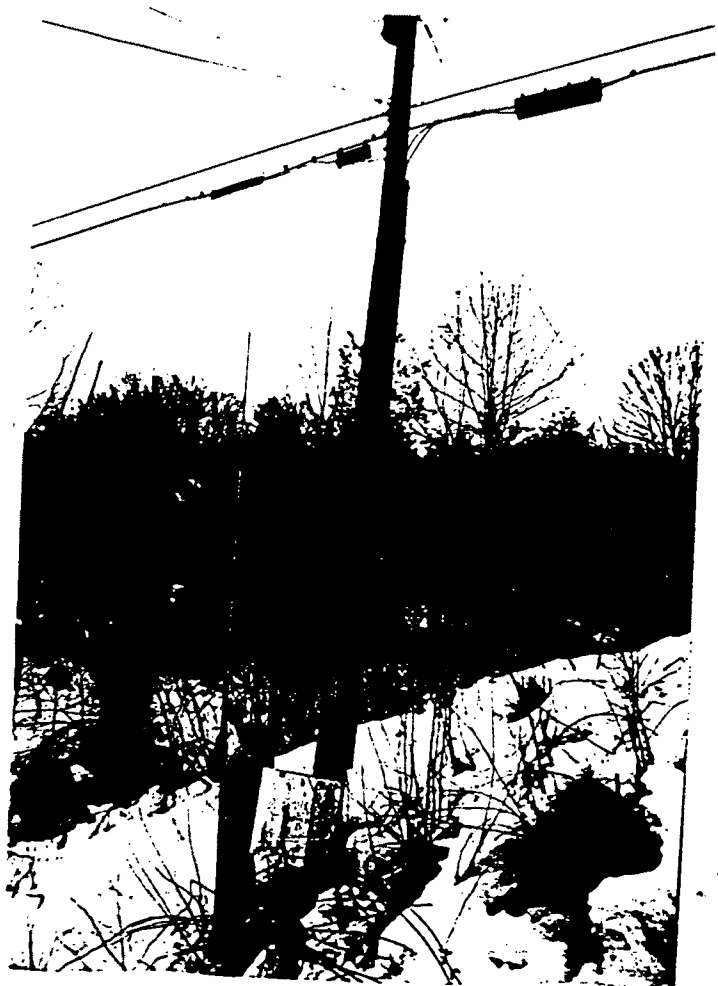
Attachment B
Photographs of Accident Site

1. On February 7, 1998, Harry Hosack, Jr., suffered burn injuries to his left hand and left foot while connecting a jumper to a 7200-volt primary line in Carter County, Kentucky.

2. At the time of the incident, Grayson RECC owned and operated the facilities in question.
3. At the time of the incident, no protective covering was being used.

9. Hosack failed to comply with NESC Rules 420H and 443A1.
10. Bush failed to require that all safety rules and operating procedures were observed by those under his direction. His failure to do so is a violation of NESC Rule 421A, which requires a person in charge to adopt such precautions as are within his
