COMMONWEALTH OF KENTUCKY
BEFORE THE PUBLIC SERVICE COMMISSION

LOUISVILLE GAS AND ELECTRIC COMPANY))
_____)) CASE NO. 98-592
ALLEGED FAILURE PURSUANT TO))
807 KAR 5:041, SECTION 3, TO COMPLY))
WITH NATIONAL ELECTRIC SAFETY CODE))
("NESC"), 1990 EDITION, SECTION 23,))
CLEARANCES, RULE 234 B, 1&2))

**UTILITY ACCIDENT
INVESTIGATION REPORT**

INVESTIGATION REPORT

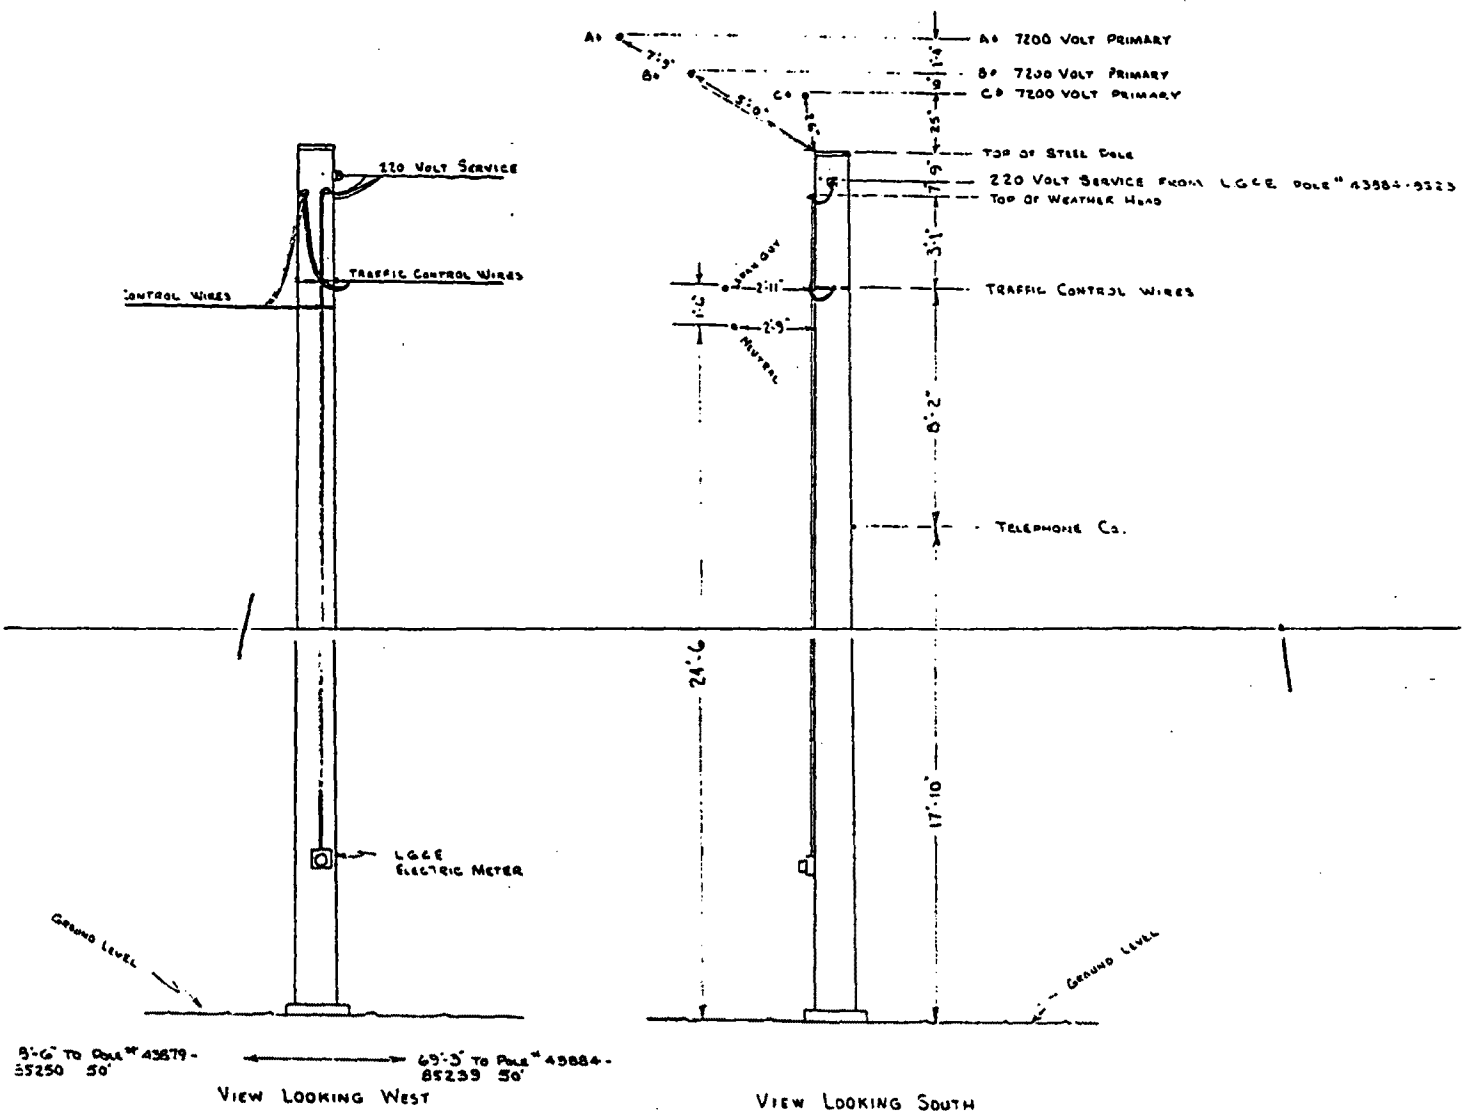
SKETCH SHOWING WEST VIEW
 SOUTH VIEW OF STEEL TRAFFIC
 CONTROL POLE NORTH/WEST
 PRESTON HWY AND GILMORE
 WHERE ACCIDENT OCCURRED
 MITCHEL METZINGER S-2
 NO SCALE DRAWN BY K.W.

3. Commission Staff examined the accident scene and, specifically, measured the line clearances at the point of the accident. It was determined by measurement that the C-Phase conductor carrying 7.2 KV was 2 feet – 2 inches from the steel pole structure. NESC, Section 23, Rule 234B, 1&2, set a minimum clearance from phase conductor to structure of 4 feet – 6 inches. NESC standards are applicable to LG&E pursuant to 807 KAR 5:041, Section 3.
