SHELBY ENERGY COOPERATIVE, INC.)	
_____)	CASE NO. 2008-00147
)	
ALLEGED FAILURE TO COMPLY)	
WITH KRS 278.042)

RE: Field Investigation Shelby Energy Cooperative, Inc.

UTILITY INSPECTION REPORT

Report Number: ShelbyEC-F-111307

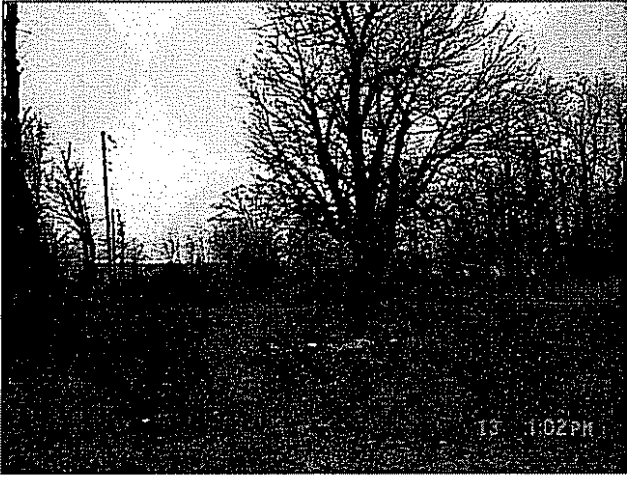
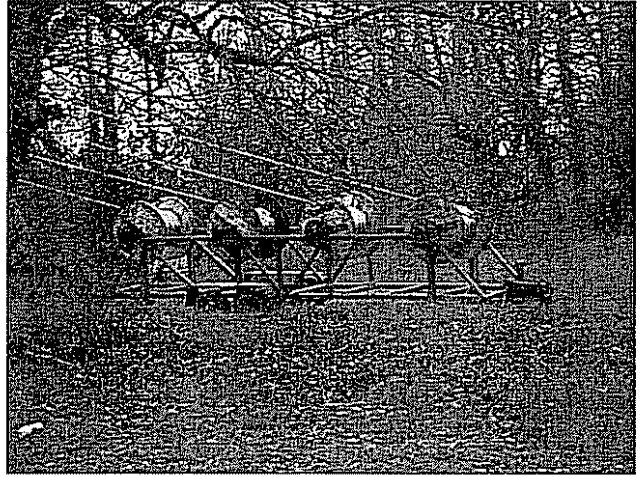
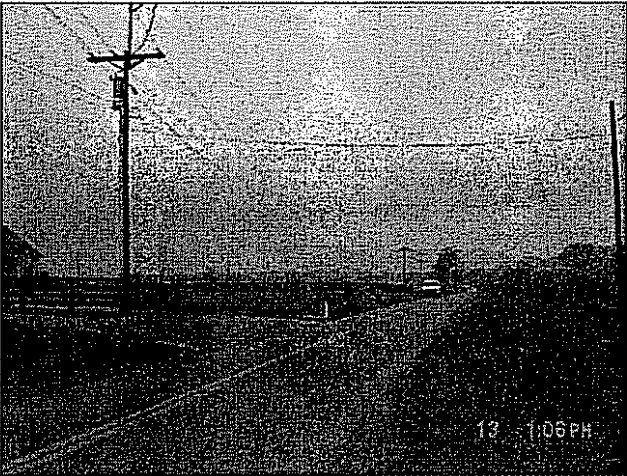
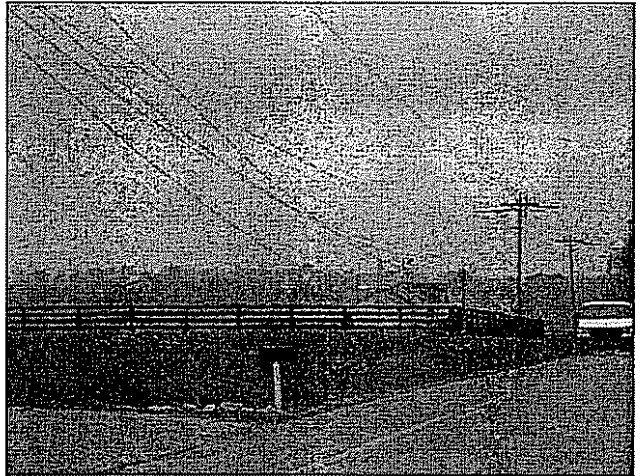
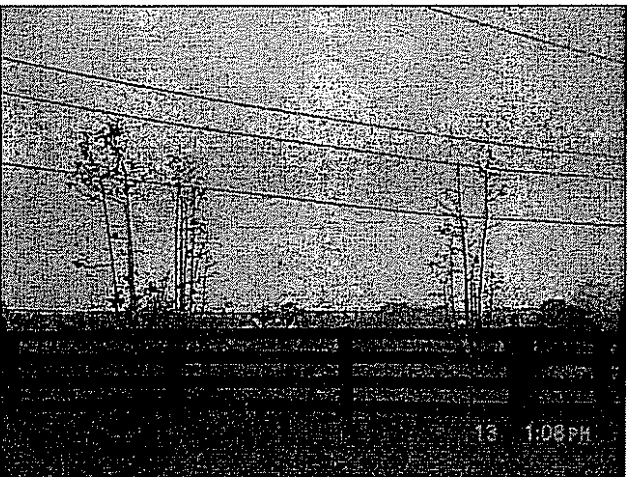
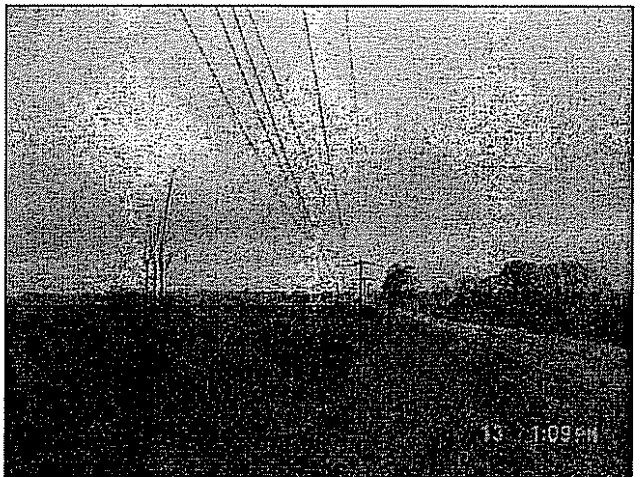
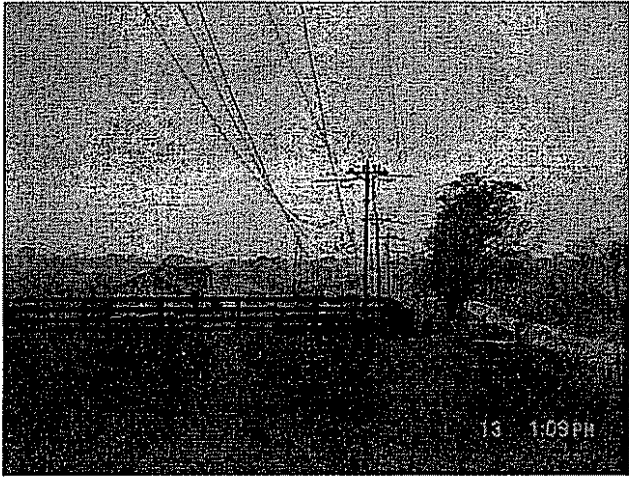
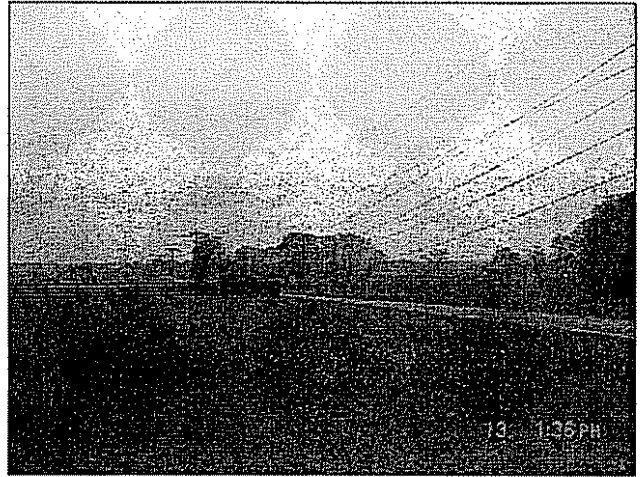
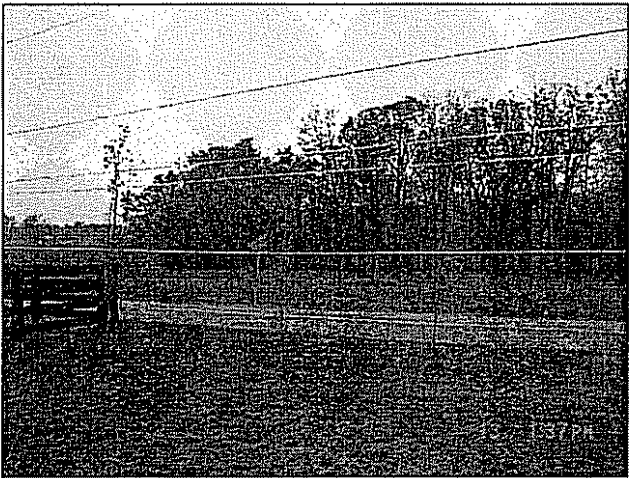
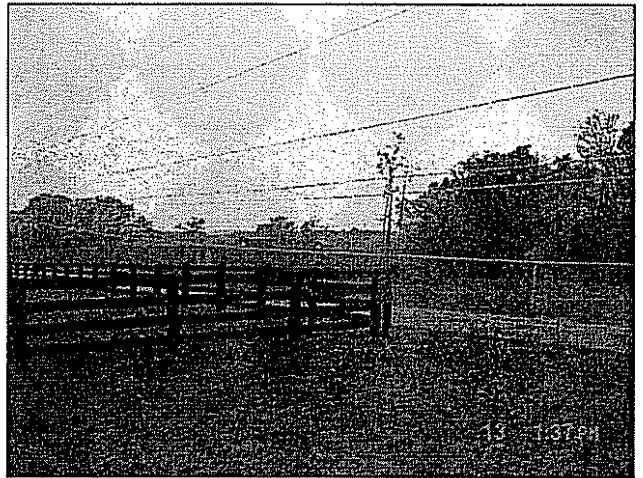
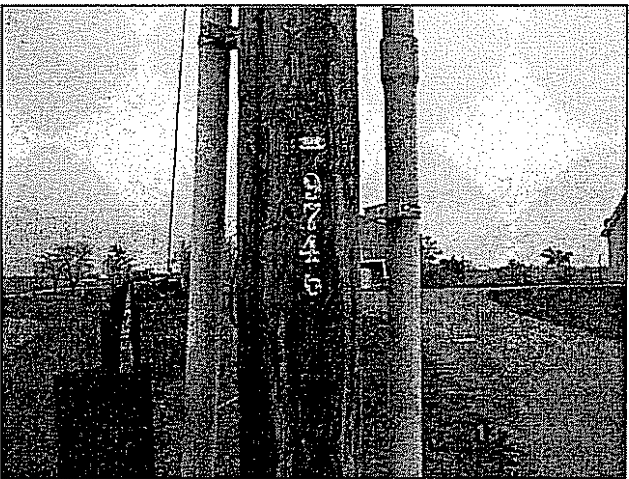
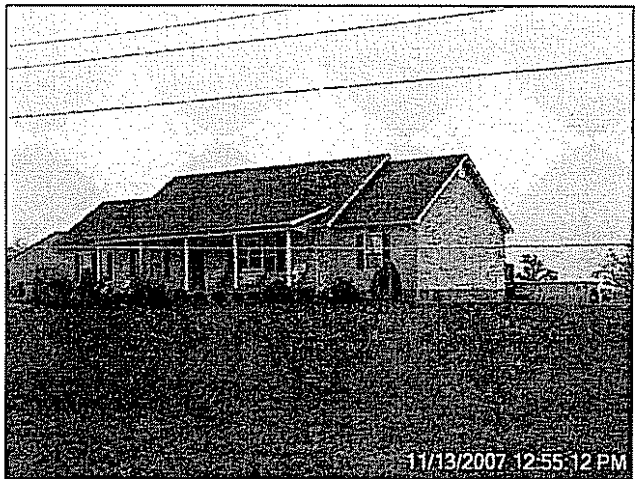
1. Vertical clearance on the new conductors.
2. The lack of sufficient grounds, and the potential of new conductors becoming energized.

After completing the accident investigation, Mr. Kingsolver and I drove east on Vigo Road. and noticed the new conductors being pulled by Dobson Power Line crews were sagging just a few feet above the ground. We stopped to investigate the area because of possible clearance violations. While looking into possible clearance violations at this site, an employee with Dobson Power Line construction drove by this location. While Mr. Kingsolver stayed at this location I followed this employee. The employee

At this time we had a possible clearance violation and potentially energized conductors. I returned to the site and talked with Mr. Kingsolver about my discussion with Mr. Dobson. I then called Mr. Martin and asked him to meet me at the site. While waiting for Mr. Martin, a Dobson Power Line employee was dropped off at the location of the low conductors. Mr. Kingsolver and I took pictures of the site while waiting for Mr. Martin.

First, a report of a low span of conductor on Vigo Road was made to Shelby Energy Cooperative on the above date. The span was observed by a representative of the Public Service Commission at approximately six (6) feet above the ground with no stationed guard of Dobson Power Line Construction within the area.

Next, the representative of the Public Service Commission reported an apparent absence of proper grounding on the new conductor being pulled in at the Vigo Road location. After review and discussion with managers of Shelby Energy's engineering and operations departments, it appears the method of grounding used by Dobson Power Line Construction did not meet the generally accepted criteria of the National Electrical Safety Code.

Actions taken to correct the deficiencies noted in this report included: immediately notifying Dobson personnel of the situation of NESC violations, particularly relative to the minimum ground clearance violation in the span between poles no. 9746 and no. 9747. This was done on the afternoon of November 13, 2007 by Wayne Anderson and David Martin, within an hour after this was called to our attention by Inspector Moore. Corrective action was taken by Dobson personnel immediately upon notice. Subsequently, conductor stringing operations by Dobson were halted until such time that Dobson could provide means of effectively bonding new conductors in stringing operations to the existing distribution system's effectively grounded neutral (namely use of mechanical, "traveling" grounds). After Shelby became aware of the safety violations, Debbie Martin, President & CEO of Shelby sent James D. Dobson the attached letter (Attachment 2-1), dated November 27, 2007, pointing out the safety violations and reminding him Dobson must abide by the NESC at all times. Subsequently, the attached letter (Attachment 2-2), dated December 20, 2007, from the cooperative's attorney, Donald T. Prather, was sent to Dobson placing it on probation, a future violation of which would result in the cancellation of the Dobson contract after the required twenty (20) day notice.

Additional action taken by Shelby to prevent potential reoccurrence of these or similar deficiencies includes: 1) requiring Dobson personnel to undergo instruction and review of the NESC, particularly to the requirements relative to the work performed on electric distribution systems and provide Shelby with evidence of compliance, 2) requiring Dobson to supply and use equipment accepted by best industry practices to effectively bond new conductors installed during conductor stringing operations to the existing electric distribution system neutral. Dobson complied with this on December 19, 2007, 3) requiring Dobson to review all work practices with employees, particularly relative to the conductor stringing operation, and furthermore recommending that at all times during the conductor stringing operation that both the conductor pay-out (reel trailer) end and the conductor take-up (tensioner) end be manned and that additional employees as necessary be used throughout the ruling span of the "conductor pull" to observe the behavior of the new conductor being installed to assure that any problems or abnormal conditions are spotted and corrective action is initiated promptly. Constant communication between both "ends" of the operation and the intermediate "scouts" or observers will also be emphasized. Shelby's responsible person for this will be David Martin – Manager of Operations.
