COMMONWEALTH OF KENTUCKY  
BEFORE THE PUBLIC SERVICE COMMISSION

| ALLEGED FAILURE TO COMPLY WITH | ) | CASE NO. |
| KRS 278.042 | ) | 2010-00317 |

O R D E R

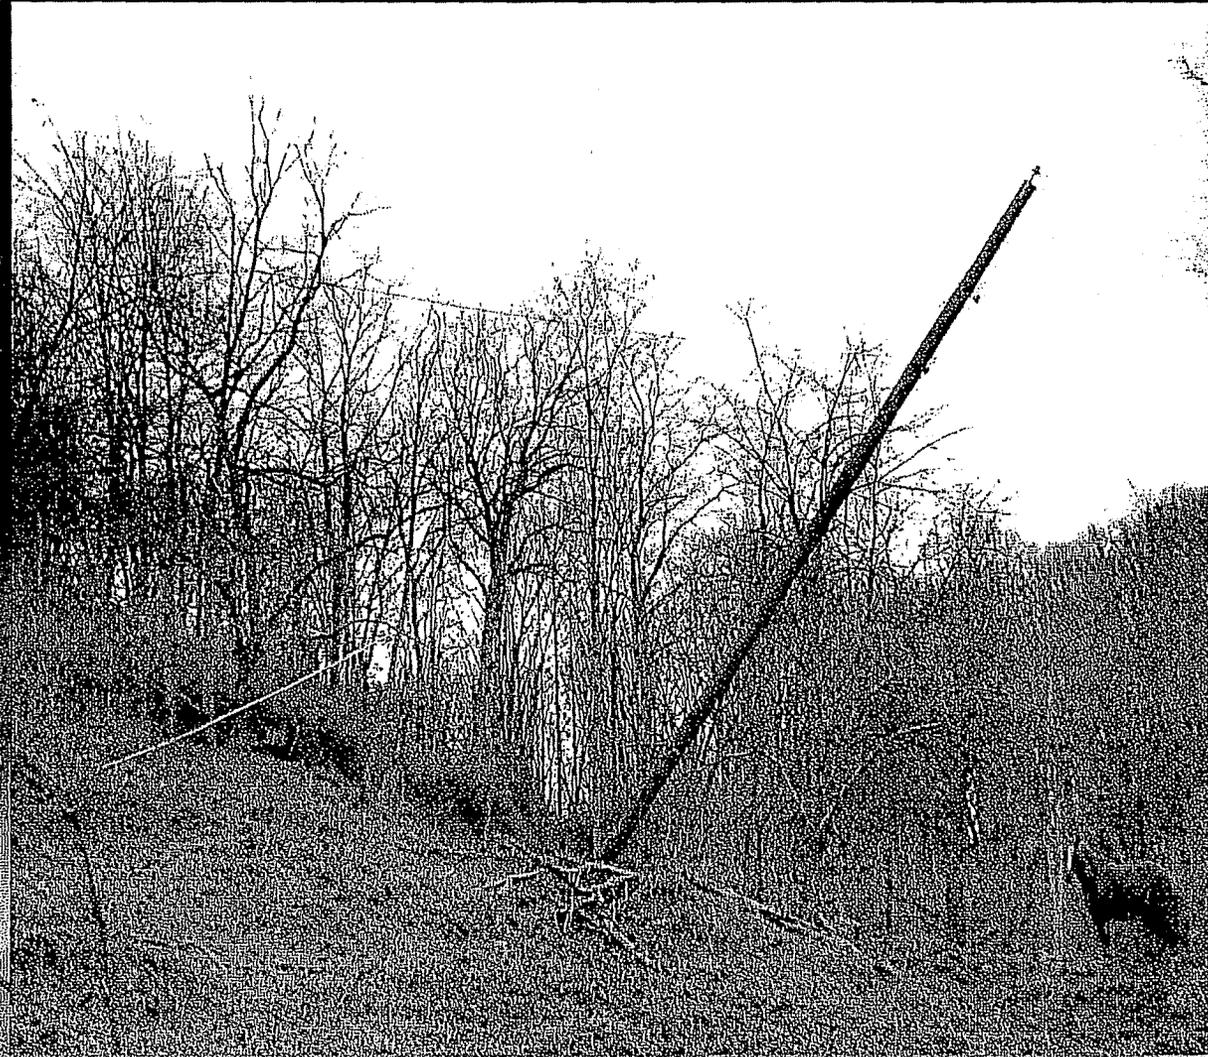
# Examples \ Pole in Slip

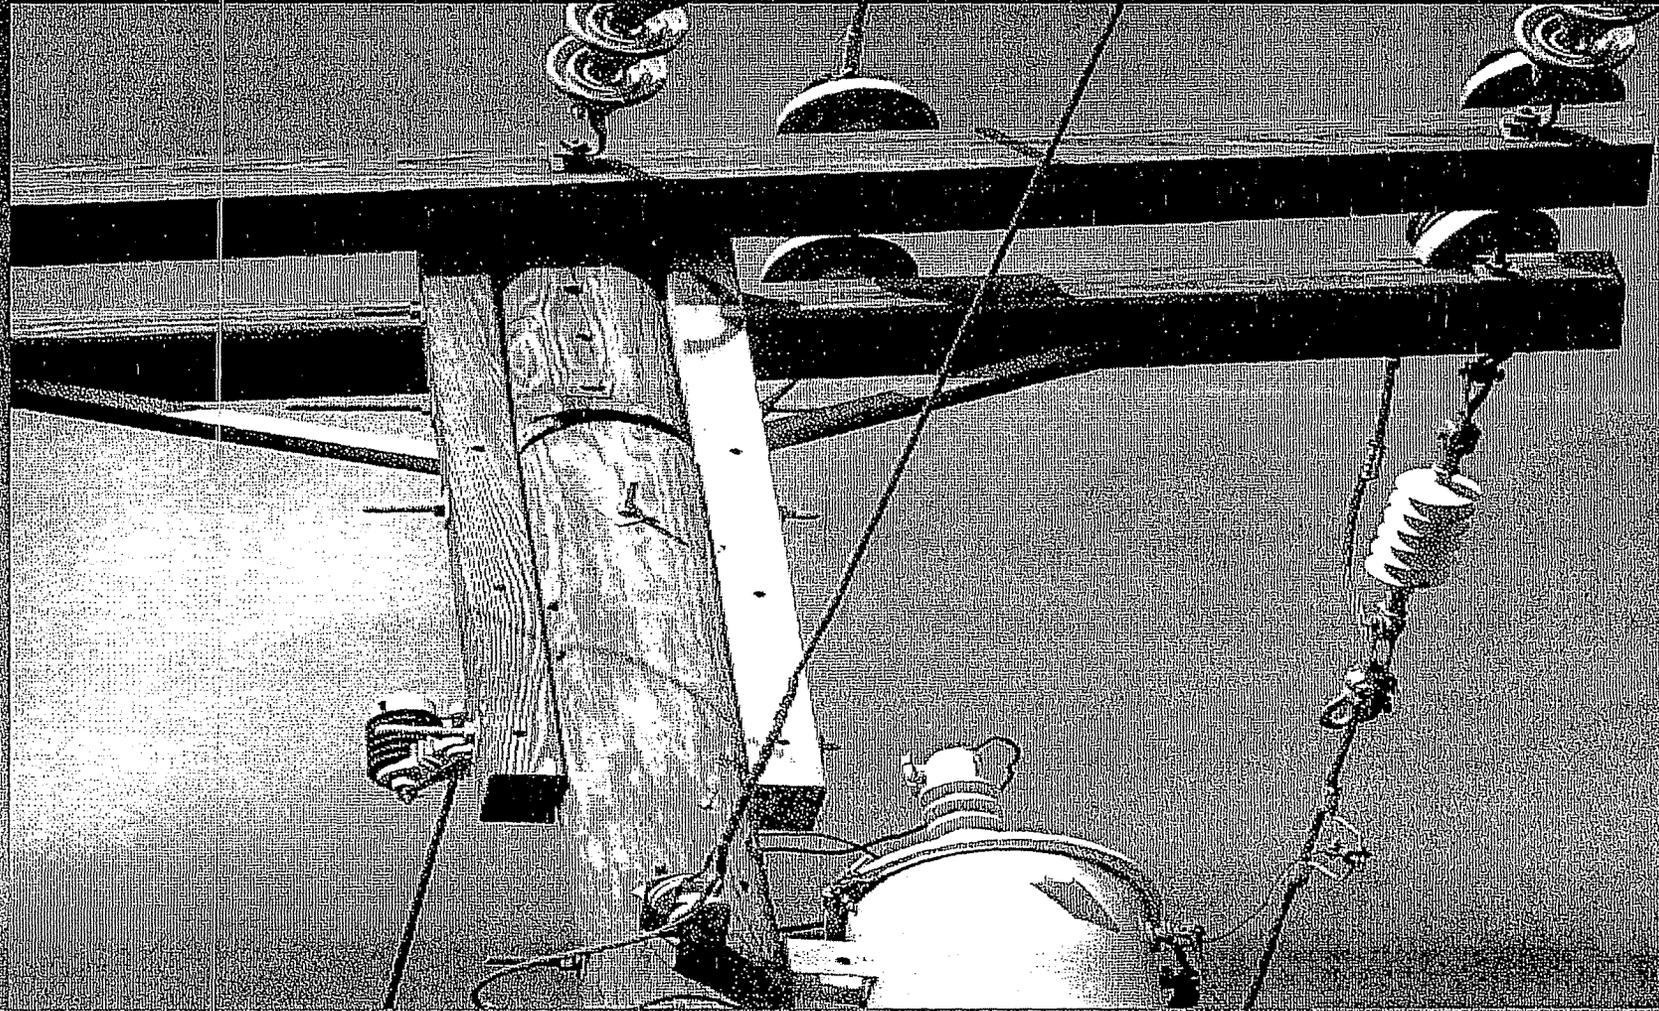
# Examples \ Pole Fire

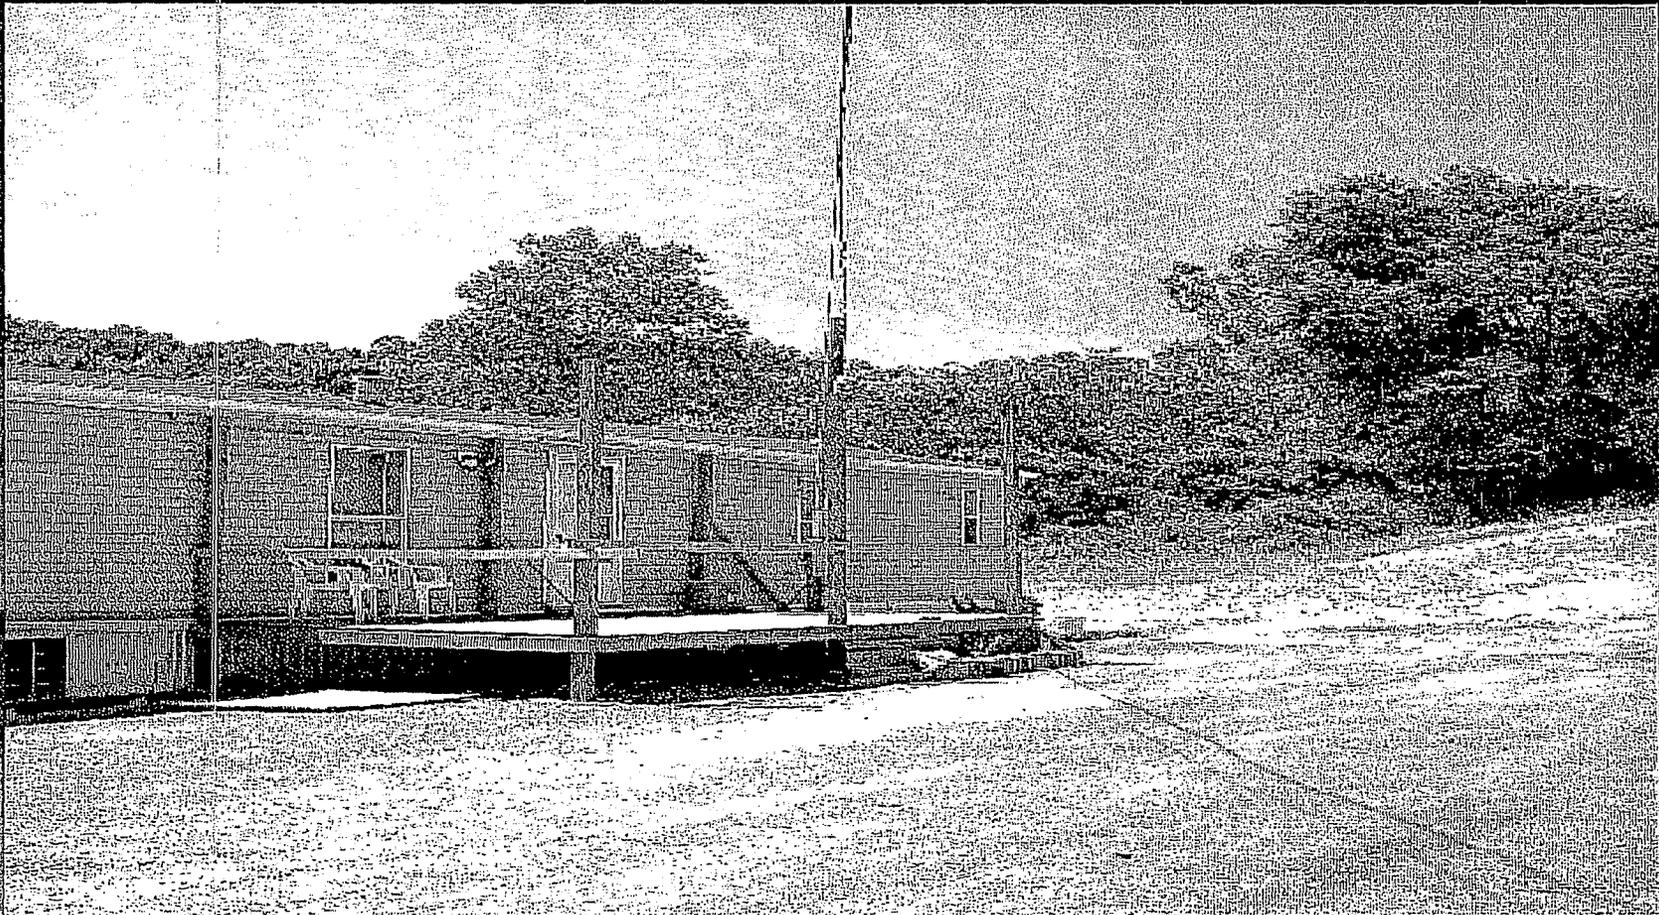
# Examples \ Drop Over Deck

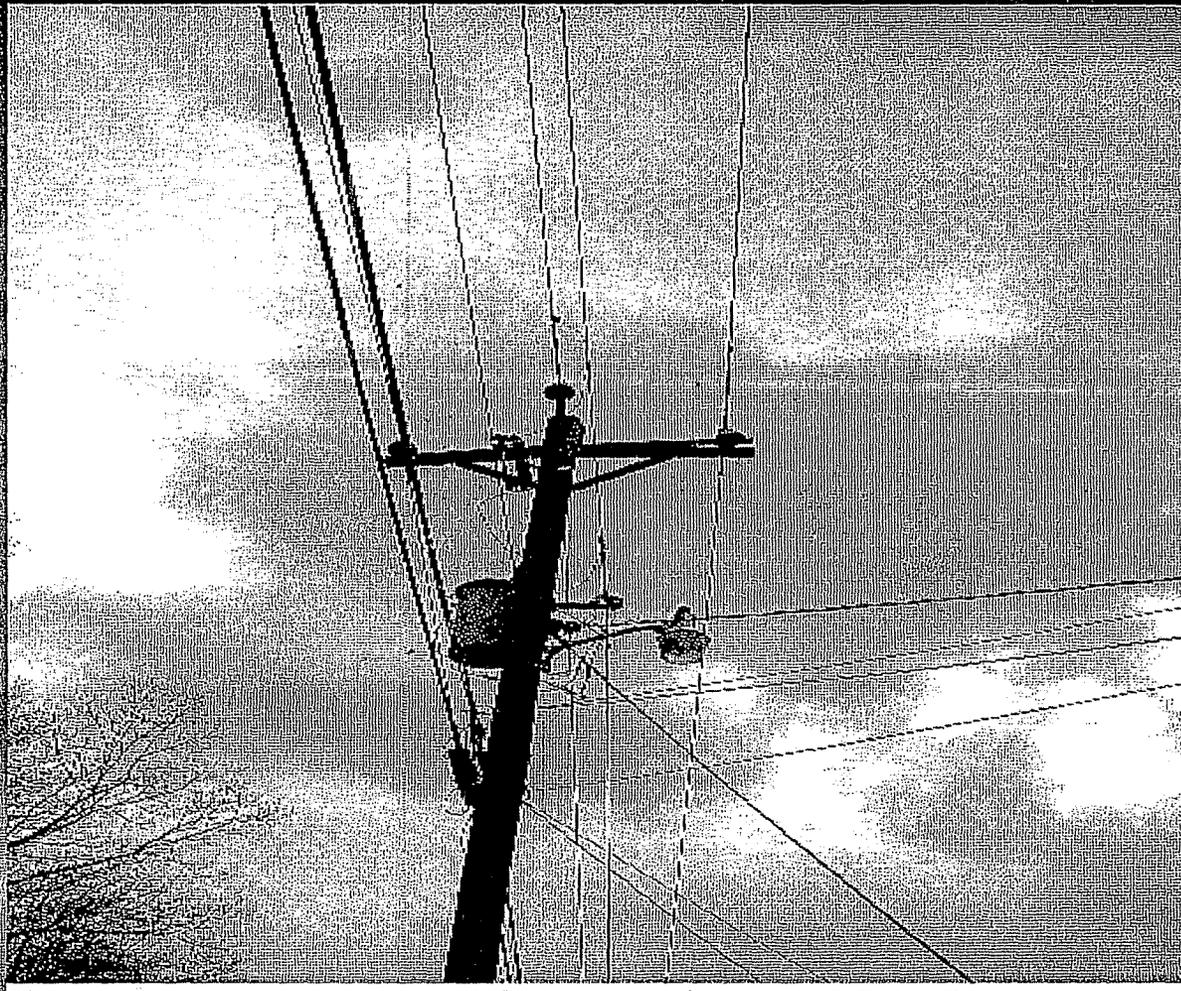
# Examples \ Bad XARM

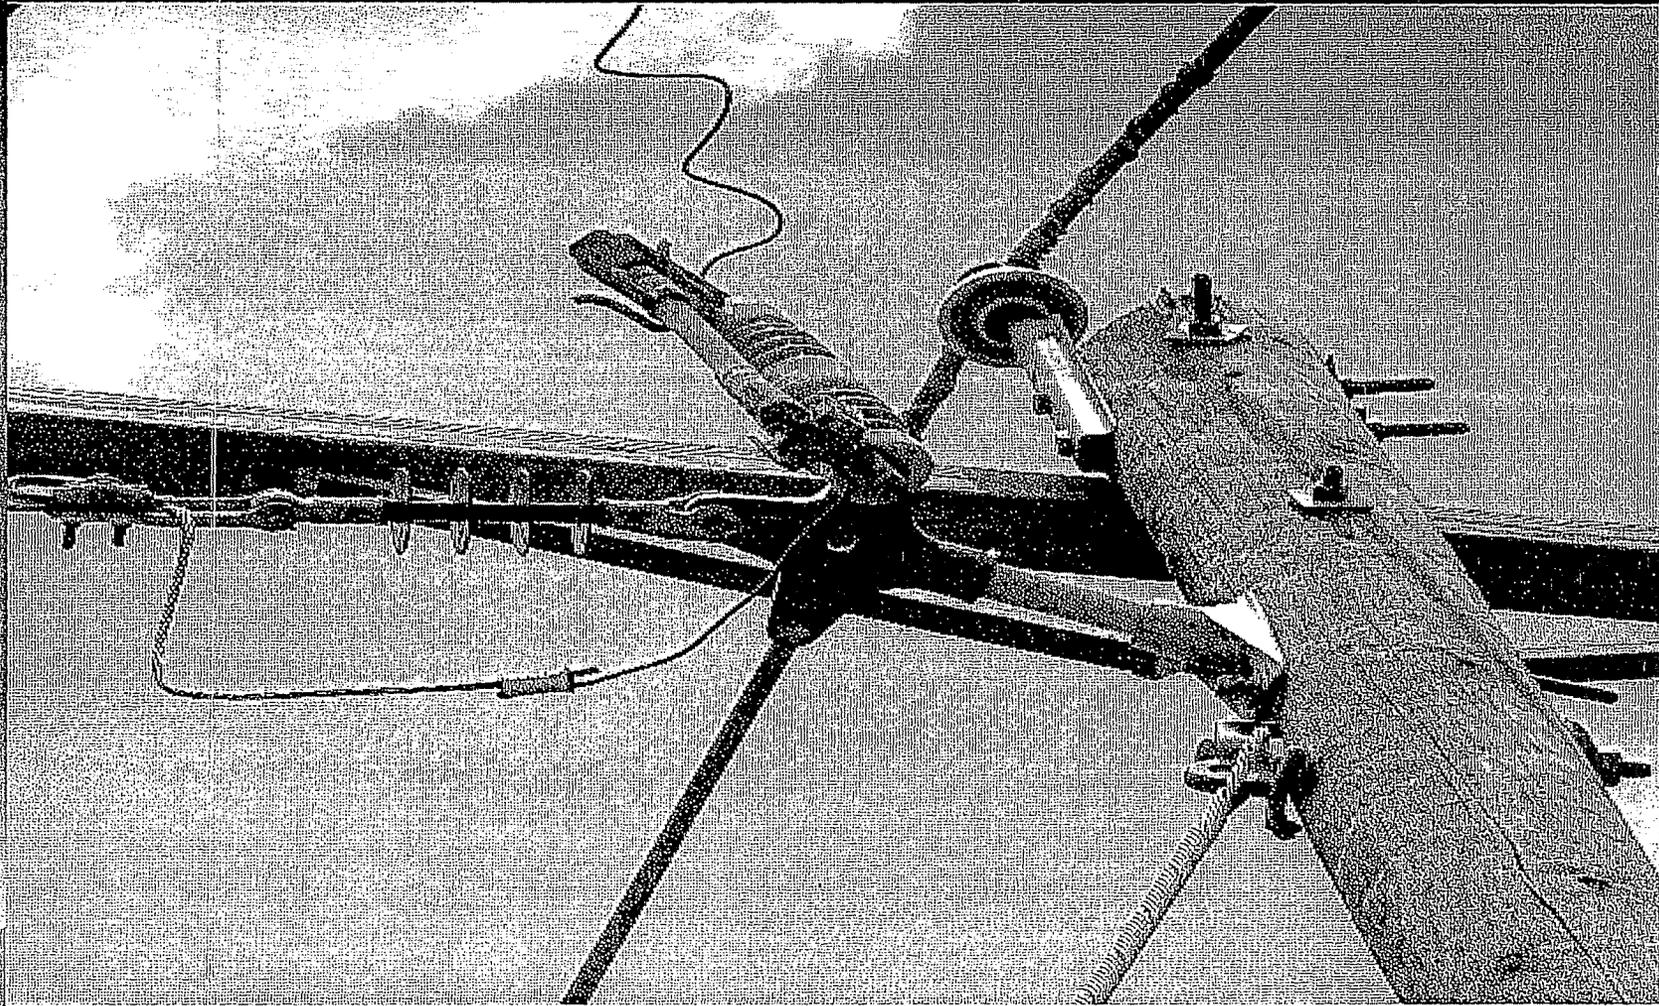
# Examples \ Non-Standard Const.

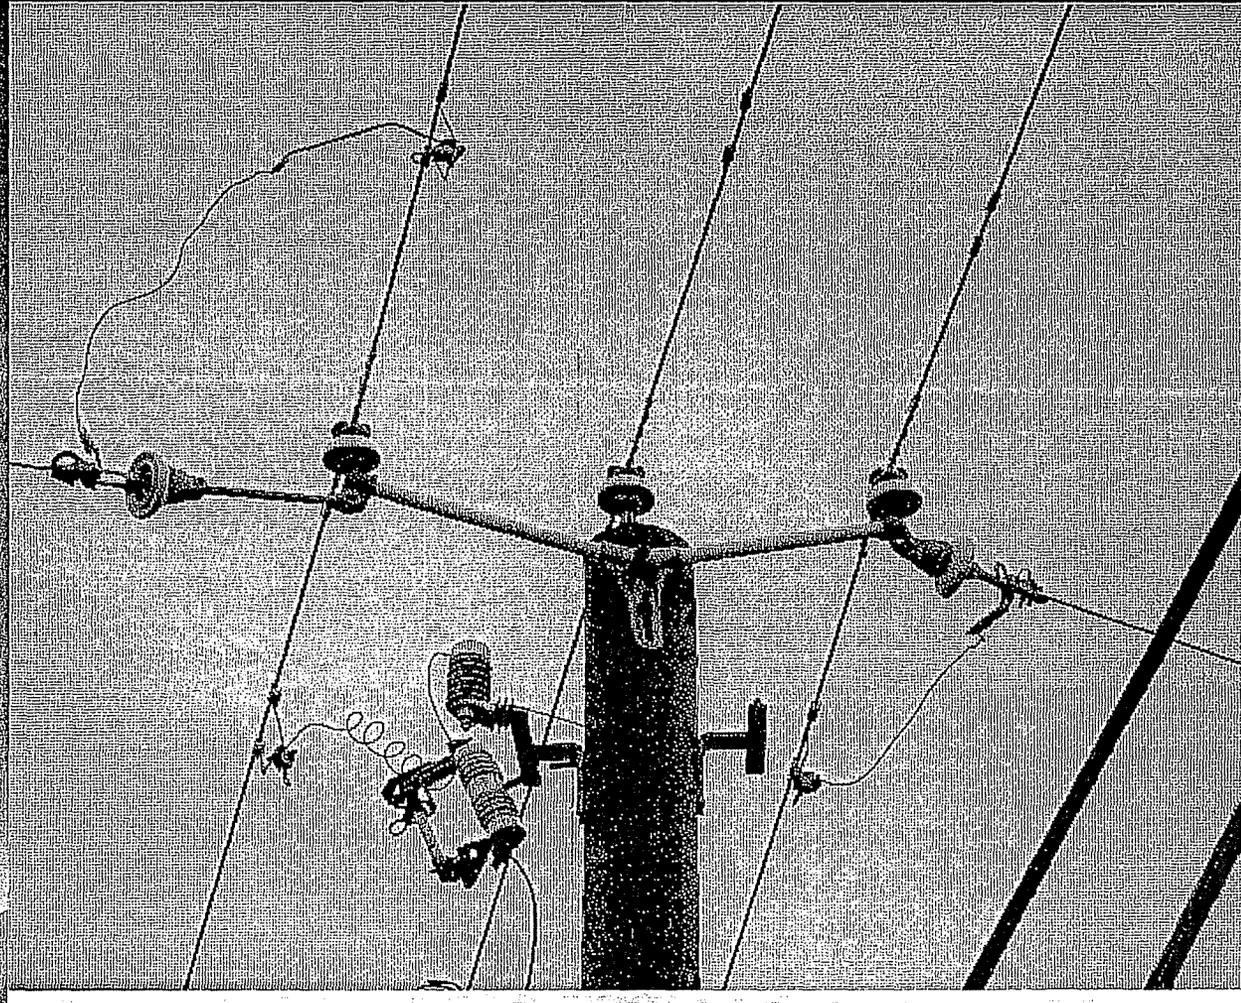
# Examples \ Non-Standard Const.

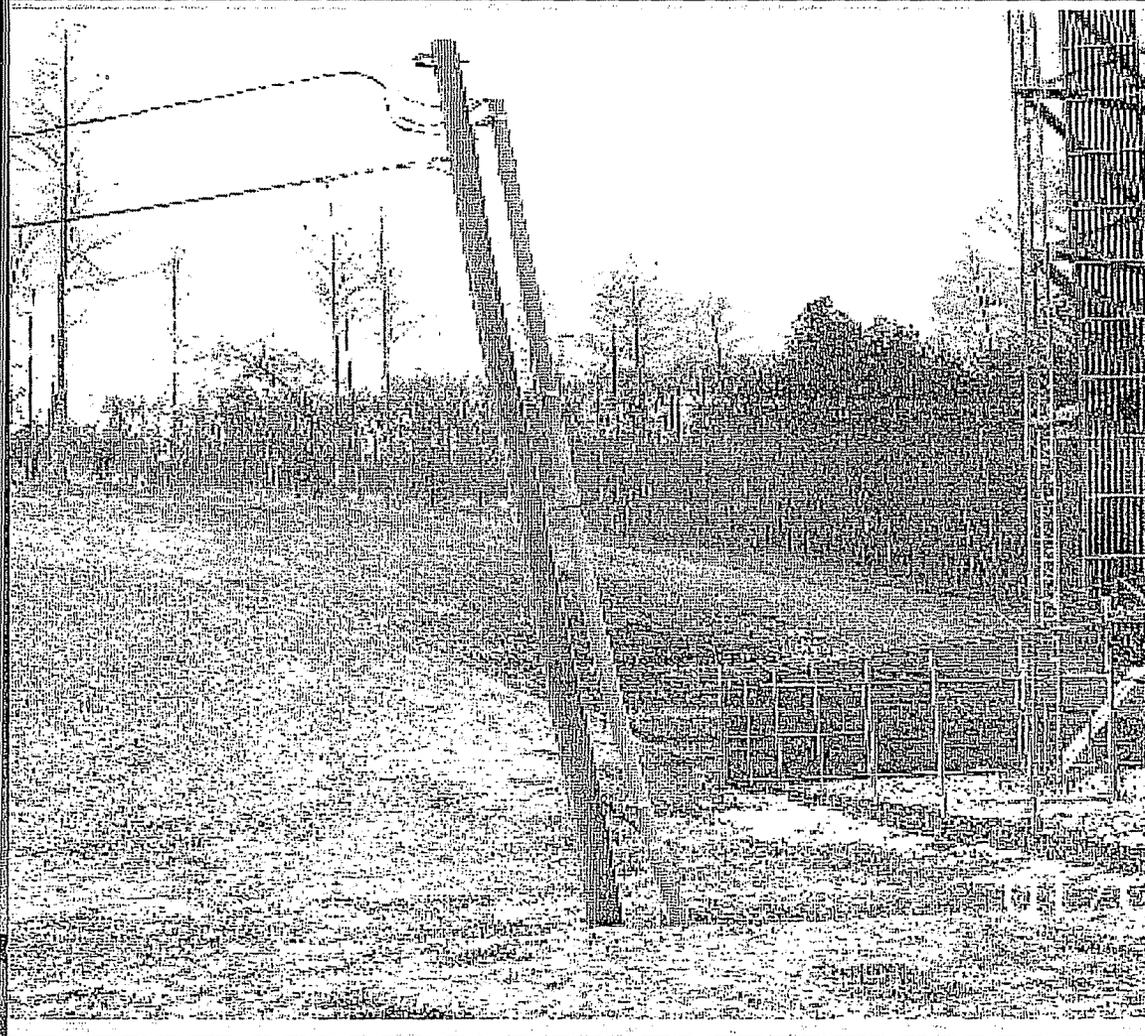
# Examples \ Un Guyed pole leaning

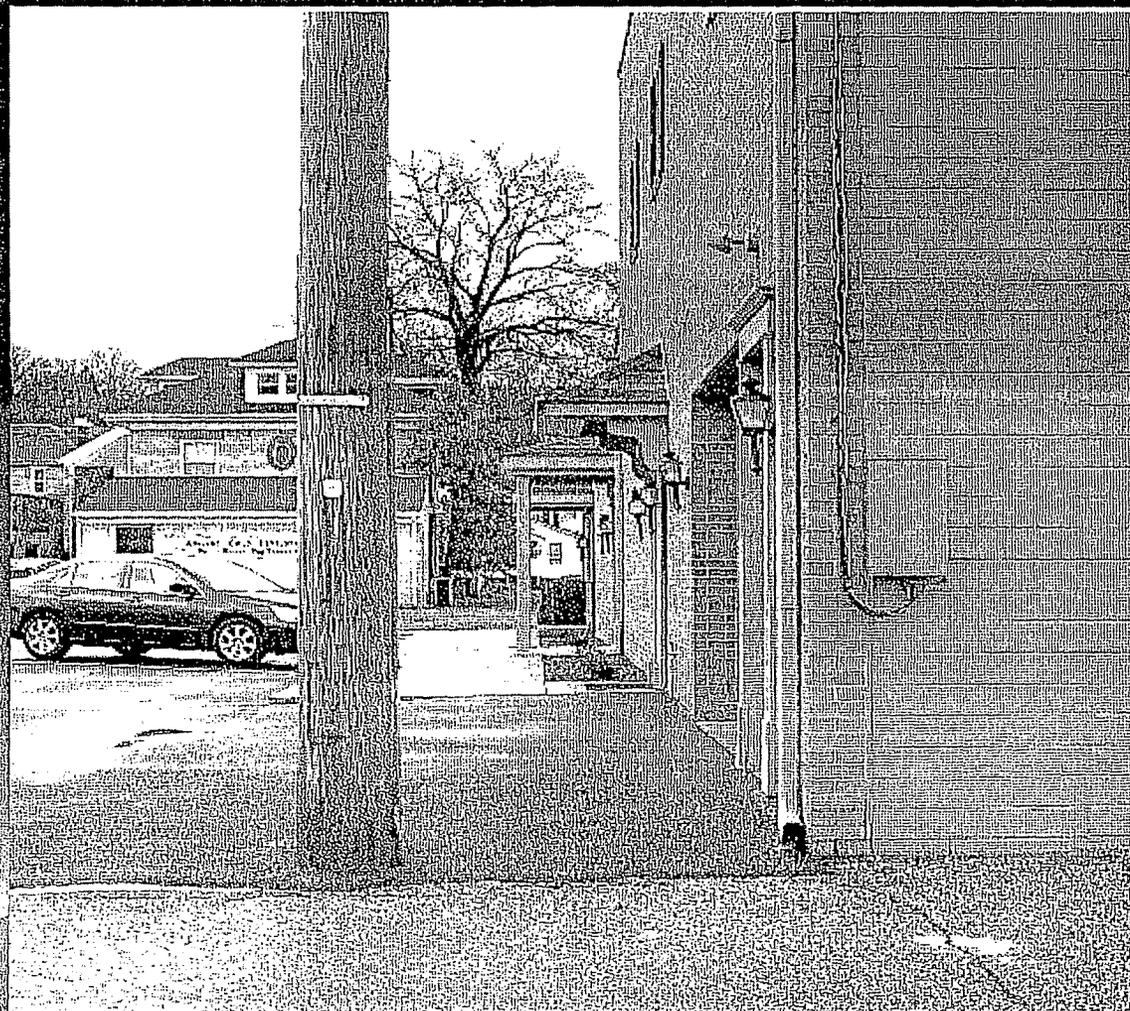
# Examples \ Pole Adjacent to Buildings

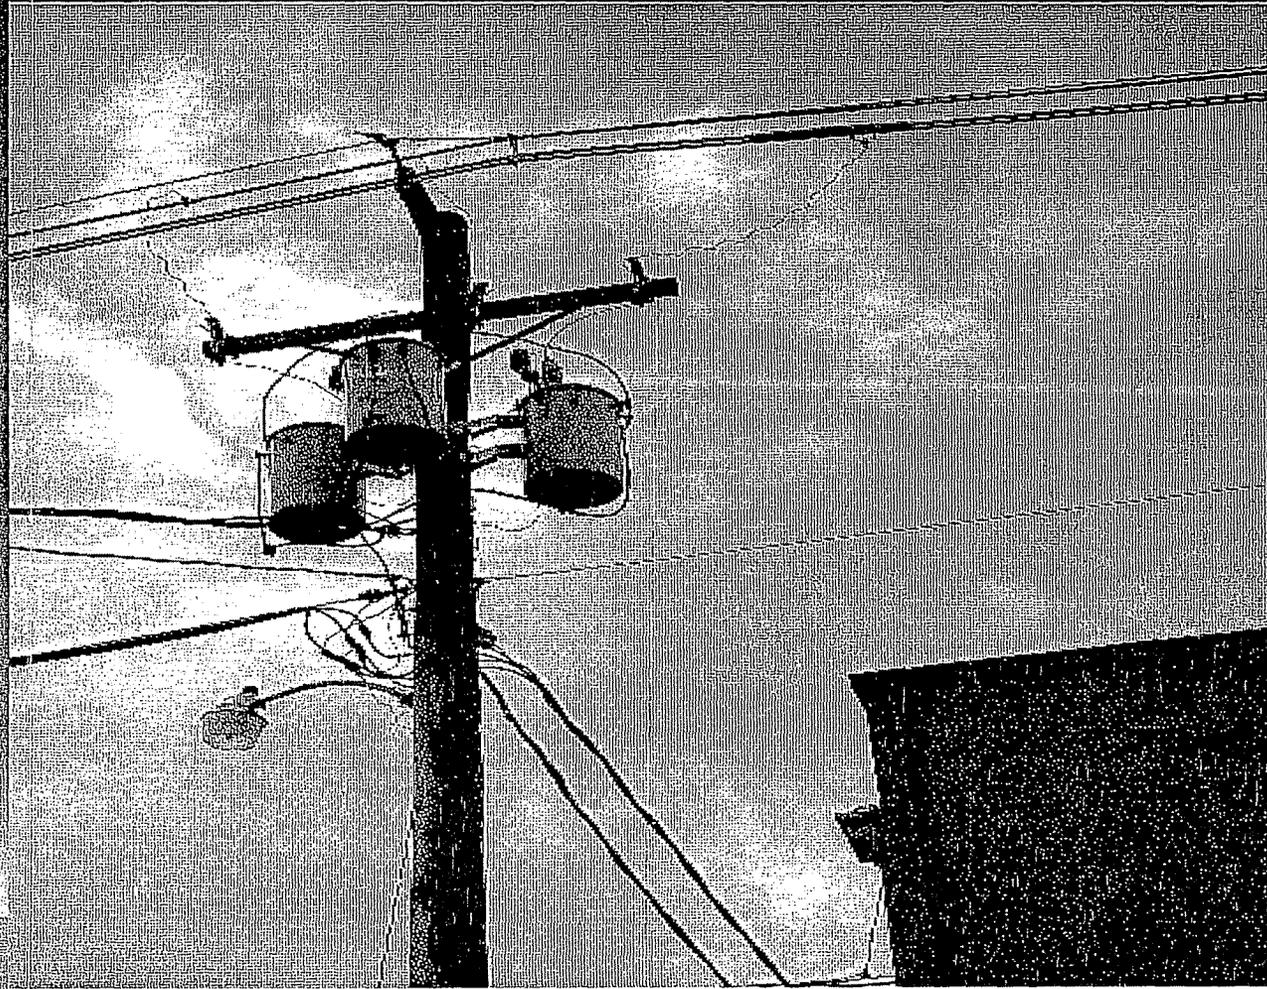
# Examples \ Pole Adjacent to Buildings

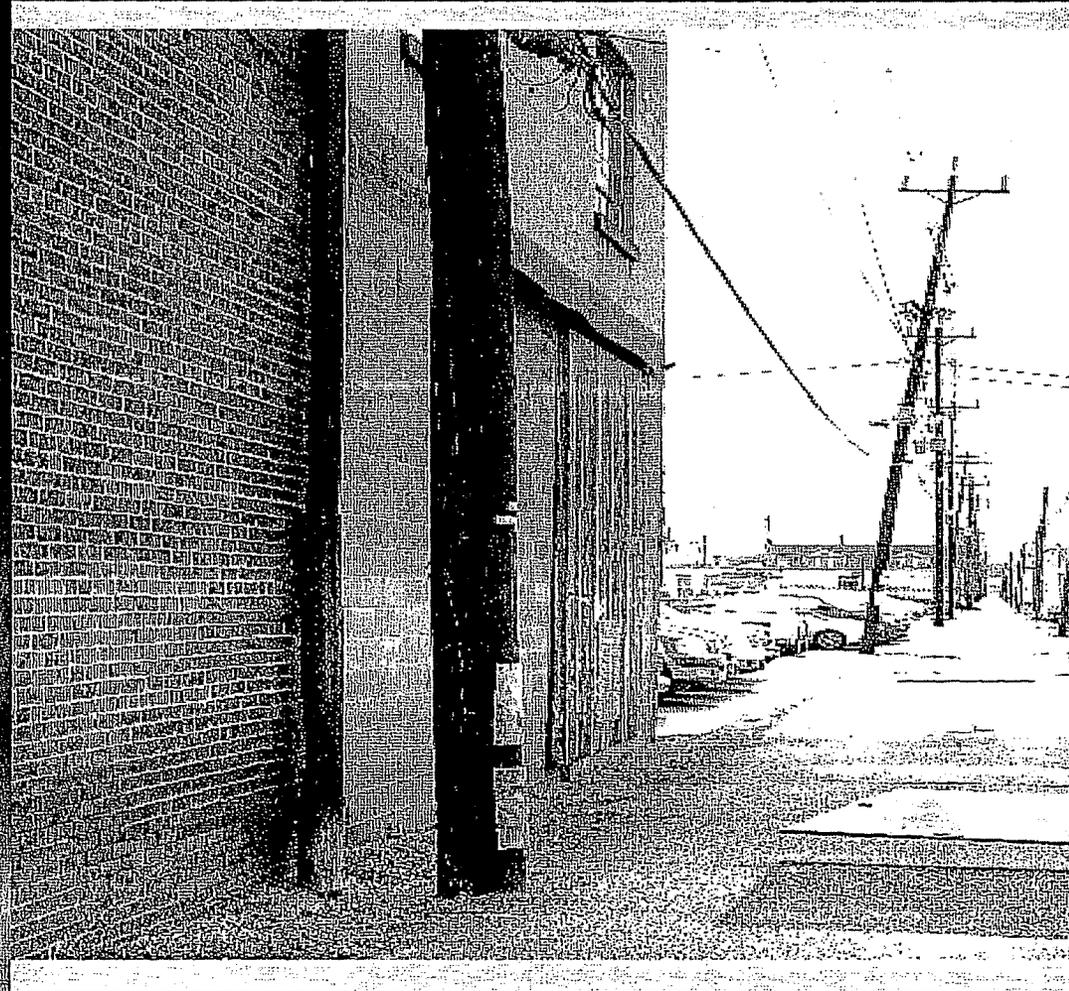
# Examples \ Pole Adjacent to Buildings

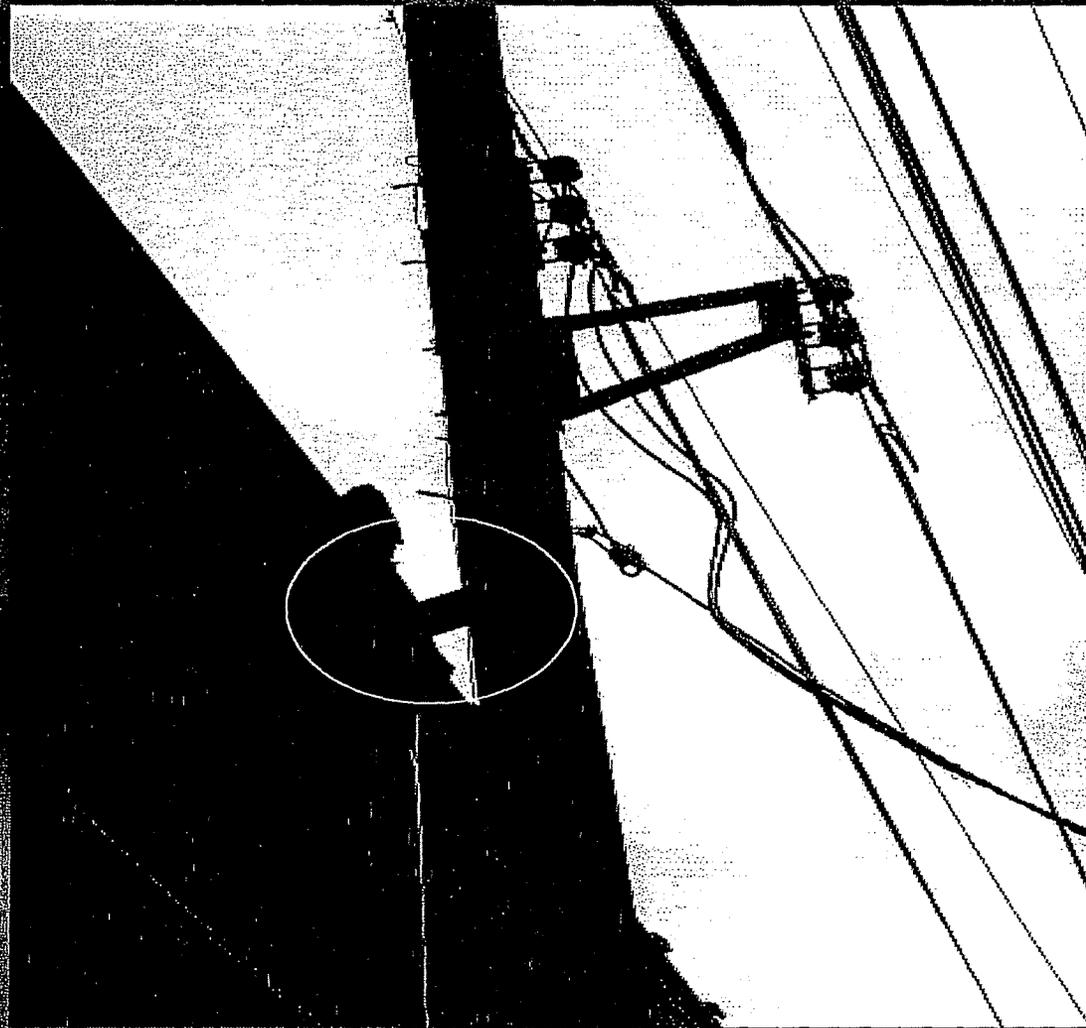
# Examples \ Pole Adjacent to Buildings

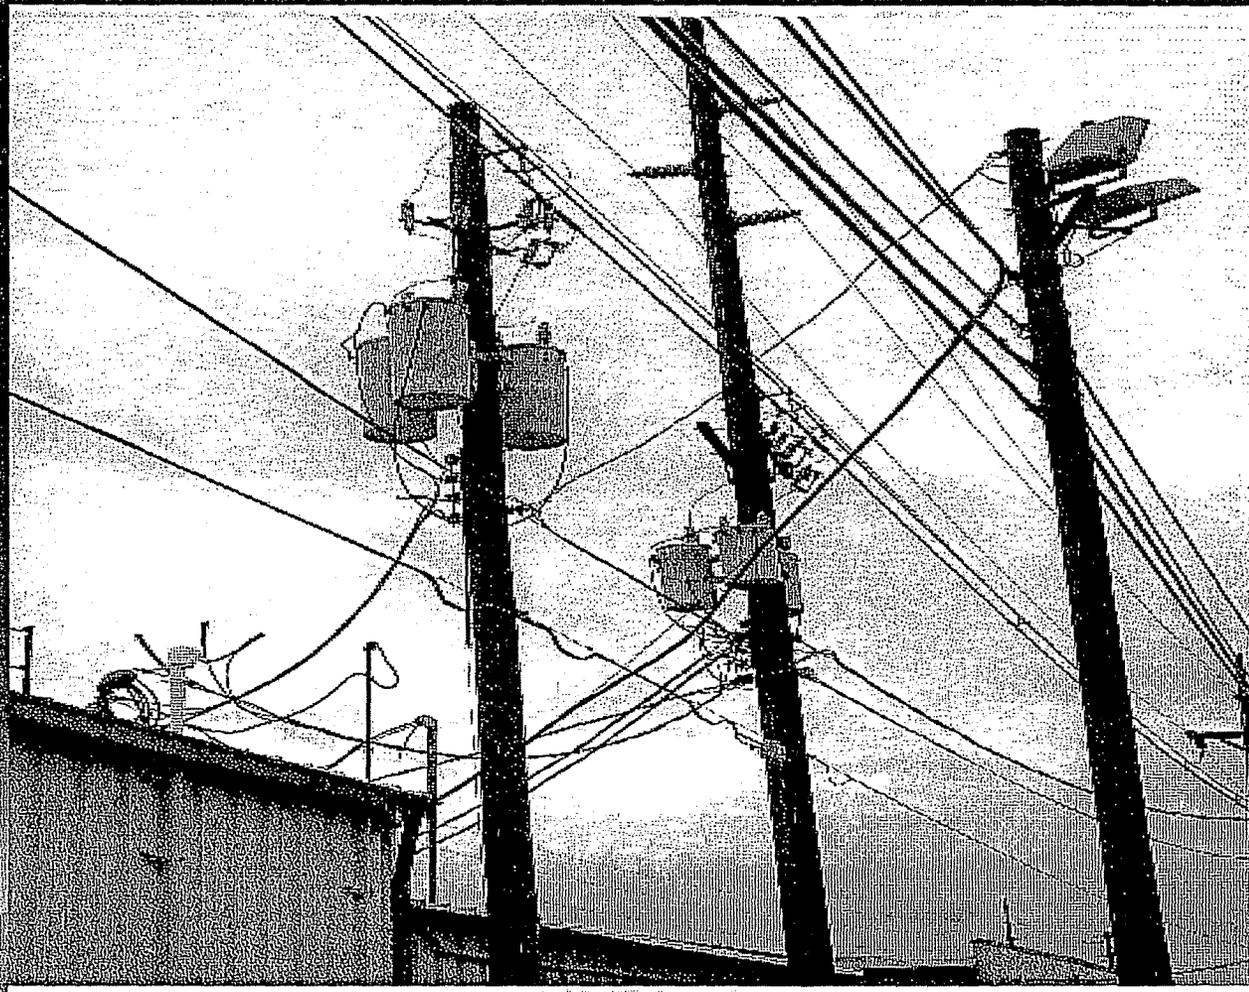
# Examples \ Pole Adjacent to Buildings

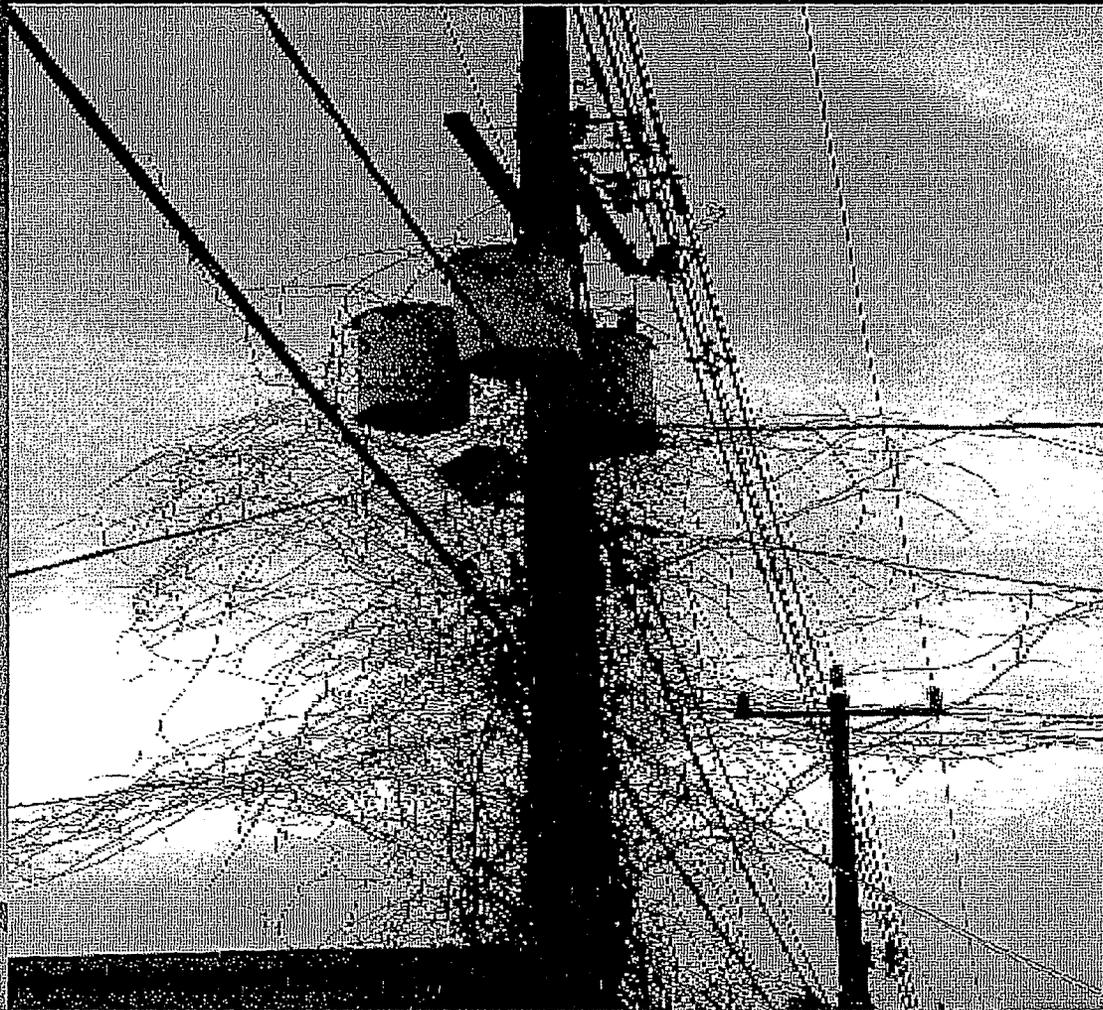
# Examples \ Vines

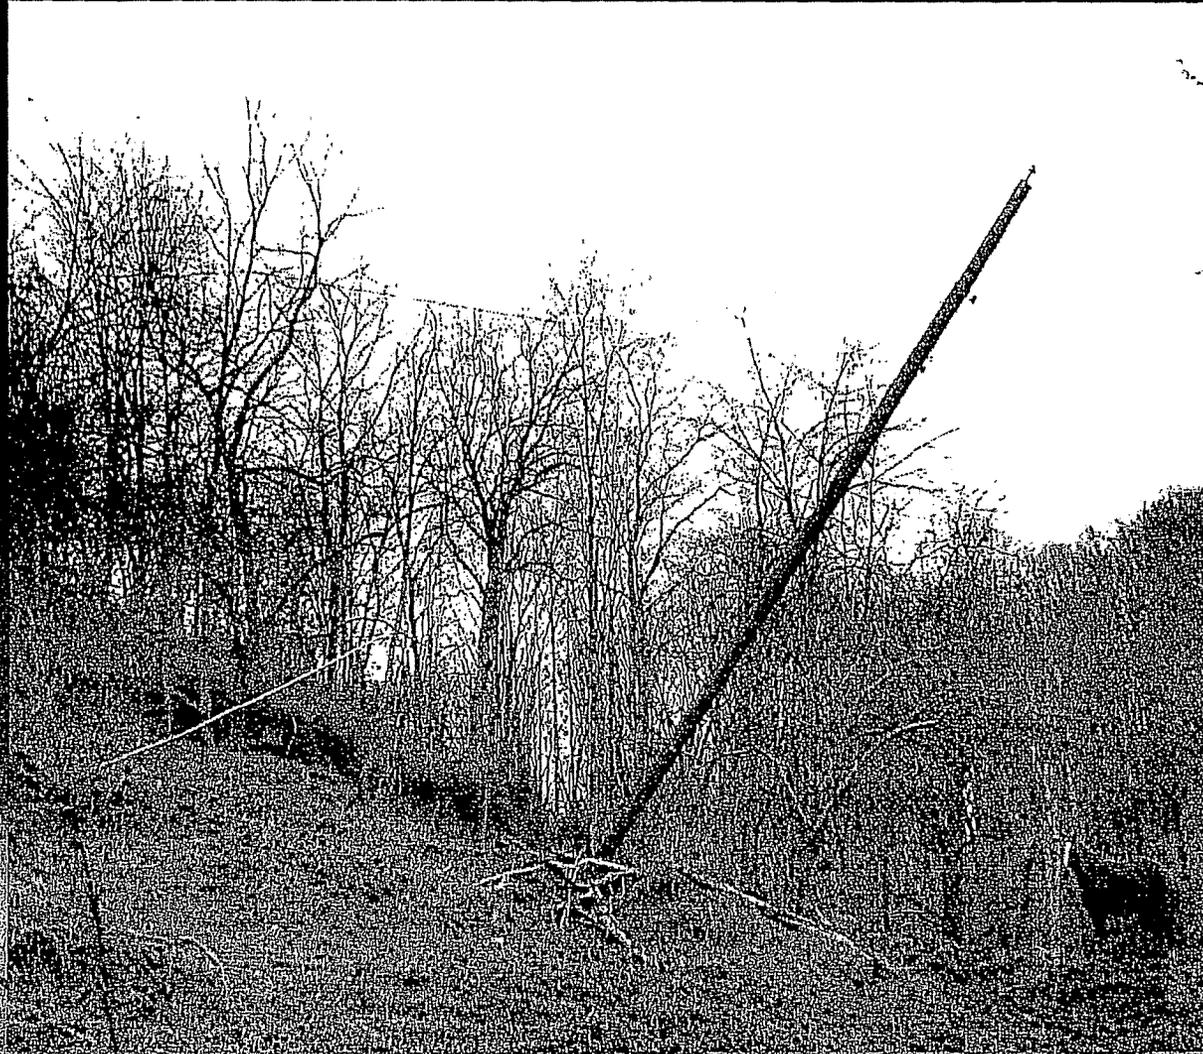
# Examples \ Pole in Slip

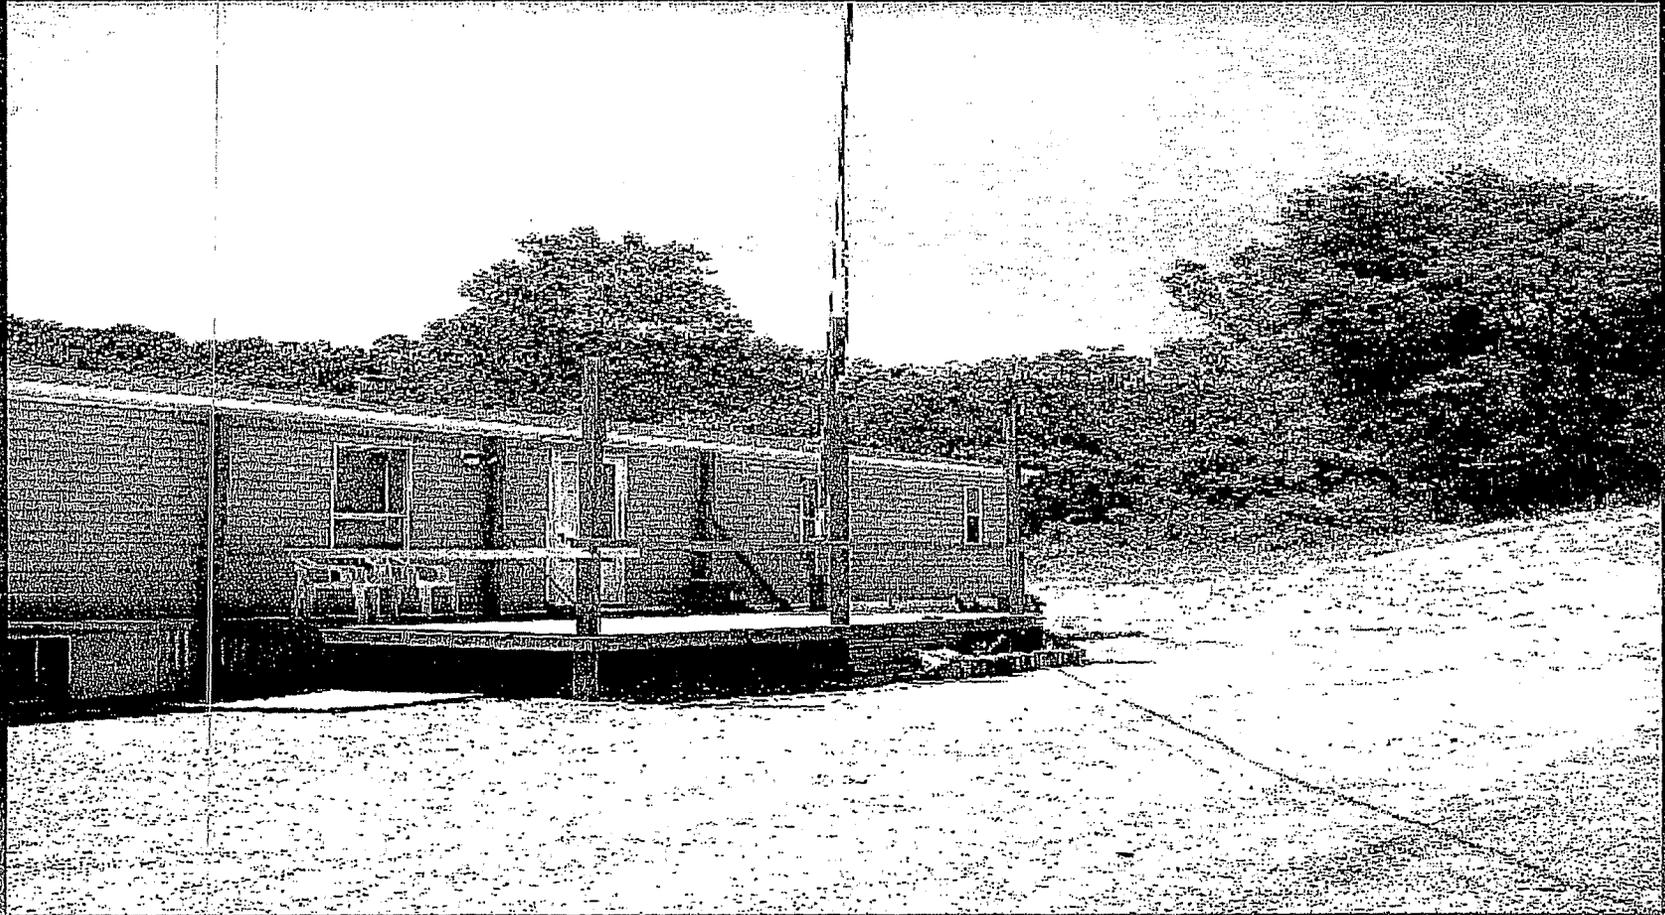
# Examples \ Drop Over Deck

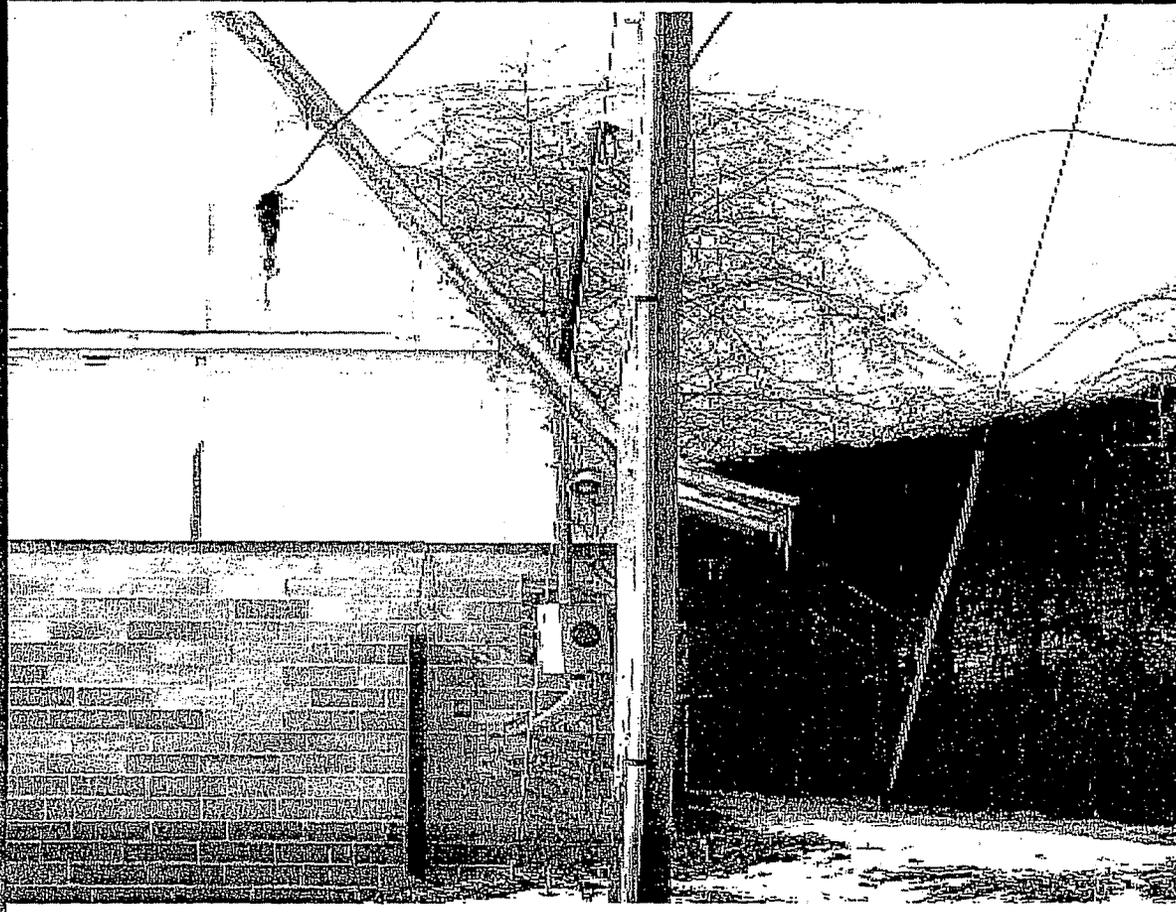
# Examples \ Loose Meter Base

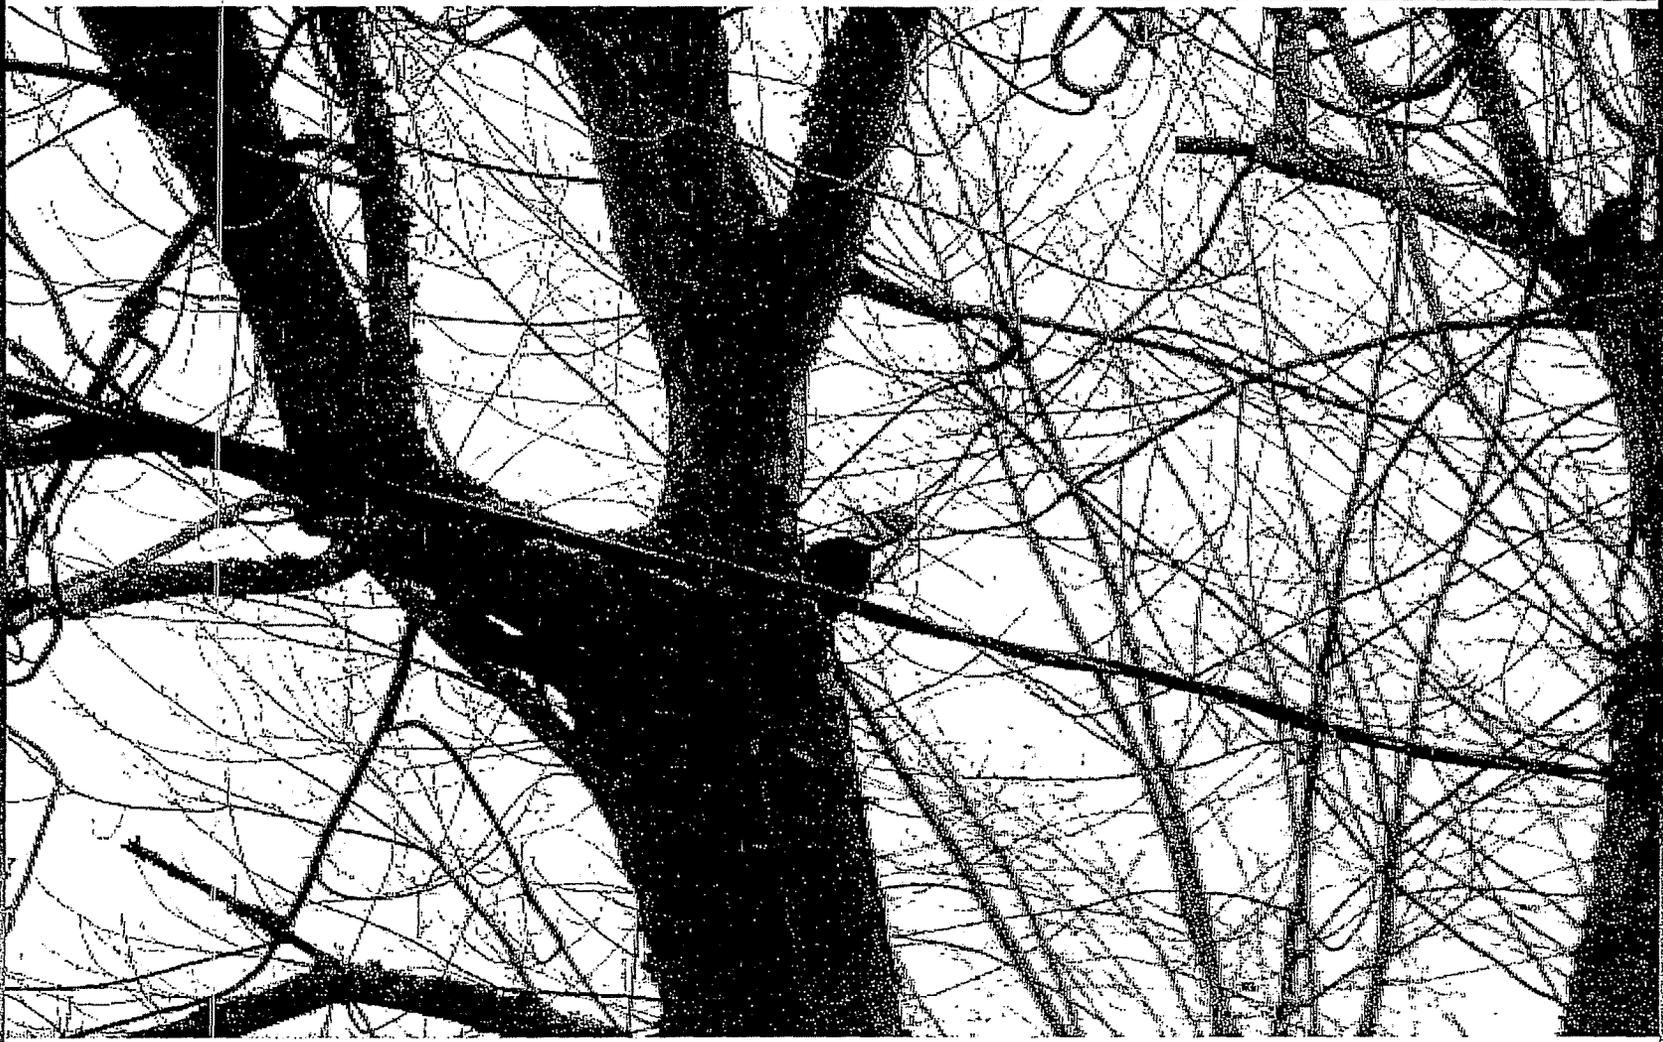
# Examples \ Service in Tree
