COMMONWEALTH OF KENTUCKY  
BEFORE THE PUBLIC SERVICE COMMISSION

| ALLEGED FAILURE TO COMPLY WITH | ) | CASE NO. |
| KRS 278.042 | ) | 2010-00317 |

O R D E R

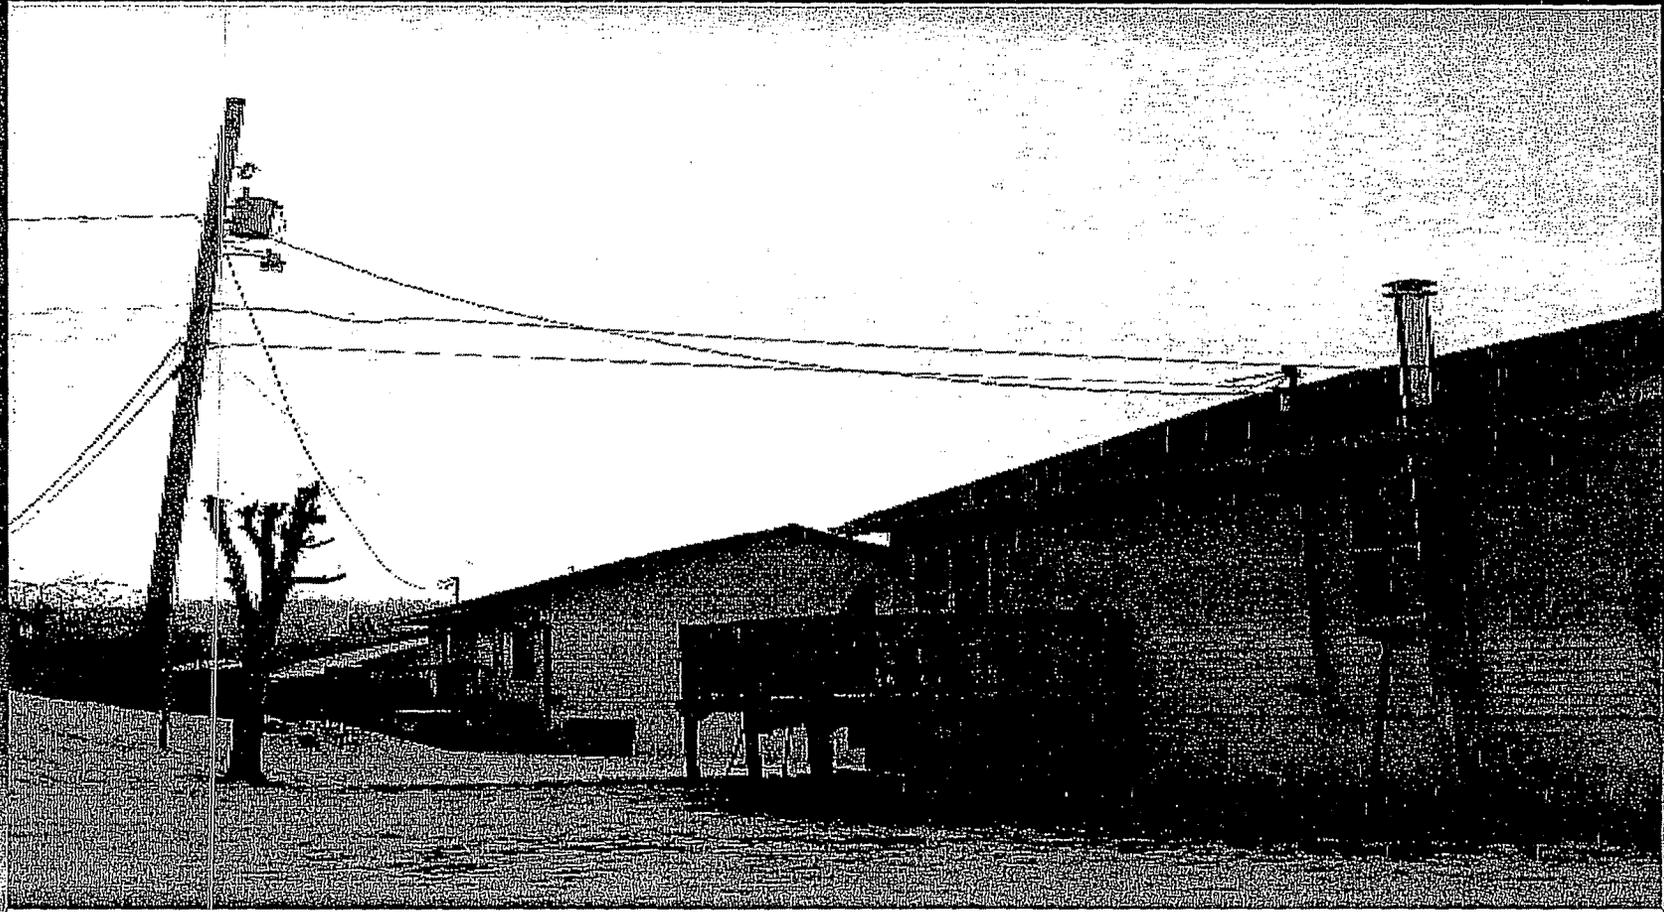
# Examples \ SD Across Deck

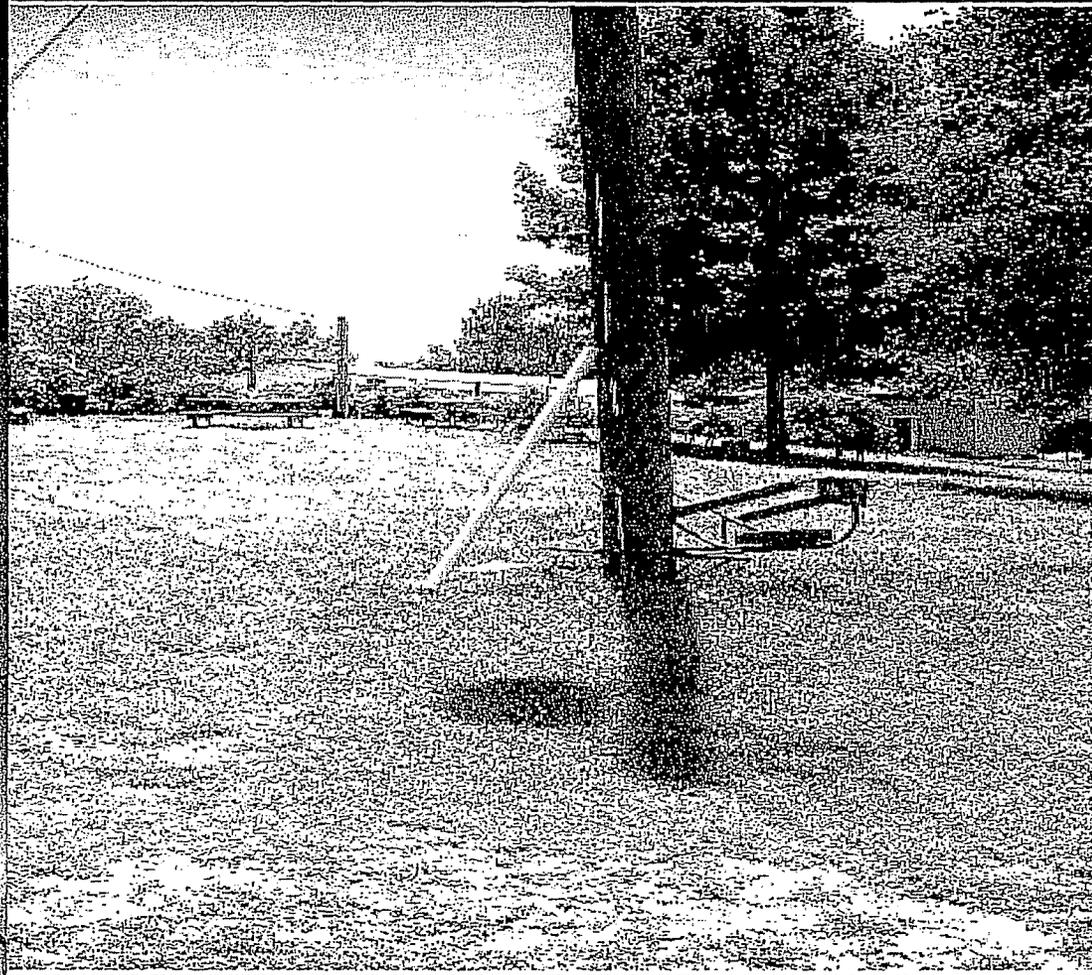
# Examples\ Tree Stand

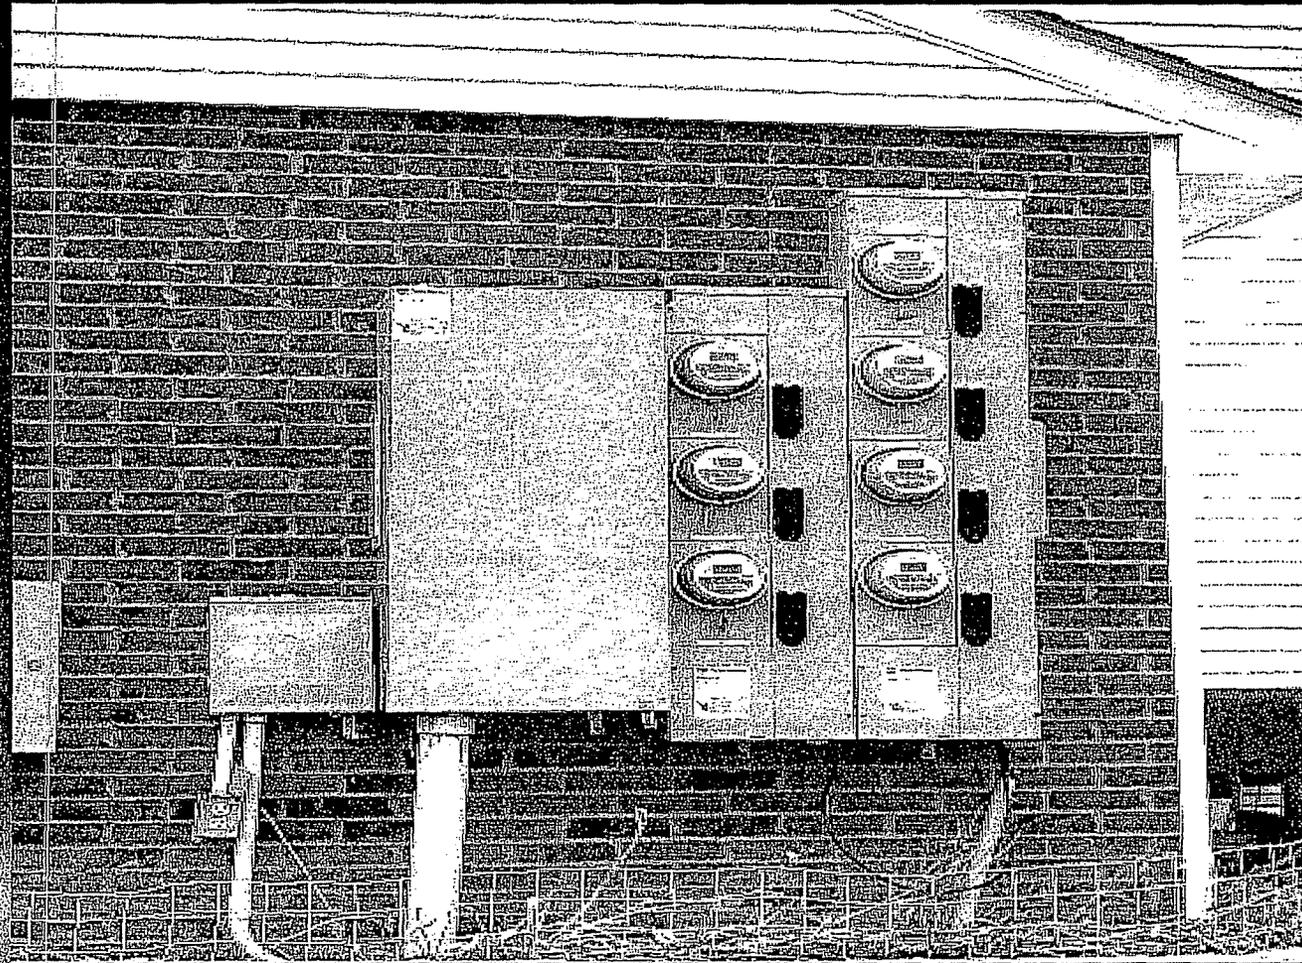
# Examples \ Loose Ground
