CLOSURE OF INVESTIGATION OF	)	
MARCH 8, 2018 INCIDENT – INTER-COUNTY	)	CASE NO.
ENERGY COOPERATIVE CORPORATION	)	2018-00268

## **ACCIDENT INVESTIGATION STAFF REPORT**

**Serving Utility:** Inter-County Energy Cooperative Corporation

**Accident Location:** 1940 Spencer Hamilton Road in Marion County,  
Kentucky

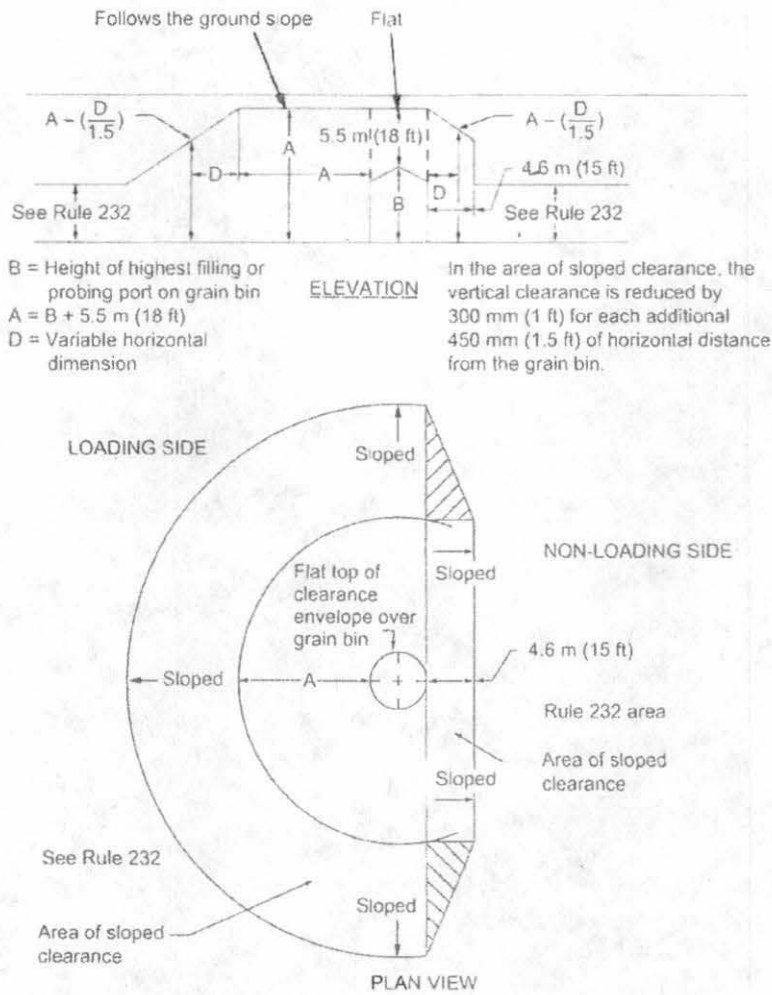
Figure 234-4(b)—Clearance envelope for grain bins filled by portable augers, conveyors, or elevators

After reviewing all of the information concerning this accident, it appears that the Inter-County Energy energized primary conductor involved in this accident was not in compliance with the NESC clearance requirements for grain bins filled by portable augers, conveyors or elevators. The energized primary conductor was in the loading zone of this grain bin.

BOTH CONDUCTORS ARE IN THE CLEARANCE ENVELOPE.  
 THIS DOES NOT MEET THE REQUIREMENTS OF THE NESL  
 FOR LOADING SIDE AND NON-LOADING SIDES OF GRAIN BIN.  
 THIS WAS A LOADING SIDE ACCIDENT.

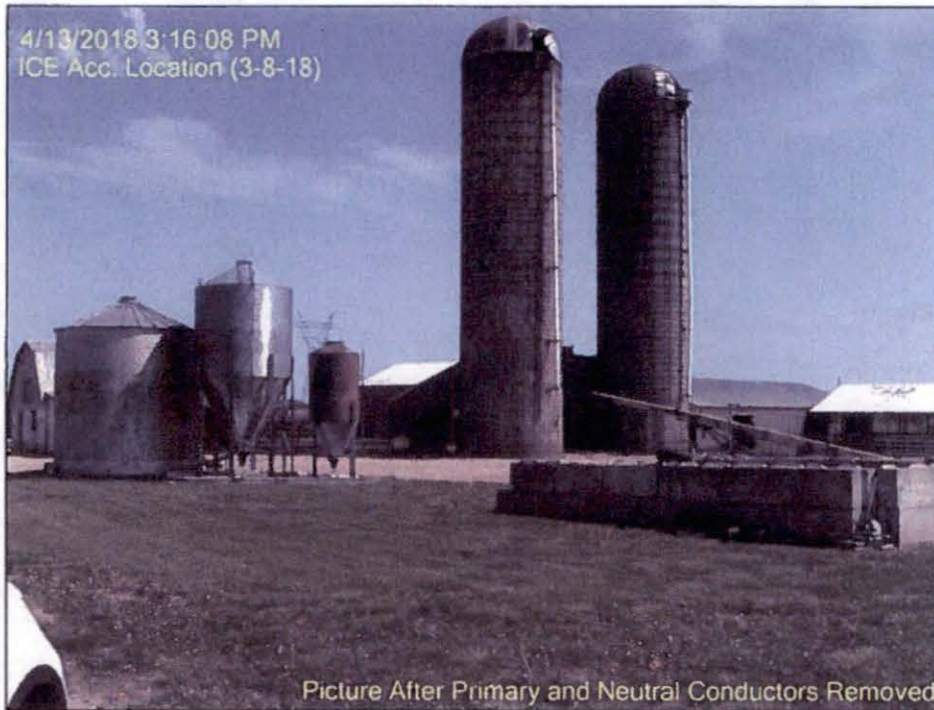
**#1**

The following photographs were taken by Steve Kingsolver, Public Service Commission, on April 13, 2018. The photographs show the area where the accident took place with the removal of the primary and neutral conductors.
