Event

Root Cause Failure Analysis

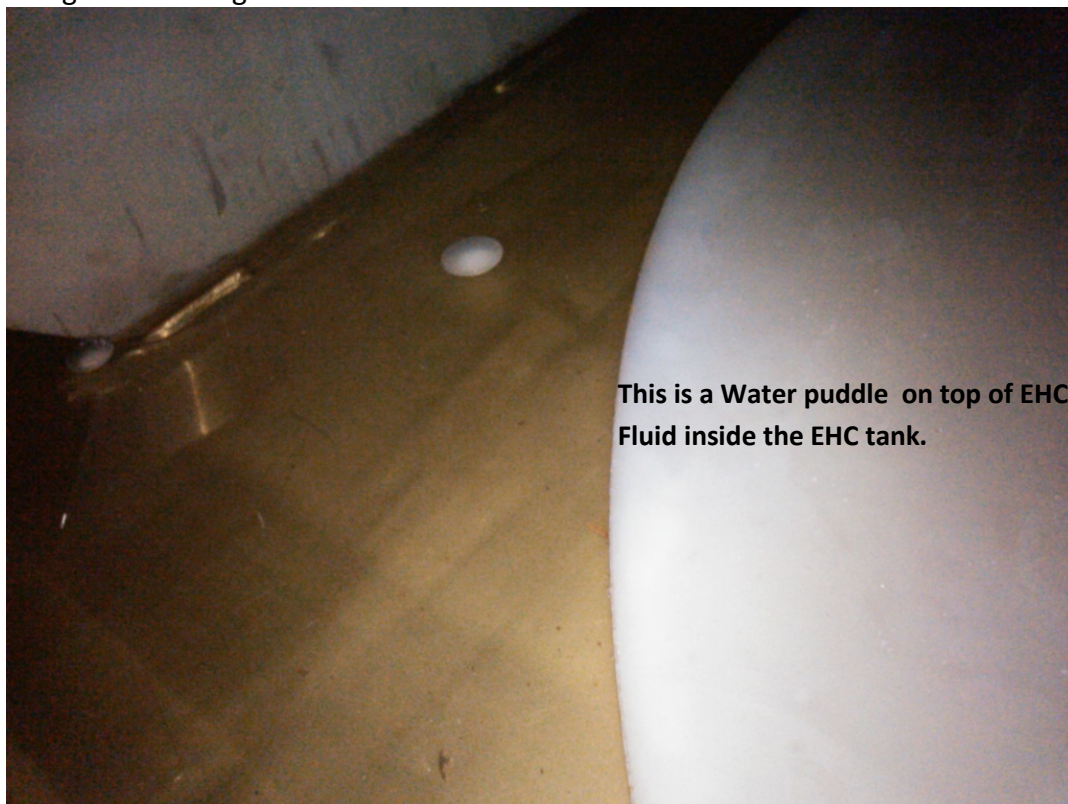
Upon opening and draining the EHC tank visual indications of water and contamination were found.

This is a Water puddle on top of EHC Fluid inside the EHC tank.

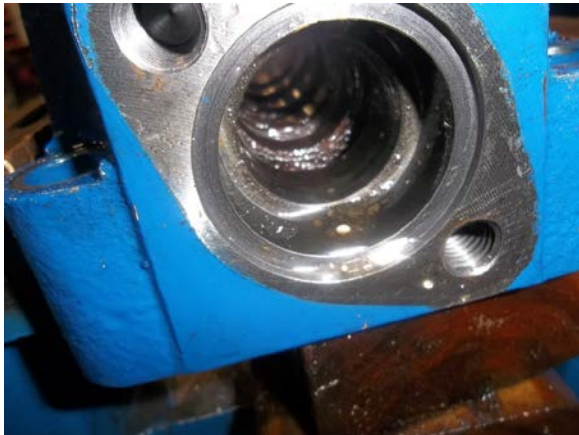
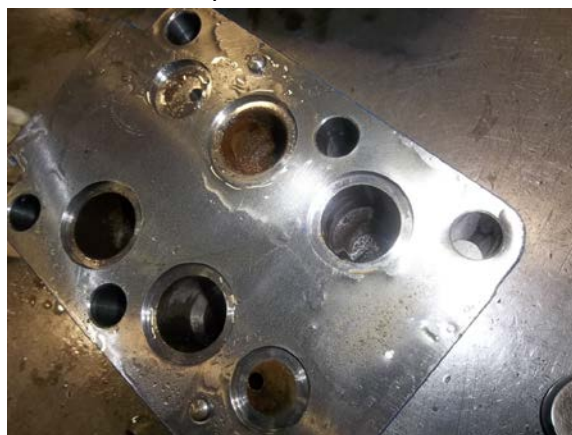
Trip Block assembly was removed from the EHC skid and shipped to Rexroth in Pennsylvania. Rexroth disassembled cleaned and is inspected the Emergency Trip Device/Master trip Solenoid Block. Photos below provided by Rexroth show water, varnish and oxidation. Some components were found in a stuck or sluggish condition. The trip valves were reported to not be functioning at all. Rexroth recommended removal of valve actuators for inspection.

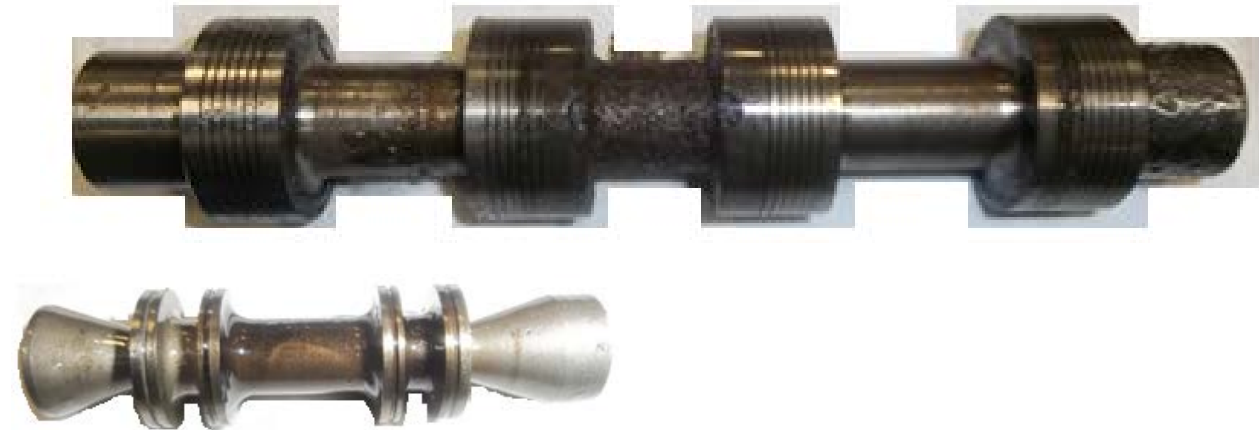
Spool and trip valve showing oxidation as well as varnishing.

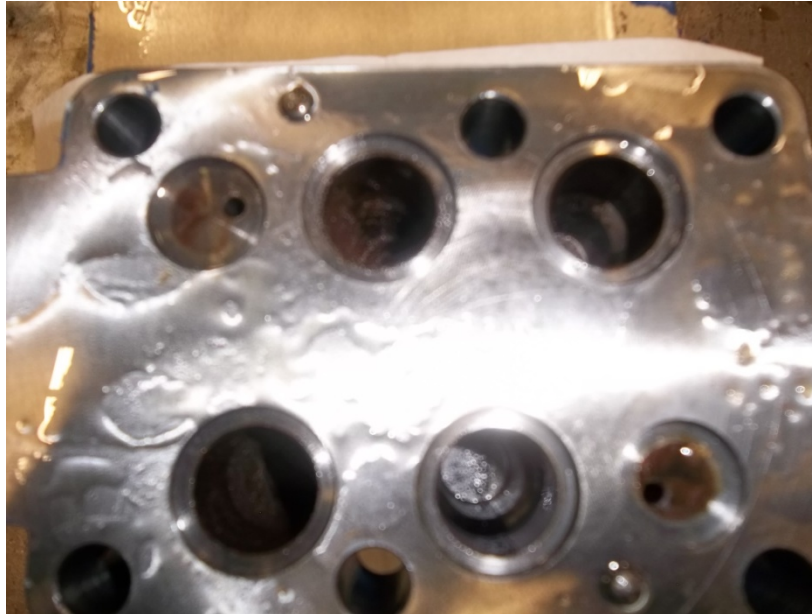
Trip Valve – 4WH 22 shows oxidation in ports

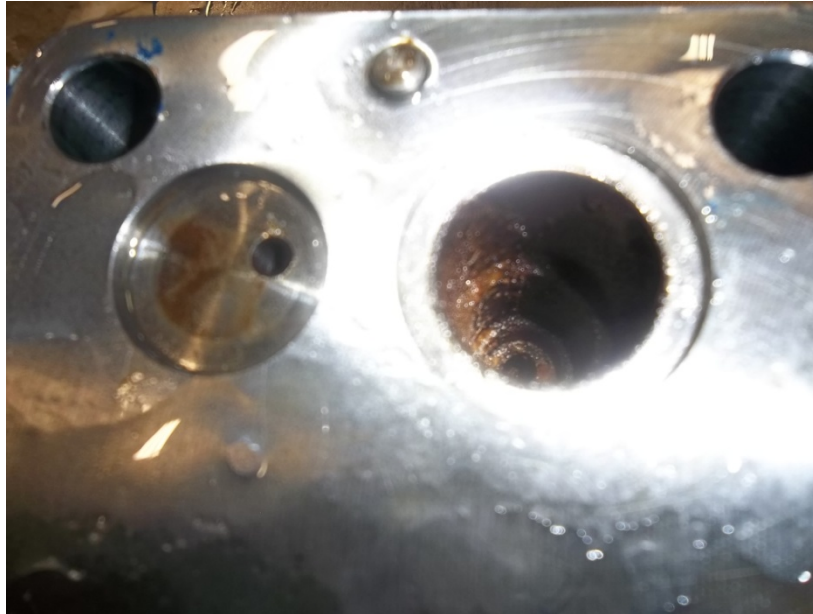
Trip Valve – 4WH 22 shows oxidation in ports

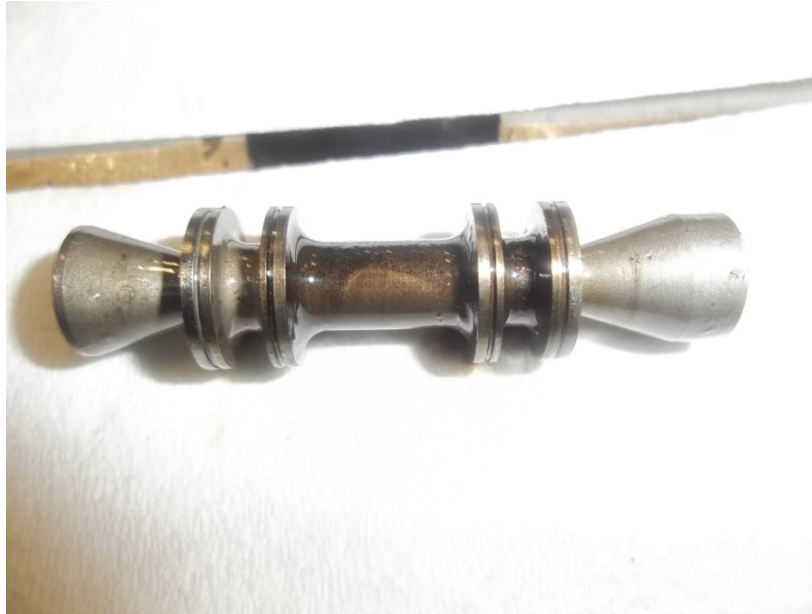
Trip Valve - 4WMM 6 shows varnish and oxidation

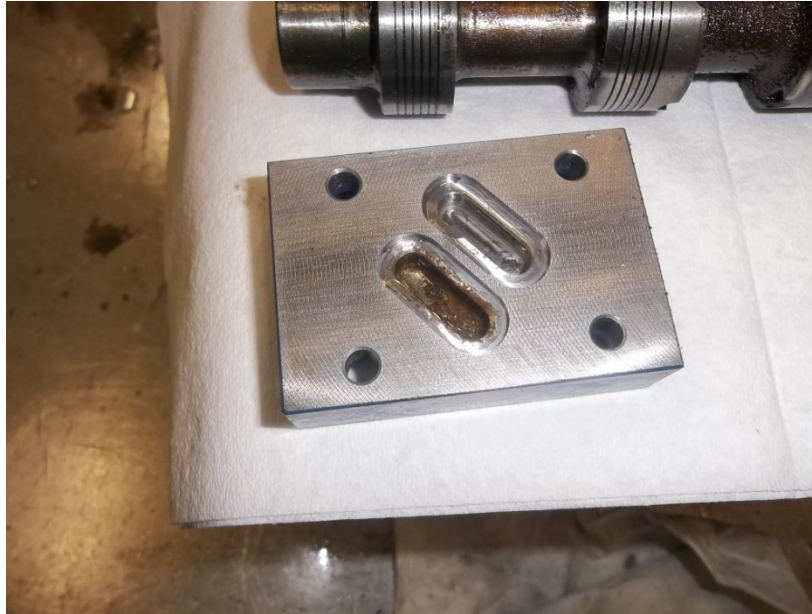
Varnish and debris in pressure port

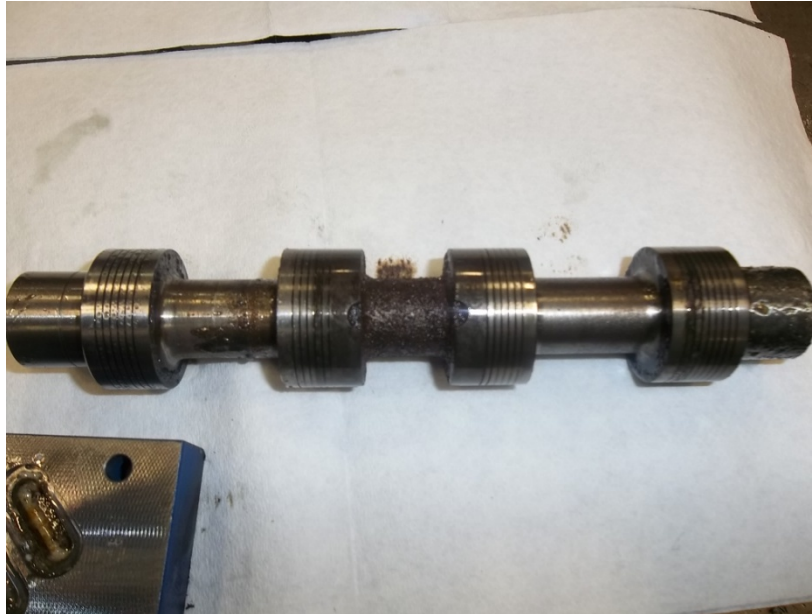
Spool shows oxidation as well as varnish

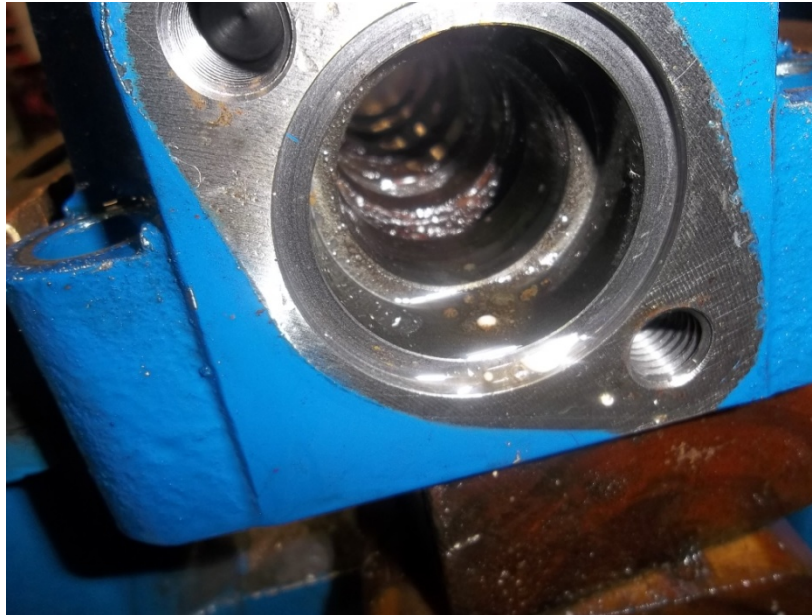
Major oxidation can be seen within the valve

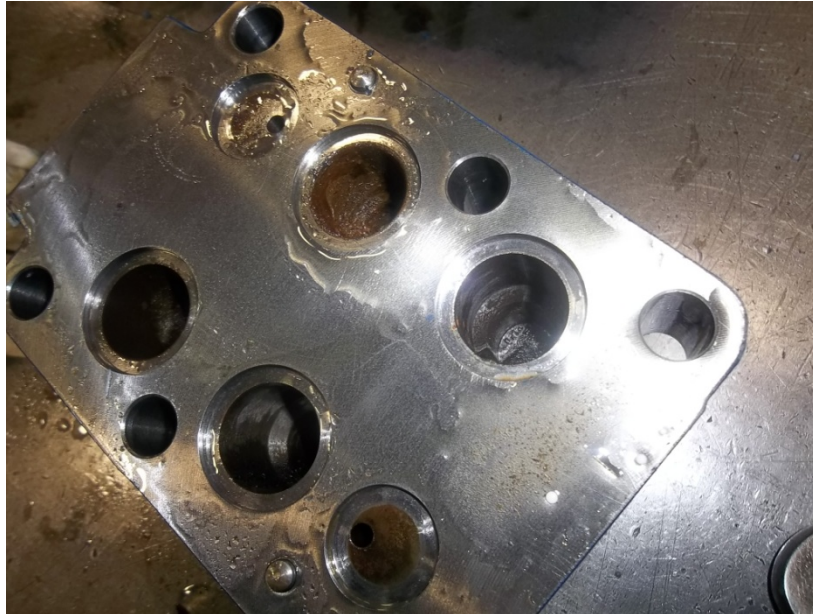
Water and oxidation shown

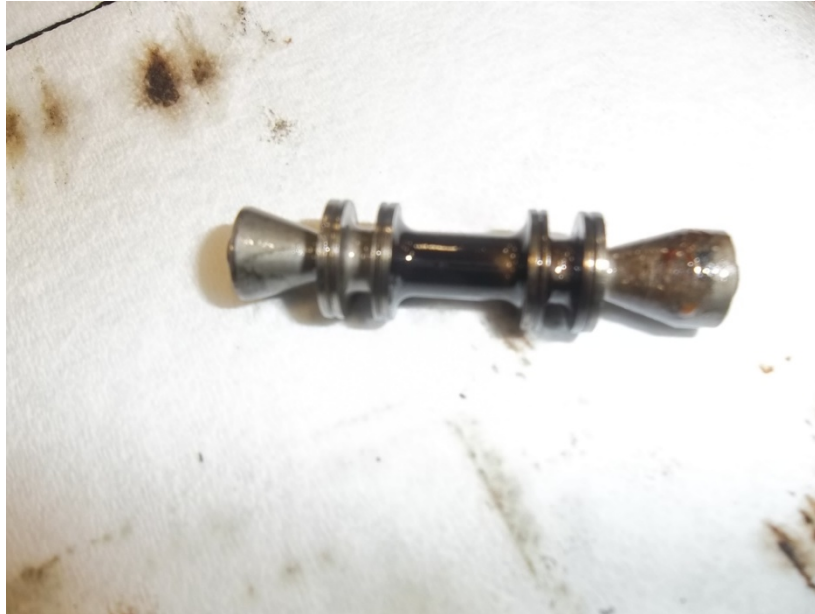
Varnish and oxidation
