Event

Root Cause Failure Analysis

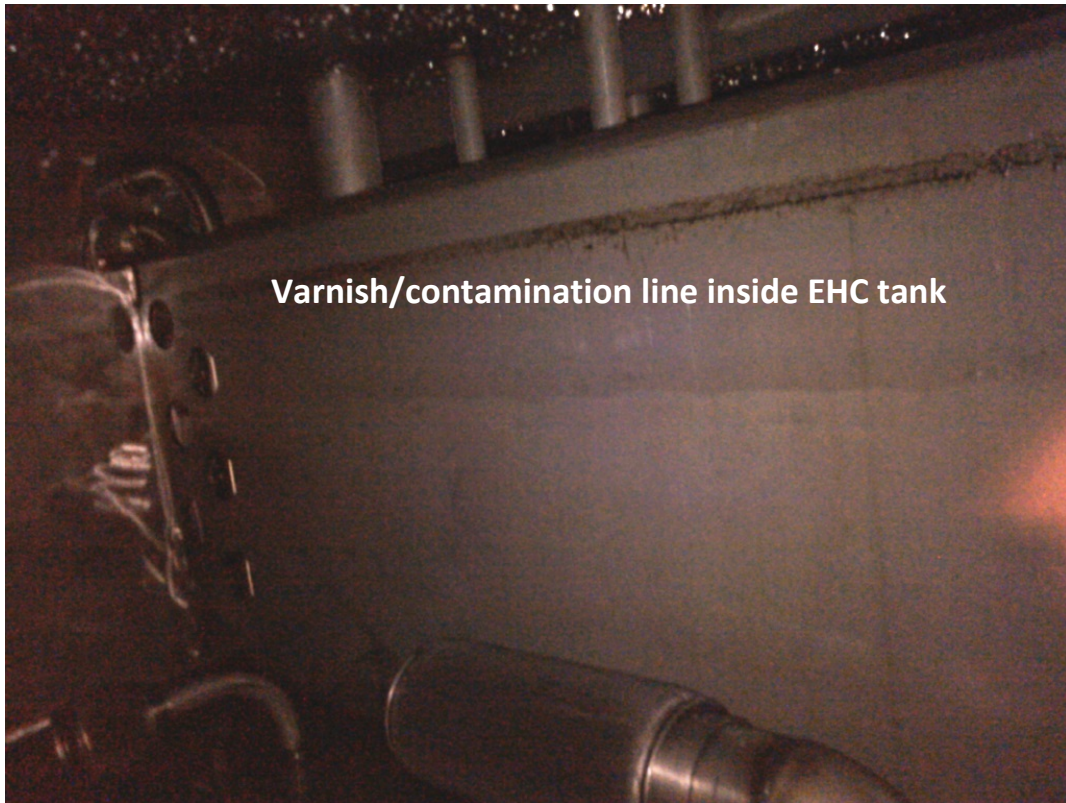
Upon opening and draining the EHC tank visual indications of water and contamination were found.

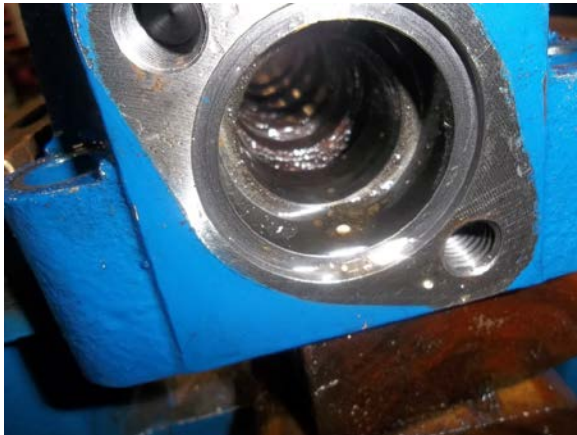
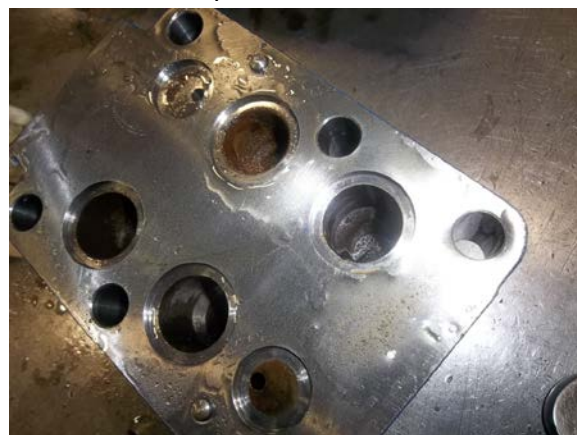
Trip Block assembly was removed from the EHC skid and shipped to Rexroth in Pennsylvania. Rexroth disassembled cleaned and is inspected the Emergency Trip Device/Master trip Solenoid Block. Photos below provided by Rexroth show water, varnish and oxidation. Some components were found in a stuck or sluggish condition. The trip valves were reported to not be functioning at all. Rexroth recommended removal of valve actuators for inspection.

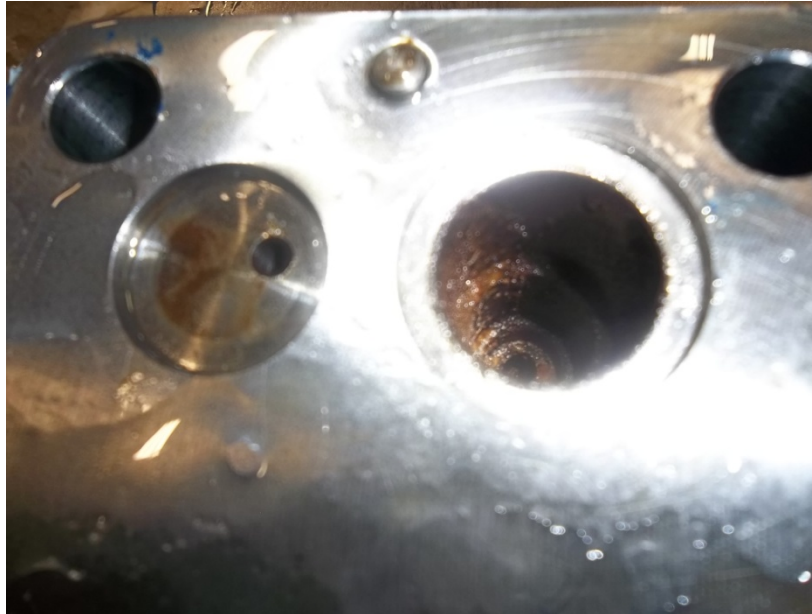
Trip Valve – 4WH 22 shows oxidation in ports

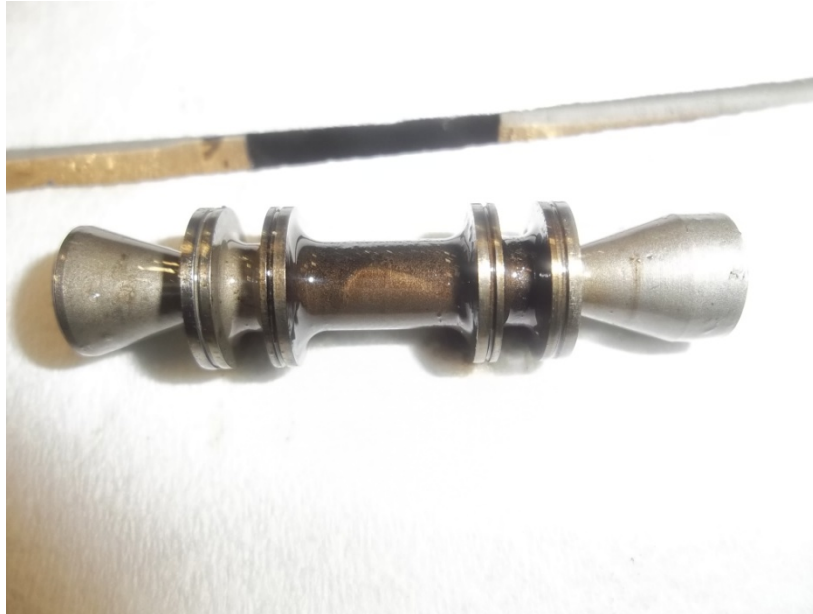
Trip Valve - 4WMM 6 shows varnish and oxidation

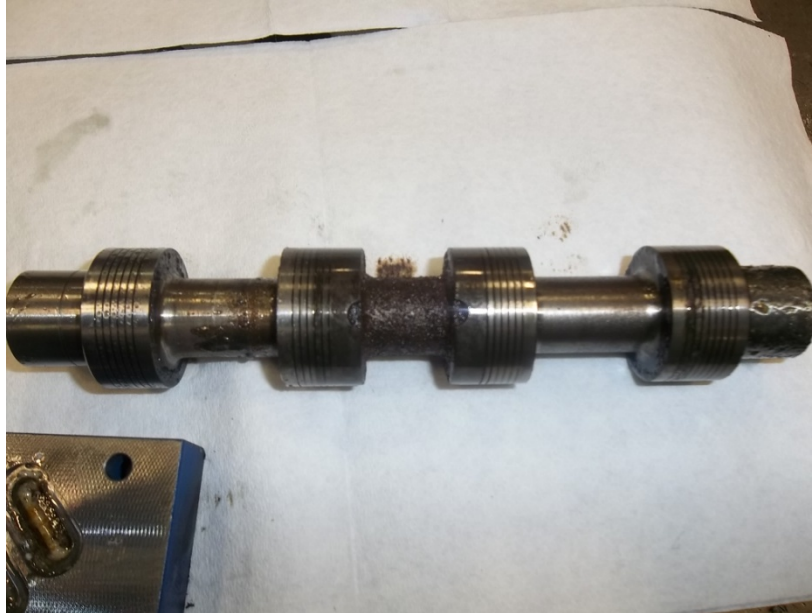
Spool shows oxidation as well as varnish

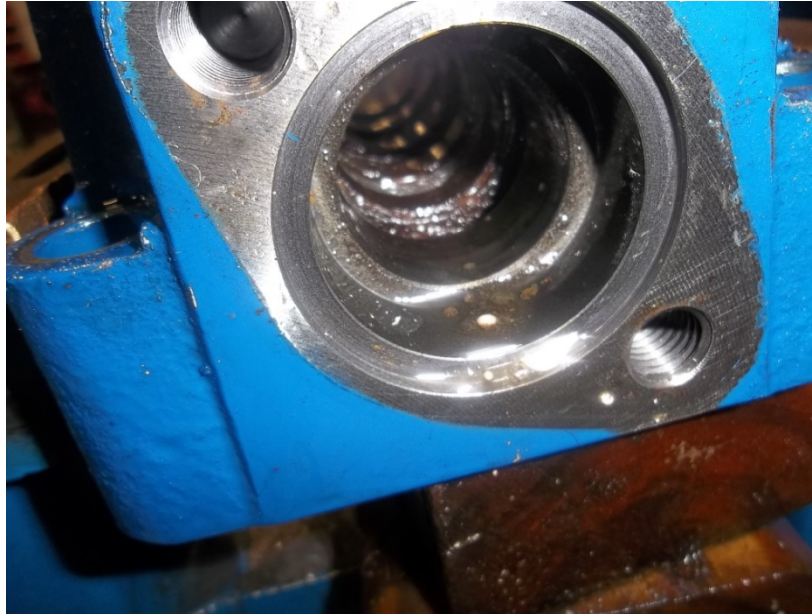
Major oxidation can be seen within the valve

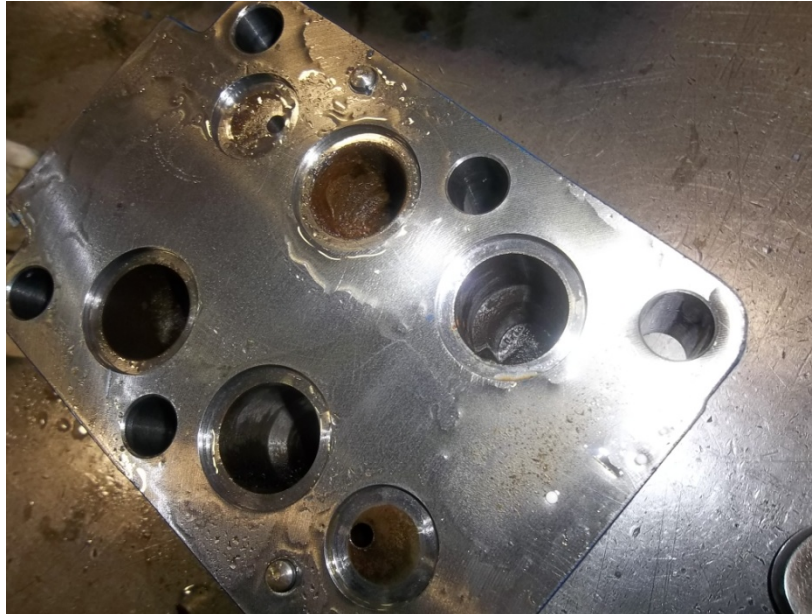
Water and oxidation shown
