COMMONWEALTH OF KENTUCKY
BEFORE THE PUBLIC SERVICE COMMISSION

APPLICATION OF LOUISVILLE GAS AND ELECTRIC)
COMPANY FOR AN ADJUSTMENT OF ITS) CASE NO.
ELECTRIC AND GAS RATES) 2014-00372

SUPPLEMENTAL RESPONSE OF
LOUISVILLE GAS AND ELECTRIC COMPANY
TO
THE FIRST SET OF DATA REQUESTS OF
KENTUCKY INDUSTRIAL UTILITY CUSTOMERS, INC.
DATED JANUARY 8, 2015

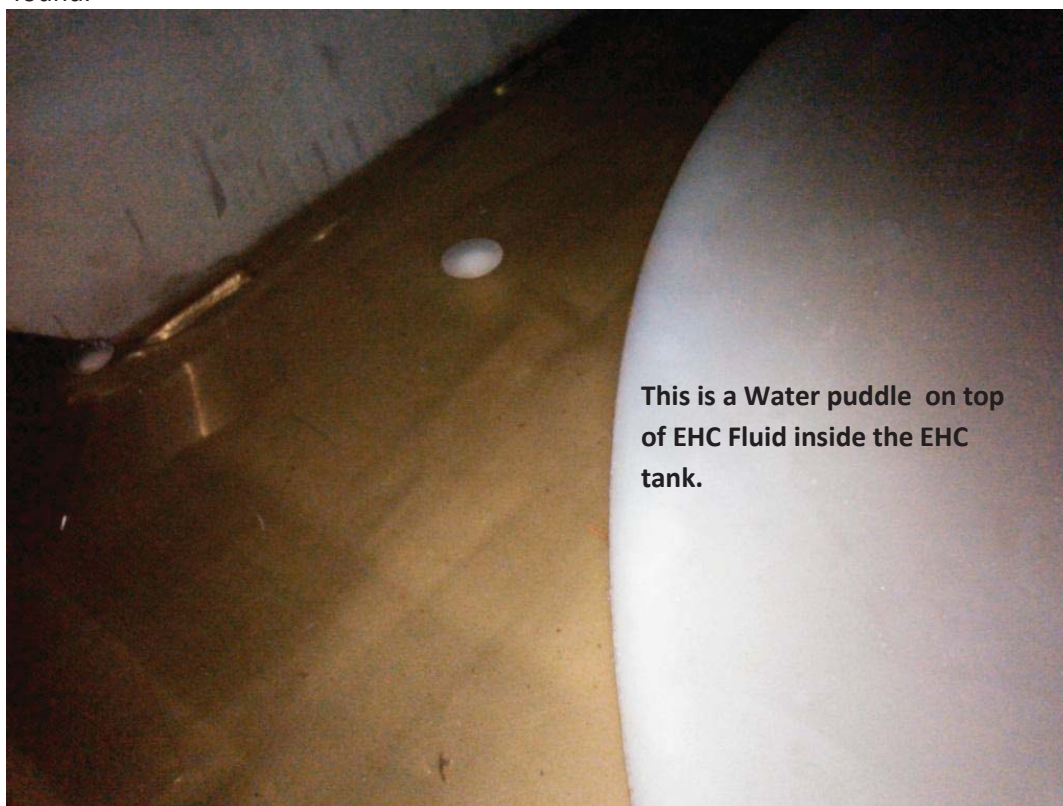
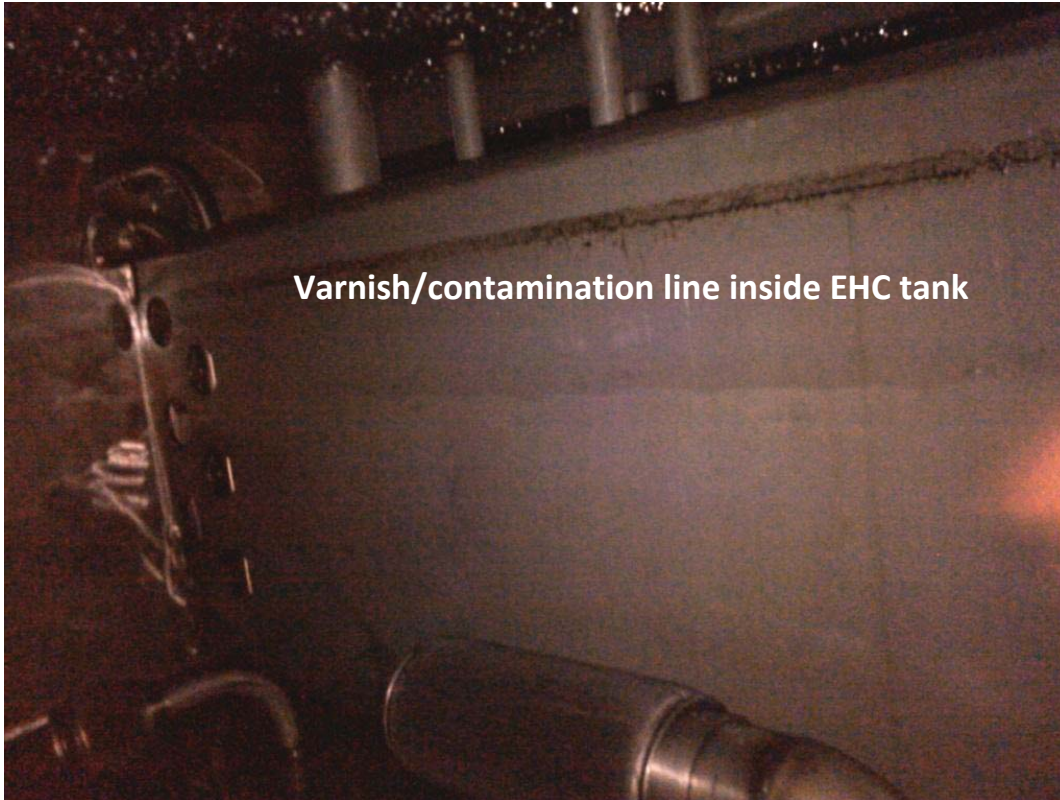
- Upon opening and draining the EHC tank visual indications of water and contamination were found.

- Call with Rexroth regarding condition of trip manifold and pictures were sent (see attachment). There was water, varnish and oxidation in the ports and on spools. One of the pilot-operated valves did not shift at all and one only shifted partially. Commented that this unit was built in 2006 and didn't think that all the oxidation could have occurred in service. They were very concerned with the condition of the actuators based on what was seen in the trip manifold. According to Rexroth, actuators can only be rebuilt in Pennsylvania and would take weeks. Decision was made to flush through the actuators and trip them in addition to the hourly stroking as part of Hydra-lube's procedure.

- As the EHC fluid tested positive for the closed cooling water corrosion inhibitor (molybdenum) during the previous week's testing, the decision was made to eliminate the EHC coolers as a possible source of water. Temporary coolers were provided by Hydralube until new replacement coolers are in place.

- Hydra-lube charged system with rinse fluid and leak checked @ 14:20
- Stroked valves and started flushing with cleaning agent @ 18:00
- New desiccant breather location made on North West corner of EHC tank

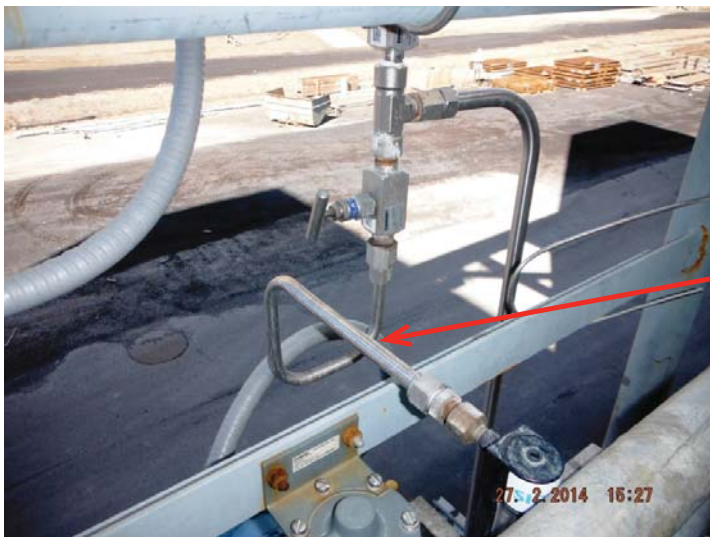
The purge air inlet pipe to the flow control unit runs between a lower header and the metal body of the flow control unit and by inspection is sufficiently flexible

Replace a 5" section of the flow control unit outlet pipe with flexible hose to remove thermal expansion

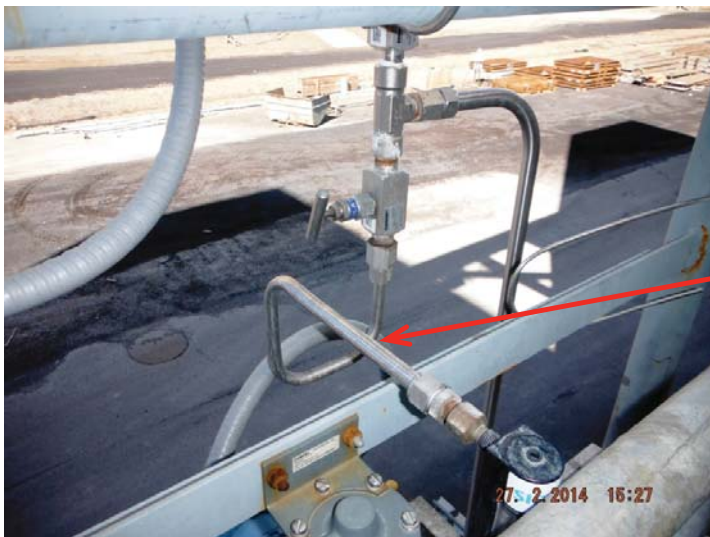
The purge air inlet pipe to the flow control unit runs between a lower header and the metal body of the flow control unit and by inspection is sufficiently flexible

Replace a 5" section of the flow control unit outlet pipe with flexible hose to remove thermal expansion

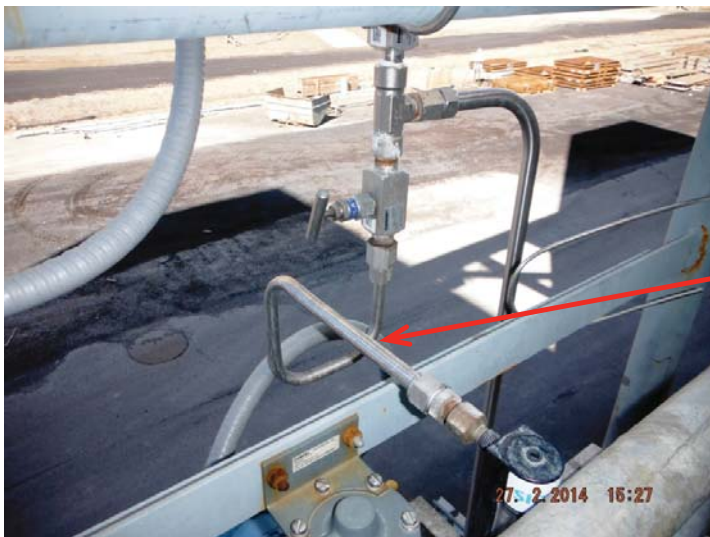
The purge air inlet pipe to the flow control unit runs between a lower header and the metal body of the flow control unit and by inspection is sufficiently flexible

Replace a 5" section of the flow control unit outlet pipe with flexible hose to remove thermal expansion

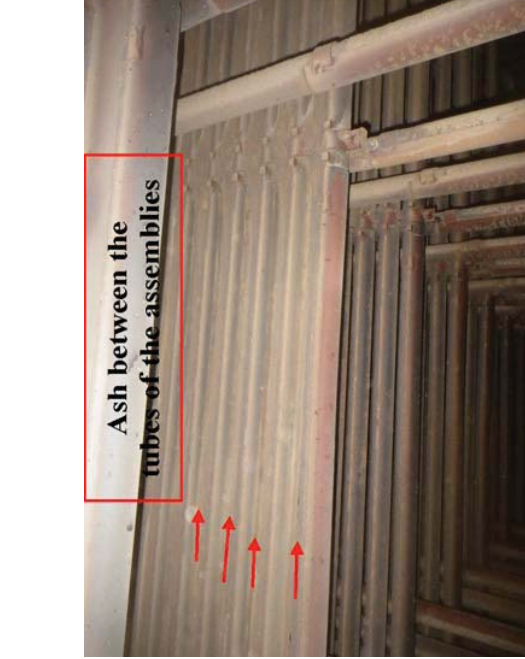
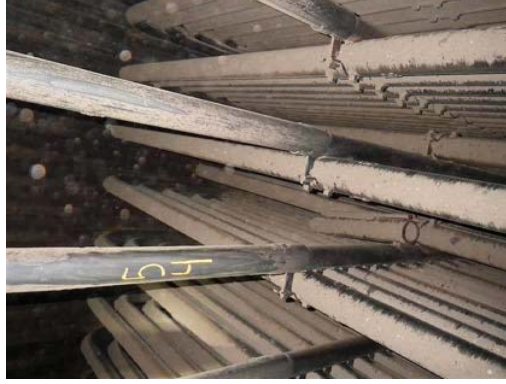
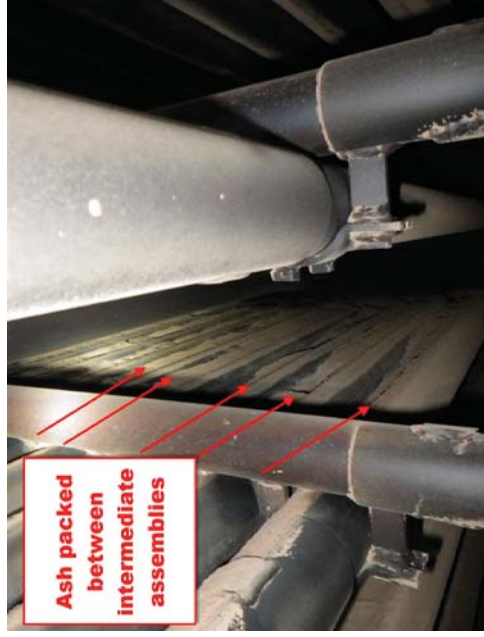
- Completed mid-way through outage to facilitate repairs.
- Most of backpass was not reinspected after waterwash.

Lack of initial wash limited access for a thorough inspection

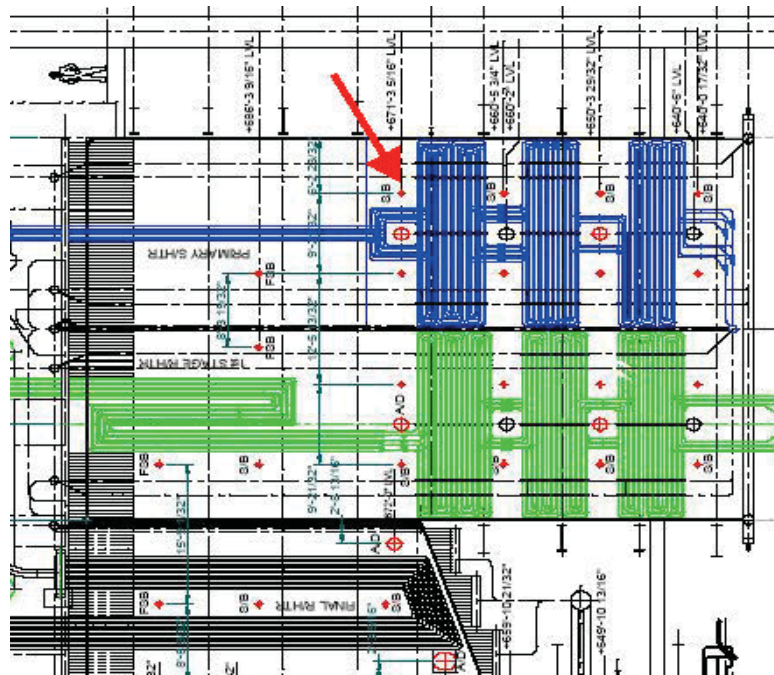
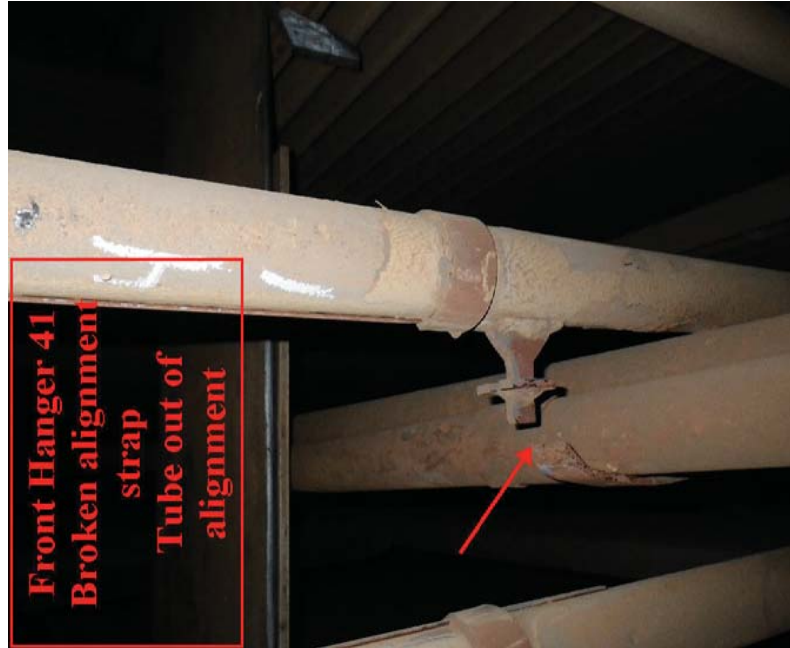
Top of Top Bank

34 out of 202 alignment straps were weld repaired

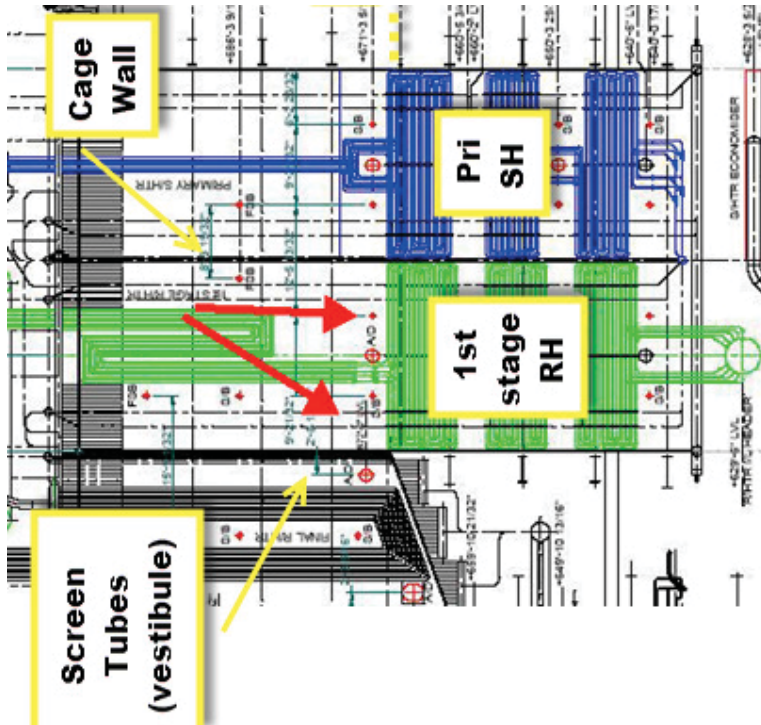
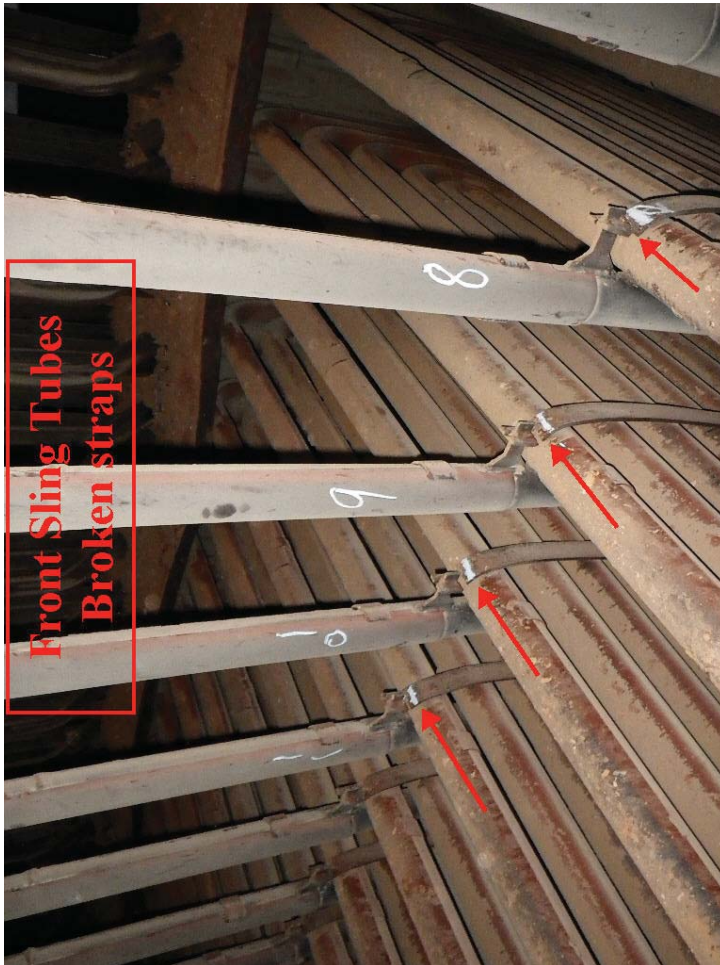
Top of Top Bank

141 out of 202 alignment straps were weld repaired

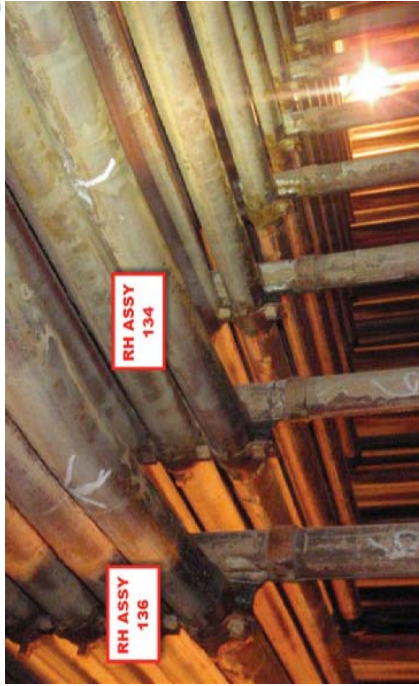
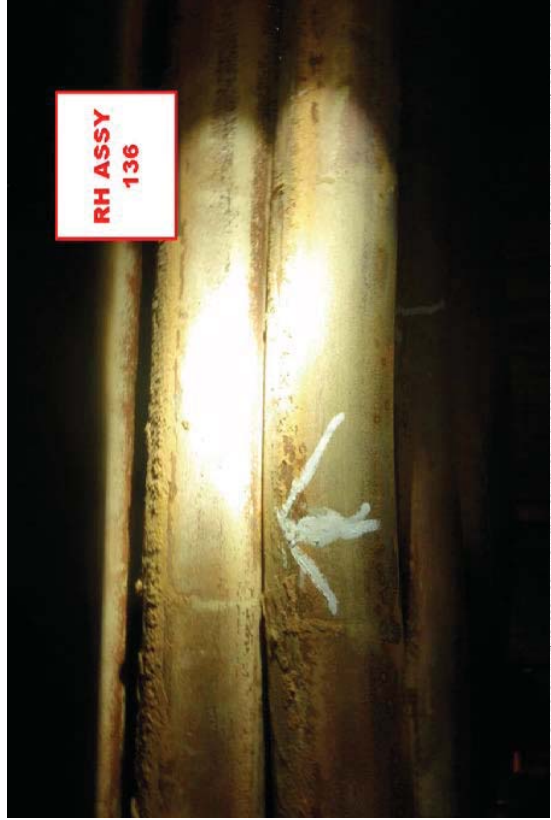
Between Top and Intermediate Bank

- Seven 3' dutchmen installed at the bottom of the top bank assembly due to disfigured circuits possibly caused during original erection

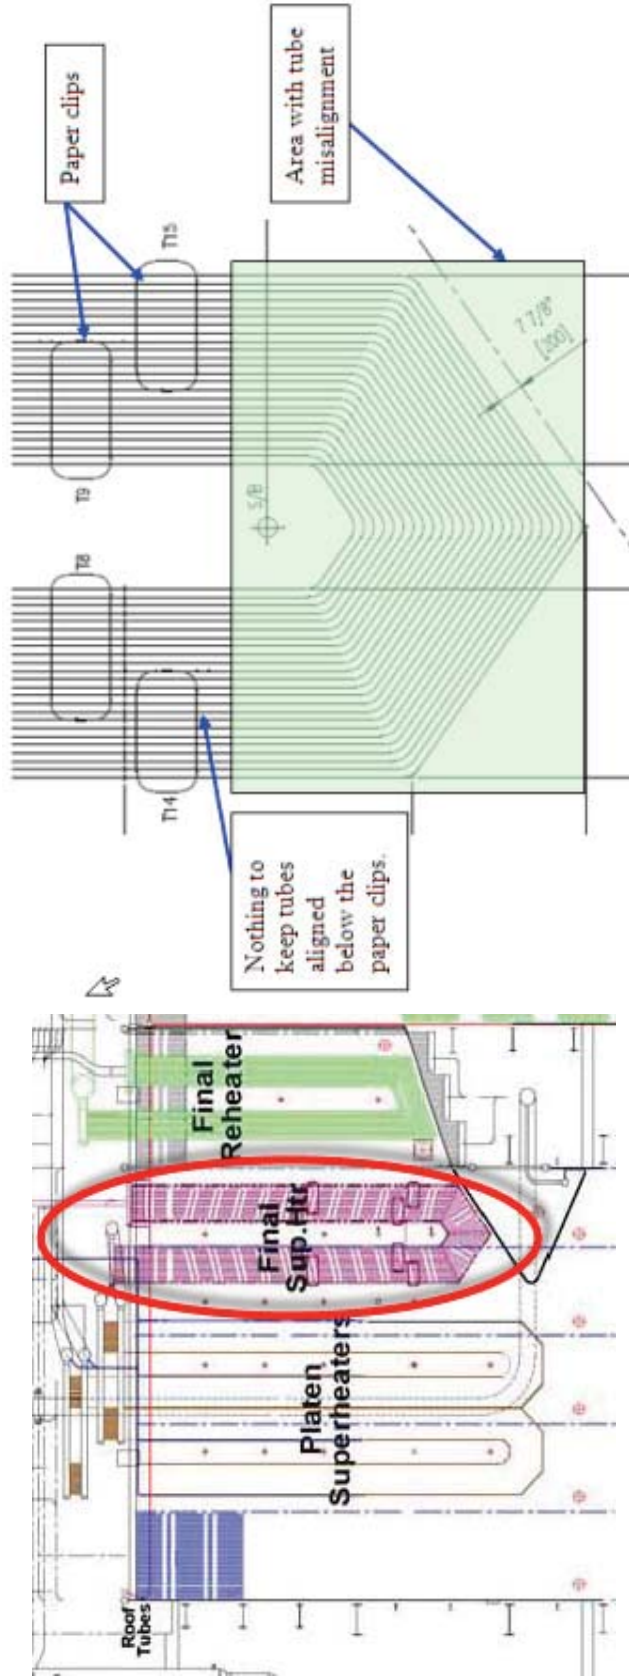
Limited Access to Lower Wrap-around Tube (Paper Clip) Elevation

- Worsening general misalignment as noted in 2012
- Minor sootblower erosion in lower IK lanes
- Only minor mechanical abrasion at wrap-around tubes

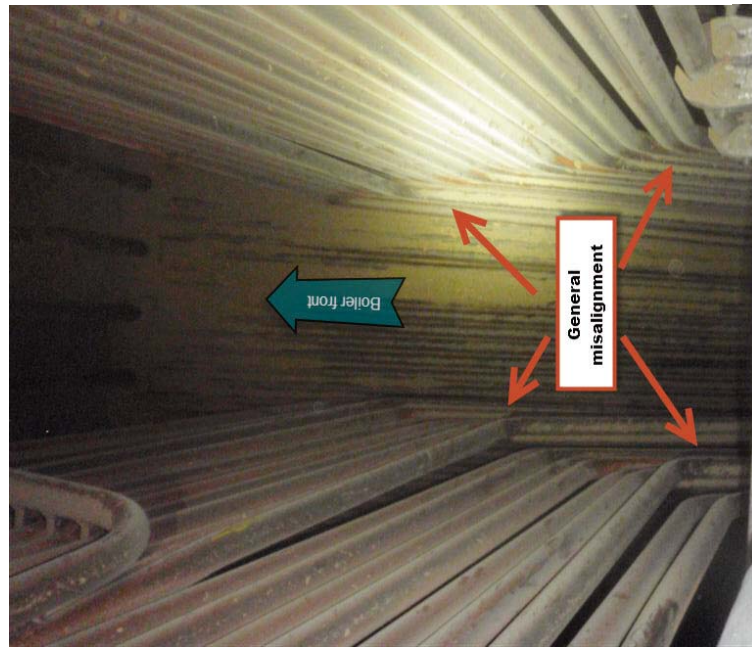
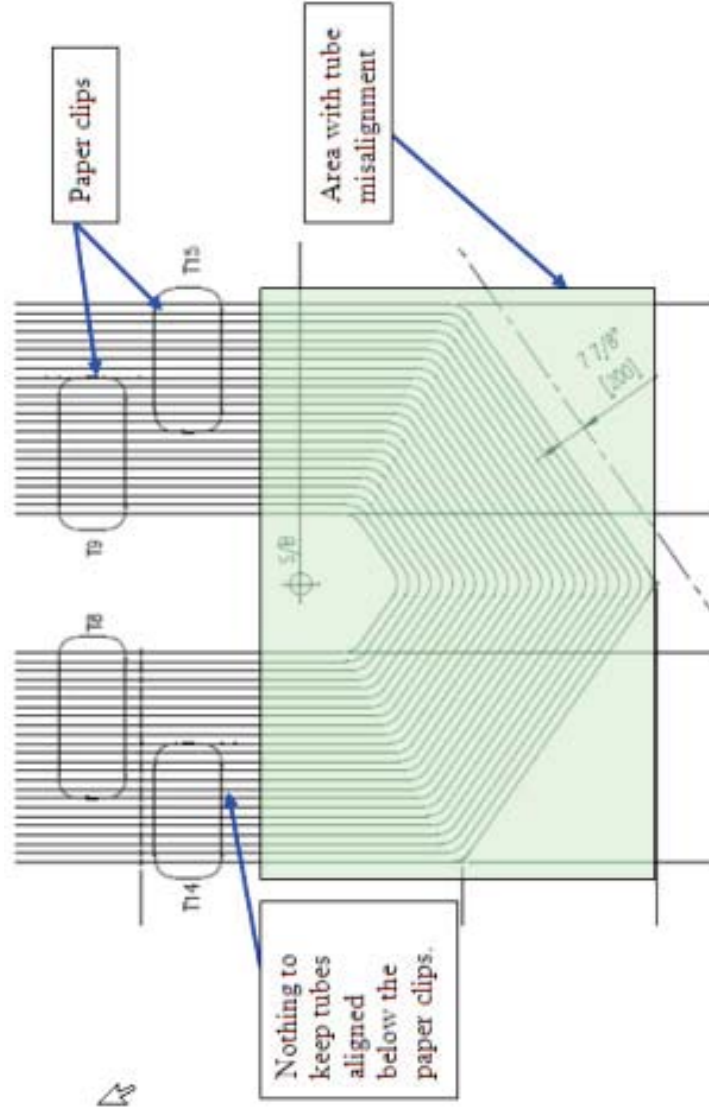
- Worsening general misalignment as noted in 2012

Consider installing additional alignment devices

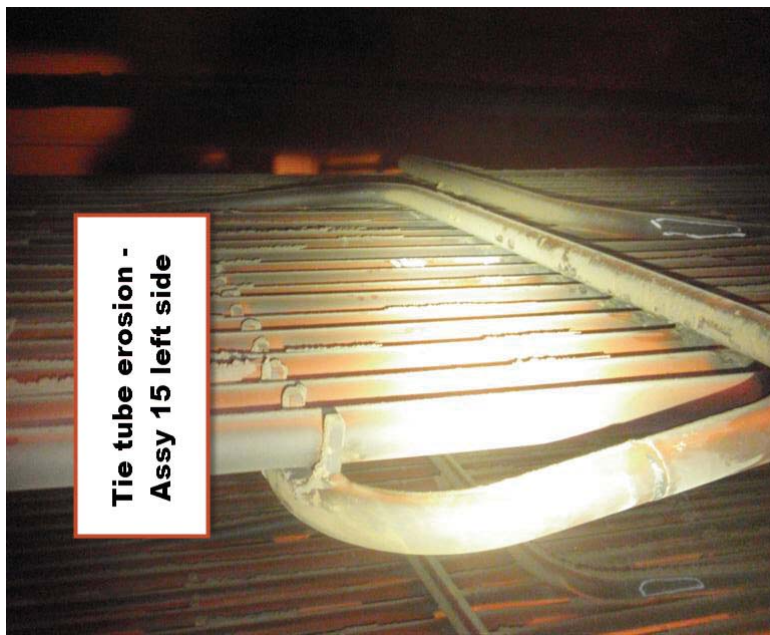
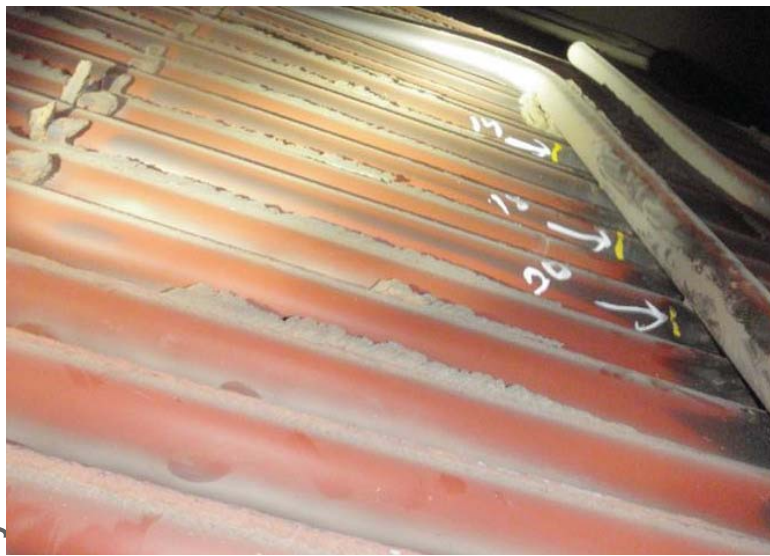
- Found at lower wrap-around tube (paperclip) IK -37/38 lane
- Limited access to front of assembly

Build scaffold for more thorough inspection 2015 outage

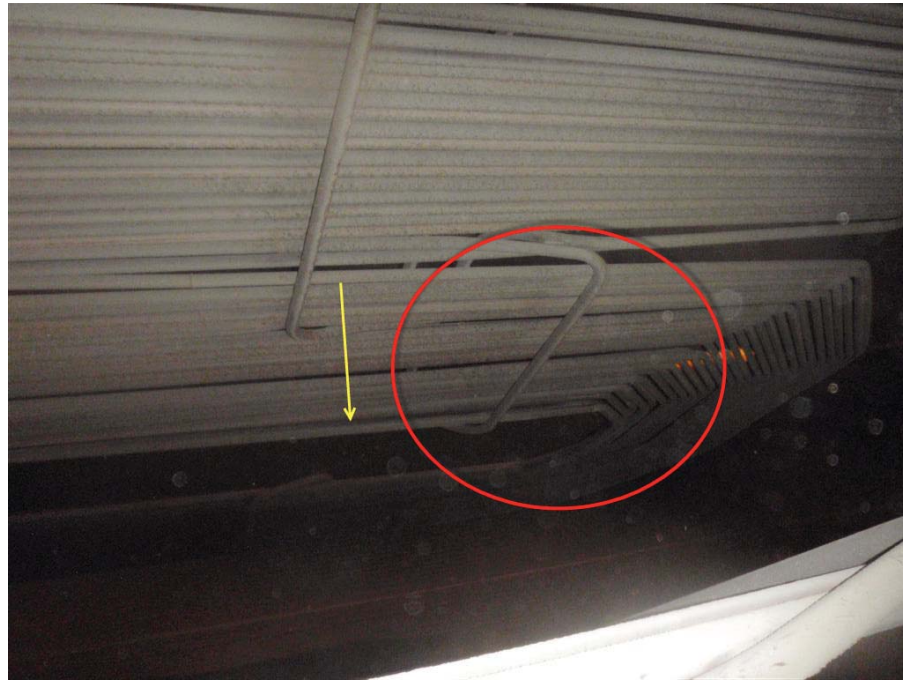
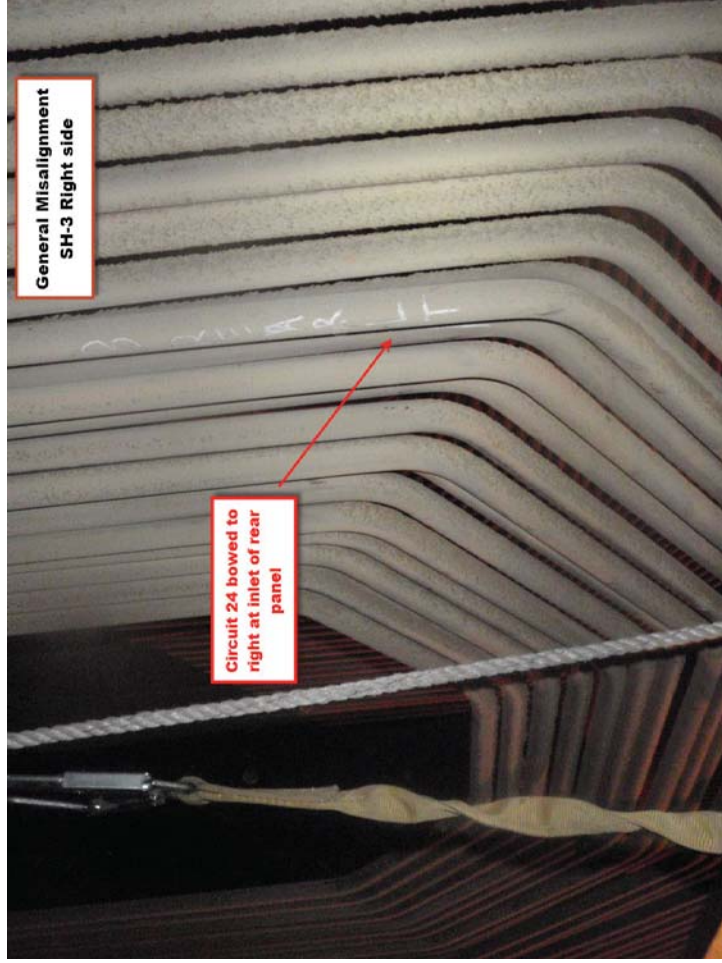
General Misalignment within Assemblies

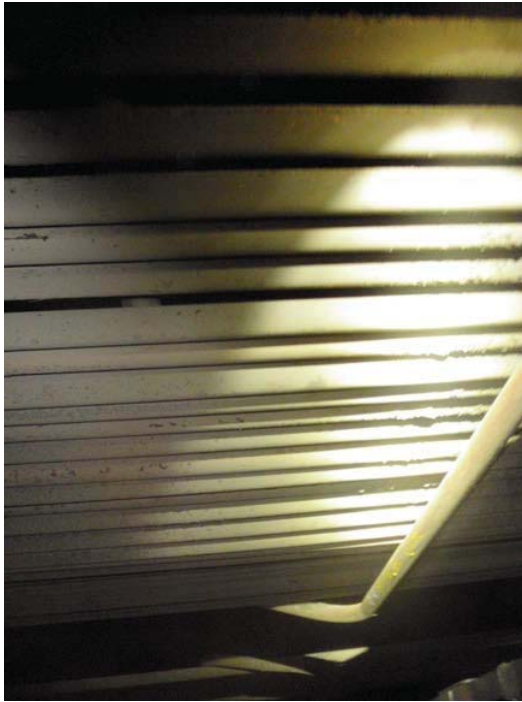
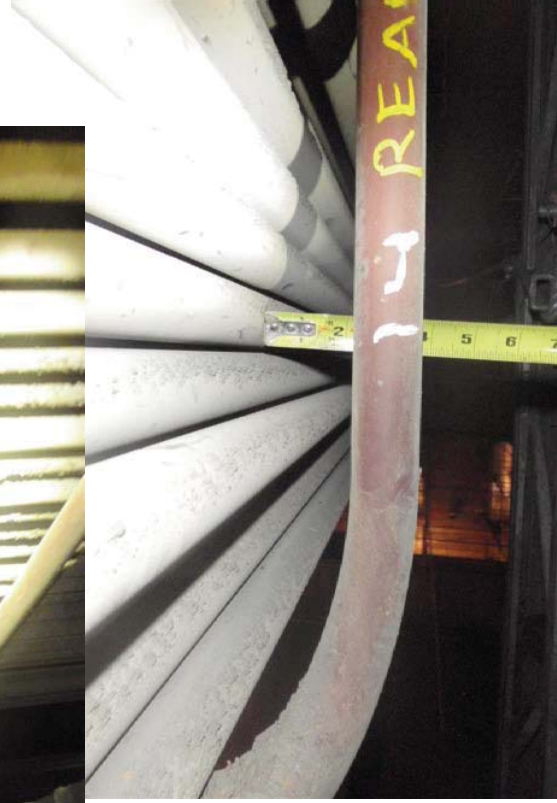
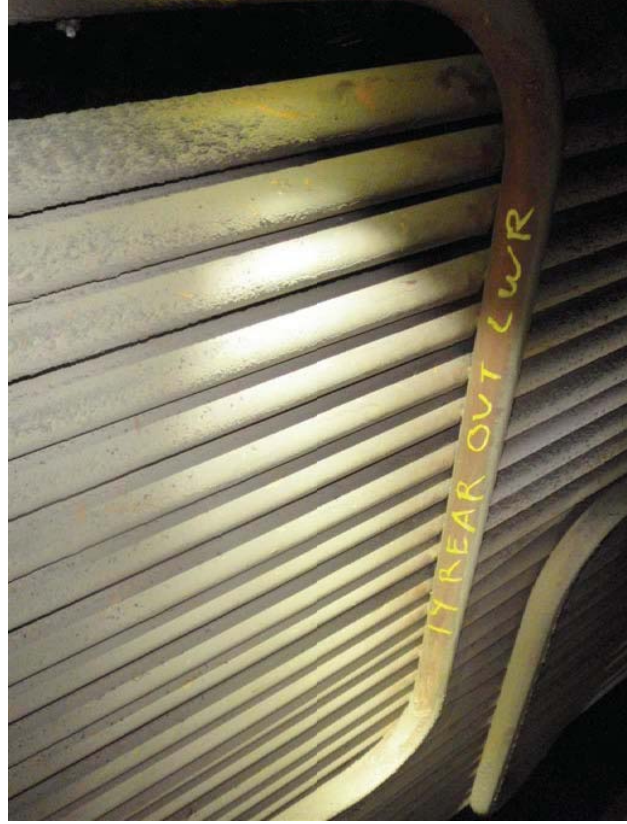
- Rear Inlet – loose circuits up to 2.5” away from tie tube
- Rear Outlet - Circuits in plane and snug to tie tube

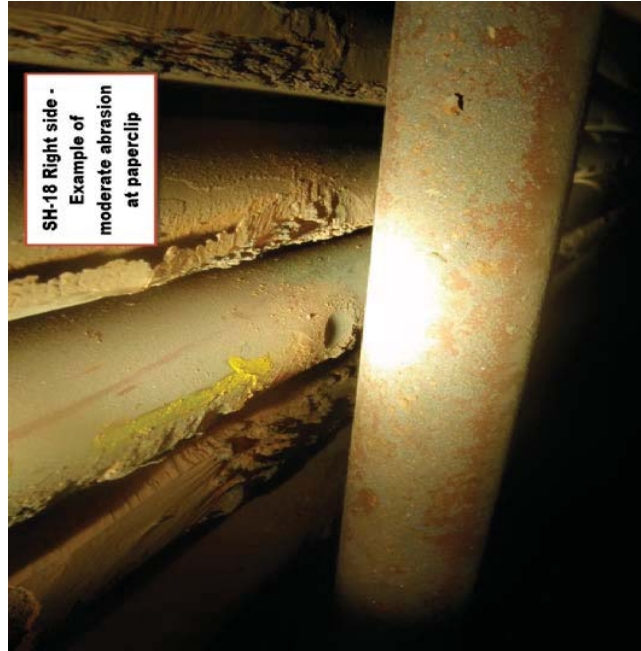
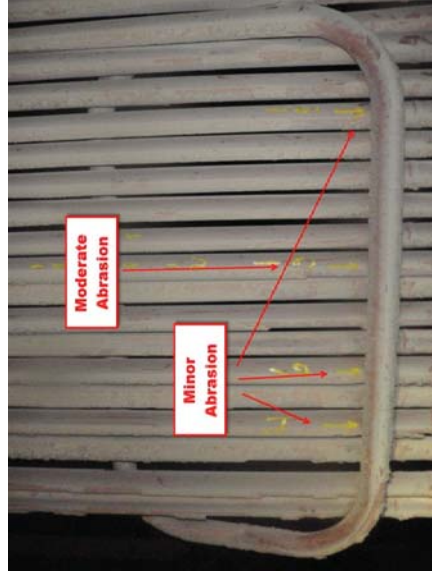
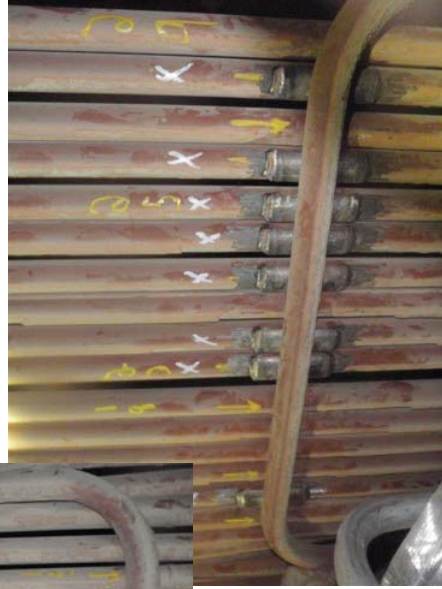
Minor – Moderate Abrasion

- Found at all 3 tie tube elevations – worse at upper
- Due to component design causing abrasion with up to 30% wall loss

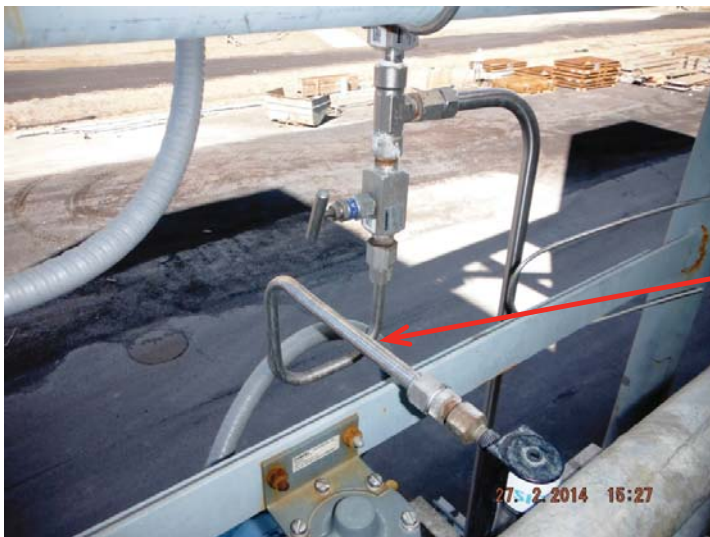
The purge air inlet pipe to the flow control unit runs between a lower header and the metal body of the flow control unit and by inspection is sufficiently flexible

Replace a 5" section of the flow control unit outlet pipe with flexible hose to remove thermal expansion

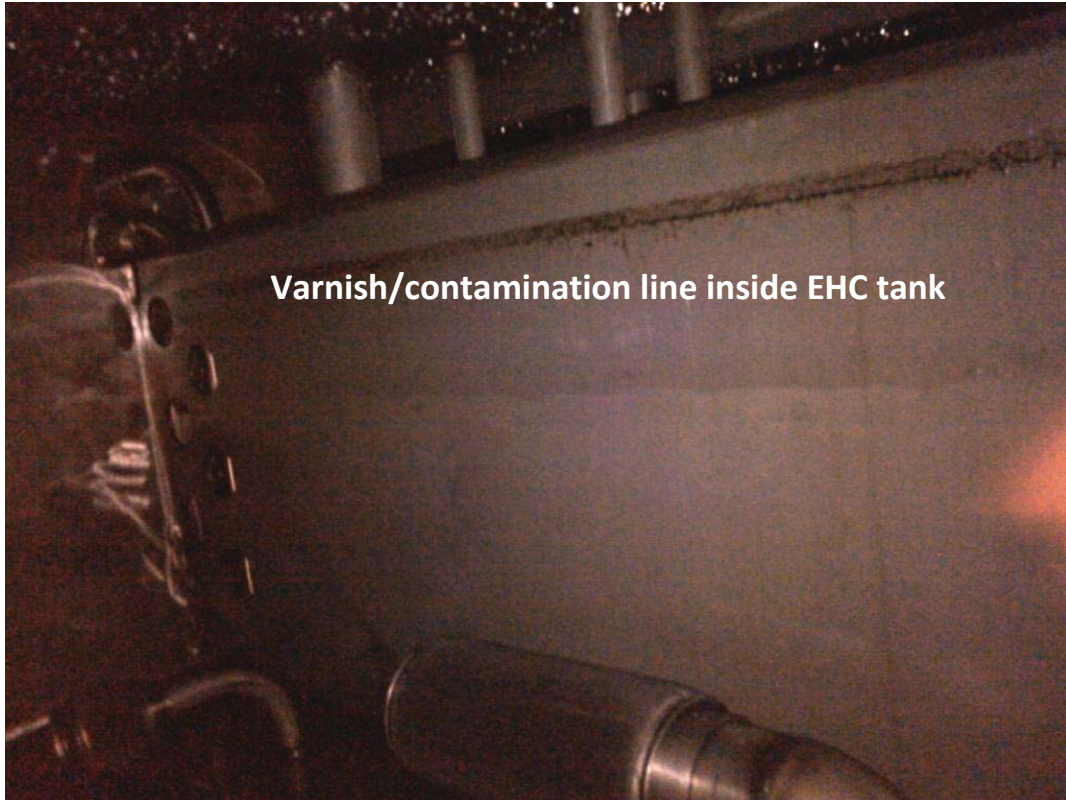
This is a Water puddle on top of EHC Fluid inside the EHC tank.

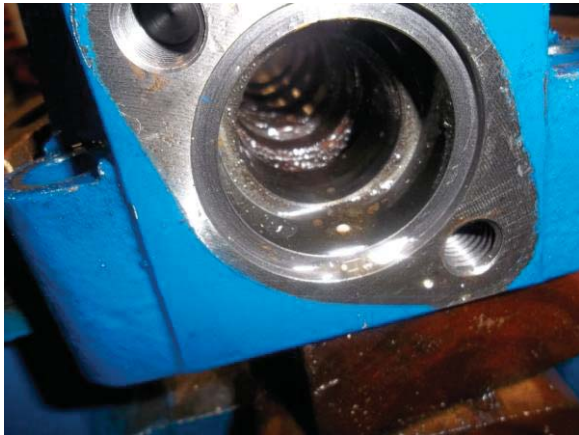
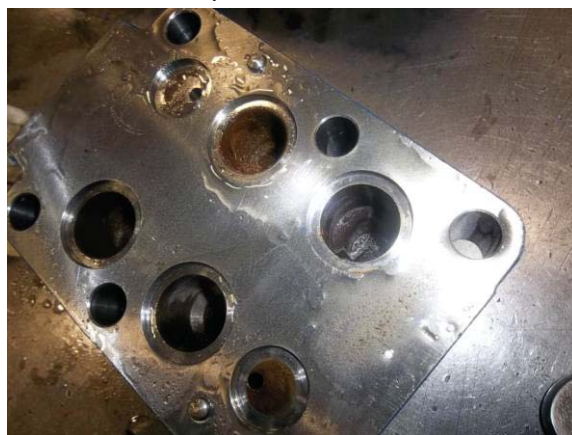
Trip Block assembly was removed from the EHC skid and shipped to Rexroth in Pennsylvania. Rexroth disassembled cleaned and is inspected the Emergency Trip Device/Master trip Solenoid Block. Photos below provided by Rexroth show water, varnish and oxidation. Some components were found in a stuck or sluggish condition. The trip valves were reported to not be functioning at all. Rexroth recommended removal of valve actuators for inspection.

Spool and trip valve showing oxidation as well as varnishing.

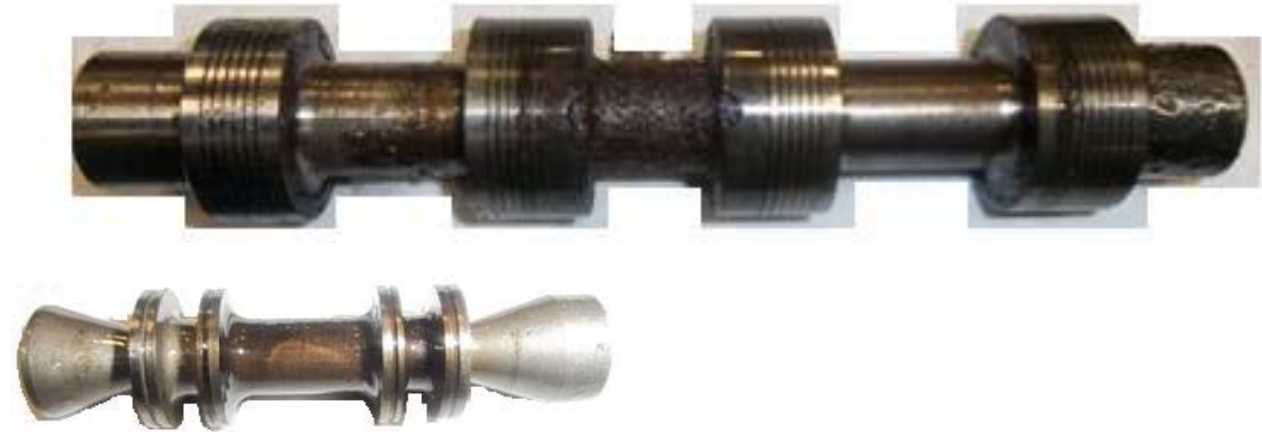
HydraLube provided EHC flushing services. EHC tank was cleaned between flushing steps. Flushing was conducted with a cleaning agent additive in new Fyrquel EHC fluid. All valves were stroked during flushing and the Emergency Trip System EHC fluid was dumped enabling valves to trip during the flushing process. DCS trends were observed to inspect for valve actuator sticking issues. Due to pressure limitations of the flushing pump only 2 valves were able to trip simultaneously and the DCS trends illustrated these pairs of valves closed closely together, (Mk VI should be observed for more accurate timing). Valve actuators were not disassembled and inspected at this time. It is recommended at the next Maintenance interval of the unit when enough time is allotted to remove All the EHC actuators and ship these to a qualified facility for disassembling and inspection.
