Assessment of Dam Safety Coal Combustion Surface Impoundments (Task 3) Final Report

American Electric Power
Big Sandy
Generating Station
Louisa, Kentucky

February 17, 2010

CHA Project No. 20085.7000.1510

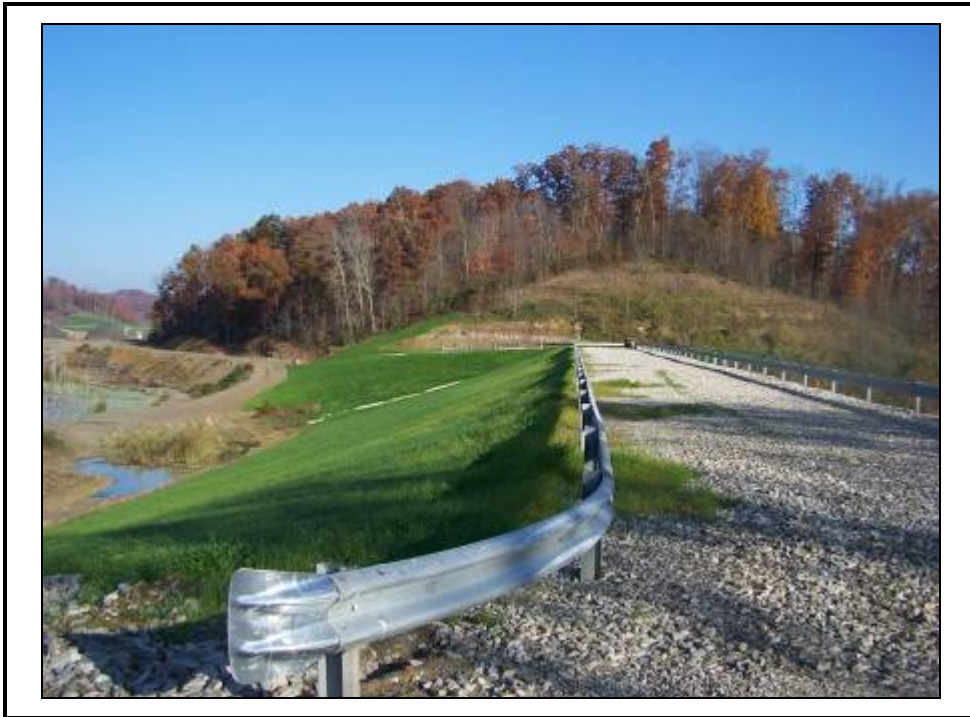
1

Crest and upstream slope of Saddle Dam, looking north.

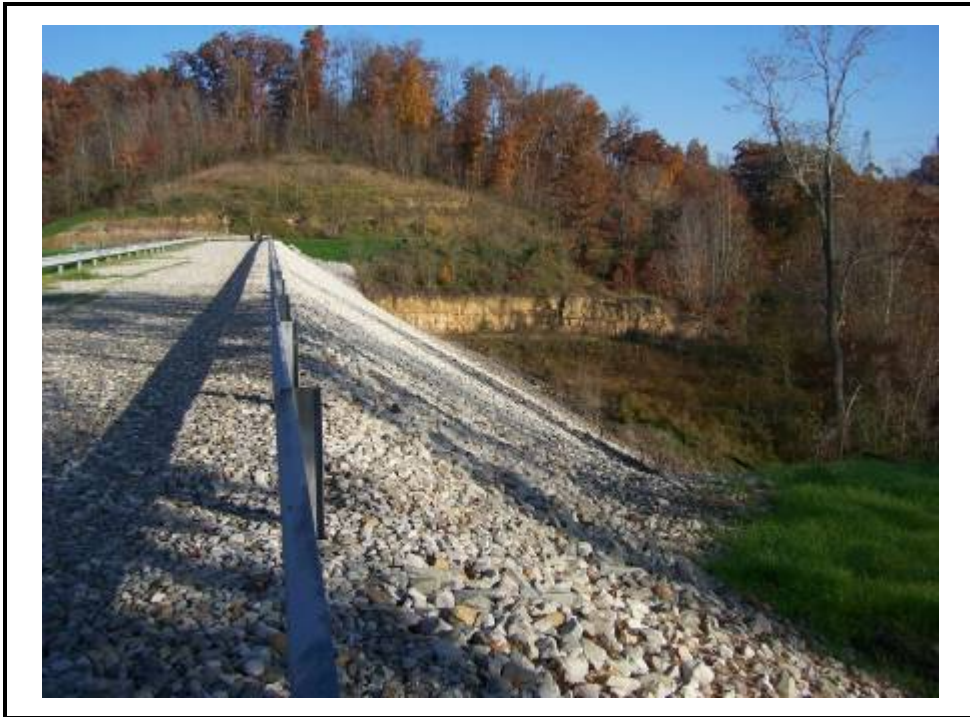
2

Downstream slope of Saddle Dam, looking north.

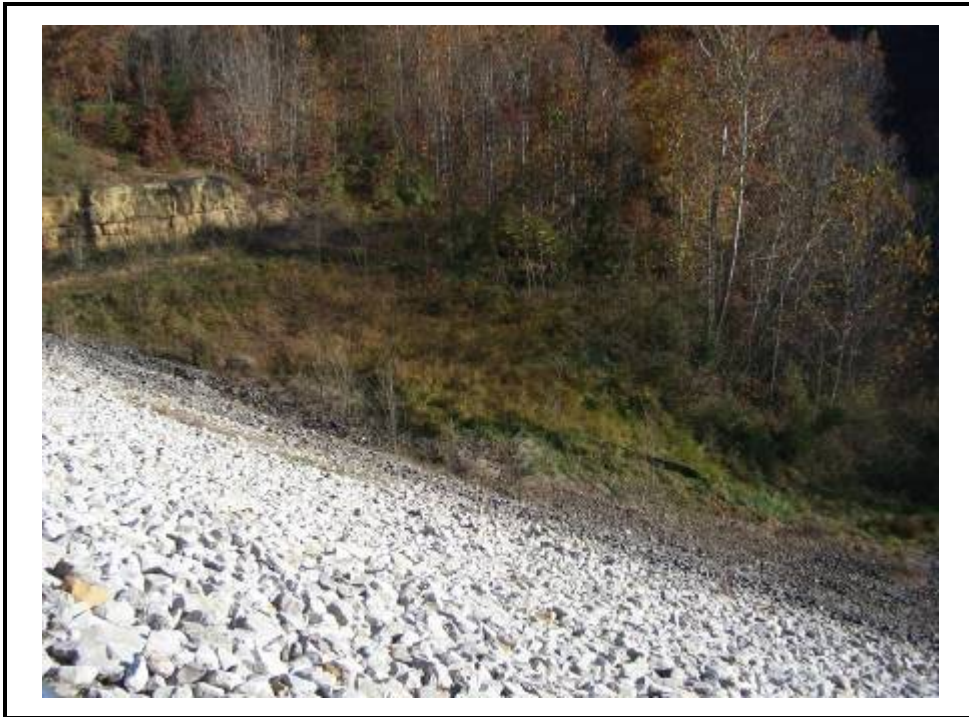
4

North downstream groin of Saddle Dam looking northeast. Bedrock in upper left is part of original emergency spillway channel which is now plugged.
Note small trees in groin have been sprayed with herbicide.

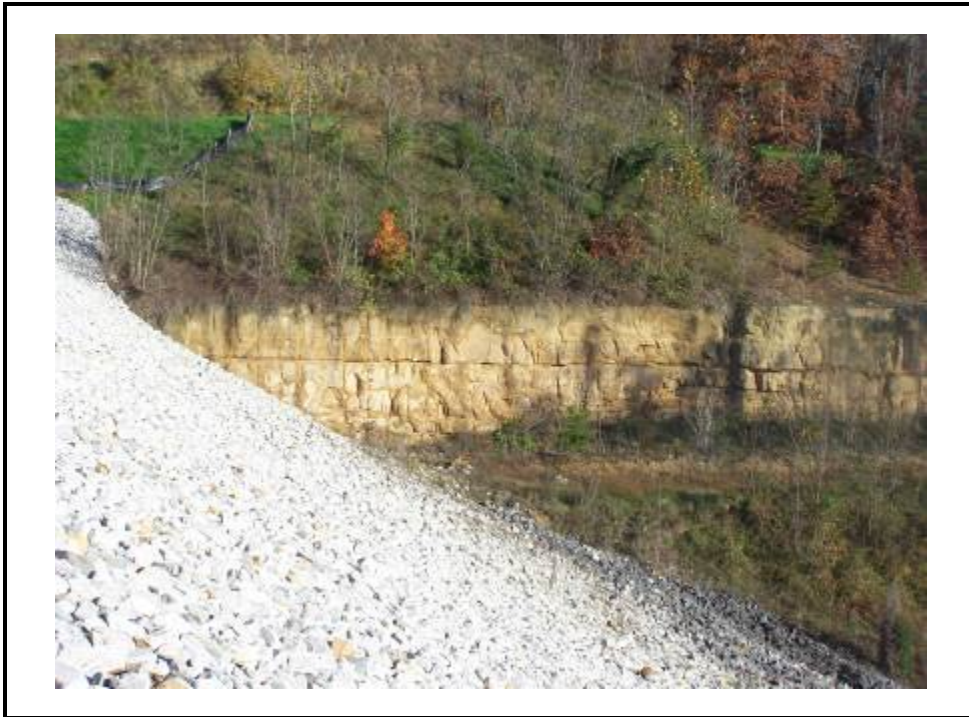
6

Downstream slope in original emergency spillway, looking north.

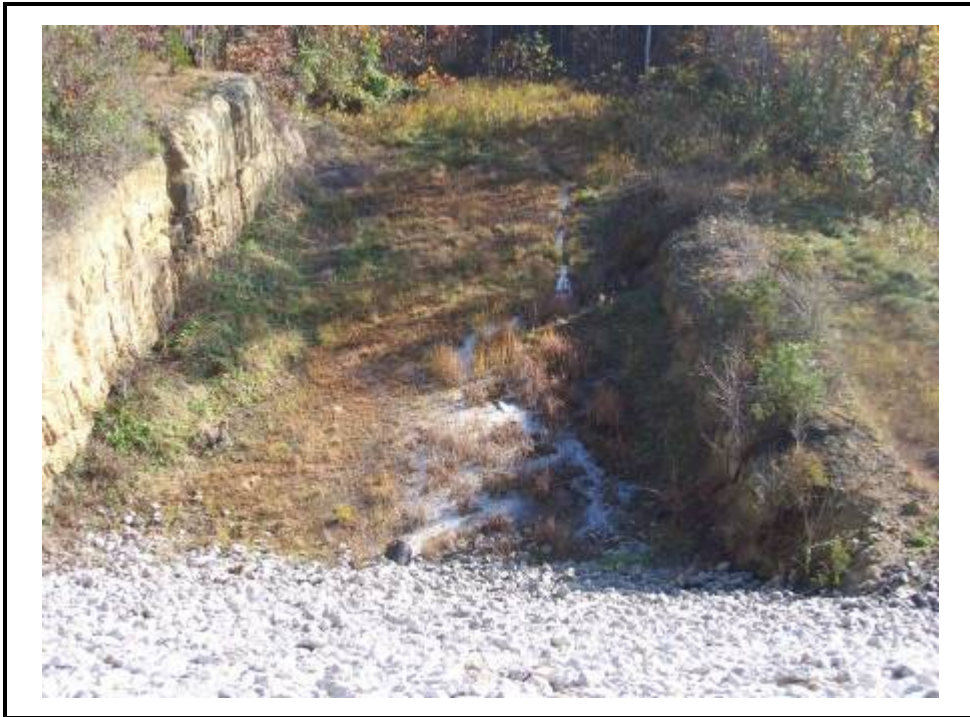
7

Original emergency spillway.
Seepage drain at approximate midpoint of channel.

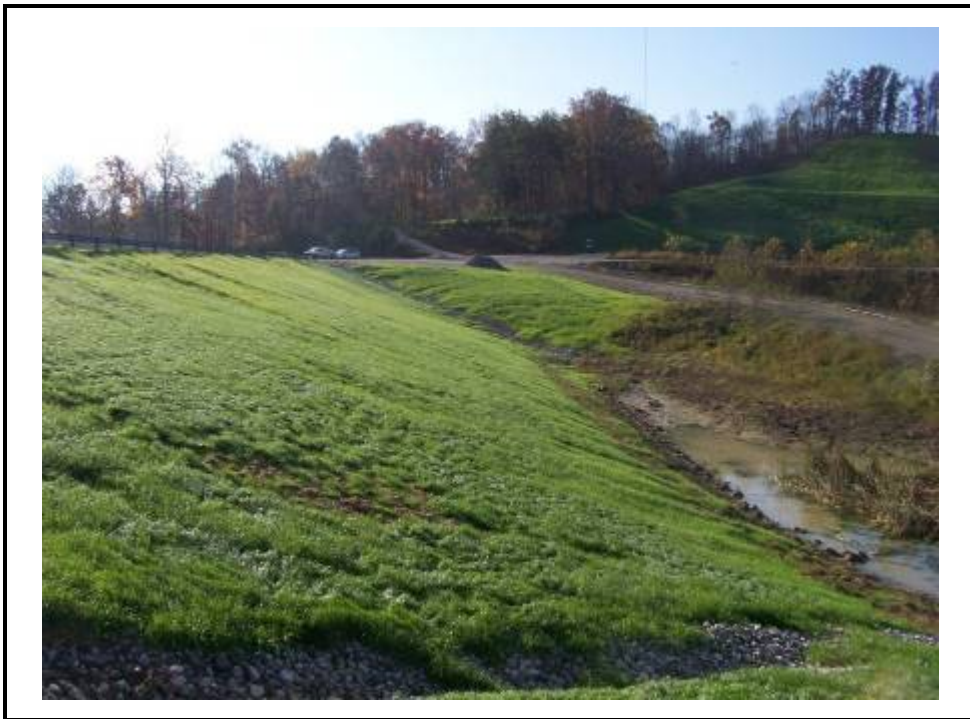
8

Upstream slope of Saddle Dam, looking south.

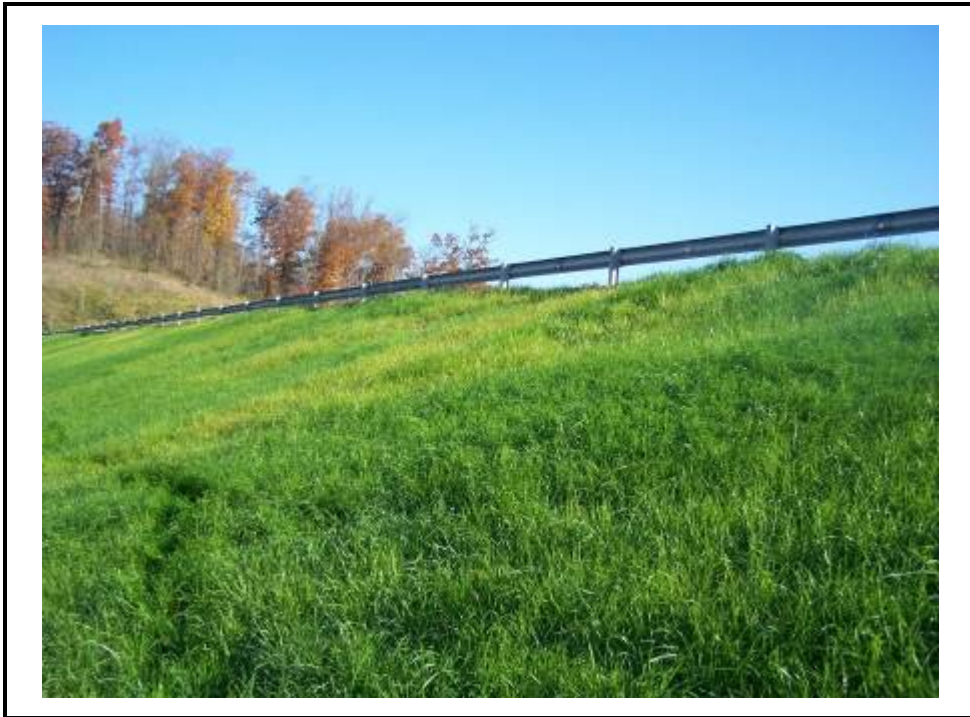
9

The upstream and downstream slopes were reasonably uniformly graded. The grass cover on the upstream slope appeared well maintained as shown in Photo 1. As shown in Photo 9, there is some grading irregularity on the south end of the upstream slope where the upstream slope meets the crest. The stone covered downstream slope appeared generally clear of vegetation as shown in Photo 2. However, brush and small trees were observed within the stone at the south and north groins (Photos 2 through 6). Plant personnel indicated that the small trees have been sprayed with herbicide.

Irregularity to grading at upstream slope/crest intersection on Saddle Dam.

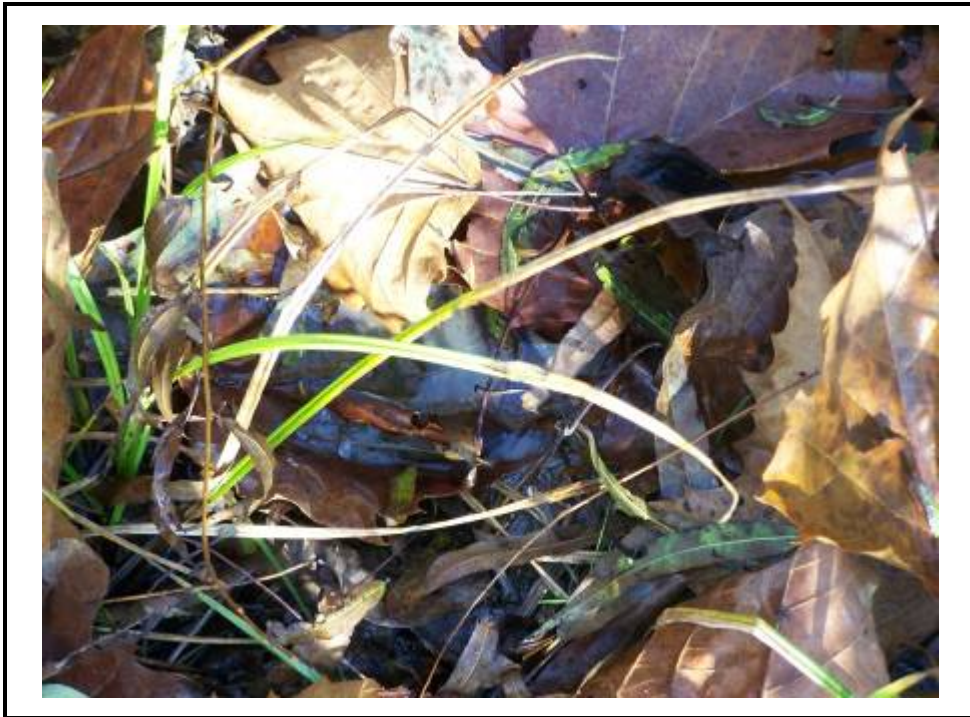
10

Toe drain outlet from under main portion of Saddle Dam.
Note the pipe is covered with vegetation.

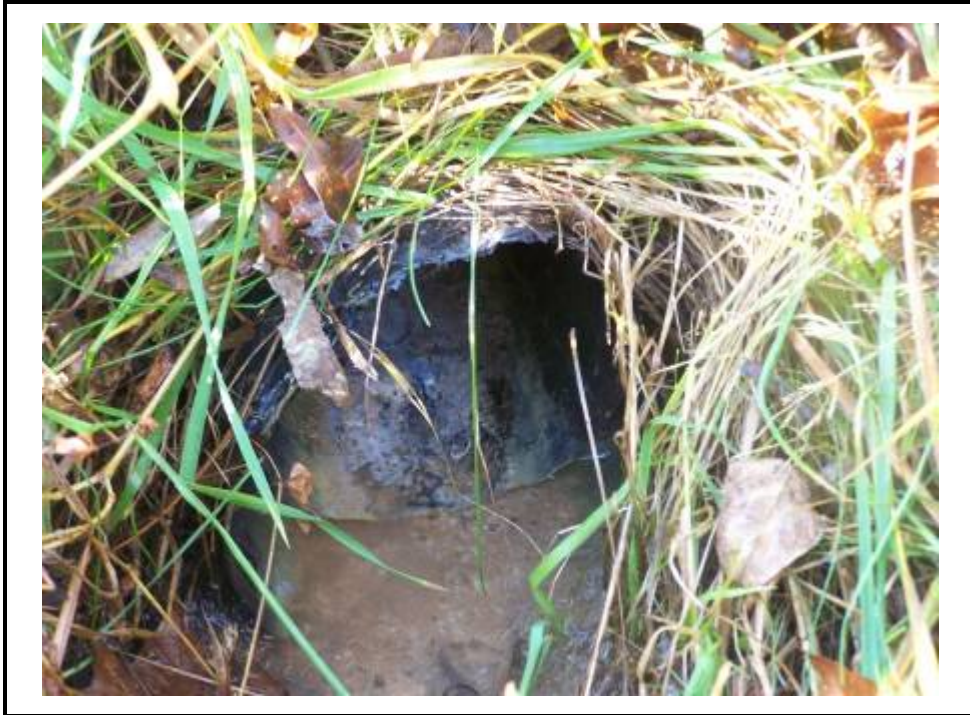
11

Toe drain outlet after clearing vegetation.

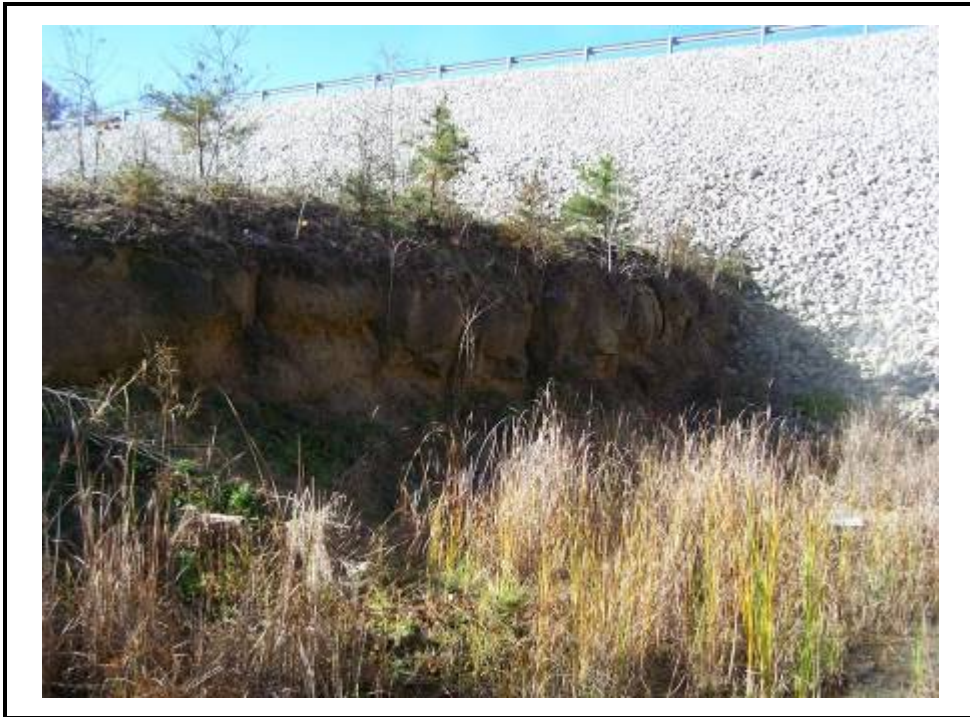
12

Downstream slope of Saddle Dam filling original emergency spillway.

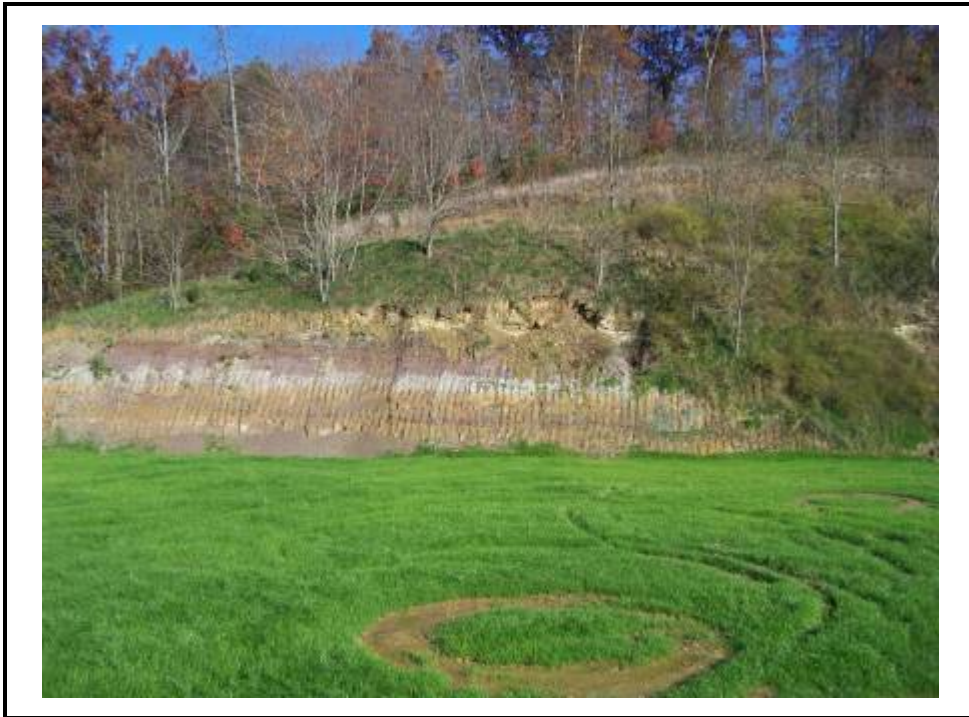
16

North abutment contact of “new” emergency spillway.

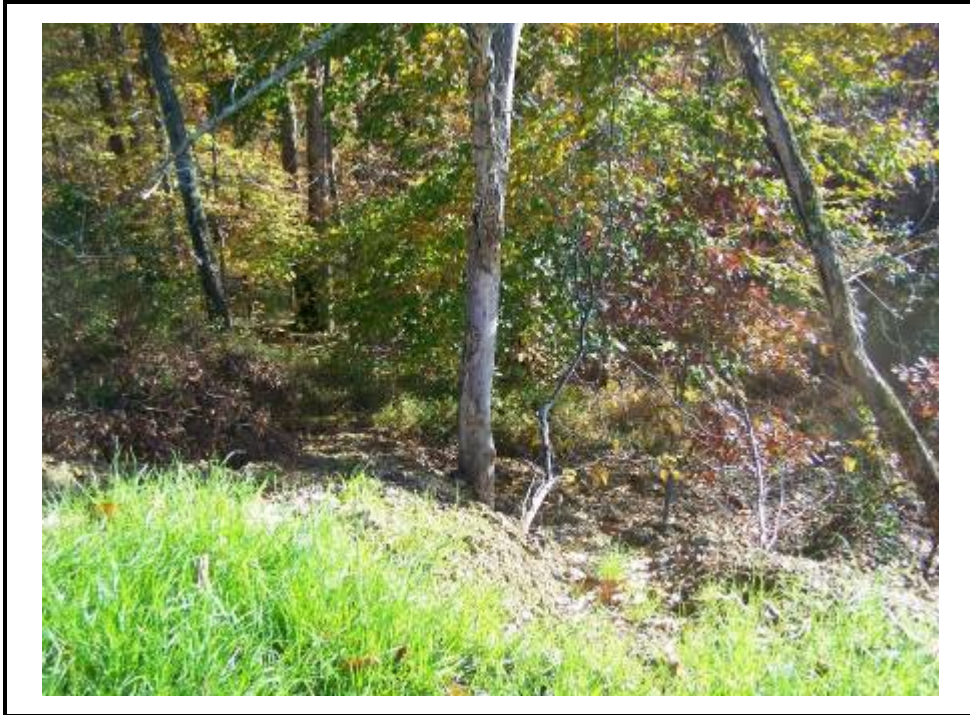
17

Downstream condition of "new" emergency spillway.

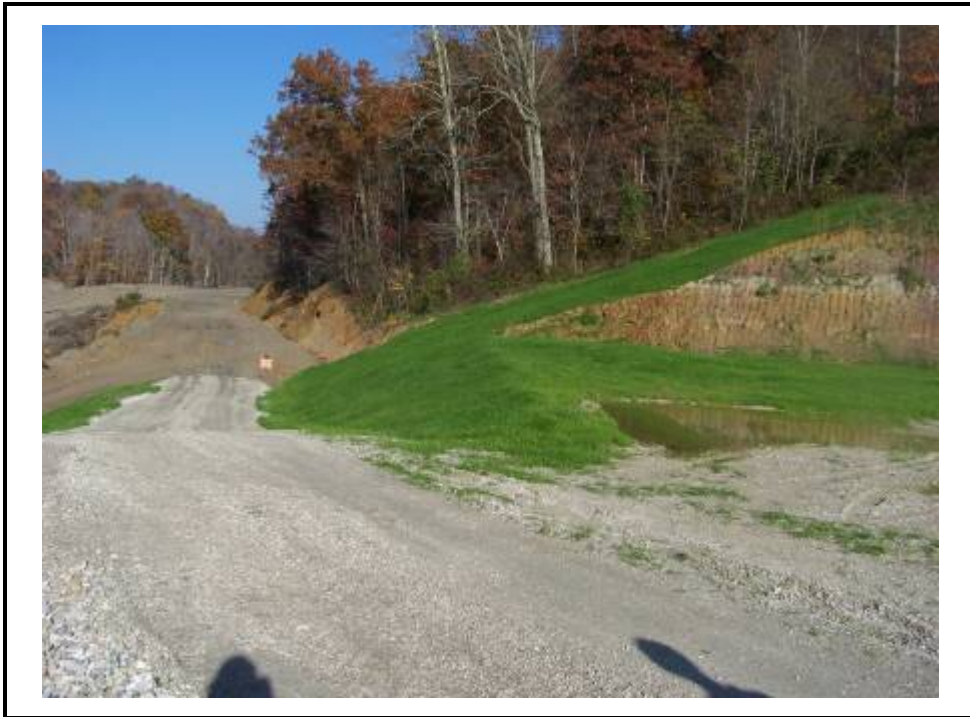
18

Entrance of "new" emergency spillway.

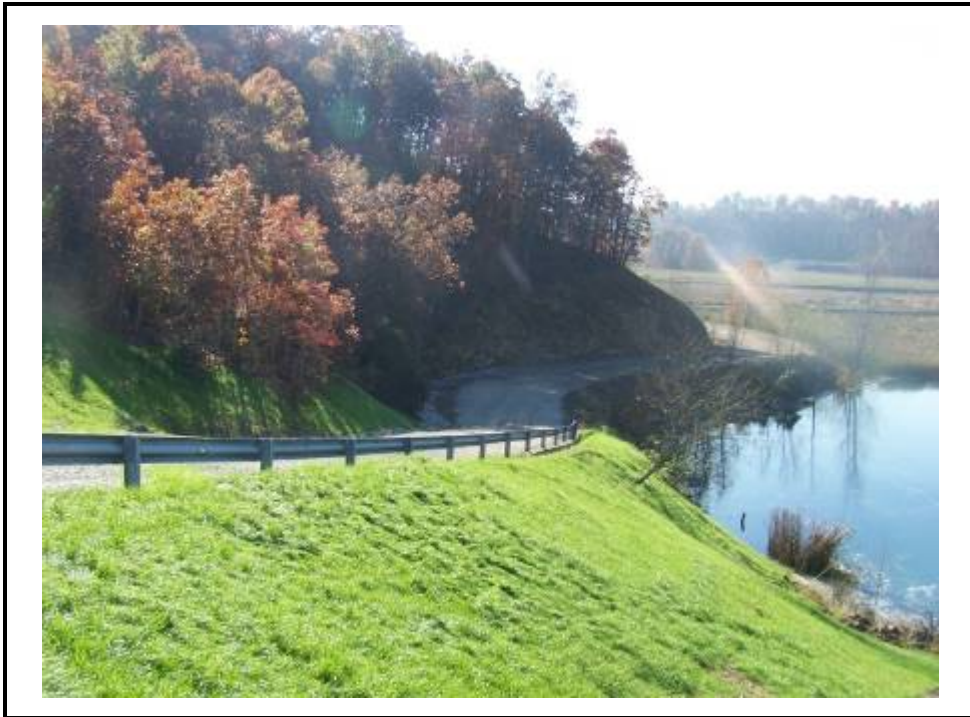
20

Access road up east abutment/Horseford Creek Dam contact, looking east.

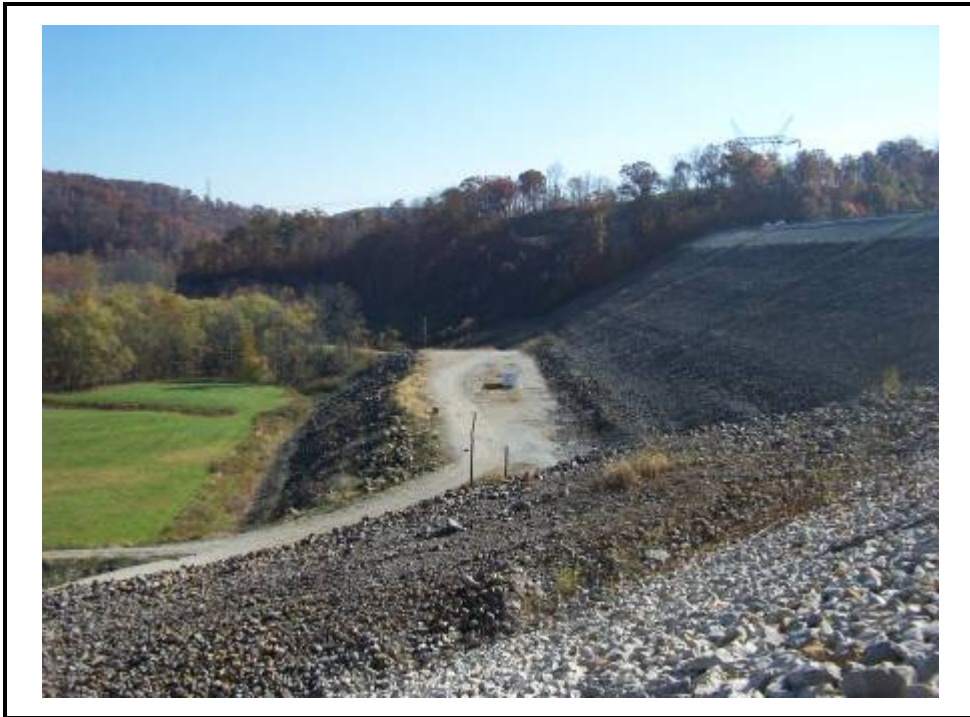
26

Downstream slope and buttress of Horseford Creek Dam, looking east.

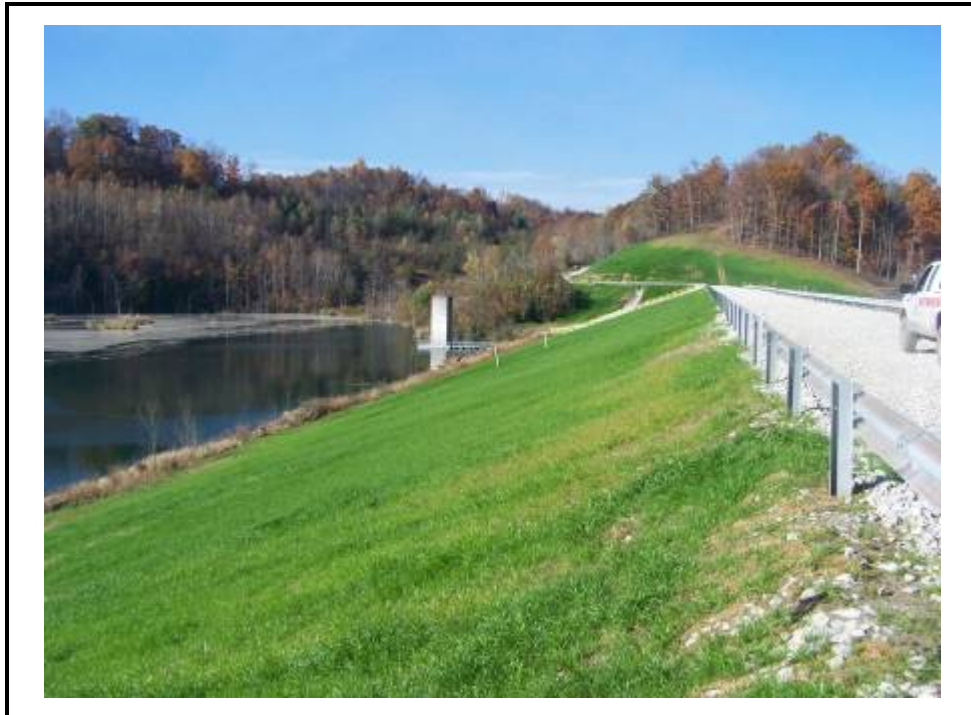
27

Upstream slope of Horseford Creek Dam, looking east.

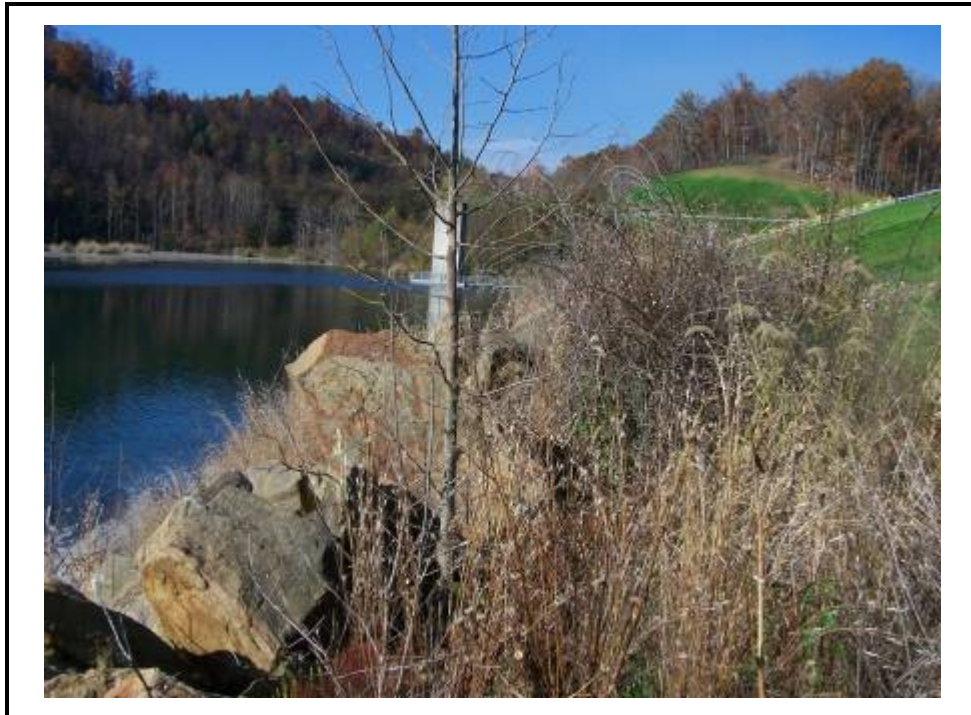
28

Brush and small trees in rip rap along the water line have been sprayed with herbicide at Horseford Dam.

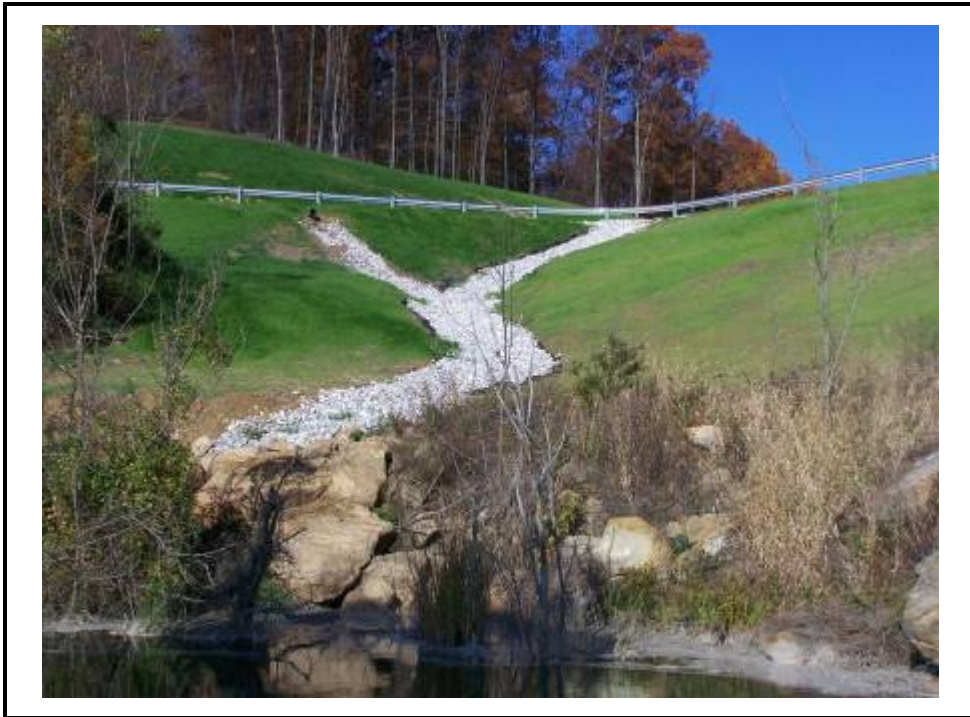
29

Upstream west abutment groin and large rip rap at Horseford Creek Dam.

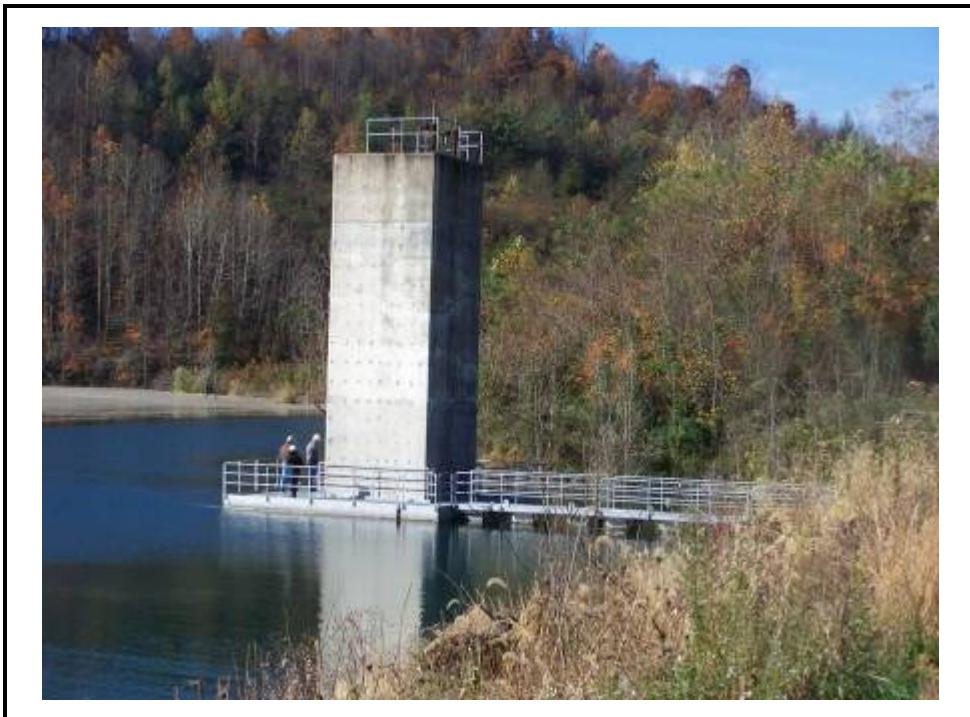
30

Outlet structure near west end of Horseford Creek Dam.

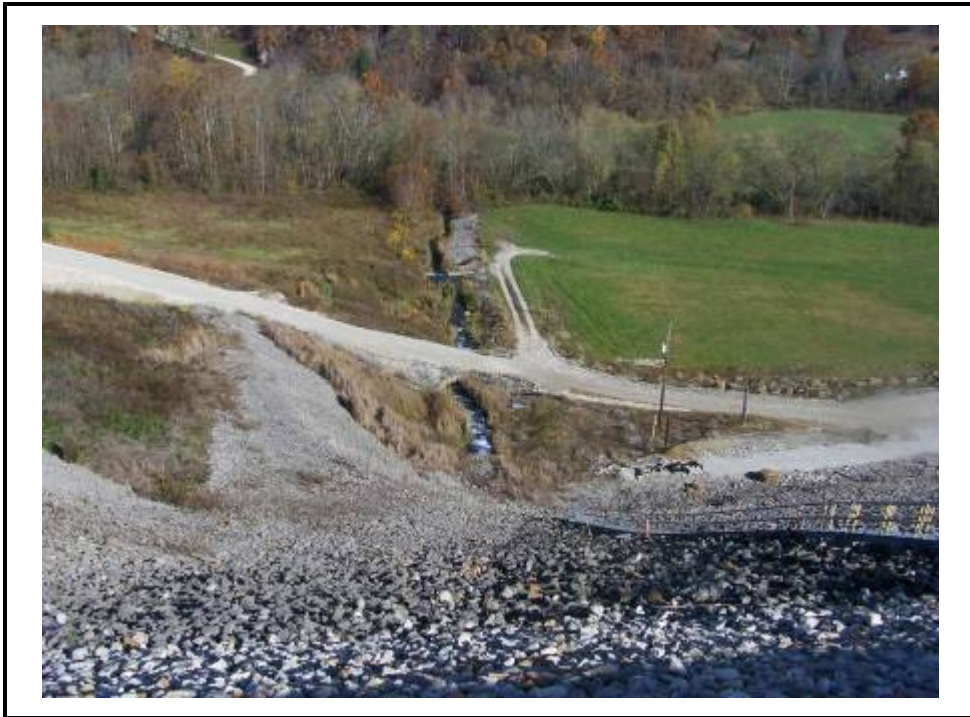
34

Discharge channel for Horseford Creek Dam.

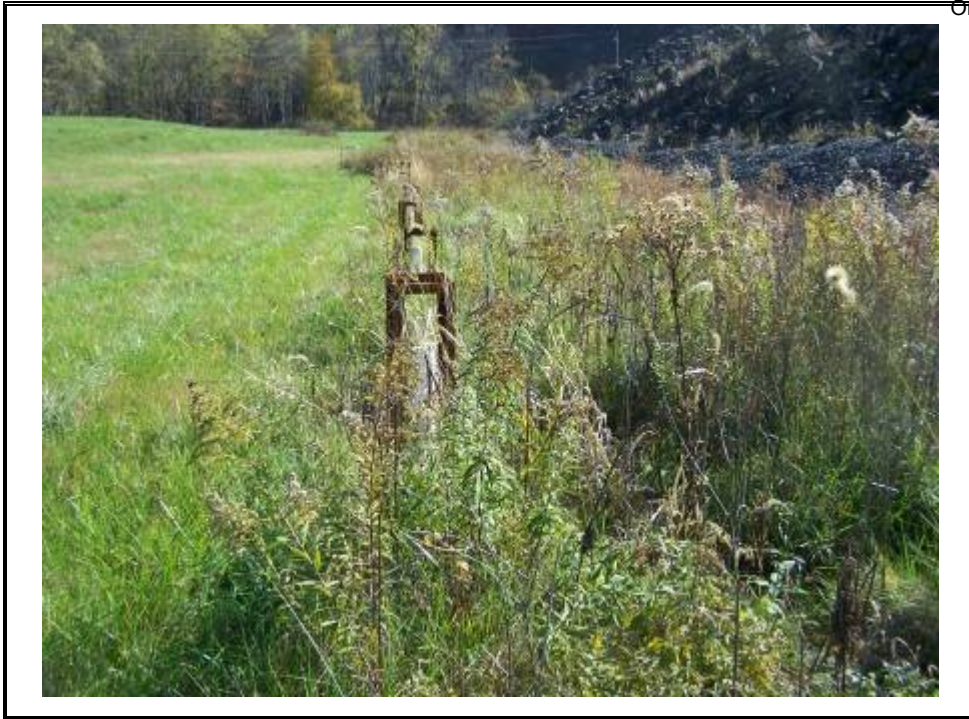
37

Relief wells part of Horseford Creek Dam toe drain system.
Area in taller grass is wet from seepage.

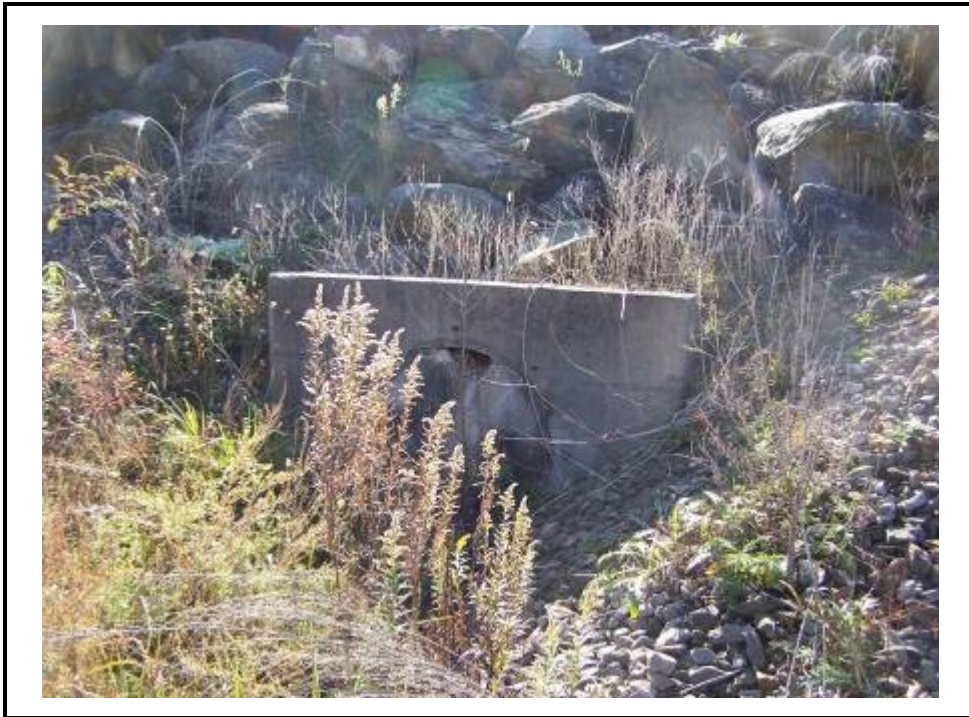
38

Phase I outlet pipe was abandoned in place.

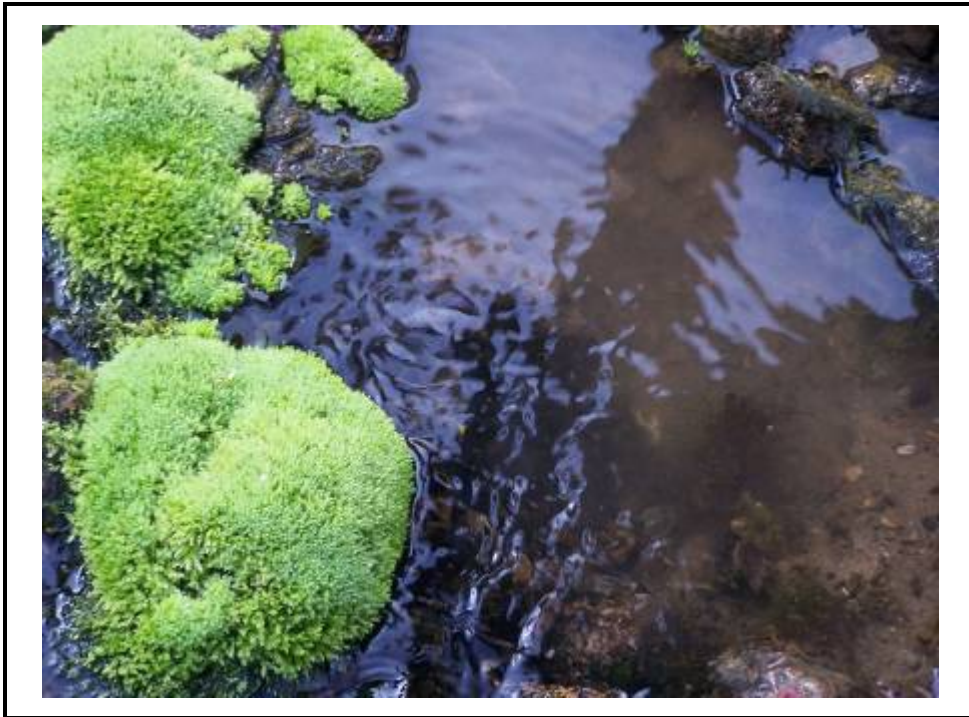
40

Toe drain discharge pipe is buried in sand and rock but flowing.

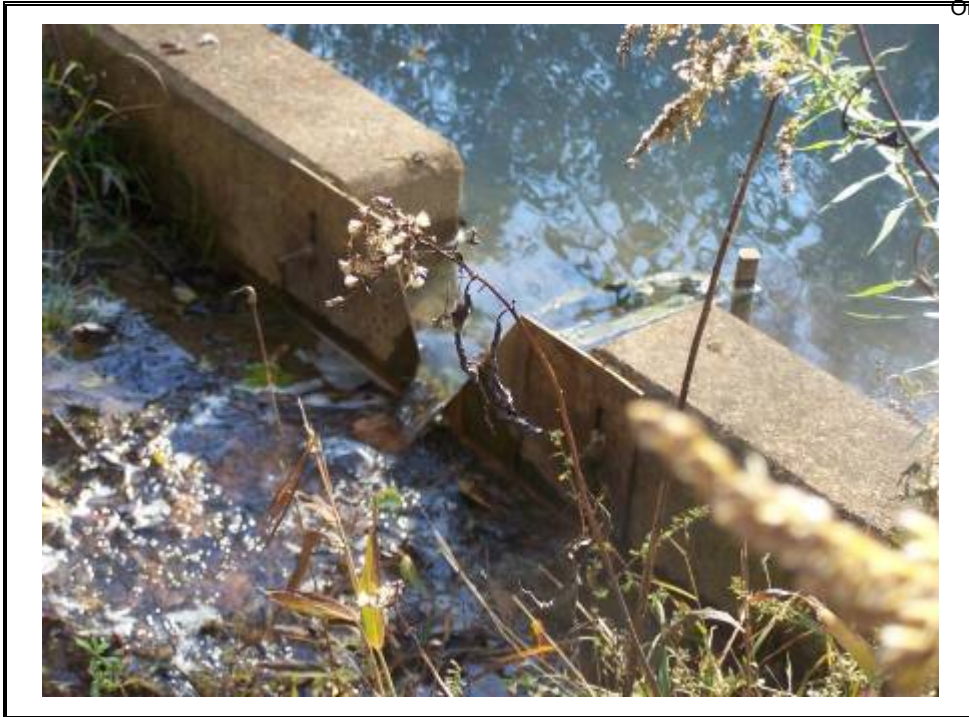
41

Monitoring weir at east abutment and toe drain discharge area.

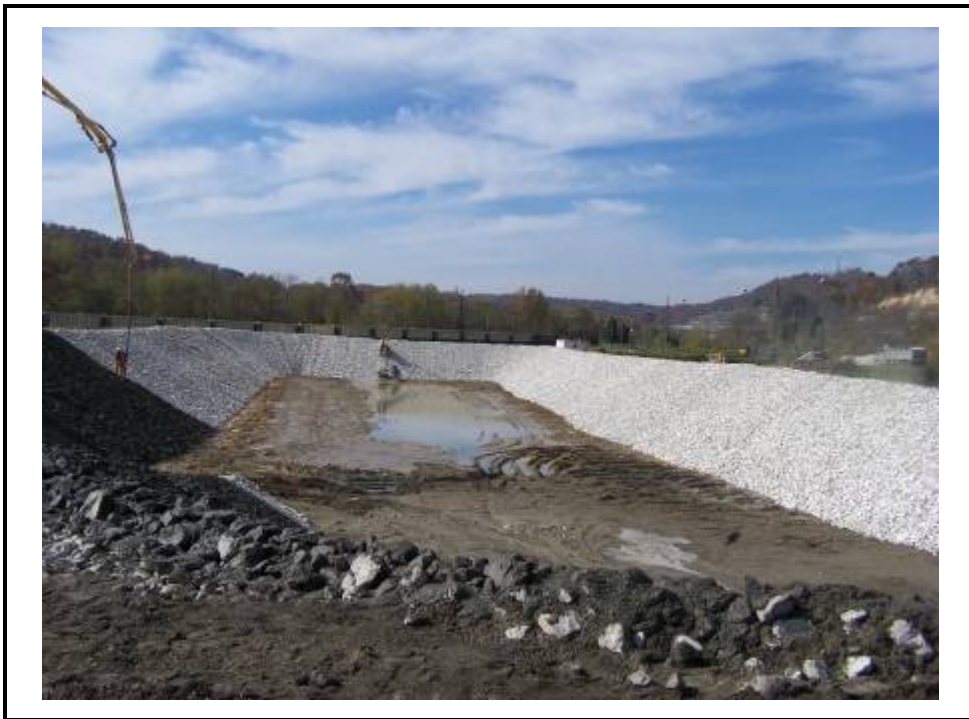
42

South Bottom Ash Pond looking west. AEP ws installing grouted rip rap on the inside slopes to reduce vegetation and erosion type maintenance.

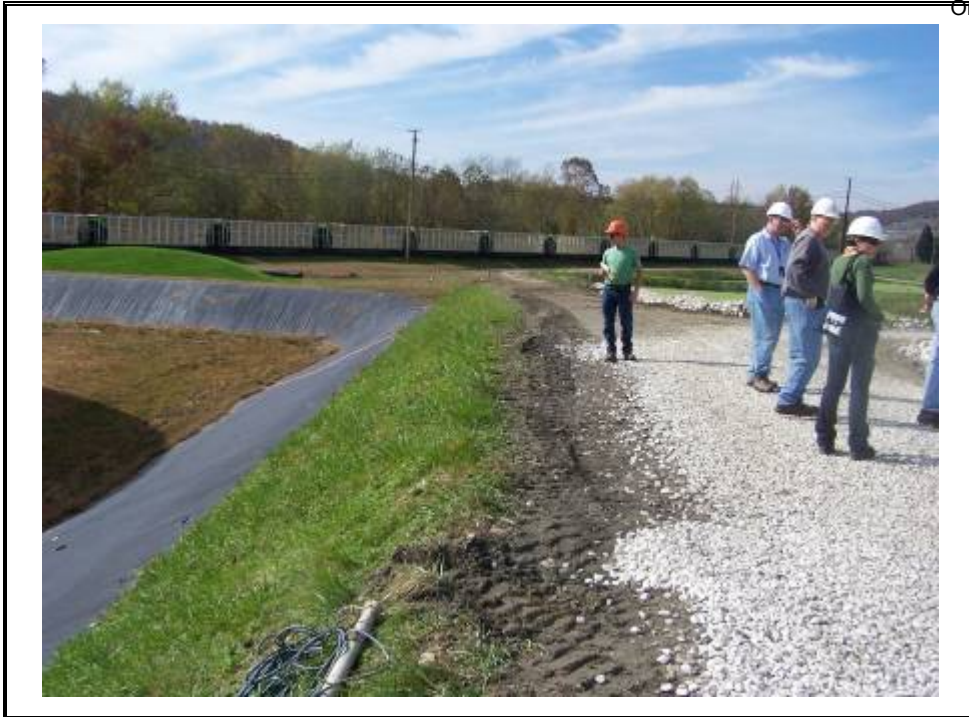
45

Crest of the South Dike at the Bottom Ash Complex looking west. Note dike crest slopes to about original grade adjacent to the south clear water pond. Liner on downstream slope is part of chemical spill containment berms.

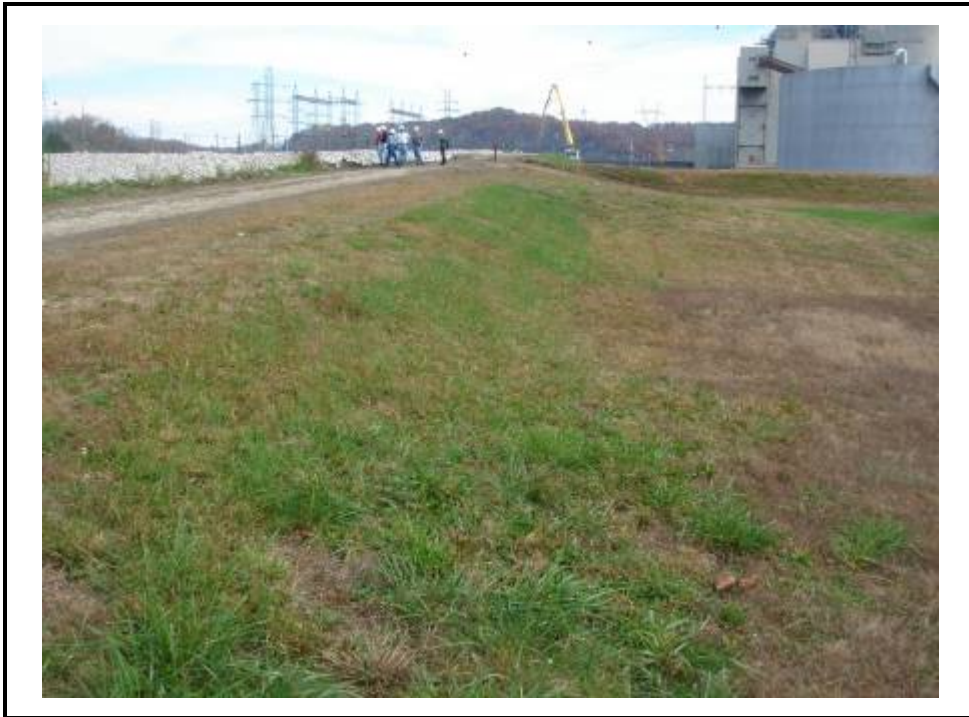
Sparse grass cover was observed on the downstream and upstream slopes of the south dike adjacent to the SCWP (Photos 46 and 47). Rip rap has been recently placed on the upstream slopes at the west end of the SCWP as shown in Photos 48 through 50.

Downstream slope of South Dike at Bottom Ash Complex adjacent to south clear water pond, looking east.

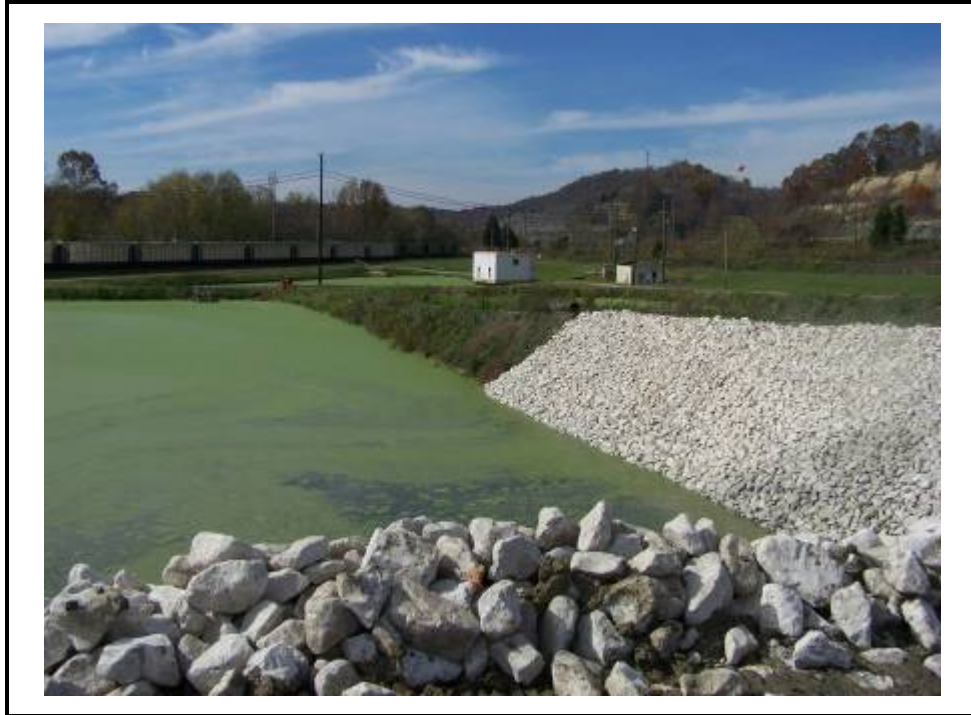
49

South side of Splitter Dike between south and north Clearwater Ponds.

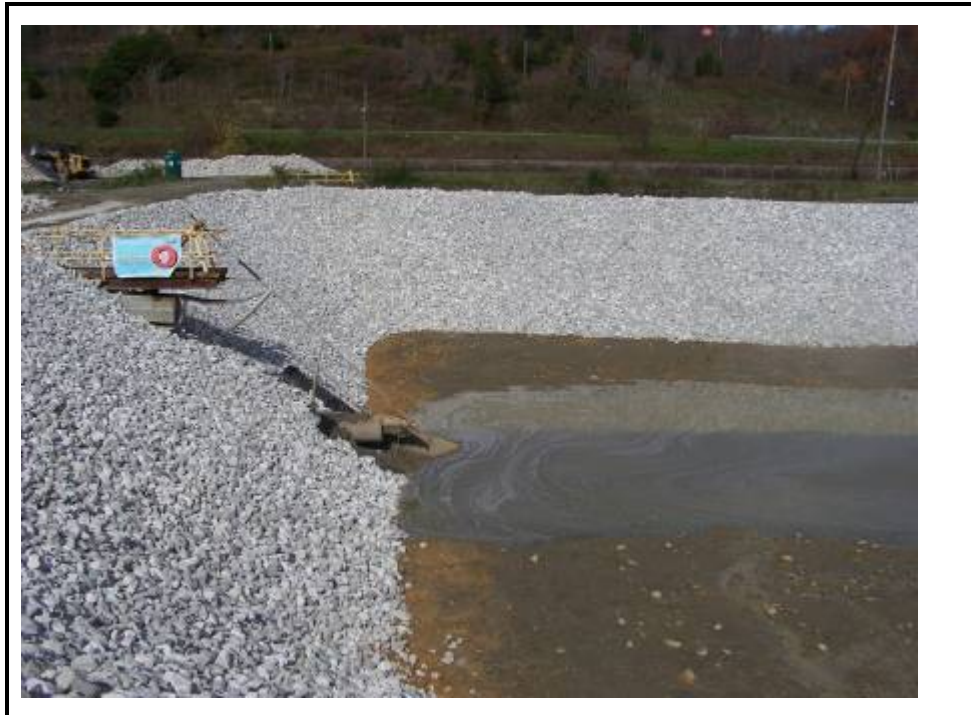
50

Decant structure (platform near top of slope) and pond drain (pipe near bottom of slope) from south Bottom Ash Pond into south Clearwater Pond.

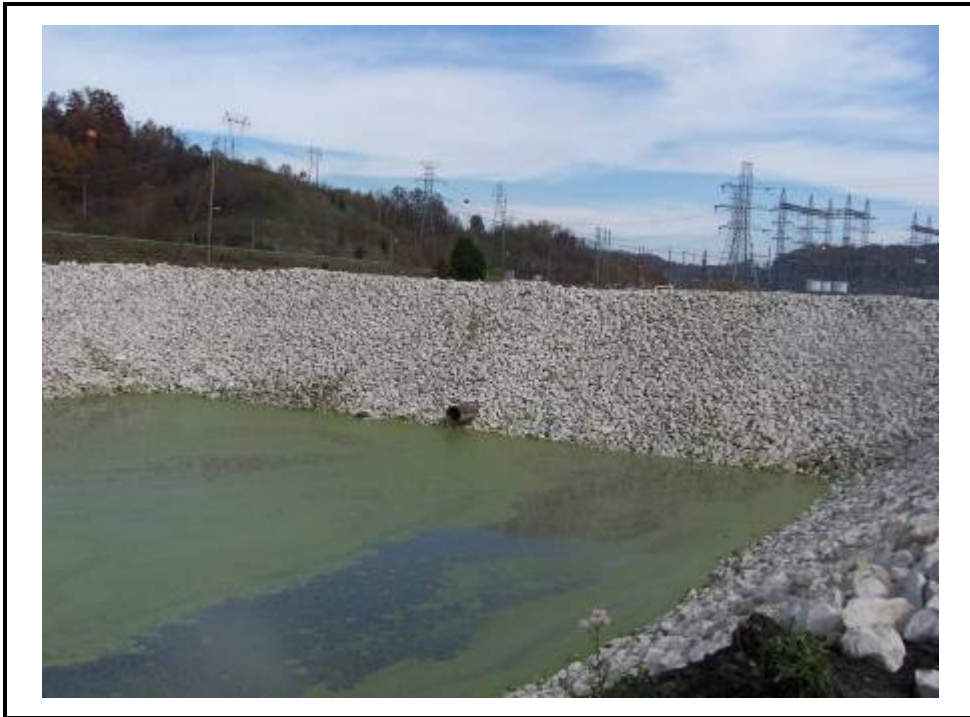
52

Discharge from South Bottom Ash Pond into South Clearwater Pond.

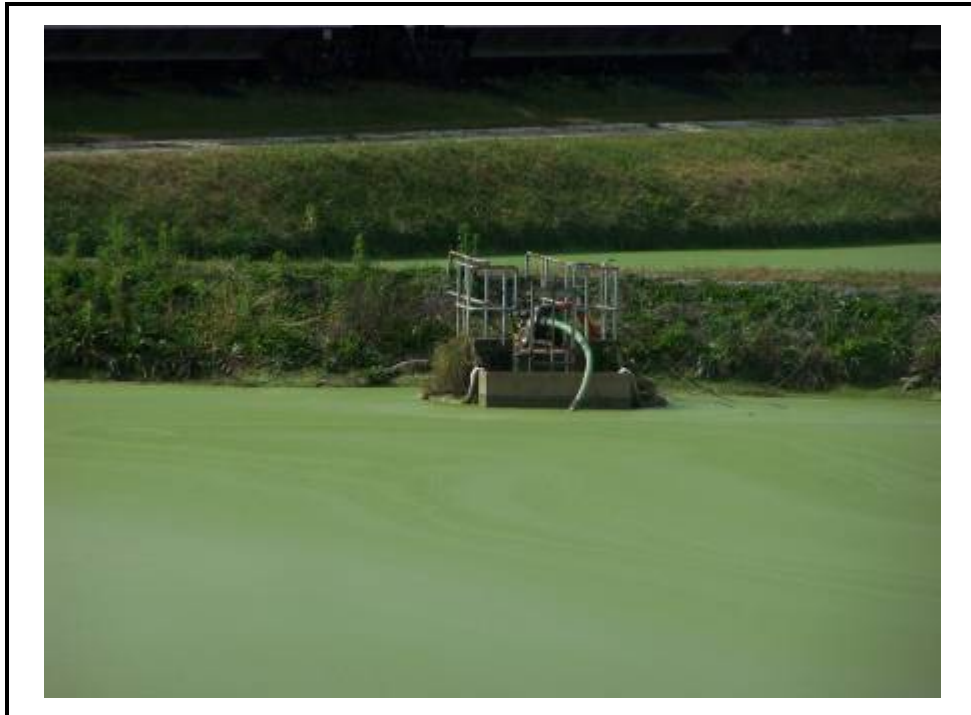
53

Decant structure from south Clearwater Pond to the Reclaim Pond.

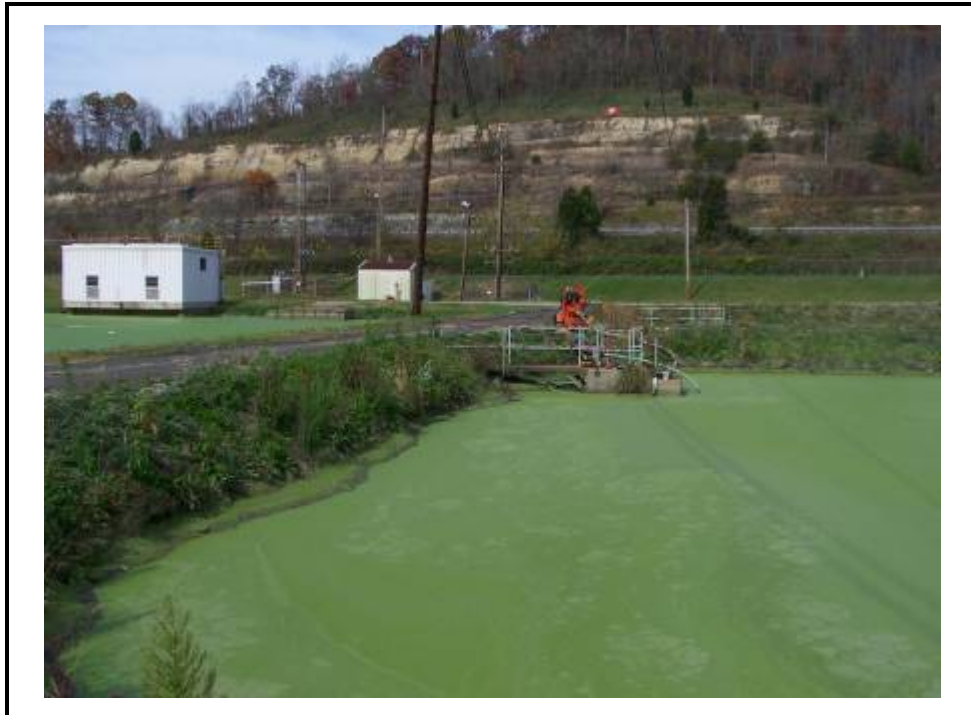
54

Splitter Dike between south Clearwater Pond (right side of photo)
and the Reclaim Pond (upper left of photo).
