Assessment of Dam Safety Coal Combustion Surface Impoundments (Task 3) Final Report

American Electric Power
Big Sandy
Generating Station
Louisa, Kentucky

February 17, 2010

CHA Project No. 20085.7000.1510

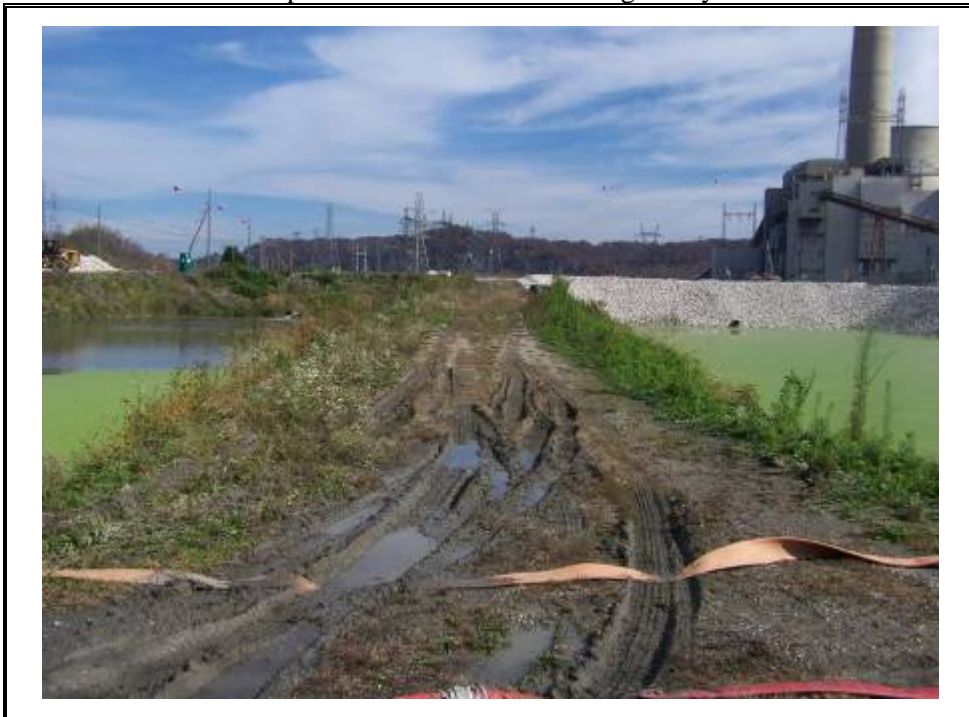
56

Standing water was observed in tire ruts on the crest of the splitter dike between the NCWP and SCWP as seen in Photo 56. Erosion has occurred at the water line on the northern toe of the splitter dike between the NCWP and SCWP due to wave action as seen in Photo 58. This mode of erosion is part of the reason for the current work to cover the slopes with grouted rip rap. Several bushes were observed growing on the west slope of the splitter dike between the NBAP and NCWP as shown in Photo 61. The crest of the splitter dike between the SBAP and SCWP is uneven as shown in Photo 63.

Crest of Splitter Dike between north and south Clearwater Ponds, looking east.

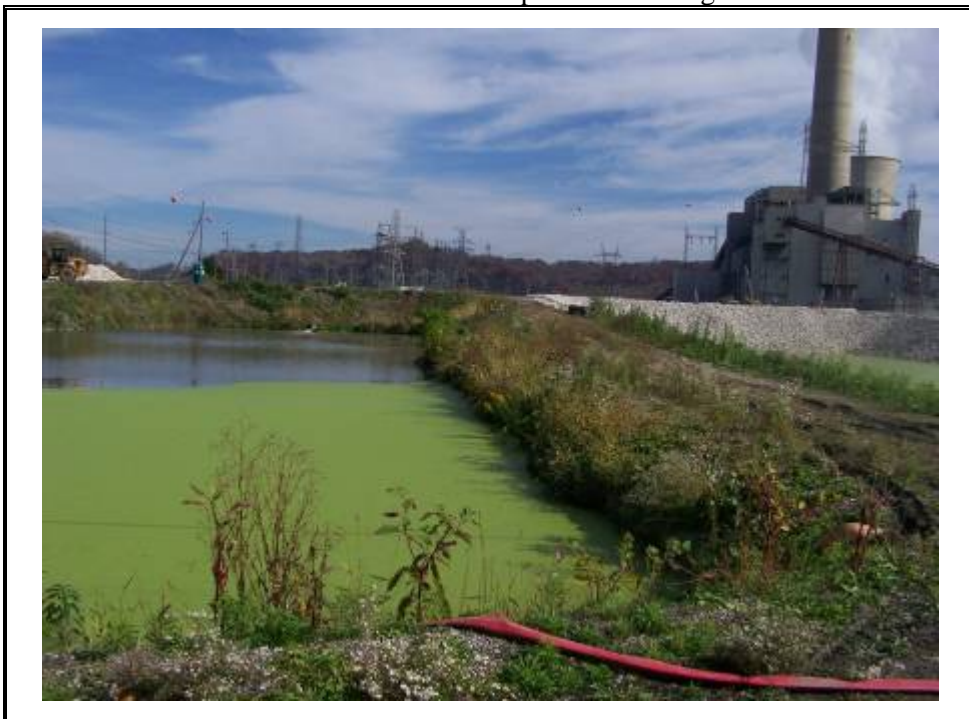
58

North side of Splitter Dike between north and south Clearwater Ponds, looking east.

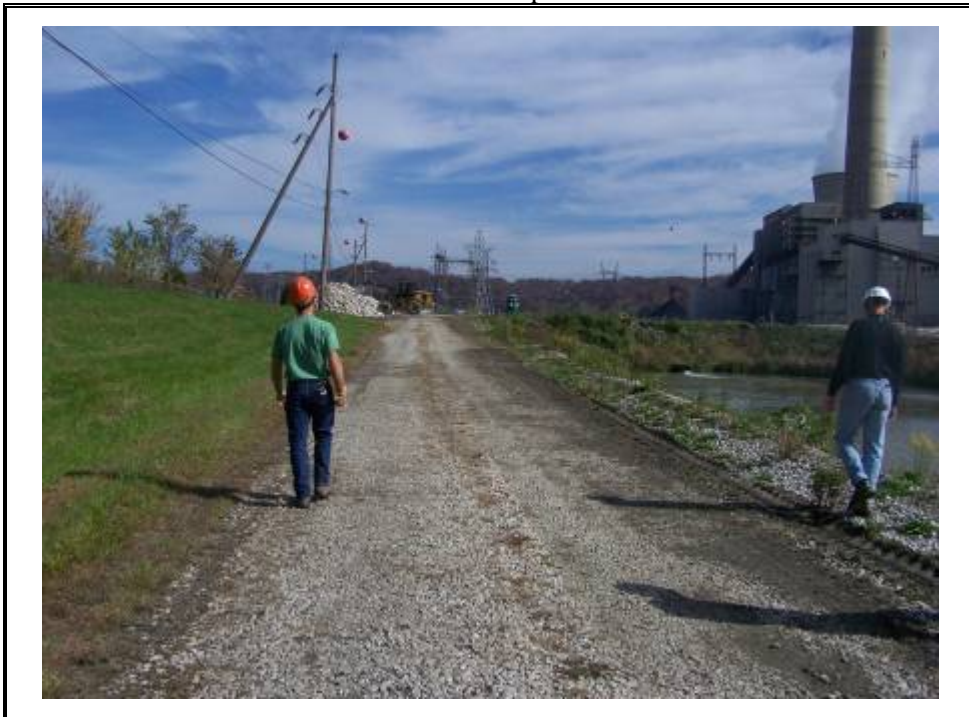
60

The western end of the north side of the NCWP is incised as shown in Photo 60. Tall grass was observed on the upstream slope of the north dike adjacent to the NBAP as shown in Photo 65. The standing water shown in the photo is from recent rain.

Crest of North Dike of Bottom Ash Complex along
north Clearwater Pond where Bottom Ash Complex is incised.

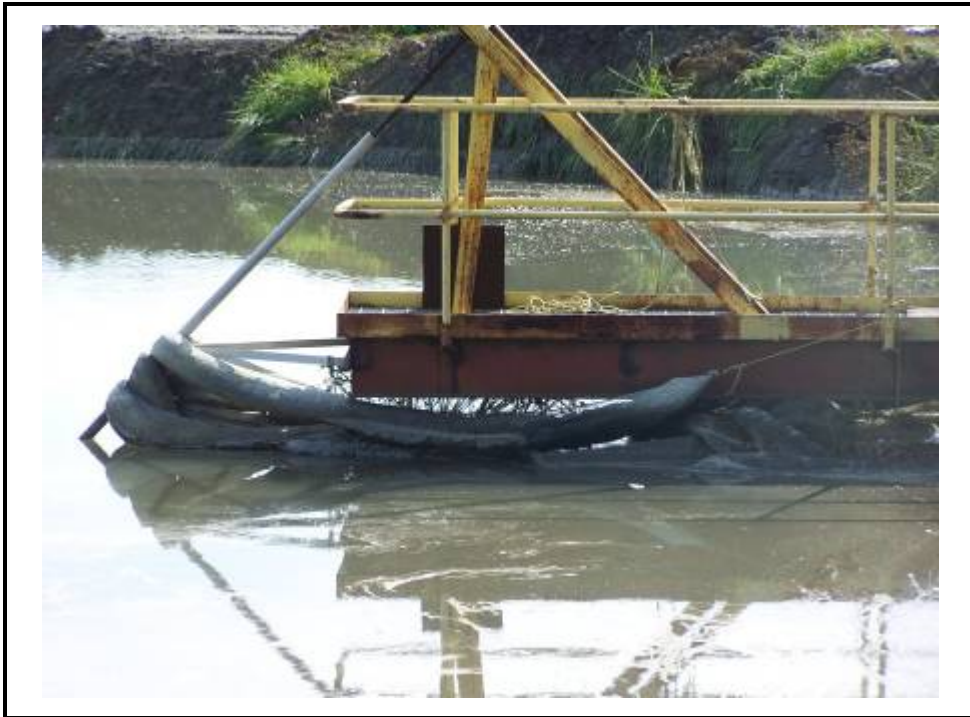
Close-up of decant structure in north Bottom Ash Pond.
