Louisville Gas and Electric Company
2021 Annual Report
Case No. 2017-00119

Exhibit A
Report No. 202102056

Metallurgical Evaluation of a 16" Coupling and Associated Hardware

Location: 7th St. and Bernheim Ln.
Designation: 2021-20

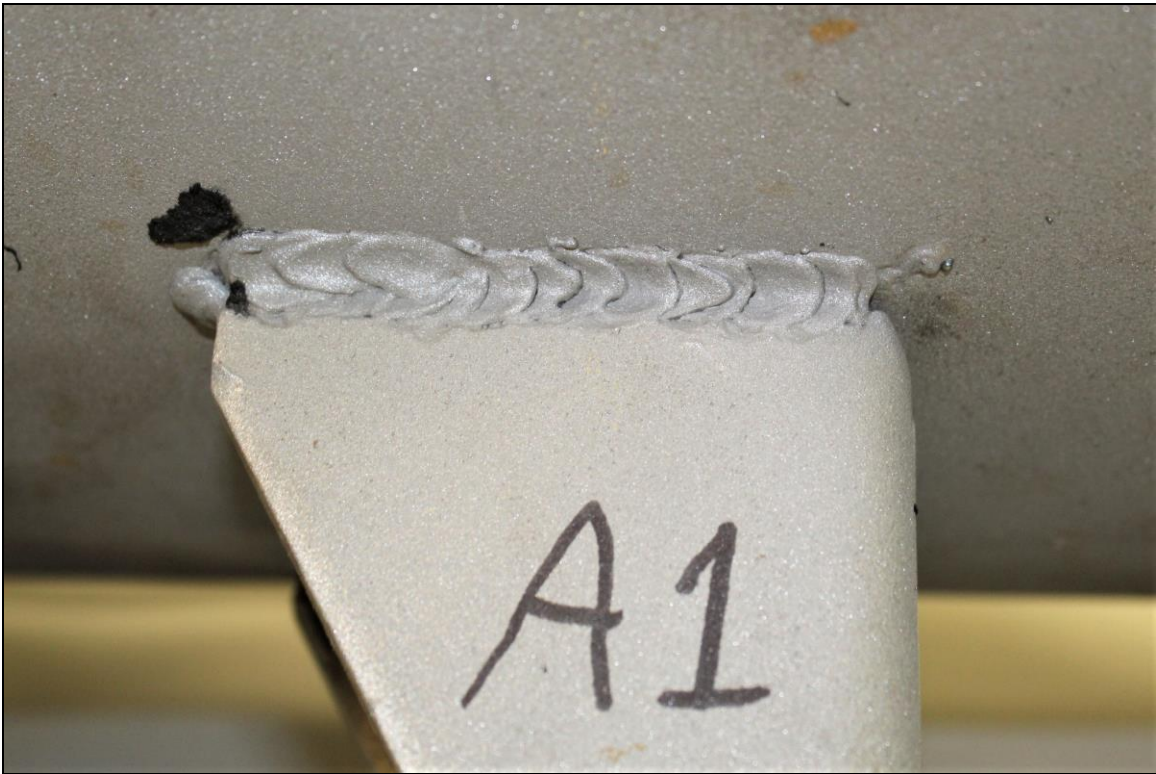
Figure 5. Image of the Lug A1 exterior bottom weld which exhibited substantial fusion except for some undercut, spatter, and arc strikes.

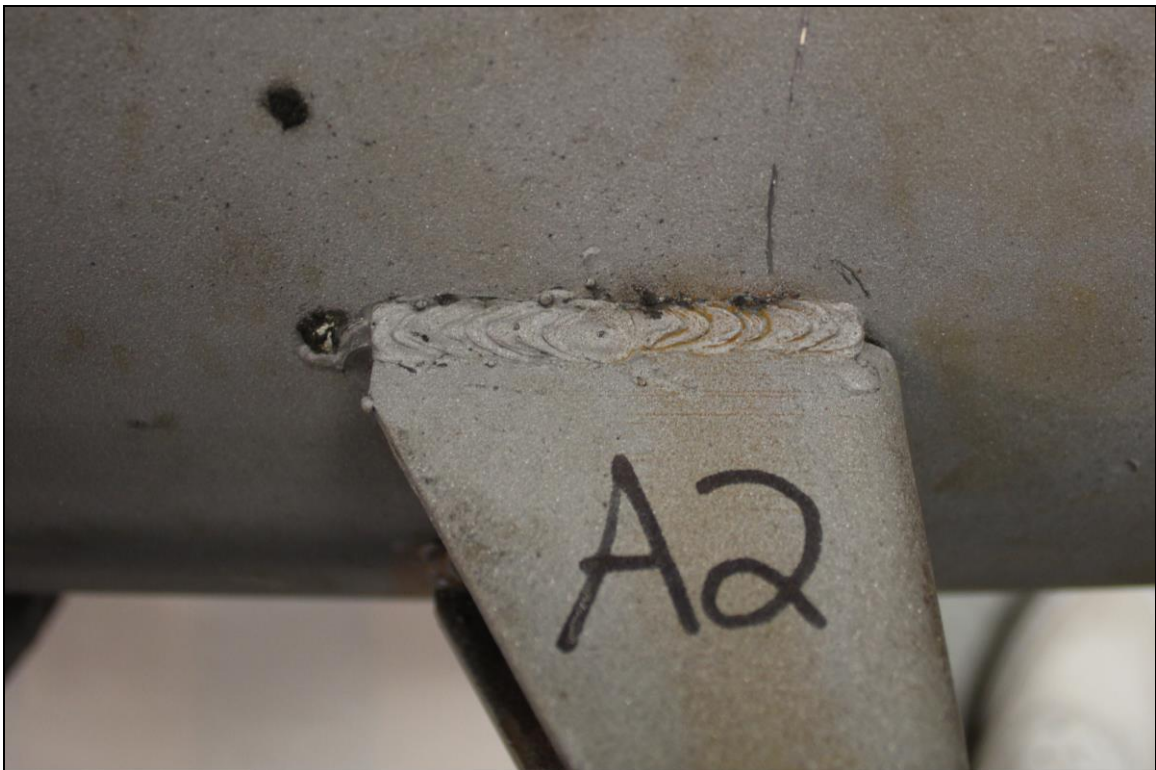
Figure 6. Image of the Lug A2 exterior top weld which was fractured and exhibited substantial fusion except for some undercut, arc strikes, and spatter.

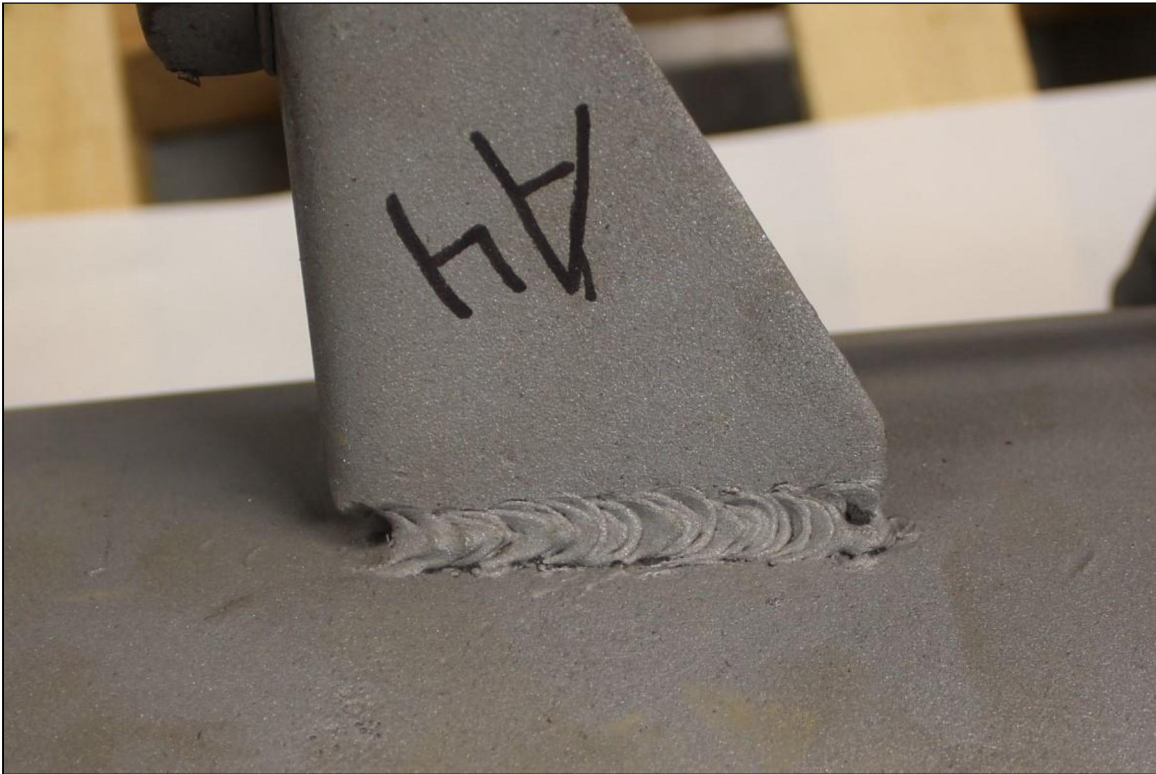
Figure 7. Image of the Lug A4 exterior bottom weld which exhibited substantial fusion except for some undercut and porosity.

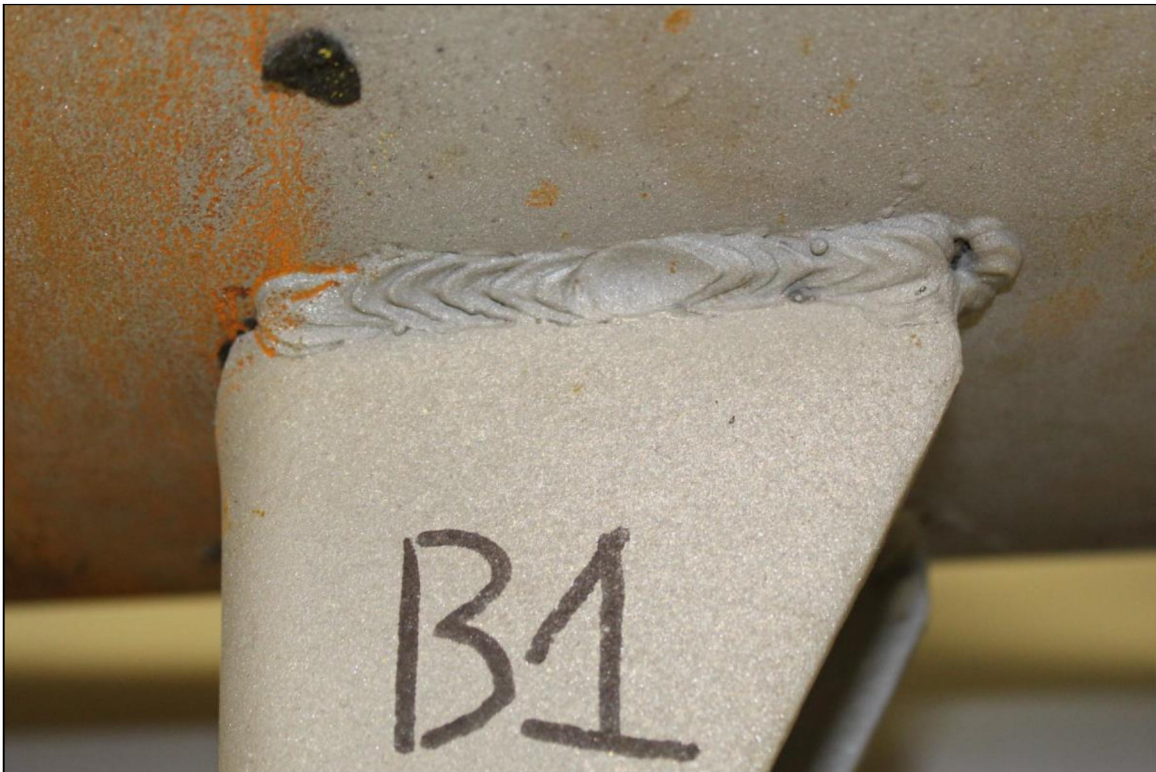
Figure 8. Image of the Lug B1 exterior bottom weld which exhibited substantial fusion except for some undercut, and spatter.

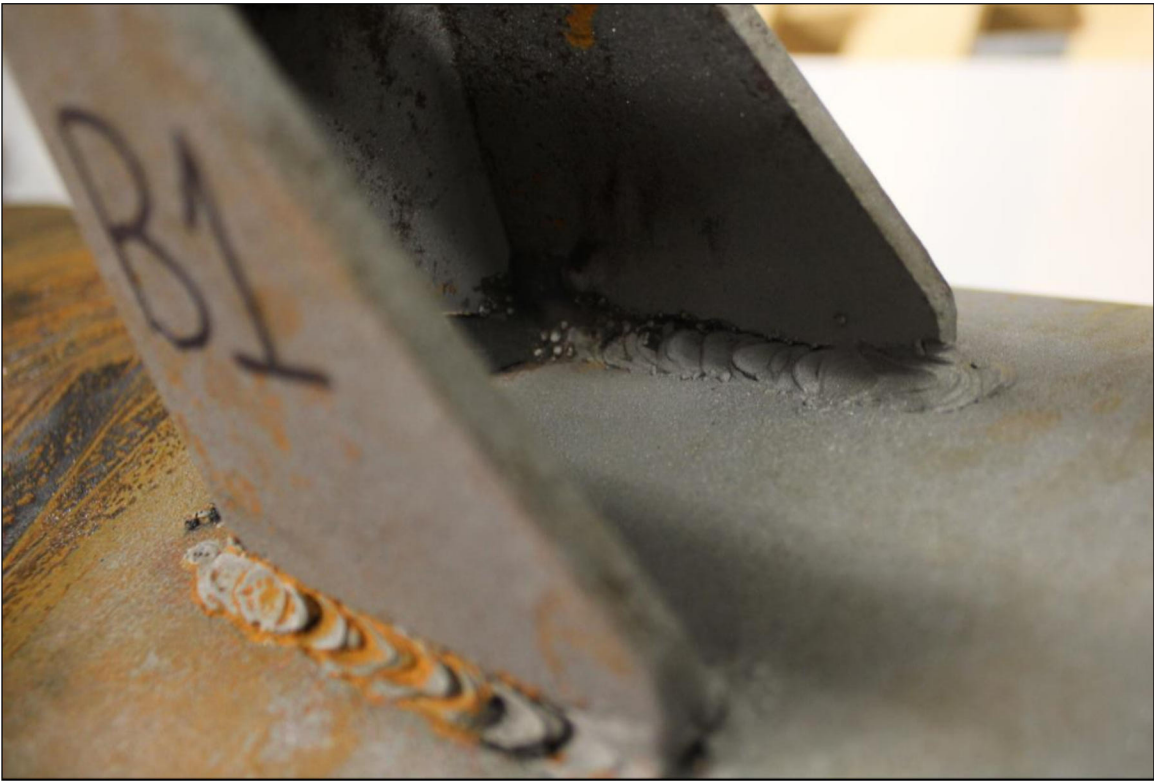
Figure 9. Image of the Lug B1 interior bottom weld which exhibited substantial fusion except for some spatter.

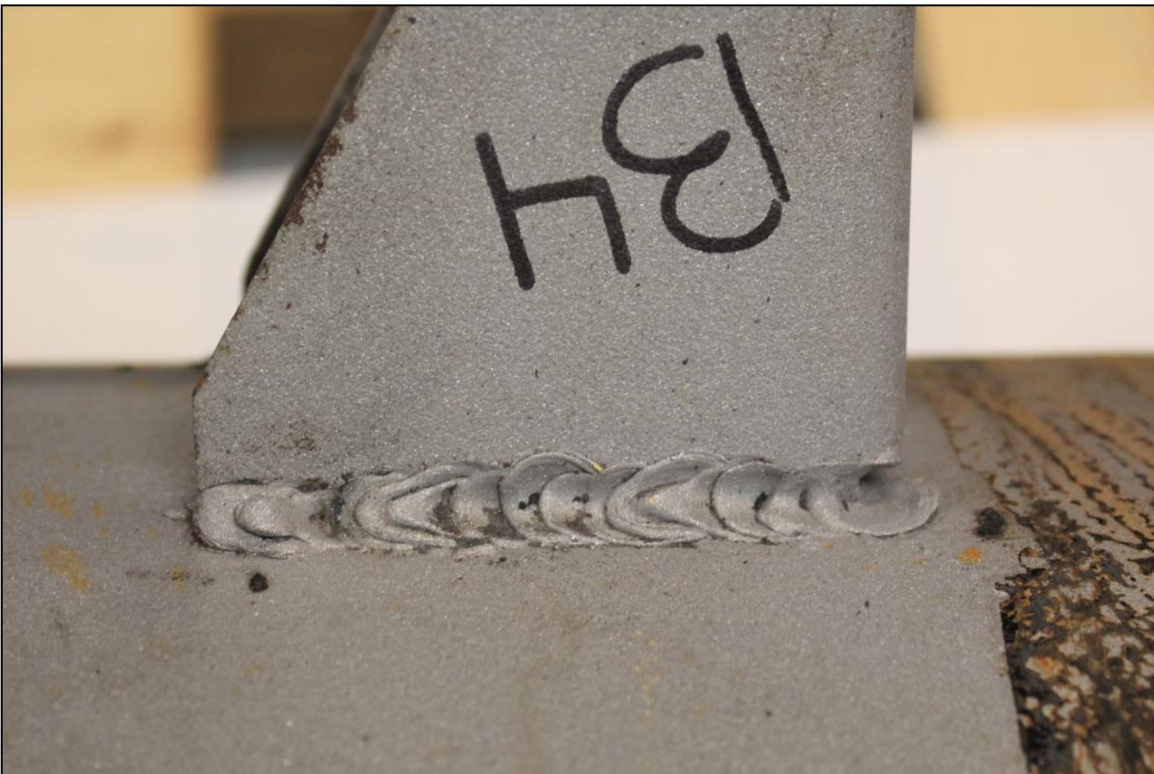
Figure 10. Image of the Lug B4 exterior bottom weld which exhibited substantial fusion except for undercut, and porosity.

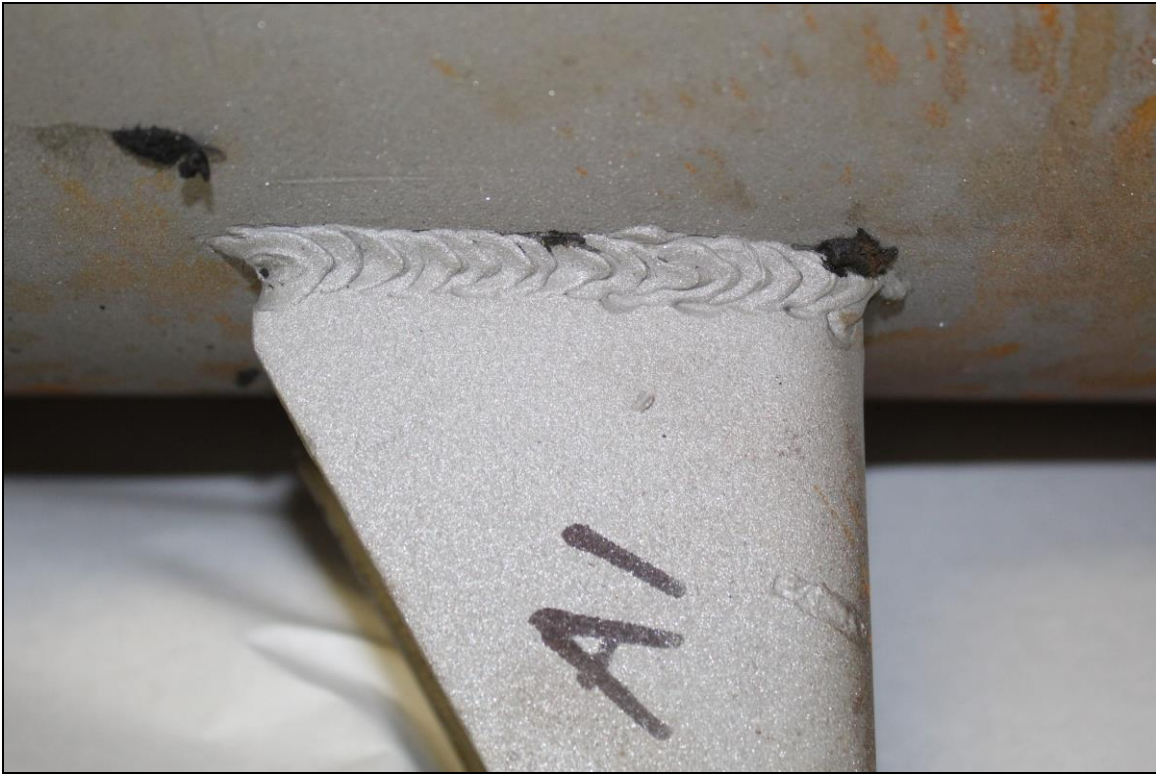
Figure 5. Image of the Lug A1 exterior bottom weld which exhibited substantial fusion except for some undercut, porosity, and arc strikes.

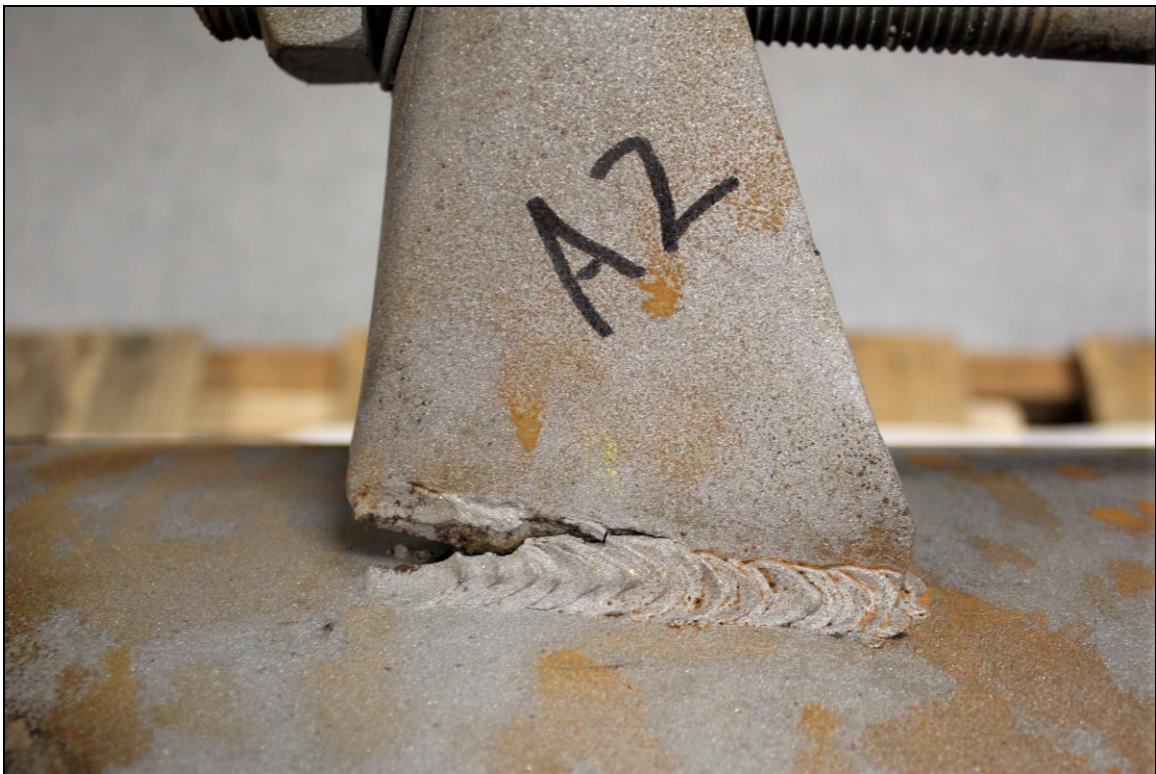
The welds contained localized discontinuities including undercut, arc strikes, porosity, and spatter. No cracking in most of the welds or base metal heat affected zones (HAZ) was visually identified. No gross corrosion was observed anywhere on the pipe or associated hardware. Welds on Lug A2 were cracked.

Figure 6. Image of the Lug A2 exterior top weld which was fractured and exhibited substantial fusion except for some undercut and porosity.

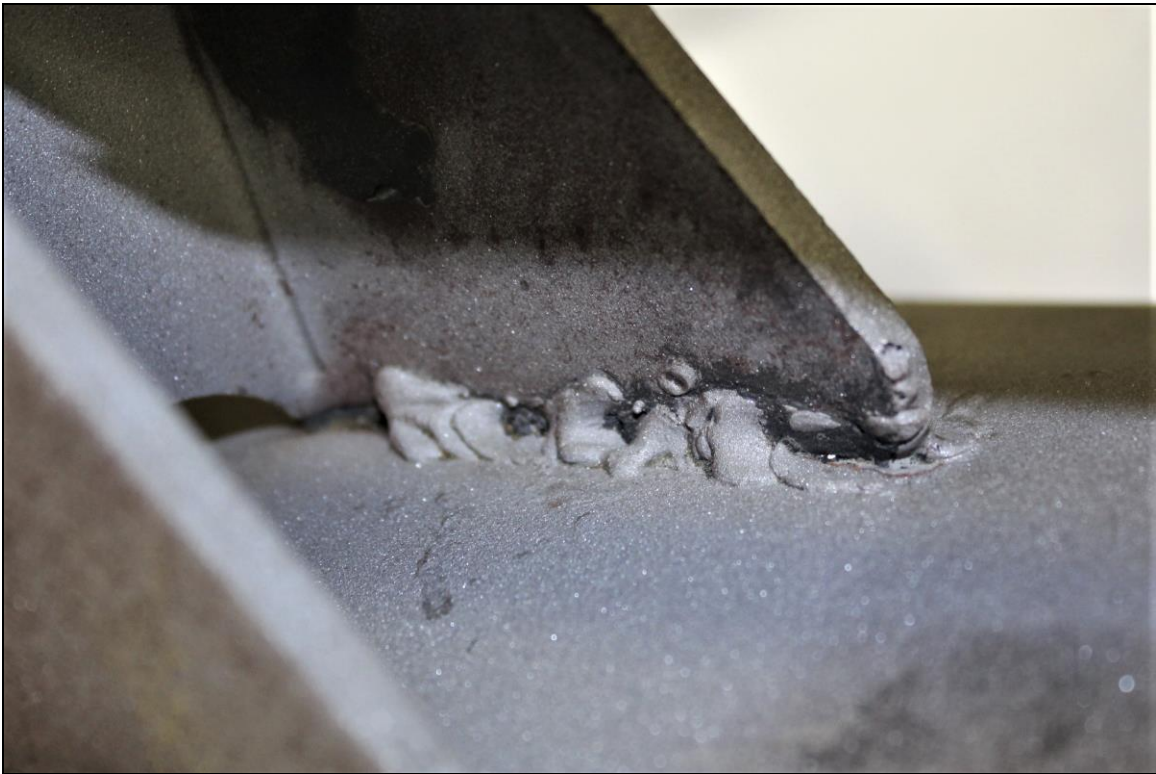
Figure 7. Image of the Lug A4 exterior top weld which exhibited substantial fusion except for some undercut and spatter.

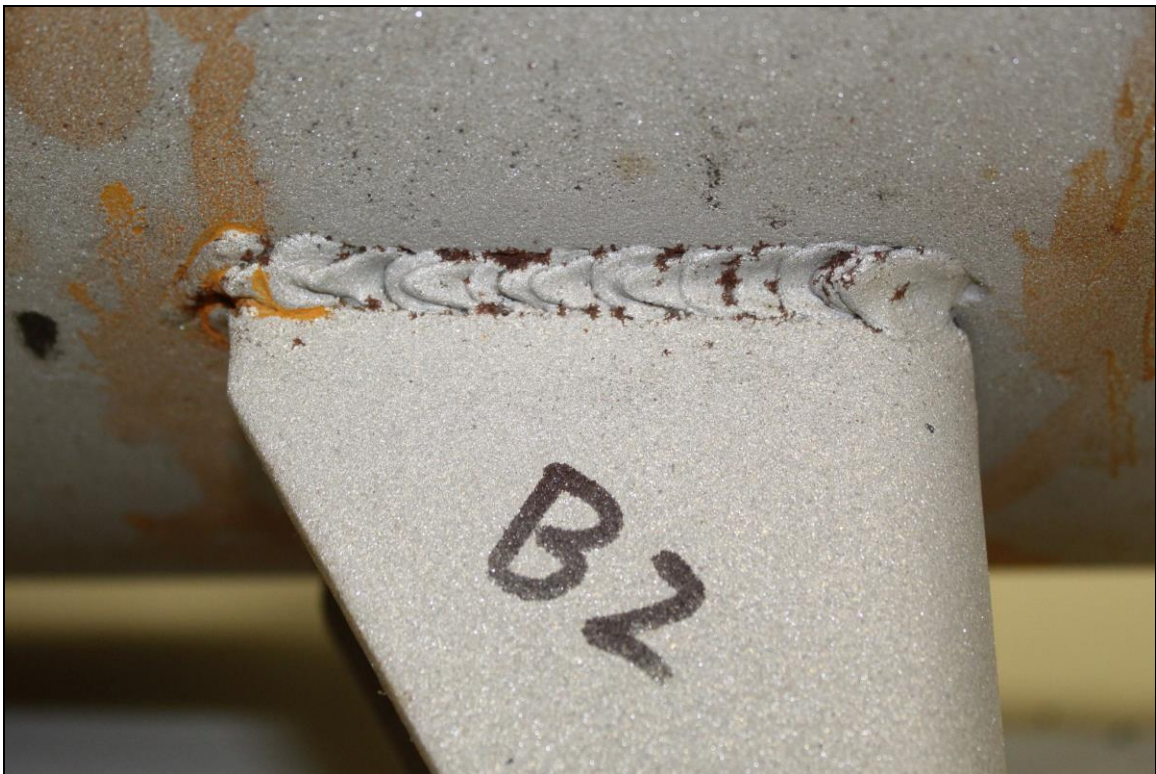
Figure 8. Image of the Lug B2 exterior bottom weld which exhibited substantial fusion except for some undercut.

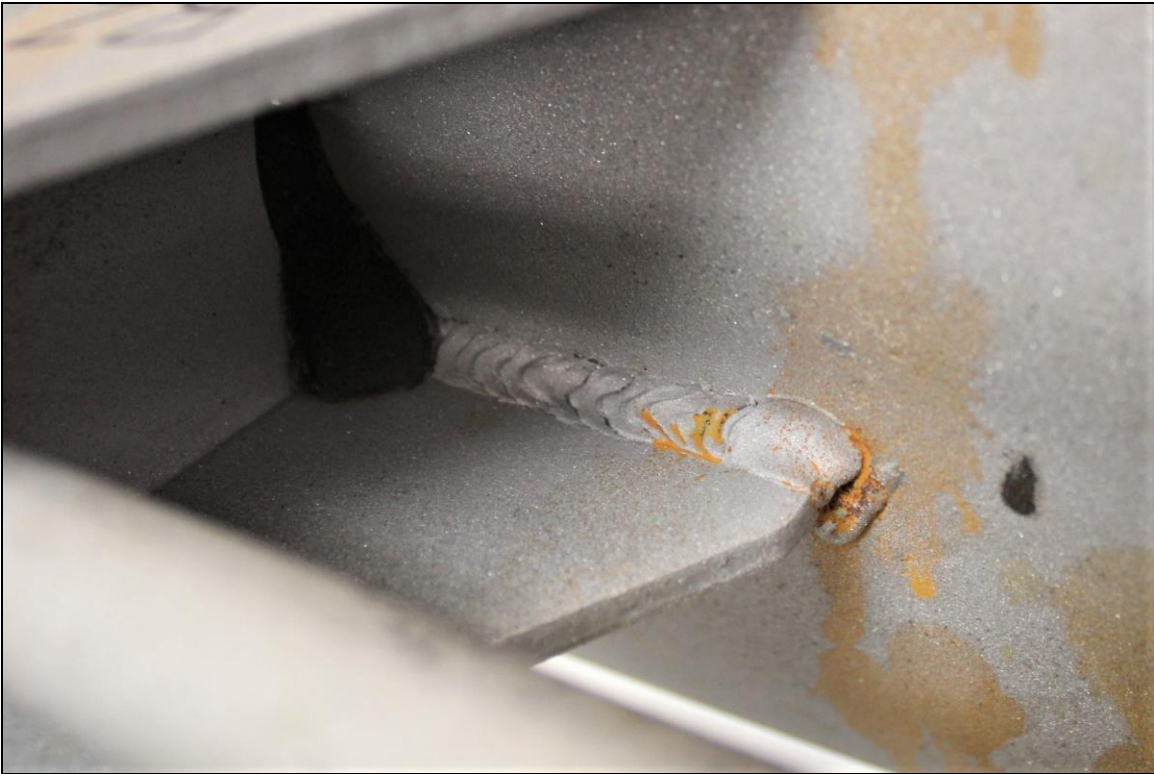
Figure 9. Image of the Lug B2 interior bottom weld which exhibited substantial fusion.

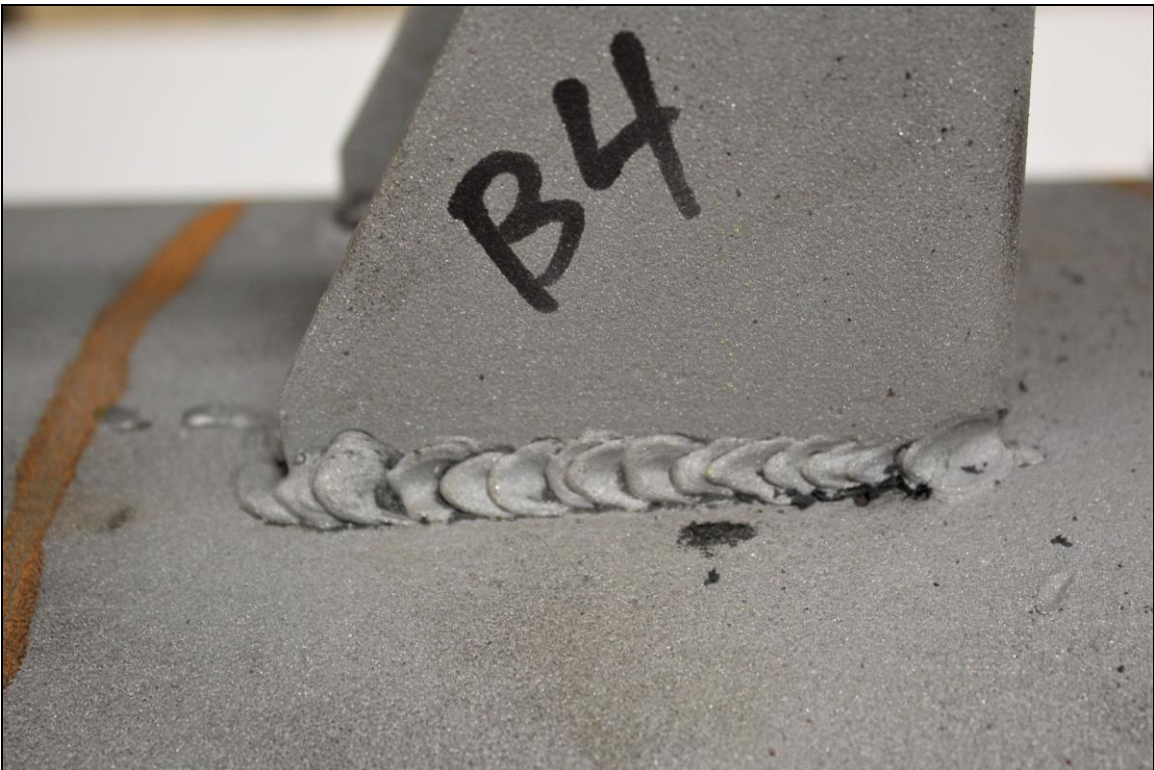
Figure 10. Image of the Lug B4 exterior top weld which exhibited substantial fusion except for arc strikes, undercut, and spatter.

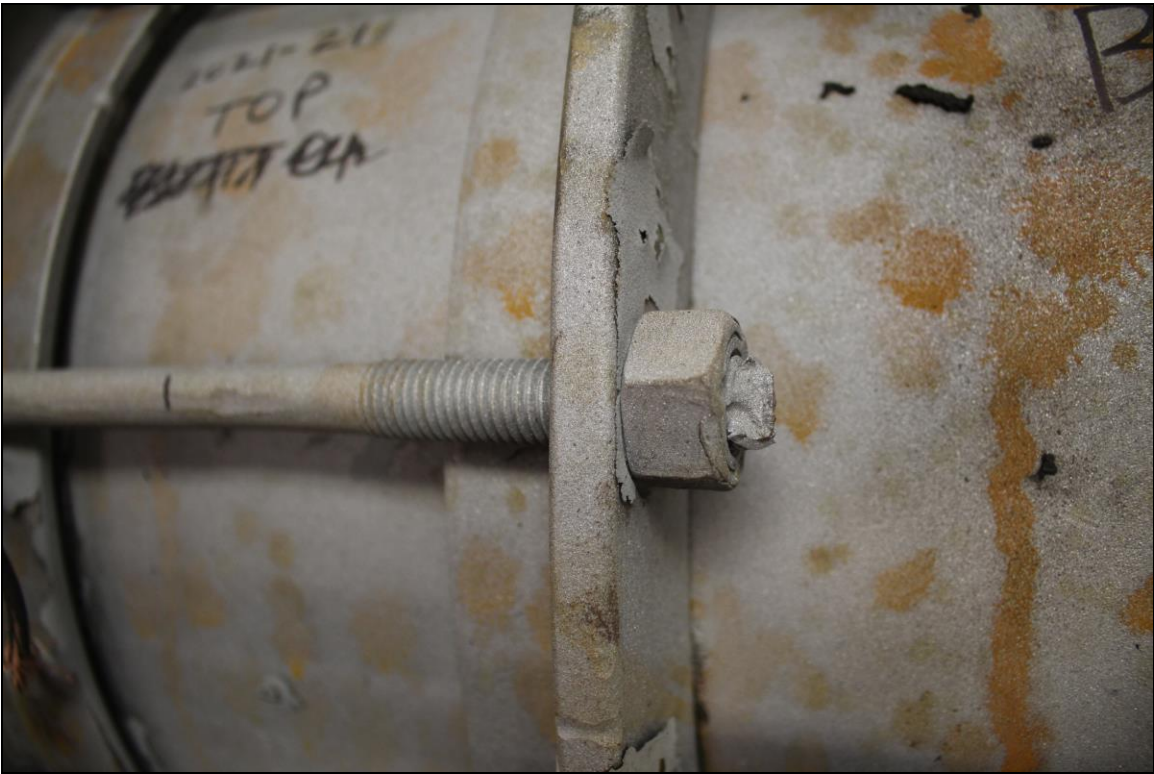
Figure 11. Image of the broken end of Bolt 1.

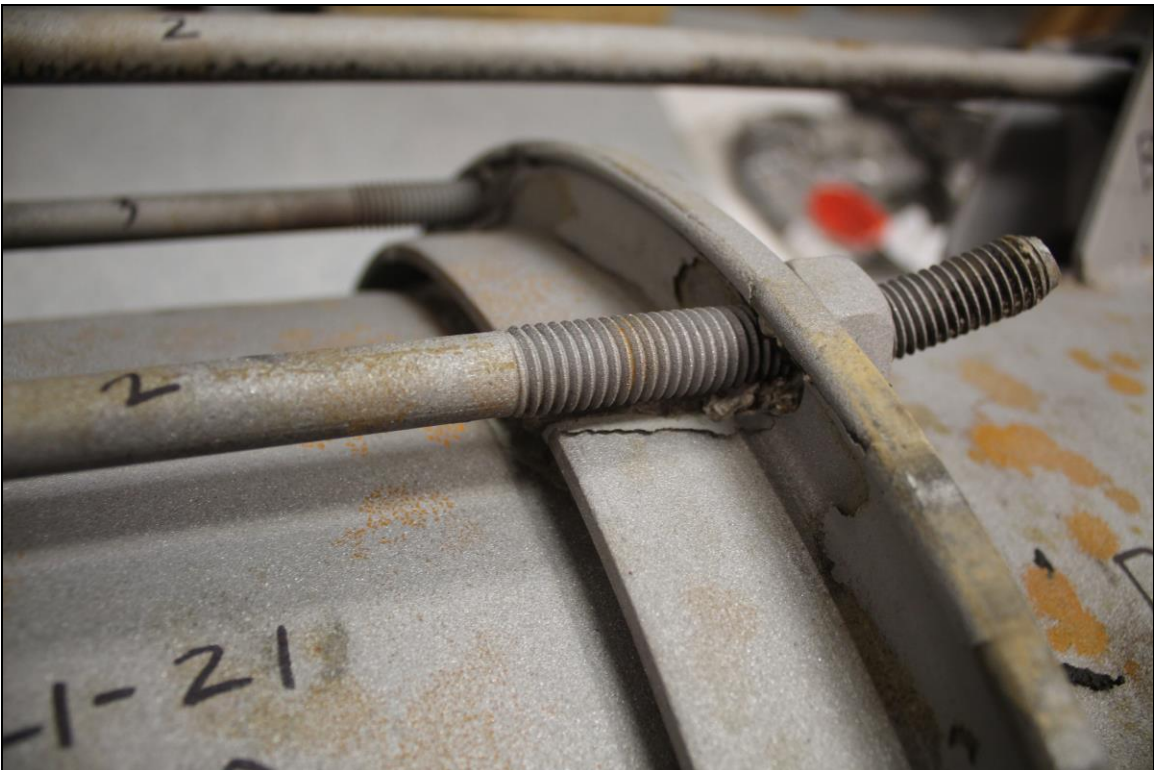
Figure 12. Image of the bent end of Bolt 2.

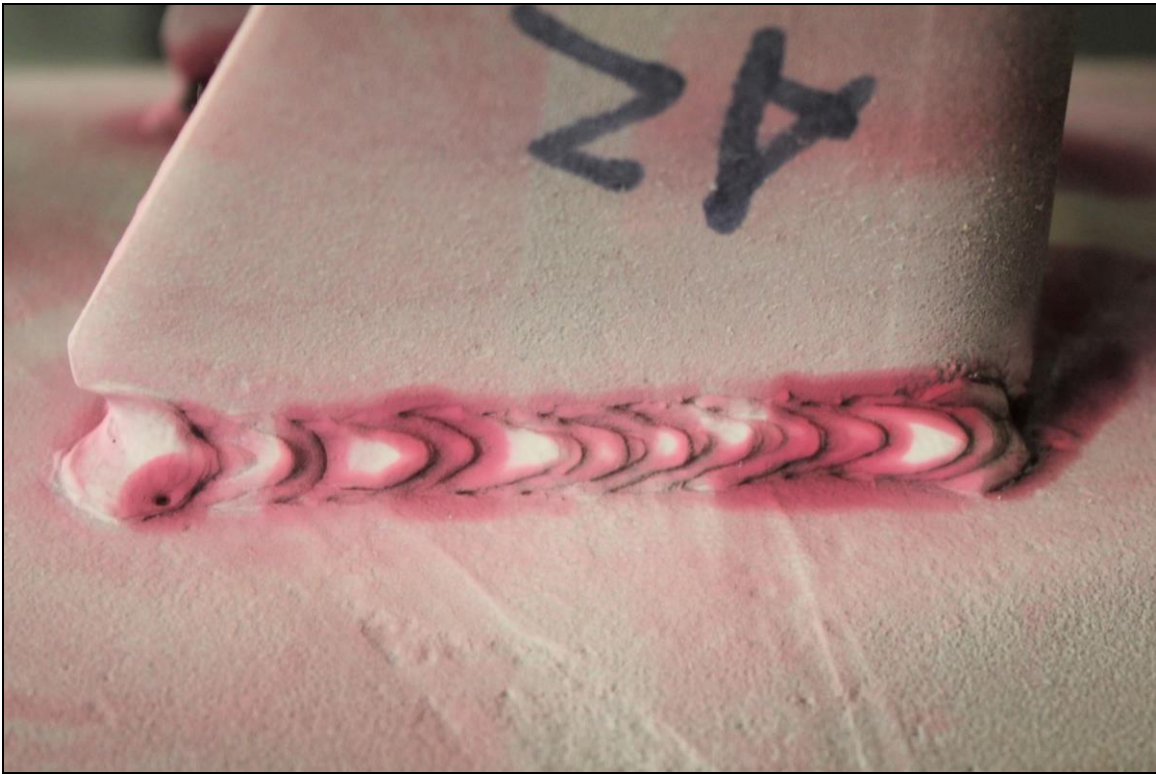
Figure 13. Image of the Lug A4 exterior top weld after dye penetrant media had been used during inspection.

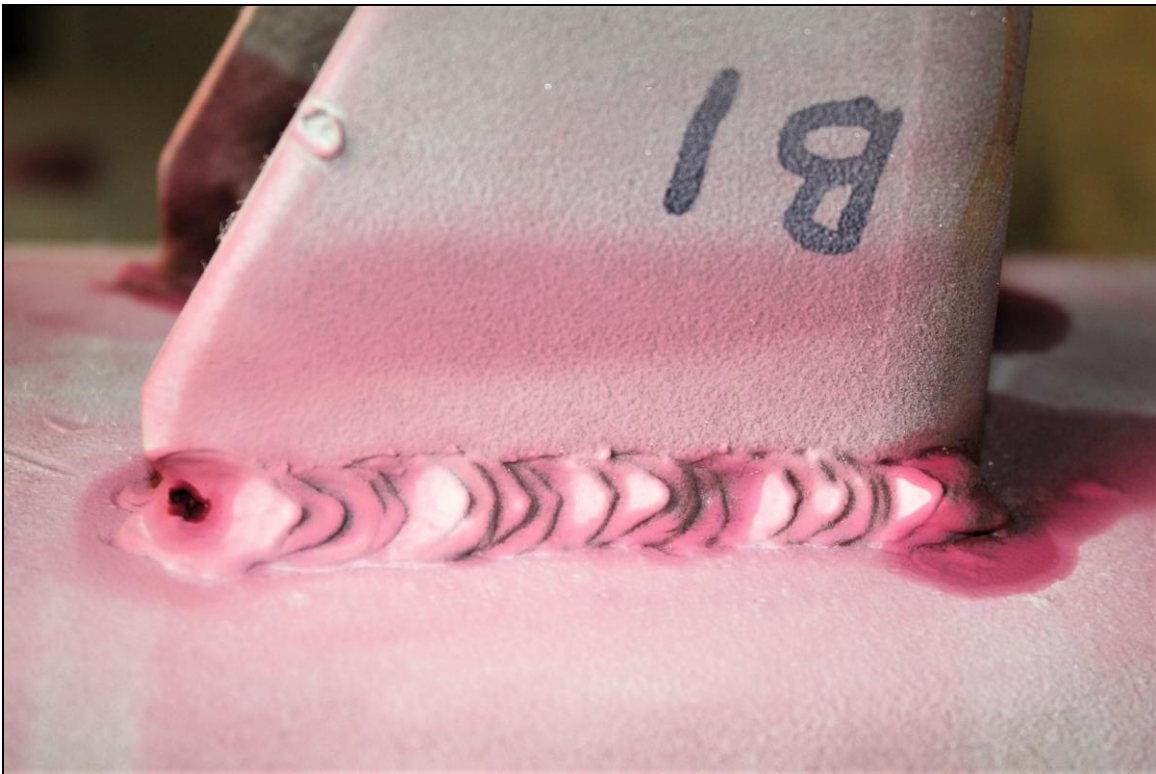
Figure 14. Image of the Lug B1 exterior top weld after dye penetrant media had been used during inspection.
