Louisville Gas and Electric Company
2022 Annual Report
Case No. 2017-00119

In accordance with the Kentucky Public Service Commission's Order of March 16, 2018 in Case No. 2017-00119, Louisville Gas and Electric Company ("LG&E") is submitting the fifth and final annual report for the years 2018– 2022. The annual report provides the completion of the implementation of LG&E's Action Plan and the number of bolted-style coupling systems removed in 2022 from distribution lines having an operating pressure in excess of 60 psig along with observations of the removed couplings. LG&E has completed all requirements of the order.

Distribution Couplings removed from the ground:

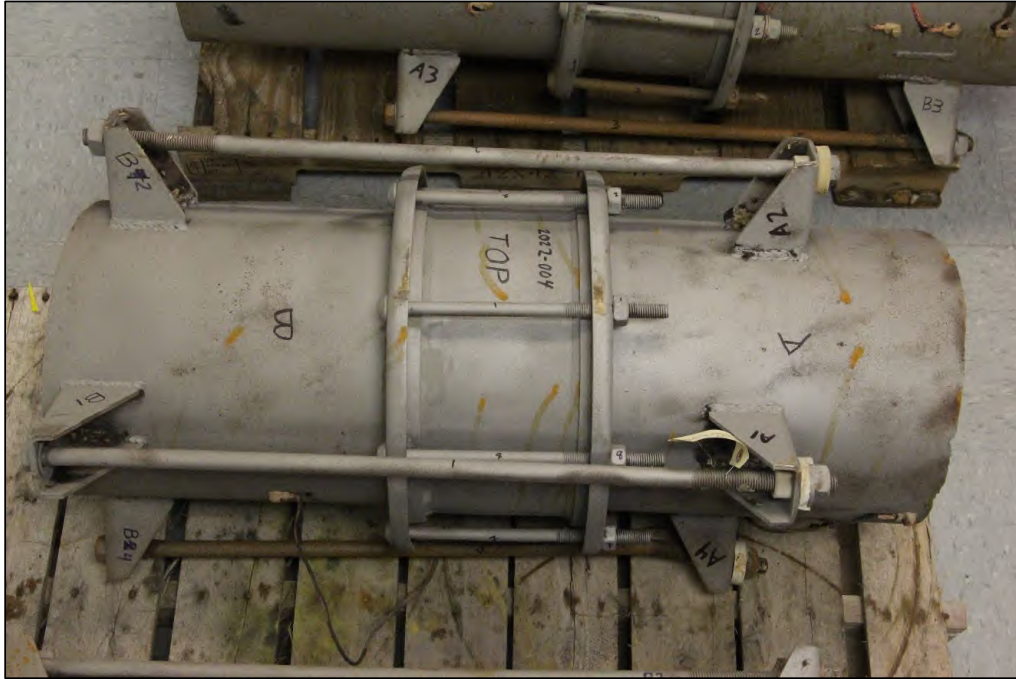
Figure 1. Photograph of the top of the submitted coupling sample.

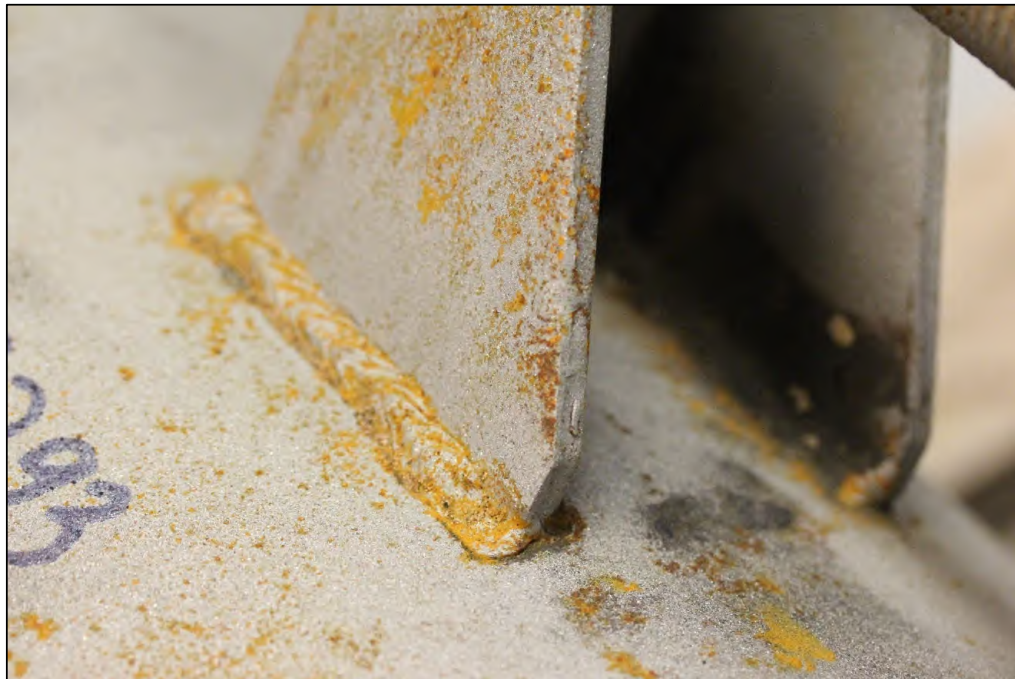
Figure 5. Image of the Lug A1 exterior bottom weld which exhibited substantial fusion except for some undercut, spatter, and arc strikes.

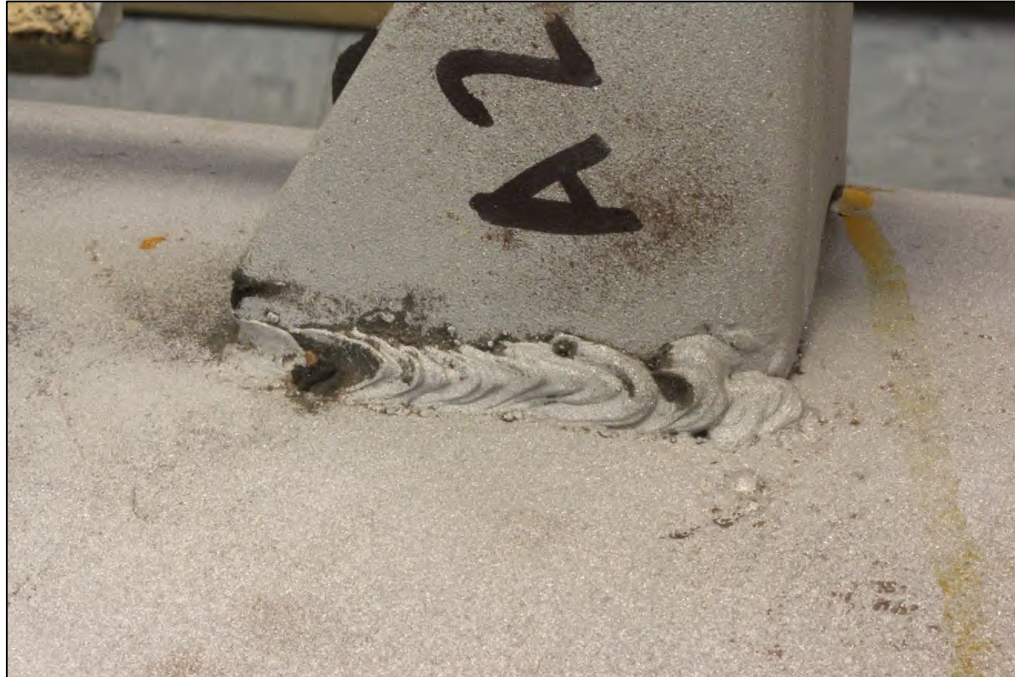
Figure 6. Image of the Lug A2 exterior bottom weld which exhibited substantial fusion except for some undercut, spatter, and arc strikes.

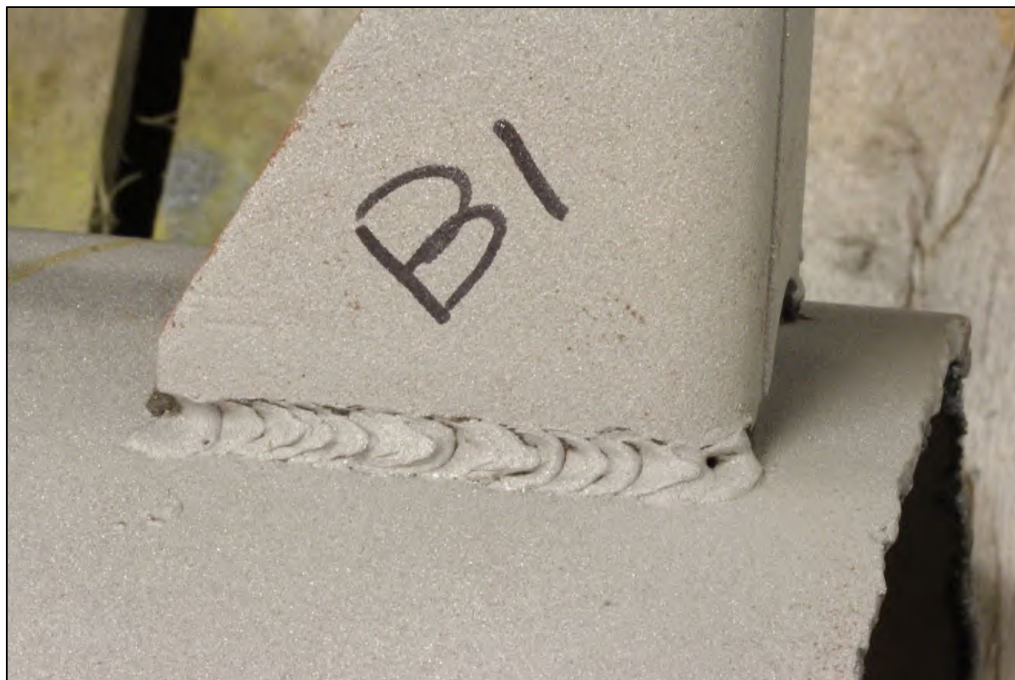
Figure 7. Image of the Lug B1 exterior bottom weld which exhibited substantial fusion except for some undercut and arc strikes.

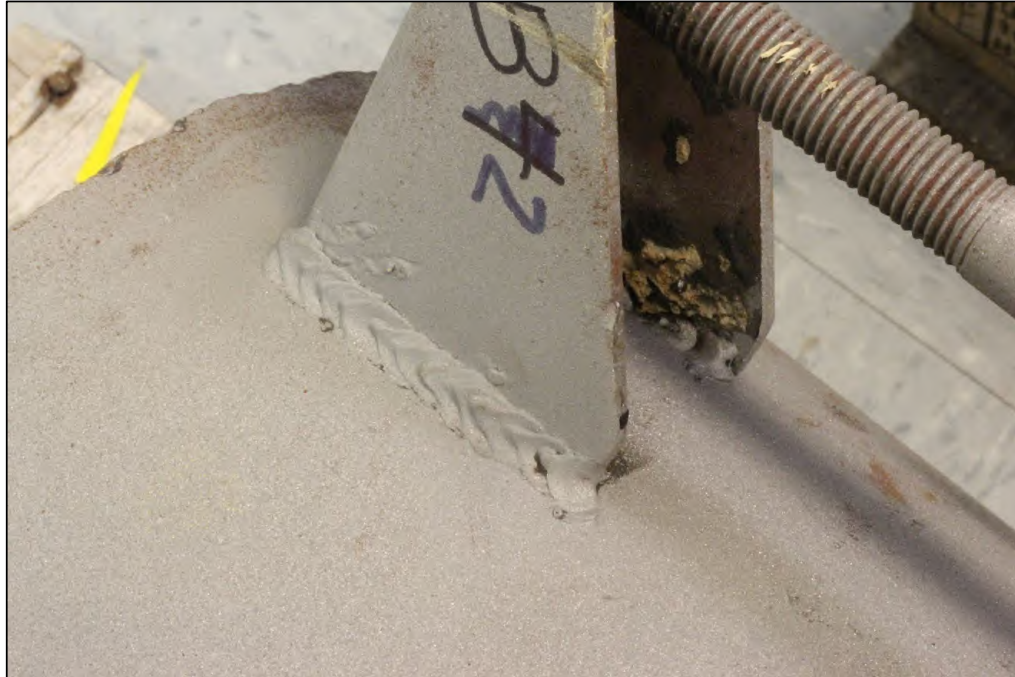
Figure 8. Image of the Lug B2 exterior bottom weld which exhibited substantial fusion except for some undercut, spatter, and arc strikes. A portion of the interior weld was obscured.

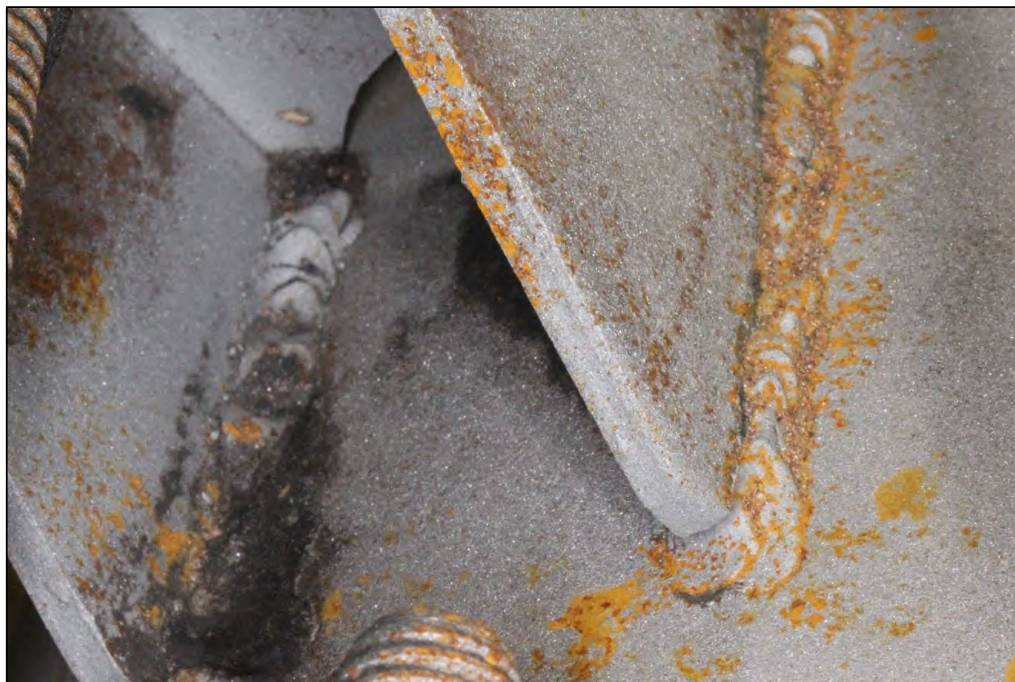
Figure 9. Image of the Lug B4 exterior top weld which was fractured and exhibited substantial fusion except for some undercut, arc strikes, and spatter.

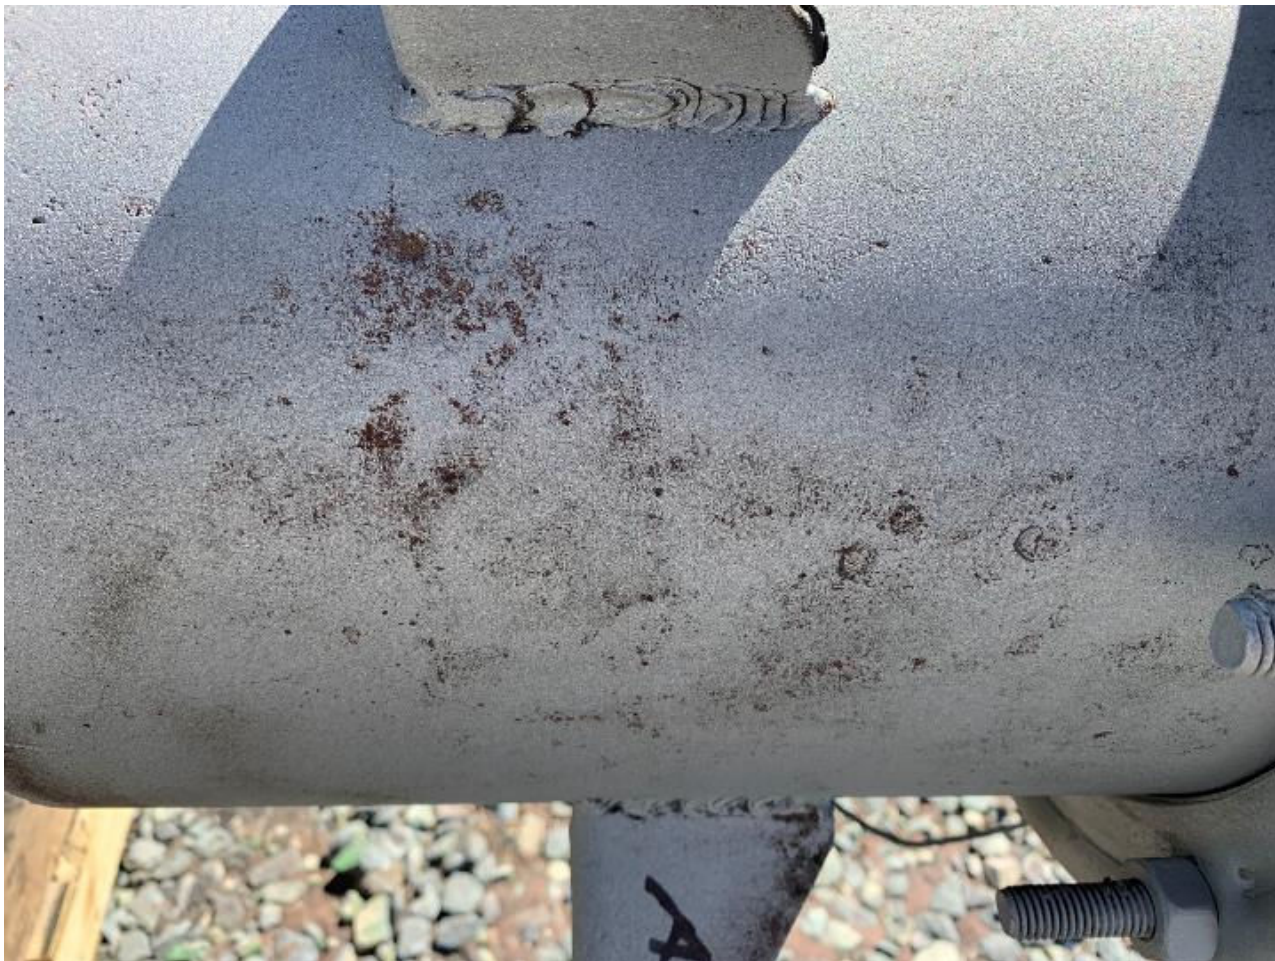
Figure 13 – General Corrosion on Pipe Side A

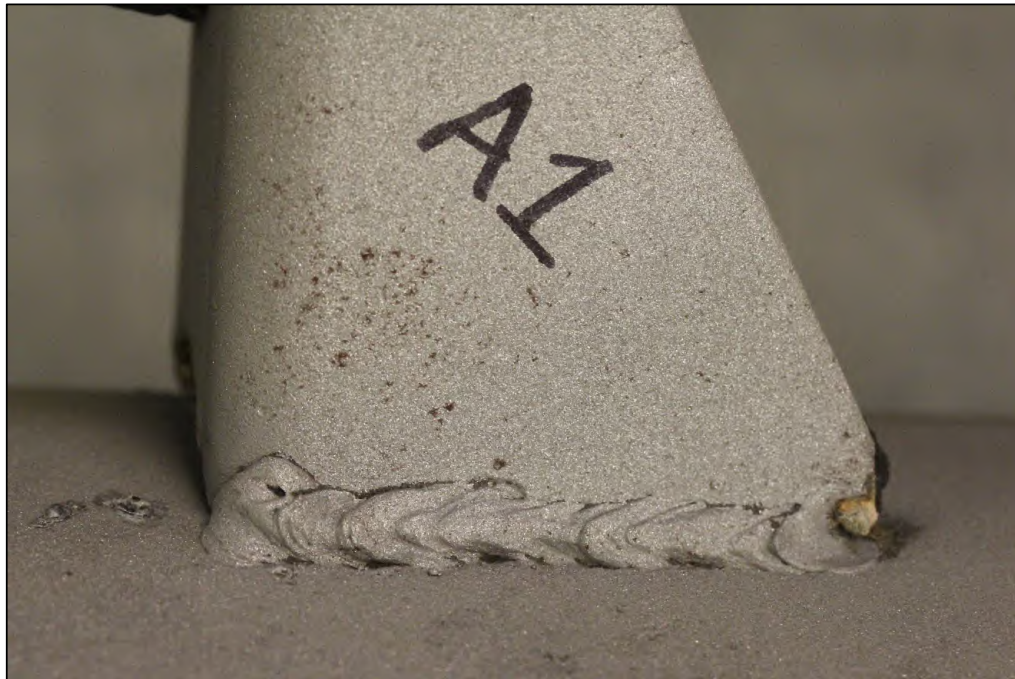
Figure 5. Image of the Lug A1 exterior weld which exhibited substantial fusion except for some undercut, arc strikes, and overlap.

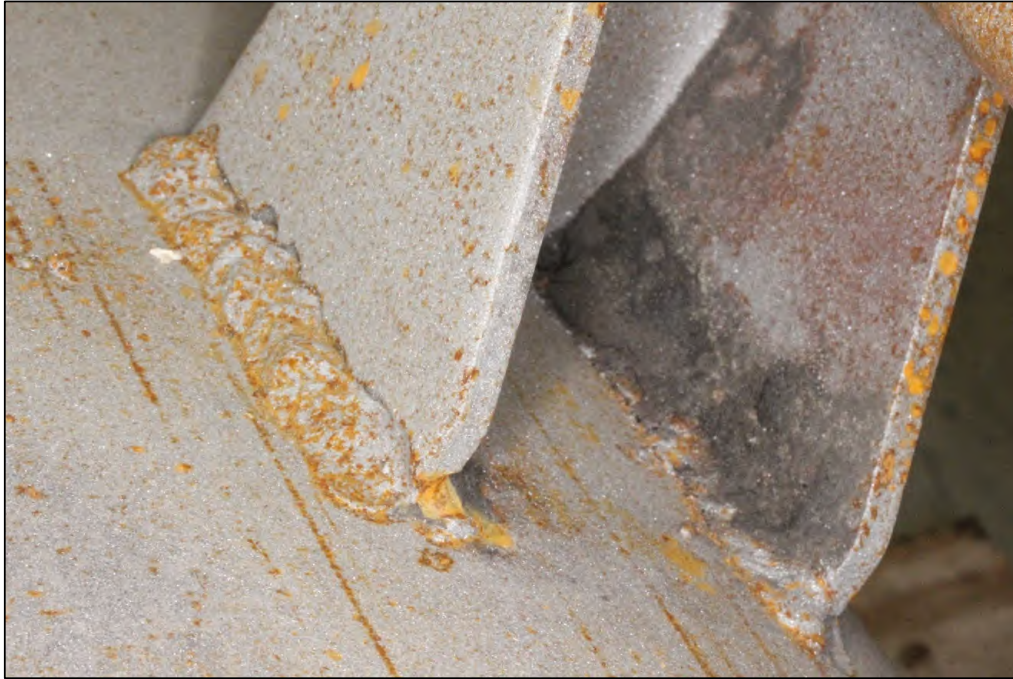
Figure 6. Image of the Lug A3 exterior and interior welds which exhibited overlap, undercut, spatter, and arc strikes.

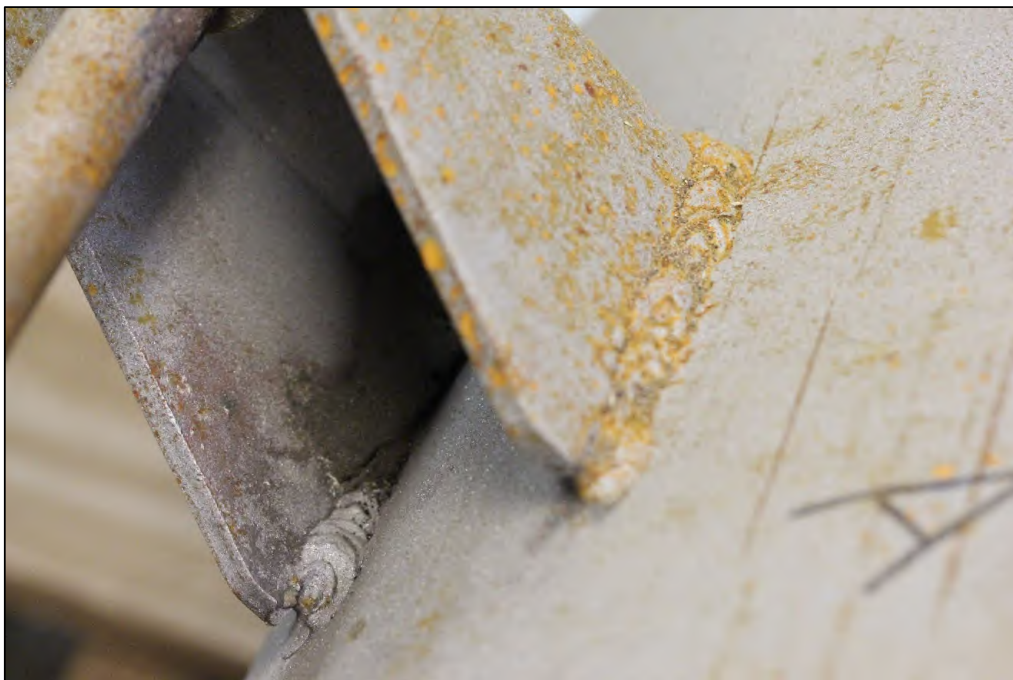
Figure 7. Image of the Lug A4 exterior and interior welds which exhibited general fusions along with undercut, spatter, and overlap.

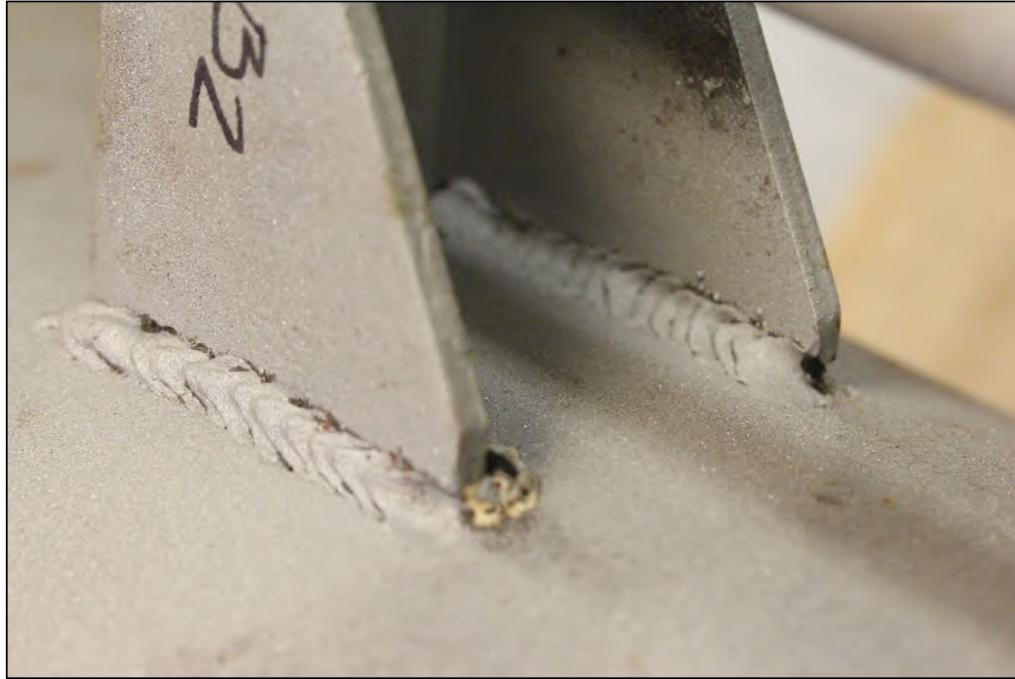
Figure 8. Image of the Lug B2 exterior weld which exhibited substantial fusion except for some undercut, and overlap.

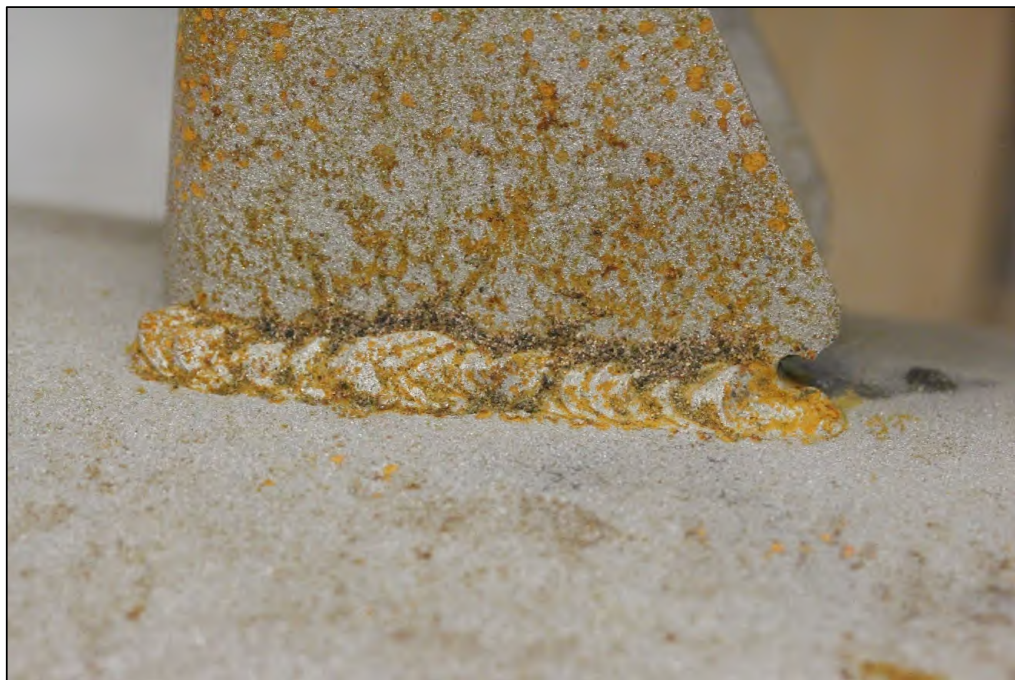
Figure 9. Image of the Lug B4 exterior weld which exhibited substantial fusion except for undercut and arc strikes.

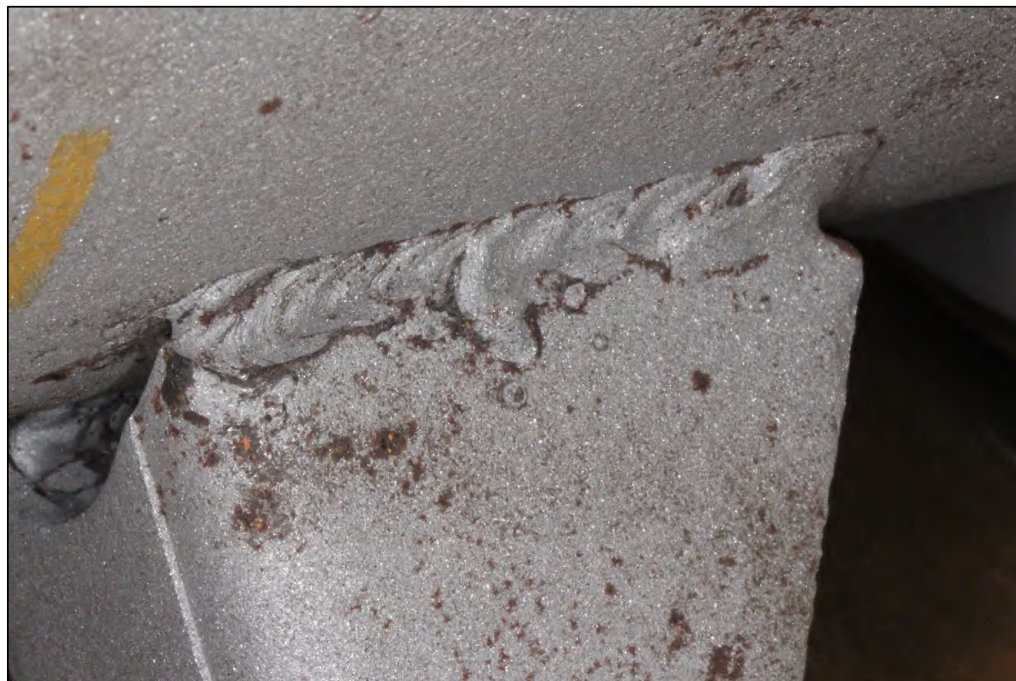
Figure 5. Image of the Lug A1 exterior bottom weld which exhibited substantial fusion except for some undercut, overlap, spatter, and arc strikes.

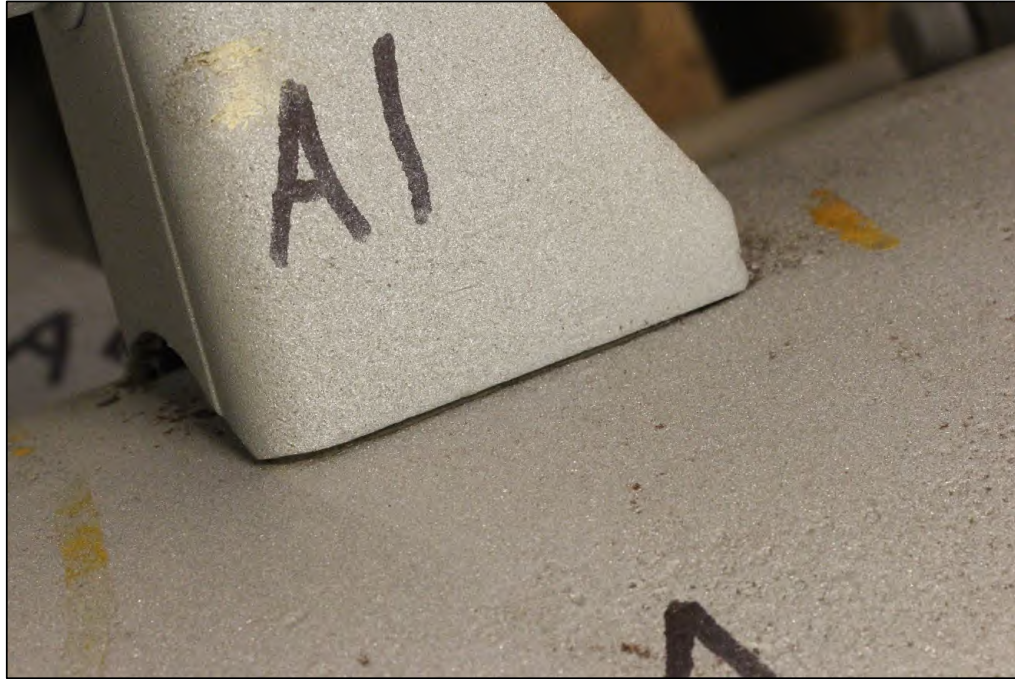
Figure 6. Image of the Lug A1 exterior top weld which was not welded.

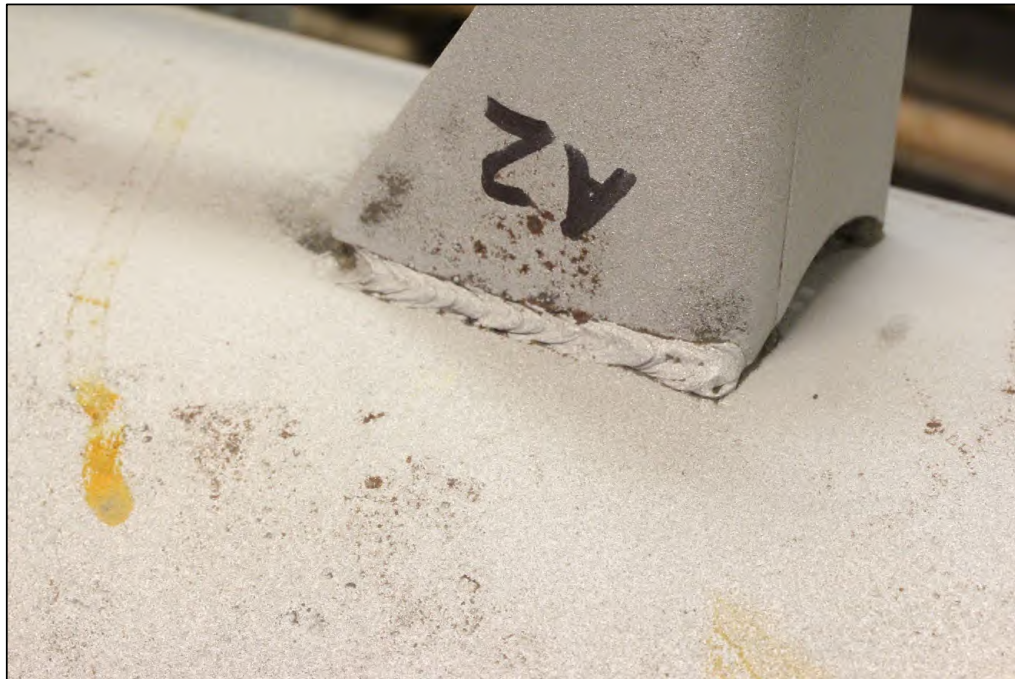
Figure 7. Image of the Lug A2 exterior top weld which exhibited substantial fusion along with undercutting.

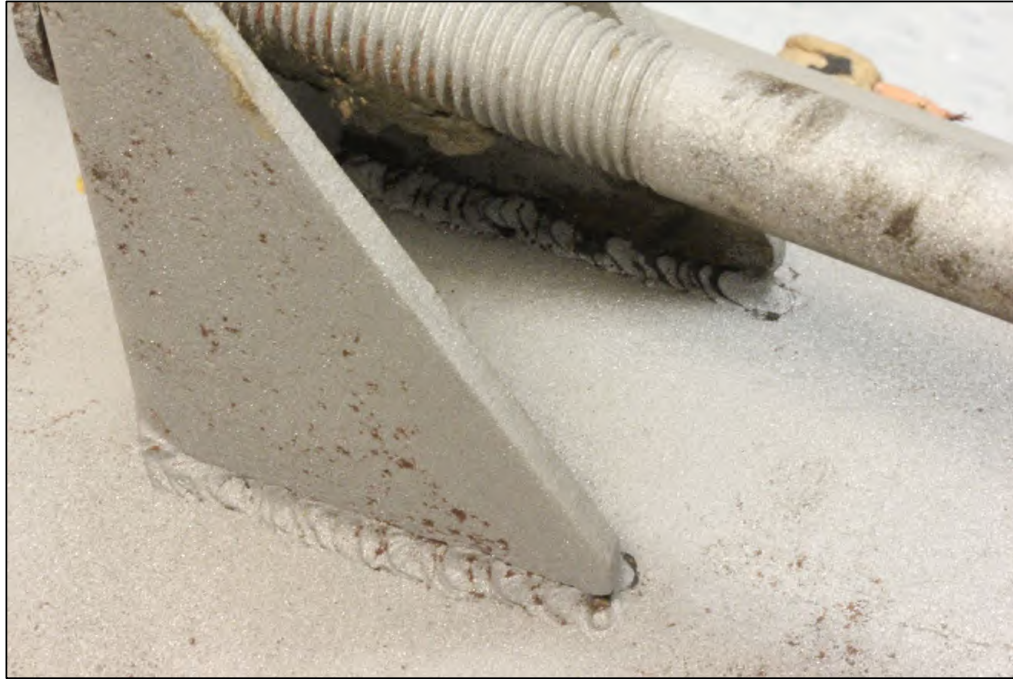
Figure 8. Image of the Lug B2 welds which exhibited substantial fusion along with undercut and overlap.

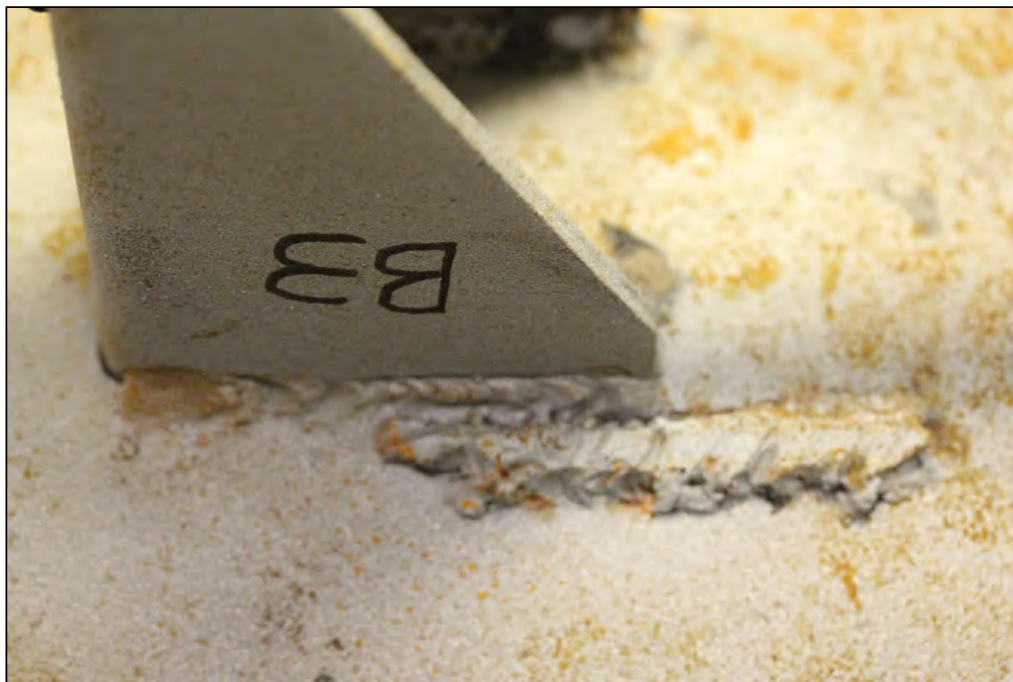
Figure 9. Image of the Lug B3 weld showing the remainder of a weld adjacent to the primary weld.

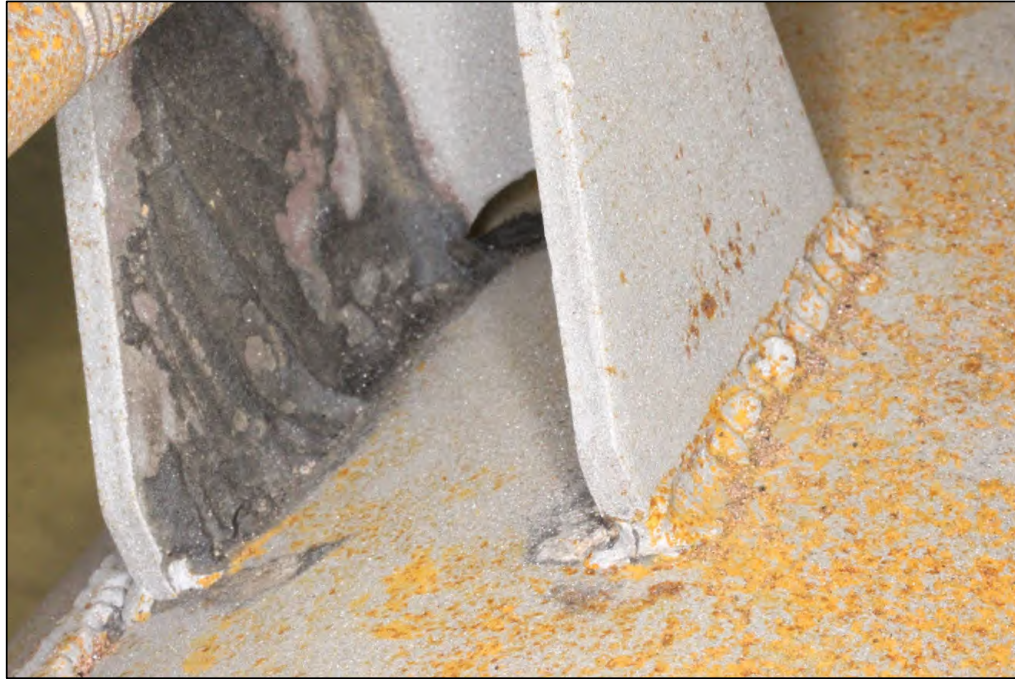
Figure 10. Image of the Lug B3 welds which exhibited substantial fusion except for some undercut, overlap, arc strikes, and spatter. The interior weld to the left was obscured.

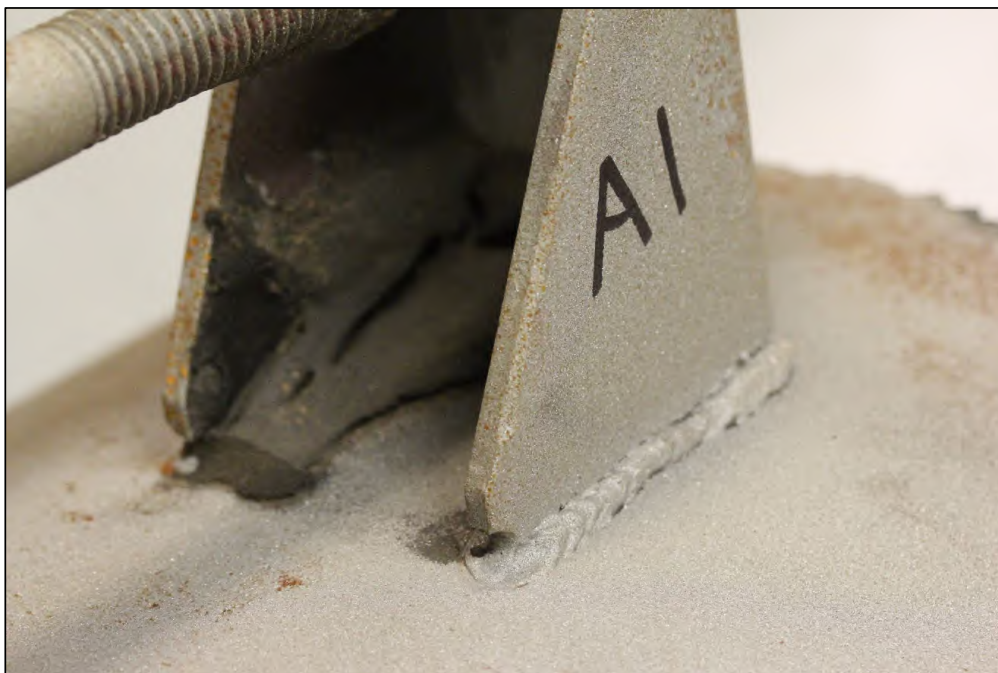
Figure 5. Image of the Lug A1 welds showing undercut. The interior weld shown was obscured by deposits.

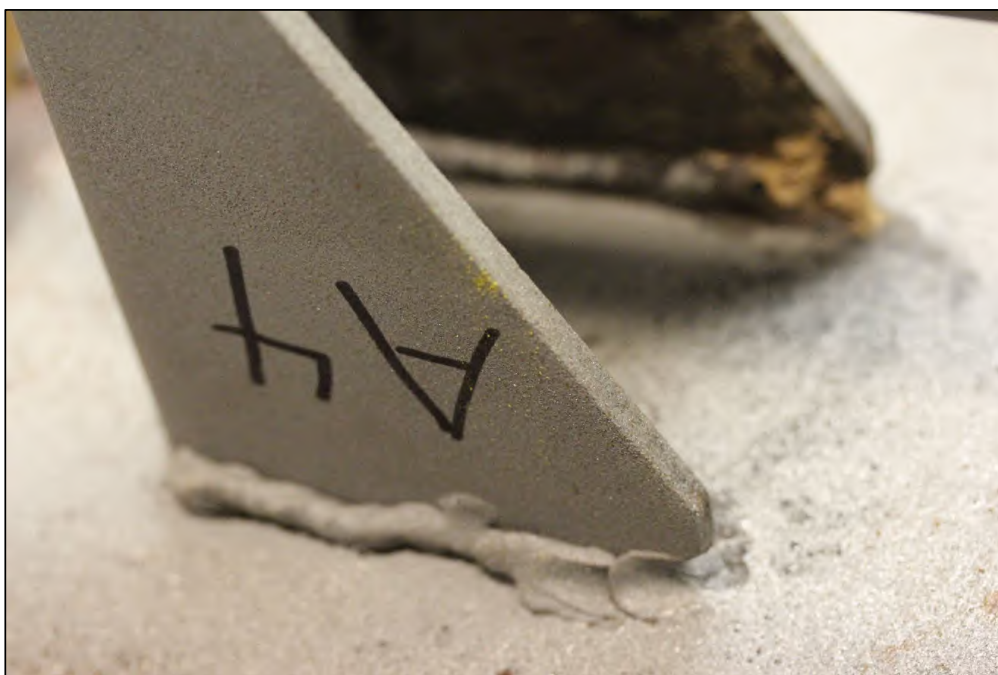
Figure 6. Image of the Lug A4 exterior bottom weld which exhibited substantial fusion except for some overlap and undercut.

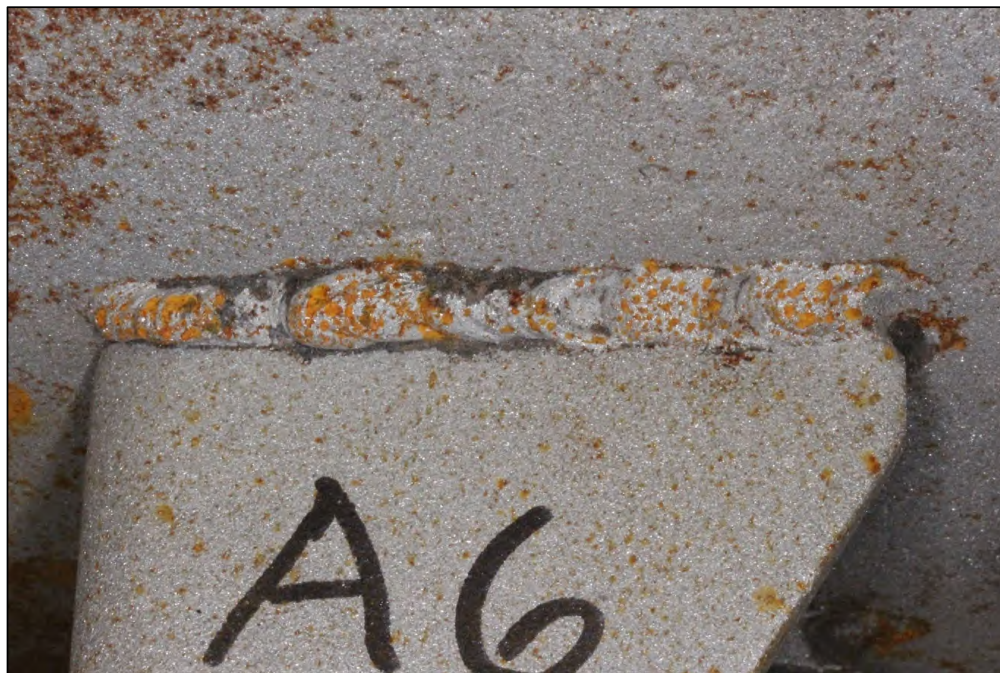
Figure 7. Image of the Lug A6 exterior bottom weld which exhibited substantial fusion except for some undercut regions.

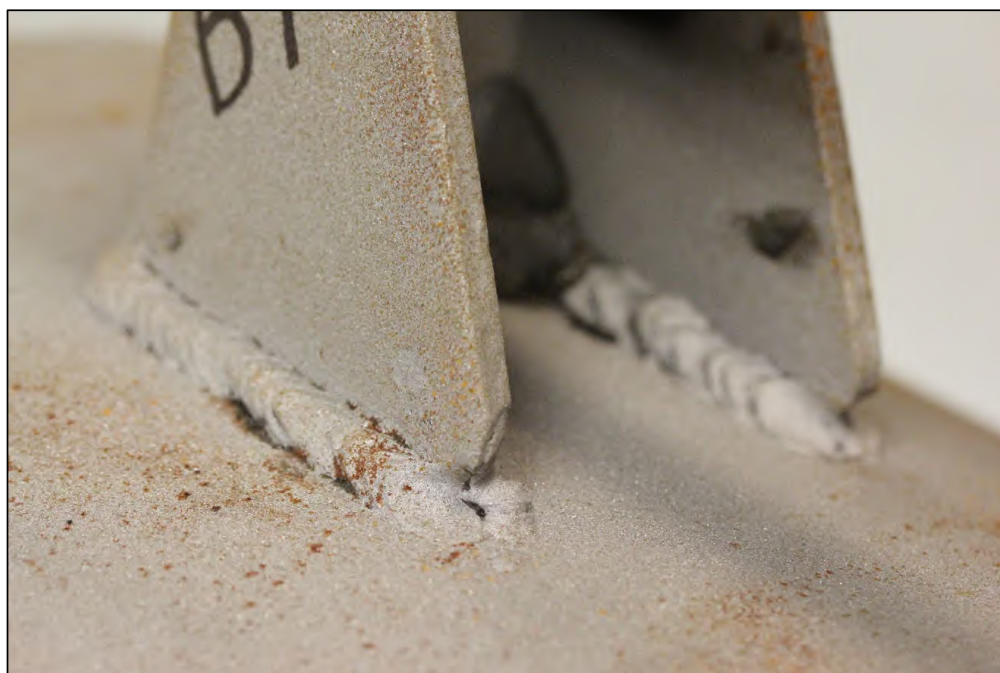
Figure 8. Image of the Lug B1 welds showing good fusion with some undercut and overlap.

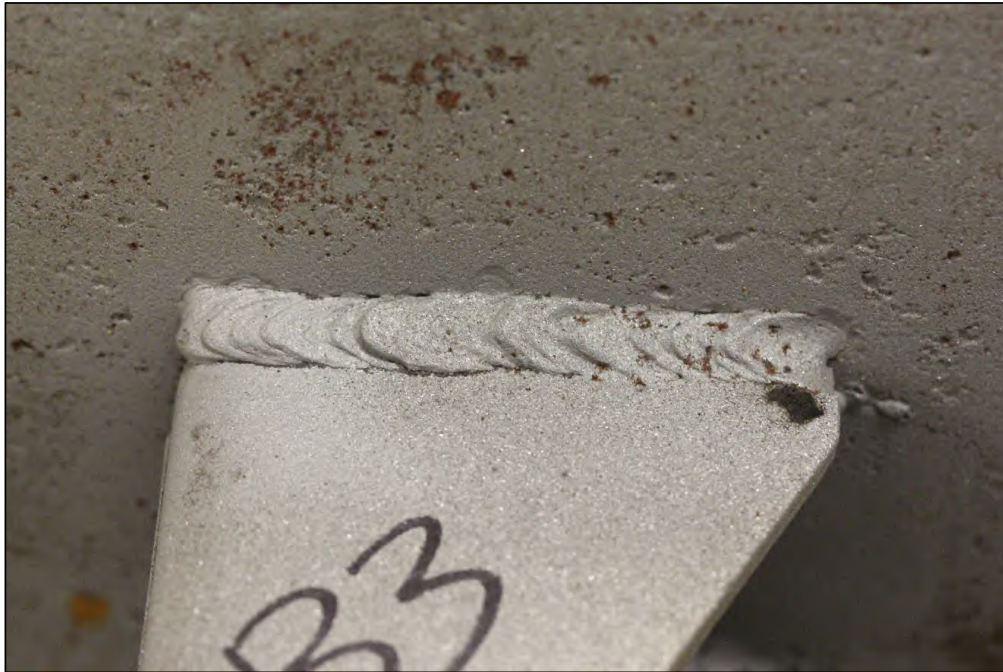
Figure 9. Image of the Lug B3 weld which exhibited substantial fusion except for some undercut and spatter.

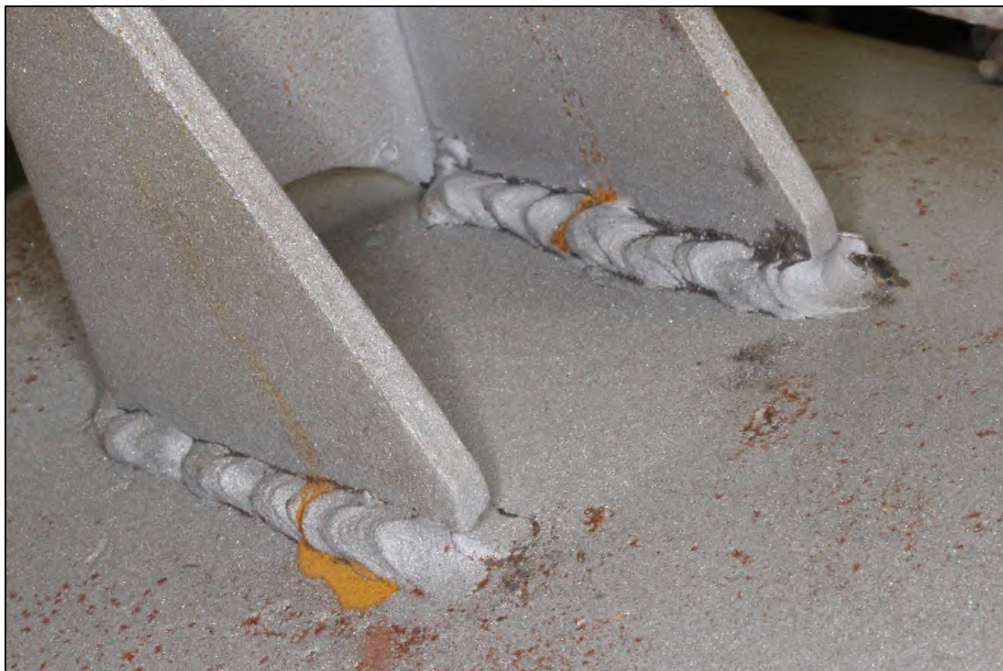
Figure 10. Image of the Lug B5 exterior bottom weld which exhibited substantial fusion except for some undercut and overlap.

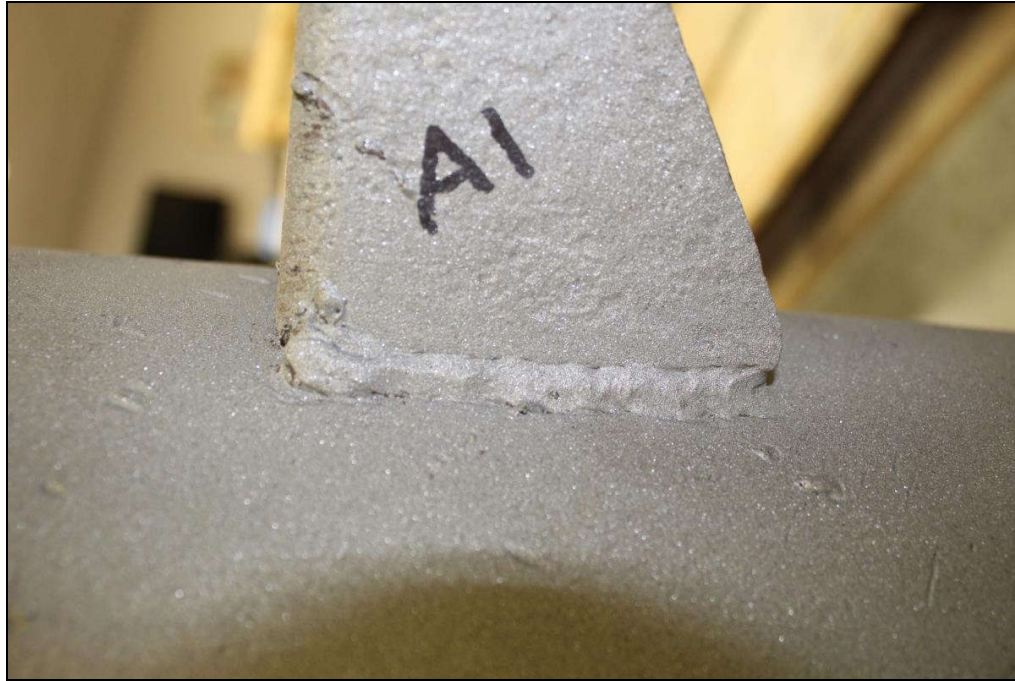
Figure 5. Image of the Lug A1 exterior top weld which exhibited substantial fusion except for some undercut, spatter, and arc strikes.

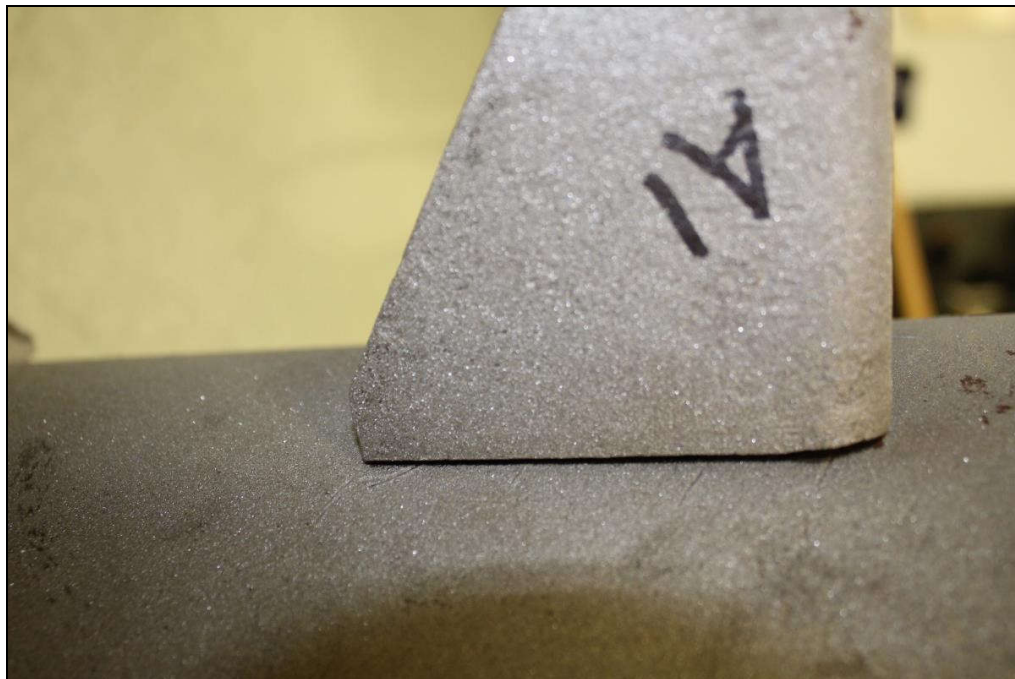
Figure 6. Image of the Lug A1 exterior bottom weld which exhibited no fusion.

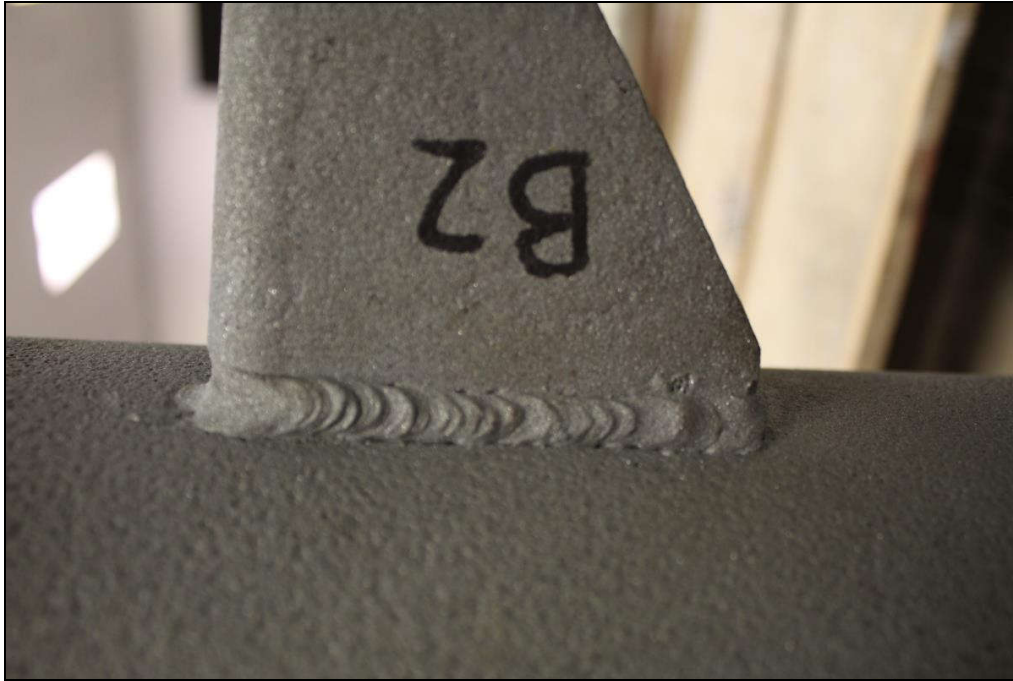
Figure 7. Image of the Lug B2 exterior top weld which exhibited substantial fusion except for some undercut and arc strikes.

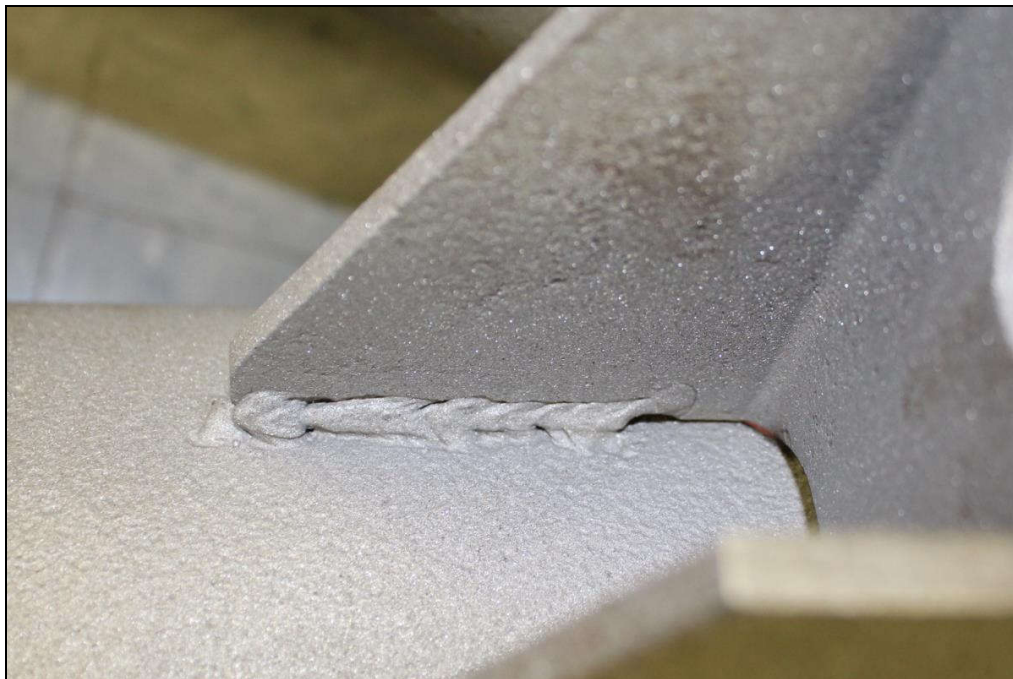
Figure 8. Image of the Lug B1 interior bottom weld which exhibited substantial fusion except for some undercut and arc strikes.
