**ELECTRONIC INVESTIGATION            )  
INTO EXCESSIVE WATER LOSS BY        )  
KENTUCKY'S JURISDICTIONAL            ) CASE NO. 2019-00041  
WATER UTILITIES                         )**

**RESPONSE OF  
FARMDALE WATER DISTRICT  
TO  
COMMISSION'S SECOND REQUEST FOR INFORMATION  
DATED MAY 3, 2019**

**Farmdale Water District  
100 Highwood Drive  
Frankfort, KY 40601  
RE: Frankfort, KY  
223,000 Gallon STP  
March 22, 2018  
Mr. David Robinson  
Water Superintendent  
(502) 223-3562  
Job No. 318079**

## STANDPIPE INSPECTION REPORT

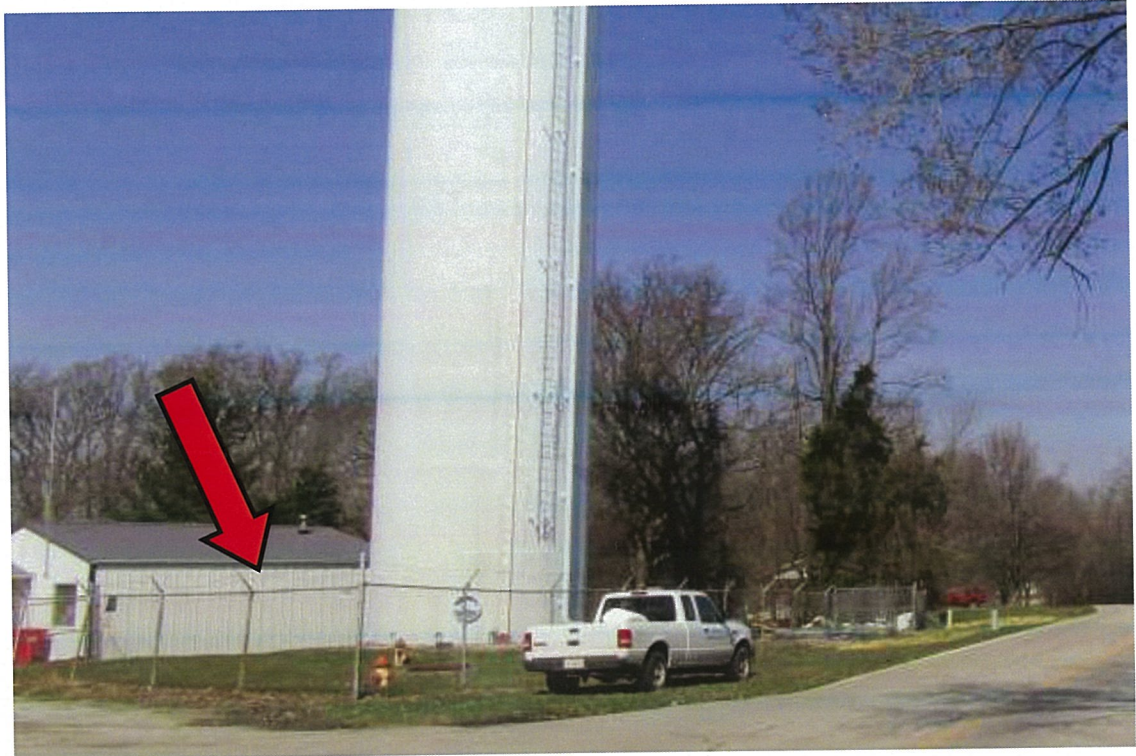
Photo shows the tank is secured with fencing. There is no signage on the fence. We recommend posting a **Warning, Tampering With This Facility is a Federal Offense** (US code title 42, section 300i-1) sign and a **No Trespassing** sign.

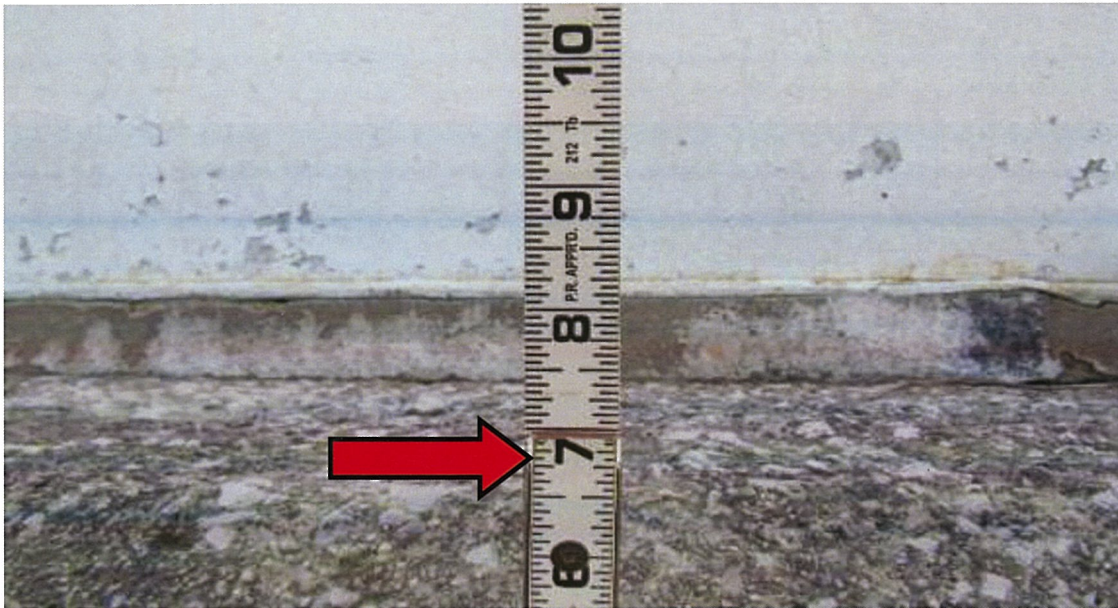
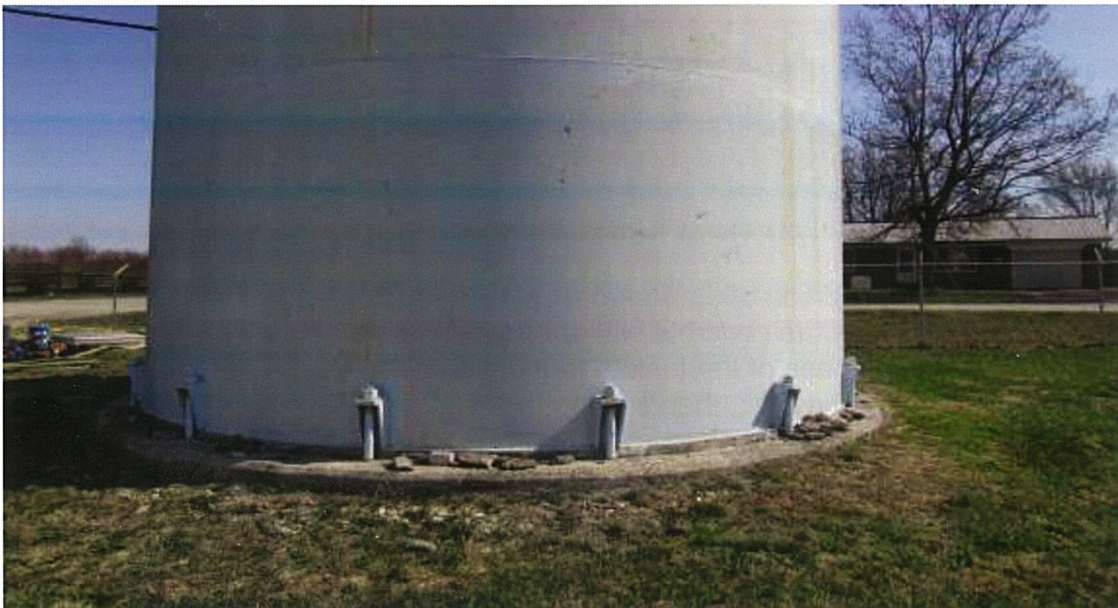
Photos show the area around the tank foundation is properly graded and in compliance with **AWWA D100-11; 12.7.1: Height aboveground.**

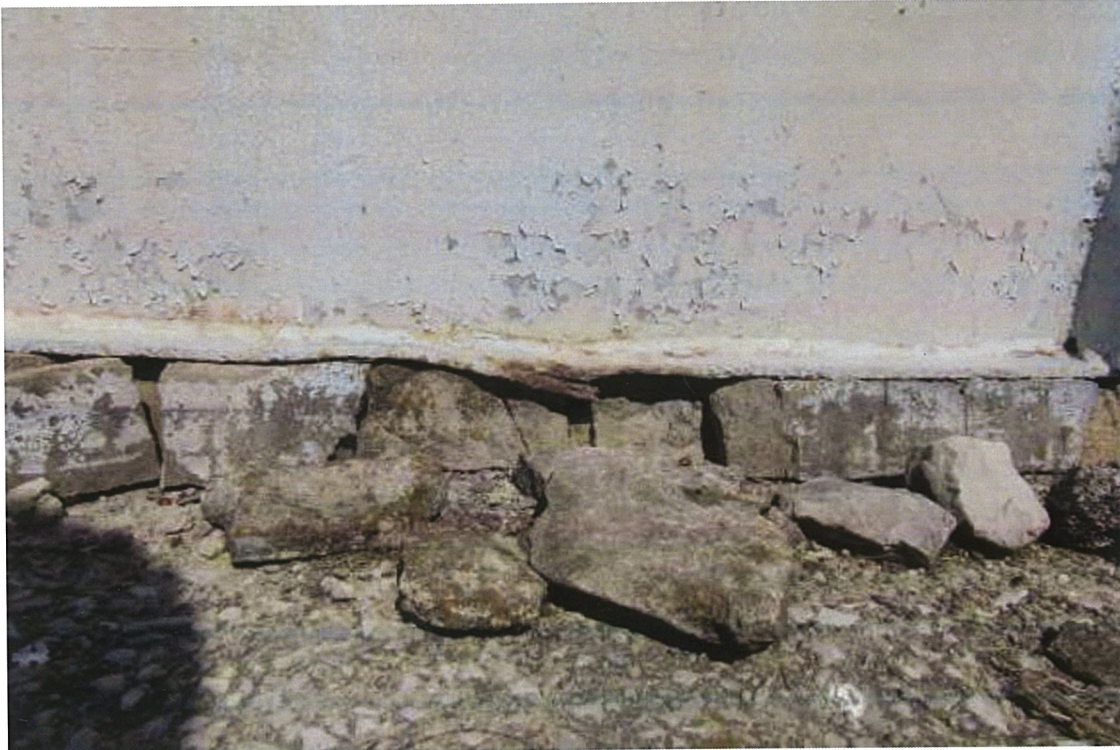
Photo shows the condition of the foundation. We recommend repairing any cracks and spalling in the concrete with a commercial non-shrinking grout, re-grouting around the base of the tank to foundation connection to prevent water from entering under the tank, then sealing the foundation with a sealant.

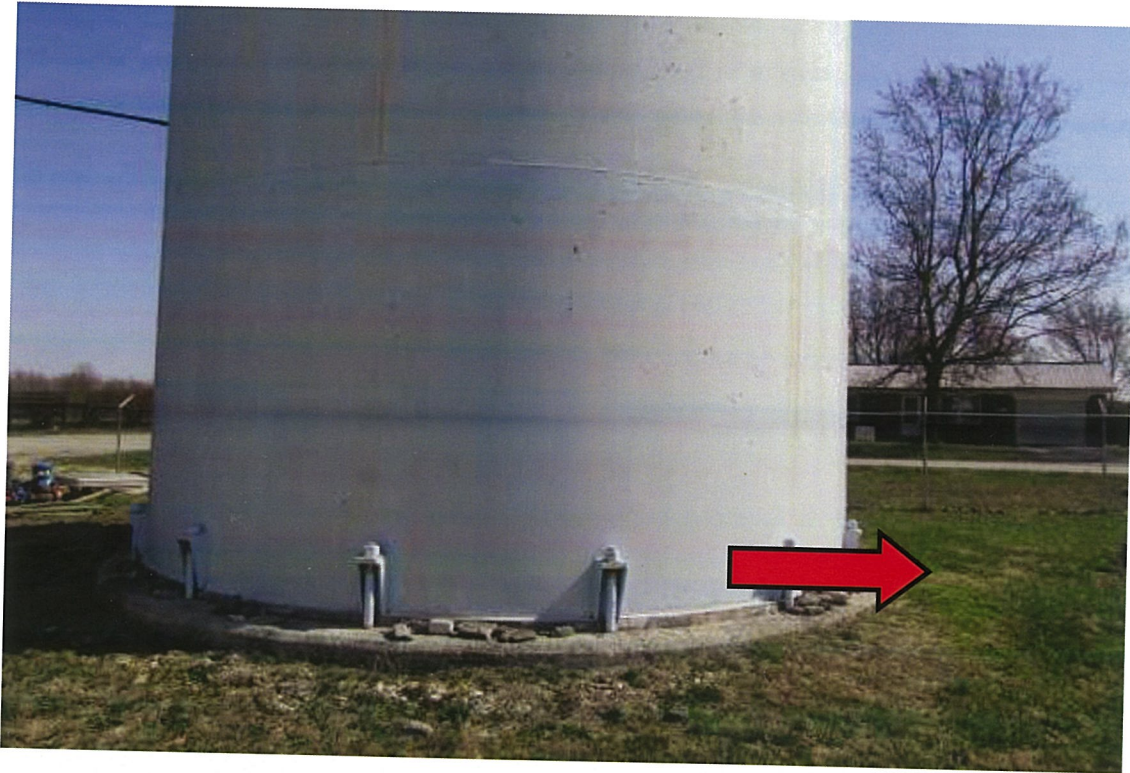
Photo shows the tank foundation. We recommend electrically grounding the tank for lightning protection as required by **OSH Act of 1970 Section 5**.

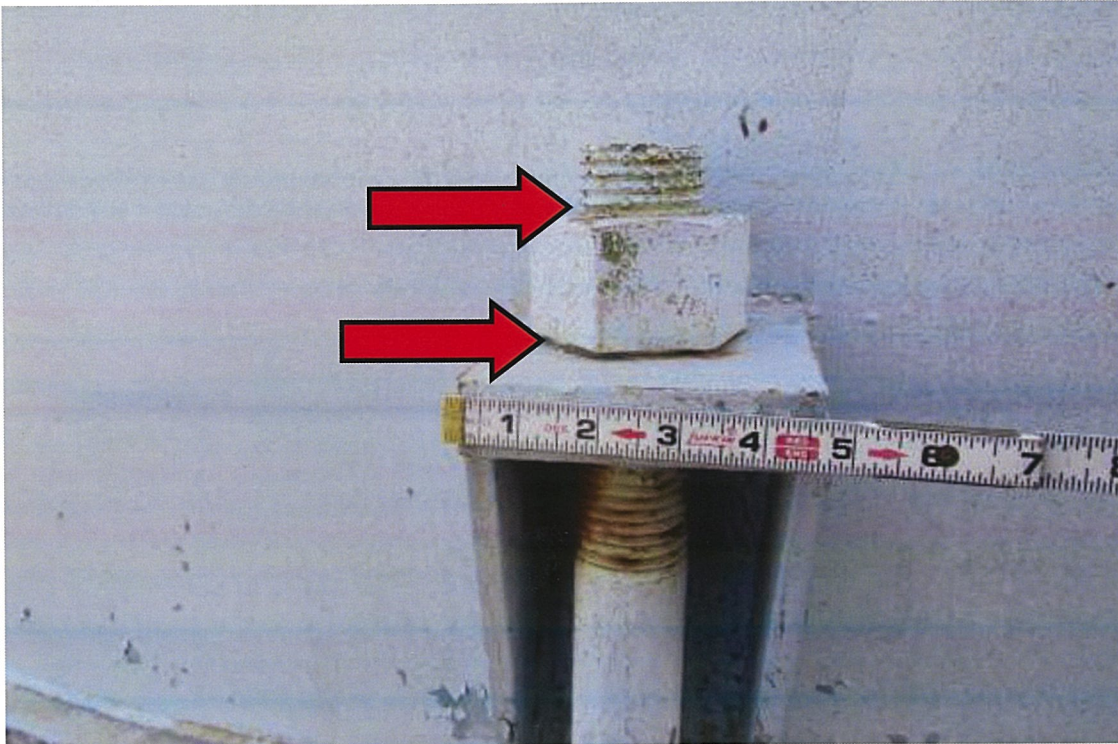
Photo shows the condition of one (1) of the sixteen (16) anchor bolts. **AWWA D100-11; 3.8.1.1: Required anchorage** states, "For ground-supported flat-bottom reservoirs and standpipes, mechanical anchorage shall be provided when the wind or seismic loads exceed the limits for self-anchored tanks." We recommend cleaning the area around the anchor bolts, tightening the anchor nuts to specifications, then tack welding the circumference of the nut-to-base plate connections and tack welding the bolt-to-nut connections for preventive maintenance.

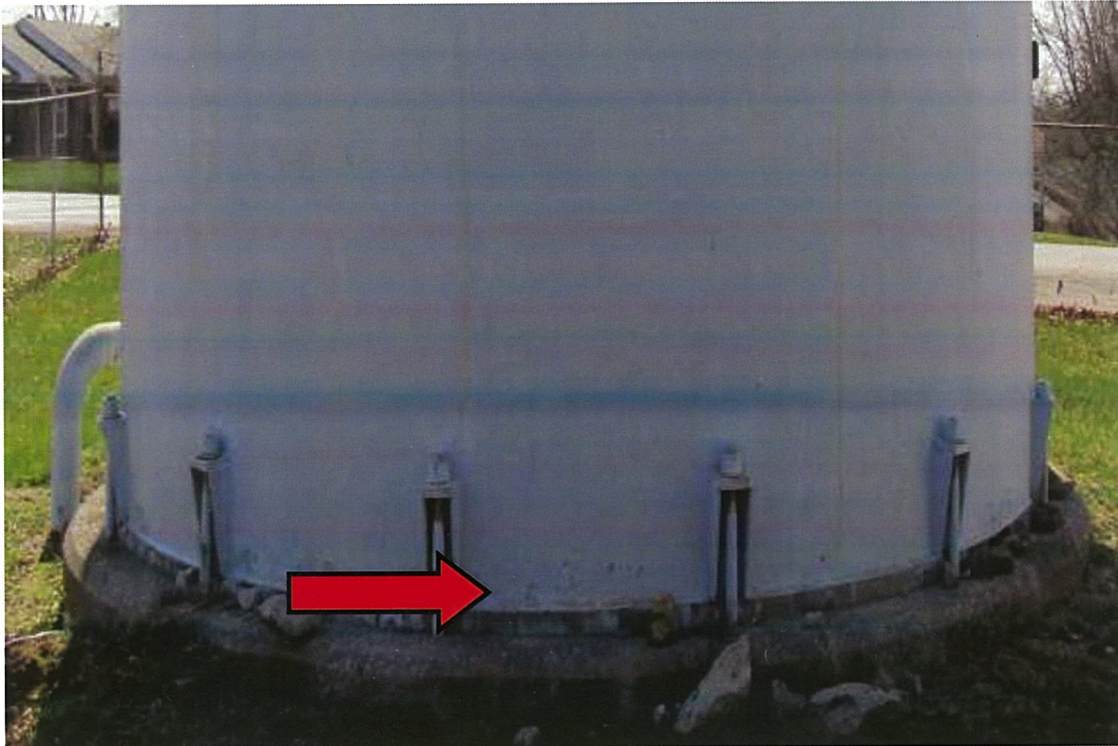
Photo shows the condition of the shell. Currently there is no drain valve. We recommend installing a frost proof drain valve near the shell-to-floor connection, complete with a locking device to prevent unauthorized draining of the tank and a splash pad to direct water away from the foundation.

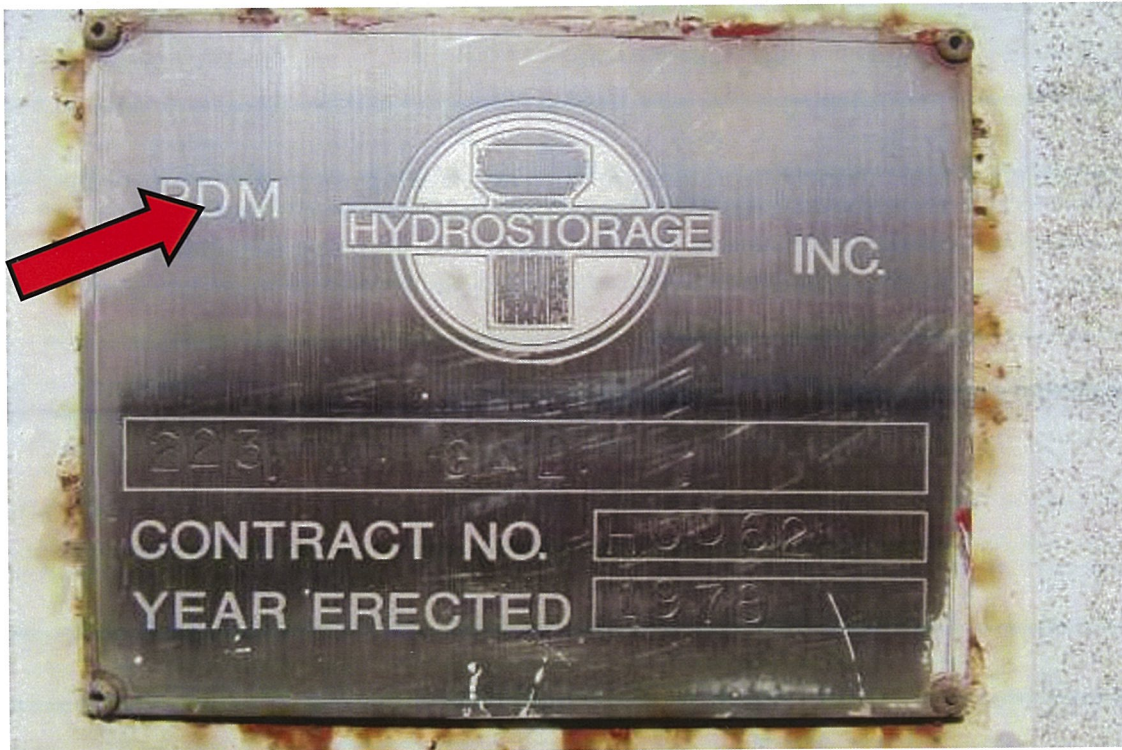
Photo shows the tank nameplate, which appears to be in good condition.

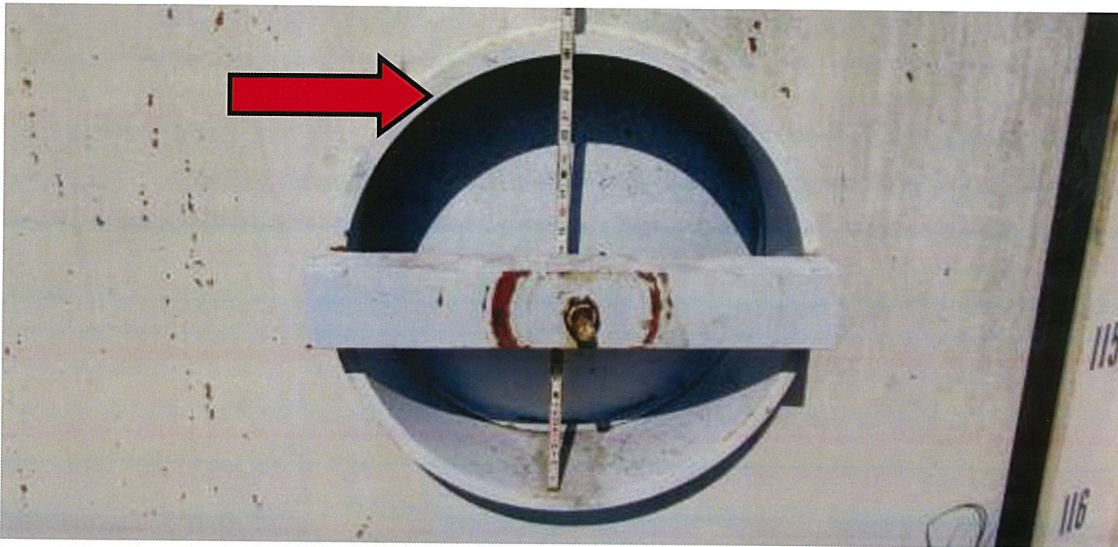
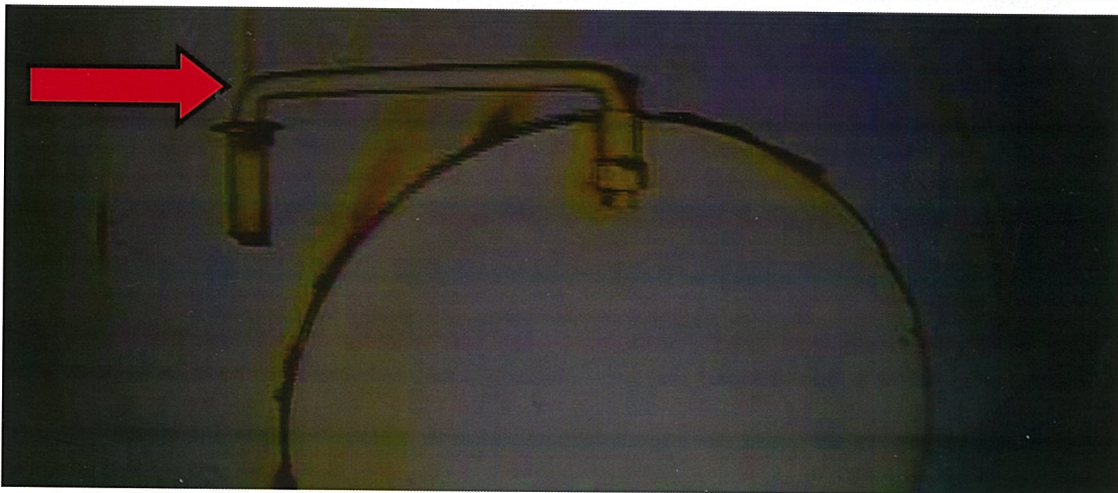
Photos show the condition of the existing 24" shell manway. Notice the interior davit arm. **AWWA D100-11; 7.4.4: Shell manholes** states, "Two shell manholes shall be provided in the first ring of the tank shell. If any access cover weighs more than 50 lbs. (22.7 kg), a hinge or davit shall be provided. At least one manhole shall be circular with a minimum diameter of 30" (760 mm)." The following is required for the tank to be in compliance with **AWWA D100-11; 7.4.4: Shell manholes** and **OSHA 1910.146(c)(2) Confined spaces**.

- Install 30" secondary shell manway 180° from primary manway
- Post **Confined Space Entry** signs
- Install maintenance free galvanized steel bolts

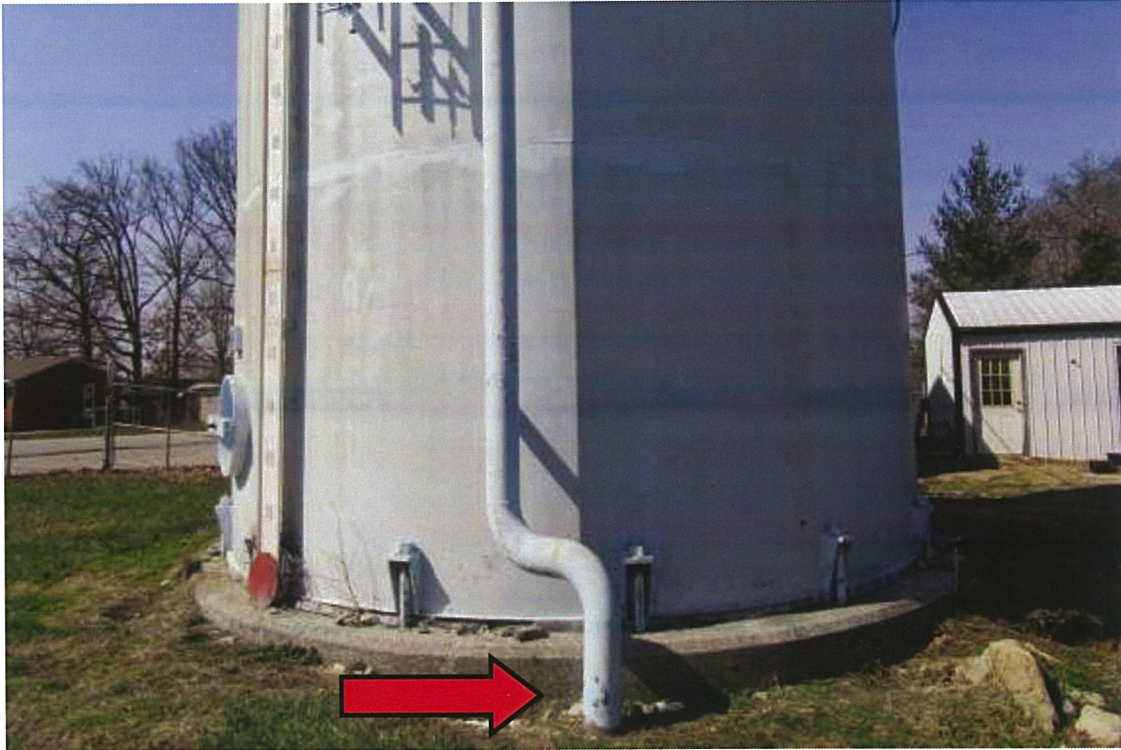
Photo shows the condition of the 6" overflow pipe system. We recommend disconnecting the pipe from the underground drain then installing an air break complete with a flapper valve and screen to prevent the ingress of contaminants into the water supply.

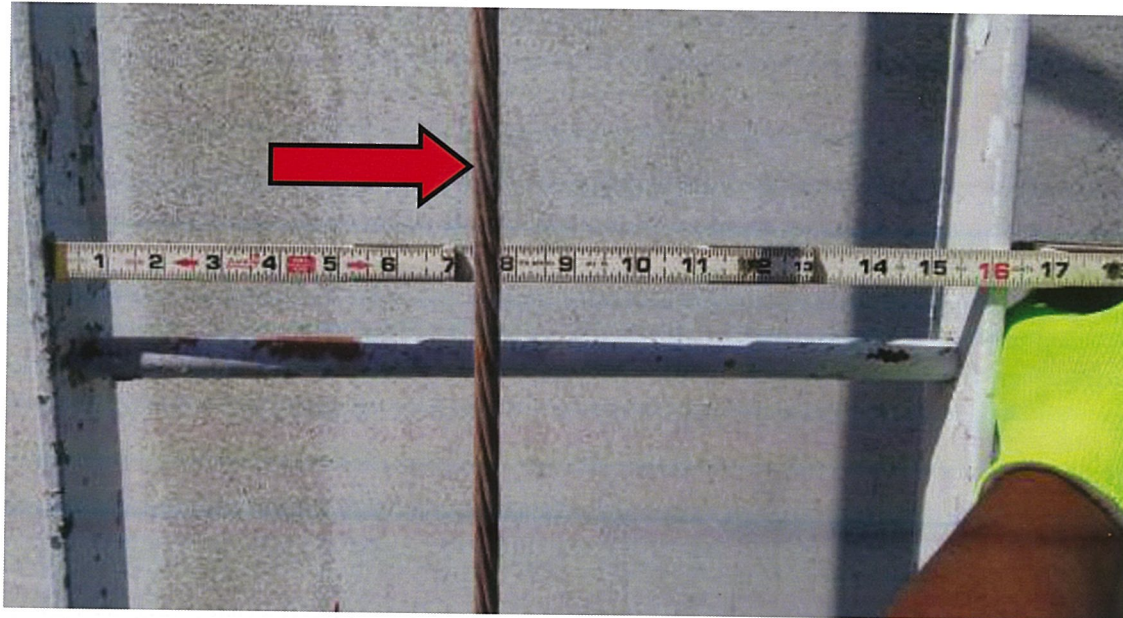
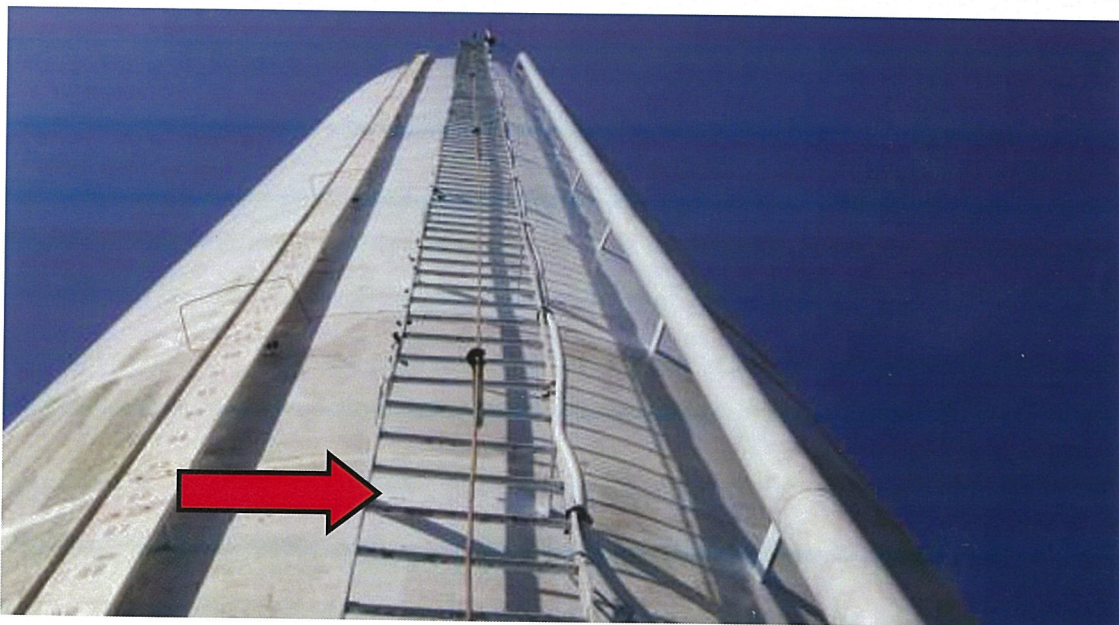
Shell access ladder in above photos is 16" wide, but is not equipped with anti-skid rungs. Notice the rusted ladder safety device. We recommend installing anti-skid rung covers, a lockable ladder guard to prevent unauthorized access, a new cable type ladder safety device, and posting a **Fall Protection Required** sign at the base of the ladder.

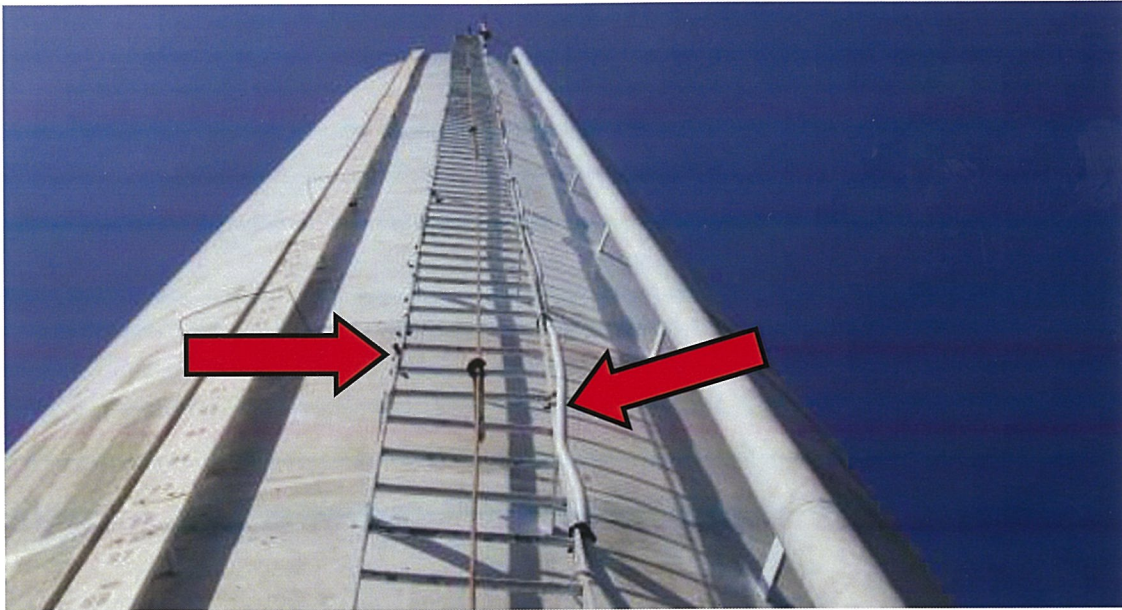
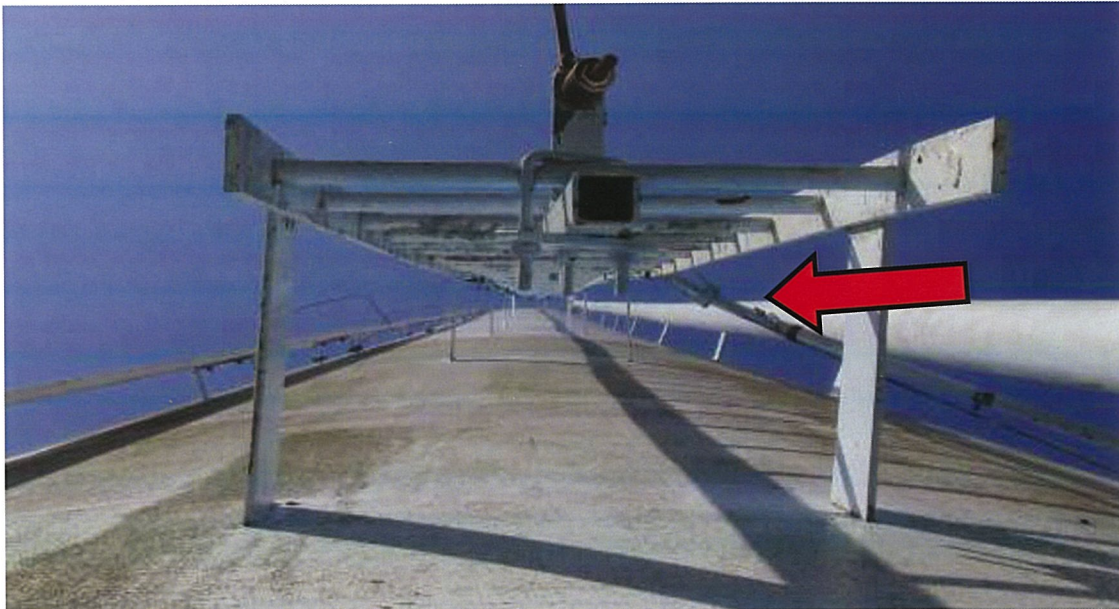
Photos show more of the condition of the existing shell access ladder. Safe climbing procedure requires a person to climb a ladder with their hands on the side rails of the ladder and not the ladder rungs. **Notice a co/ax is mounted on the ladder side rail, creating a climbing safety hazard.** We recommend removing the co/ax from the ladder, and securing it with standoffs to the tank shell to eliminate this climbing safety hazard.

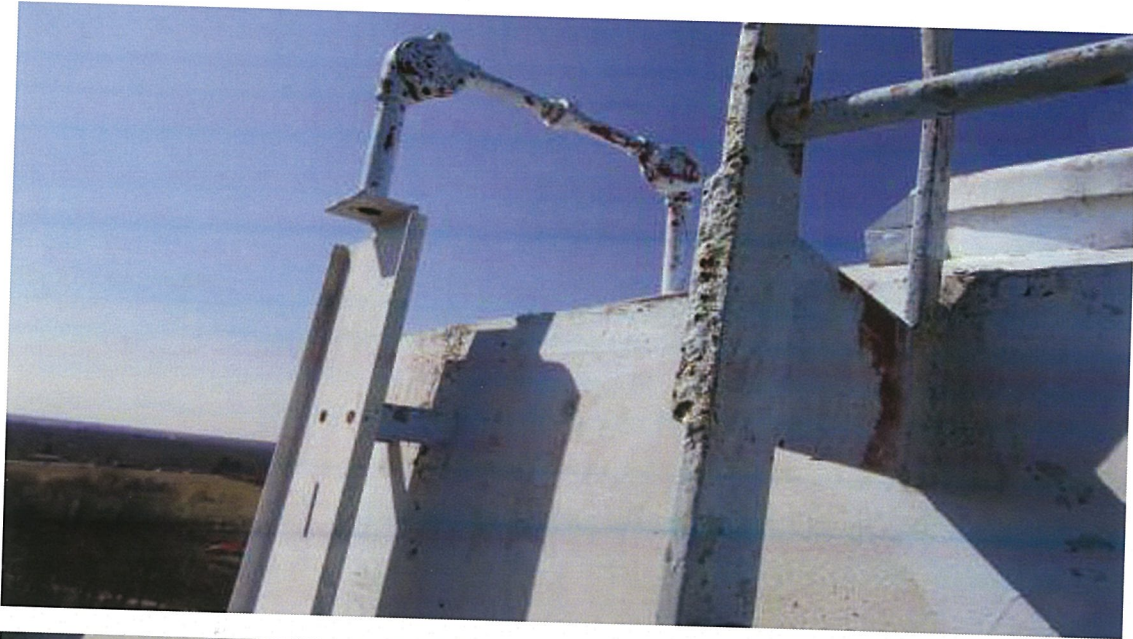
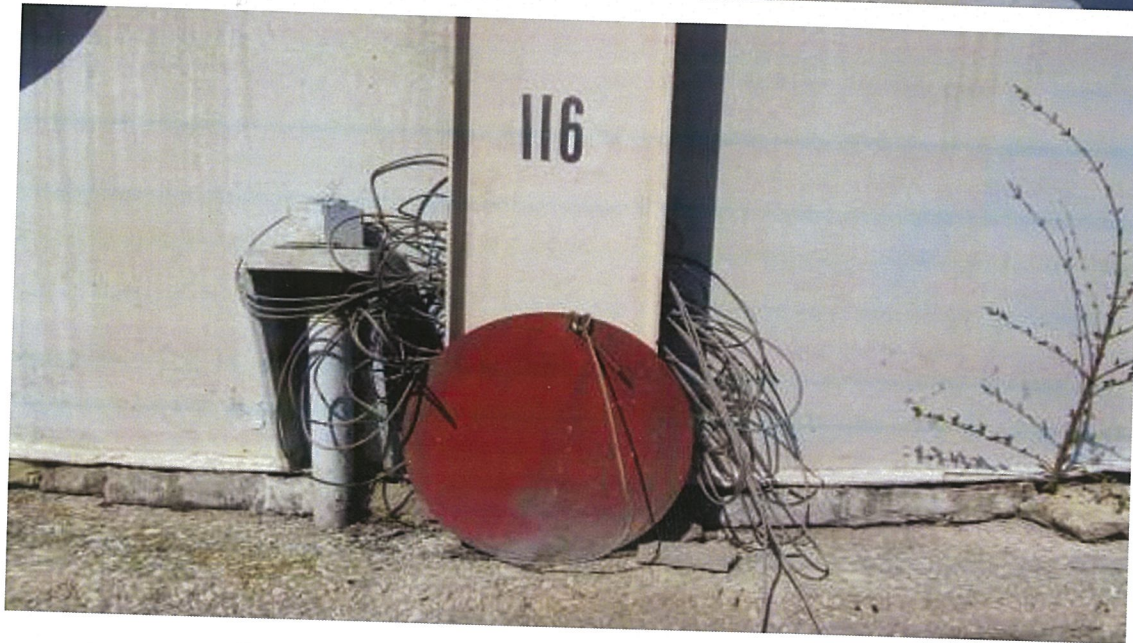
Photos show the condition of the liquid level indicator. Due to the condition of the indicator, we recommend replacing the existing liquid level indicator.

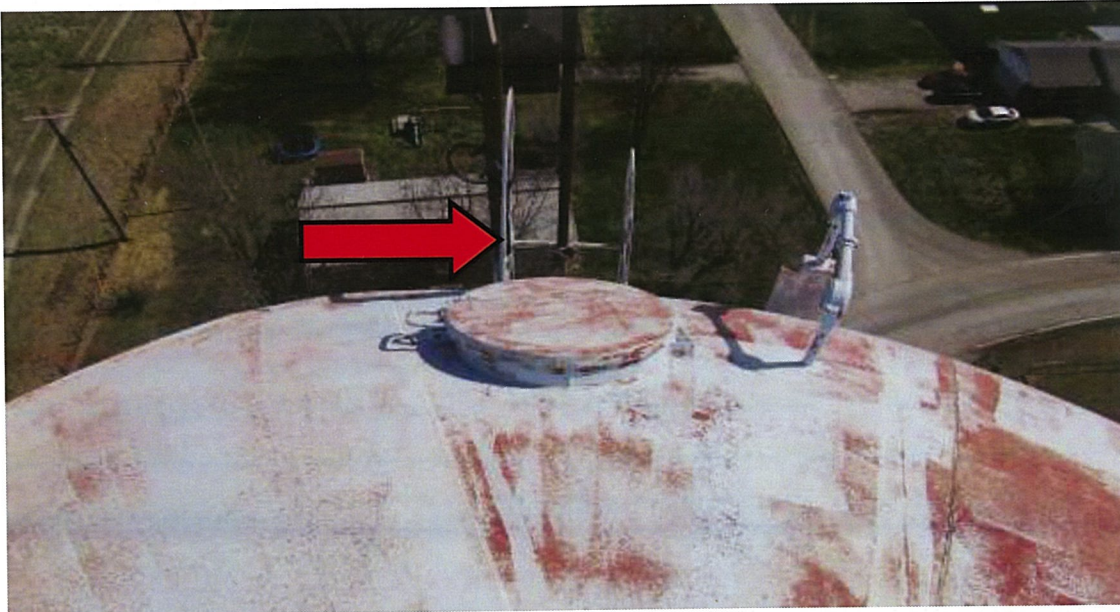
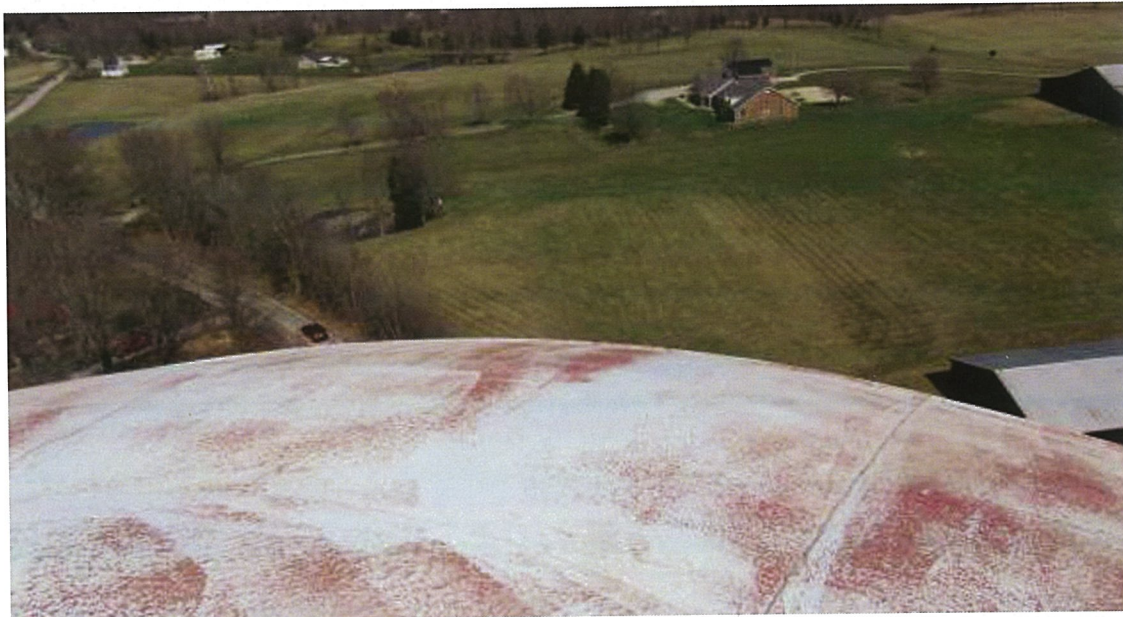
Photos show the tank roof edge is not equipped with a required handrail system for fall protection. **OSHA 1910.28(b)(1)(i)** states, "...the employer must ensure that each employee on a walking-working surface with an unprotected side or edge that is 4 feet (1.2 m) or more above a lower level is protected from falling by one or more of the following: **1910.28(b)(1)(i)(A) Guardrail systems.**" We recommend installing an **OSHA** compliant 42" high handrail system around the circumference of the tank roof, complete with intermediate rail, toeboard and a swing gate at the junction of the shell-to-roof access ladder and tank roof.

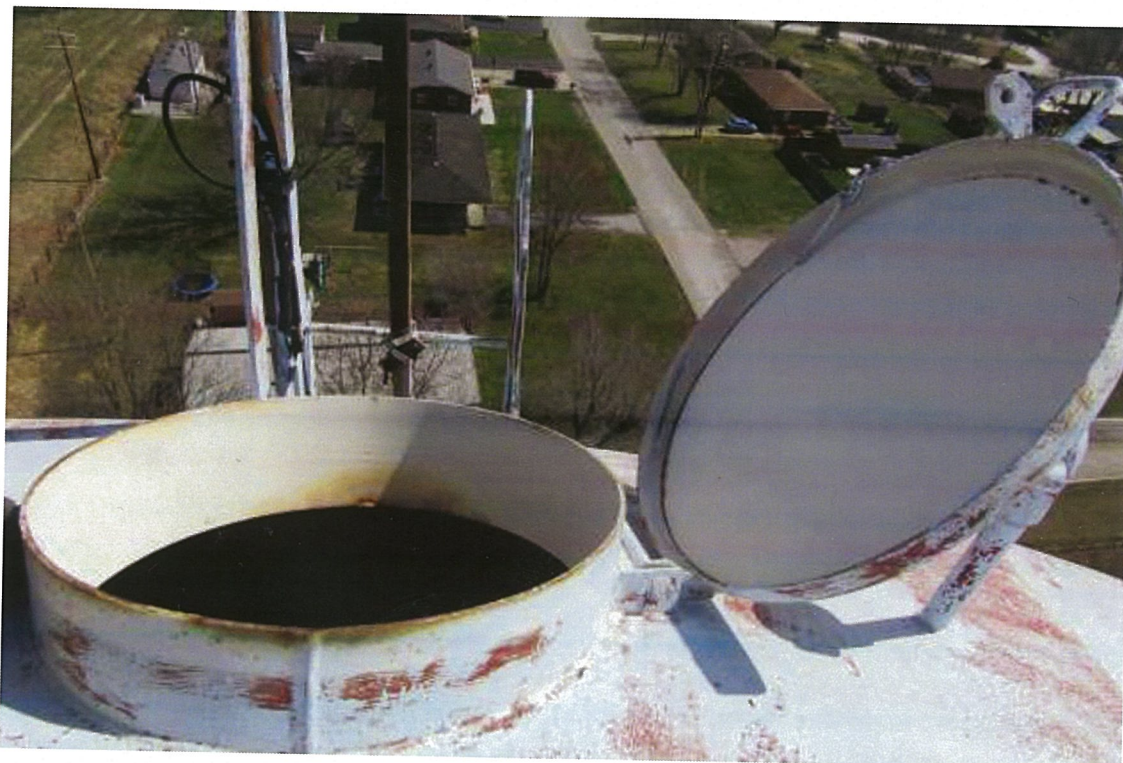
Photo shows the condition of the existing 24" roof hatch. Roof openings on this tank require the following to be in compliance with **AWWA D100-11; 7.4.3: Roof openings** and **OSHA 1910.146(c)(2) Confined spaces**.

- Post **Confined Space Entry** sign
- Install lock on existing roof hatch

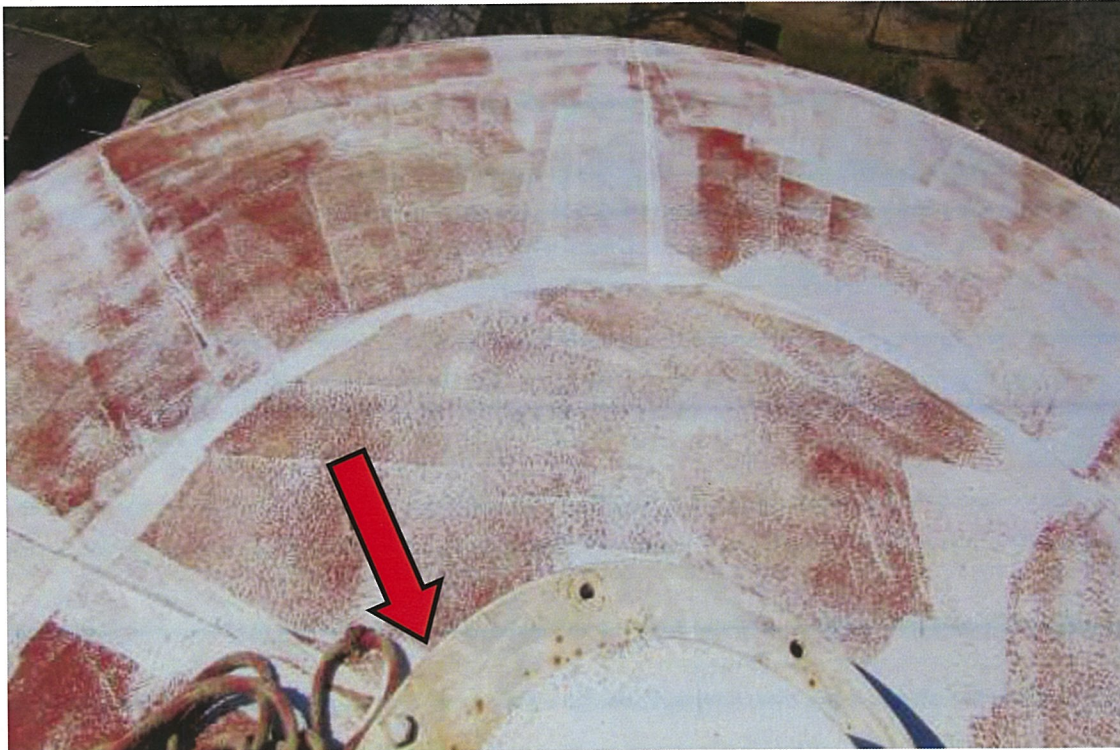
Photo shows the secondary access point / fan mount. Roof openings on this tank require the following to be in compliance with **AWWA D100-11; 7.4.3: Roof openings** and **OSHA 1910.146(c)(2) Confined spaces**.

Post **Confined Space Entry** sign

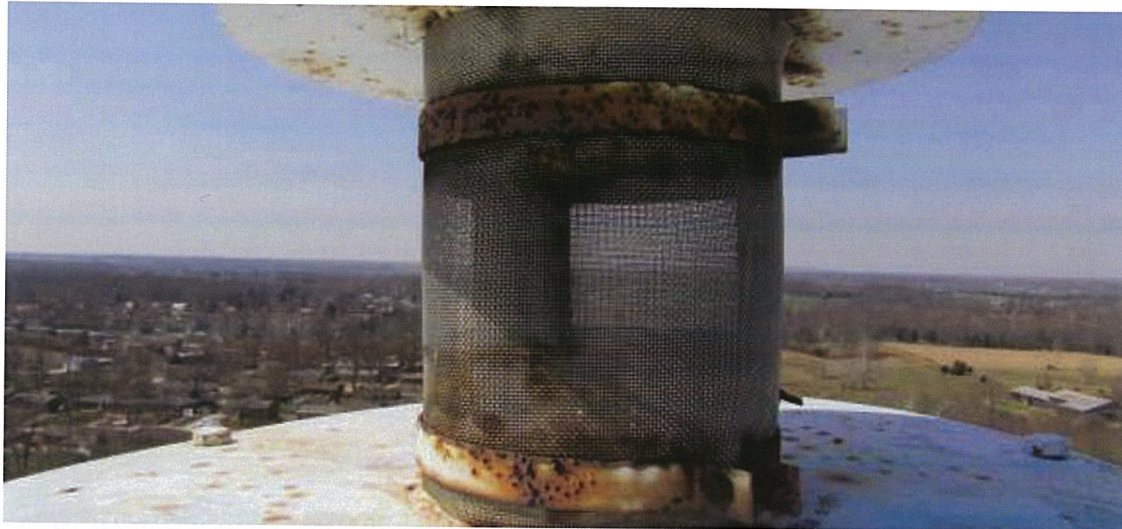
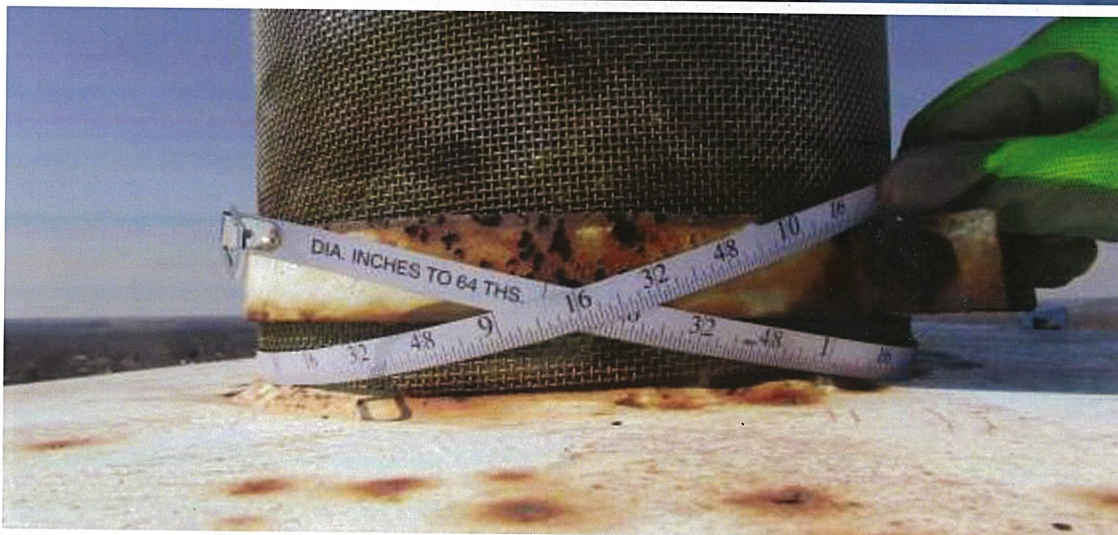
Photos show the condition of the existing 9" roof vent. **EPA SCWDA Drinking Water Act Violation EPA August 15, 2002, 2.1 Potential Health Impacts 2.1.2 Pathogen Contamination and Microbial Growth** states, "Microbial contamination from birds or insects is a major water quality problem in storage tanks. . . have serious sanitary defects and various minor flaws that could lead to sanitary problems. Most of these sanitary defects stem from design problems with roof hatch systems and vents that do not provide a watertight seal." **This vent is allowing the ingress of rain and wind-borne contaminants into the water system. An improperly vented tank may cause external pressure to act on the tank which can cause buckling even at low pressure differential.** We recommend replacing the existing roof vent with a vacuum-pressure, frost proof vent and screen.

**This work should be performed on an emergency basis.**

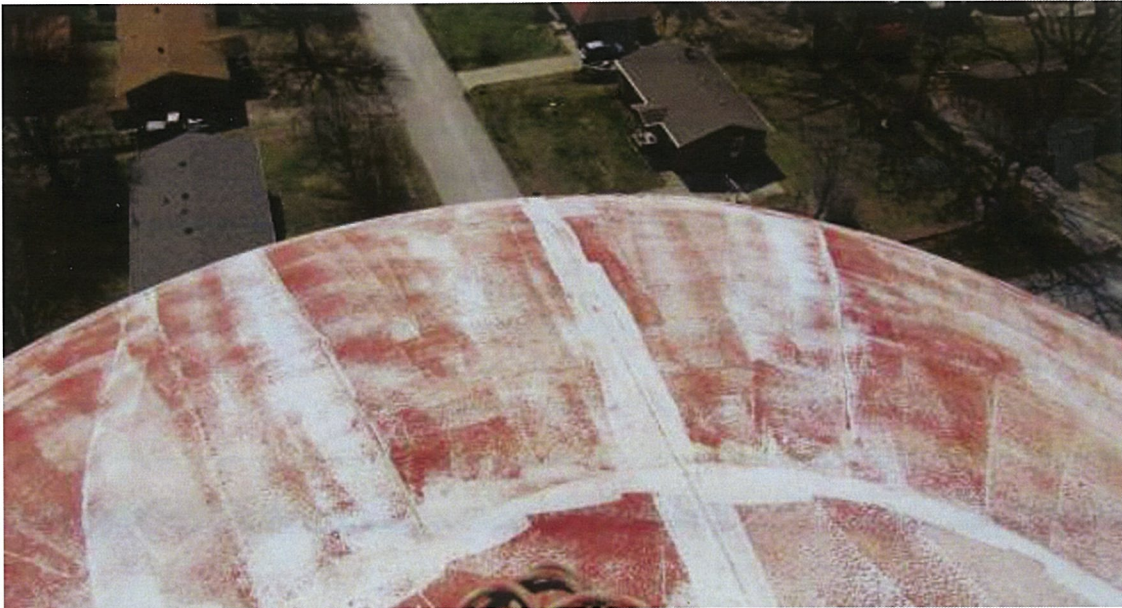
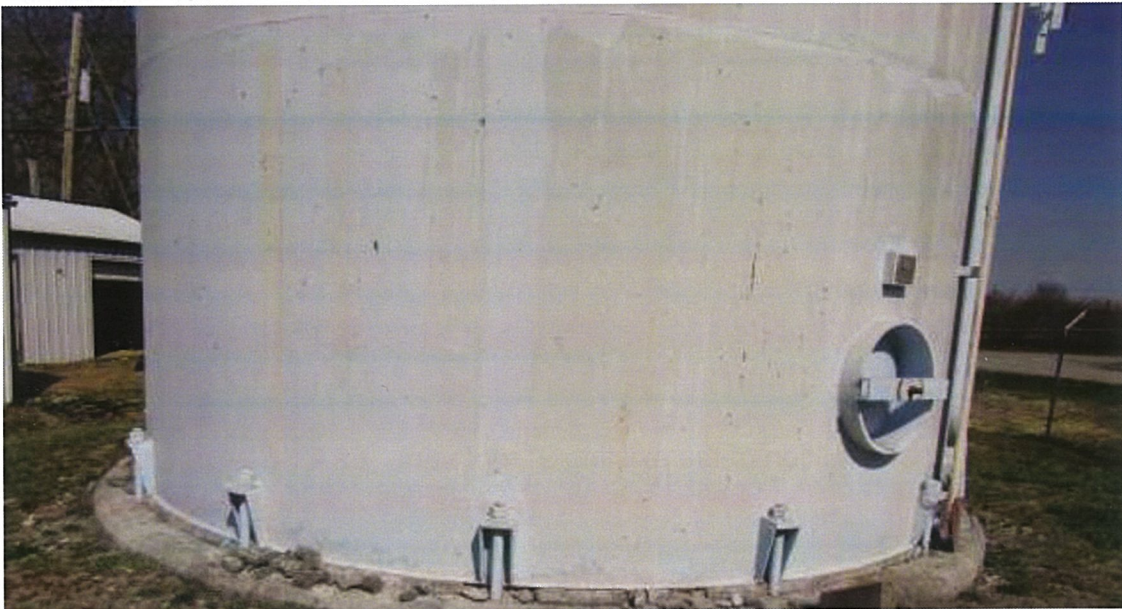
Photos show the tank exterior coating system. We recommend pressure washing the tank exterior with biodegradable detergent injection (minimum 3,500 psi at 3.0 gpm) then removing all loose rust and scale with wire brushes and hand scrapers in accordance with SSPC#2 (hand tool cleaning), spot priming and applying one (1) finish coat of acrylic paint.

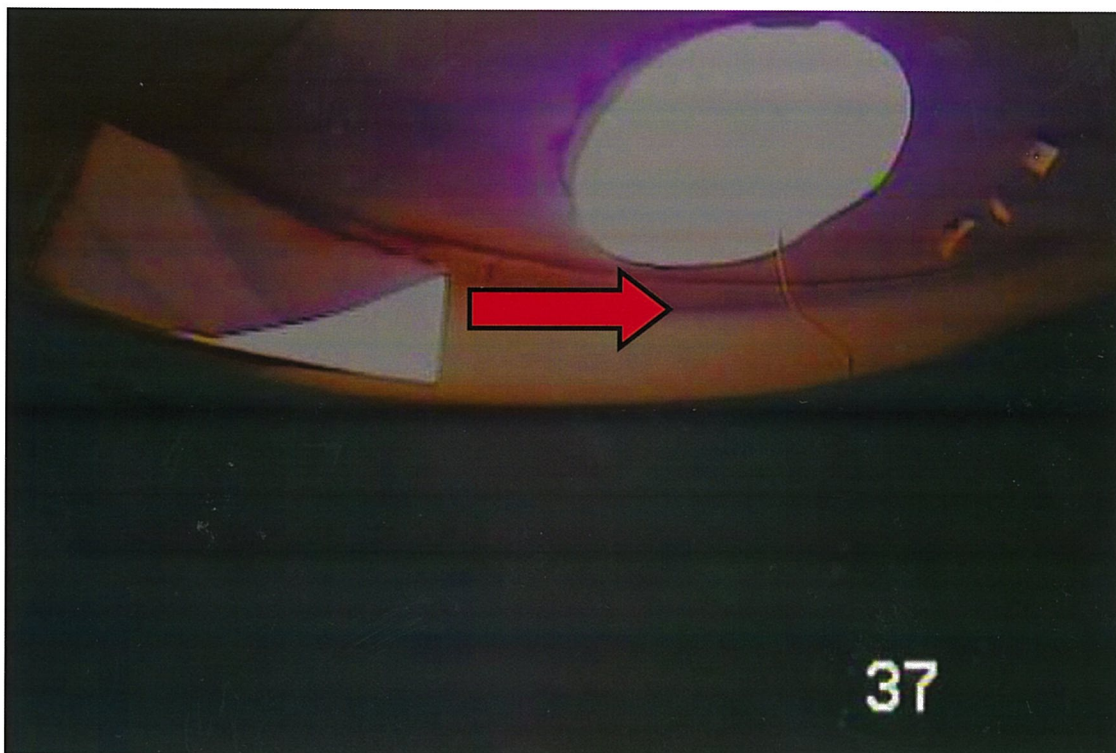
Photo shows tank is not equipped with an interior access ladder. **AWWA D100-11; 7.4.2.4: Inside tank ladder** states, "When specified, an inside tank ladder shall be provided for access from the roof to the bottom of the tank." We recommend installing an **OSHA** compliant interior access ladder complete with stand-offs every 10' on center, and a cable type ladder safety device.

*\*In cold climates it's up to the owner's discretion on placement of internal ladders.*

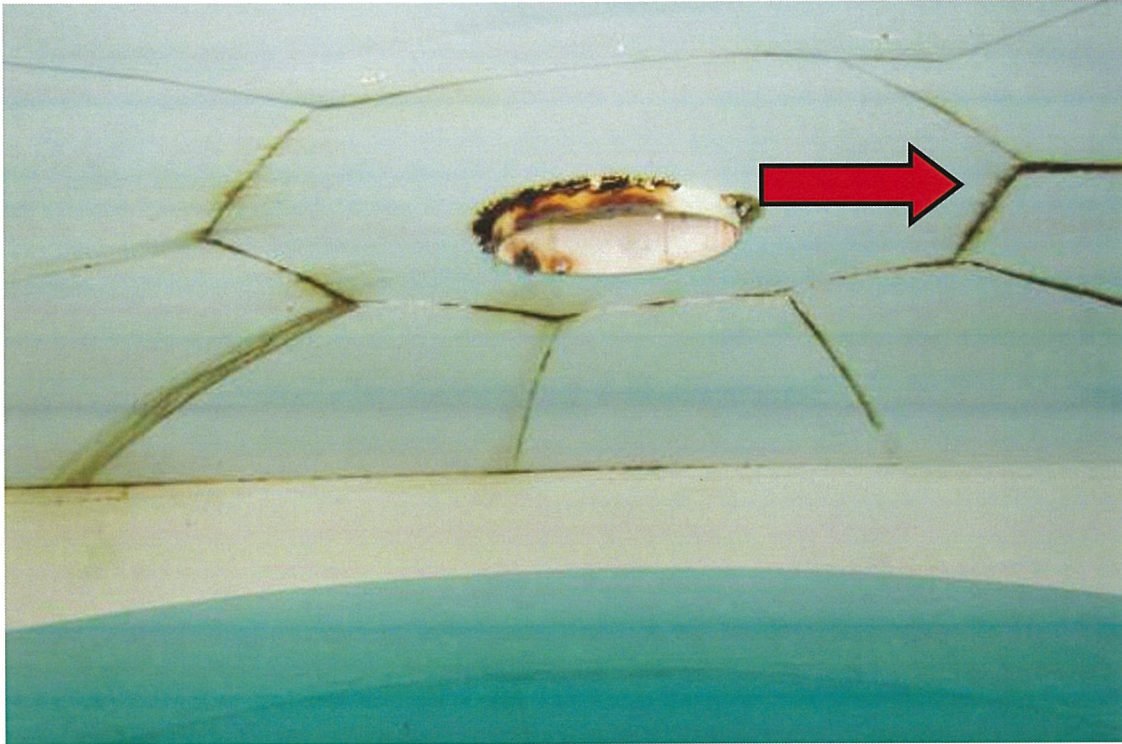
Photo shows the condition of the interior roof. Notice the rust forming at the roof lap seams. We recommend seam sealing using Sikaflex® 1a on all un-welded interior roof lap seams to prevent failure of a new interior liner. This work is to be performed in conjunction with application of new interior liner.

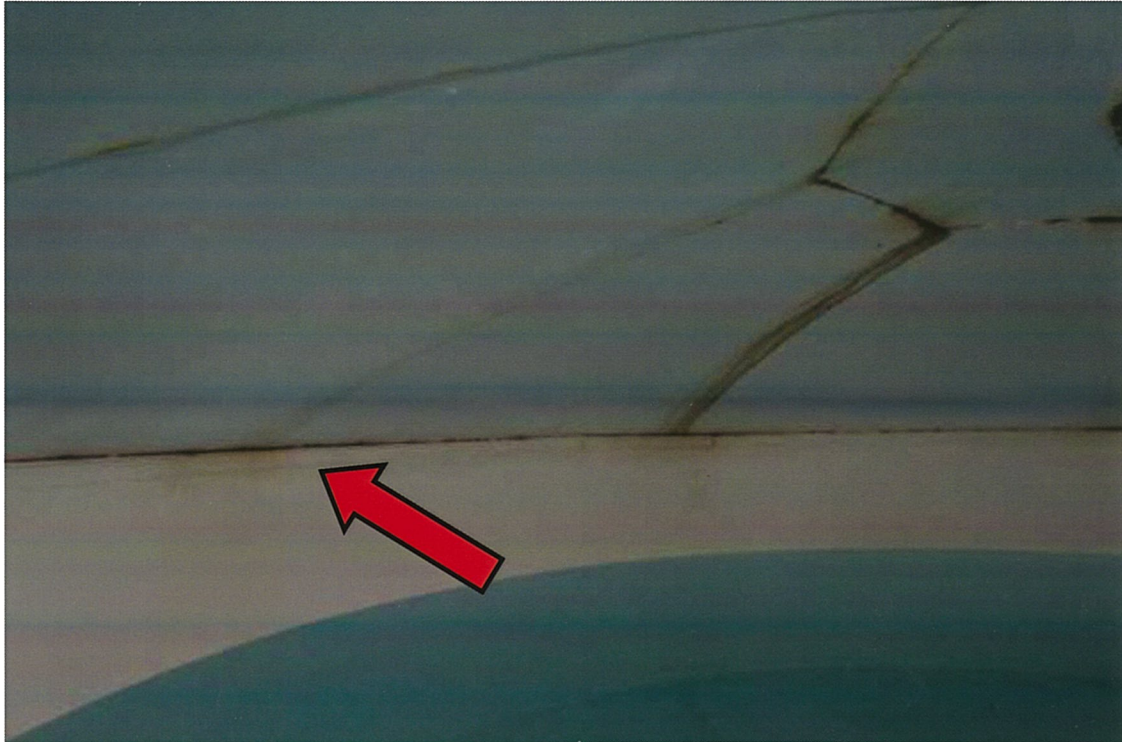
Photo shows the condition of the interior roof-to-rim angle connection. Notice the rust forming in the crevice between the roof and rim angle. We recommend seam sealing using Sikaflex® 1a around the circumference of this connection to prevent failure of a new interior liner. This work is to be performed in conjunction with application of new interior liner.
