**ELECTRONIC INVESTIGATION            )  
INTO EXCESSIVE WATER LOSS BY        )  
KENTUCKY'S JURISDICTIONAL            ) CASE NO. 2019-00041  
WATER UTILITIES                         )**

**RESPONSE OF  
FARMDALE WATER DISTRICT  
TO  
COMMISSION'S SECOND REQUEST FOR INFORMATION  
DATED MAY 3, 2019**

**Farmdale Water District  
100 Highwood Drive  
Frankfort, KY 40601  
RE: Frankfort, KY  
223,000 Gallon STP  
March 22, 2018  
Mr. David Robinson  
Water Superintendent  
(502) 223-3562  
Job No. 318079**

## STANDPIPE INSPECTION REPORT

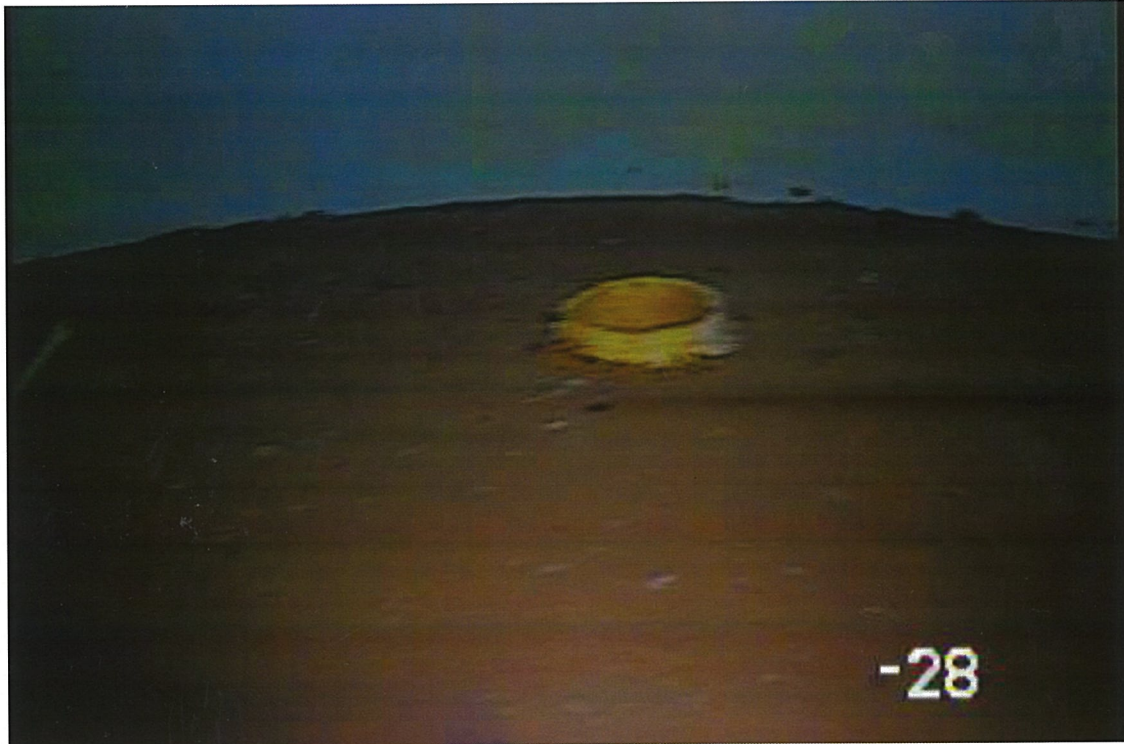
Photo shows a fill pipe on the tank interior. A temperature difference between the water in the top and bottom of a tank, even as little as 1-2 degrees Fahrenheit, is an indication of thermal stratification and the tank water not being completely mixed. Incomplete mixing would result in short-circuiting, and localized increase in water age would develop inside the tank. This typically leads to water quality problems, such as loss of residual, DBP spikes, HPC spikes, bacteria regrowth, formation of bio-film, changes in pH and dissolved oxygen. We recommend installing a mixing system. Electrical work to be done by others.

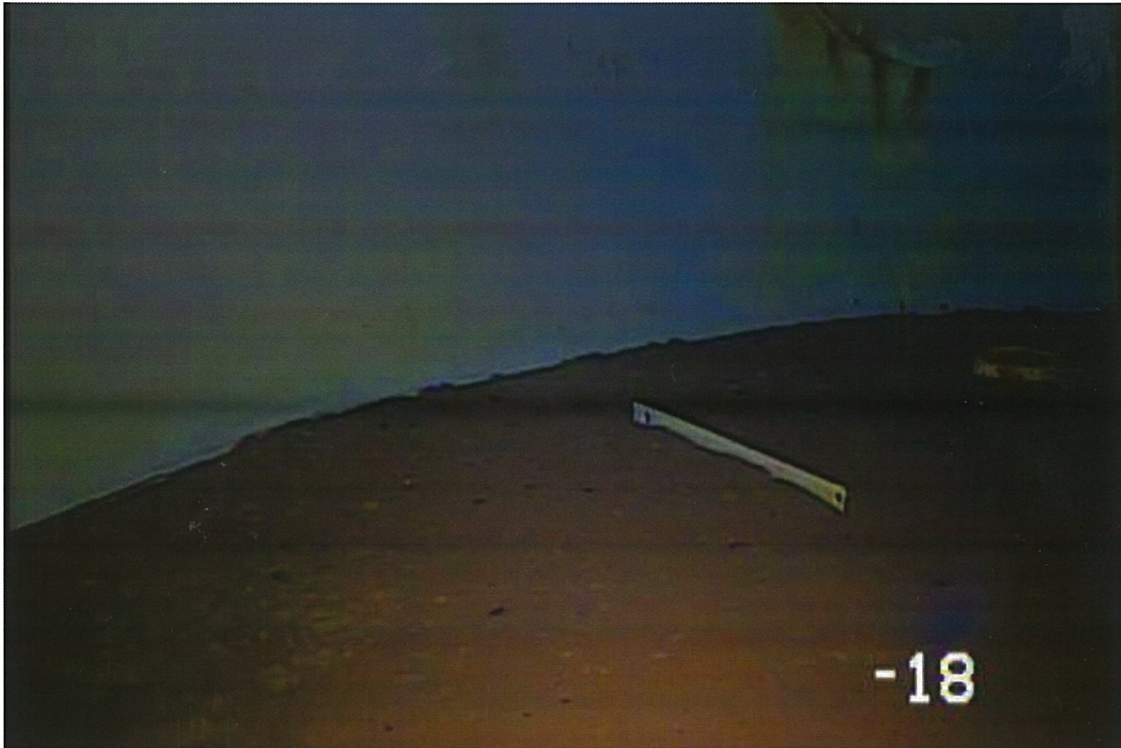
Photo shows sediment in the tank before the performance of the tank cleanout.

We recommend installing a passive cathodic protection system.

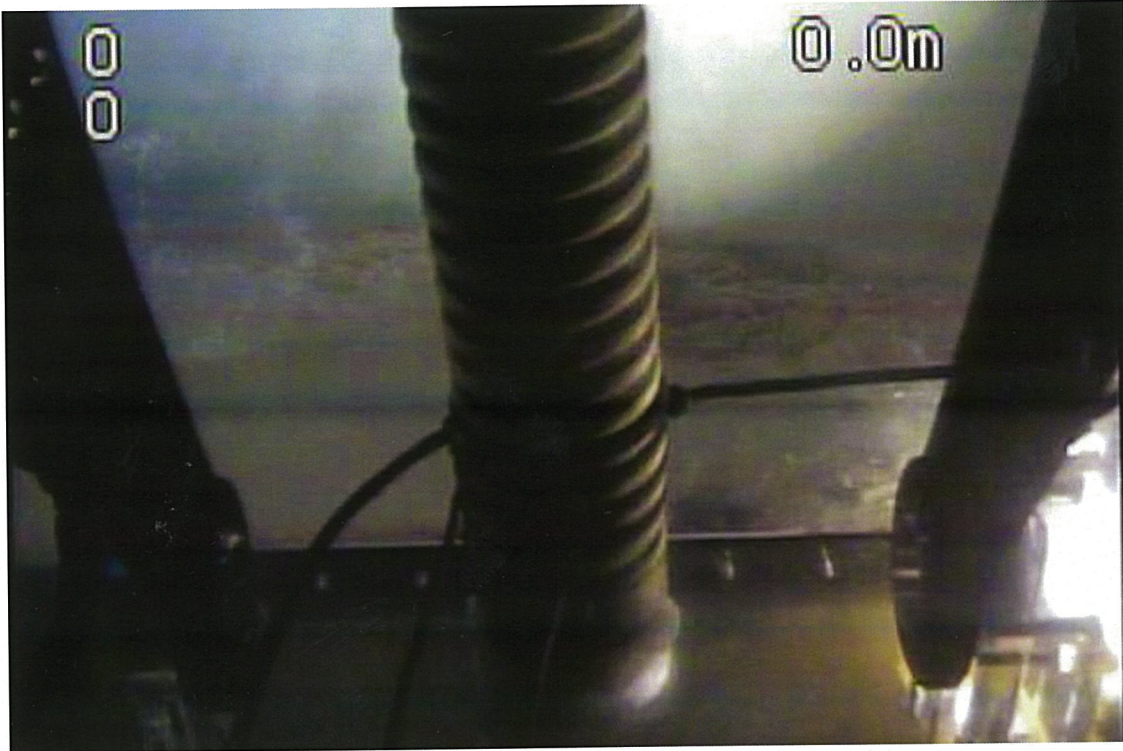
Photo shows the condition of the tank during the performance of the tank cleanout.

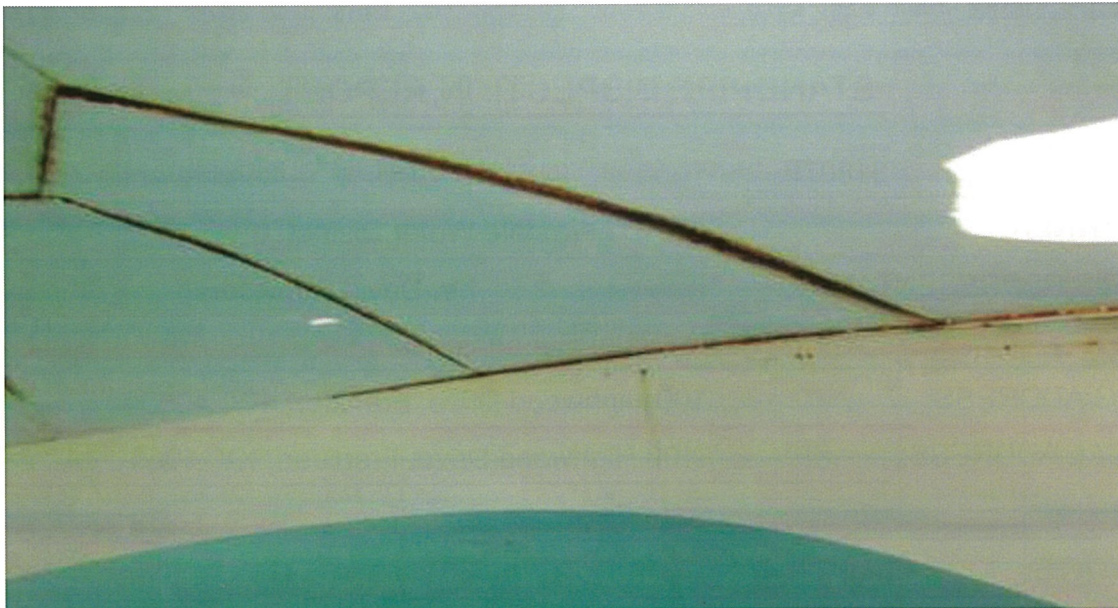
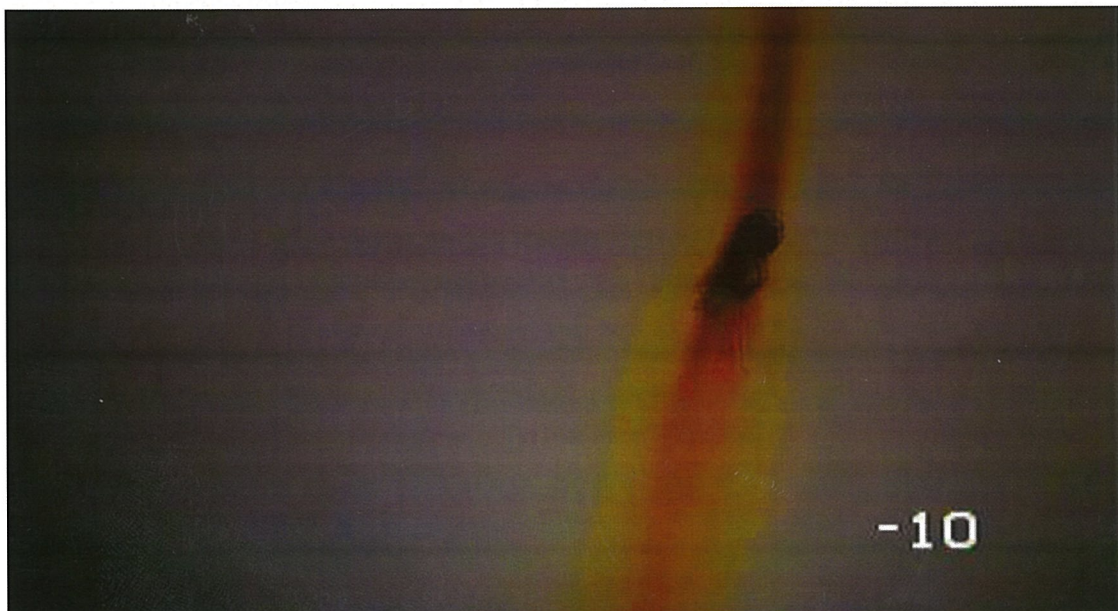
Photos show the condition of the interior coating system. We recommend sandblasting all rusted and abraded interior areas to SSPC-SP10 (near white), and brush blasting all remaining interior areas to SSPC-SP7; then applying one (1) spot coat of epoxy primer to all areas sandblasted to #10, stripe coating all weld seams, and applying one (1) full coat of epoxy to the entire tank, to achieve 8 to 10 mils of total dry film thickness. Total mil thickness will include a combination of the existing and new coating.
