ELECTRONIC INVESTIGATION INTO)
EXCESSIVE WATER LOSS BY KENTUCKY'S) Case No. 2019-00041
JURISDICTIONAL WATER UTILITIES)

**West Carroll Water District
Case No. 2019-00041
Commission Staff's Second Request for Information issued May 3, 2019**

100,000 GALLON ELEVATED WATER TANK

50,000 GALLON ELEVATED WATER TANK

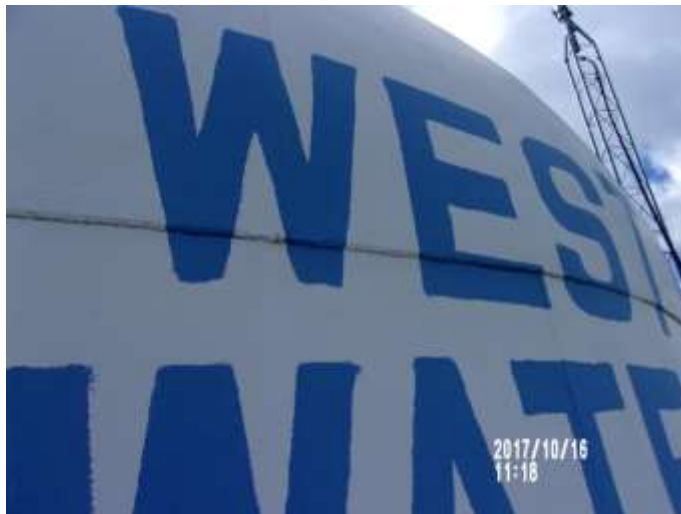
PHOTO SHOWS EXTERIOR OF TANK

OVERALL, THE EXTERIOR COATING APPEARS TO BE IN GOOD CONDITION. IN ORDER PROMOTE THE LONGEVITY OF THE EXISTING COATING, WE RECOMMEND TO POWER WASH ALL EXTERIOR SURFACES AND TOUCH UP COATING AS NECESSARY.

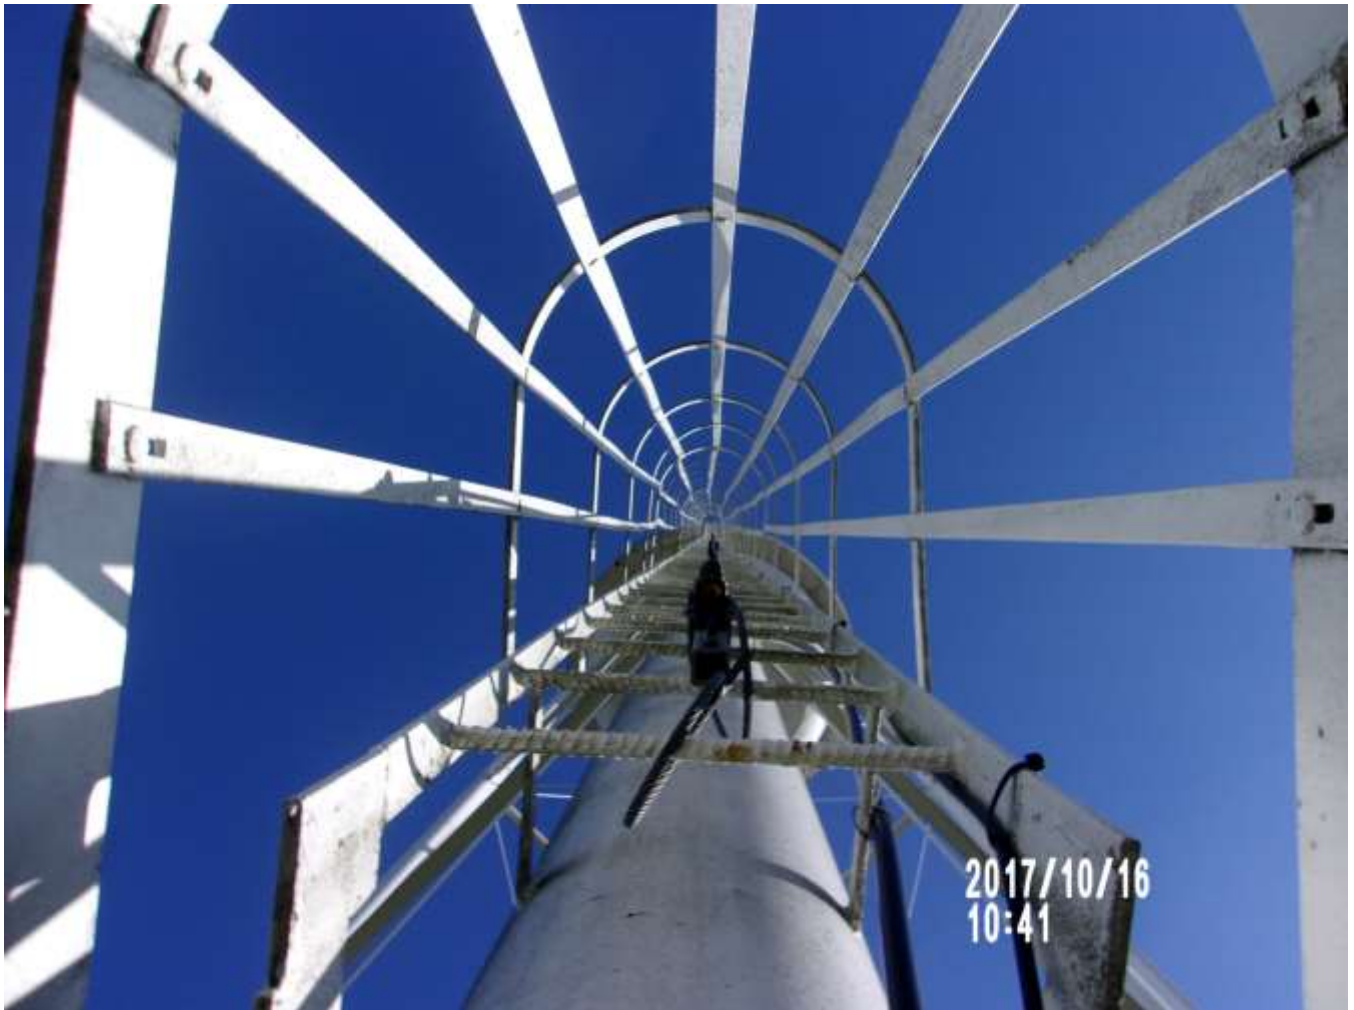
PHOTO SHOWS UPWARD VIEW OF LADDER

THE EXTERIOR LADDER DOES NOT HAVE AN ANTI CLIMB DEVICE INSTALLED. WE RECOMMEND TO FURNISH AND INSTALL A LOCKABLE ANTI CLIMB DEVICE ON THE EXTERIOR LADDER TO PREVENT UNAUTHORIZED ACCESS AND VANDALISM.

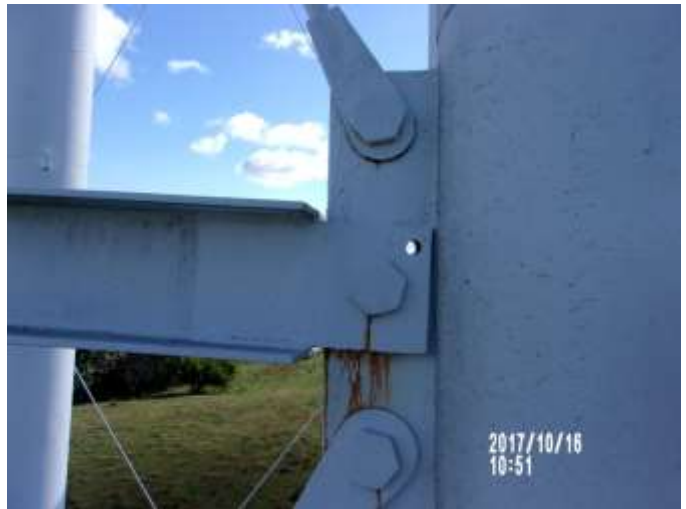
PHOTO SHOWS STRUTS

WE RECOMMEND RE-ENFORCING THE STRUT ENDS BY WELDING AFTER ADJUSTING WINDAGE AND STAY RODS.

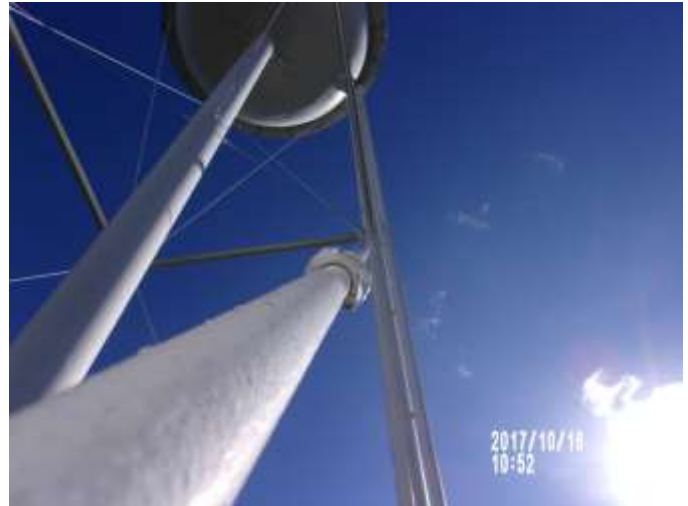
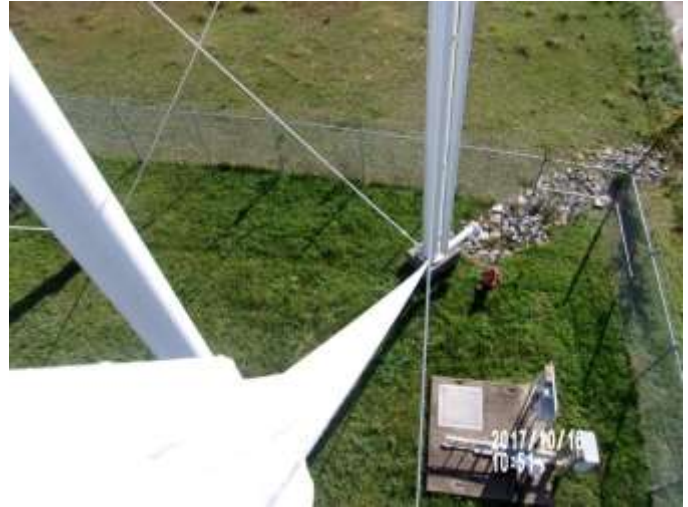
PHOTO SHOWS WINDAGE RODS

THE WINDAGE RODS ARE DESIGNED TO RESIST AND STABILIZE THE TANK STRUCTURE AGAINST WIND AND SEISMIC LOADS COMBINED WITH DEAD AND LIVE LOADS. THE RODS SHOULD WITHSTAND 100 MPH WINDS BLOWING FROM ANY DIRECTION. IF THE BRACING REMAINS LOOSE, A SUDDEN COLLAPSE COULD OCCUR. WE RECOMMEND TO ADJUST THE WINDAGE RODS AND RISER STAY RODS TO WITHSTAND 100 MPH WINDS BLOWING FROM ANY DIRECTION, AS REQUIRED BY AWWA D100-11 3.1.4, REQUIREMENTS. THIS SHOULD BE DONE ON AN EMERGENCY BASIS.

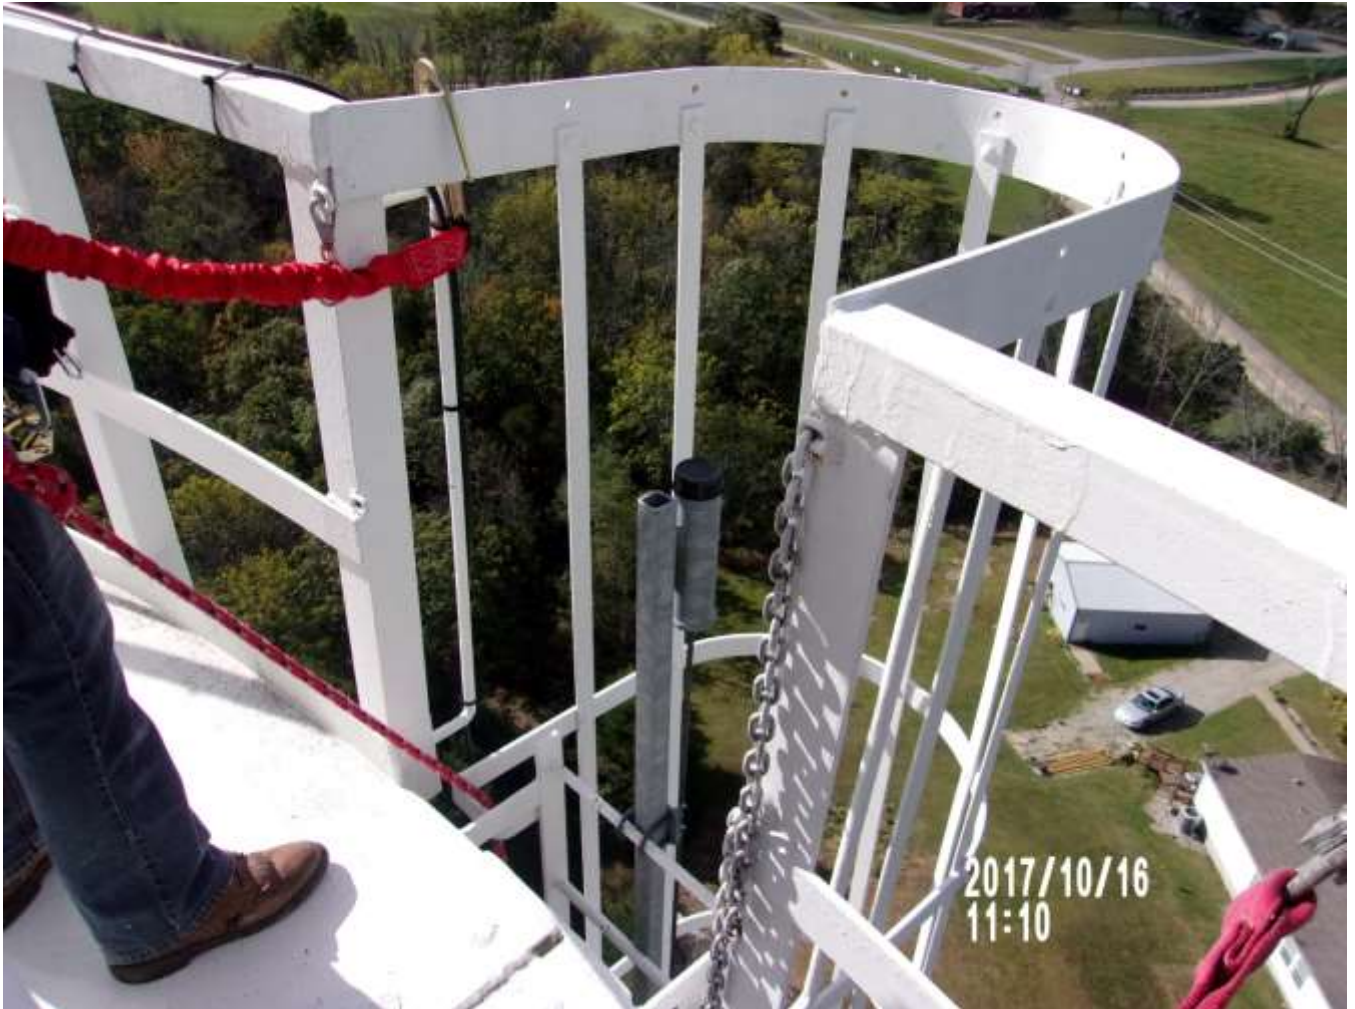
PHOTO SHOWS CATWALK OPENING OF LADDER

THE HANDRAIL OPENING IS NOT PROTECTED BY A SWING GATE. WE RECOMMEND TO FURNISH AND INSTALL A SWING GATE IN THE HANDRAIL OPENING IN ACCORDANCE WITH OSHA, AWWA D100-11 3.1.7, AND NFPA 22 2013 8.7.9 REQUIREMENTS.

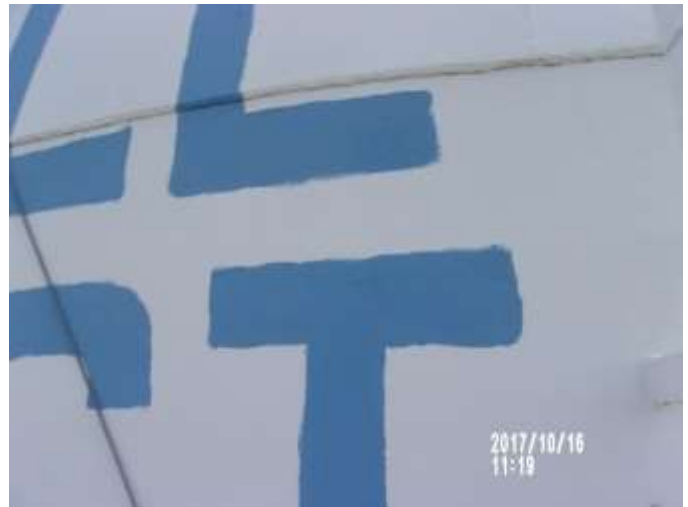
PHOTO SHOWS EXTERIOR OF TANK

AT MINIMUM, WE RECOMMEND TO POWER WASH ALL EXTERIOR SURFACES, PROPERLY PREPARE SURFACE, PRIME, AND APPLY ONE COMPLETE COAT OF ENAMEL. FURTHERMORE, FOR SUPERIOR COLOR, GLOSS RETENTION, AND LONGEVITY OF COATING PERFORMANCE, WE RECOMMEND A FULL COAT OF PRIMER FOLLOWED BY A FINISH COAT OF ACRYLIC OR URETHANE.

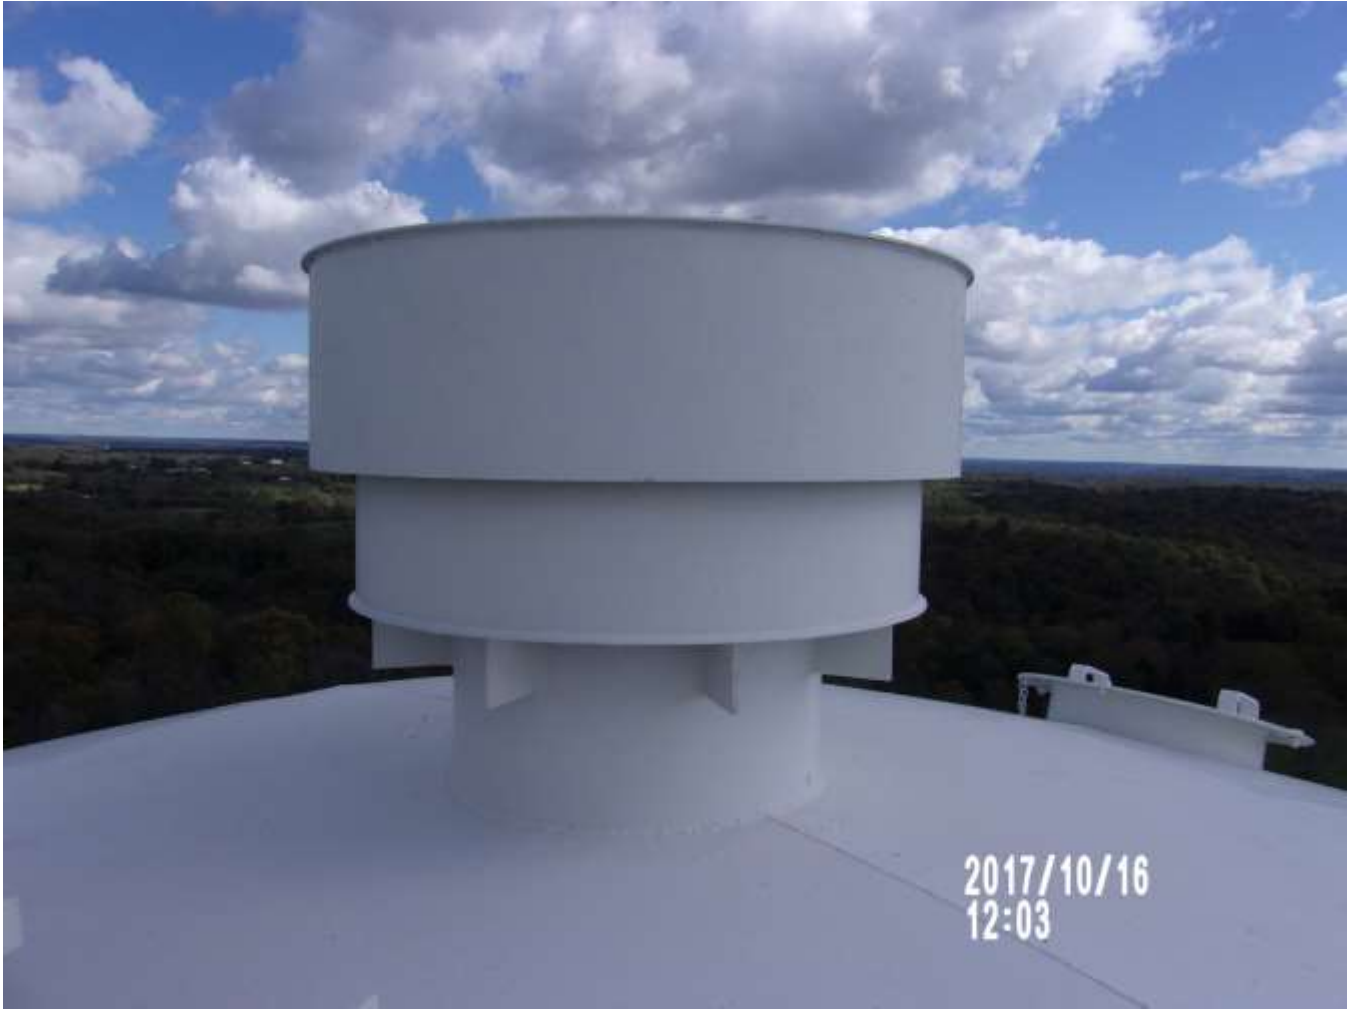
PHOTO SHOWS ROOF VENT

WE RECOMMEND TO REMOVE AND REPLACE THE NON COMPLIANT ROOF VENT WITH A FROST PROOF/PRESSURE PROOF VENT IN ACCORDANCE WITH AWWA D100-11 7.5, 7.5.1 AND 7.5.2 REQUIREMENTS. ADDITIONALLY, WE RECOMMEND TO FURNISH AND INSTALL A FLANGED NECK/NOZZLE BETWEEN ROOF TOP AND THE NEW ROOF VENT TO ALLOW ATTACHMENT OF A VENTILATION FAN IN ACCORDANCE WITH NFPA 22 2013 4.15.11 REQUIREMENTS TO ALLOW REMOVAL OF THE VENT AND ATTACHMENT OF A FAN TO PROVIDE PROPER AIRFLOW AND QUALITY WHILE WELDING, WORKING, SANDBLASTING AND PAINTING INSIDE THE TANK AS WELL AS TO ALLOW PROPER VENTILATION VIA A FAN FOR CURING OF THE INTERIOR COATING.

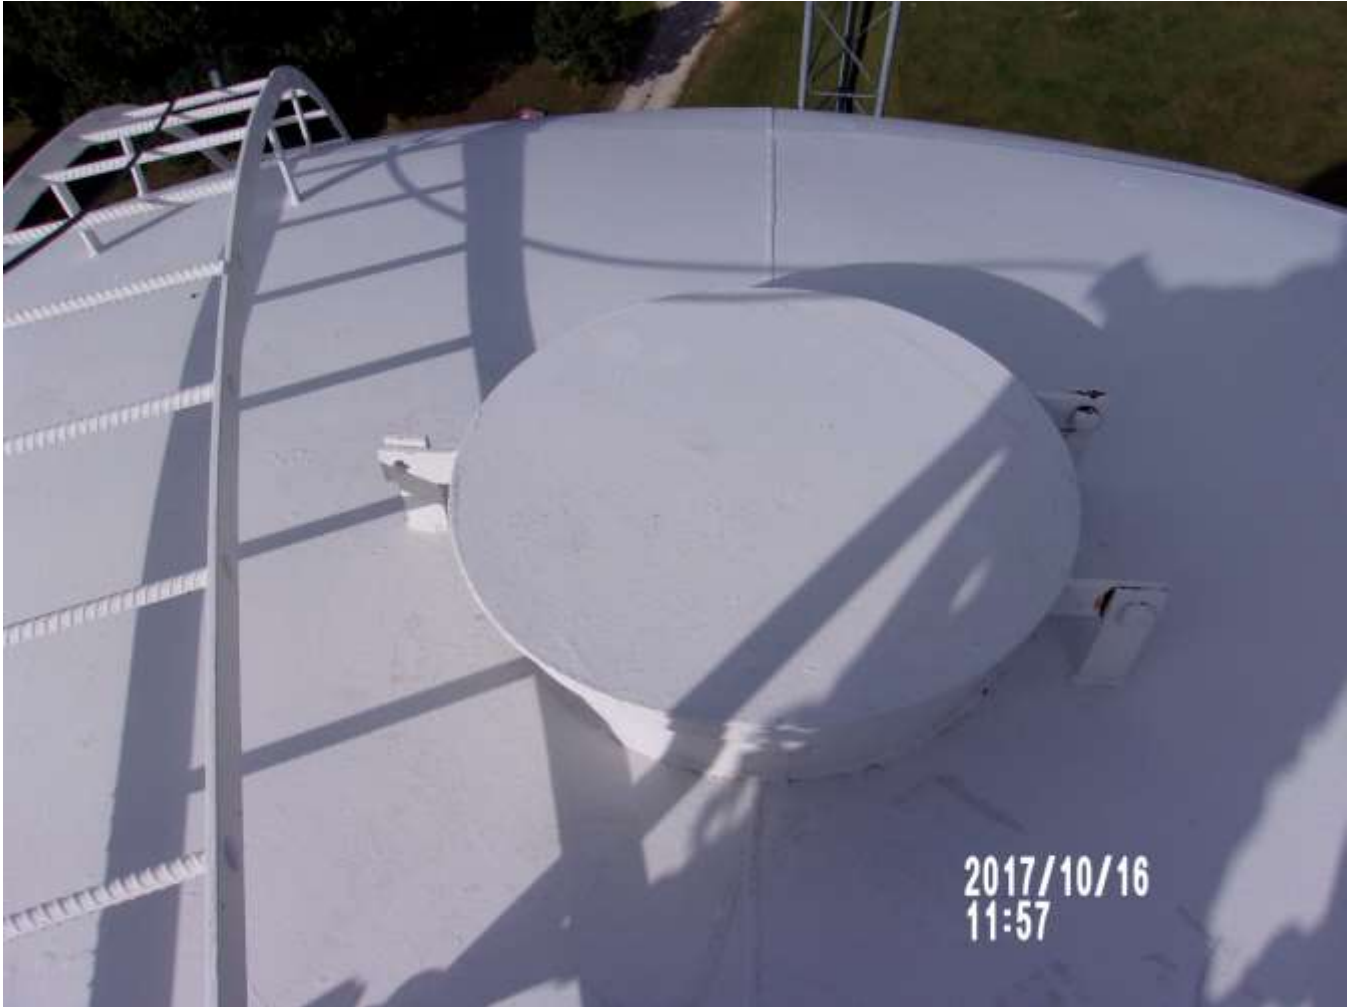
PHOTO SHOWS CLOSED ROOF HATCH

WE RECOMMEND TO REPLACE THE EXISTING ROOF HATCH WITH A 24" X 24" SQUARE HATCH IN ACCORDANCE WITH AWWA D100-11 5.4.3.1 AND NFPA 22 2013 5.7.3.1 CODE REQUIREMENTS.

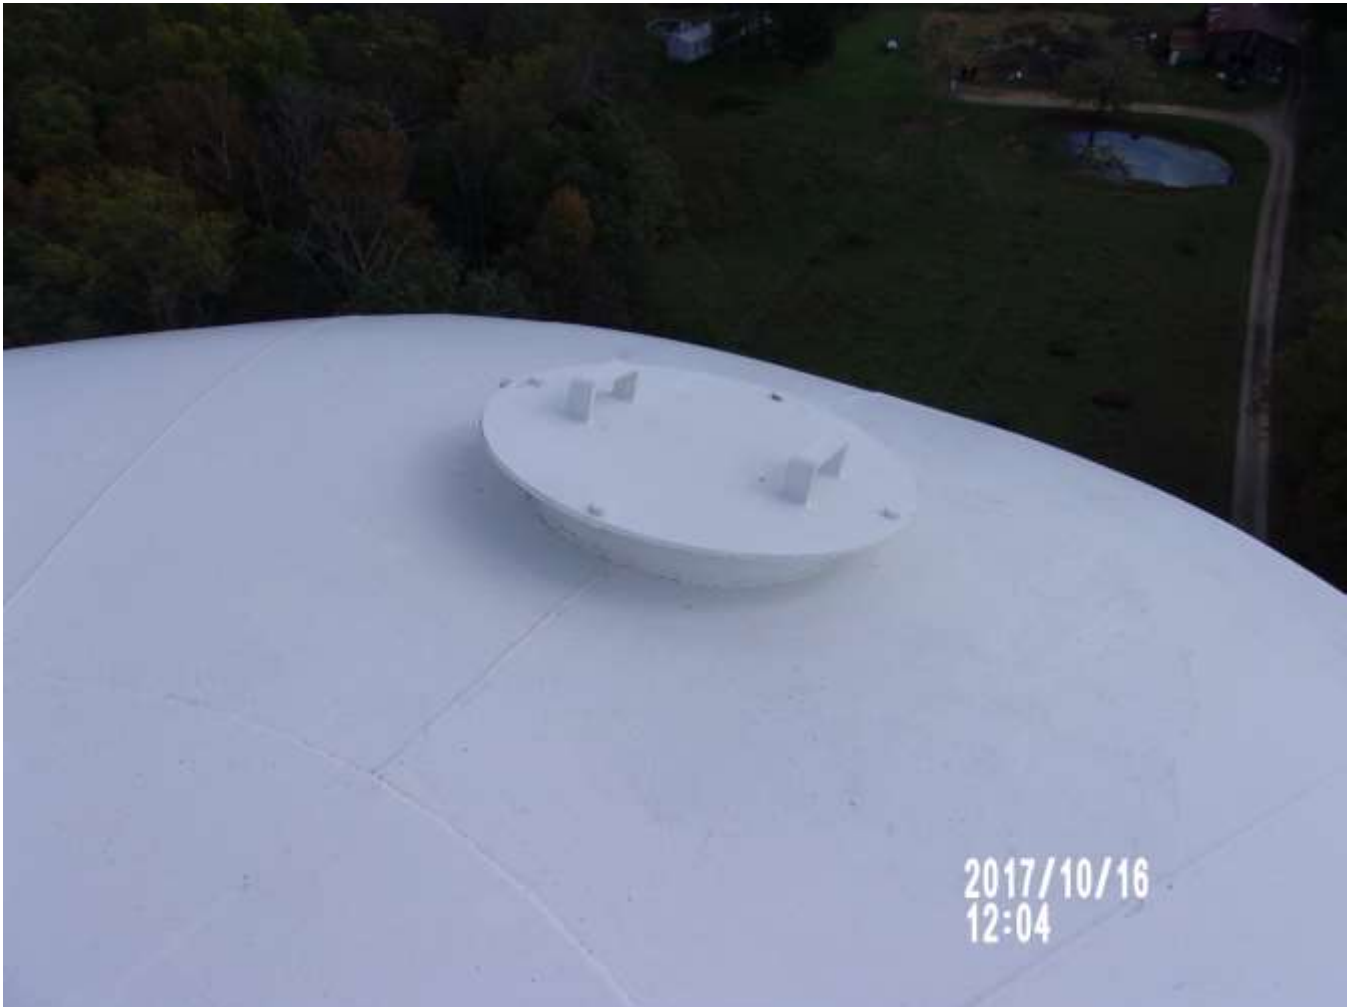
PHOTO SHOWS SECONDARY ROOF HATCH CLOSED

WE RECOMMEND TO REPLACE THE EXISTING SECONDARY ROOF HATCH WITH A 24" X 24" SQUARE ROOF HATCH IN ACCORDANCE WITH AWWA D100-11 5.4.3.1 AND NFPA 22 2013 5.7.3.1 CODE REQUIREMENTS.

WE RECOMMEND TO FURNISH AND INSTALL A SECONDARY INTERIOR AND AN EXTERIOR LADDER INCLUDING SAFETY CLIMB DEVICES AND AN ANTI CLIMB DEVICE IN CONJUNCTION WITH THE INSTALLATION OF A SECONDARY 24" SQUARE ROOF HATCH 180 DEGREES FROM THE PRIMARY ROOF HATCH IN ACCORDANCE WITH OSHA, AWWA D100-11 5.4.2.5 AND NFPA 22 2013 5.7.4 REQUIREMENTS.

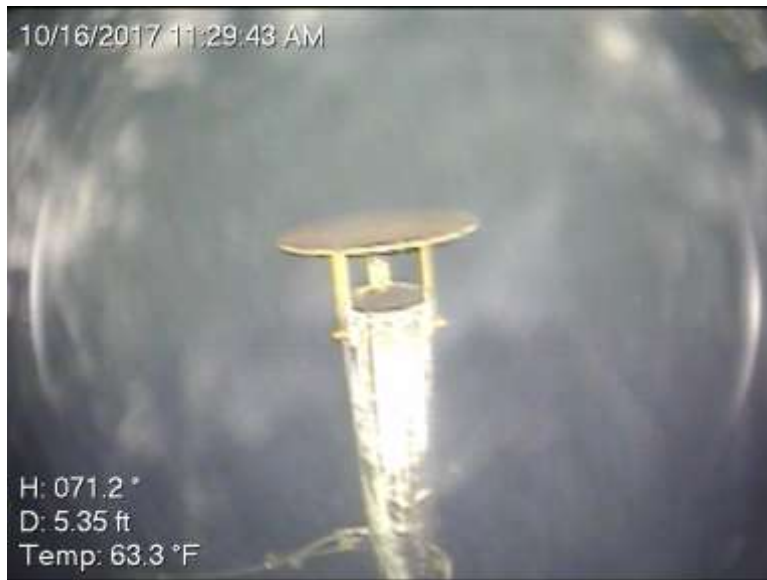
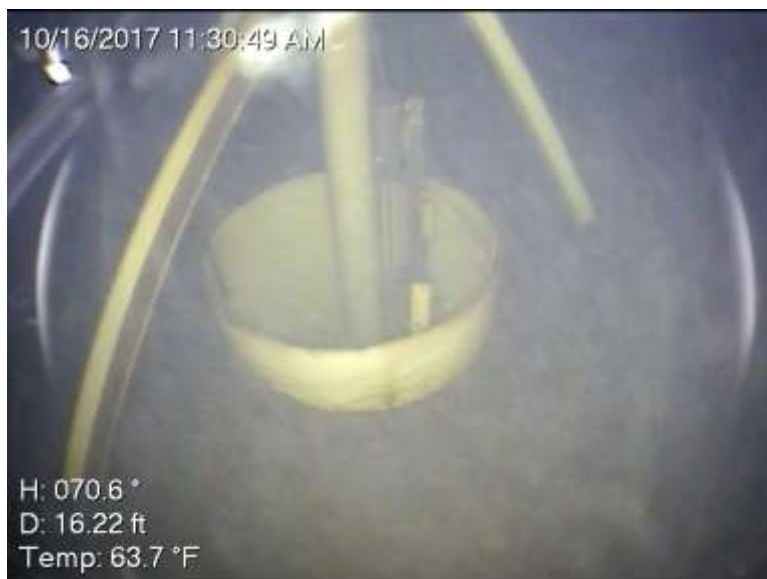
PHOTO SHOWS RISER LADDER & RISER OPENING

THERE ISN'T A SAFETY GRATE PROTECTING THE RISER OPENING. WE RECOMMEND TO FURNISH AND INSTALL SAFETY GRATE AT RISER OPENING IN ACCORDANCE WITH OSHA REQUIREMENTS.

WE RECOMMEND TO FURNISH AND INSTALL AN OSHA APPROVED HANDRAIL SYSTEM AROUND RISER OPENING.

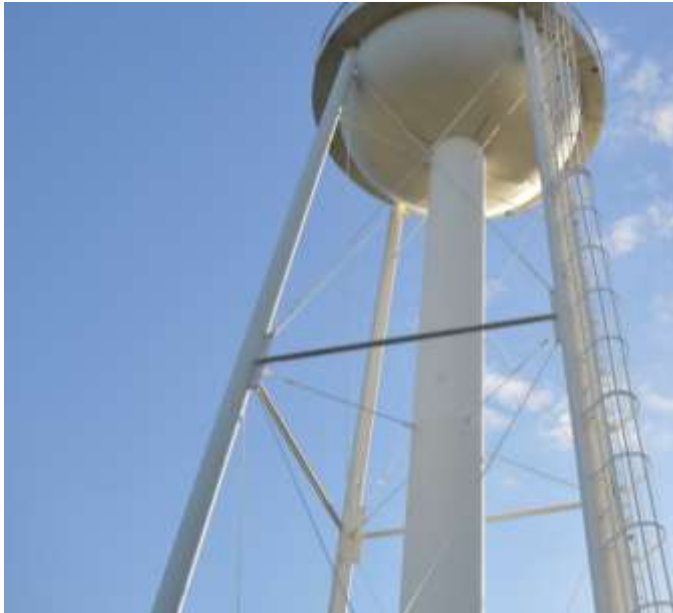
PHOTO SHOWS OVERFLOW

WE RECOMMEND TO FURNISH AND INSTALL A FLAPPER VALVE ON EXISTING OVERFLOW IN ACCORDANCE WITH AWWA D103-09 7.3 AND NFPA 22 2013 14.6 CODE REQUIREMENTS.

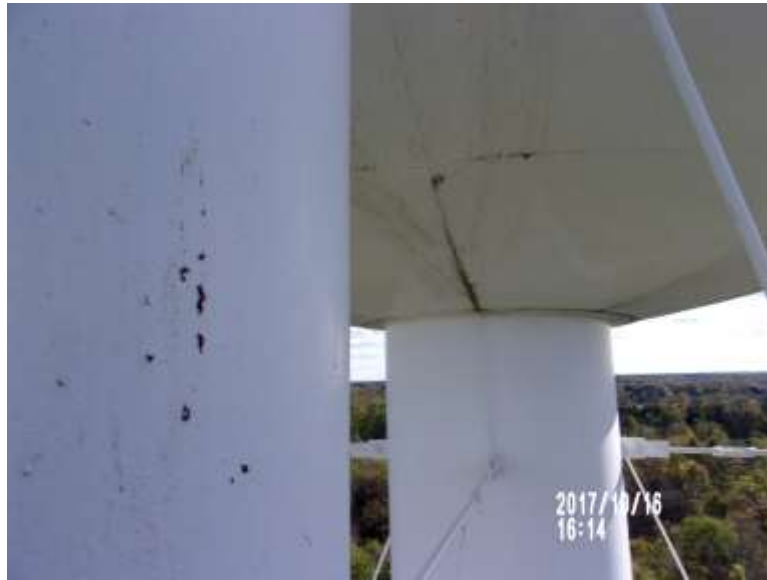
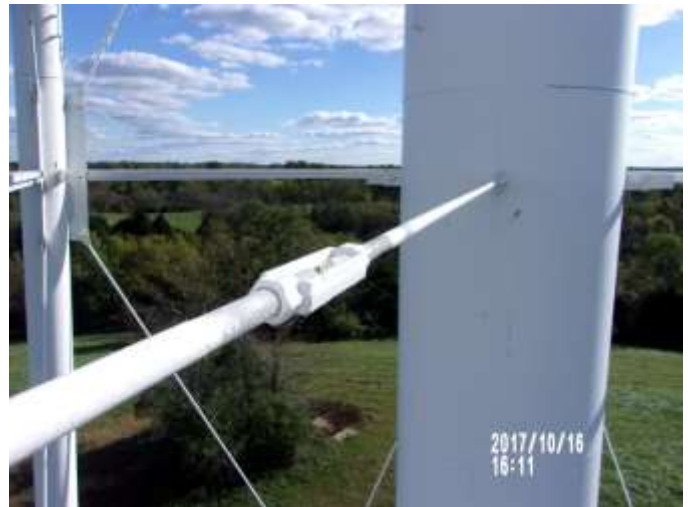
PHOTO SHOWS RISER TO BOWL CONNECTION/STAY RODS

WE RECOMMEND TO ADJUST THE RISER RODS TO WITHSTAND 100 MPH WINDS BLOWING FROM ANY DIRECTION, AS REQUIRED BY AWWA.

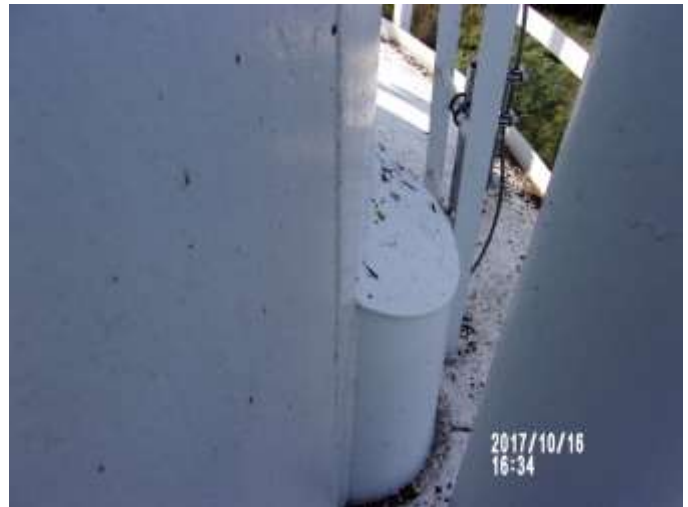
PHOTO SHOWS CATWALK AND POSTHEAD CONNECTIONS

**TO ENSURE THE STRUCTURAL INTEGRITY OF THE TANK, WE RECOMMEND TO RE-WELD
POST HEAD CONNECTIONS ABOVE THE CATWALK.**

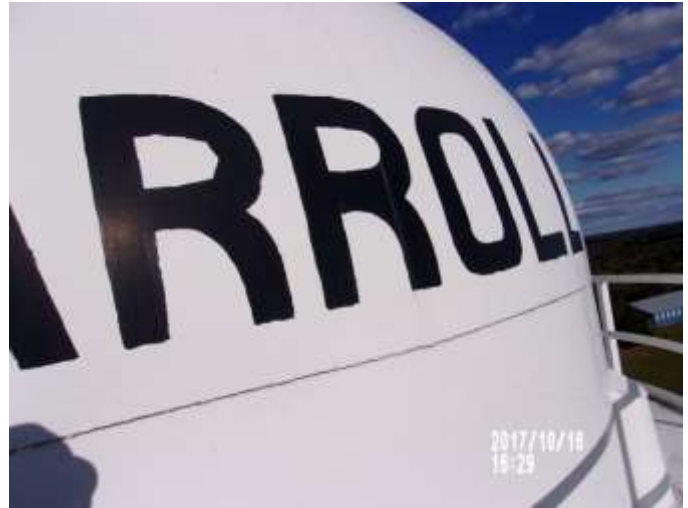
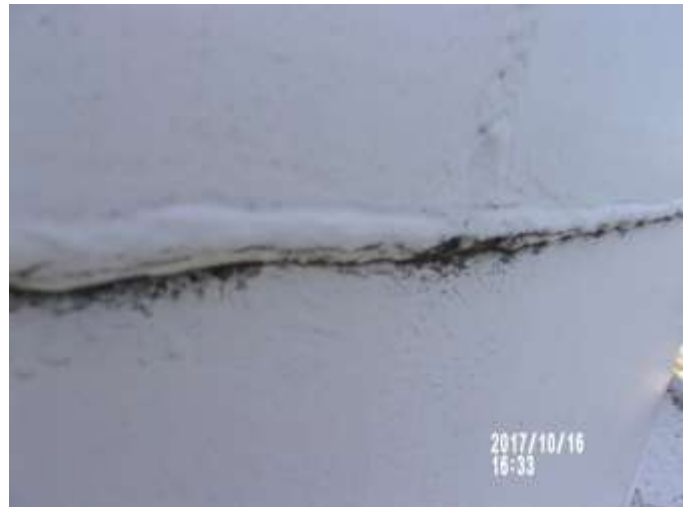
PHOTO SHOWS EXTERIOR OF TANK

AT MINIMUM, WE RECOMMEND TO POWER WASH ALL EXTERIOR SURFACES, PROPERLY PREPARE SURFACE, PRIME, AND APPLY ONE COMPLETE COAT OF ENAMEL. FURTHERMORE, FOR SUPERIOR COLOR, GLOSS RETENTION, AND LONGEVITY OF COATING PERFORMANCE, WE RECOMMEND A FULL COAT OF PRIMER FOLLOWED BY A FINISH COAT OF ACRYLIC OR URETHANE.

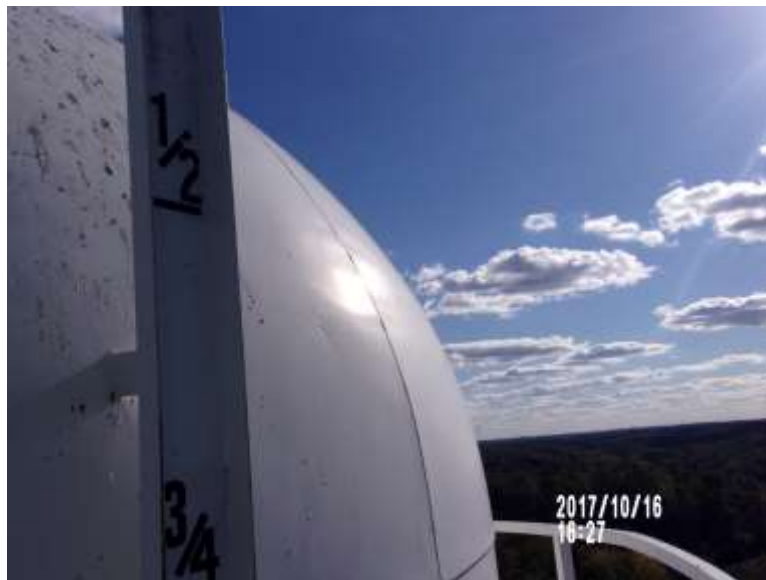
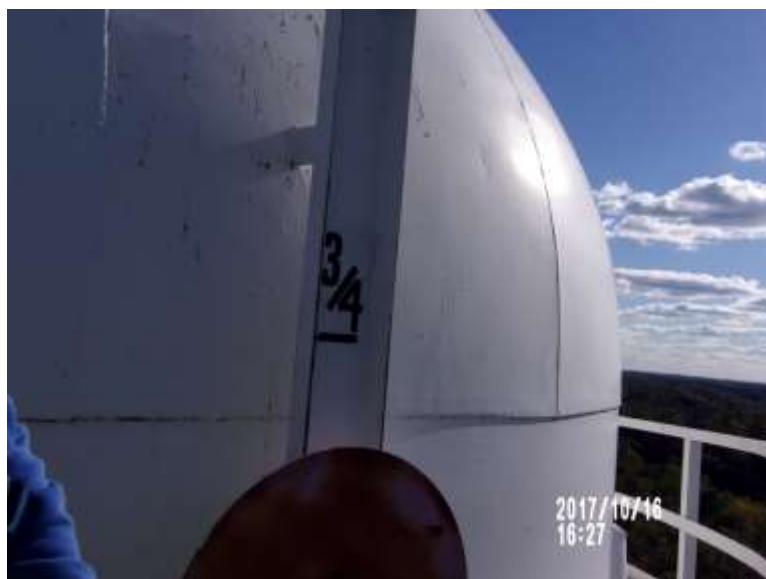
PHOTO SHOWS LIQUID LEVEL INDICATOR

THE LIQUID LEVEL INDICATOR IS BROKEN. WE RECOMMEND TO REPAIR, CLEAN, AND LUBRICATE THE EXISTING LIQUID LEVEL INDICATOR AS NECESSARY IN ACCORDANCE WITH NFPA 22 2013 14.1.8 REQUIREMENTS.

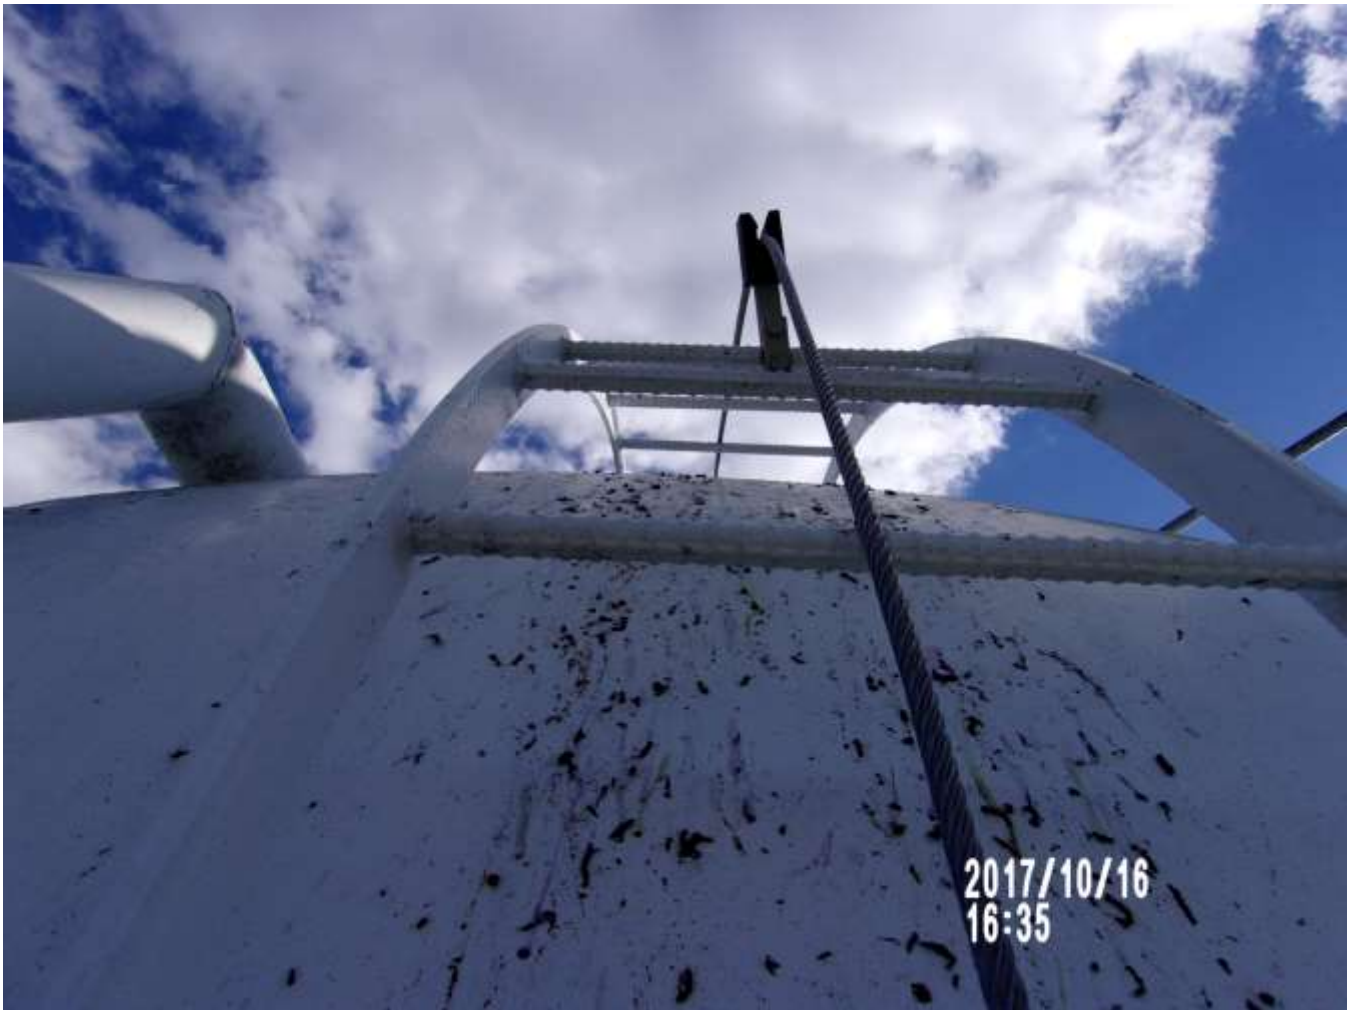
PHOTO SHOWS SHELL LADDER

THE LADDER RUNGS ARE NOT SKID RESISTANT. WE RECOMMEND TO APPLY A SKID RESISTANT COATING TO THE LADDER RUNGS IN ACCORDANCE WITH OSHA REQUIREMENTS.

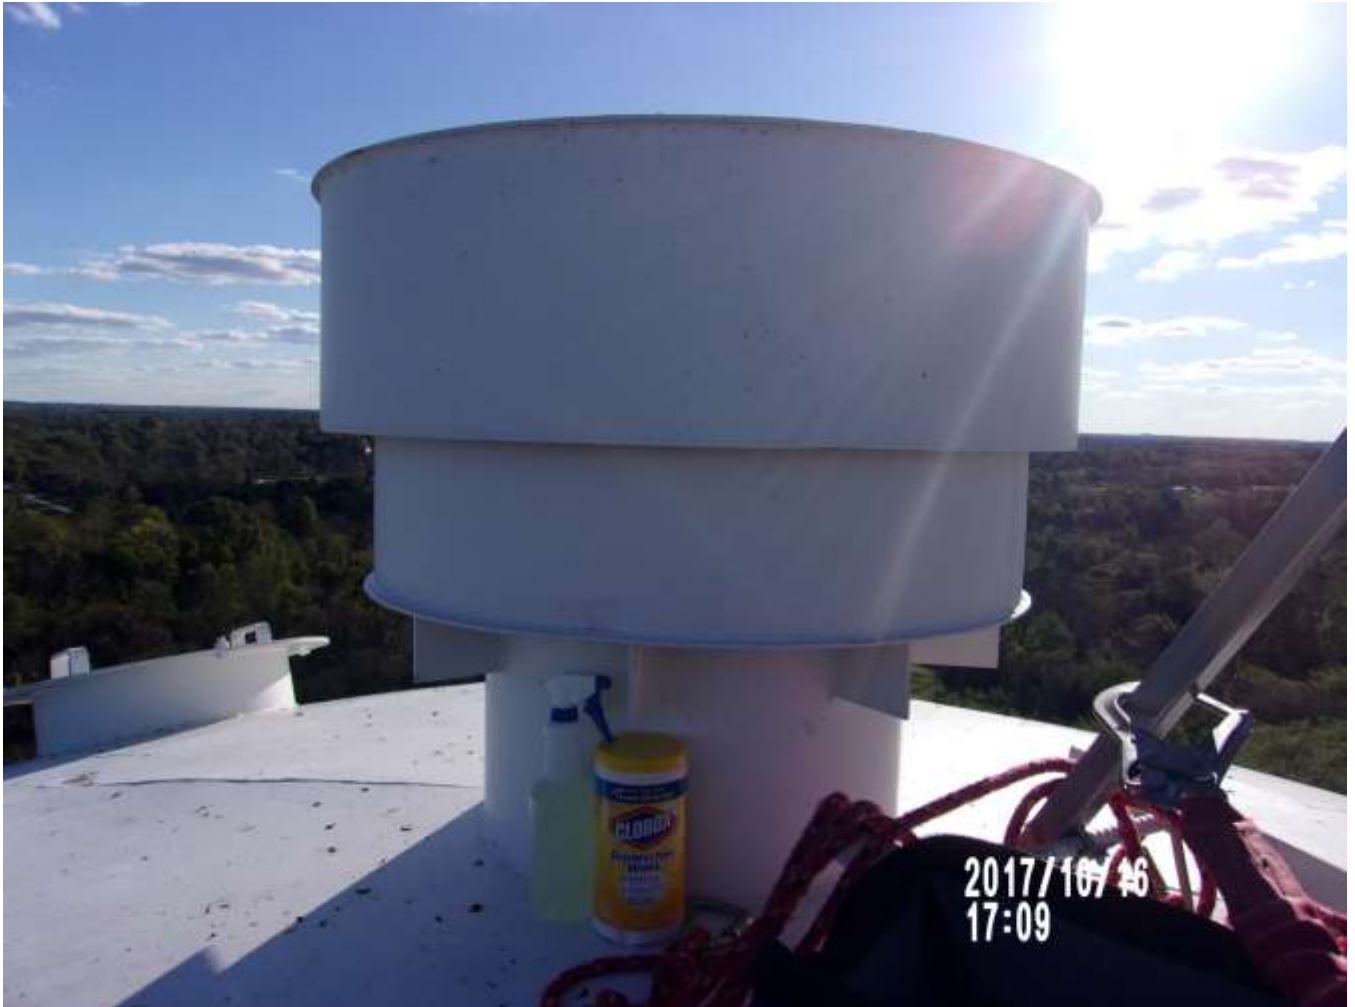
PHOTO SHOWS ROOF VENT

WE RECOMMEND TO REMOVE AND REPLACE THE NON COMPLIANT ROOF VENT WITH A FROST PROOF/PRESSURE PROOF VENT IN ACCORDANCE WITH AWWA D100-11 7.5, 7.5.1 AND 7.5.2 REQUIREMENTS. ADDITIONALLY, WE RECOMMEND TO FURNISH AND INSTALL A FLANGED NECK/NOZZLE BETWEEN ROOF TOP AND THE NEW ROOF VENT TO ALLOW ATTACHMENT OF A VENTILATION FAN IN ACCORDANCE WITH NFPA 22 2013 4.15.11 REQUIREMENTS TO ALLOW REMOVAL OF THE VENT AND ATTACHMENT OF A FAN TO PROVIDE PROPER AIRFLOW AND QUALITY WHILE WELDING, WORKING, SANDBLASTING AND PAINTING INSIDE THE TANK AS WELL AS TO ALLOW PROPER VENTILATION VIA A FAN FOR CURING OF THE INTERIOR COATING.

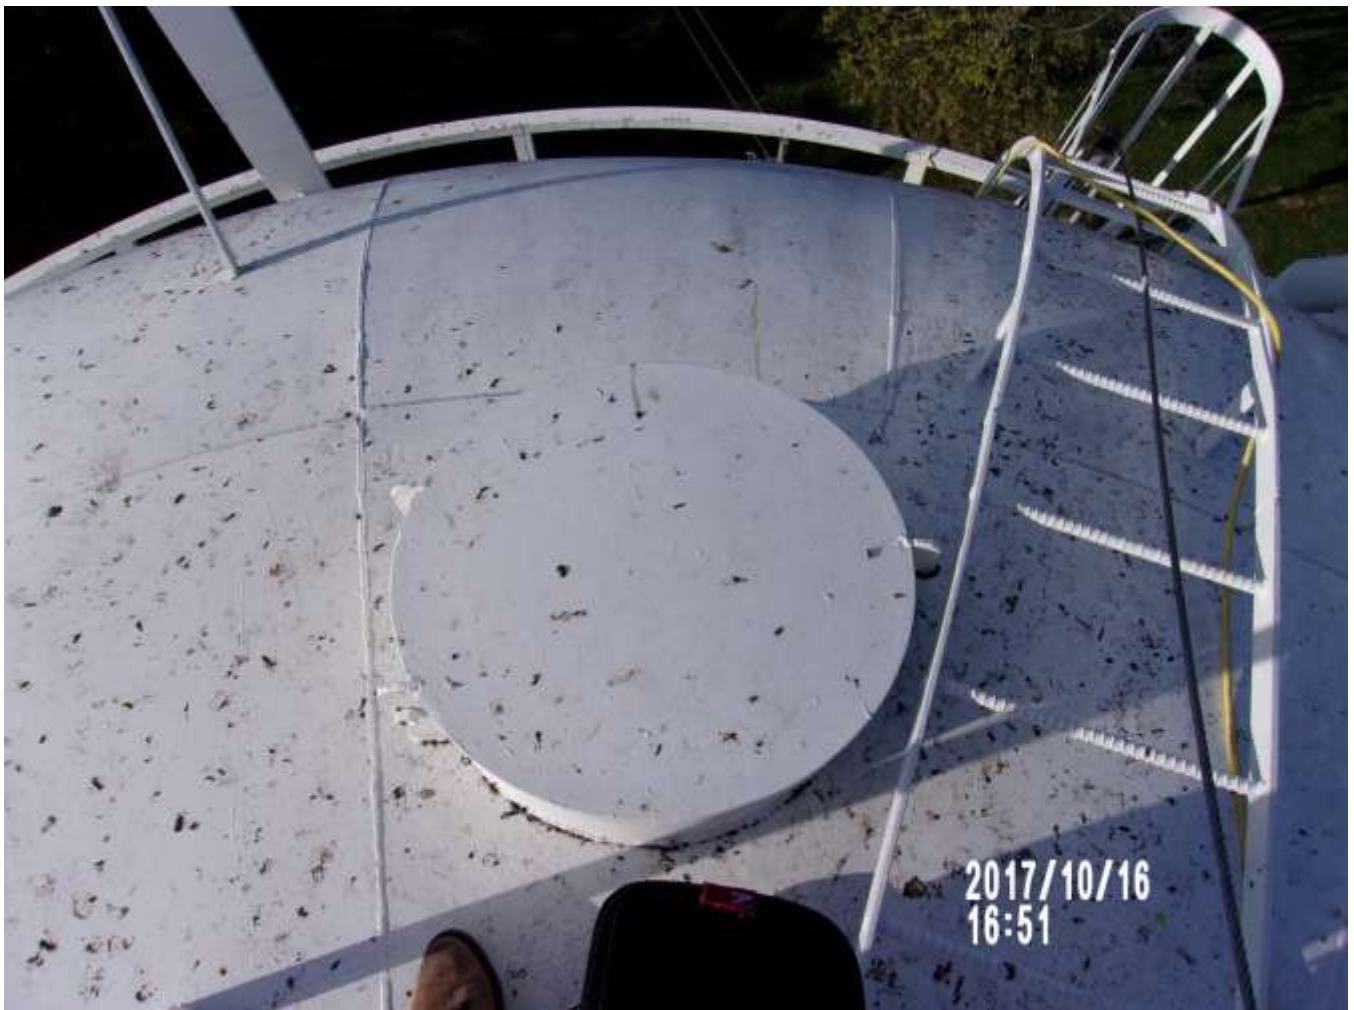
PHOTO SHOWS CLOSED ROOF HATCH

WE RECOMMEND TO REPLACE THE EXISTING ROOF HATCH WITH A 24" X 24" SQUARE HATCH IN ACCORDANCE WITH AWWA D100-11 5.4.3.1, AND NFPA 22 2013 5.7.3.1 REQUIREMENTS.

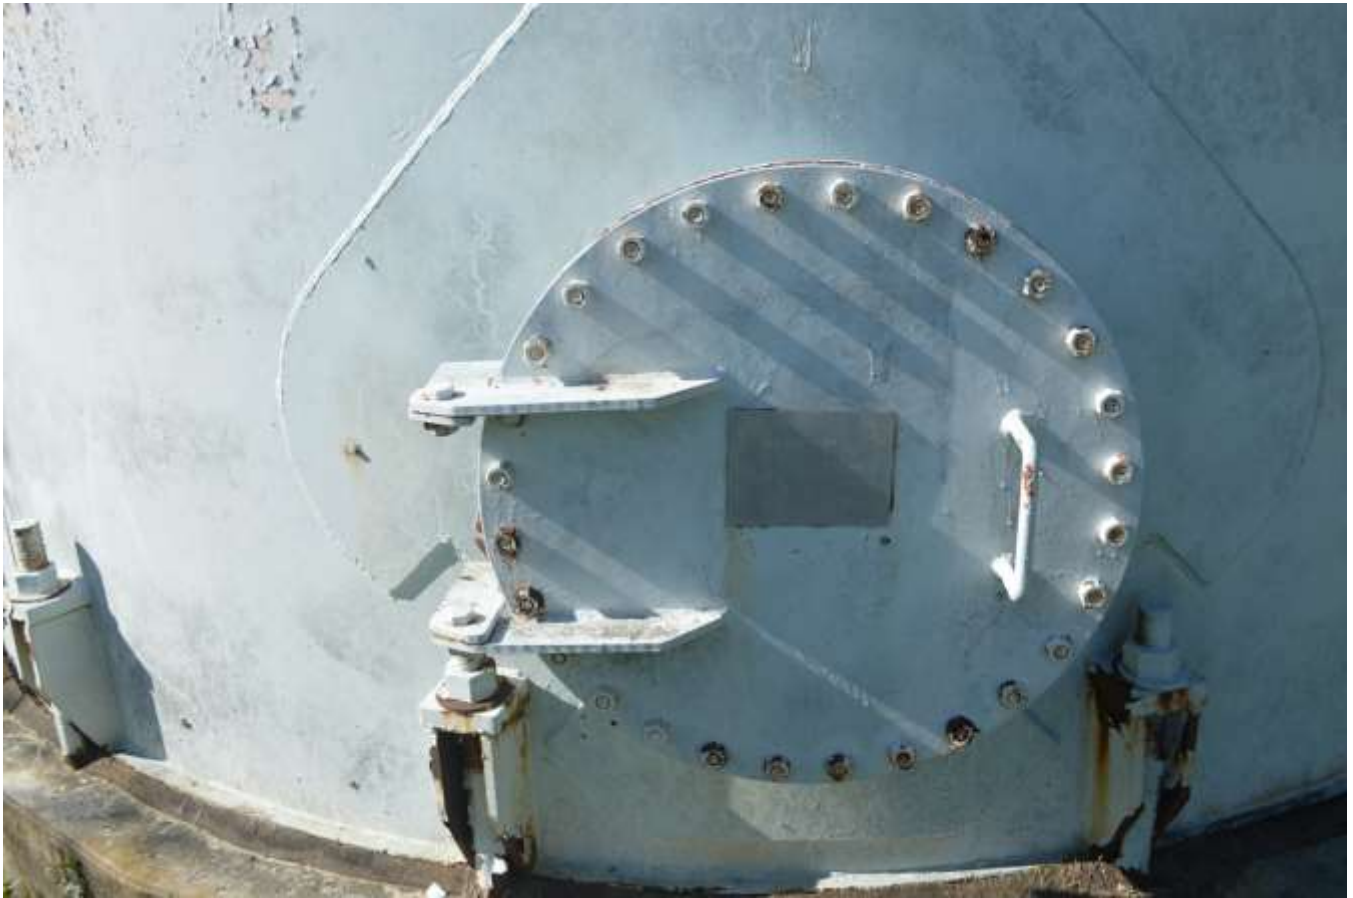
PHOTO SHOWS MANWAY

THE EXISTING MANWAY BOLTS ARE SHOWING SIGNS OF CORROSION, WHICH CAN LEAD TO BOLT FAILURE AND STAINING OF FINISHED SURFACES. WE RECOMMEND TO REPLACE EXISTING BOLTS WITH GALVANIZED BOLTS AS A PREVENTATIVE MEASURE TO ENSURE PROPER FASTENER OPERATION AND TO SAFE GUARD EXTERIOR COATING.

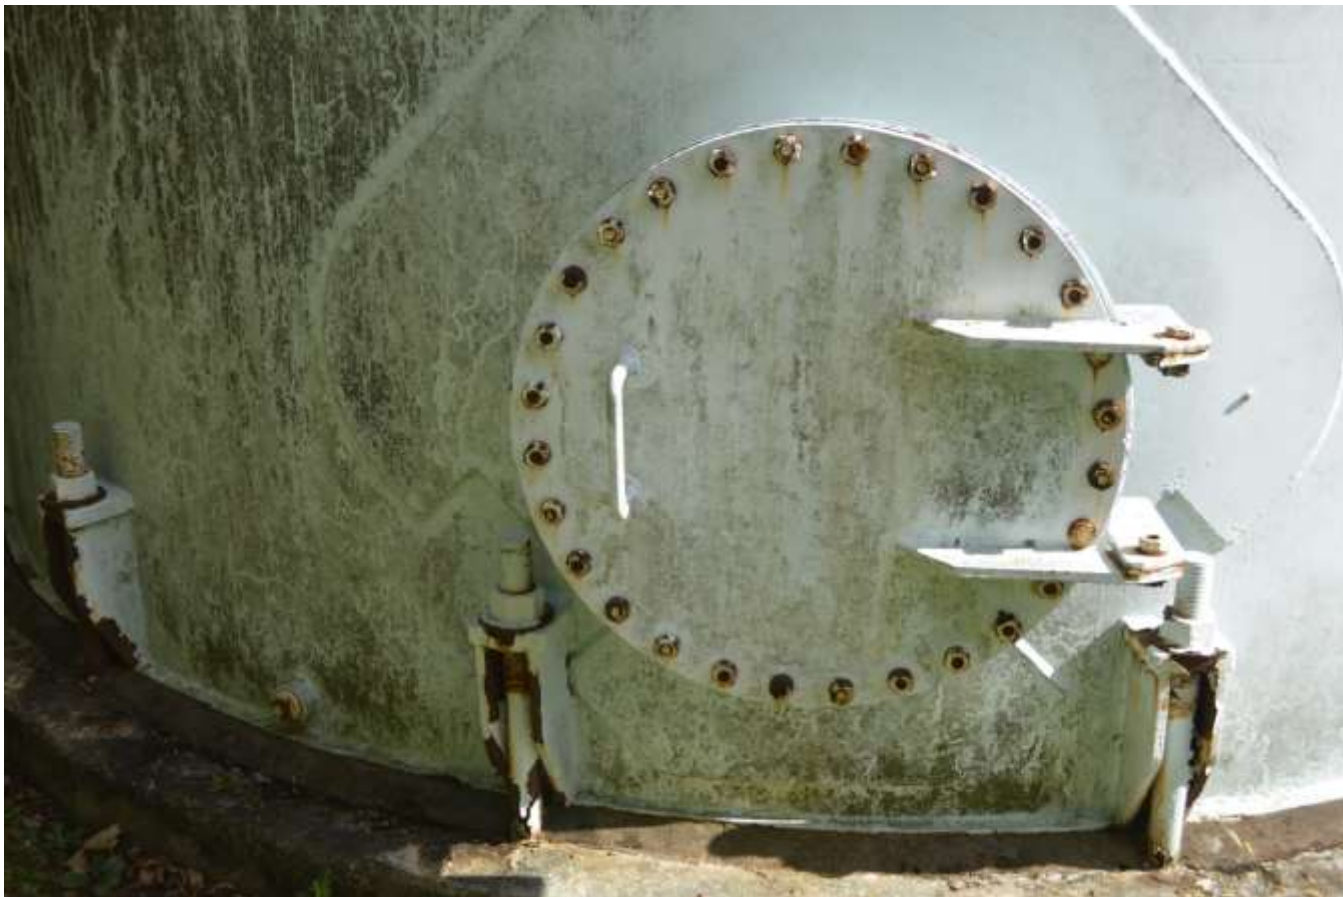
PHOTO SHOWS SECONDARY MANWAY

THE EXISTING MANWAY BOLTS ARE SHOWING SIGNS OF CORROSION, WHICH CAN LEAD TO BOLT FAILURE AND STAINING OF FINISHED SURFACES. WE RECOMMEND TO REPLACE EXISTING BOLTS WITH GALVANIZED BOLTS AS A PREVENTATIVE MEASURE TO ENSURE PROPER FASTENER OPERATION AND TO SAFE GUARD EXTERIOR COATING.

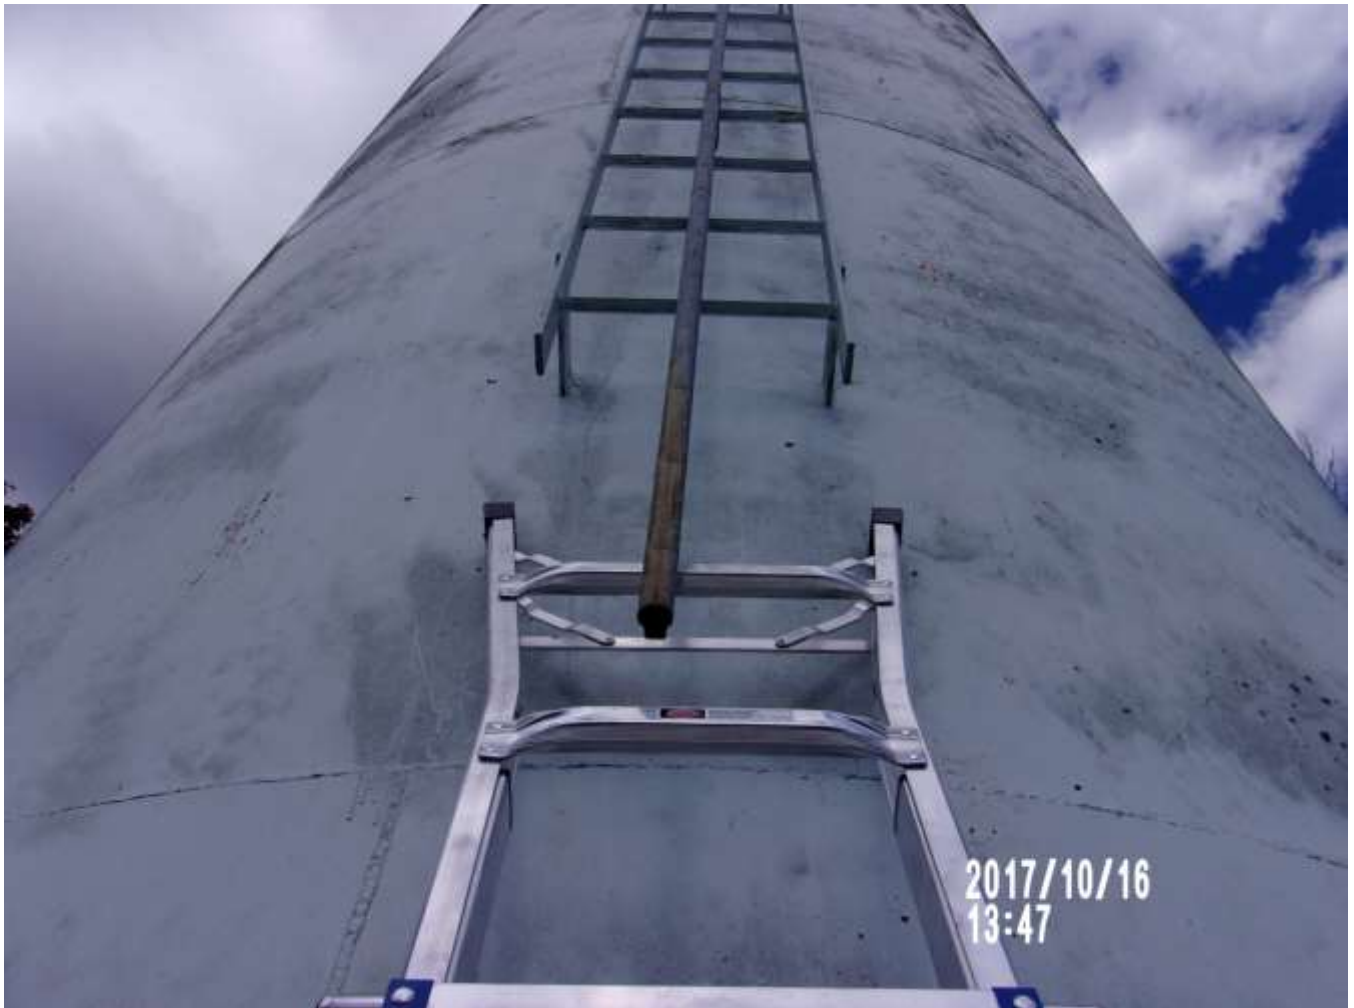
PHOTO SHOWS UPWARD VIEW OF LADDER

THE EXTERIOR LADDER DOES NOT HAVE AN ANTI CLIMB DEVICE INSTALLED. WE RECOMMEND TO FURNISH AND INSTALL A LOCKABLE ANTI CLIMB DEVICE ON THE EXTERIOR LADDER TO PREVENT UNAUTHORIZED ACCESS AND VANDALISM.
