ELECTRONIC INVESTIGATION INTO)
EXCESSIVE WATER LOSS BY KENTUCKY'S) Case No. 2019-00041
JURISDICTIONAL WATER UTILITIES)

**West Carroll Water District
Case No. 2019-00041
Commission Staff's Second Request for Information issued May 3, 2019**

100,000 GALLON ELEVATED WATER TANK

50,000 GALLON ELEVATED WATER TANK

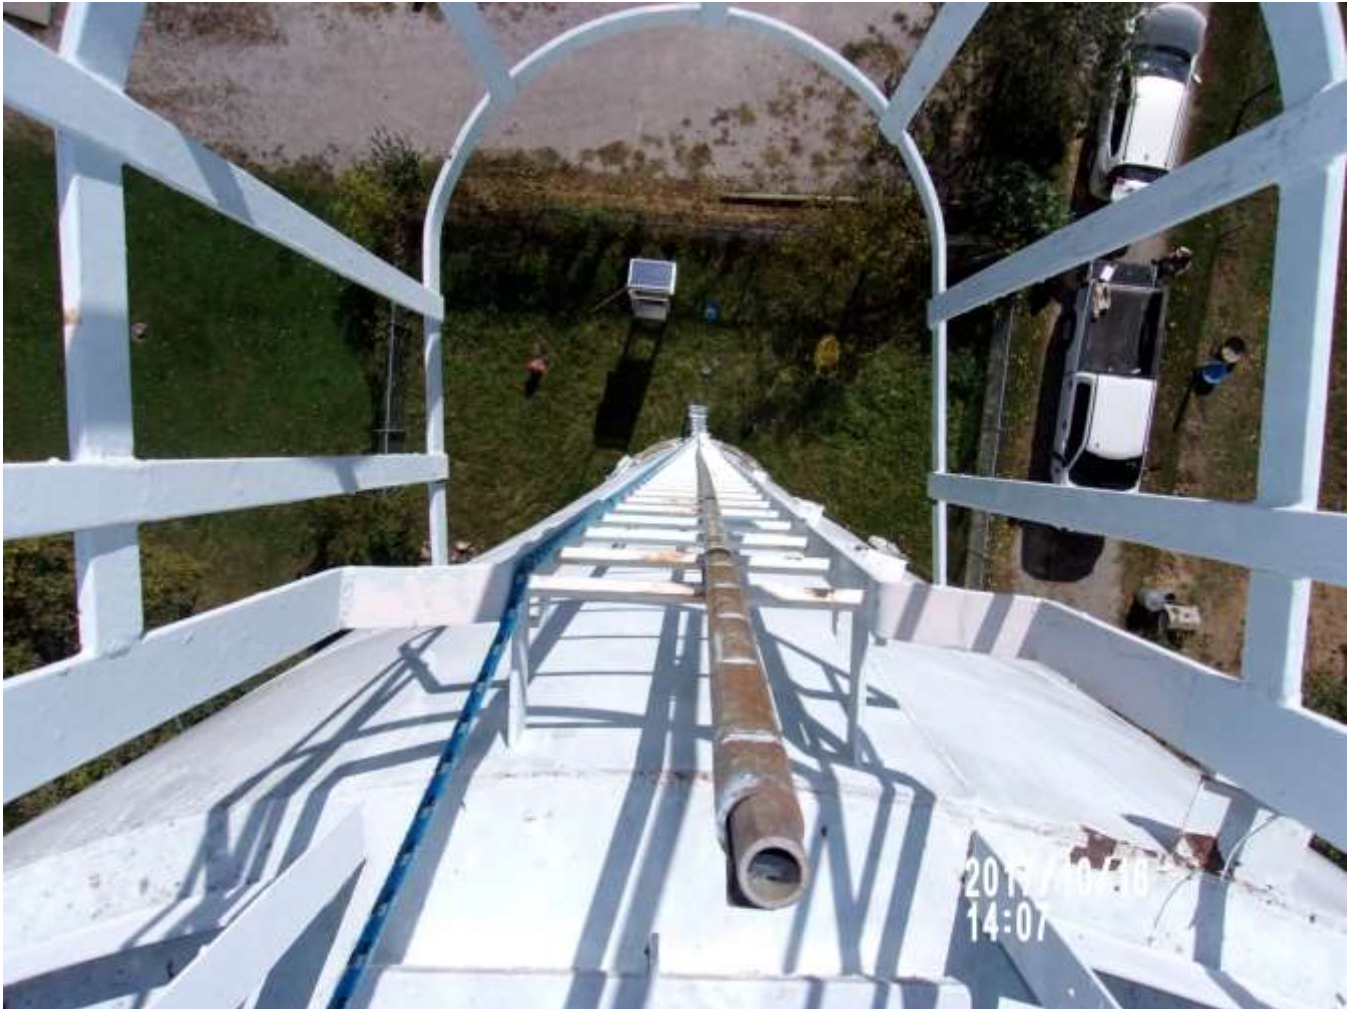
PHOTO SHOWS DOWNWARD VIEW OF LADDER

AS PREVIOUSLY MENTIONED, WE RECOMMEND TO REPLACE THE RAIL TYPE SAFETY CLIMB DEVICE WITH A CABLE TYPE SAFETY CLIMB IN ACCORDANCE WITH OSHA REQUIREMENTS.

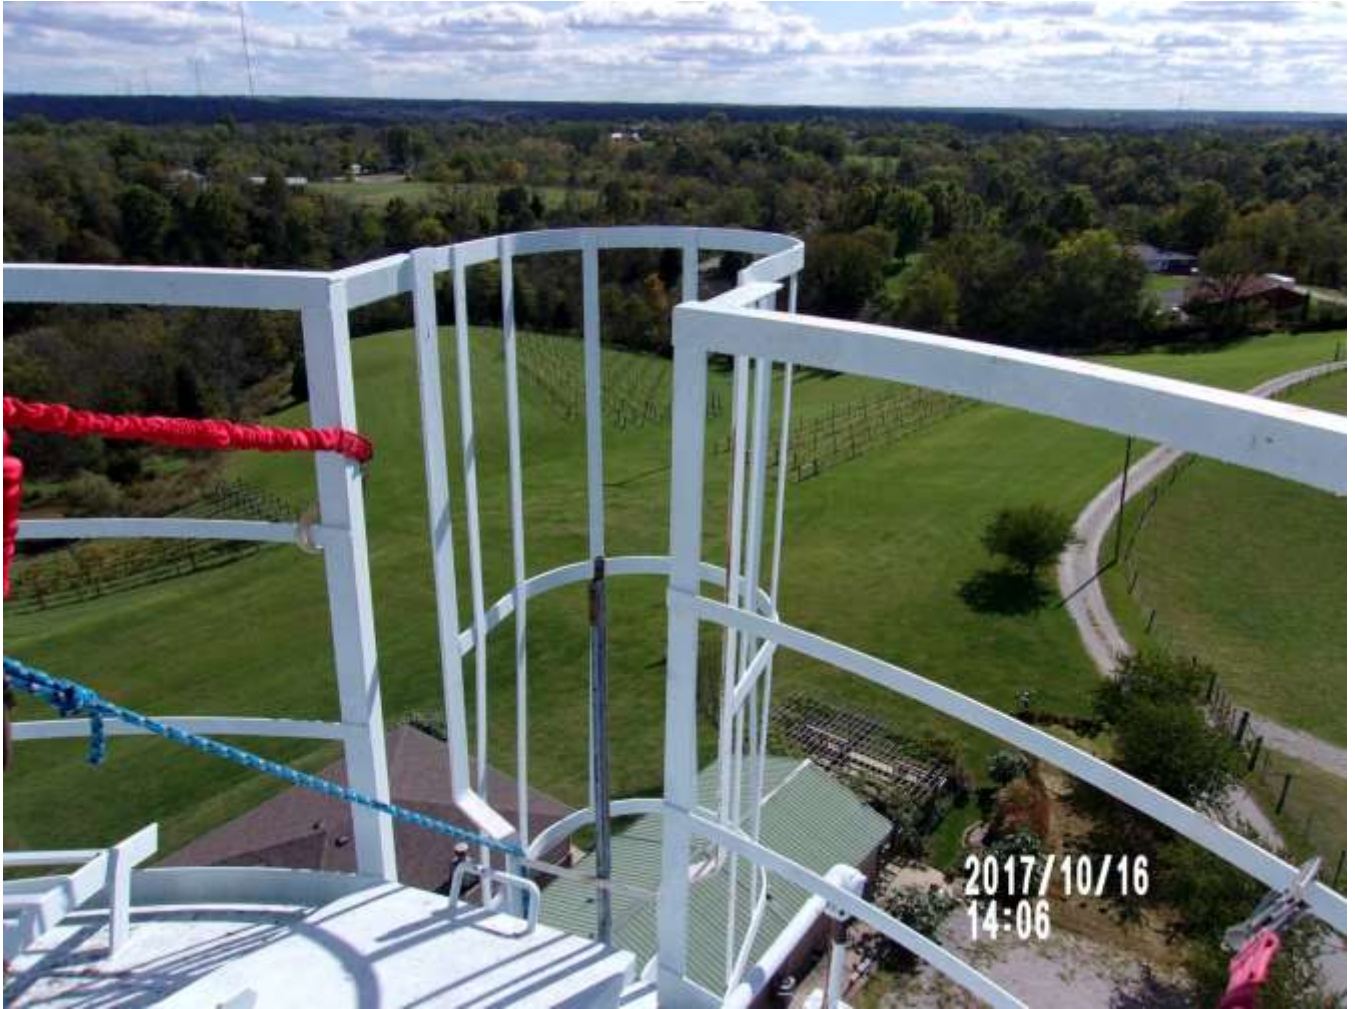
PHOTO SHOWS OPENING OF LADDER

THE LADDER OPENING IS NOT PROTECTED BY A SWING GATE. WE RECOMMEND TO FURNISH AND INSTALL A SWING GATE IN THE HANDRAIL OPENING IN ACCORDANCE WITH OSHA, AWWA D100-11 3.1.7 AND NFPA 22 2013 8.7.9 REQUIREMENTS.

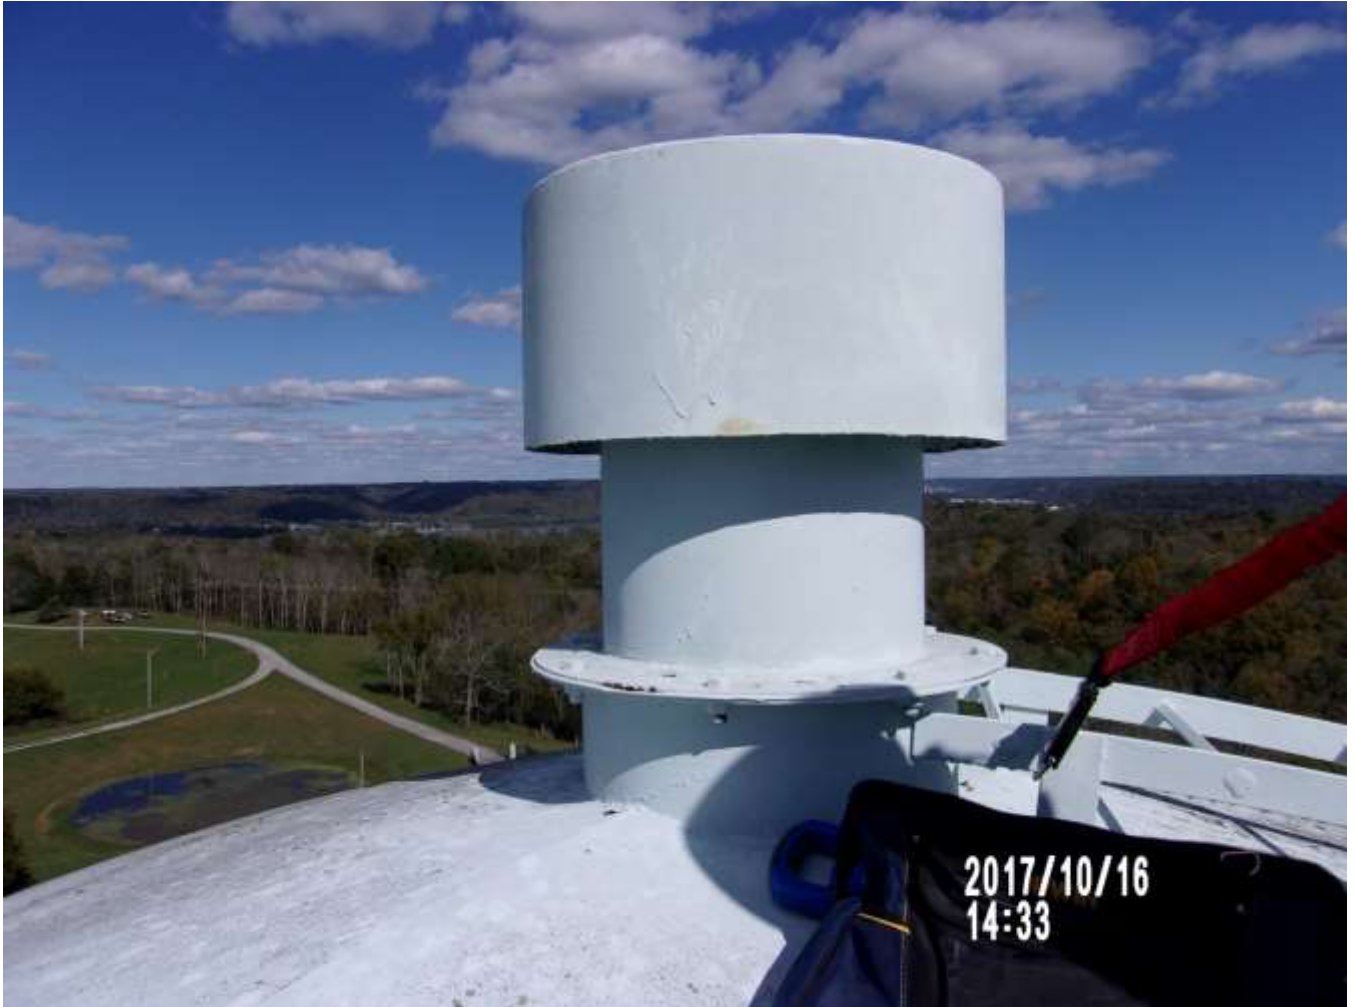
PHOTO SHOWS ROOF VENT

WE RECOMMEND TO REMOVE AND REPLACE THE NON COMPLIANT ROOF VENT WITH A FROST PROOF/PRESSURE PROOF VENT IN ACCORDANCE WITH AWWA D100-11 7.5, 7.5.1 AND 7.5.2 REQUIREMENTS.

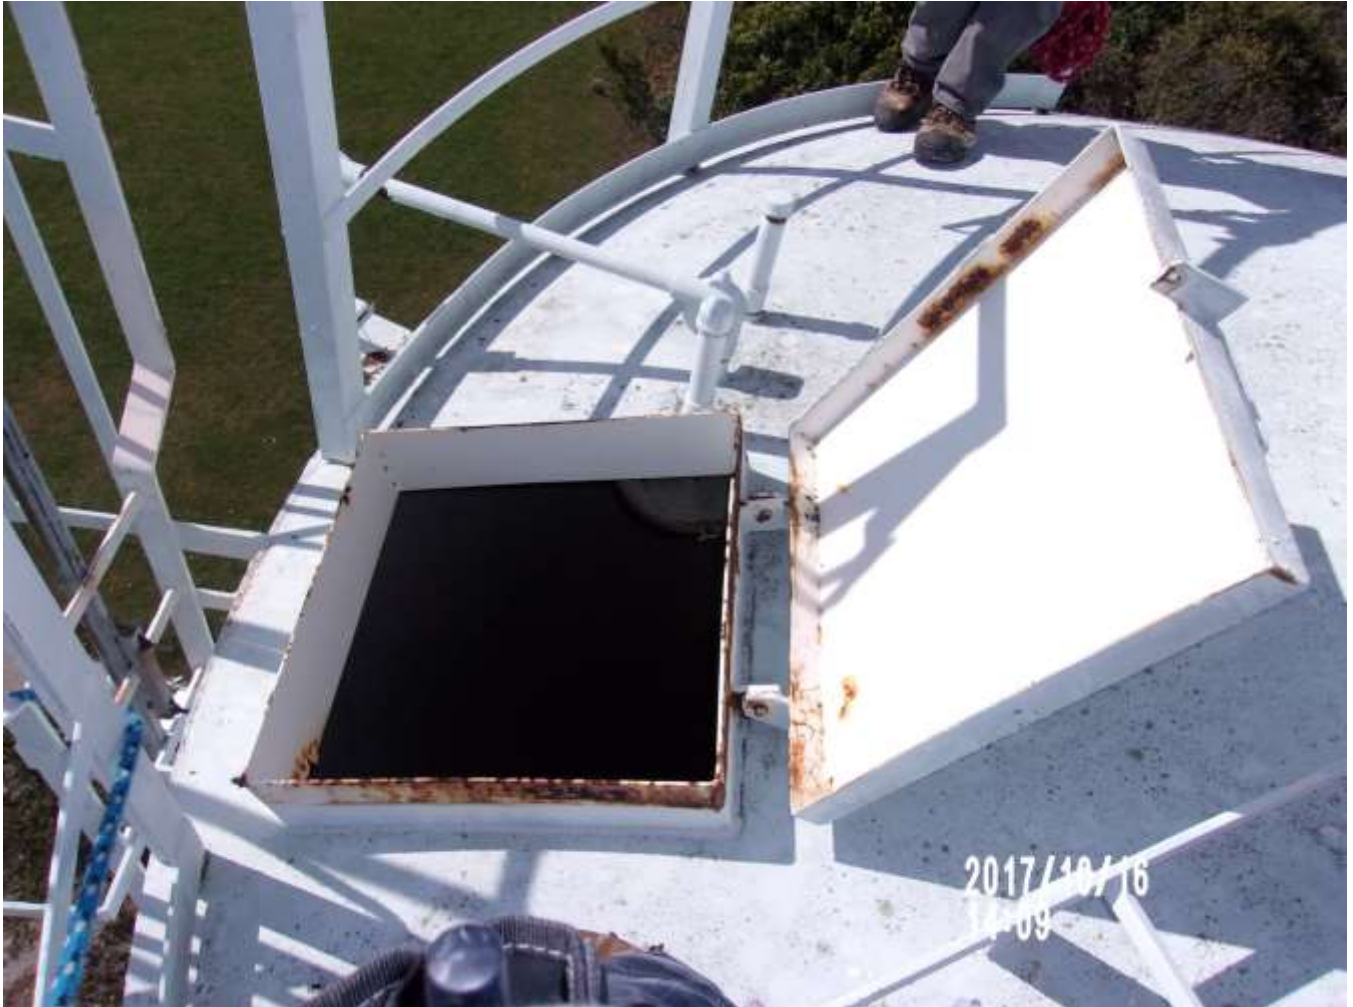
PHOTO SHOWS OPEN VIEW OF PRIMARY ROOF HATCH

THE TANK DOES NOT HAVE AN INTERIOR LADDER INSTALLED. WE RECOMMEND TO FURNISH AND INSTALL AN INTERIOR LADDER WITH SAFETY CLIMB DEVICE IN ACCORDANCE WITH OSHA, AWWA D100-11 5.4.2.5 AND NFPA 22 2013 5.7.4 REQUIREMENTS.

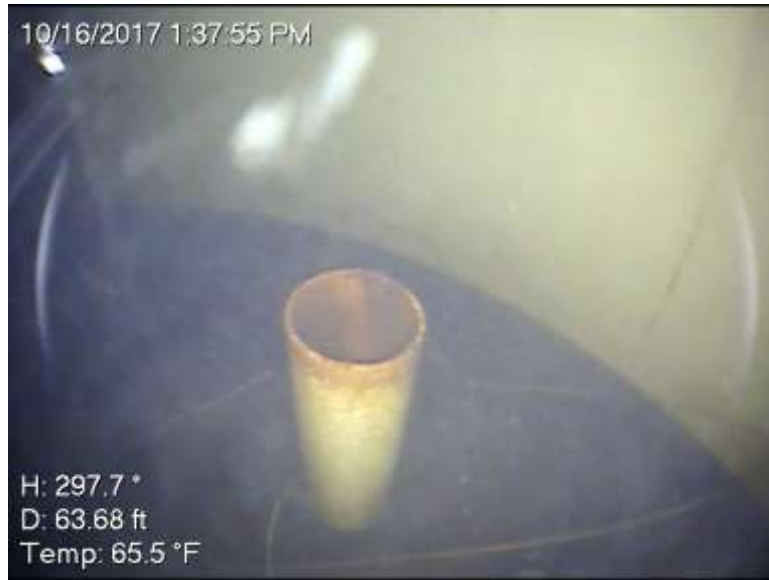
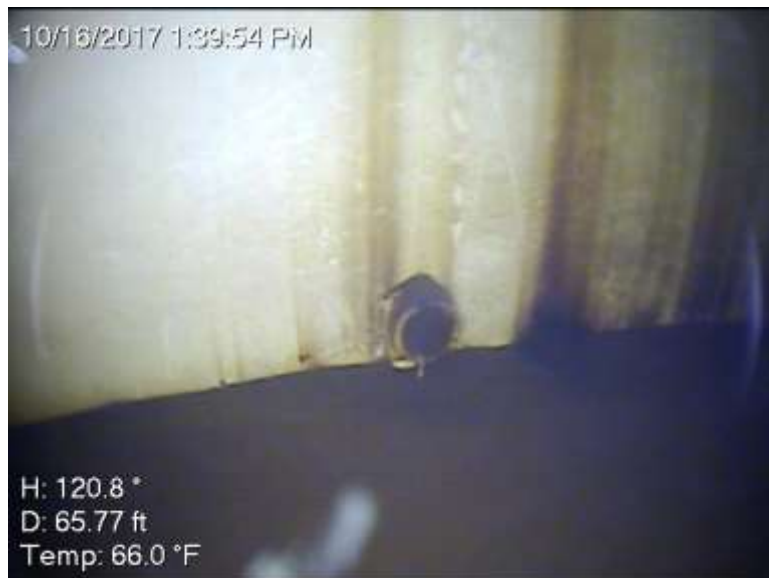
PHOTO SHOWS INLETS / OUTLETS OR PIPING

THE FILL PIPE TERMINATES BELOW THE WATER LEVEL. WE RECOMMEND TO FURNISH AND INSTALL AN OVER THE TOP FILL LINE WITH 90 DEGREE ELBOW AT TERMINATION.
