Corrosion Solutions, LLC
858 Wellington Way
Collierville, TN 3801
Office 901-491-856

November 23, 2021

City of Drakesboro
Honorable Mike Jones
212 Mose Rager Blvd.
Drakesboro, KY 42337

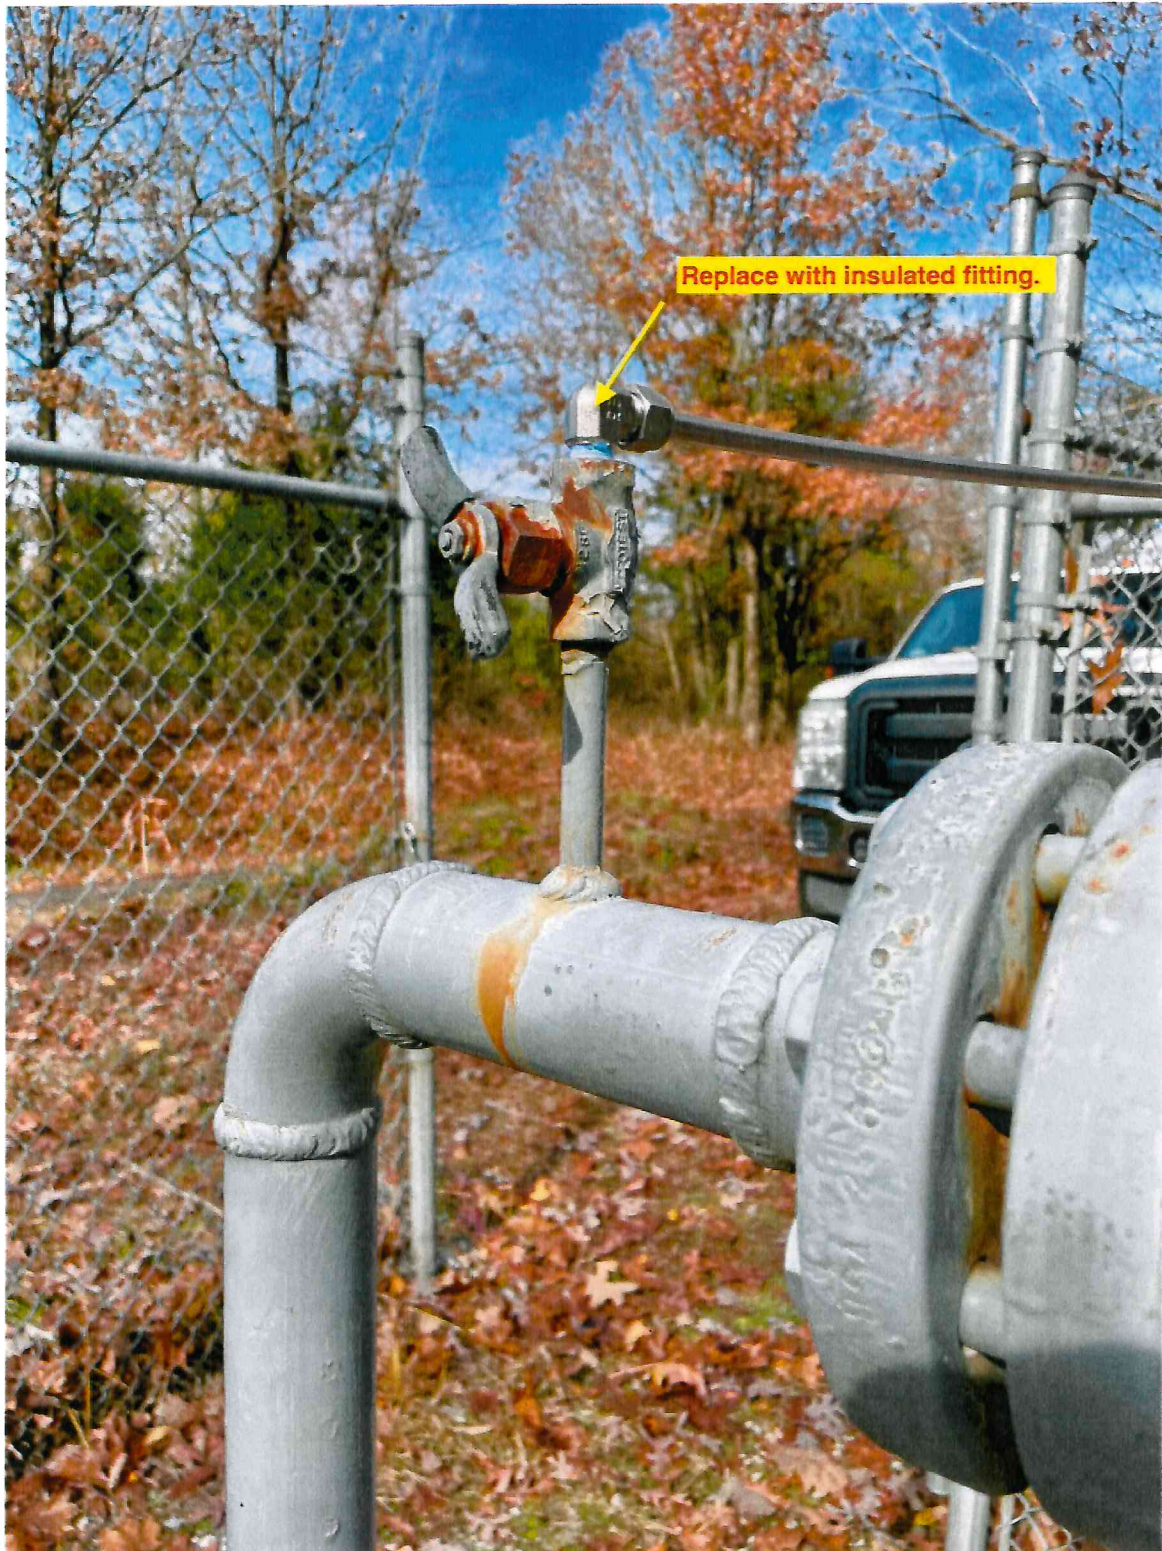
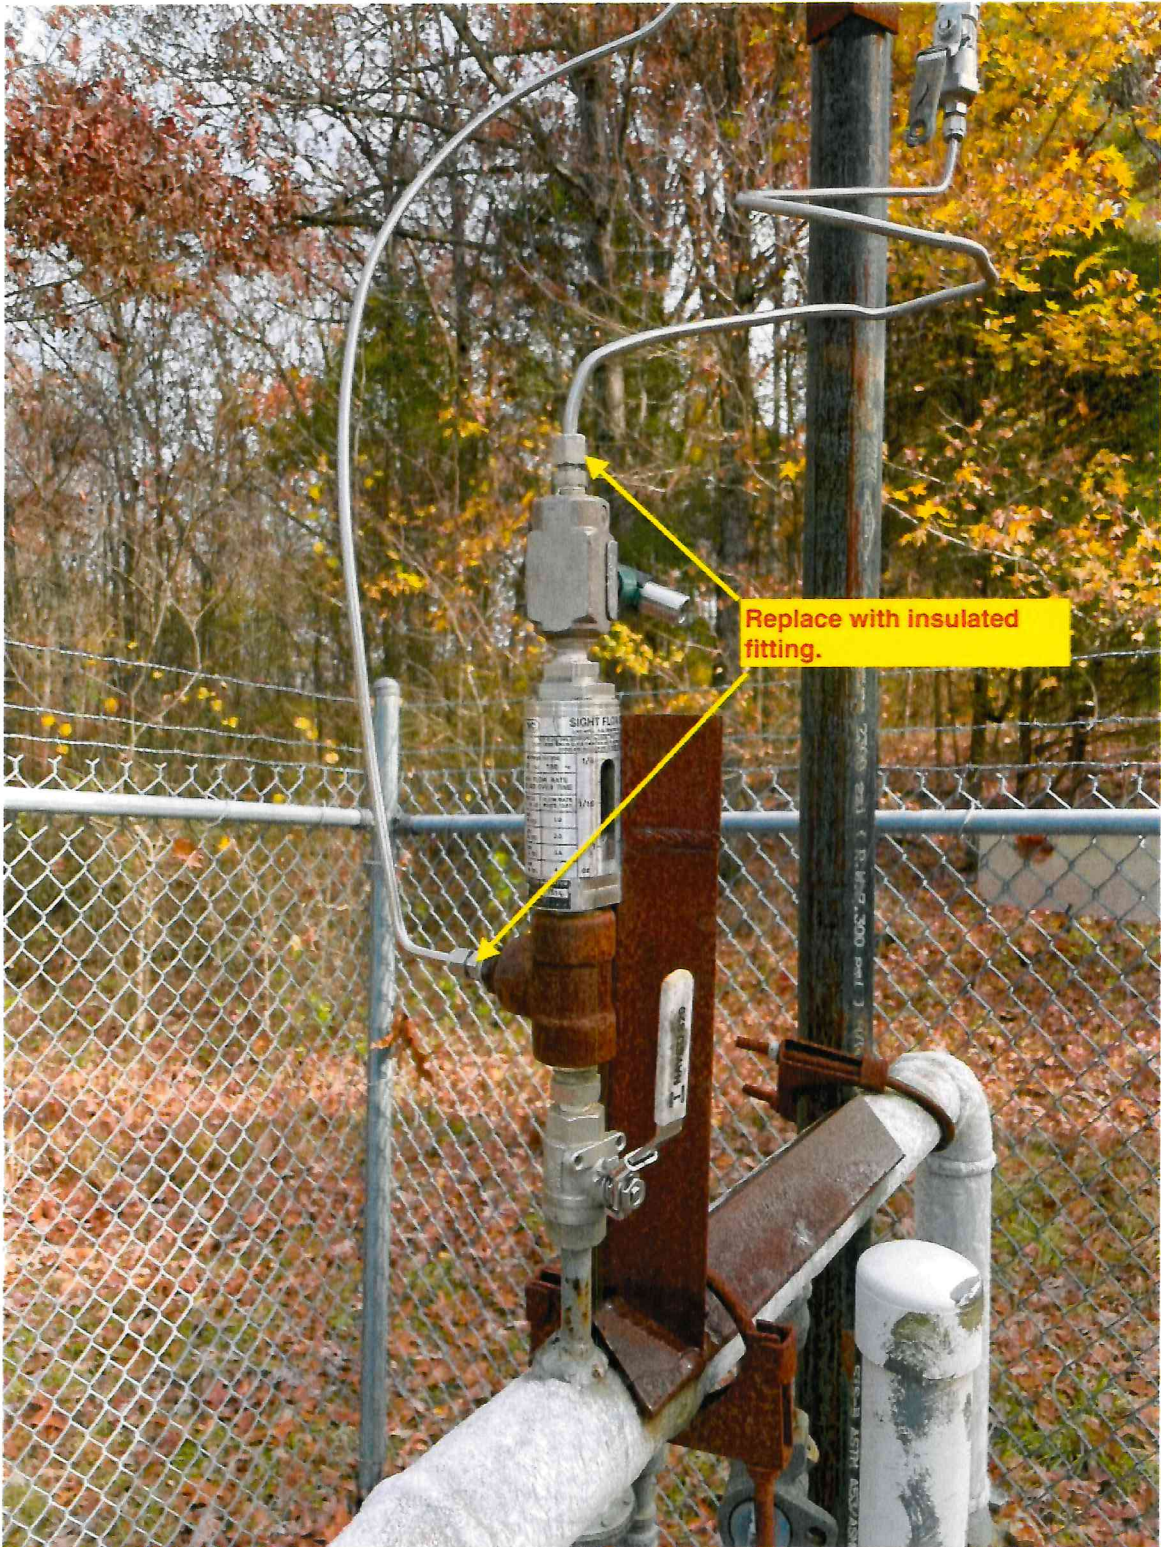
- Purchase Meter Station, gas piping it shorted to security fence and support structure. These issues where shown to Brian and RussMar representative Abe. Control stainless steel tubing fittings should be replaced with insulated (dielectric) fittings as they leave gas piping. Support structure should be isolated from gas piping with heavy-duty rubber and industrial high strength zip ties or equivalent. (See attached pictures)

Replace with insulated fitting.
