RE: Drakesboro Natural Gas Pipeline Excavation and Inspection_2023

DRAKESBORO NATURAL GAS

Highways 431 and 176 Pipeline Inspection Project

Drakesboro, Kentucky

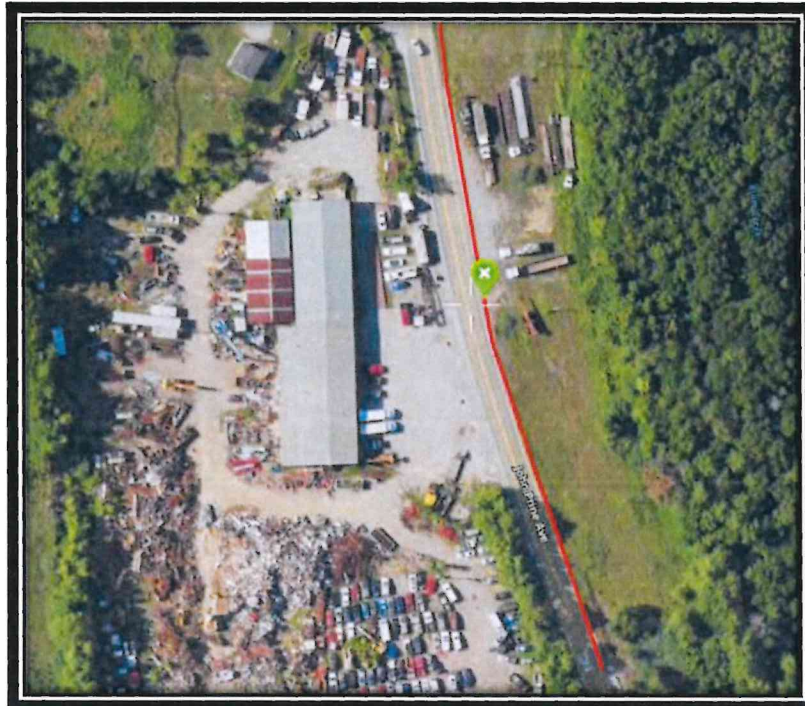
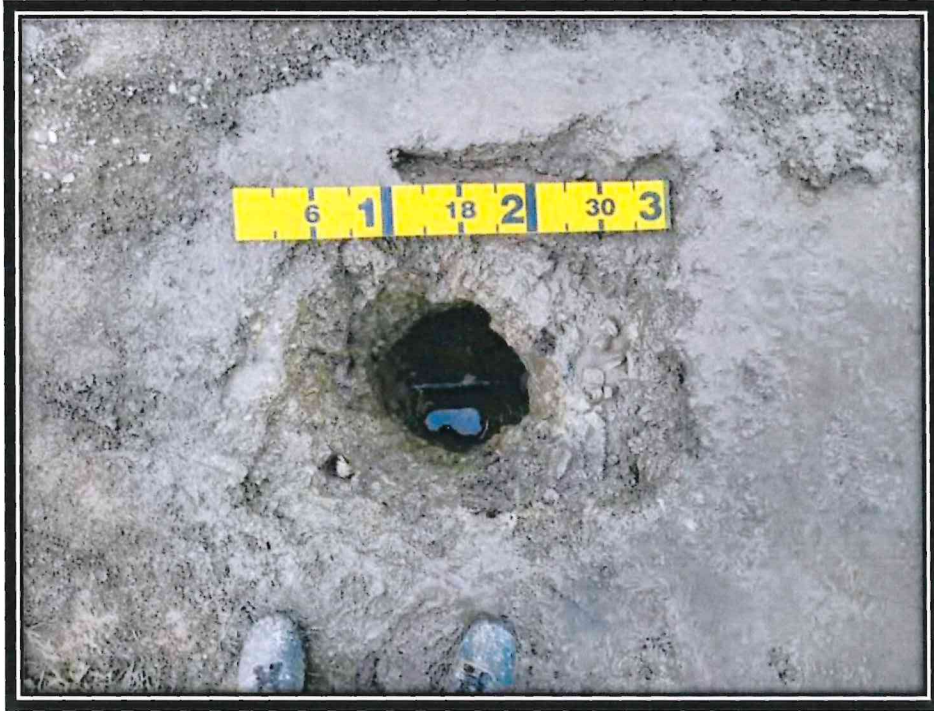
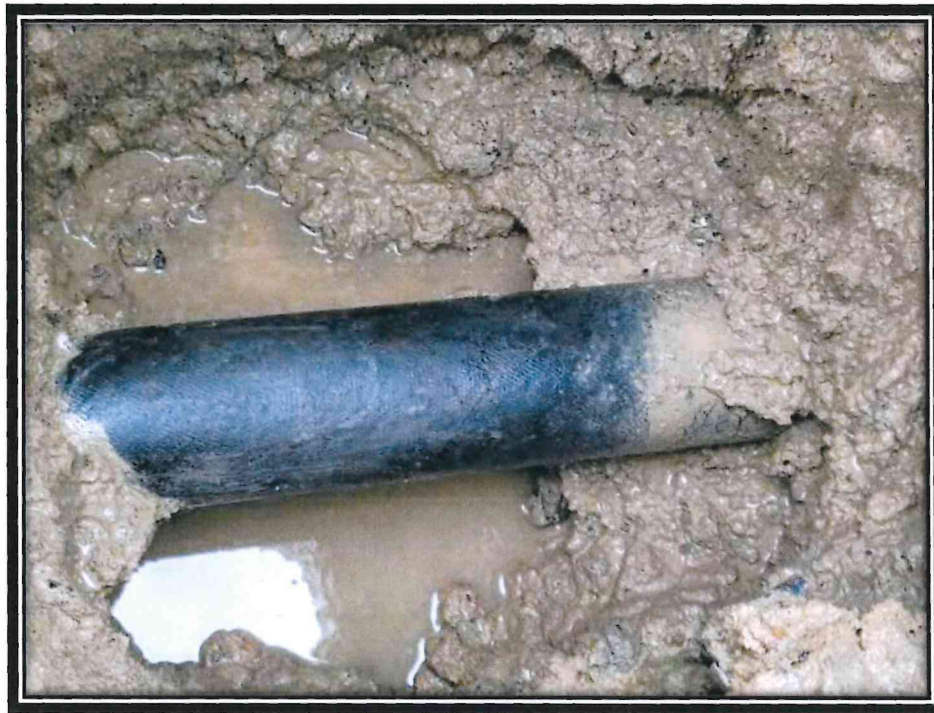
3.1 DIG #1- HIGHWAY 431

Location: Highway 431, Drakesboro, KY
Lat/Long: 37.21332, -87.04461
General: Dig #1 was located on the east side of Highway 431 near Gregory's Recycling, described in the Abacus report as the beginning of the identified segment.
Diameter: 4"
Coating: Coal Tar
Findings: The section of pipe exposed was about 12" in length and approximately 38" deep. The coating was in good condition, showed no signs of disbondment, and no holidays were observed. No other equipment, fittings, or welds were exposed at this location. No corrosion was identified on this section of pipe.

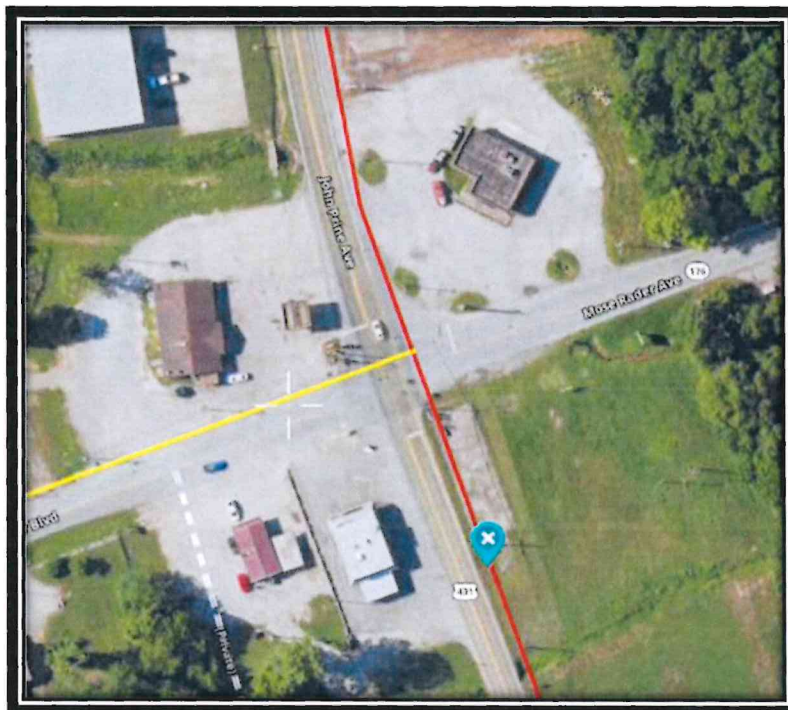
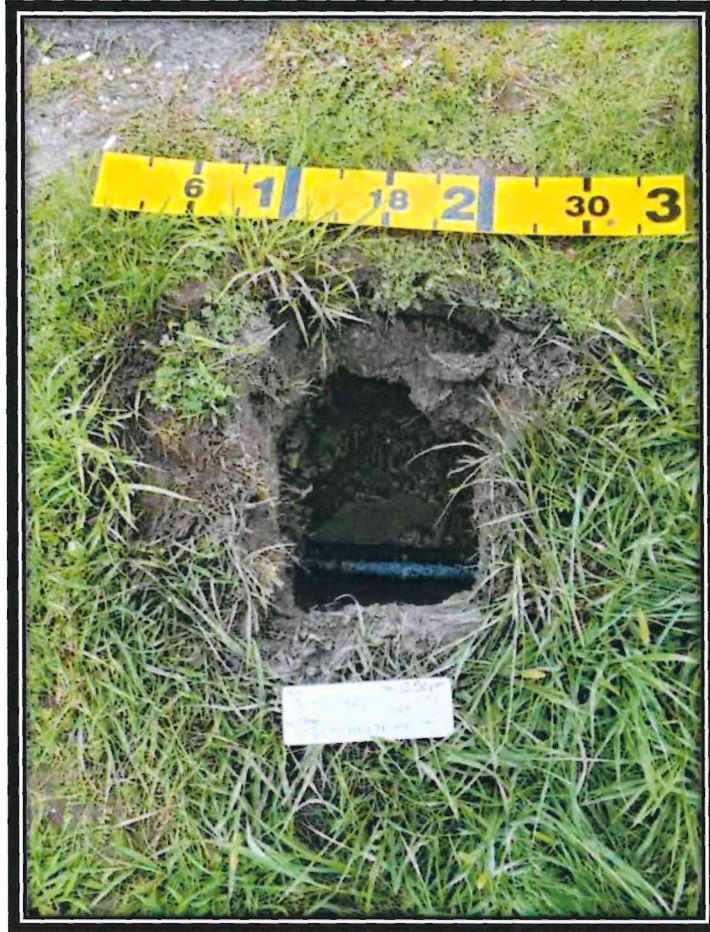
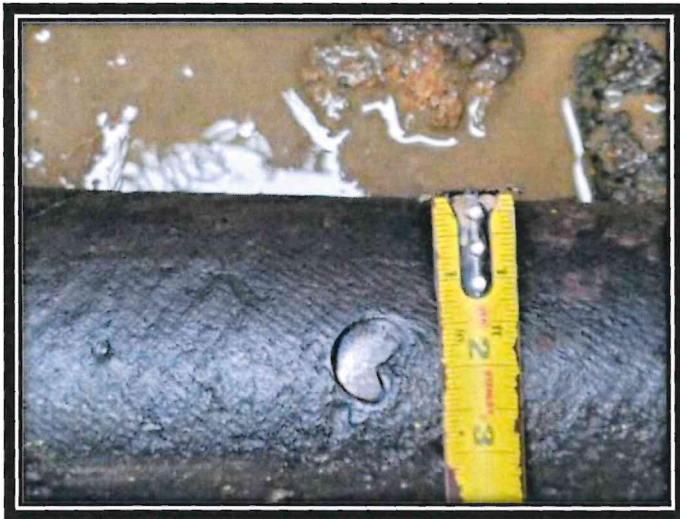
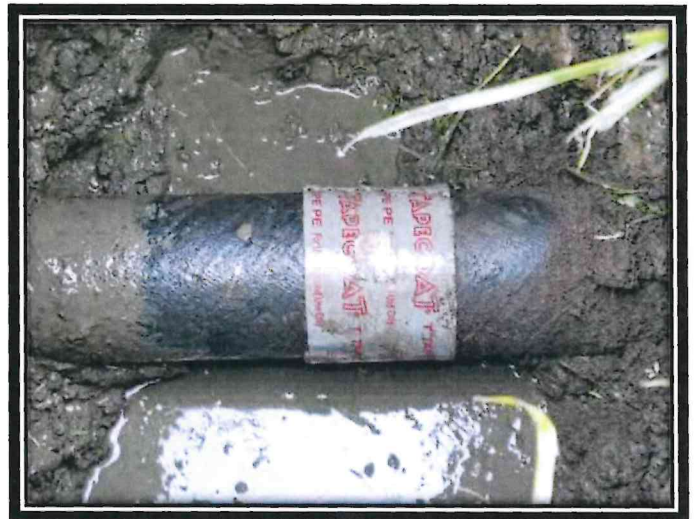
3.2 DIG #2- HIGHWAYS 431 AND 176

Location: Highways 431 and 176, Drakesboro, KY
Lat/Long: 37.21840, -87.04568
General: Dig #2 was located on the east side of Highway 431 across from Country Boy Liquors, approximately 150 feet south of the intersection of Highways 431 and 176.
Diameter: 4"
Coating: Coal Tar
Findings: The section of pipe exposed was about 18" in length and approximately 28" deep. The coating was in good condition and showed no signs of disbondment. One holiday (missing coating), approximately ½" x 1", was identified on the exposed pipe. The pipe surface was smooth and showed no indications of corrosion. No other equipment, fittings, or welds were exposed at this location. A pipe-to-soil reading of 0.923 Vdc taken directly on the pipe indicates it is adequately protected against corrosion. The holiday was cleaned and recoated with TapeCoat.

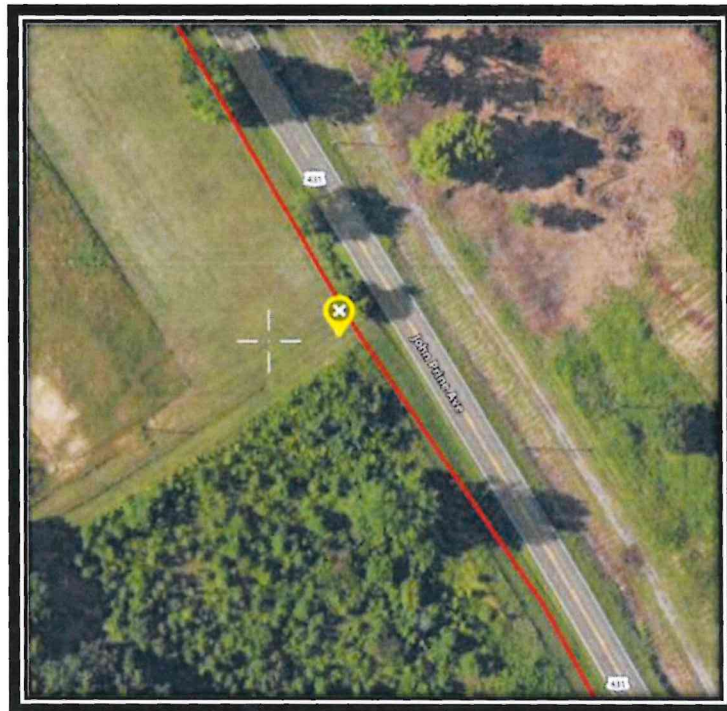
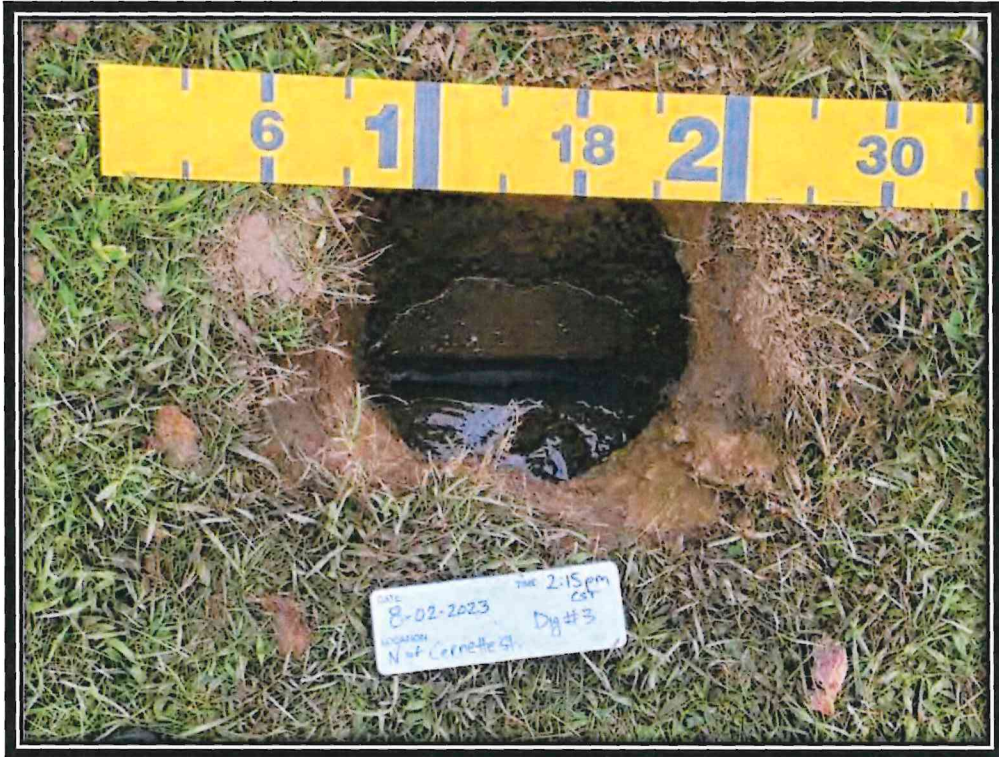
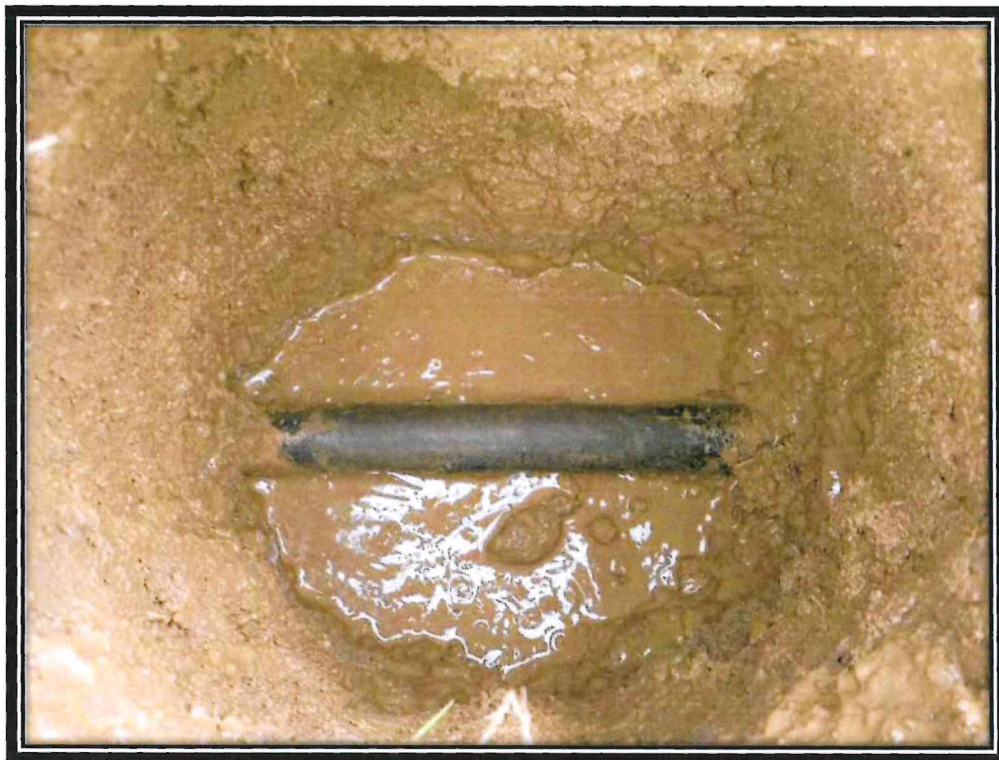
3.3 DIG #3- SOUTH OF CORNETTE STREET

Location: South of Cornette Street, Drakesboro, KY
Lat/Long: 37.22276, -87.04782
General: Dig #3 was located on the west side of Highway 431, approximately 725 feet south and east of Cornette Street and near the end of the segment identified in the Abacus report.
Diameter: 2"
Coating: Coal Tar
Findings: The section of pipe exposed was about 14" in length and approximately 32" deep. The coating was in good condition, showed no signs of disbondment, and no holidays were observed. No other equipment, fittings, or welds were exposed at this location. No corrosion was identified on this section of pipe.

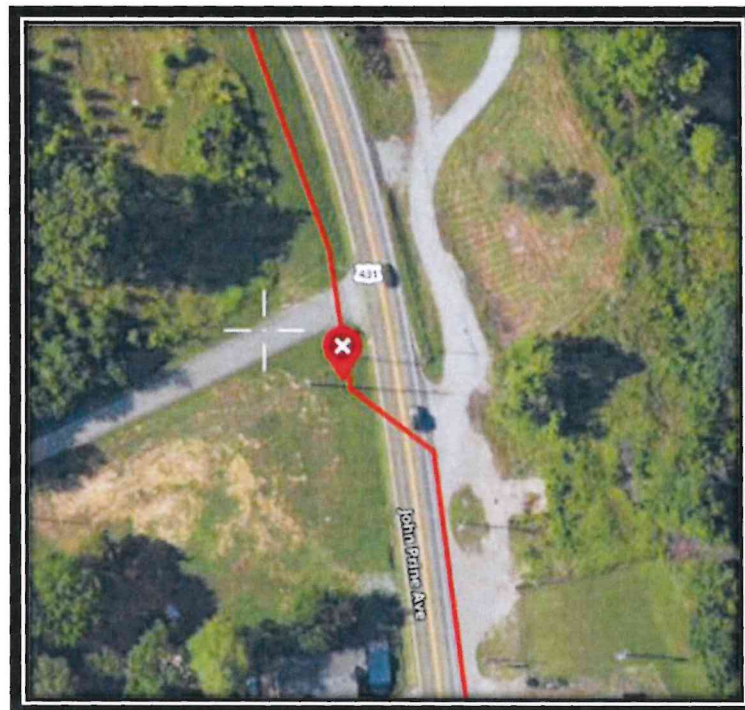
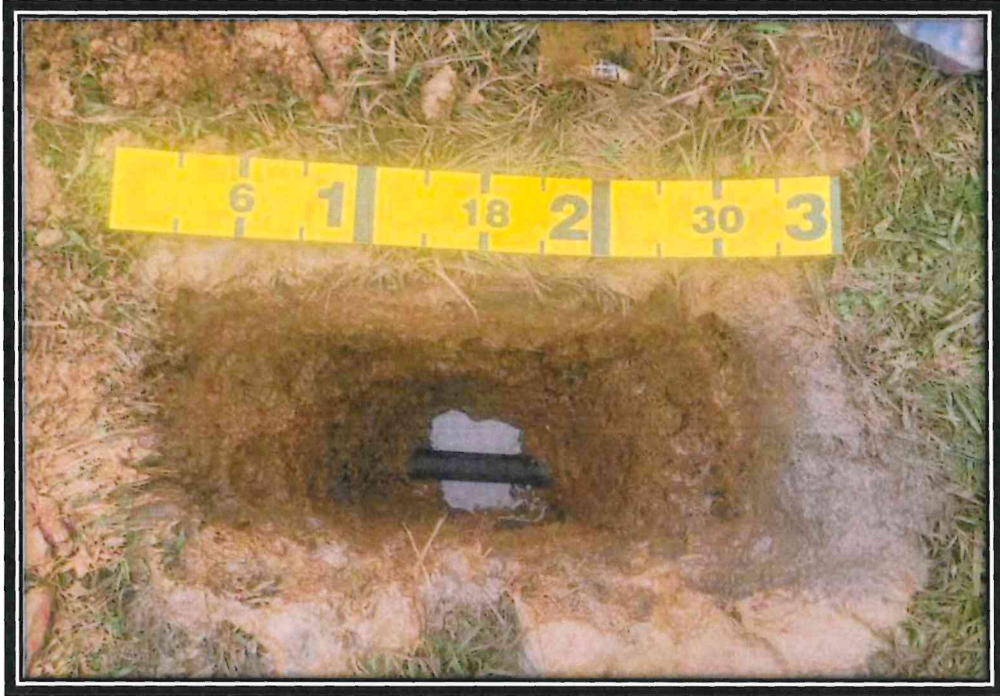
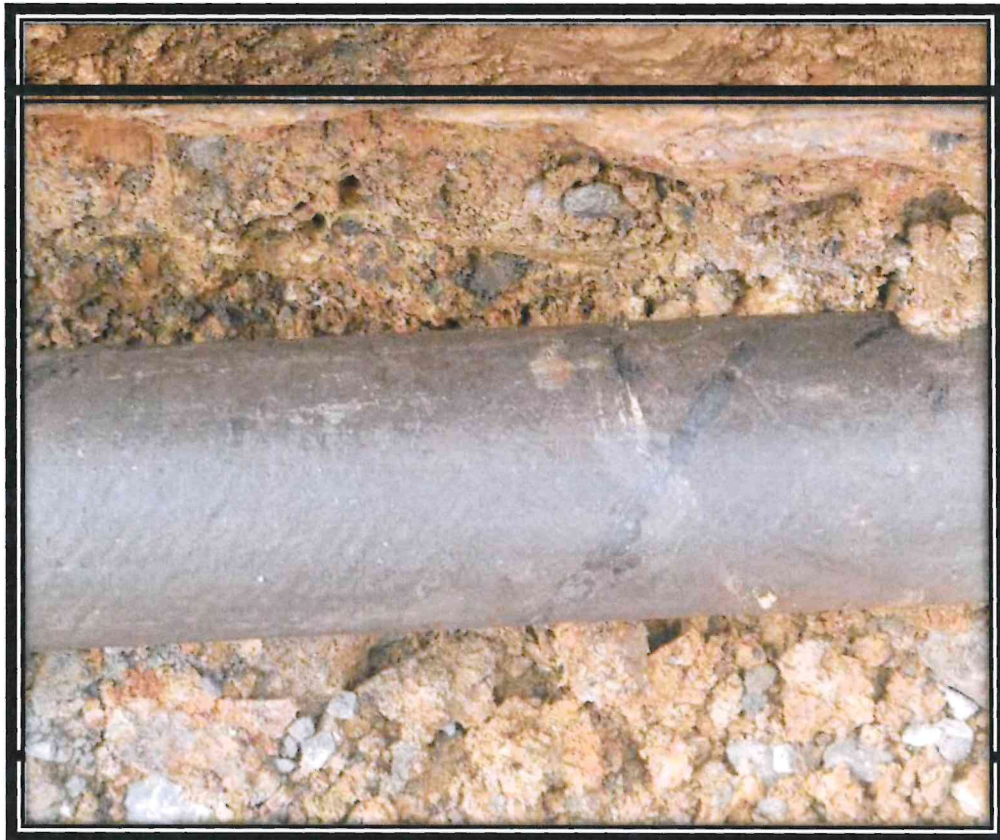
3.4 DIG #4- BROAD STREET AND HIGHWAY 431 (JOHN PRINE AVE)

Location: Broad Street, Drakesboro, KY
Lat/Long: 37.22066, -87.04647
General: Dig #4 was located near the intersection of Broad Street and Highway 431 (John Prine Ave). It was located south of Broad Street and West of Highway 431.
Diameter: 2"
Coating: Coal Tar
Findings: The section of pipe exposed was about 12" in length and approximately 32" deep. The coating was in good condition, showed no signs of disbondment, and no holidays were observed. No other equipment, fittings, or welds were exposed at this location. No corrosion was identified on this section of pipe.

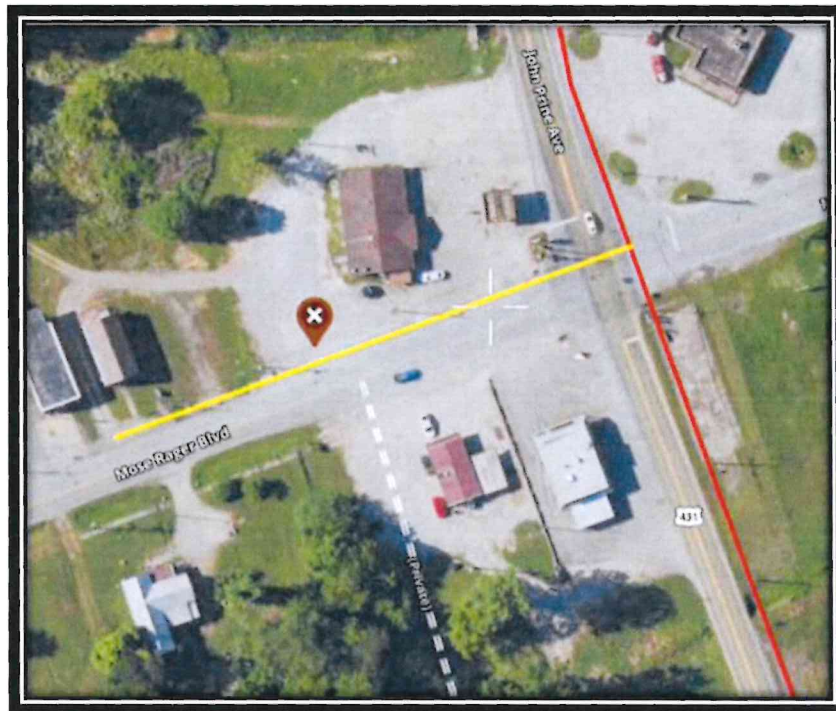
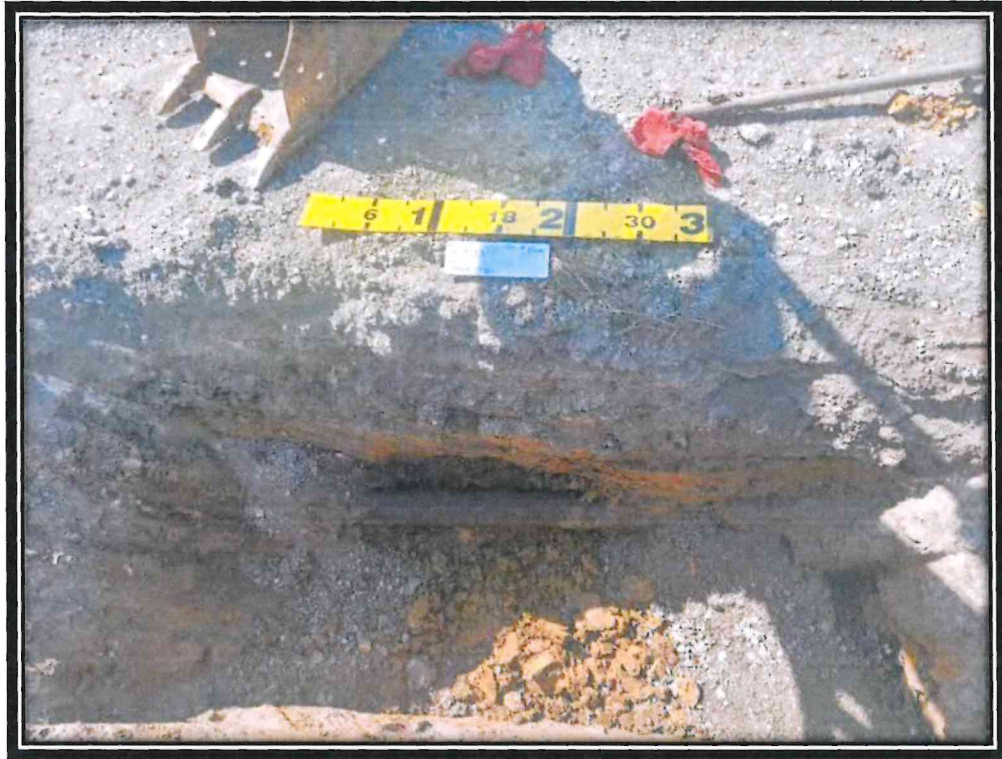
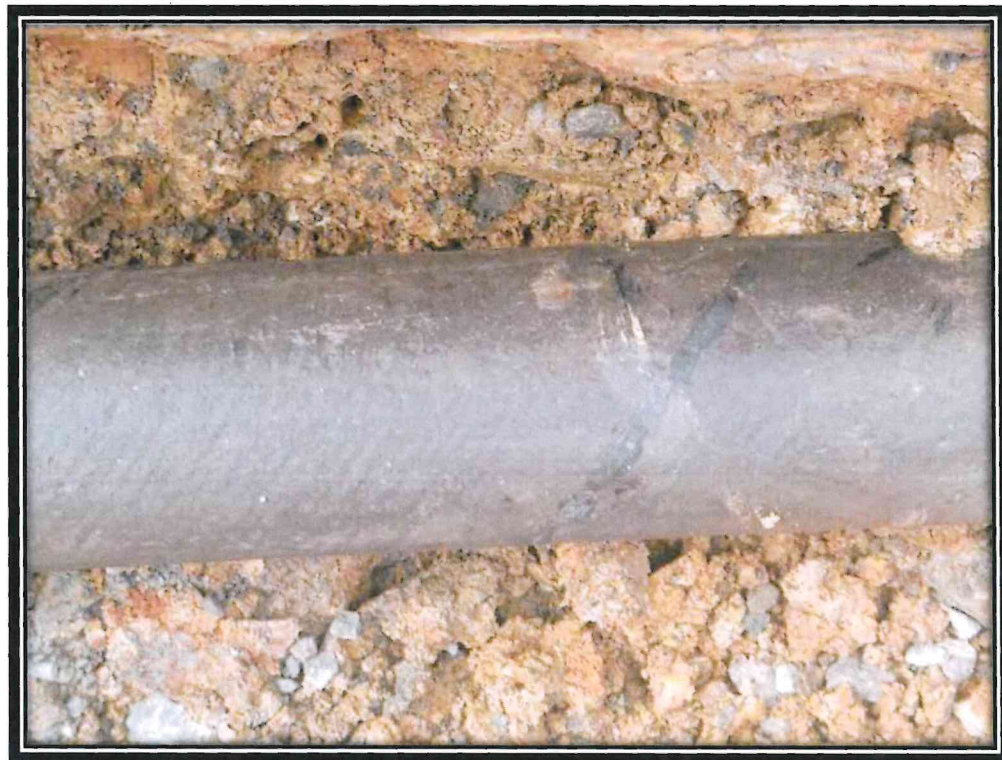
3.5 DIG #5- HIGHWAY 176 (NEAR USPS)

Findings: The section of pipe exposed was about 36" in length and approximately 33" deep. The coating was in good condition, showed no signs of disbondment, and no holidays were observed. No other equipment, fittings, or welds were exposed at this location. No corrosion was identified on this section of pipe.

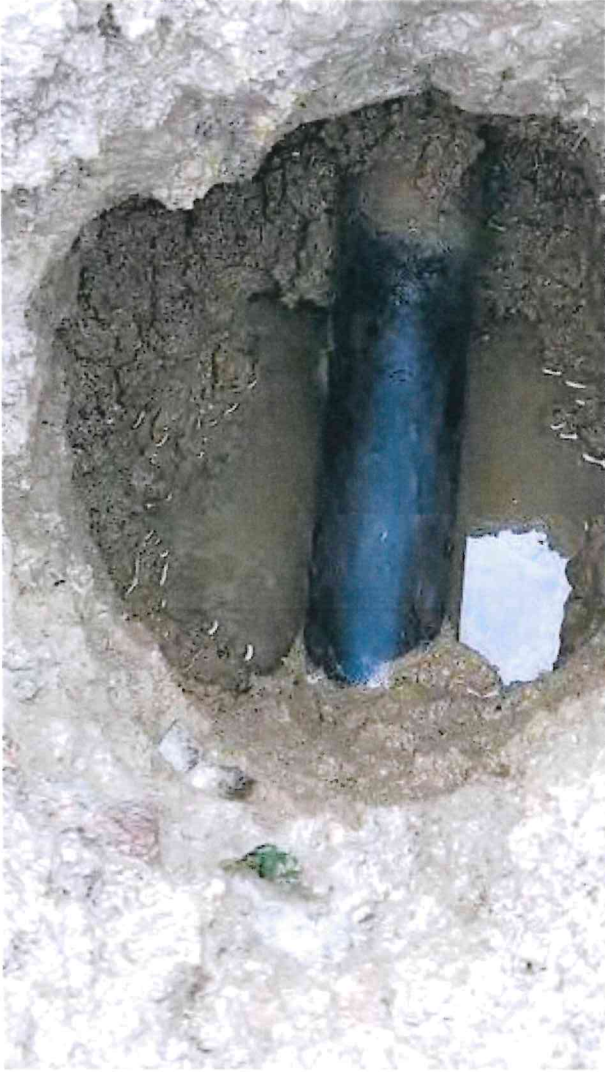
Coating Condition:	Good		
Pipe to Soil Reading:	No	Reading:	VDC
Cathodic Protection:	Rectifier		
External Condition:	Smooth	Pit Depth:	IN
Internal Condition:		Pit Depth:	IN
# of Anodes Installed:	0		
Anode Type and Size:	/		
Anode Location:	N/A		
Depth of Cover:	38 IN		
Soil Condition:	Other		
Soil Packing:	Medium		
Moisture:	Dry		
Coupon Taken:	No

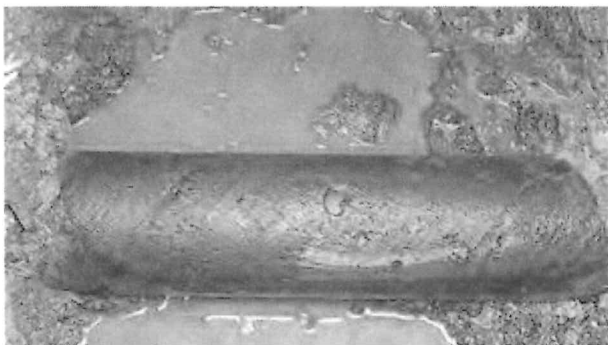
Coating Condition:	Good, one holiday (1/2" x 1")		
Pipe to Soil Reading:	Yes	Reading:	0.923 VDC
Cathodic Protection:	Rectifier		
External Condition:	Smooth	Pit Depth:	IN
Internal Condition:		Pit Depth:	IN
# of Anodes Installed:	0		
Anode Type and Size:	/		
Anode Location:	N/A		
Depth of Cover:	28 IN		
Soil Condition:	Other		
Soil Packing:	Medium		
Moisture:	Dry		
Coupon Taken:	No

Other Structures in Area Endangering Pipeline? If Yes, specify utility, structure, clearance, etc.:	No, N/A		
Condition of Right of Way:	Clear		
Corrective Measures Taken (if needed):	Recoated holiday with tapecoat		
Other Remarks:

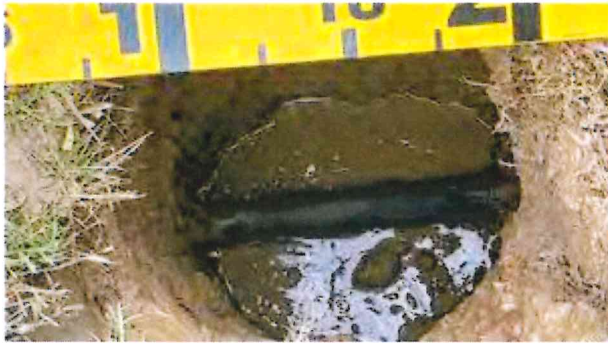
Coating Condition:	Good		
Pipe to Soil Reading:	No	Reading:	VDC
Cathodic Protection:	Rectifier		
External Condition:	Smooth	Pit Depth:	IN
Internal Condition:		Pit Depth:	IN
# of Anodes Installed:	0		
Anode Type and Size:	/		
Anode Location:	N/A		
Depth of Cover:	32 IN		
Soil Condition:	Clay		
Soil Packing:	Medium		
Moisture:	Damp		
Coupon Taken:	No

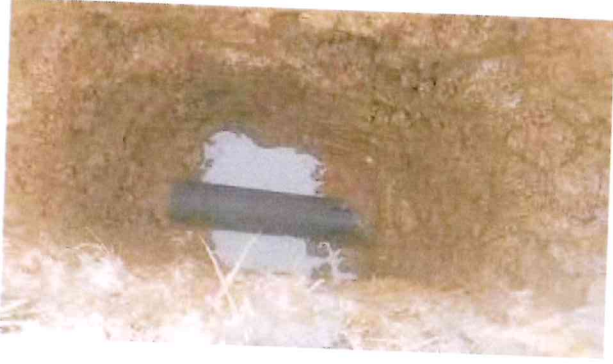
Coating Condition:	Good		
Pipe to Soil Reading:	No	Reading:	VDC
Cathodic Protection:	Rectifier		
External Condition:	Smooth	Pit Depth:	IN
Internal Condition:		Pit Depth:	IN
# of Anodes Installed:	0		
Anode Type and Size:	/		
Anode Location:	N/A		
Depth of Cover:	32 IN		
Soil Condition:	Clay		
Soil Packing:	Medium		
Moisture:	Damp		
Coupon Taken:	No
