Gas Pipeline Inspection

Address: 1335 UNION RIDGE RD.

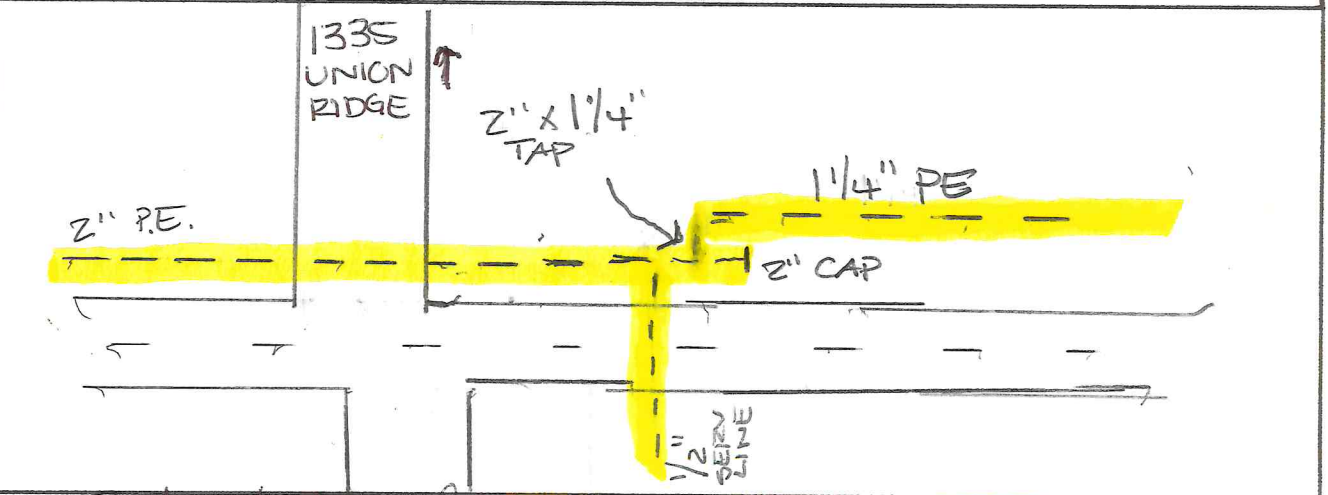
Discription	Comments
DUG 500' OF 1 1/4 P.E. FOUND NOTHING MARTIN UTILITIES FOUND BLOCK AT 2" X 1 1/4" TAP AND RETAP 2" PE LINE
