Gas Pipeline Inspection

Address: MERLE TRAVIS HWY

Gas Service Work Order

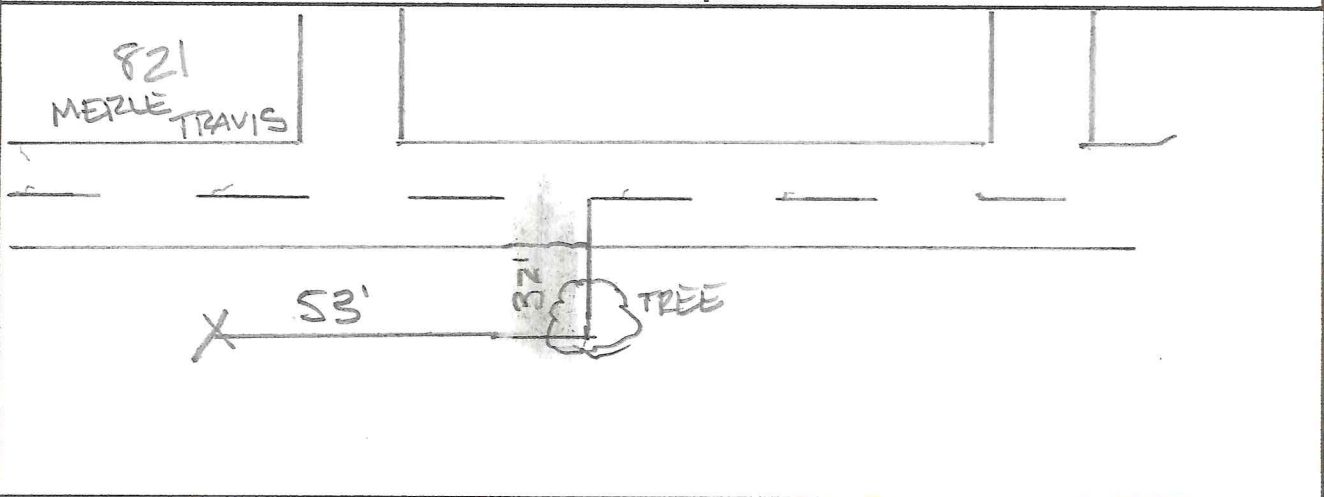
Discription	Comments
	STATE MOWING CREW KNOCKED GAS RISER OFF CAUSING PIPE TO BREAK.

Description of Leak: STATE ROAD CREW BACKED OVER GAS RISER

Pipe Size: 3/4" IN Pipe Material: STEEL Coating: MILL WRAP Pipe Condition: BROKEN EFV

Description of Repair: REMOVED BROKEN RISER/WELD A STEEL CAP @ LINE
