2371 Irvine Road, Richmond, KY 40475
(TEL.) 859-623-0112 (FAX.) 859-626-0822
A MEASURE OF EXCELLENCE IN UTILITY PROFESSIONAL SERVICES

RE: Drakesboro Leak Order Repair: September 8,9, 2021

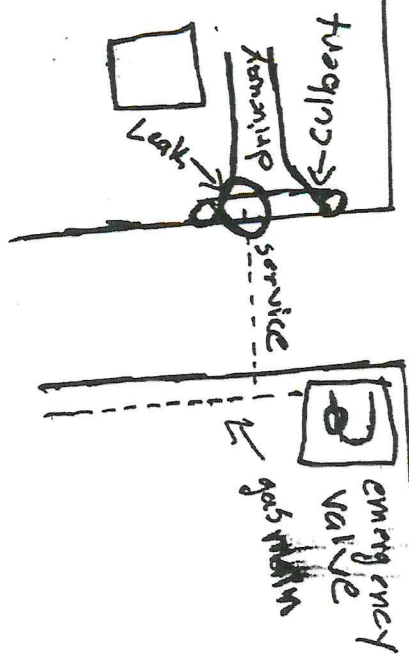
Customer Name: _____ Phone #: _____
 Installer Name: _____ Date Received: _____ Customer Account #: _____ Date Installed: _____ No. 0556
 Address: 45 Beech Creek Boulder Rd City/County: Dukesboro / Wmhamburg State KY
 Date: 7-2001

Leak order 0556 Temporary Repaired needs replaced 9-9-2021

Dug up tap at the main and shut tap down using Mueller stopper tool. Removed an existing 6” all seal that was leaking. Cleaned pipe and installed a new 12” all seal. This was meant as a temporary fix, new service needs to be ran due to condition of pipe.

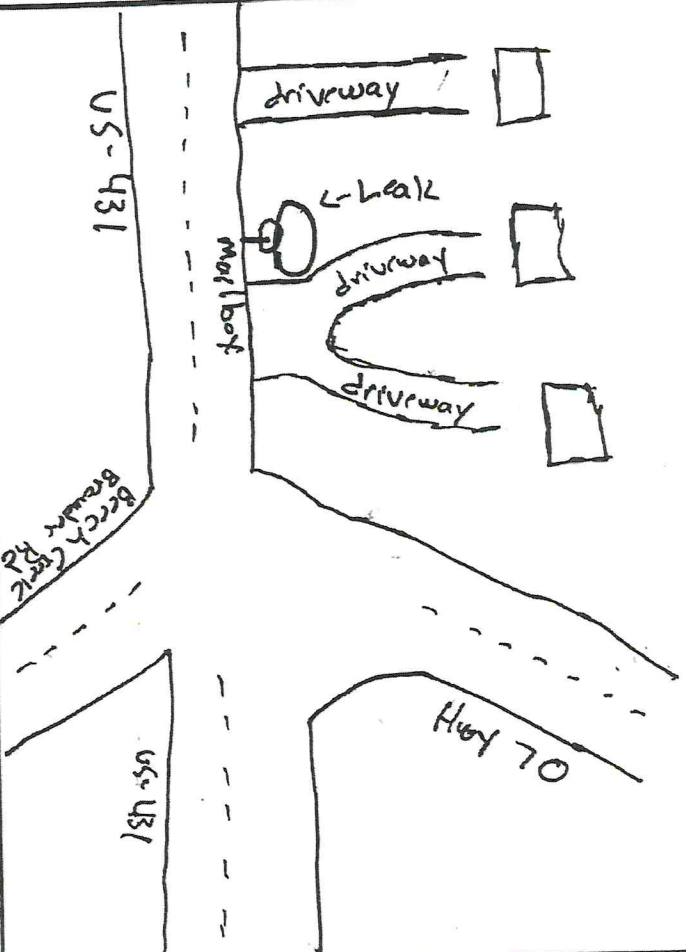
Leak order 0555 repaired 9-8-2021

Shut off the above ground valve at the intersection of Hwy 70 and US – 431, also closed down the above ground valve on 431 before entering Drakesboro. Replaced a section of 4” steel 72” long and welded in new service tap and reconnected service. Wrapped pipe and backfilled, re-checked on 9-9-21.
