Gas Pipeline Inspection

Address: 48 BEECHCREEK/BROWDER **Location:**

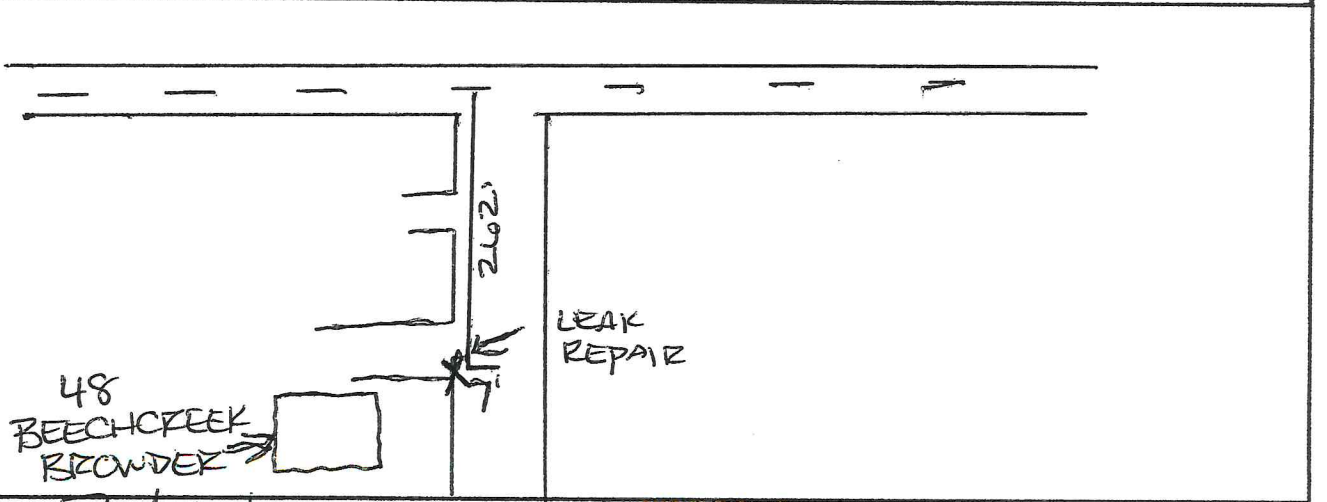
Discription	Comments
2" STEEL LINE	LEAK WAS FOUND DURING SURVEY. WAS DUG UP AND A CLAMP WAS PUT ON. TESTED GOOD AND BACKFILED WITH SAND / GRAVEL

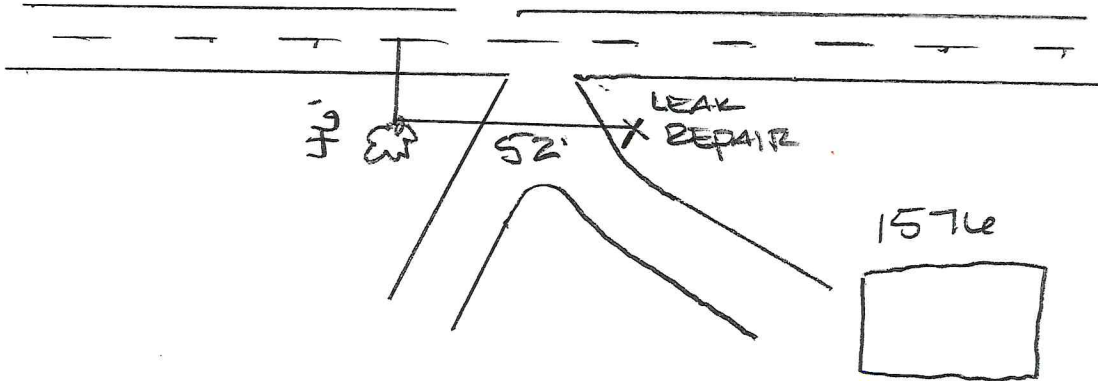
Discription	Comments
4" STEEL MAIN	LEAK WAS DETECTED DURING SURVEY. REPLACED 6' OF STEEL LINE & TAP. WELD WAS TESTED AND BACKFILLED WITH GRAVEL SAND
