Notice of Filing per 9/16/2022 Order

Phase I Environmental Site Assessment

Golden Solar Site • Fredonia,
Kentucky

Karst Survey and Assessment

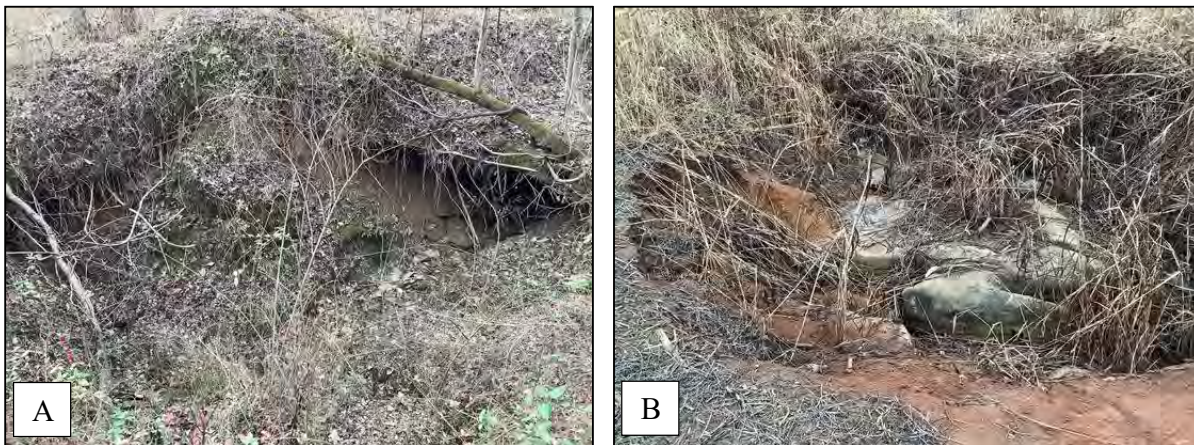
Type 1 – This type of karst feature is characterized by the presence of an open throat at the base and active erosion along the walls and parapet of the feature. These features are considered the highest risk since they are actively growing and may continue to collapse and widen during construction activities and post development. Two examples of such features are shown below in Image 1.

Image 1. (A) Example of a sinkhole with a very ragged edged parapet which appears to be under cut and widening. (B) Sinkhole with ragged edged parapet, drainage channel leading in from the top of the photo, and throats at the base of the bedrock outcrop.

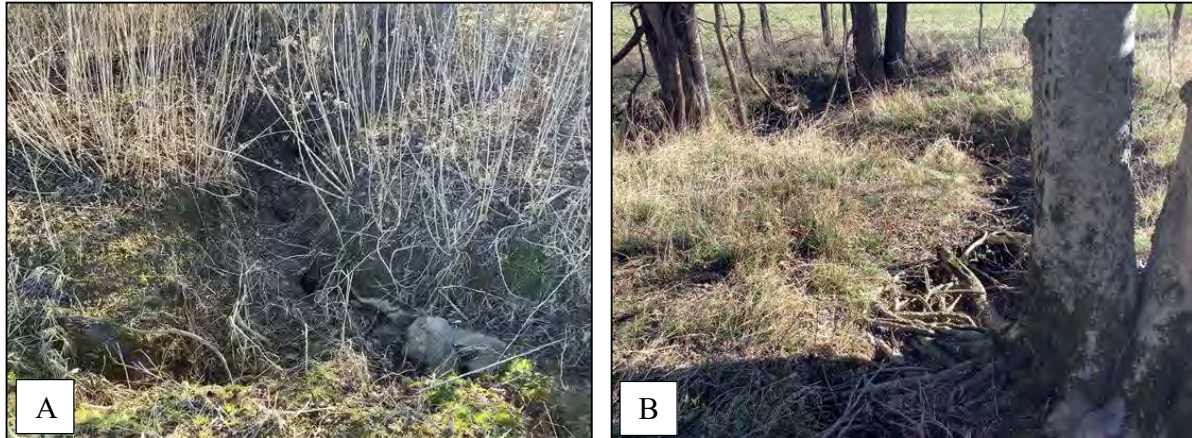
Type 2 – This type of karst feature is characterized by the presence of an incised drainage channel leading to the karst feature indicating that focused drainage enters the structure, which

commonly results in active erosion and growth of the sinkhole (Image 2). Additionally, this type of feature is problematic because possible construction activities within the drainage may result in the uncontrolled flow of water transporting sediment and contaminants into the subsurface. Awareness of the drainage catchment extent and implementation of proper erosion and sediment controls (ESC) is crucial for these types of karst features.

Image 2. (A) Sinkhole with drainage channel which focuses drainage into this feature. Note the series of open throats along the base of the drainage channel. (B) Incised drainage channel leading to a sinkhole.

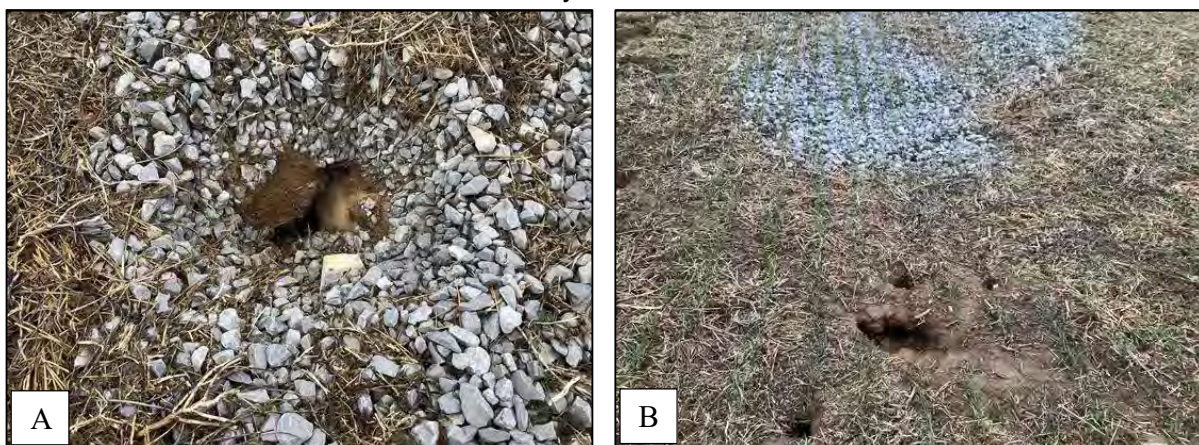
Type 3 – This type of karst feature has an open throat and rough, irregular parapet edges, indicating active erosion, collapse, and growth. The features are typically small (<5 feet) yet indicate that the area around the soil piping is undergoing sinkhole development which may widen, deepen, and affect the surrounding area (Image 3). It is commonplace to observe multiple soil piping features which may all be feeding into a single open throat in the subsurface. In the field these soil piping features were observed near or within patches of washed stone, which was presumably used by the property owners to fill in the features. The development of the soil piping features indicates that the filling in process was not sufficient to stop sinkhole development. These features pose a significant risk because the karst features are actively developing; therefore, official remediation or avoidance is necessary.

Image 3. (A) Open throat and soil piping present within a patch of washed stone. (B) Soil piping present along the edge of a filled in sinkhole, indicates that new conduits may have formed around the initial “fix”.

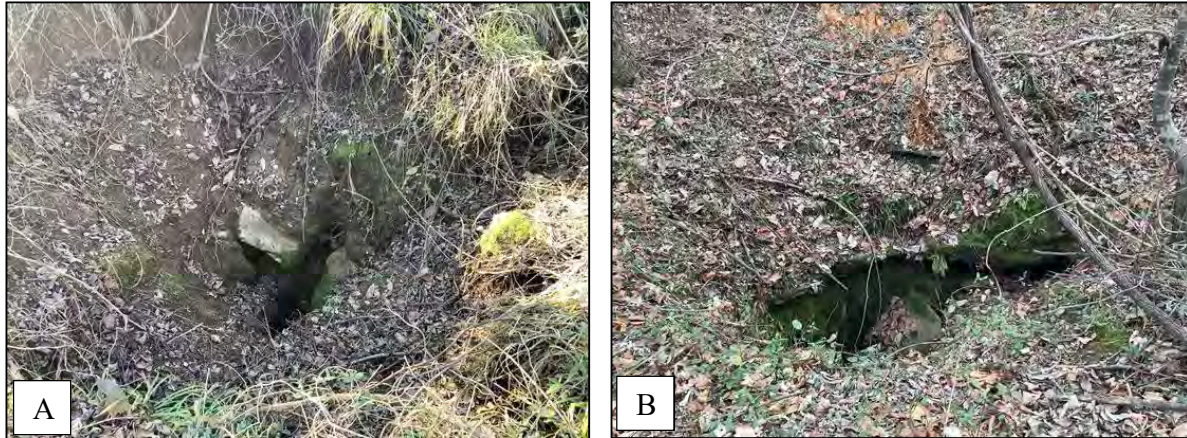
Type 4 – This type of karst feature is a sinkhole with a cave entrance located at the base or within the sidewall of the structure (Image 4). Caves pose a significant risk since they are relatively large openings that can receive surface runoff, may contain significantly sized chambers and passages below the surface, and may host cave fauna and sensitive biological habitats. Unless the cave is newly formed (Image 4A) the entrances are often stable and surrounded by bedrock as shown in Image 4B. Aside from having certified spelunkers enter the caves and map out the passages, geophysical techniques are often utilized to determine the presence, extent, depth, and size of cave passages in relationship to planned construction.

Image 4. Two examples of cave entrances located within sinkholes.

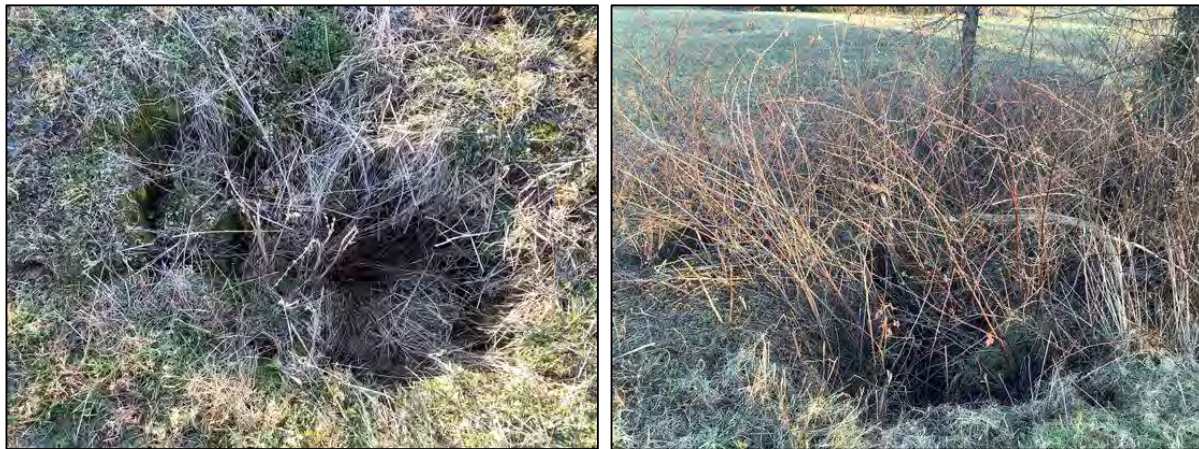
Type 5 – This type of karst feature has an open throat within the structure, yet the remainder of the sinkhole is overgrown with vegetation and the parapet appears to be stable² (Image 5). Although there is an opening present leading into the subsurface, the protection and stabilization of the feature by maintaining a vegetated buffer dramatically reduces the risk of impacting the subsurface habitat during construction activities.

Image 5. Small overgrown closed depressions. The open throats at the bases of these structures receive drainage but the vegetated buffer provides stability to the parapet.

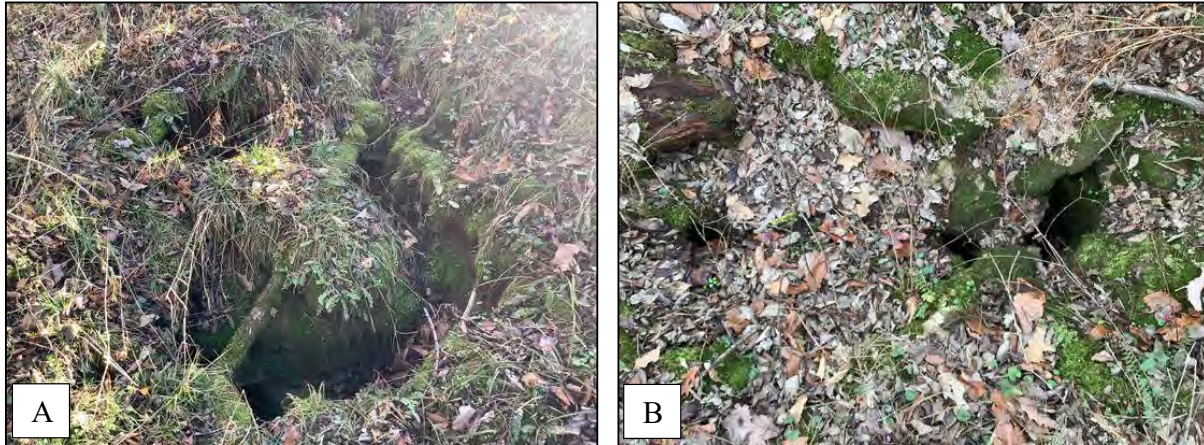
Type 6 – This type of karst feature is characterized by bedrock bound open throats and rock outcrops either located at the base of sinkholes or within generally flat laying bedrock benches (Image 6). Although the open throats clearly connect to the subsurface, the bedrock does not present much risk of collapse or change in architecture unless the soil layer is very thin above an open chamber. The general shape of these features is anticipated to remain mostly static, yet the open throat should be buffered and protected from surface runoff during construction activities.

Image 6. (A) Bedrock bound open throat located at the end of a deeply incised channel. (B) Small bedrock bound open throat located at the base of a gentle closed depression, which only receives minor amounts of sheet flow.

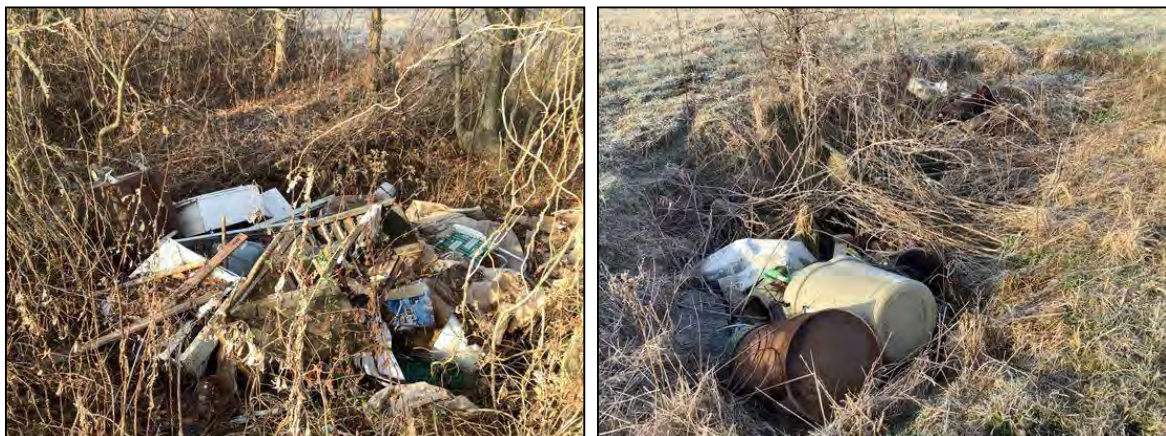
Type 7 – This type of sinkhole has been used by farmers and landowners as a convenient place to deposit field rock, trees, trash, and a menagerie of various items and materials. This practice of depositing trash is highly discouraged since the contaminants originating from the infill material may quickly reach and may affect the subsurface aquifer. Nevertheless, these karst features were present within the AOI and most typically observed to be infilled with trash and occasional trees (Image 7). Since these may have been partially or completely filled, it is impossible to fully characterize these features for the presence or absence of an open throat. Therefore, we assume that there is an open throat at the base in order to be conservative for protection measures during construction activities.

Image 7. A series of filled in sinkholes with trash and debris

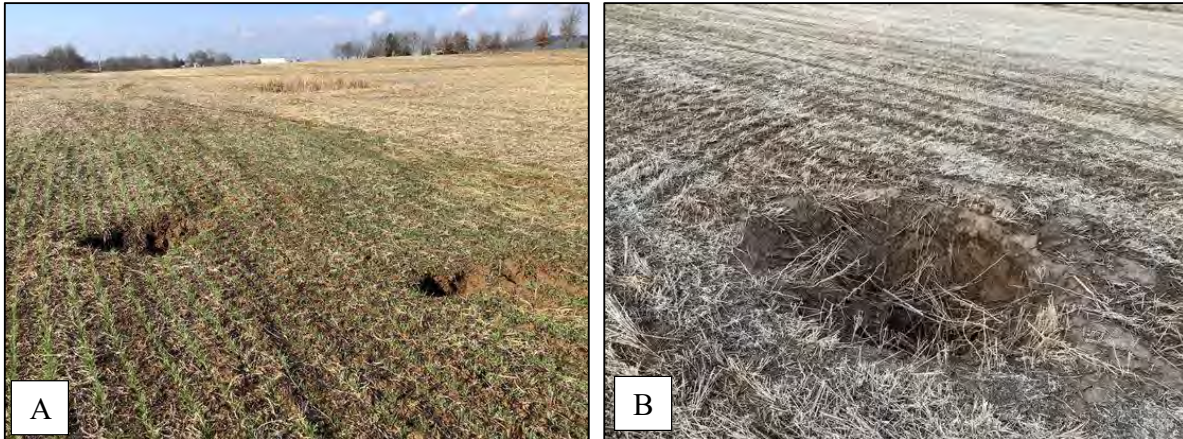
Type 8 – This type of feature is present as small depressions ranging in size from a few feet in length, width and depth, and are typically flush with the ground and exhibit minor/major soil raveling but no open throat (Image 8). Typically, little to no substantial growth of the feature occurs over time unless the topography and hydrology change.

Image 8. (A) A series of small collapses within row crops. (B) Typical newly formed cover collapse feature.

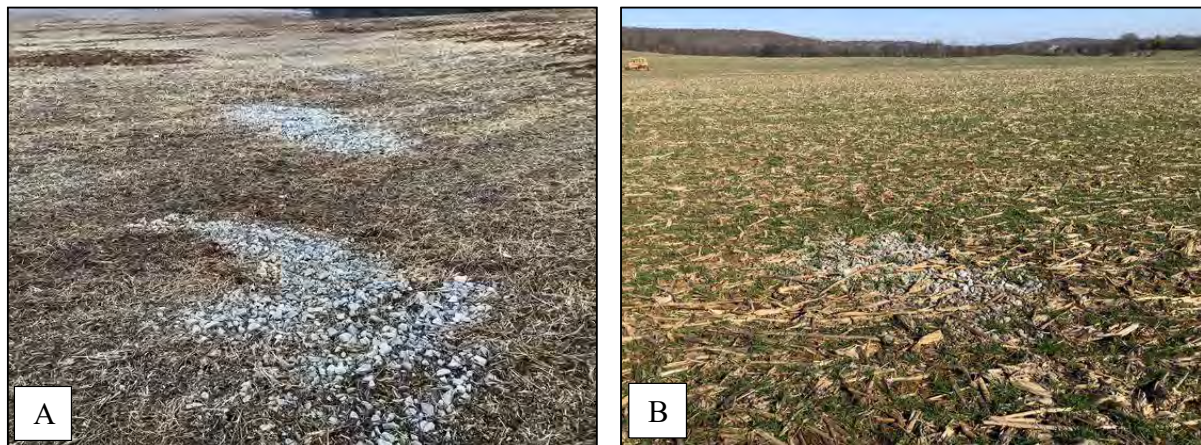
Type 9 – These types of features are presumably sinkholes which had been filled in with washed stone or field rock by the property owner (Image 9). This “remediation” only serves as a temporary fix to the existing problem but may at times be enough to clog the throat or change the flow of water, resulting in apparent stabilization. If these features do not show signs of reactivation such as in the type 4 features, then they are considered to have minimal risk. Caution is recommended for the filled in features where the “remediation” is recent (e.g. disturbed ground) because there is a chance that the features may reactivate.

Image 9. (A) A series of filled in sinkholes with washed stone. (B) Filled in sinkhole that appears to have stabilized due to the developed nature of ground surface.

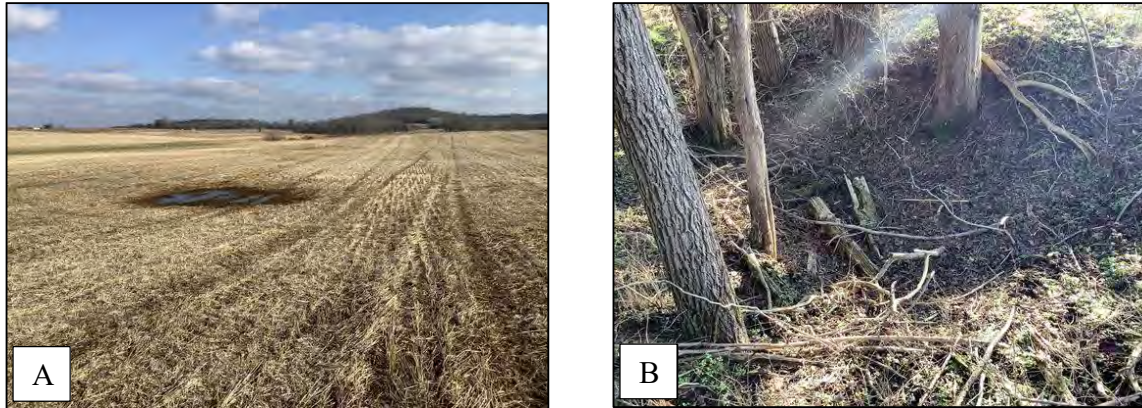
Type 10 – These types of sinkholes are present as broad and shallow depressions which may range in size from tens to hundreds of feet in diameter and are commonly referred to as “mature” or paleokarst sinkholes (Image 10). Mature sinkholes often have a roughly circular parapet outline, are bowl shaped, lacking any opening to the subsurface (i.e. “throat”) or showing evidence

of active soil raveling or tension cracks around the parapet. Thus, whatever conduit or opening into the underlying karst aquifer that may have functioned to create the structure is probably now clogged with soil, which would act as a filter for water infiltrating from the surface. Therefore, this feature does not pose a significant risk to the karst groundwater aquifer.

Image 10. (A) Broad and shallow mature sinkhole in a pasture with some water ponding. (B) Mature sinkhole covered in leaf litter within a forest.

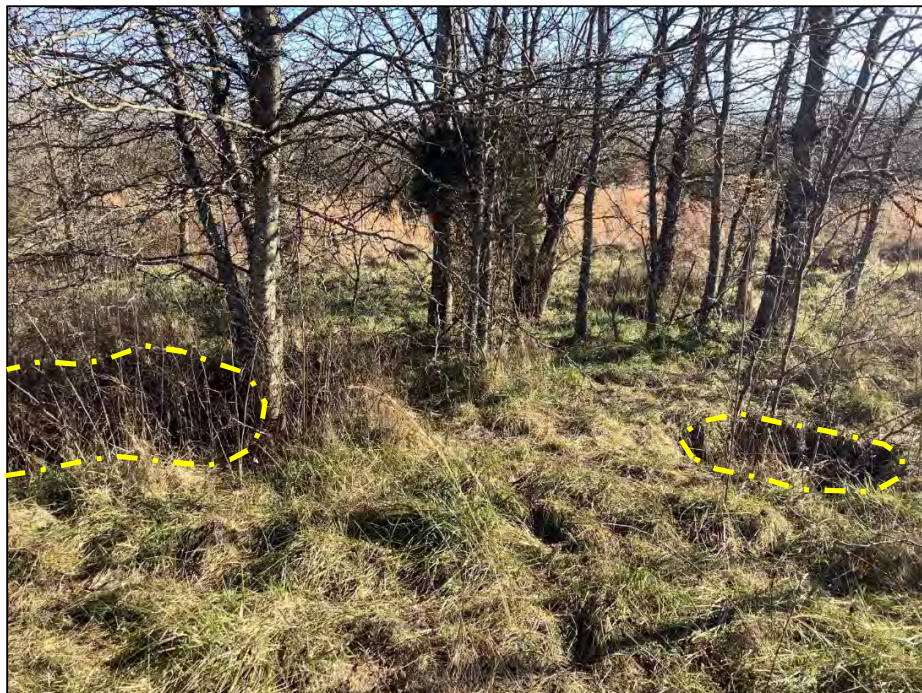
25-1-202 – This feature is specifically worth discussing due to the fact that a large chamber was observed through a small opening flush with the ground. The surficial expression of the feature was in a patch of trees and brush surrounding three depressions. Two of the overgrown depressions (shown by the yellow dashed lines) and the relatively nondescript overview of the feature is shown in Image 11.

Image 11. Surface characteristics of karst feature 25-1-202.

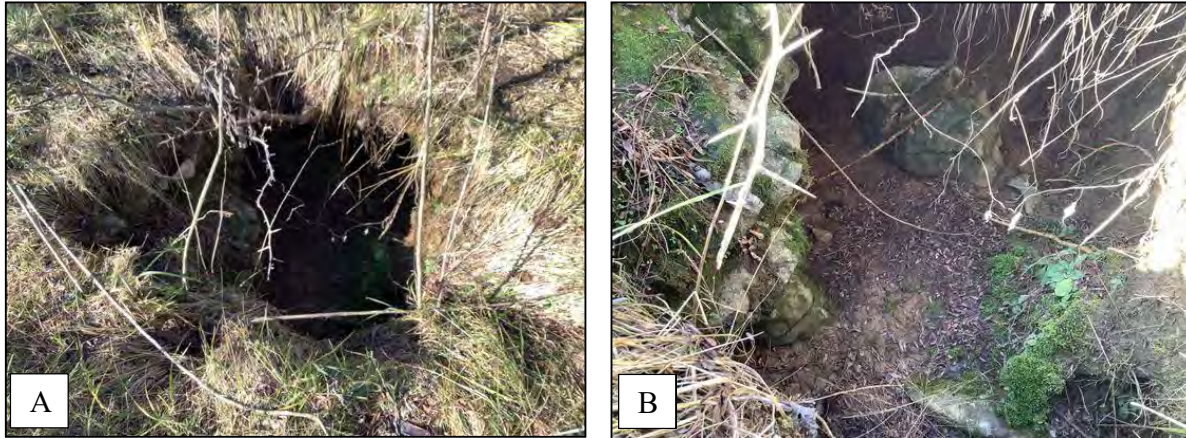
Upon closer inspection of one of the small depressions (right feature in Image 11) a chamber approximately 8-10 feet deep was observed that “belled out” a few feet below the surface (Image 12A). This widening extends past the view from the surface and indicates that there is a significant void underneath the area, which is supported by a thin septum of limestone (Image 12B). Although there is no official scale, the plant life and leaf litter observed at the bottom of the chamber can be used to generally estimate the dimensions. We believe this feature to be high risk of future collapse and it should be buffered and avoided during all construction activities. A geophysical investigation may delineate the direction and extent of the observed passages.

Image 12. (A) Small depression at the surface leading to a significant chamber below. (B) View of the chamber from the entrance shows a room continuing to the top of the photograph and fallen boulders. Although there is no official scale, the plant life and leaf litter can be used to generally estimate the dimensions.
