Airview-Kentucky (Wastewater)

Engineering Memorandum

Date: December 22, 2018

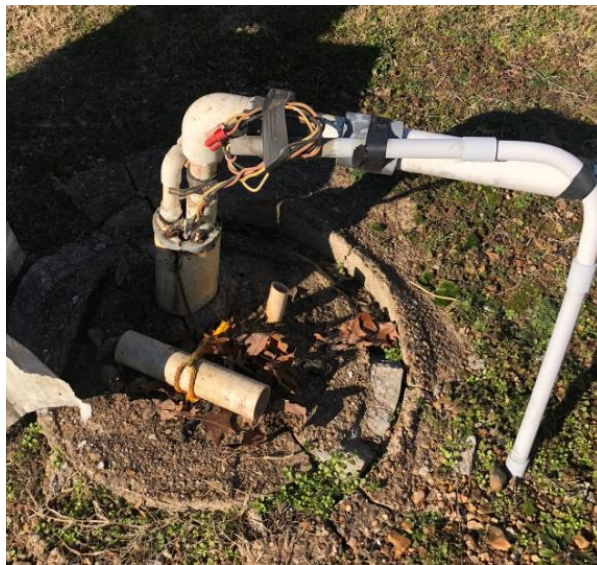
Wellhead with Exposed Wiring

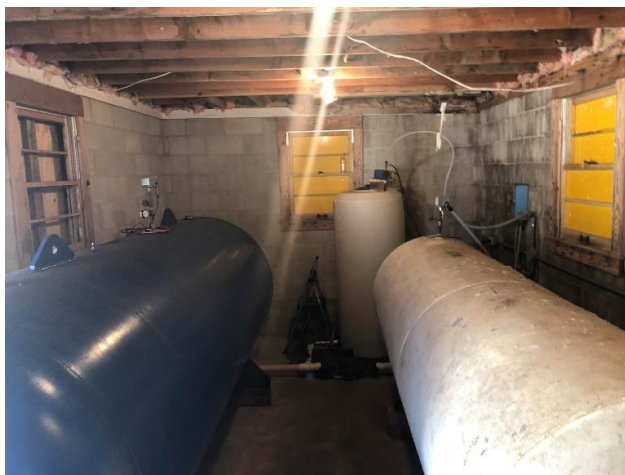
Hydro-Tank, Chlorination System, No Ceiling

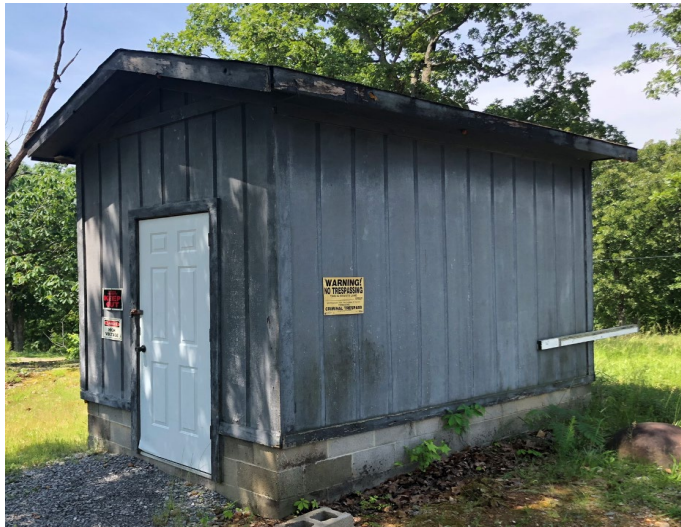
Wellhouse of Active Well to be placed on “Emergency” Classification

Improvements required: Place active well on “emergency” backup classification. Close well that is not active. Building Repair for well that will be placed on “emergency” classification. Construct interconnect with Center Ridge Water District #3.

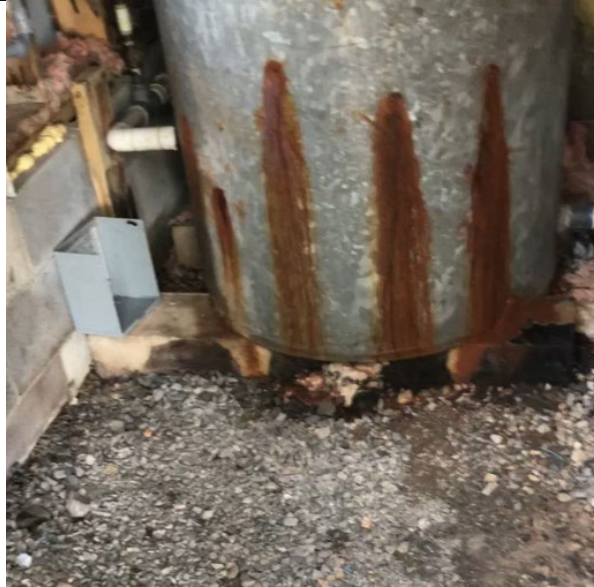
Holes in Tank Due to Rusting

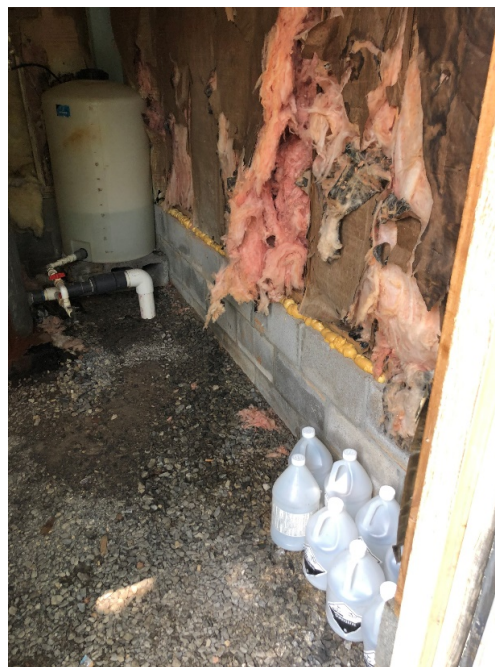
Typical interior finishing in well to remain in service as "emergency backup"

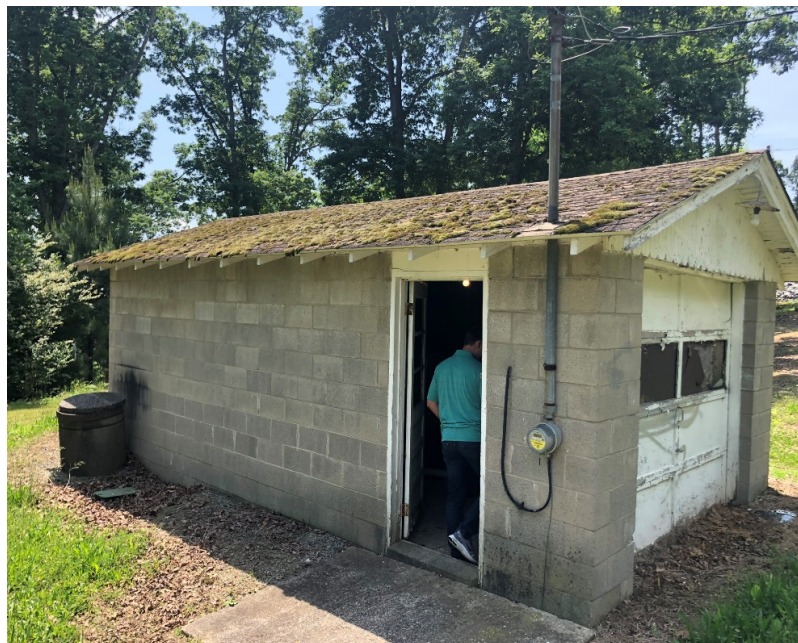
Wellhouse of Dilapidated Well to be closed Per State Guidelines

Consideration should be given to closing the second well that is currently not connected due to failing piping in the well house. The active well house will need some building repair work to extend its useful life.

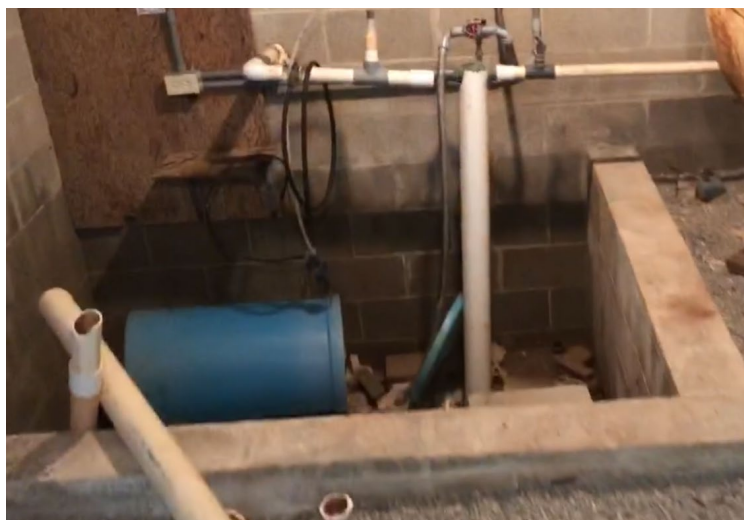
Broken Pipes in Dilapidated Well House

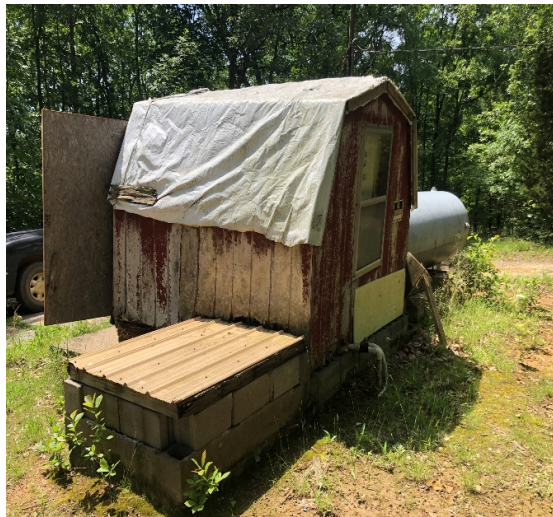
Failing Well House

Improvements required: New well house structure, new well house piping, electrical overhaul, install pitless adaptor and steel piping to wellhouse, install all electrical wiring in conduit to eliminate hazard, bury electrical conduit, install standpipe and booster station, install mission monitoring system, add quick connections on site, new chlorination system. Install interconnect with District #2 to minimize future maintenance.

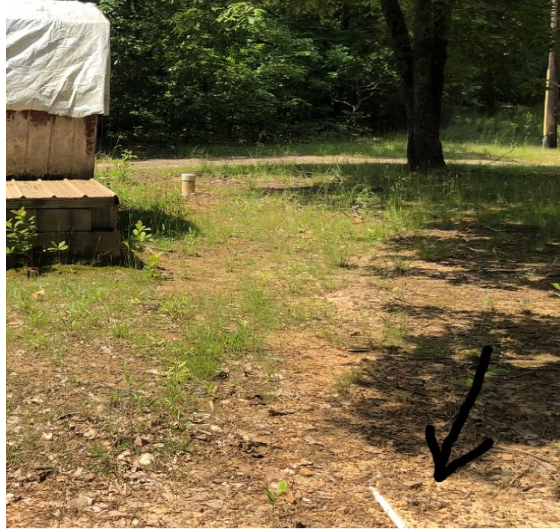
Exposed Electrical Conduit

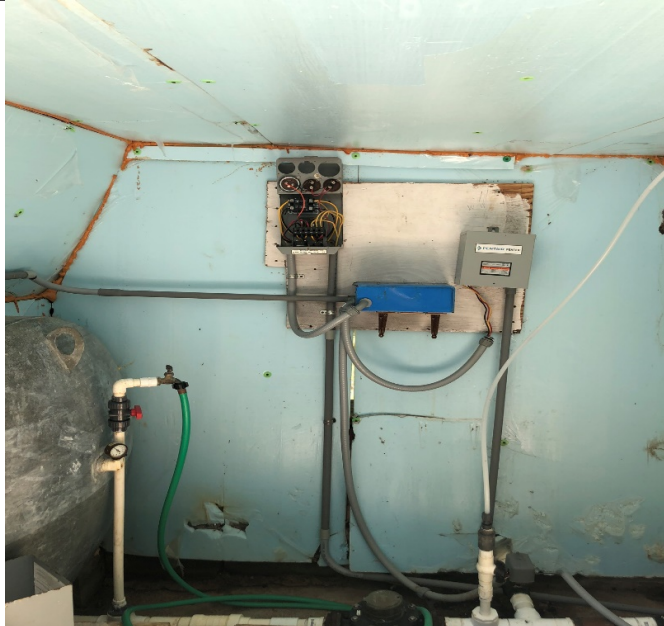
Exposed Electrical Wiring and PVC Piping That Needs to Be Converted to Steel

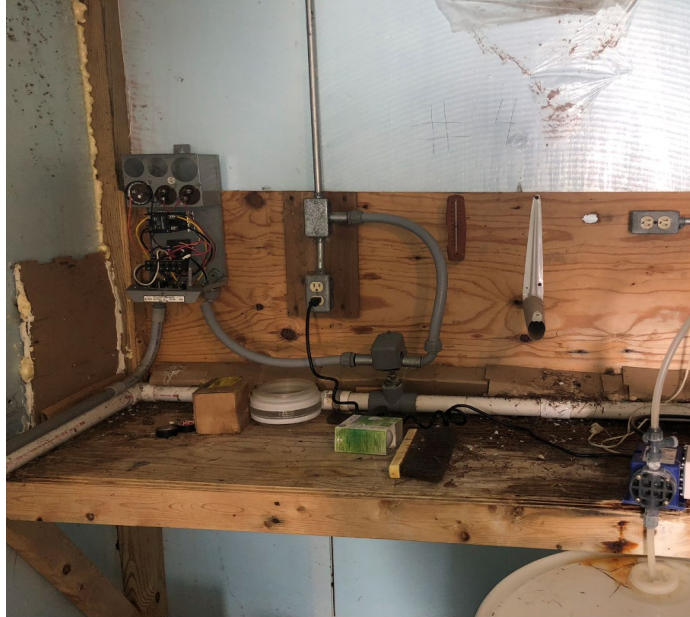
Exposed Wiring and Foamboard Being Used for Insulation

Improvements required: Building repair/cleanup (insulation, install ceiling, repair any damage due to water), steel piping in wellhouse, install electrical wiring in conduit to eliminate hazard.

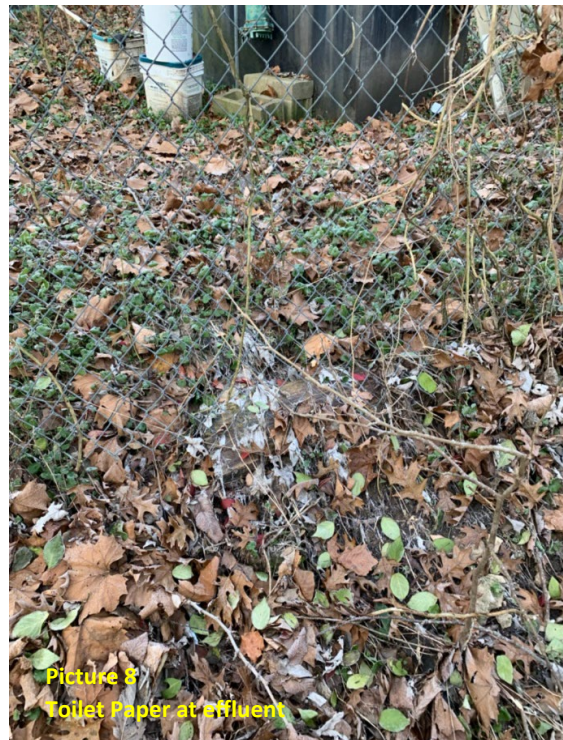
Picture 8
Toilet Paper at Effluent

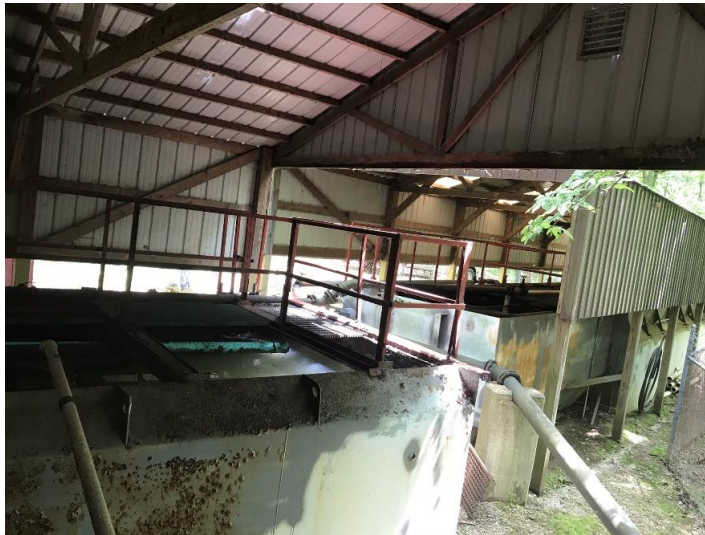
Treatment Tanks are rusting and have gone unmaintained

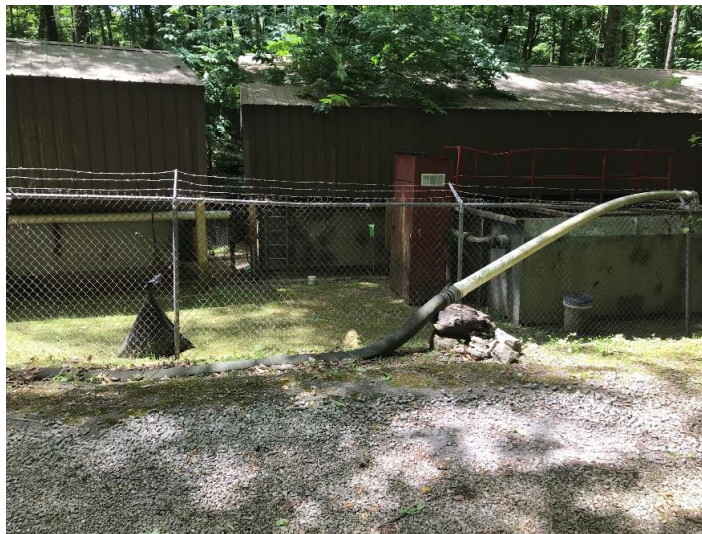
Influent PVC line is fastened to the top of the fence and should be properly buried.

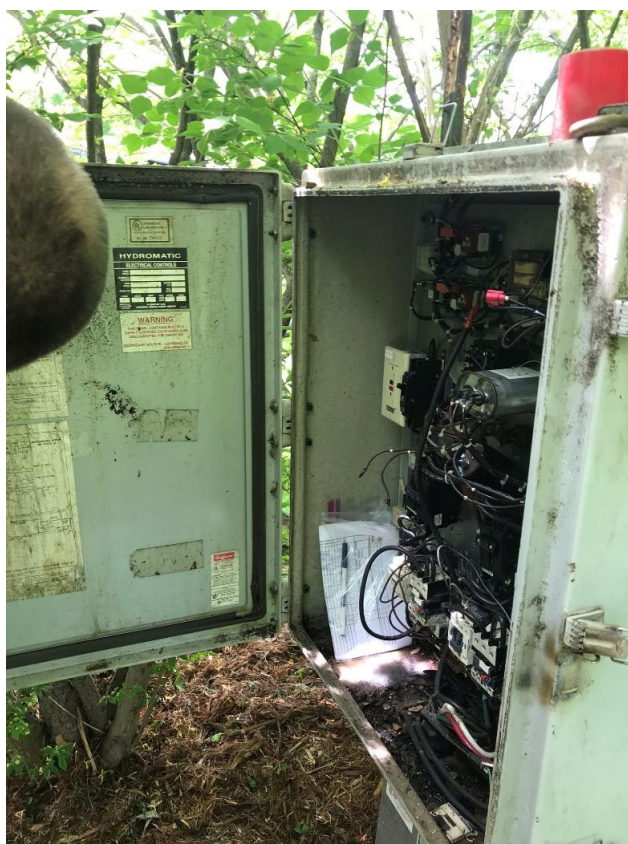
**Lift station control panels appear to be poorly wired
and are a safety concern.**

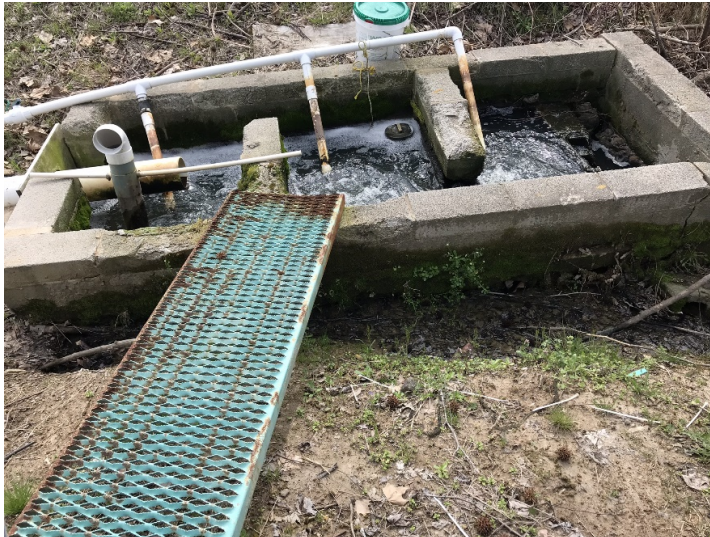
Chlorination Contact Chamber not up to code

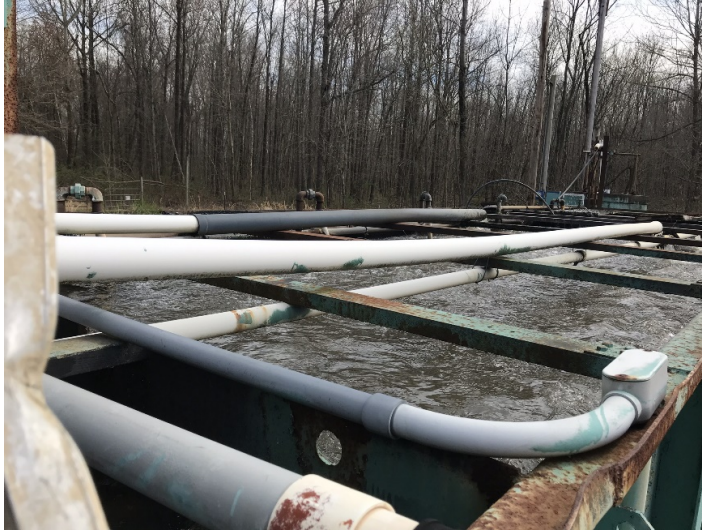
PVC lines need to be replaced

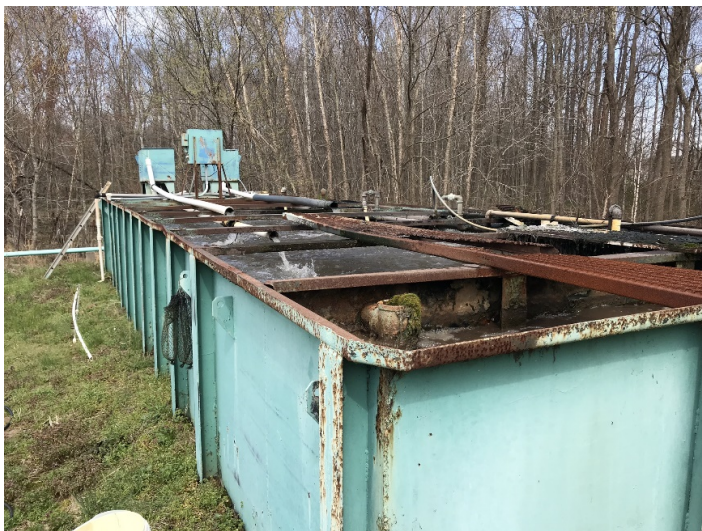
Activated Sludge – Extended Aeration tank beginning to rust/fail

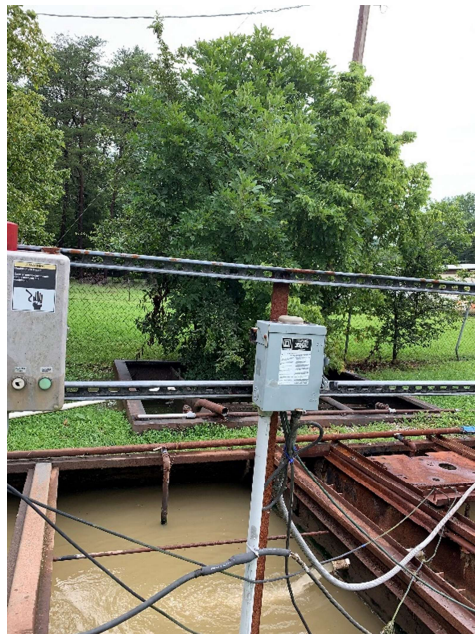
**Electrical Boxes and
Electrical Cabling**

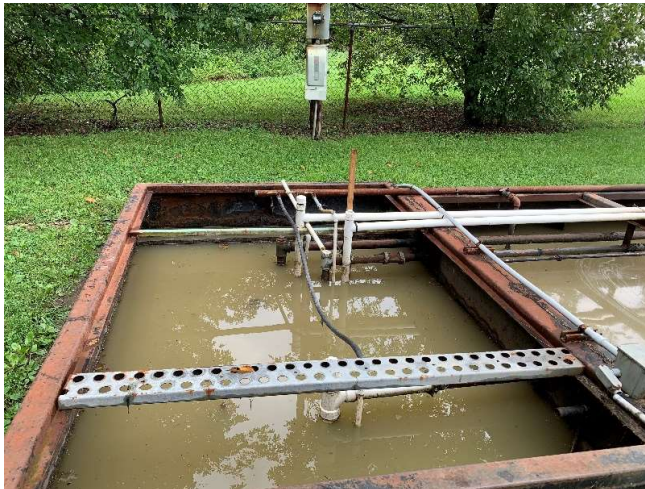
**Clarifier Performance During Wet Weather
(and No Aeration in Aeration Tank)**
