COMMONWEALTH OF KENTUCKY  
BEFORE THE PUBLIC SERVICE COMMISSION

<i>Electronic</i> Application of Bluegrass	)	
Water Utility Operating Company, LLC	)	Case No. 2020-00290
for an Adjustment of Rates and Approval	)	
of Construction	)

**Supplement to Responses  
to Post-Hearing Data Requests**

SUPPLEMENT: Bluegrass attaches hereto a series of stills taken from the video file, *Bluegrass Water UOC\_Before Reel.mp4*, showing the condition of the systems that it acquired before June 30, 2020. The following is an index with the PDF page number of each still, the time counter on the video file, and a description of what is depicted by title or facility and status:

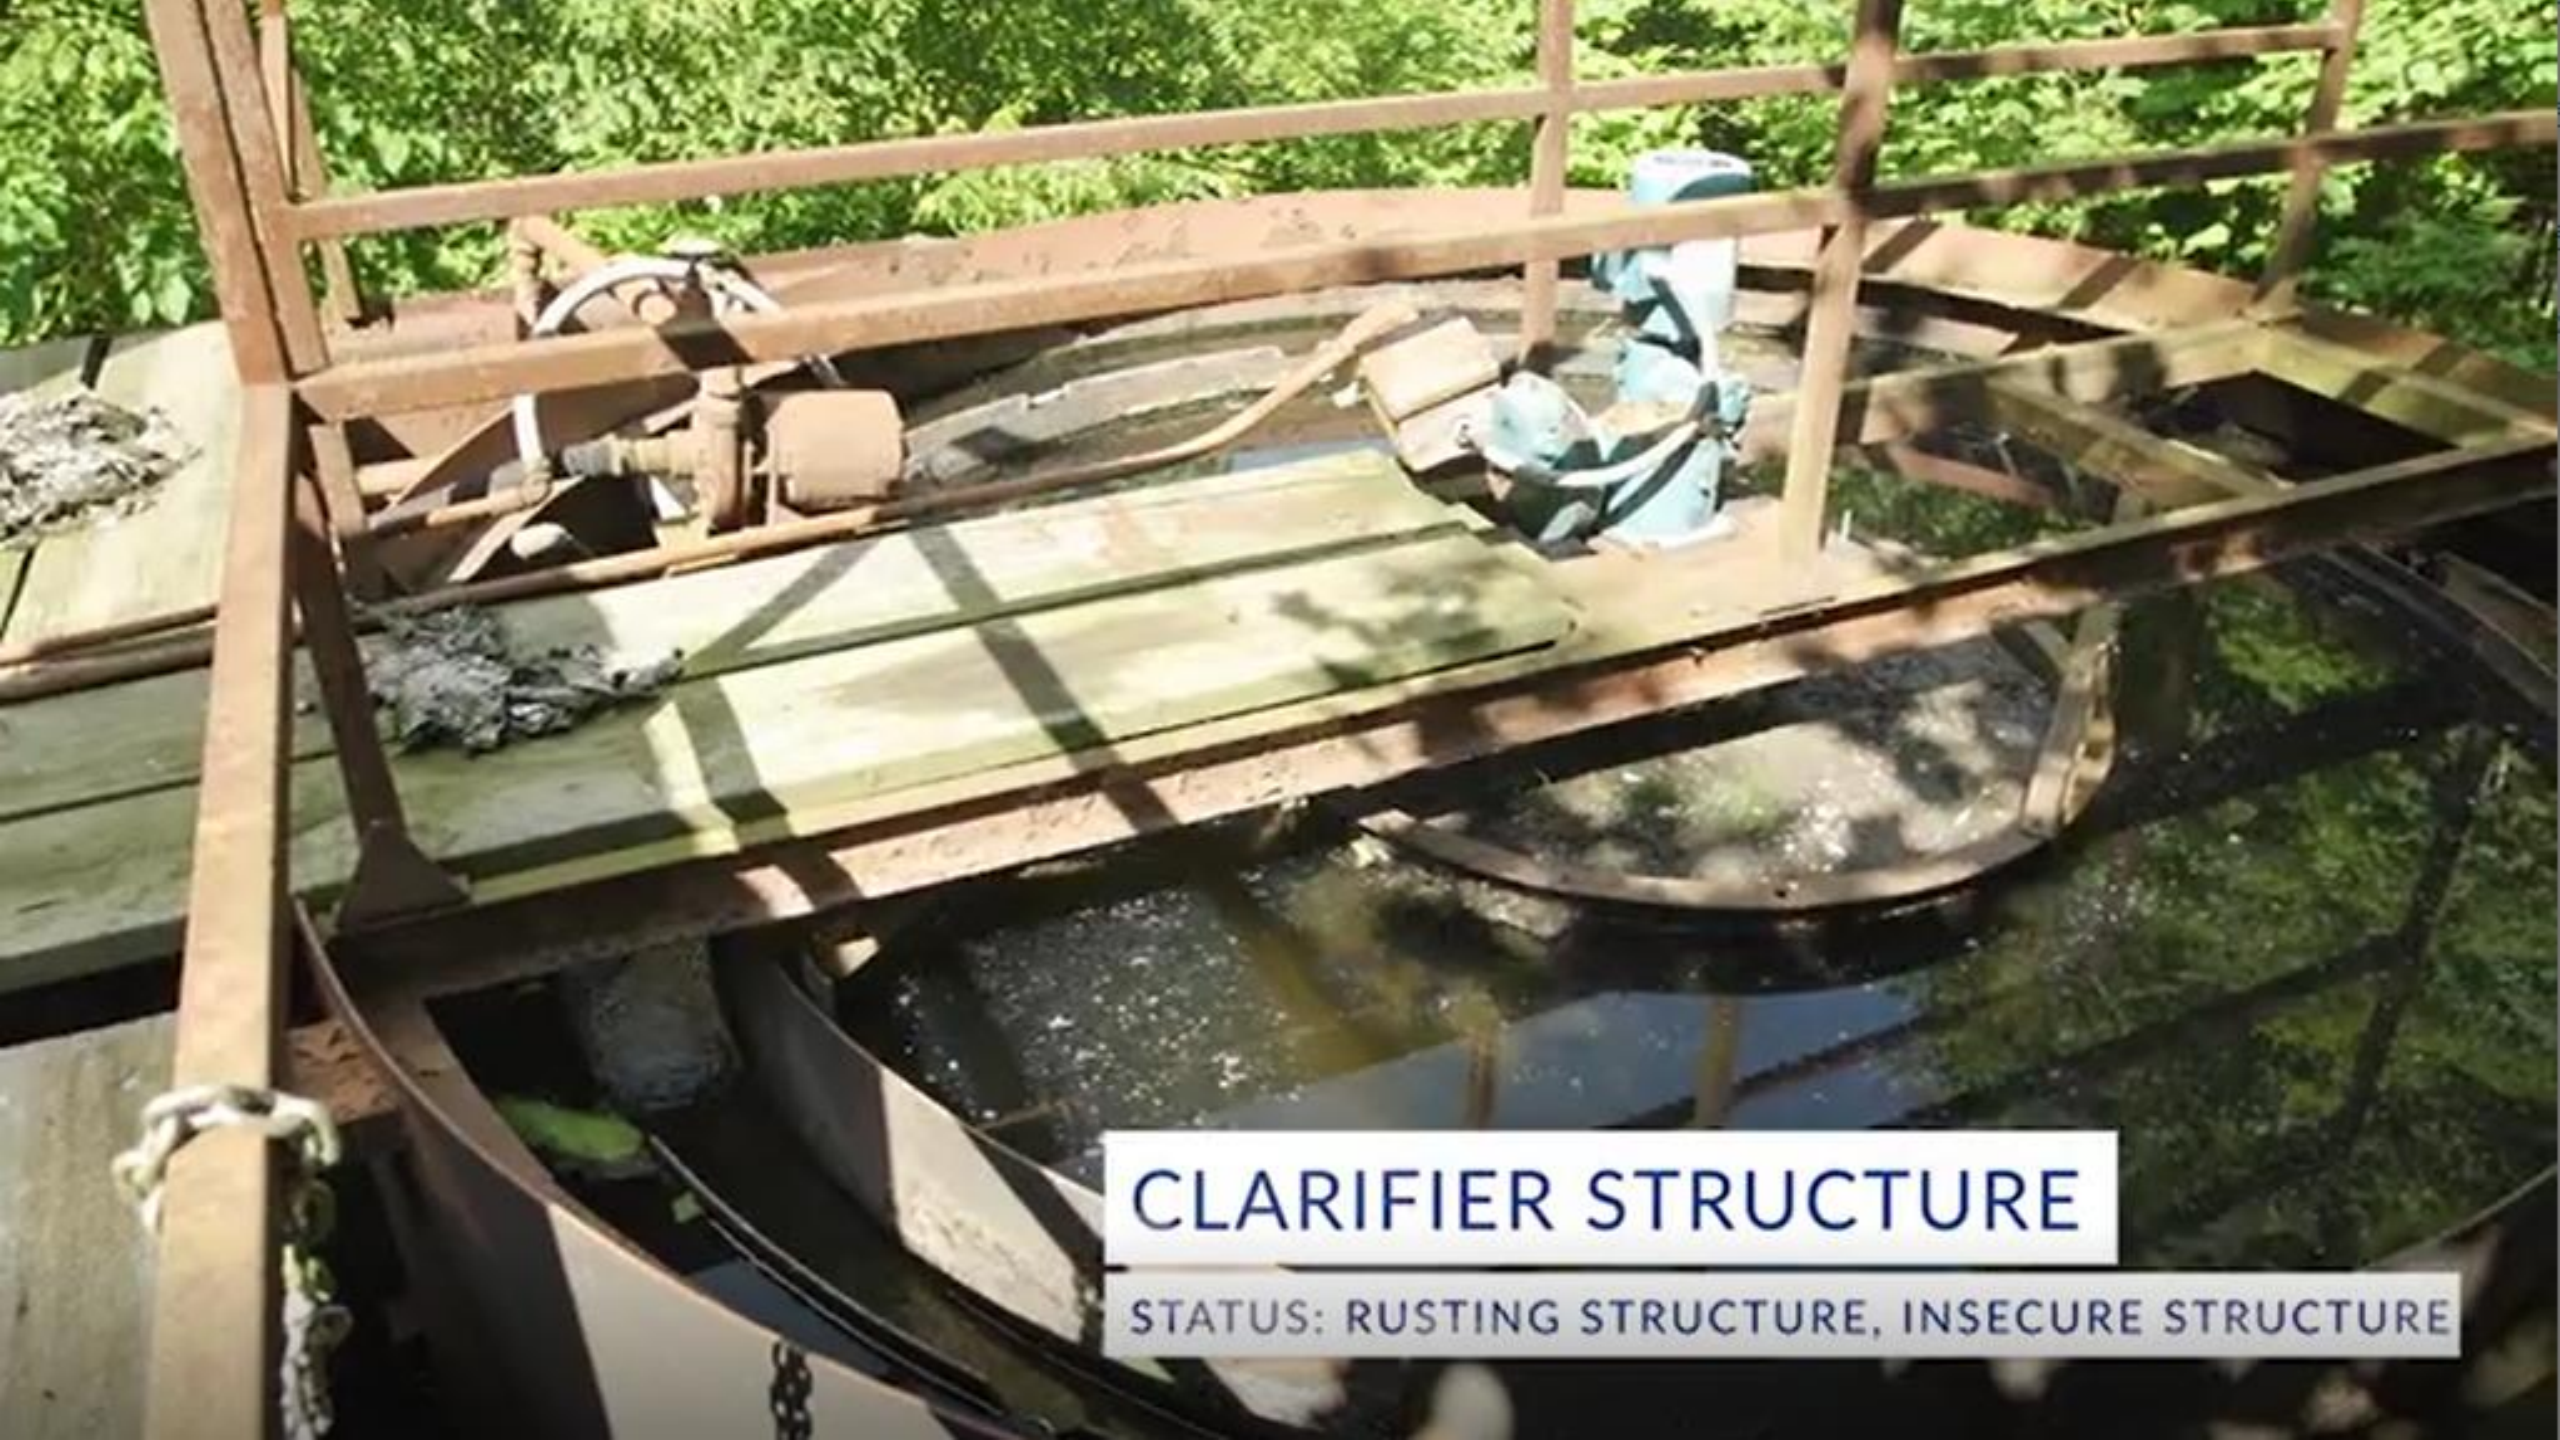
## CLARIFIER STRUCTURE

STATUS: RUSTING STRUCTURE, INSECURE STRUCTURE

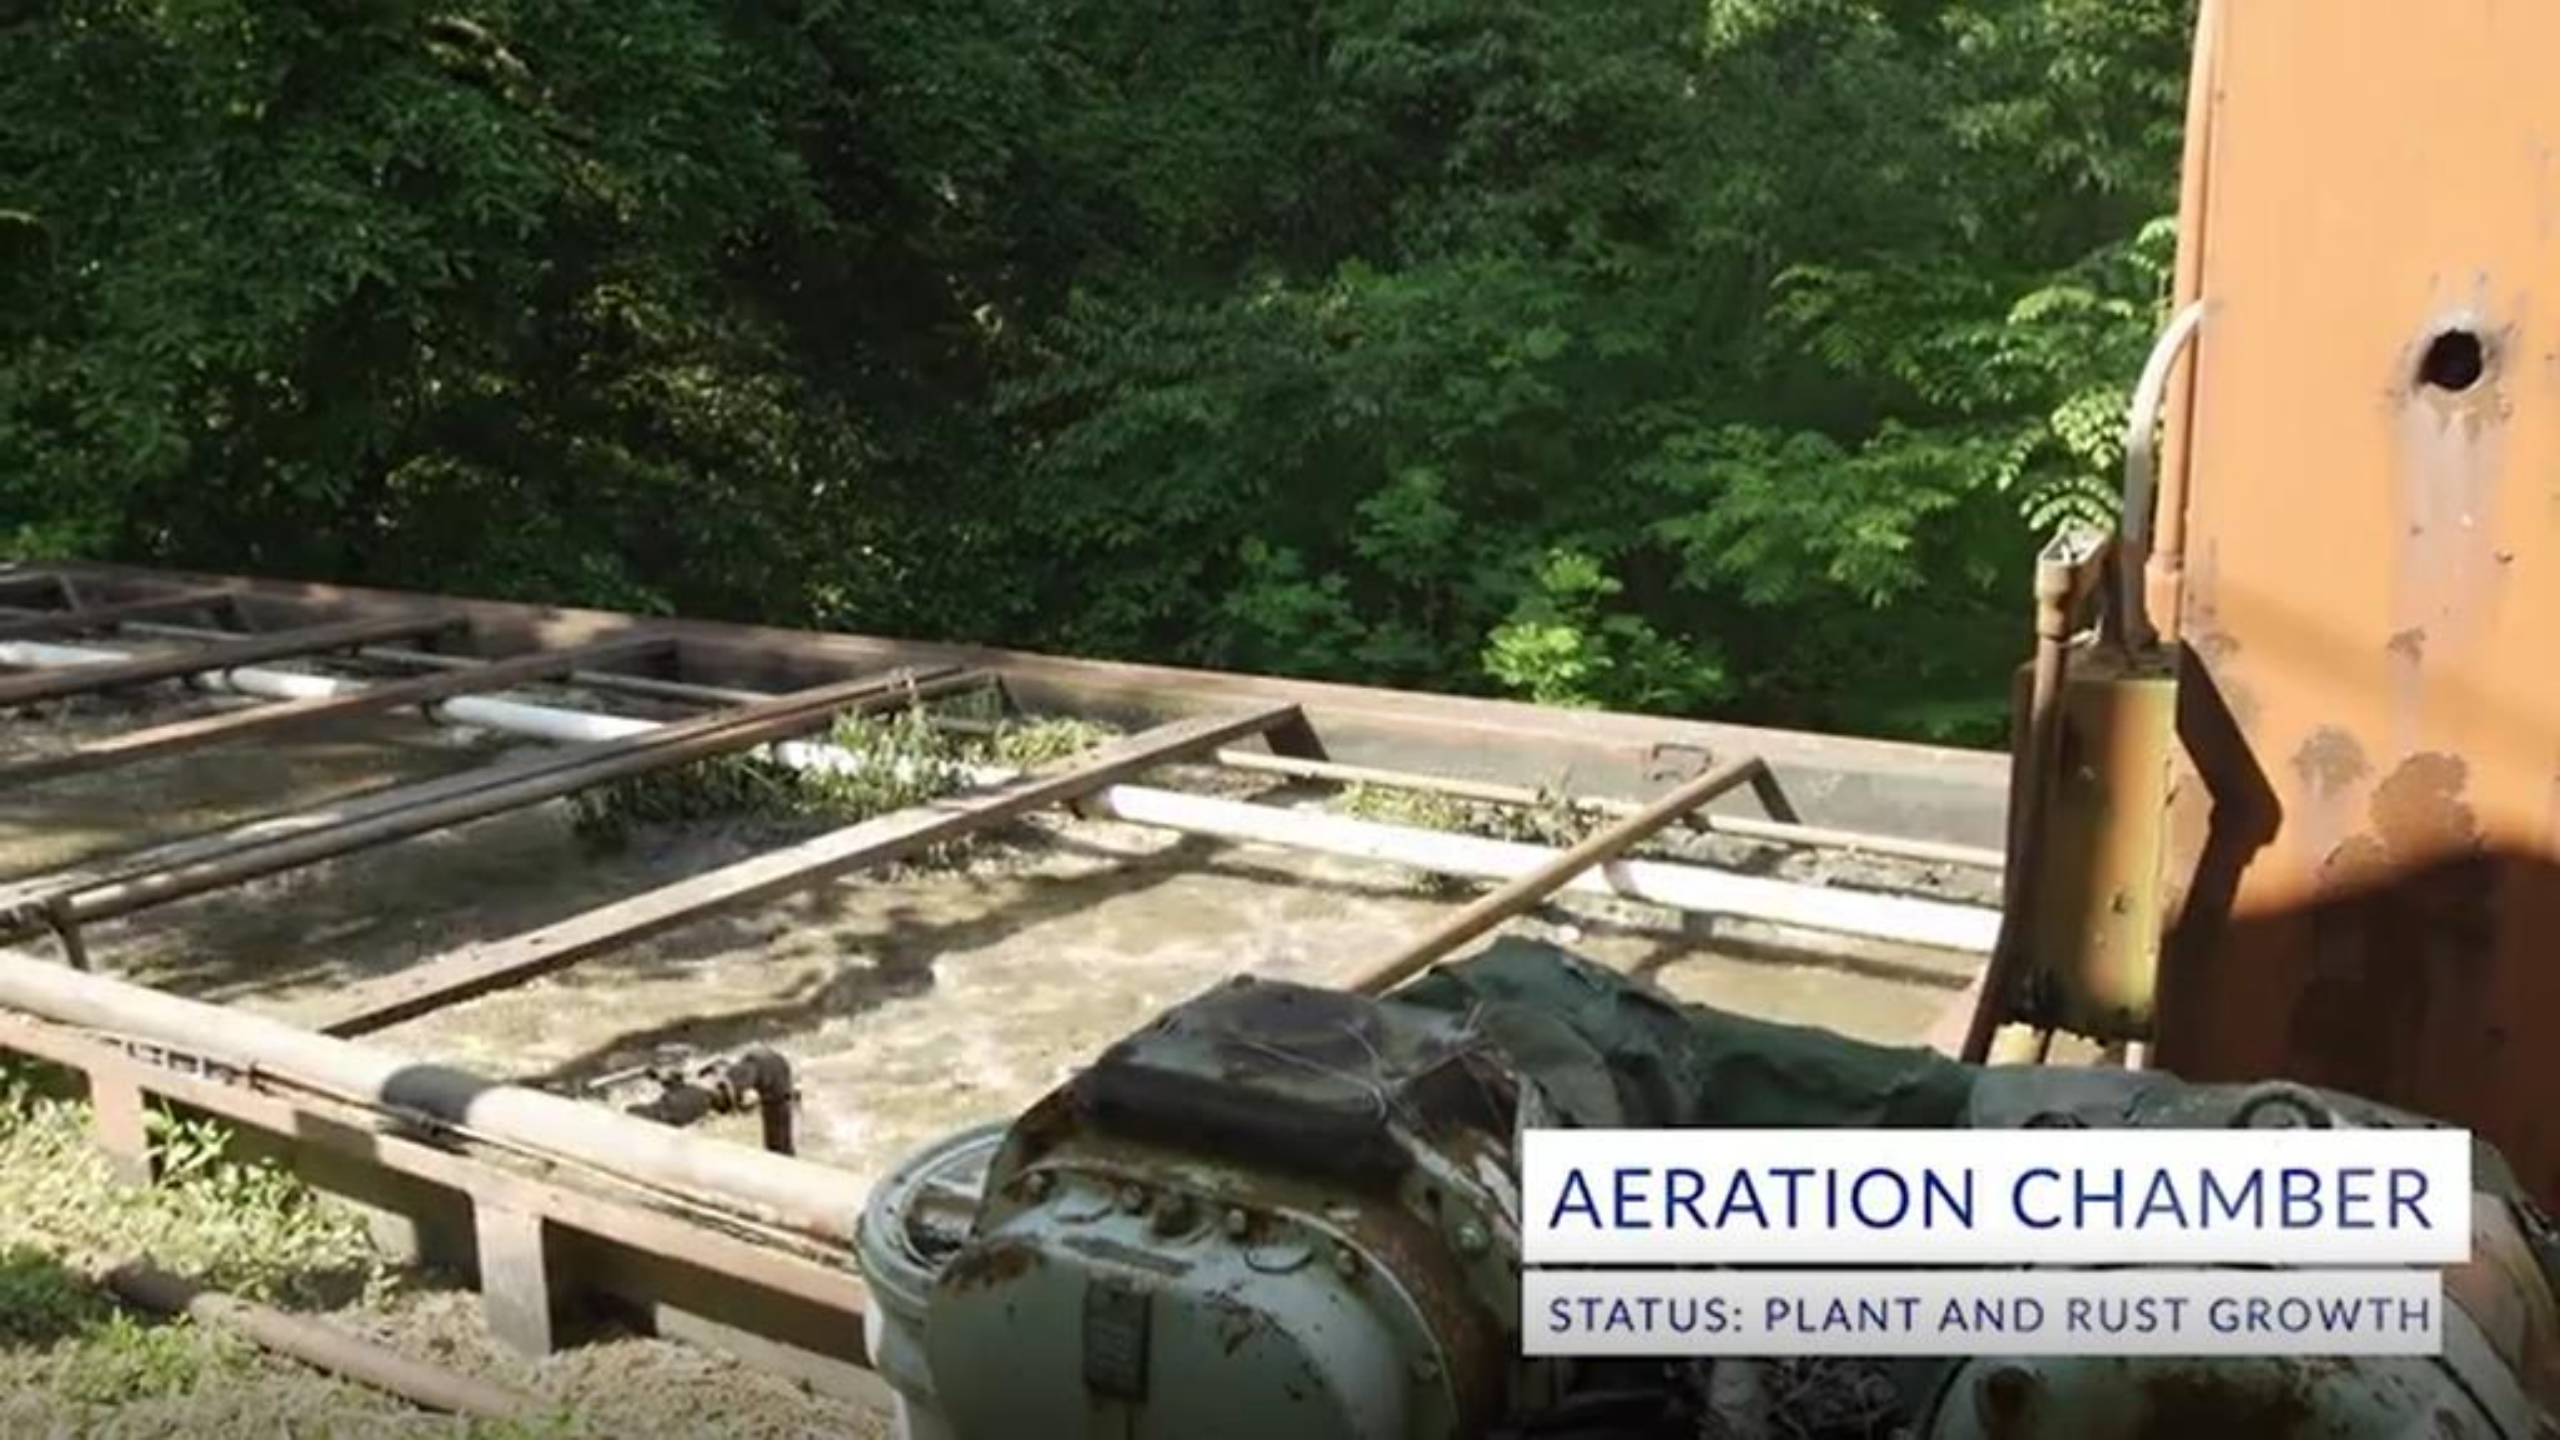
## AERATION CHAMBER

STATUS: PLANT AND RUST GROWTH

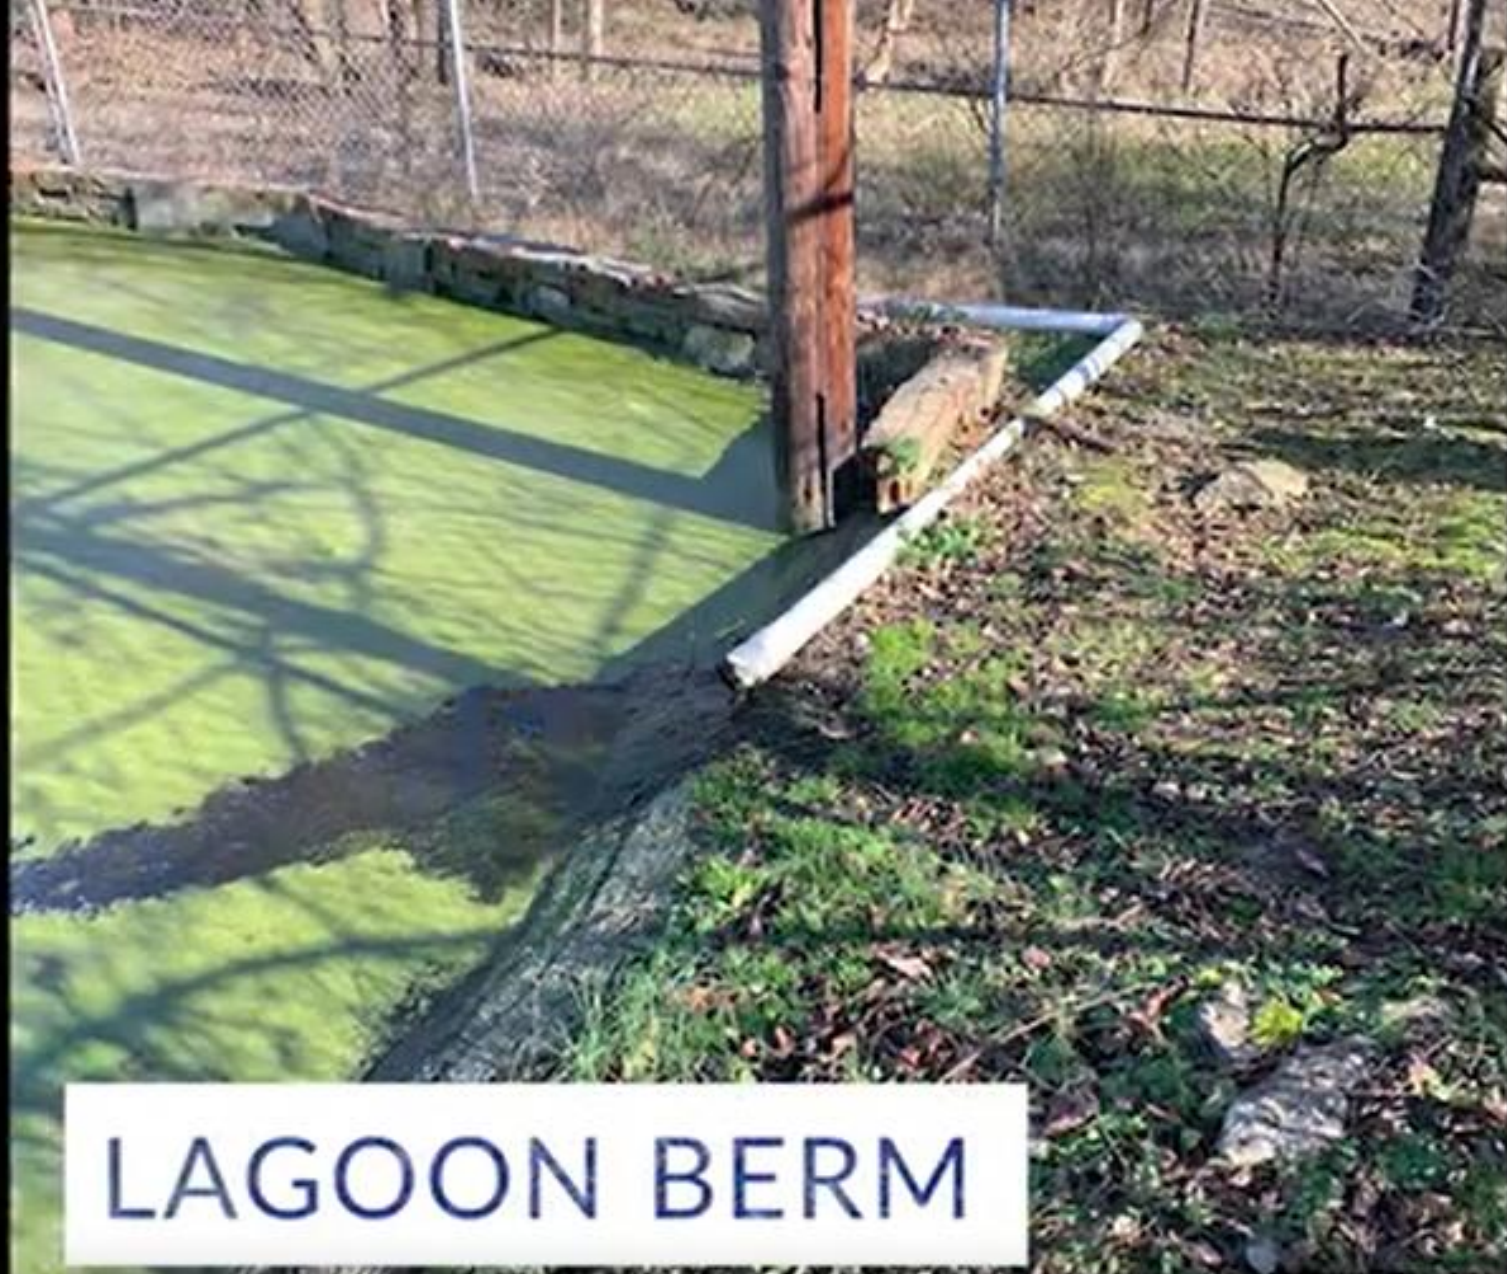
## LAGOON BERM

STATUS: STRUCTURE DETERIORATING AND LEAKING

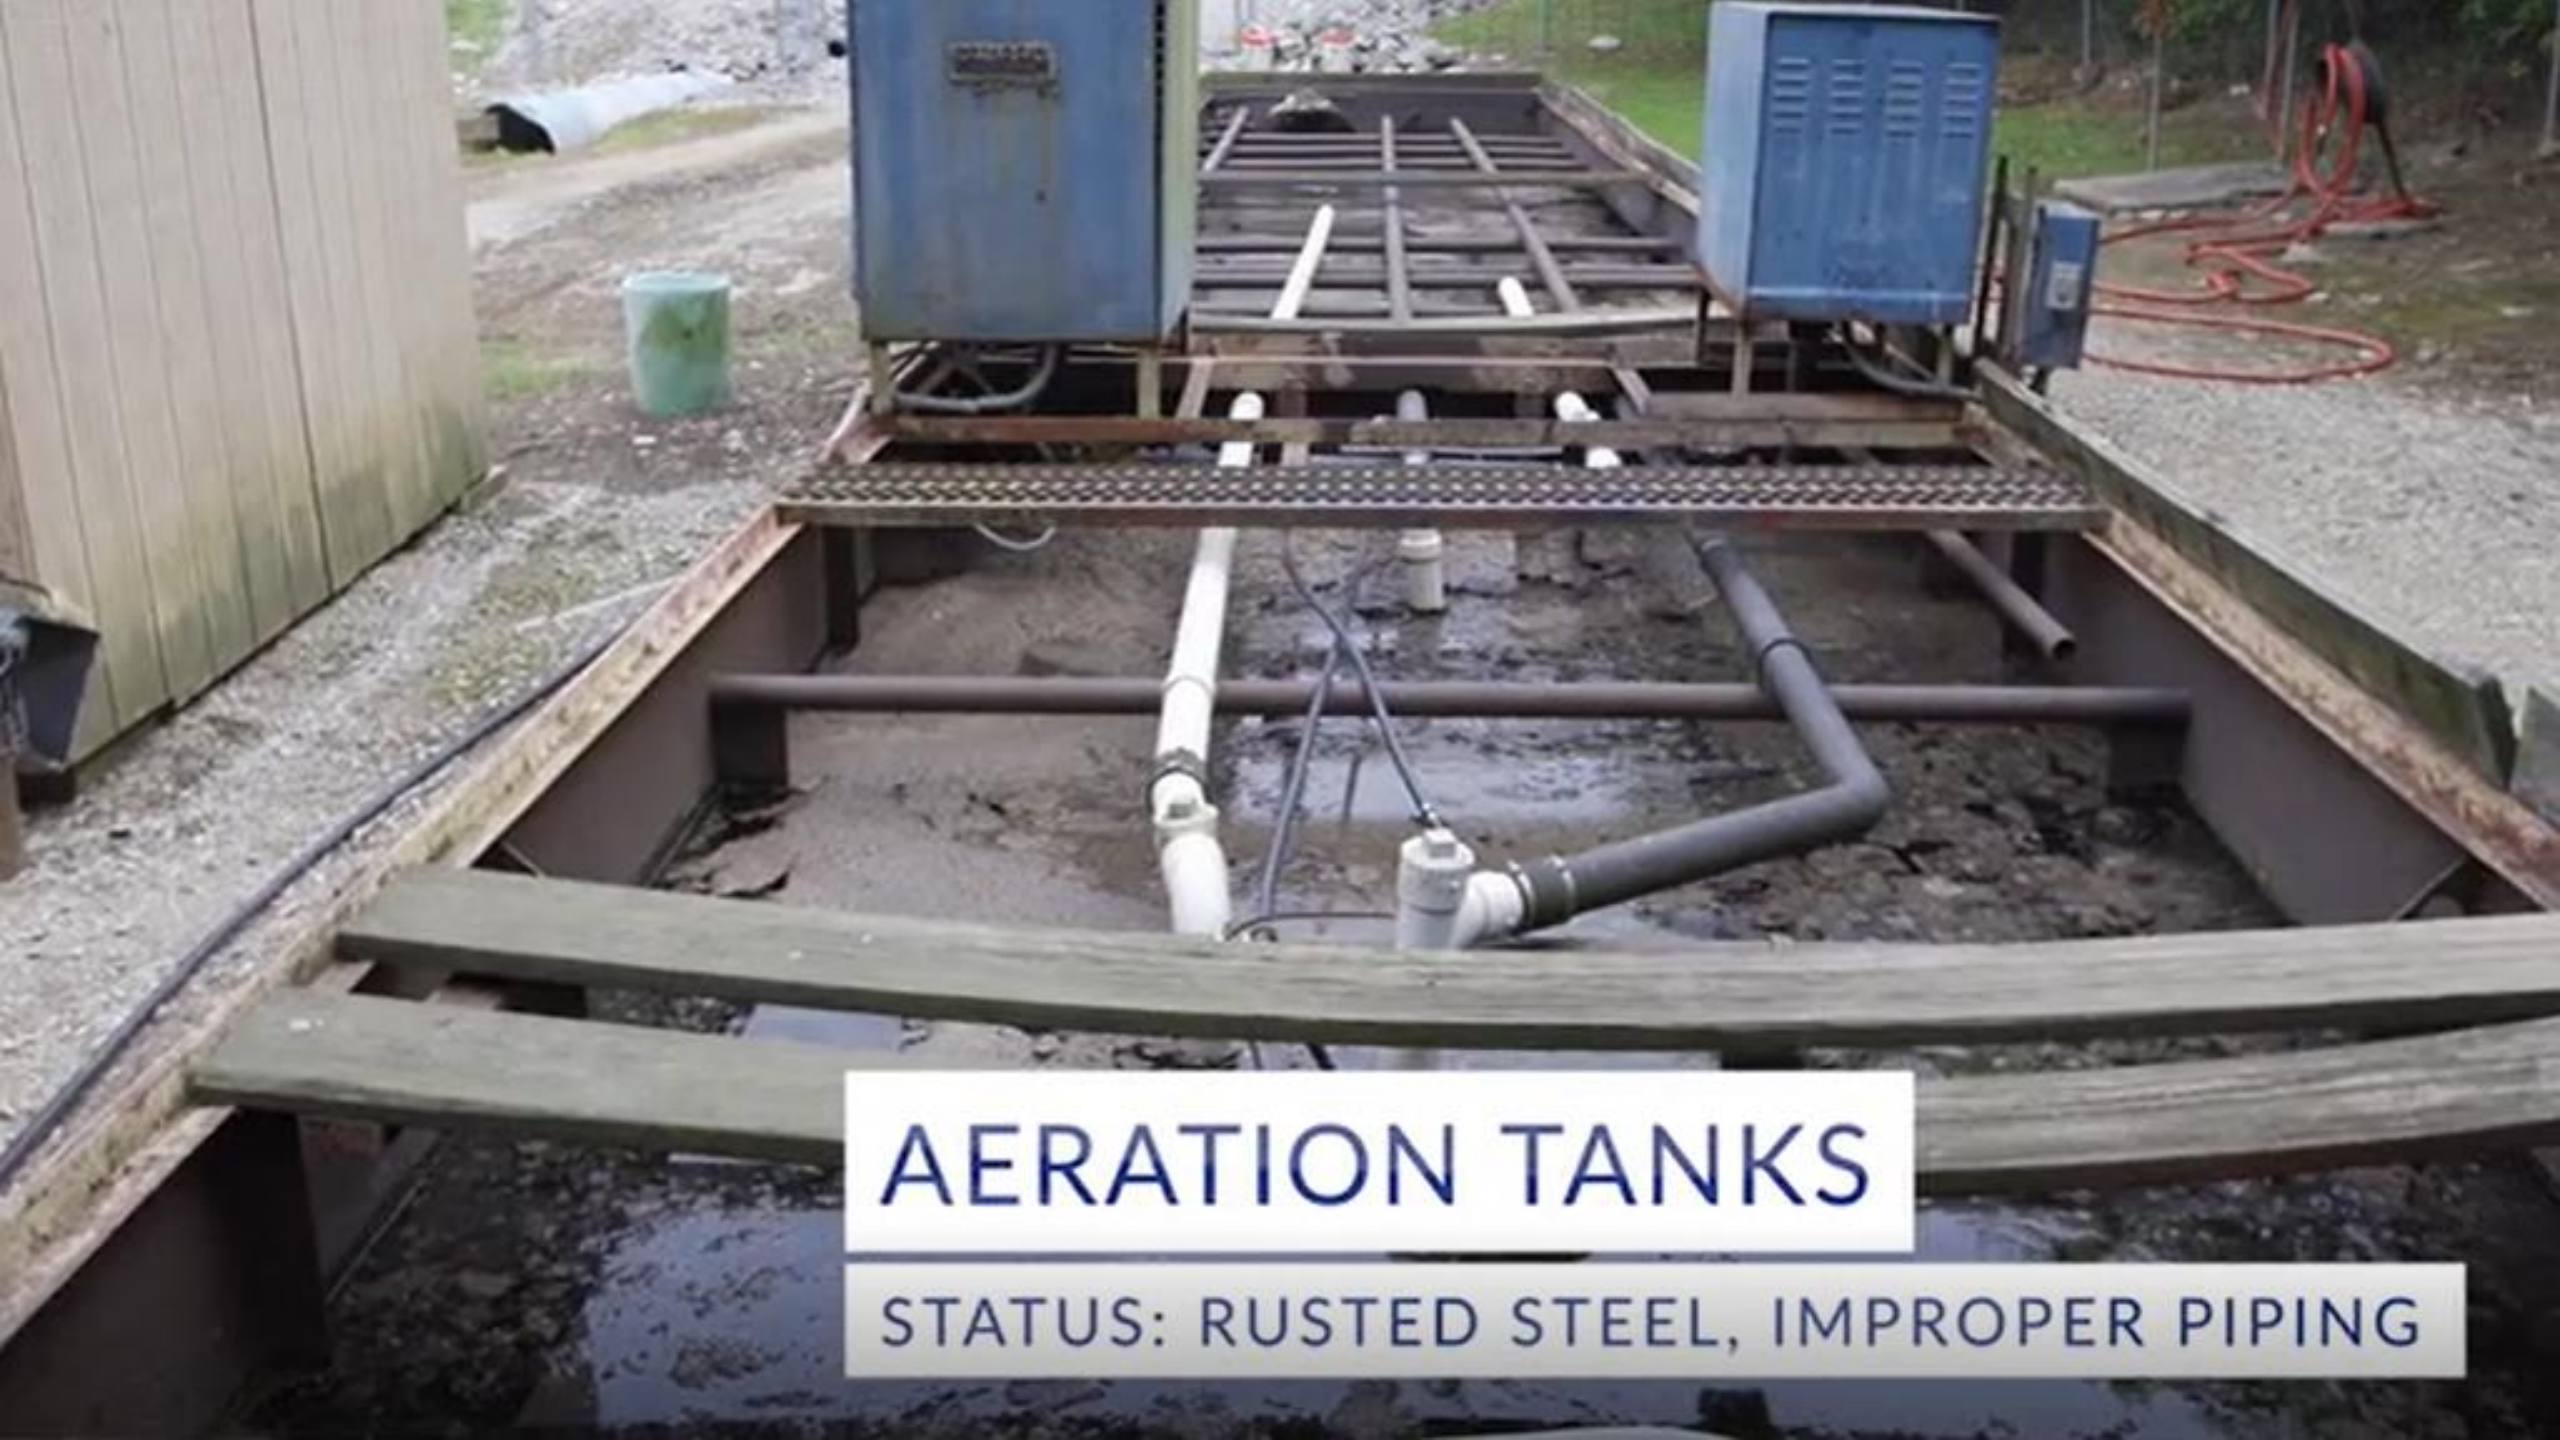
## AERATION TANKS

STATUS: RUSTED STEEL, IMPROPER PIPING

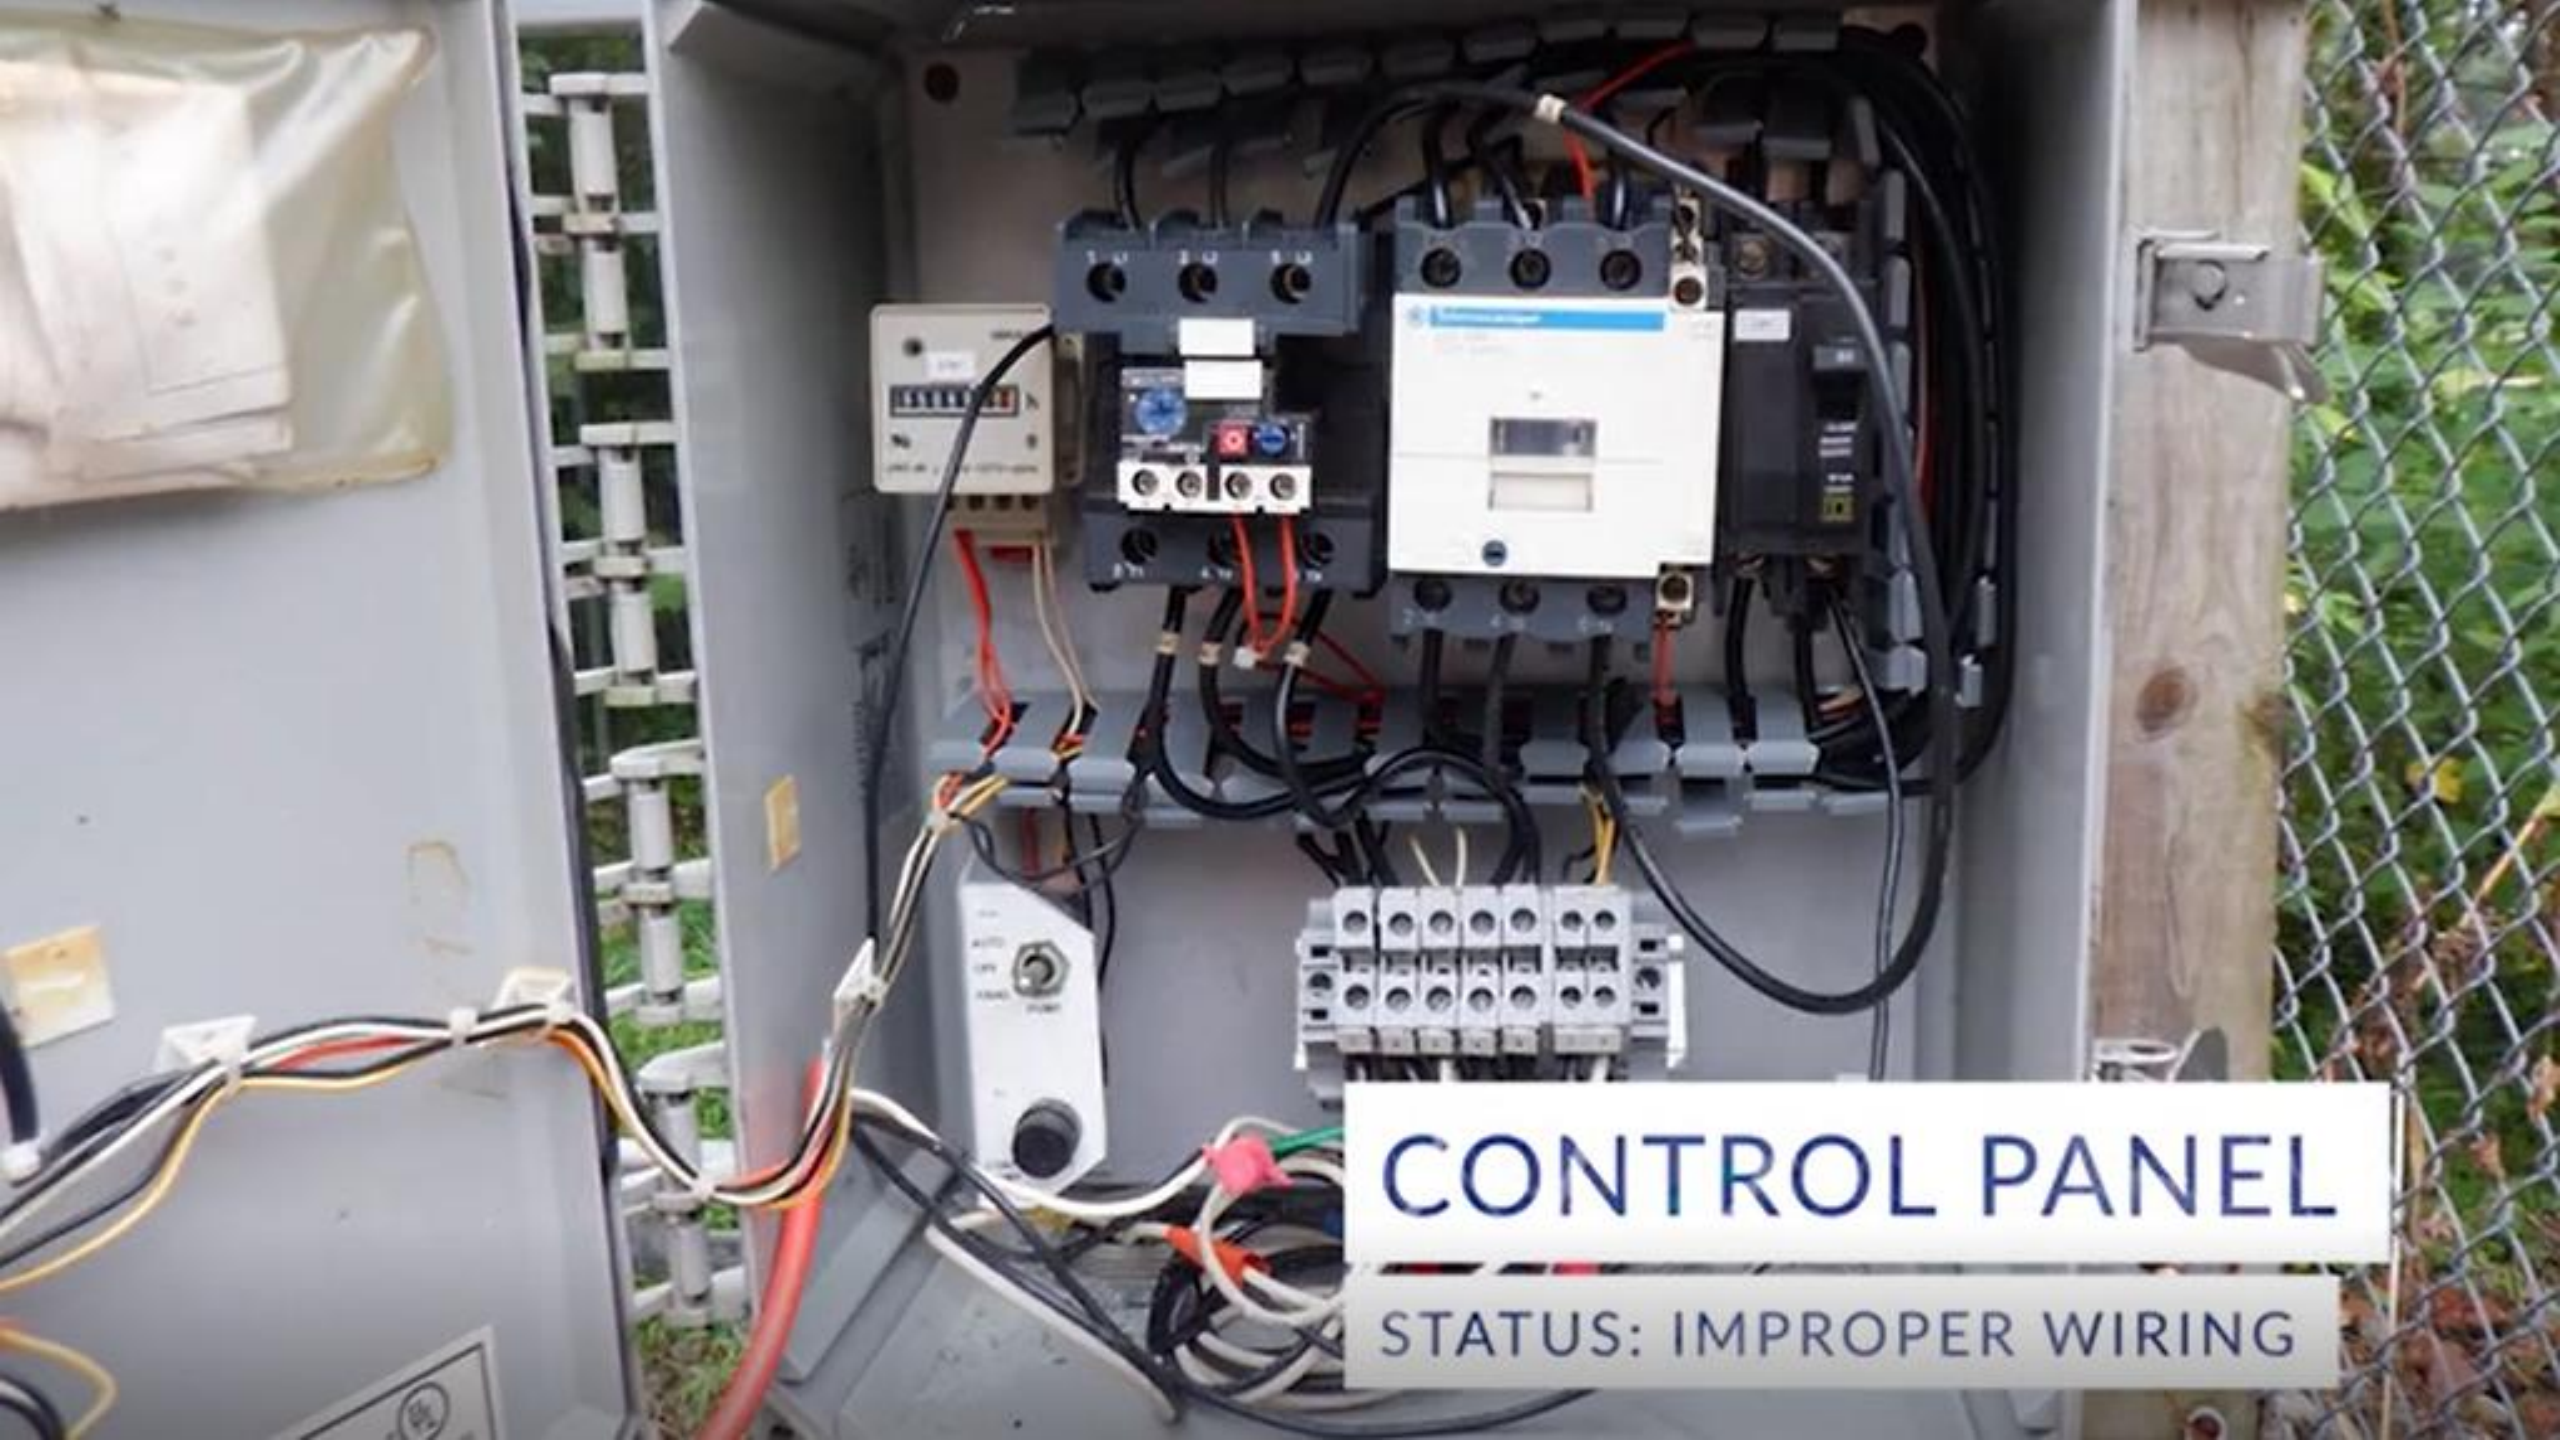
# CONTROL PANEL

STATUS: IMPROPER WIRING

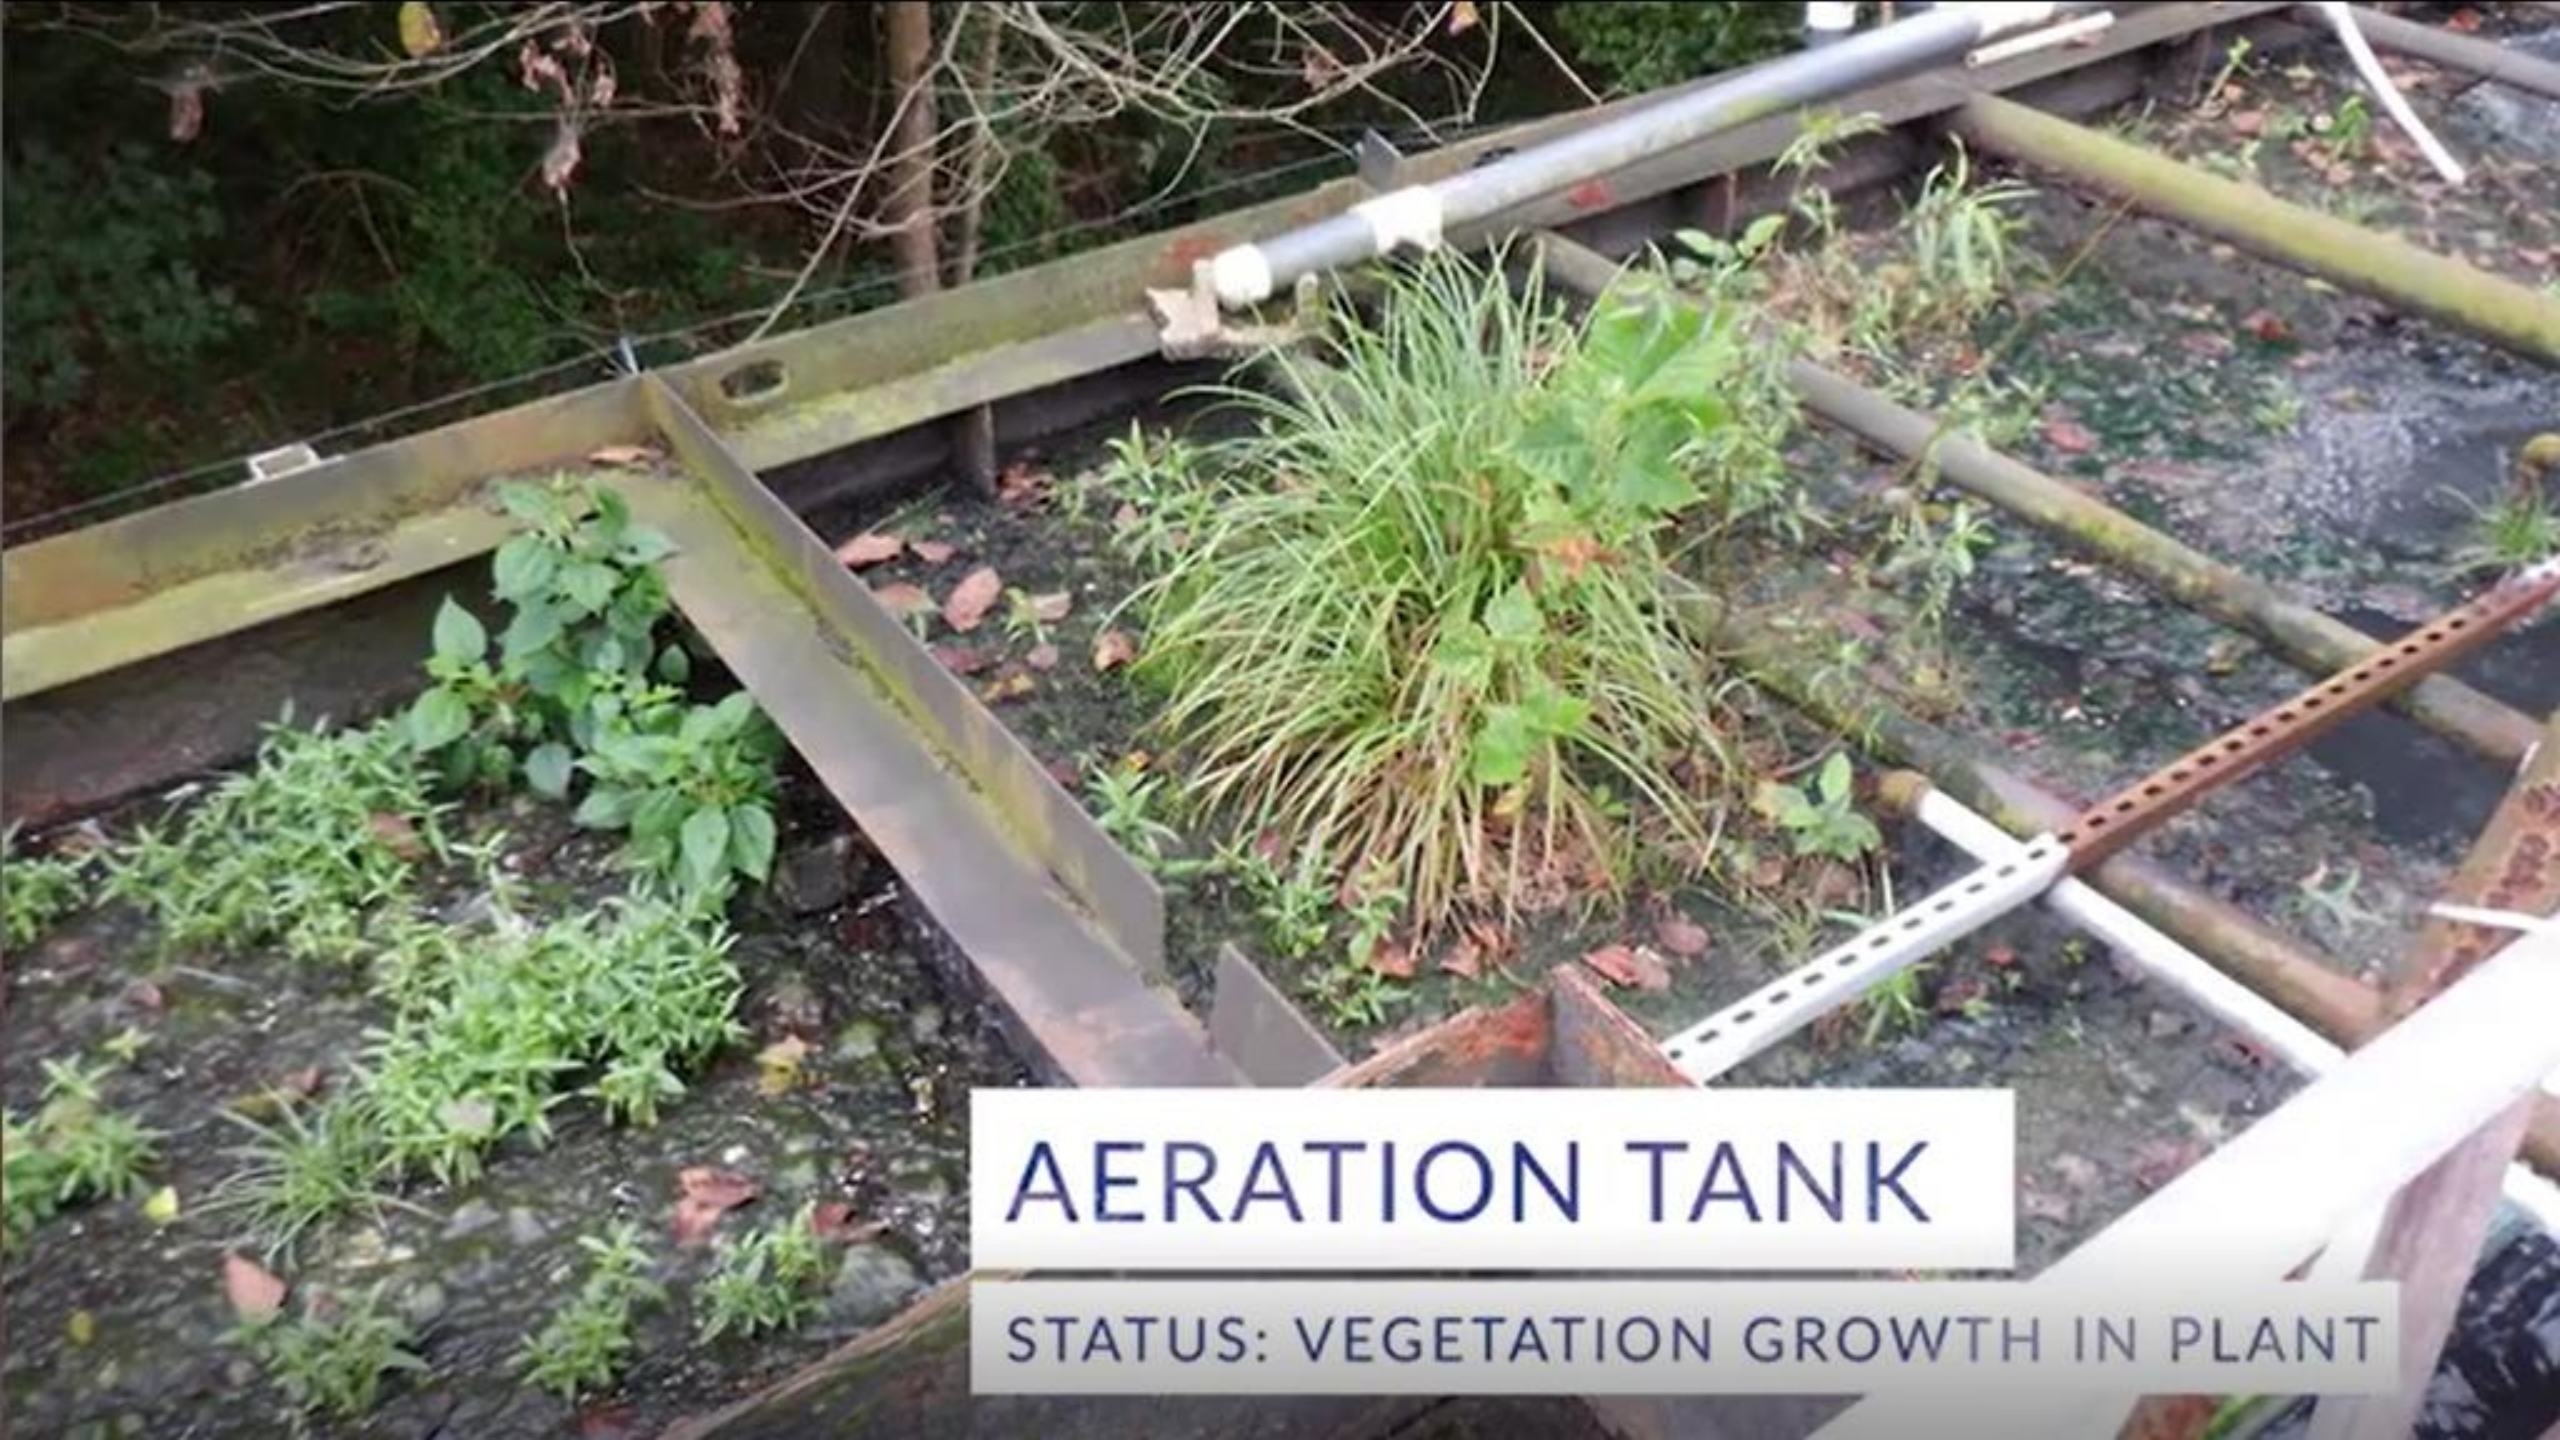
## AERATION TANK

STATUS: VEGETATION GROWTH IN PLANT

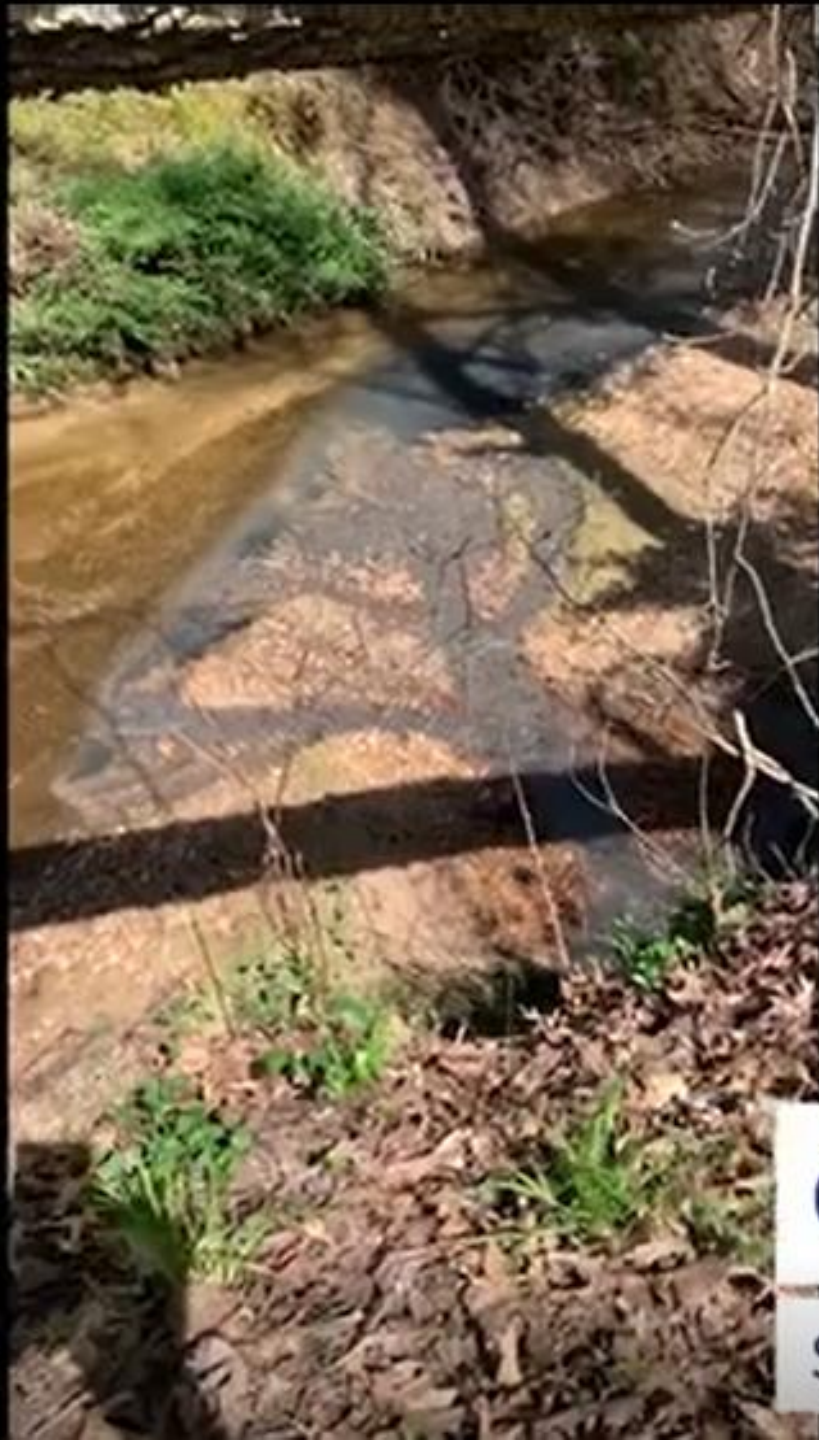
OUTFALL

STATUS: POLLUTION
