COMMONWEALTH OF KENTUCKY  
BEFORE THE PUBLIC SERVICE COMMISSION

<i>Electronic</i> Application of Bluegrass	)	
Water Utility Operating Company, LLC	)	Case No. 2020-00290
for an Adjustment of Rates and Approval	)	
of Construction	)

**Supplement to Responses  
to Post-Hearing Data Requests**

SUPPLEMENT: Bluegrass attaches hereto a series of stills taken from the video file, *Bluegrass Water UOC\_Before Reel.mp4*, showing the condition of the systems that it acquired before June 30, 2020. The following is an index with the PDF page number of each still, the time counter on the video file, and a description of what is depicted by title or facility and status:

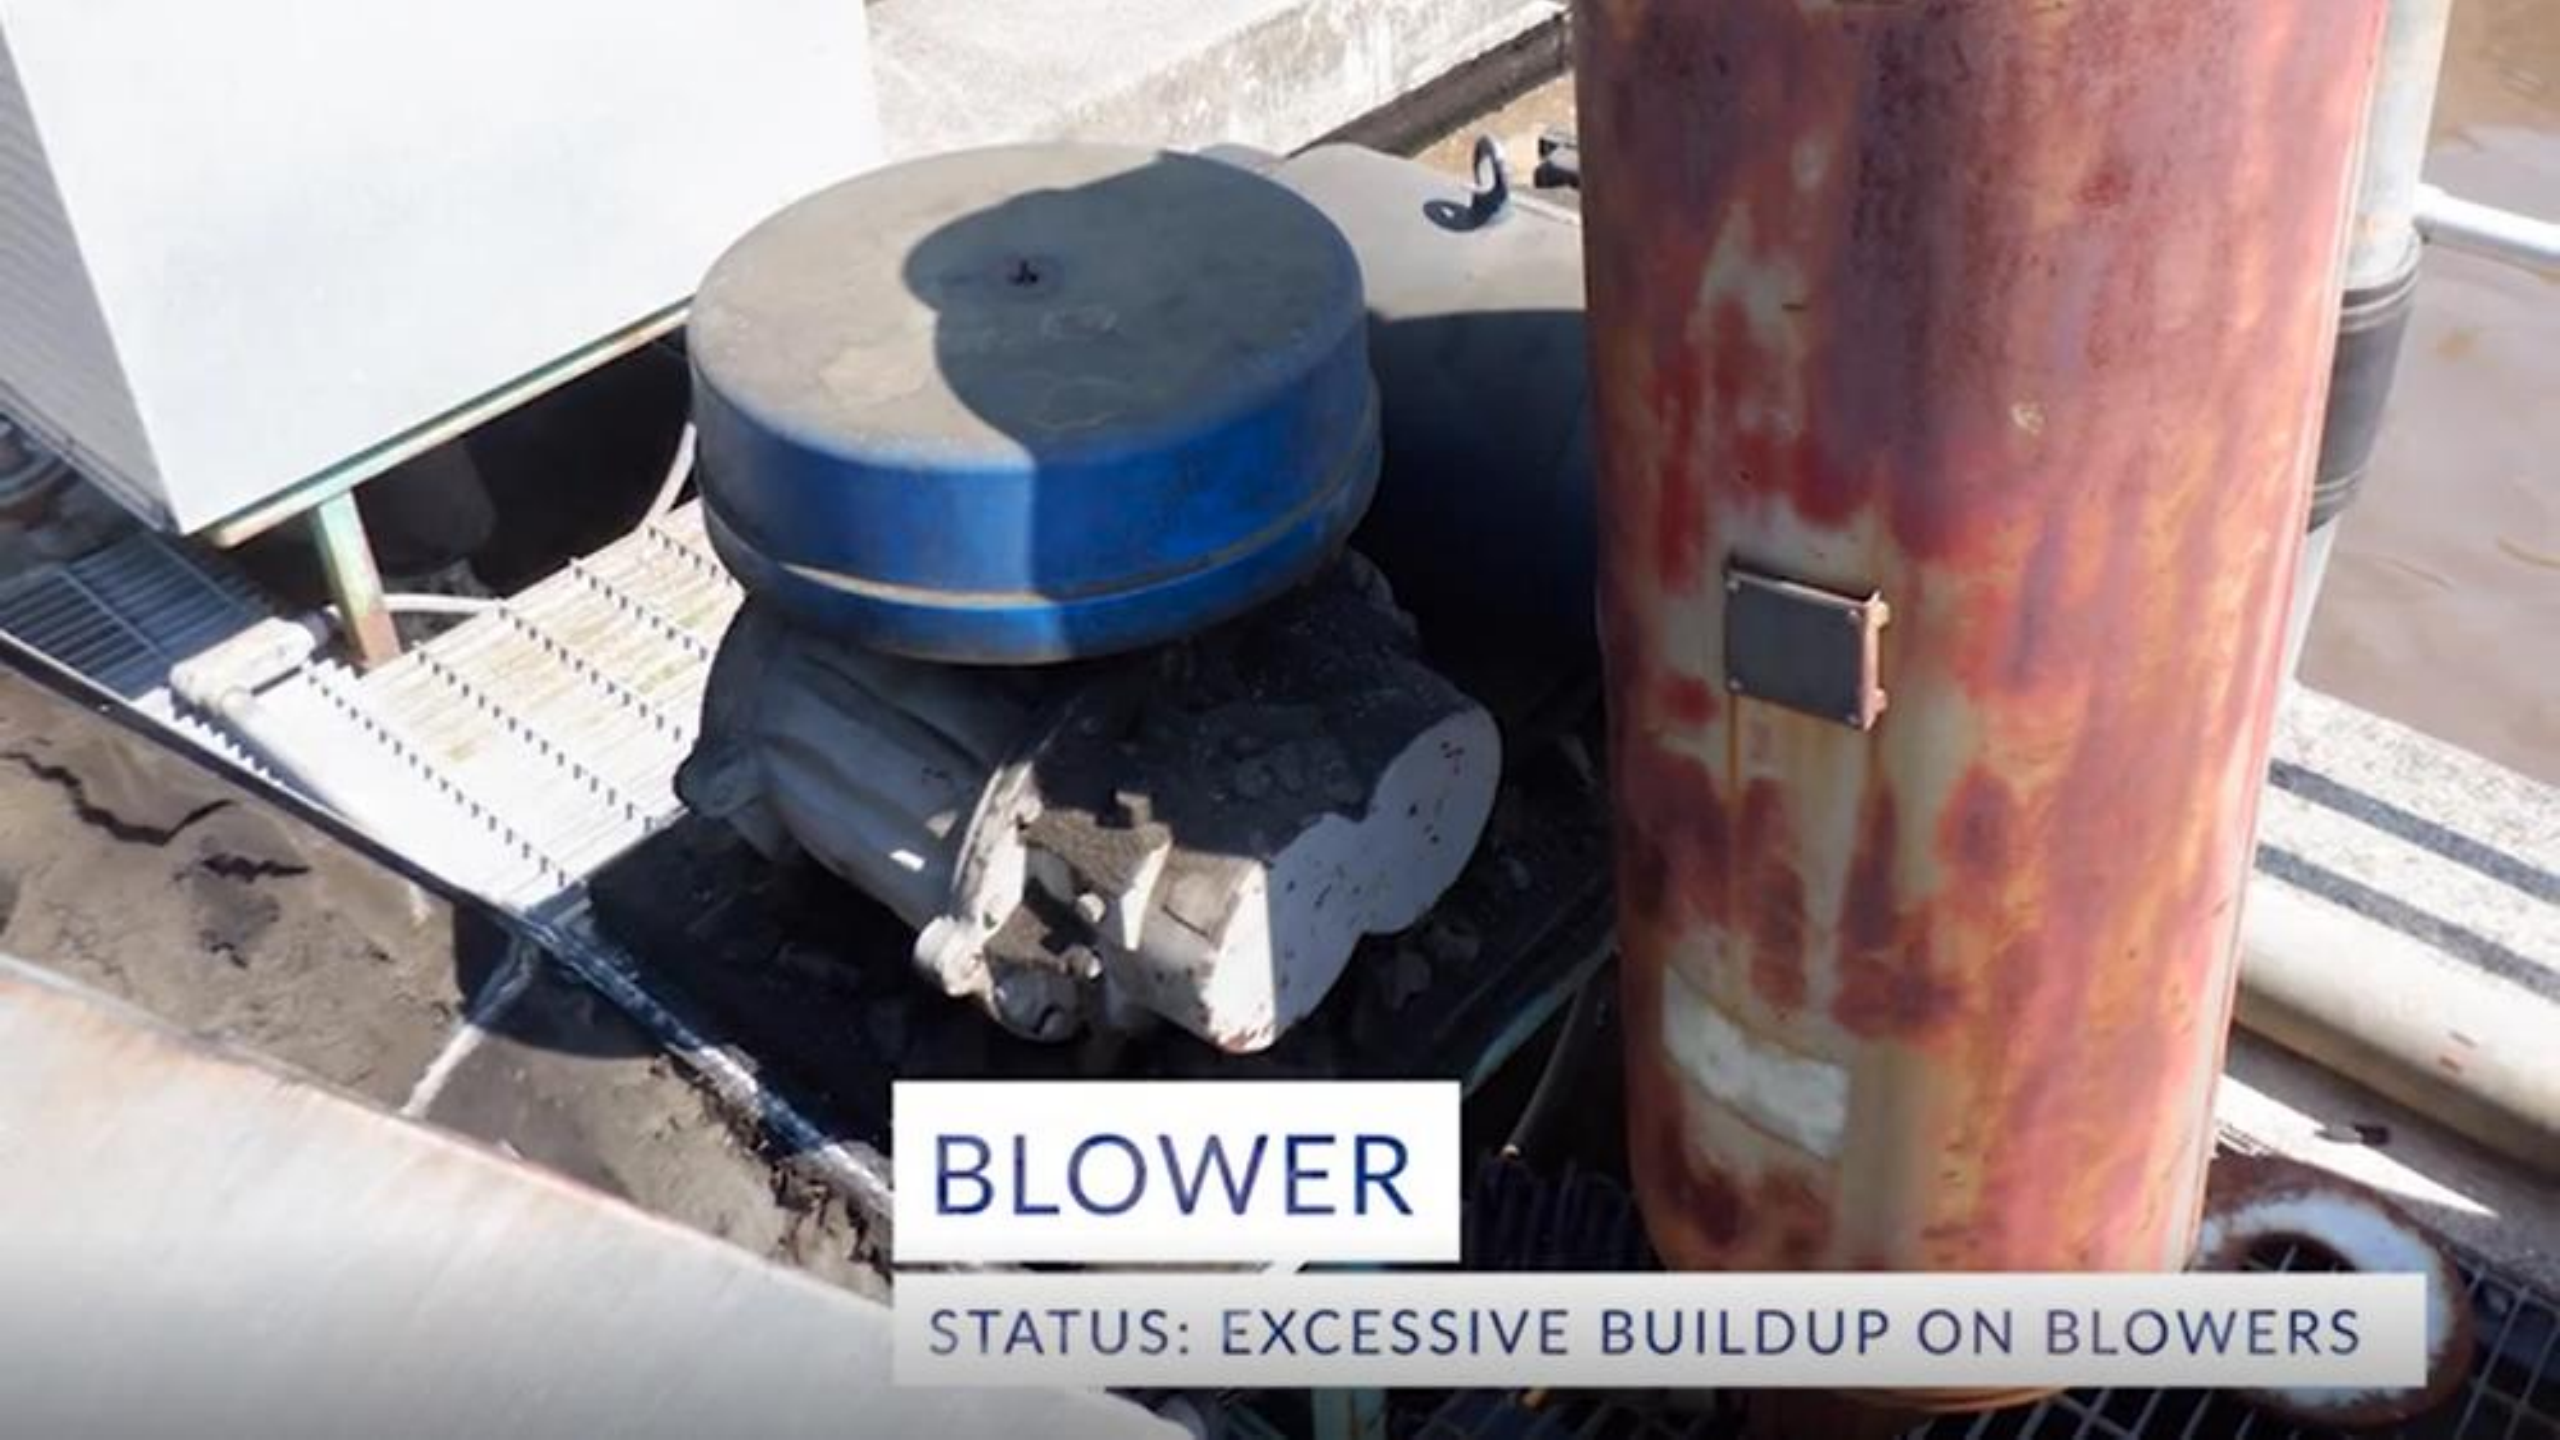
**BLOWER**

STATUS: EXCESSIVE BUILDUP ON BLOWERS

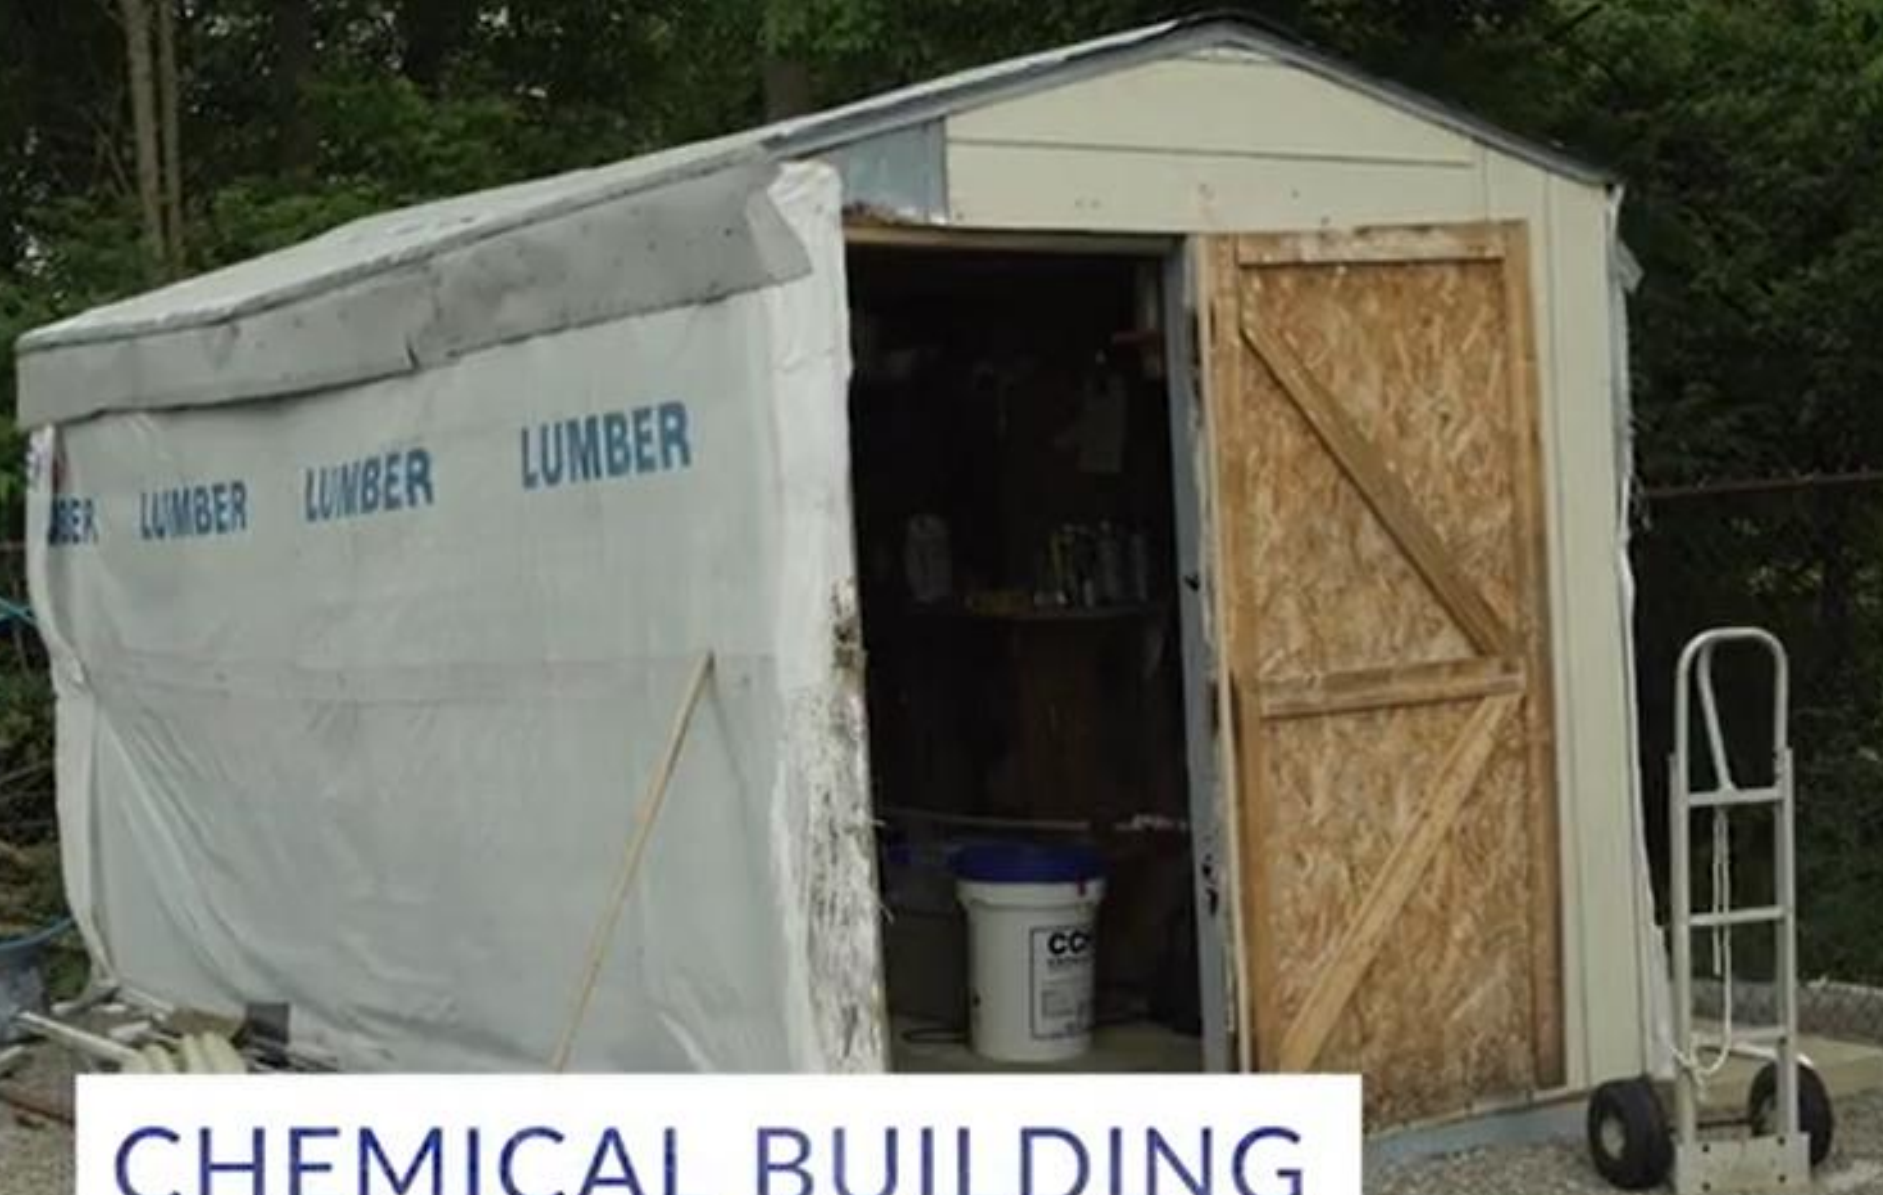
## CHEMICAL BUILDING

STATUS: DEGRADED STRUCTURE, IMPROPER REPAIRS

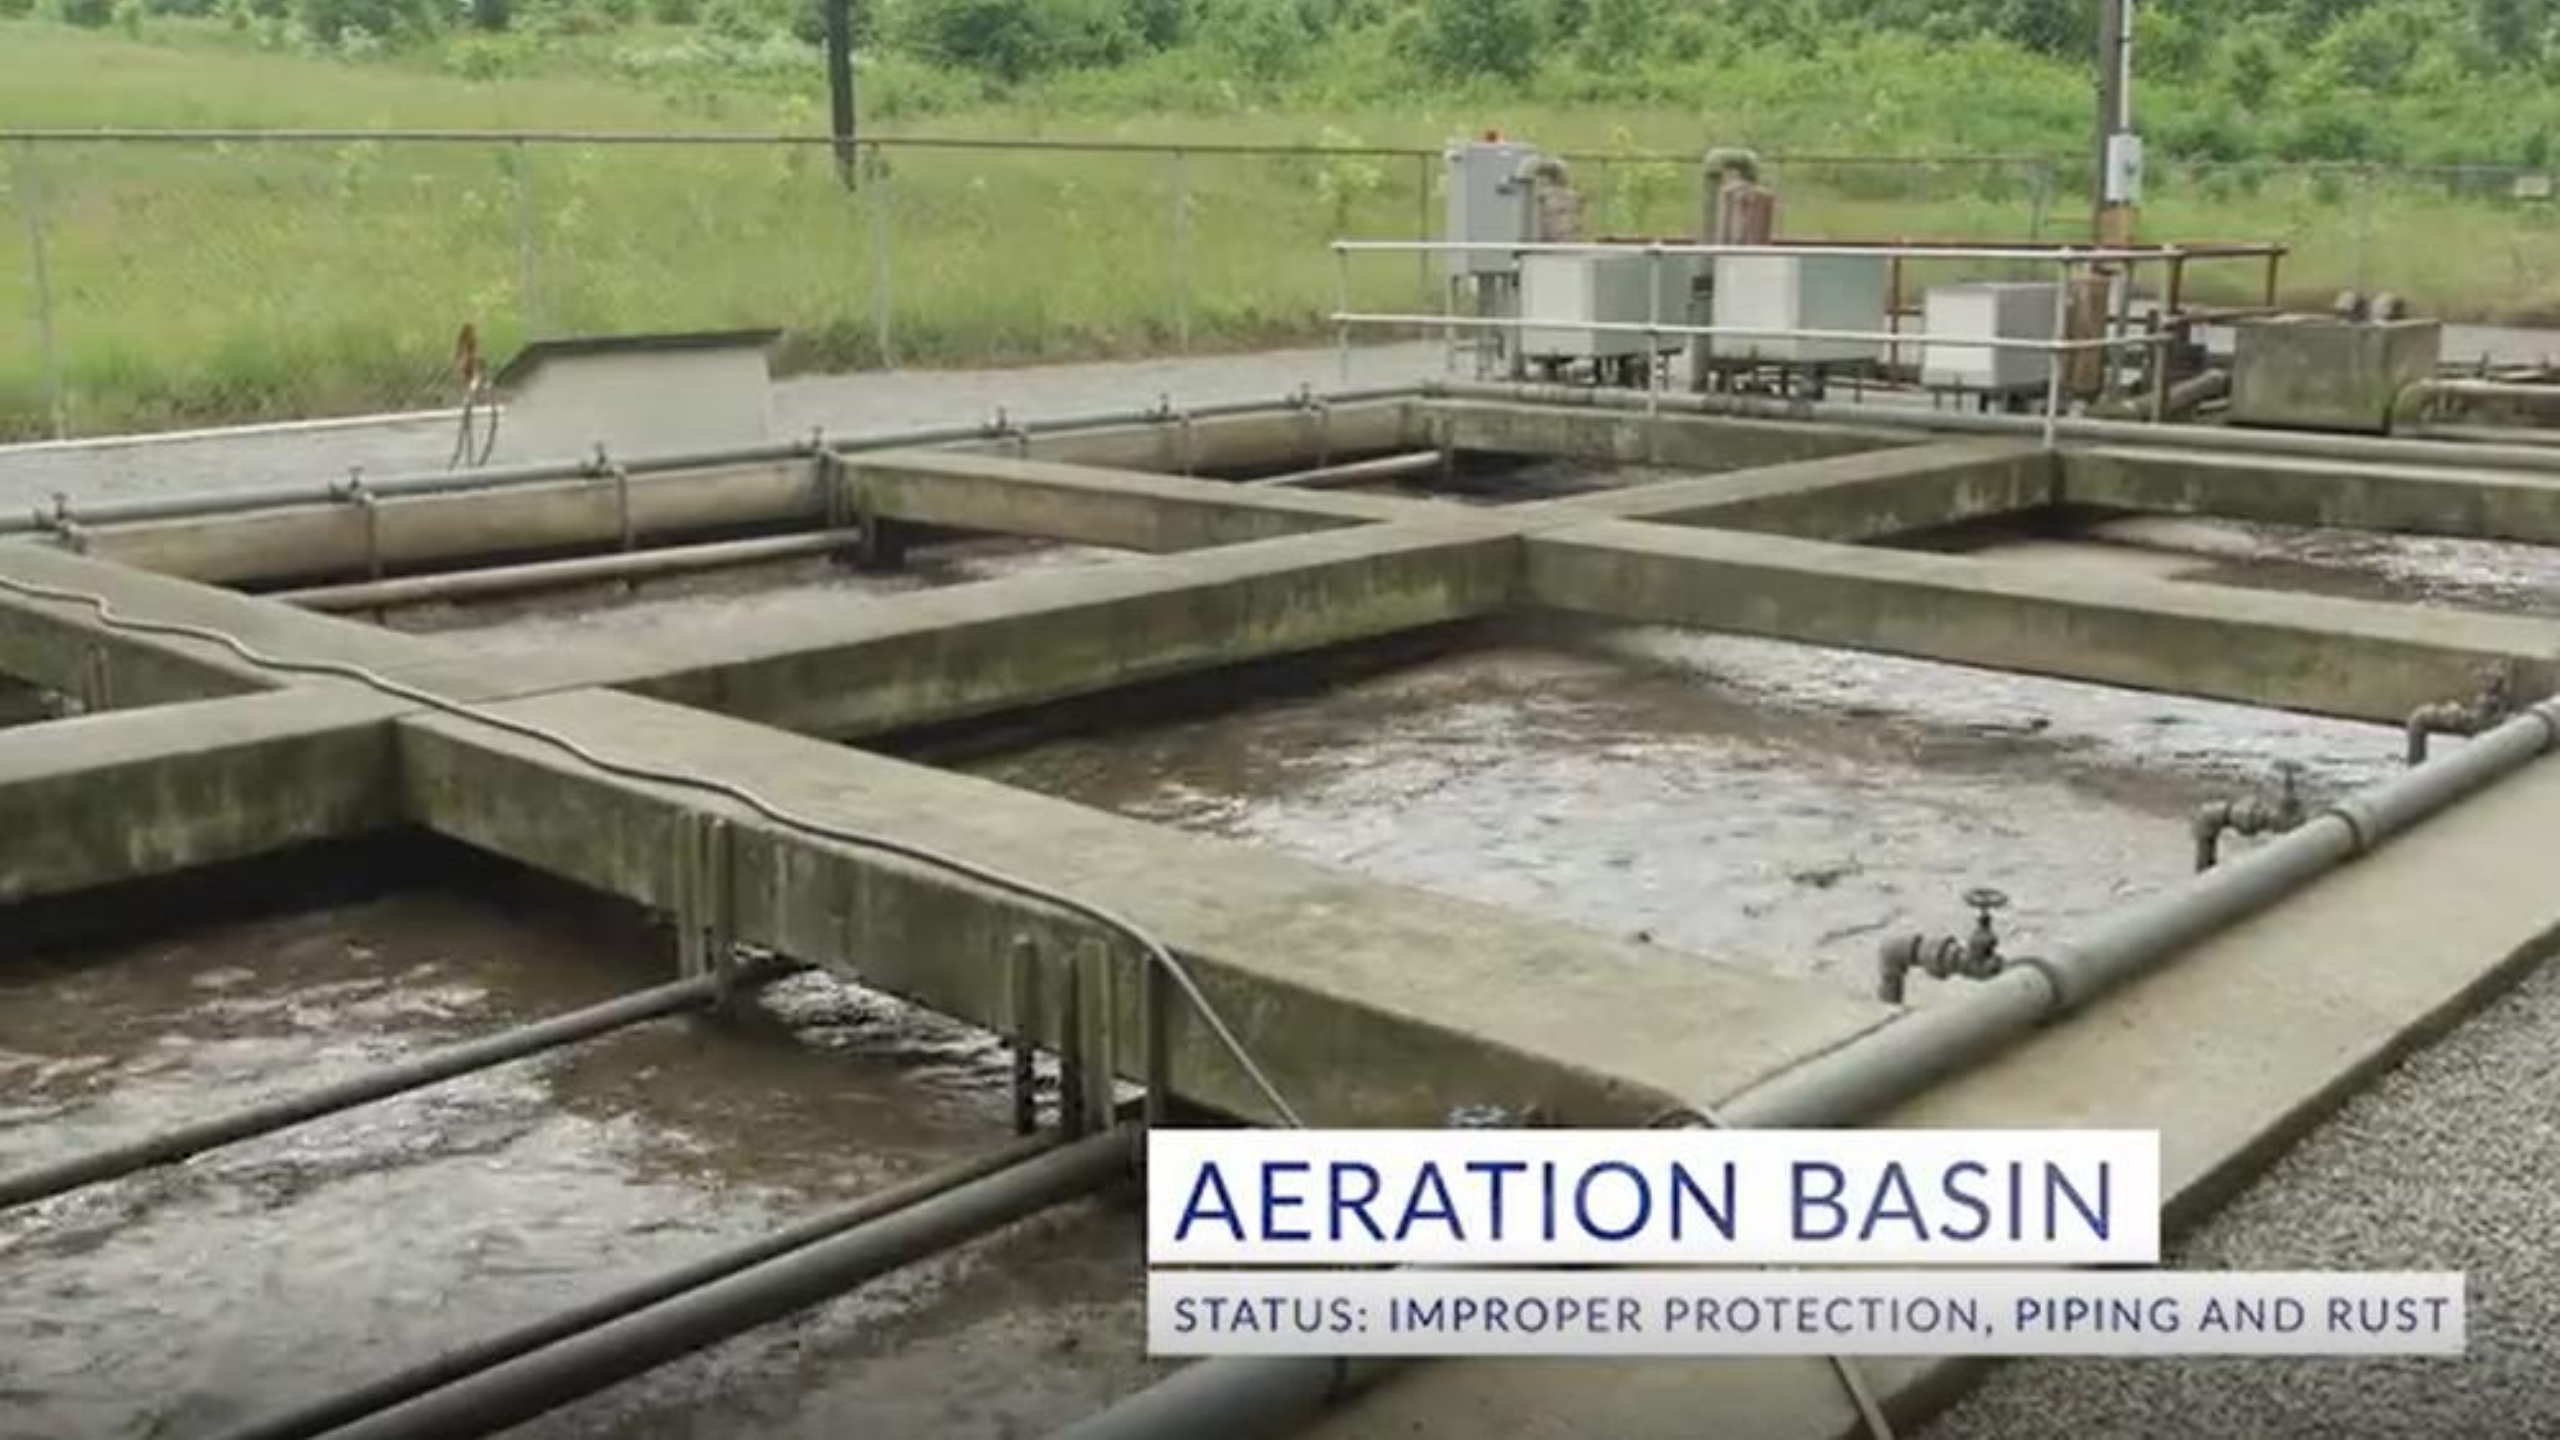
## AERATION BASIN

STATUS: IMPROPER PROTECTION, PIPING AND RUST

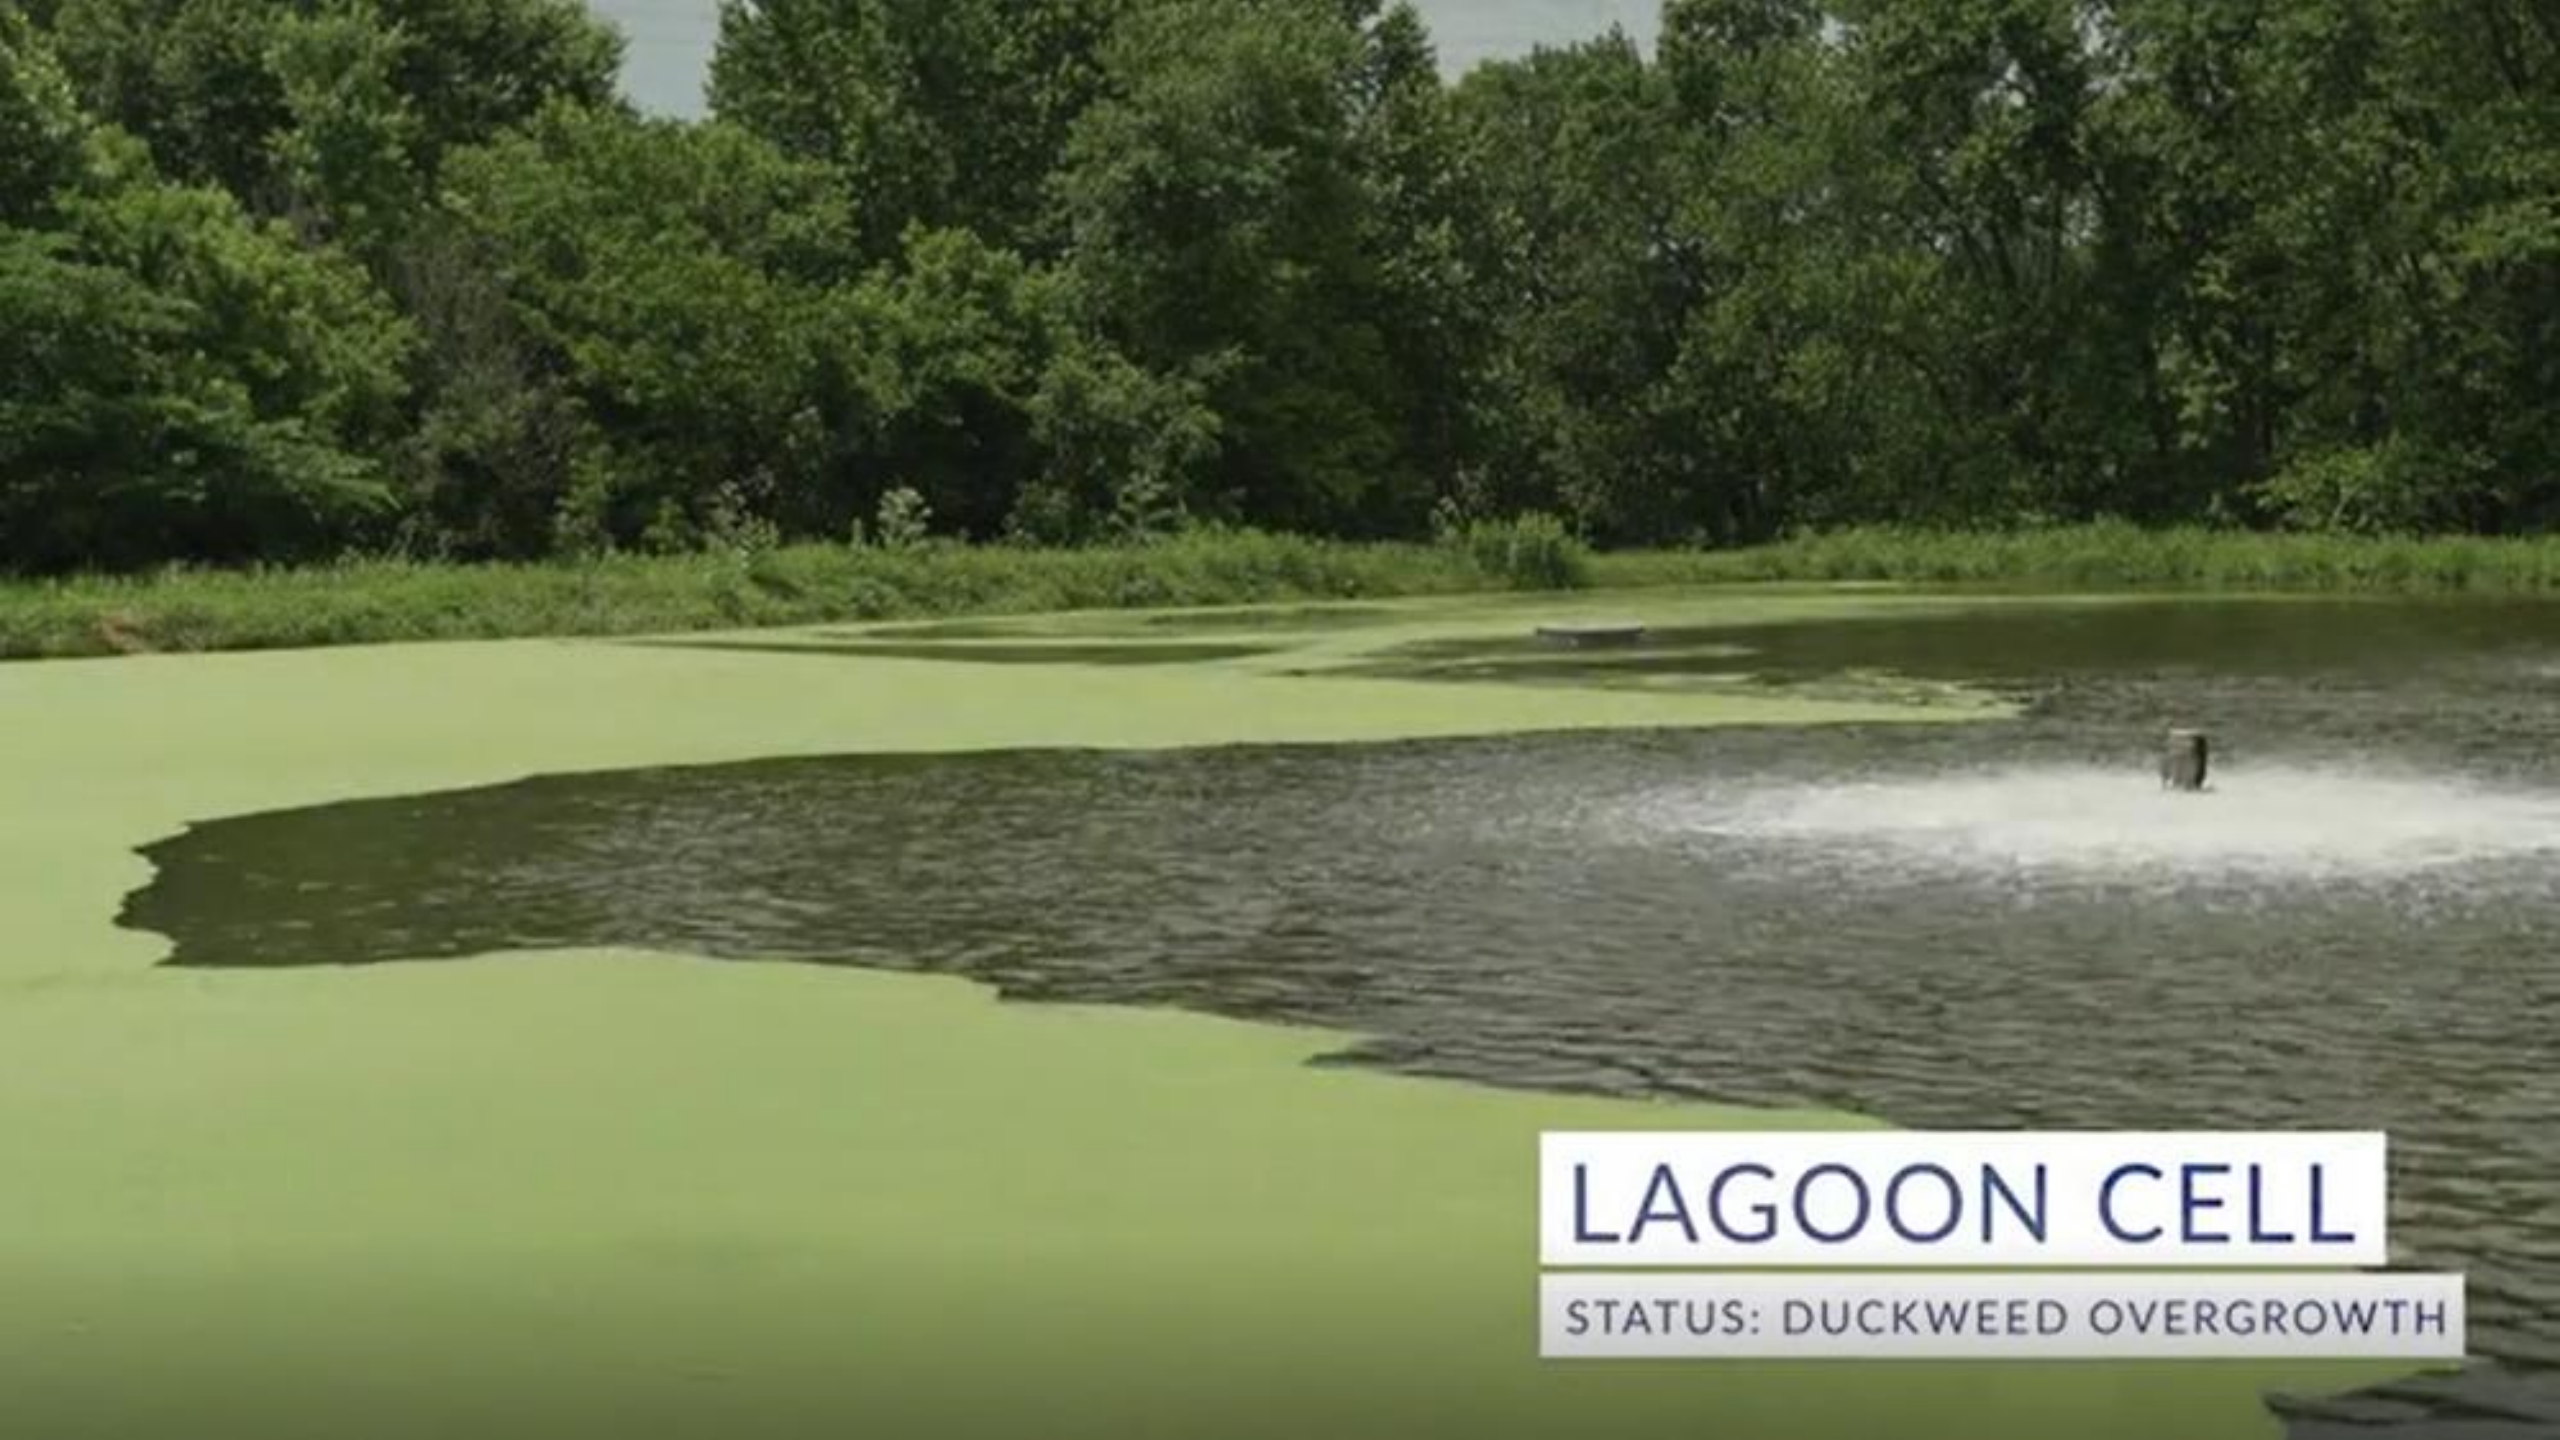
# LAGOON CELL

STATUS: DUCKWEED OVERGROWTH

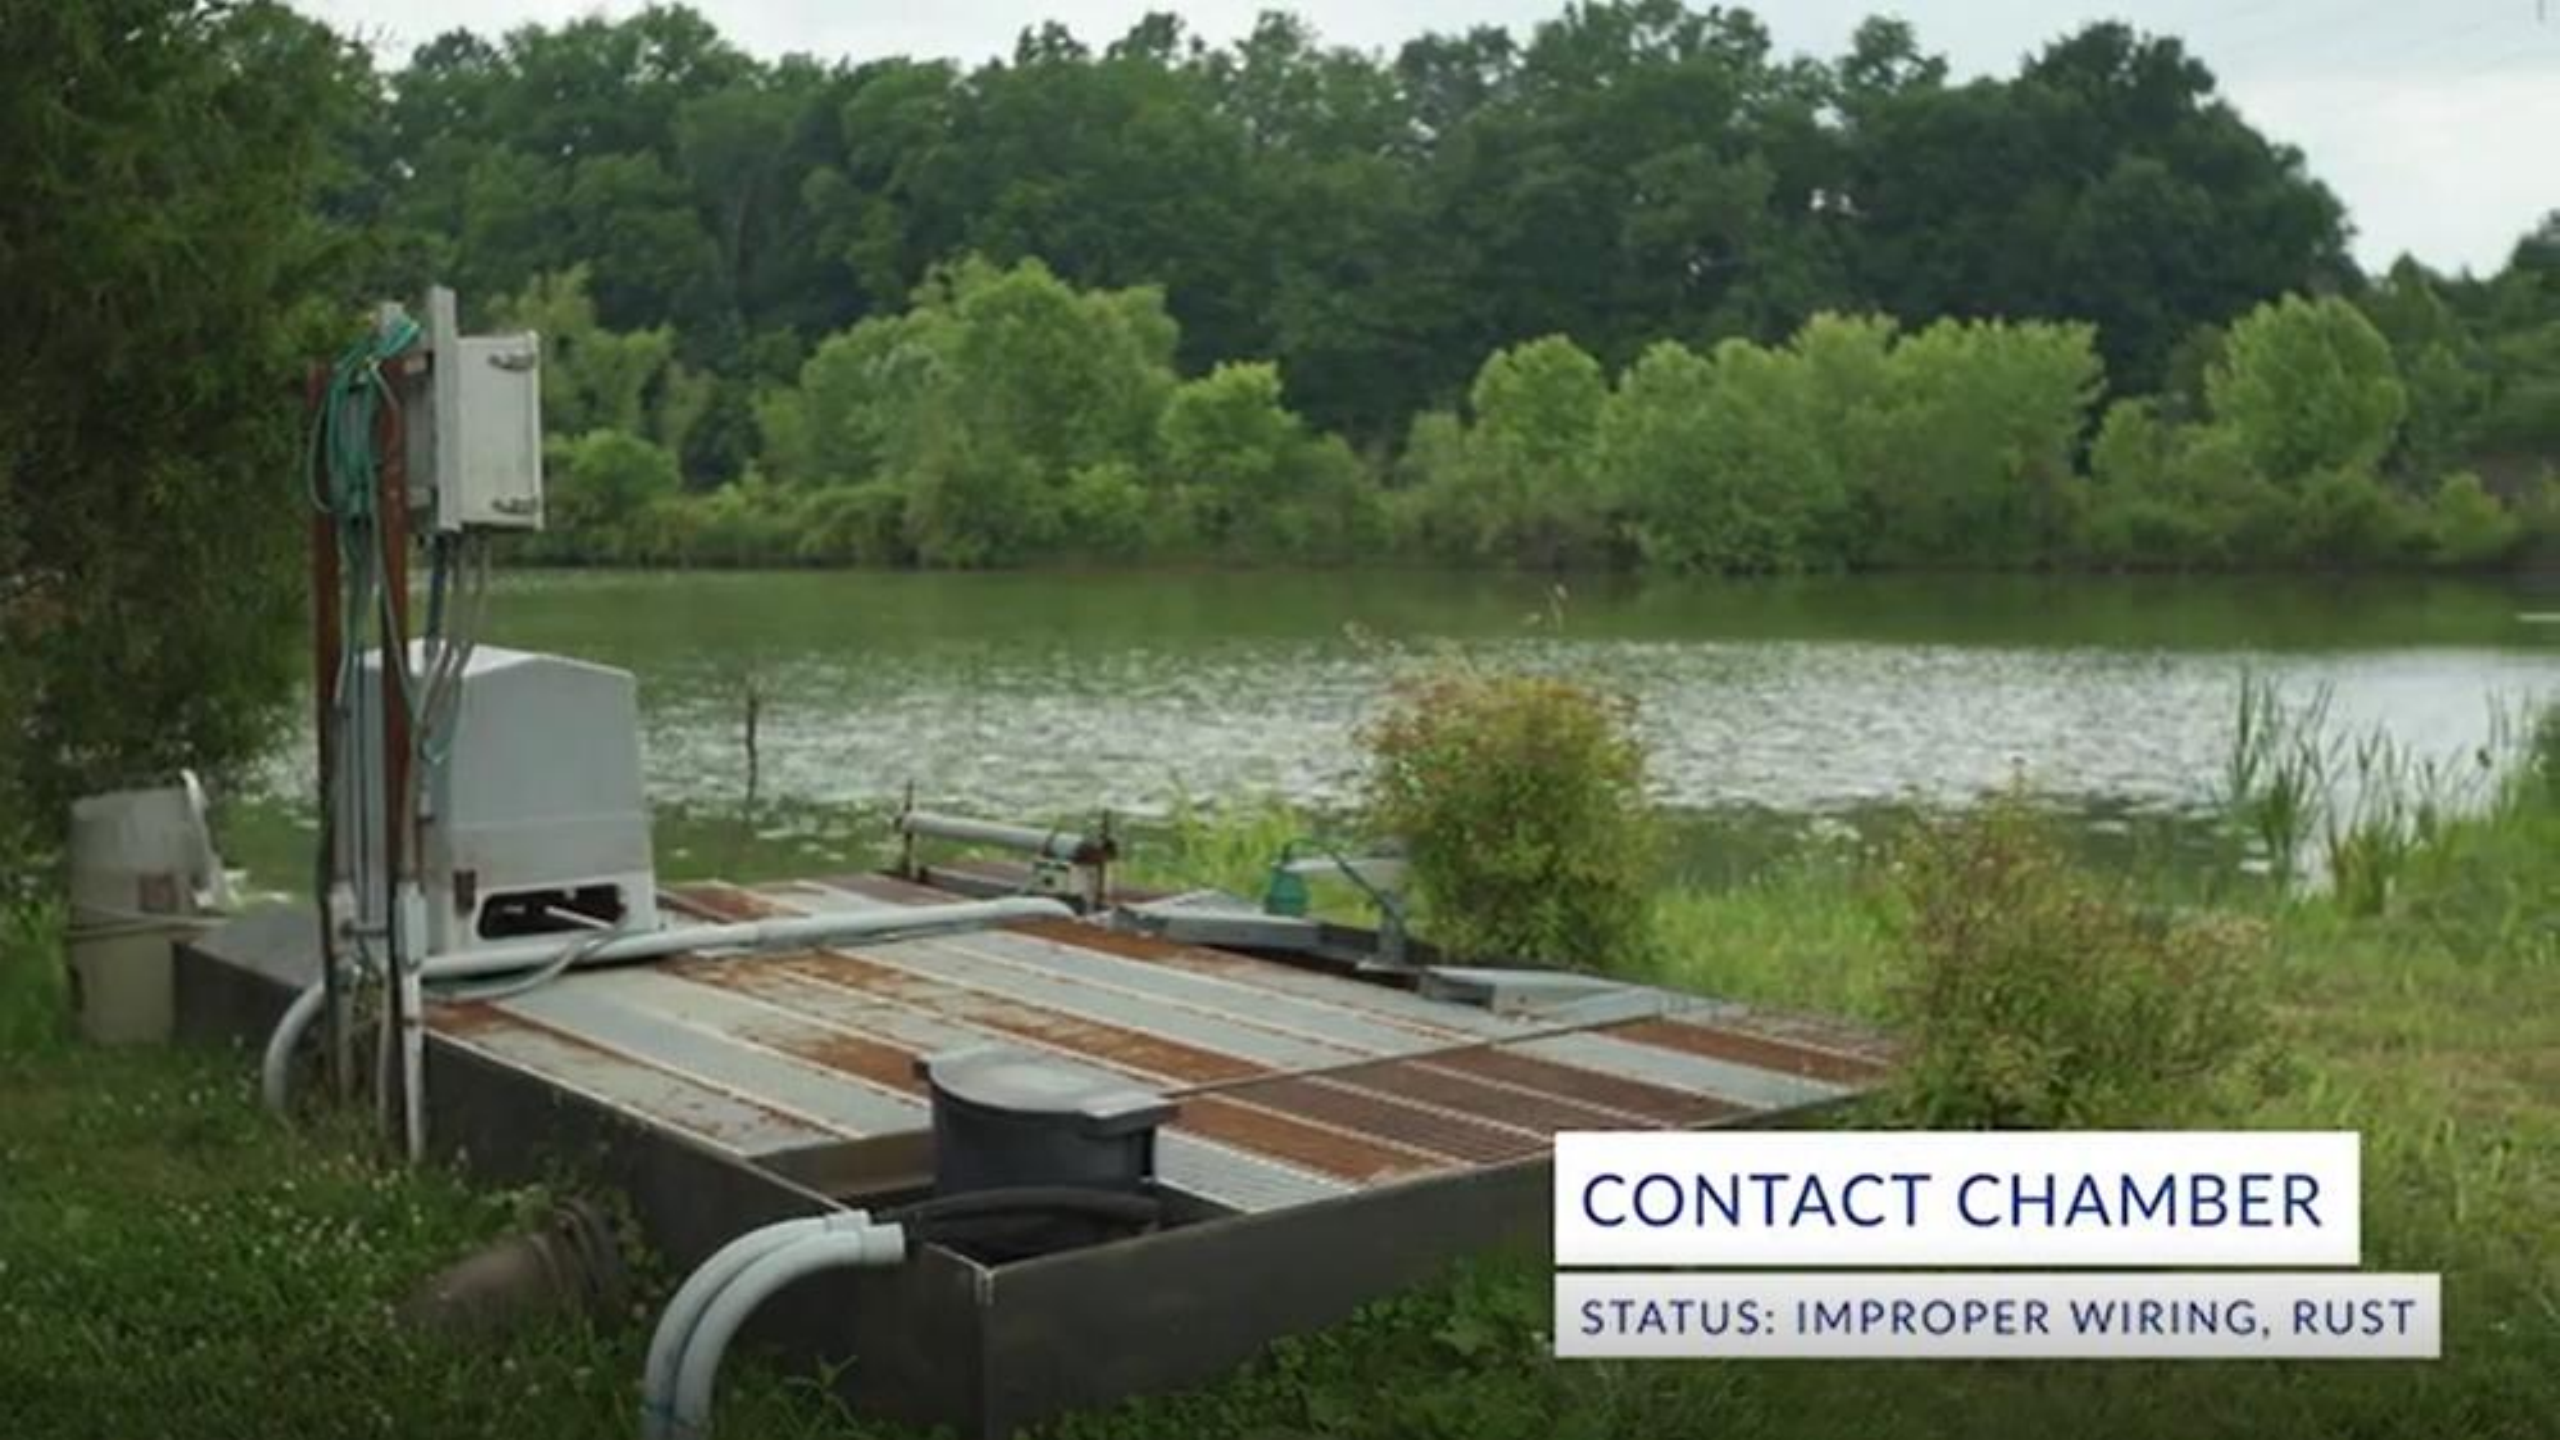
CONTACT CHAMBER

STATUS: IMPROPER WIRING, RUST

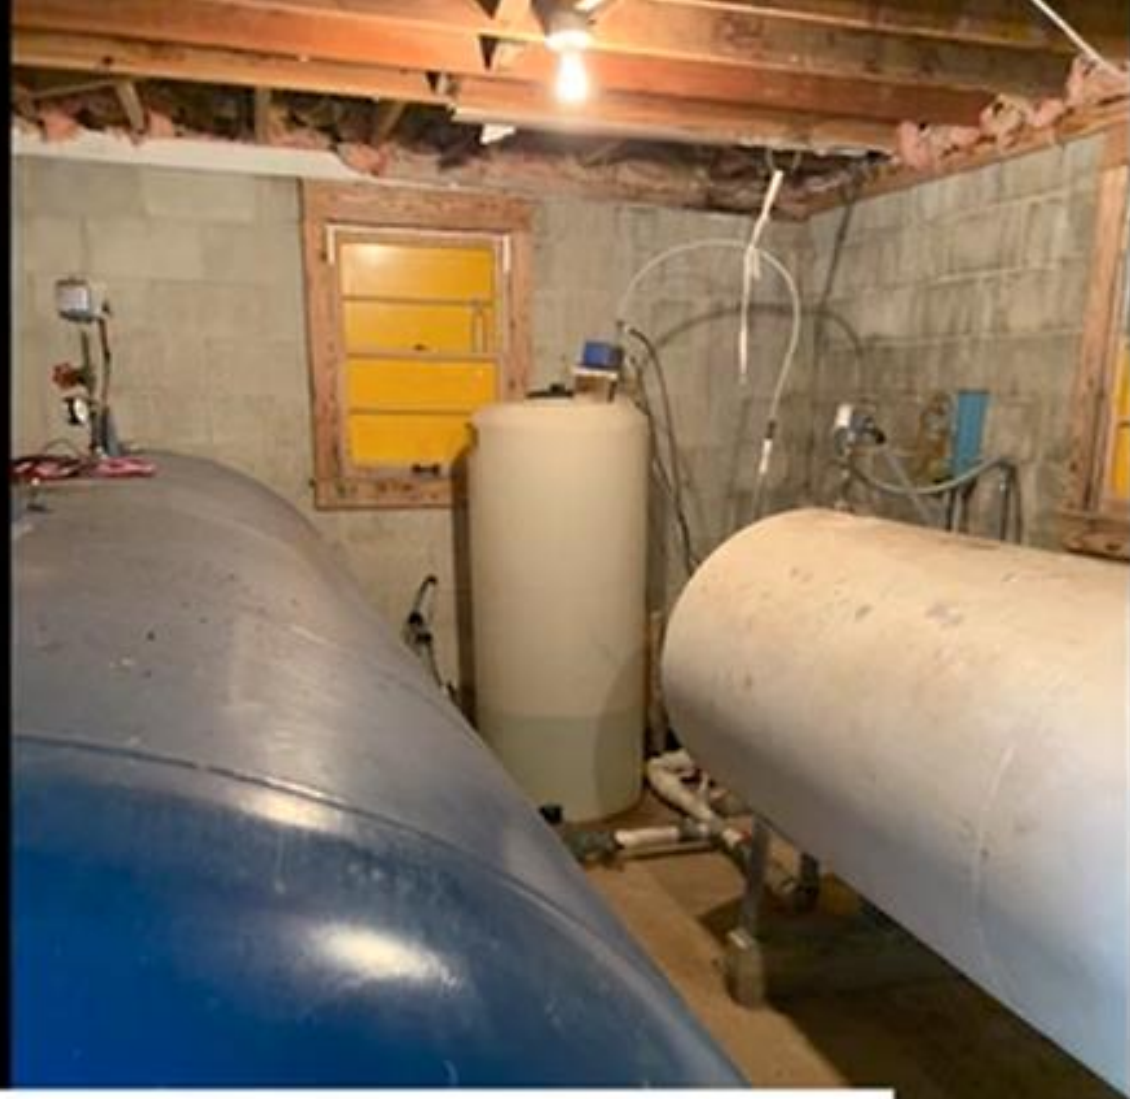
## WELL HOUSE INTERIOR

STATUS: NO SEPERATION OF CHLORINE AND STORAGE, EXPOSED WIRING AND RAFTERS

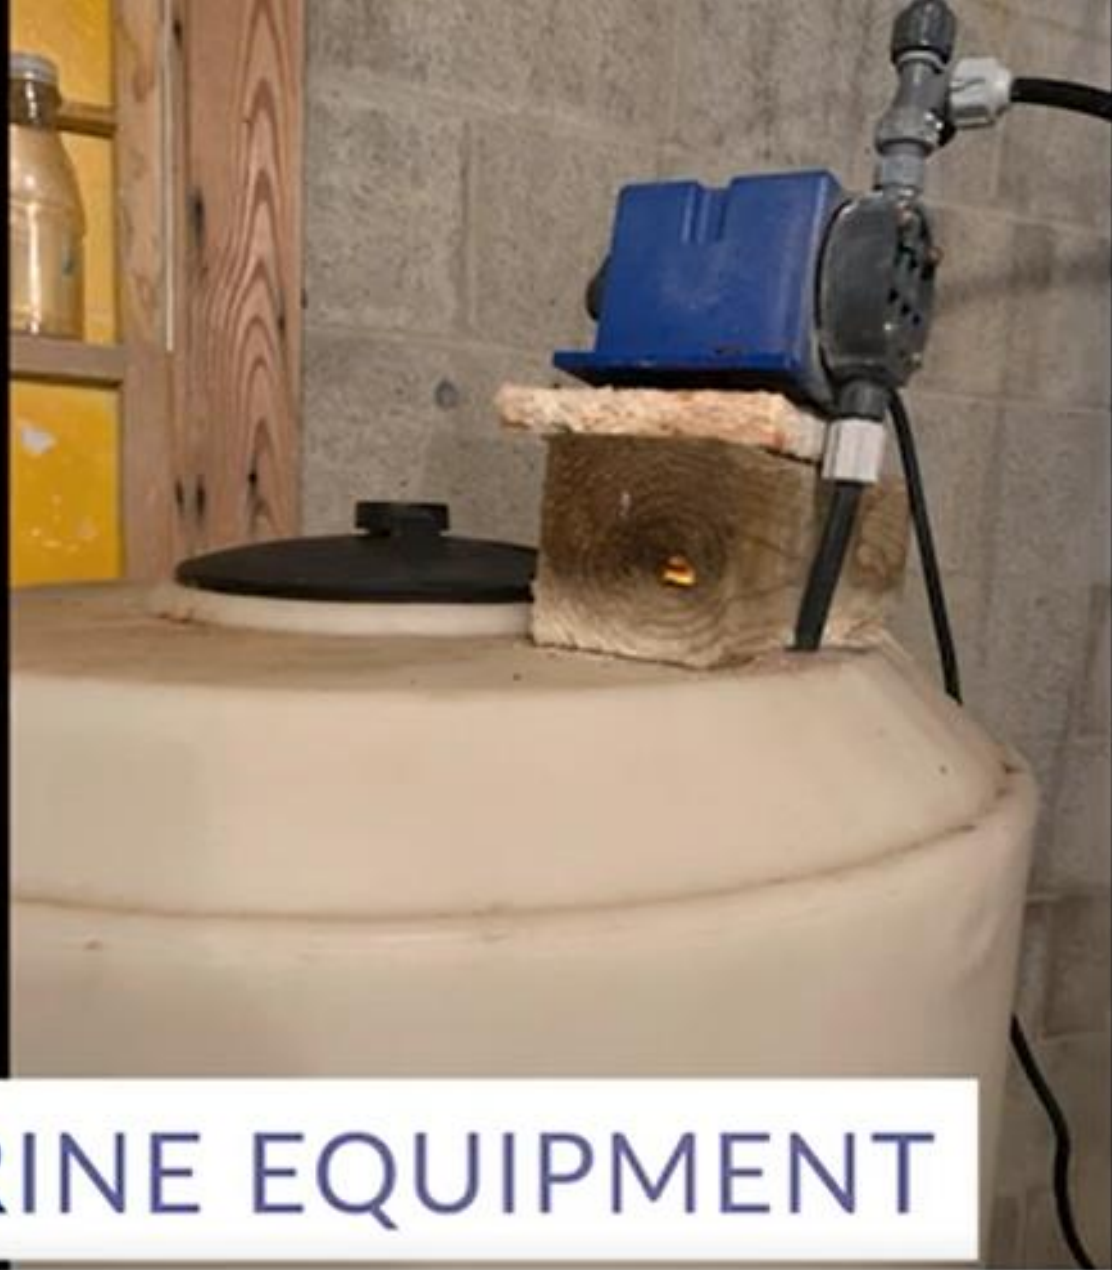
## CHLORINE EQUIPMENT

STATUS: OBSOLETE AND IMPROPERLY INSTALLED DOSING PUMP

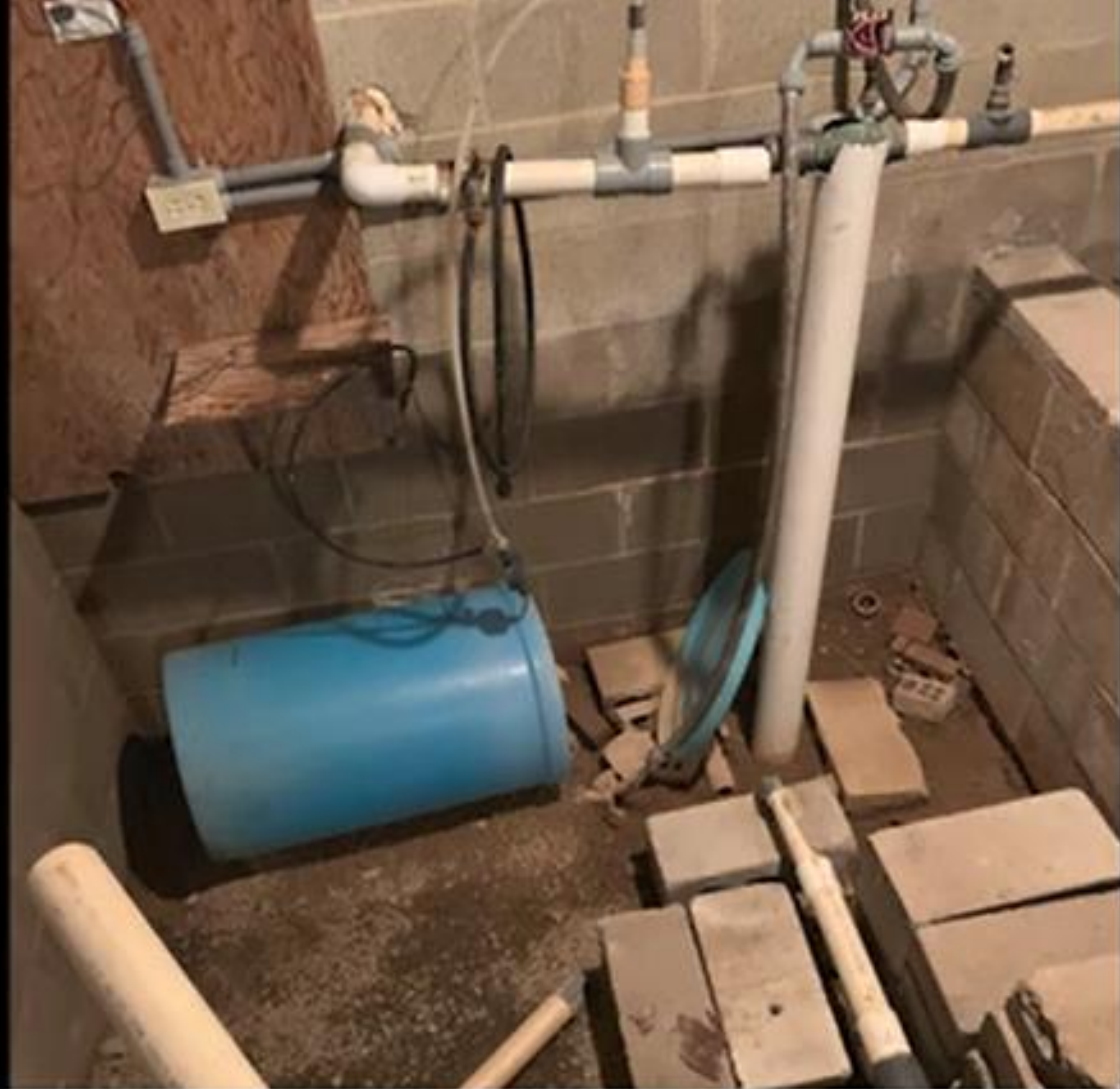
## OUT OF SERVICE WELL HOUSE

STATUS: ICE DAMAGED WELL, PIPING, AND STORAGE OUT OF SERVICE
