COMMONWEALTH OF KENTUCKY  
BEFORE THE PUBLIC SERVICE COMMISSION

<i>Electronic</i> Application of Bluegrass	)	
Water Utility Operating Company, LLC	)	Case No. 2020-00290
for an Adjustment of Rates and Approval	)	
of Construction	)

**Supplement to Responses  
to Post-Hearing Data Requests**

SUPPLEMENT: Bluegrass attaches hereto a series of stills taken from the video file, *Bluegrass Water UOC\_Before Reel.mp4*, showing the condition of the systems that it acquired before June 30, 2020. The following is an index with the PDF page number of each still, the time counter on the video file, and a description of what is depicted by title or facility and status:

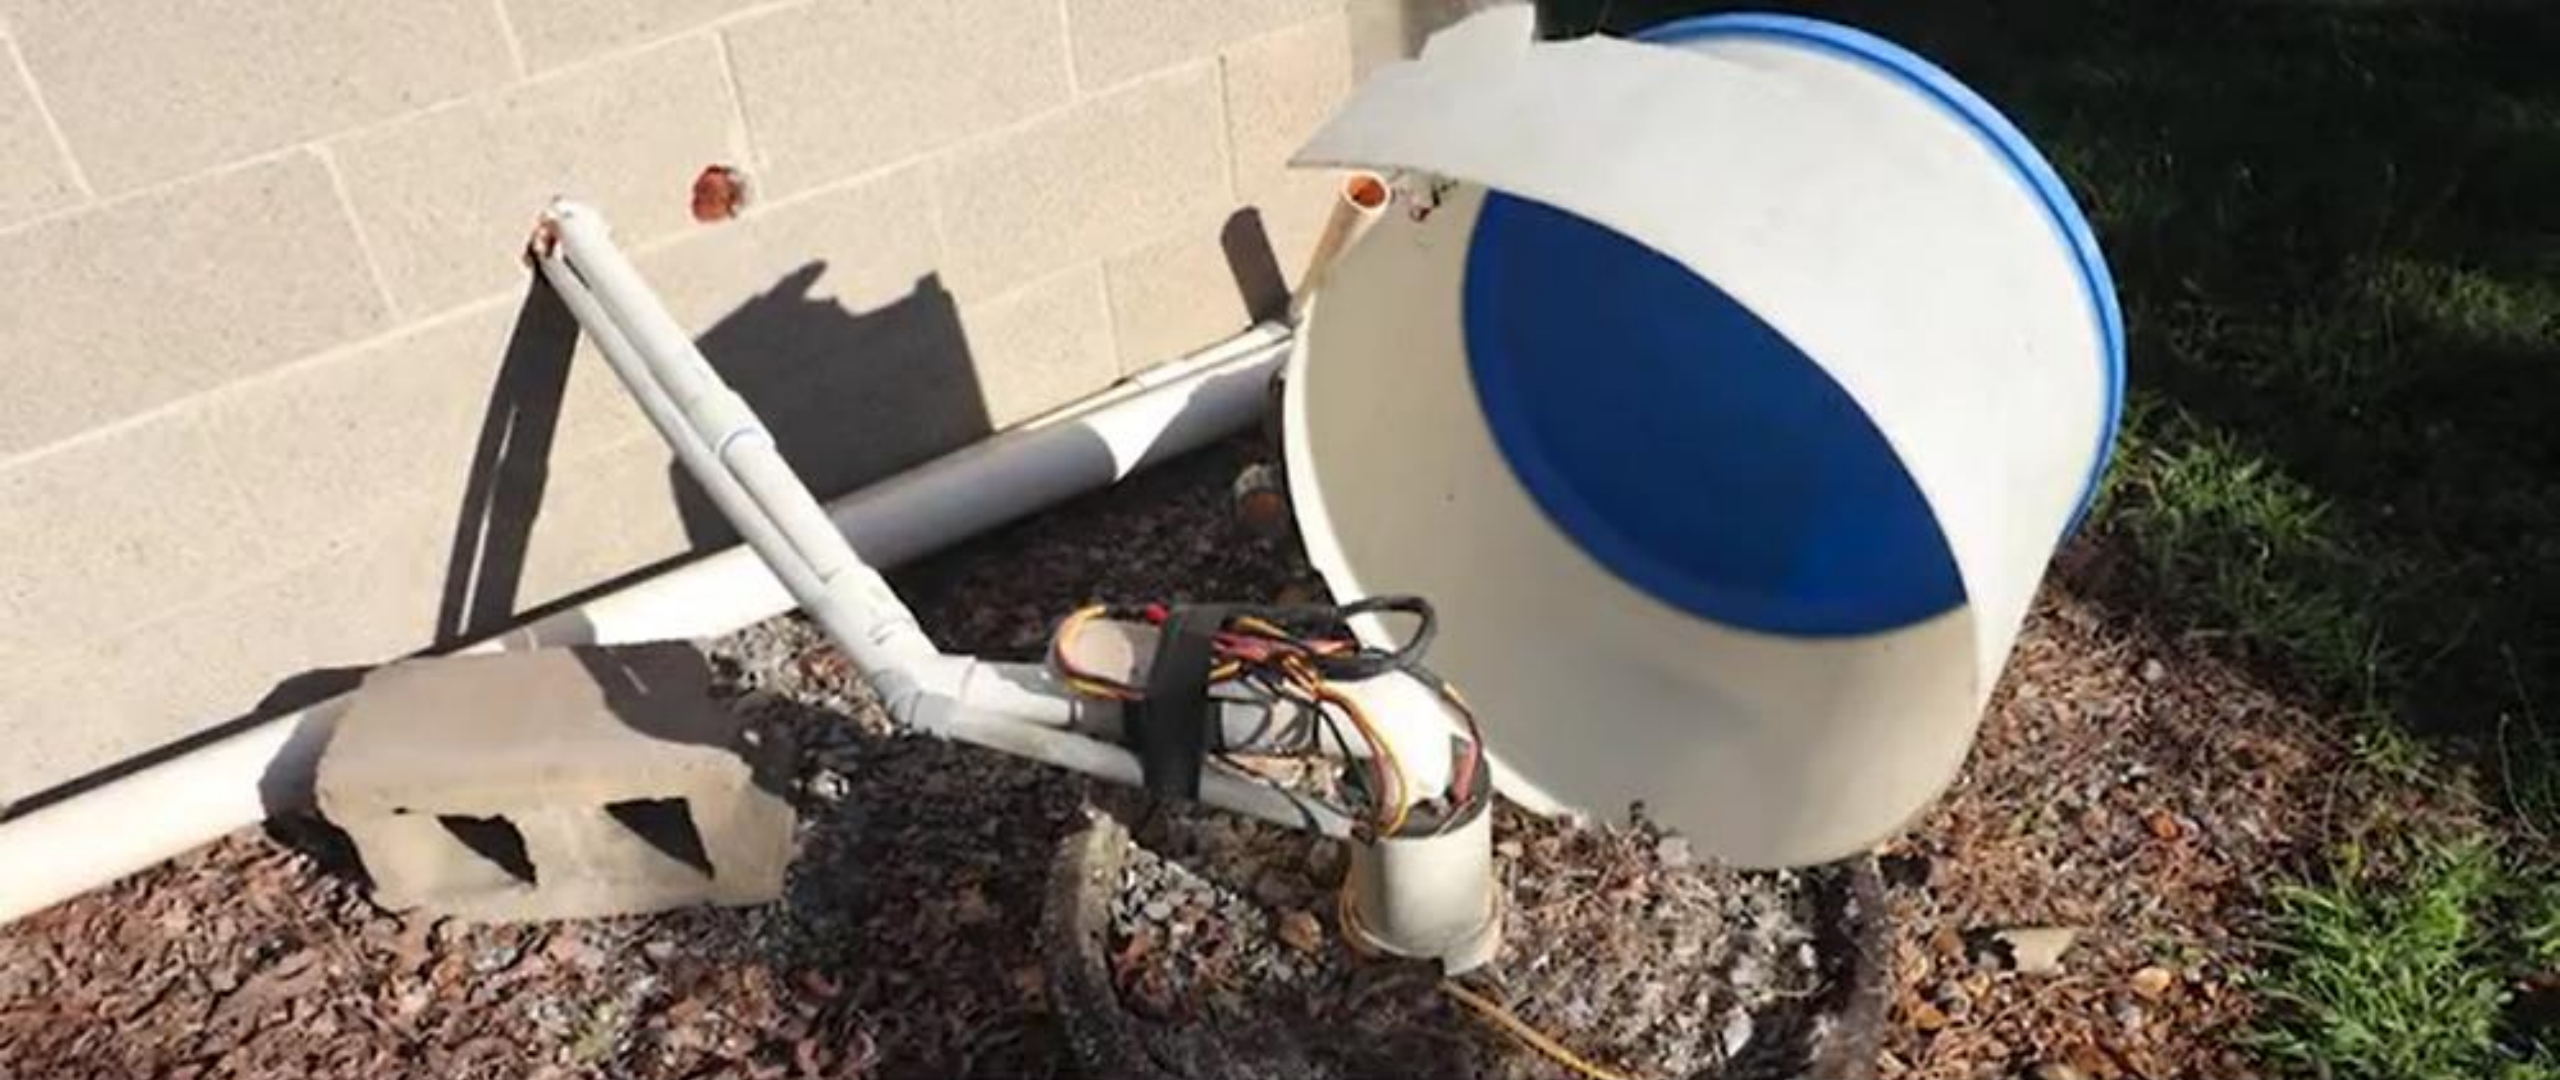
**OUT OF SERVICE WELL HOUSE**

STATUS: EXPOSED WIRING ON WELL HEAD

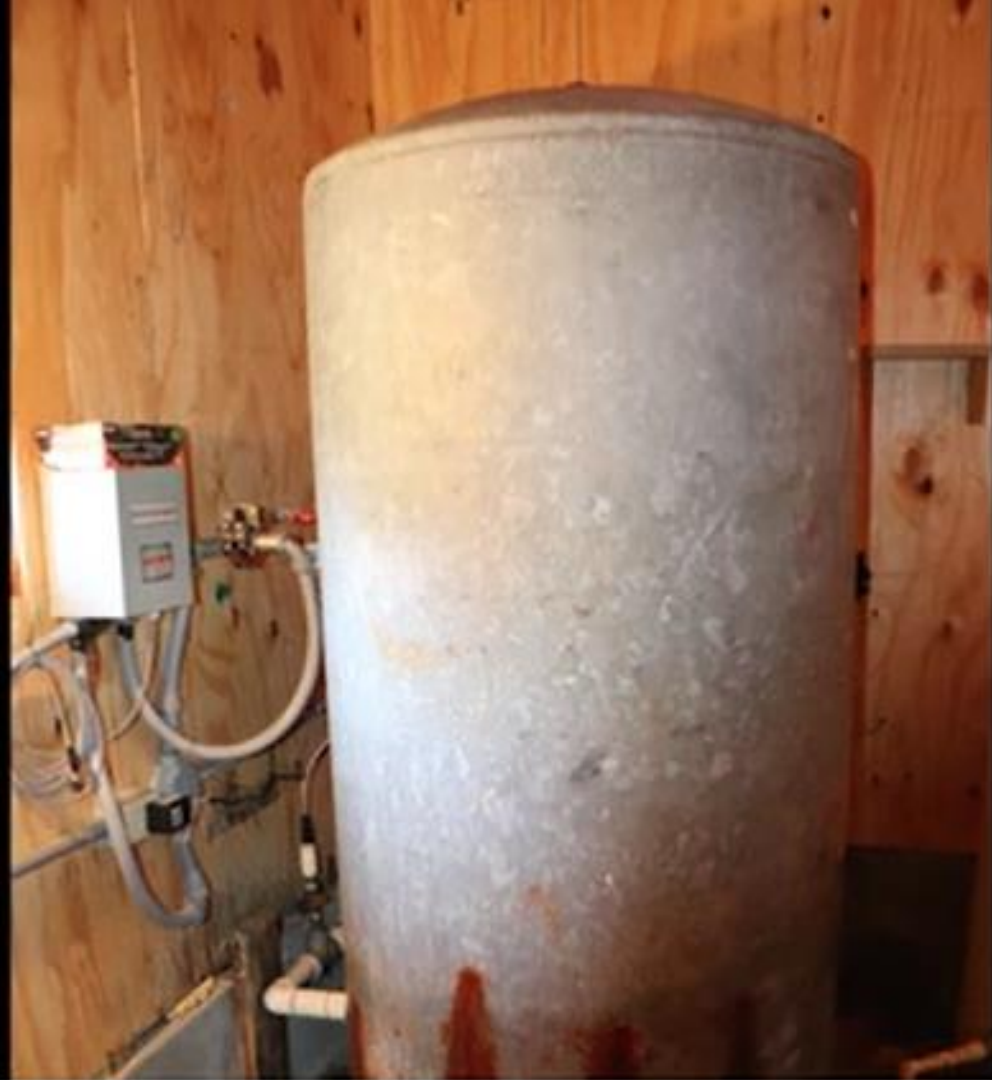
## HYROPNEUMATIC TANK

STATUS: TANK HAS PINHOLE LEAKS AT ACTIVE WELL SITE

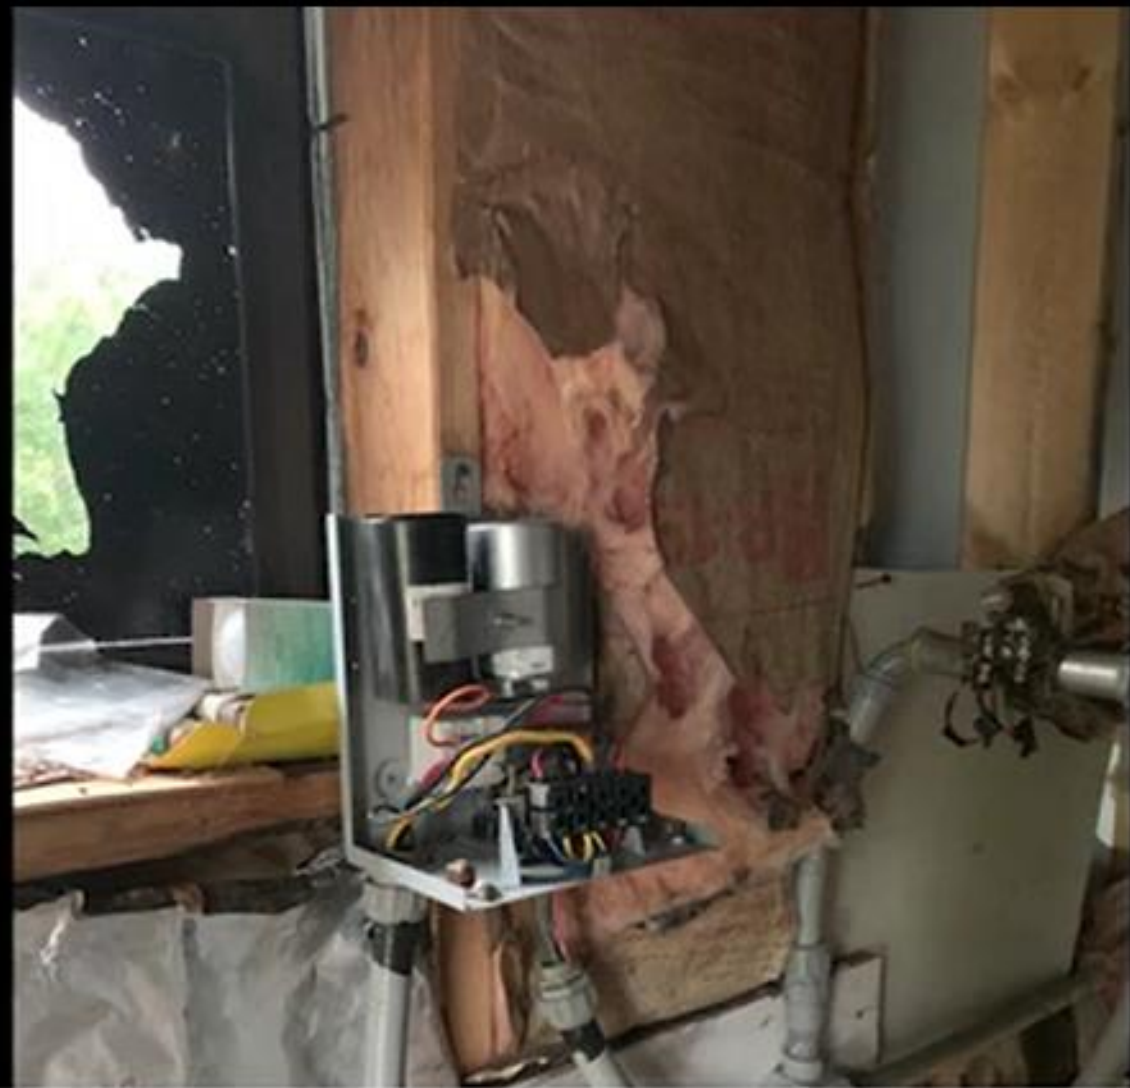
## ACTIVE WELL HOUSE

STATUS: EXPOSED WIRING, DAMAGED INSULATION

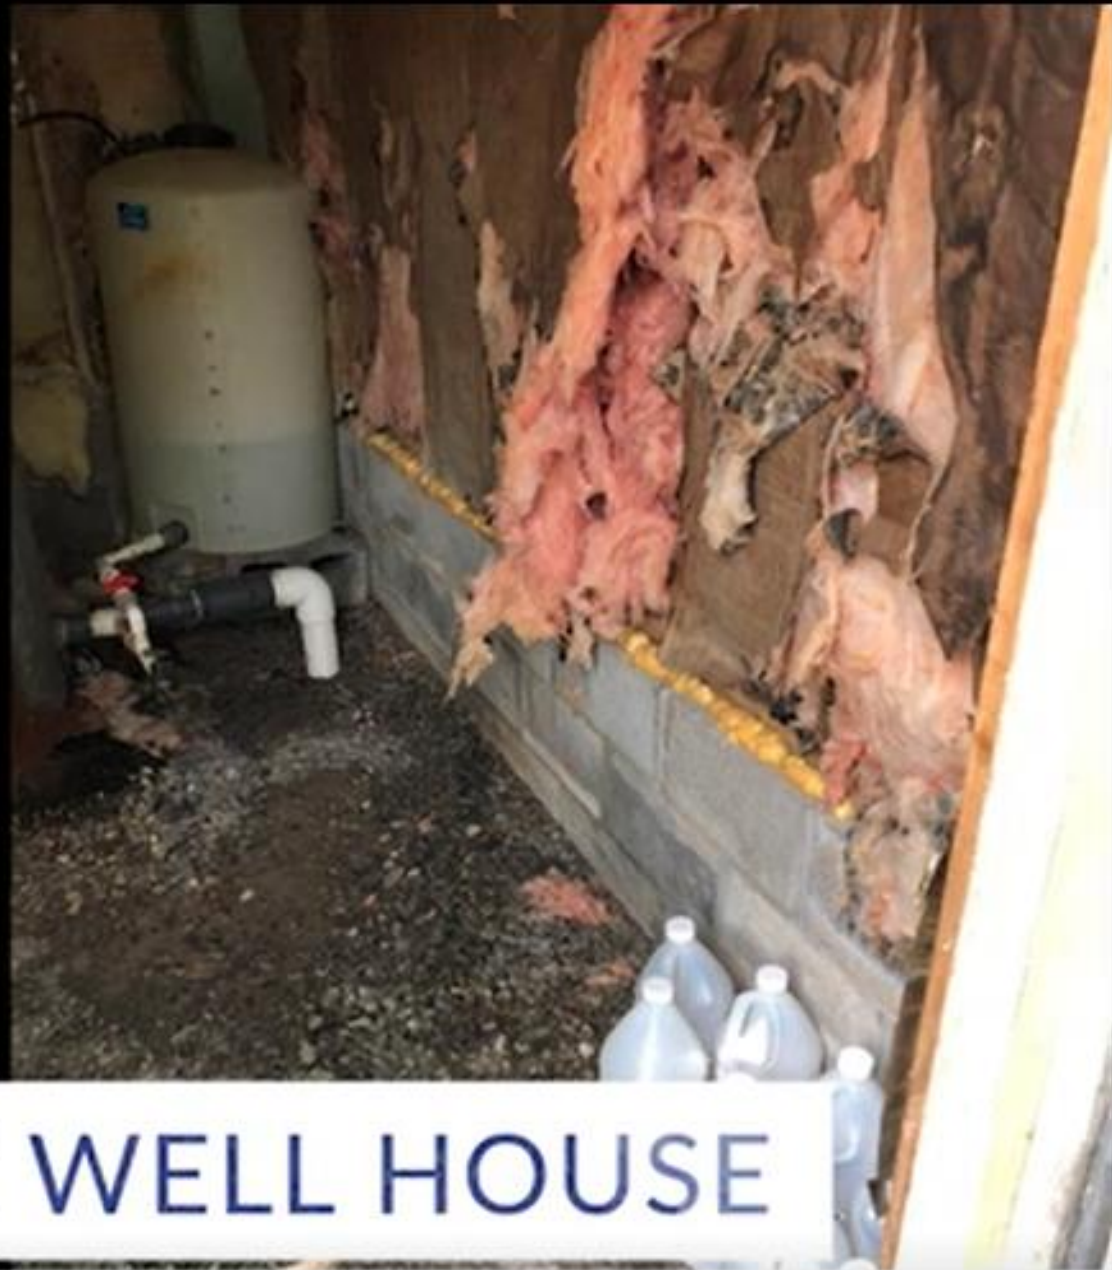
## ACTIVE WELL HOUSE

STATUS: INSULATION DAMAGED, CHLORINE IN SAME ROOM AS STORAGE

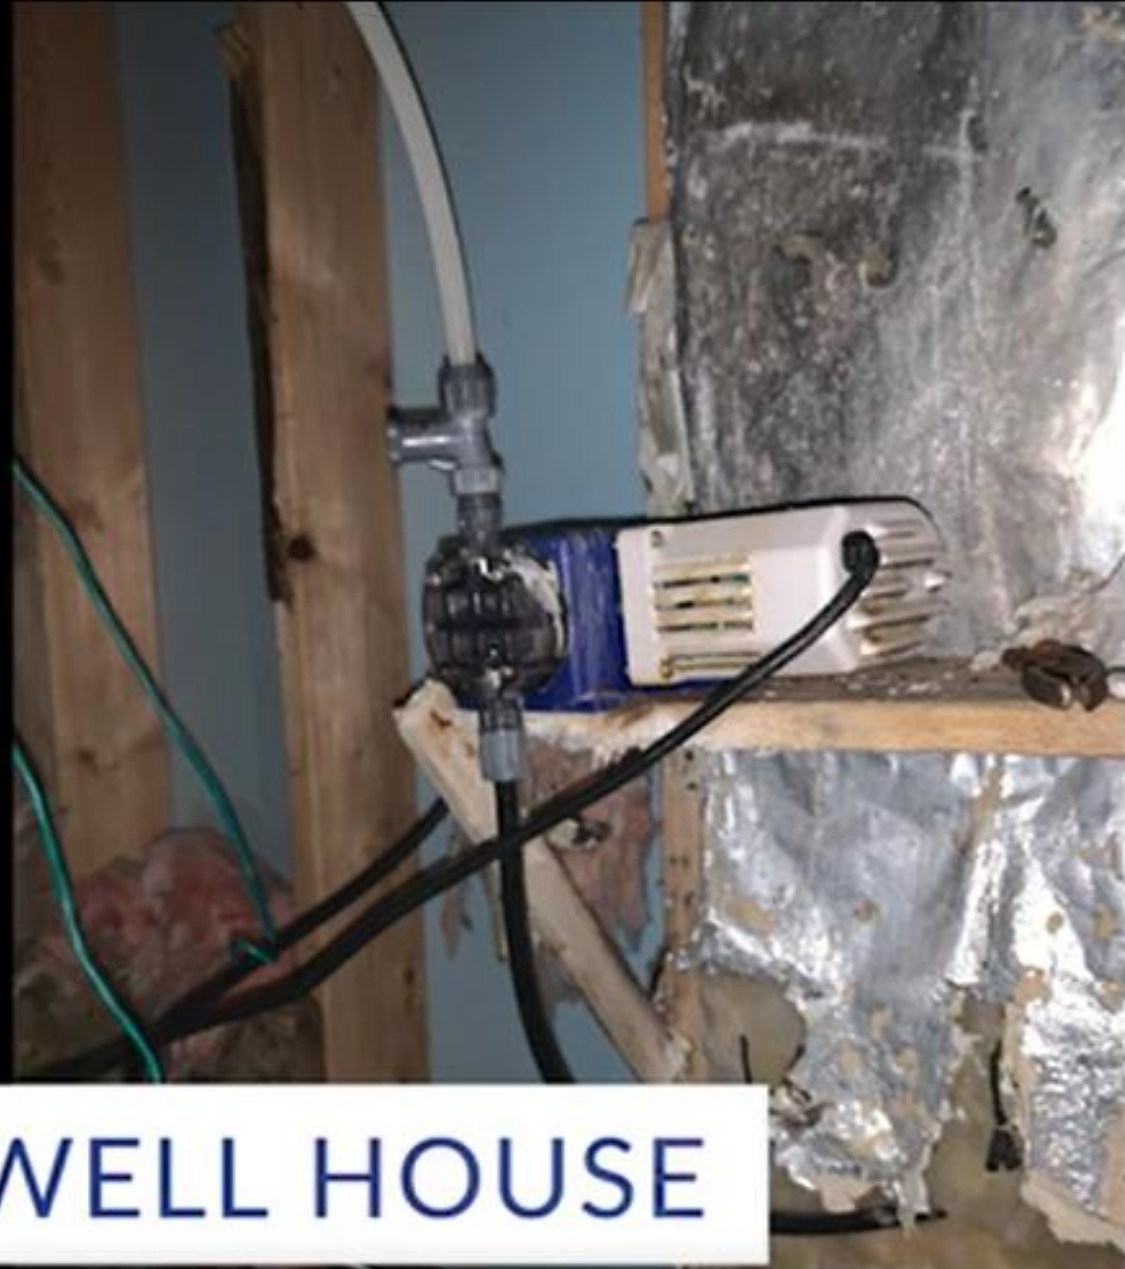
## ACTIVE WELL HOUSE

STATUS: OBSOLETE AND IMPROPERLY INSTALLED DOSING PUMP, EXPOSED WIRING

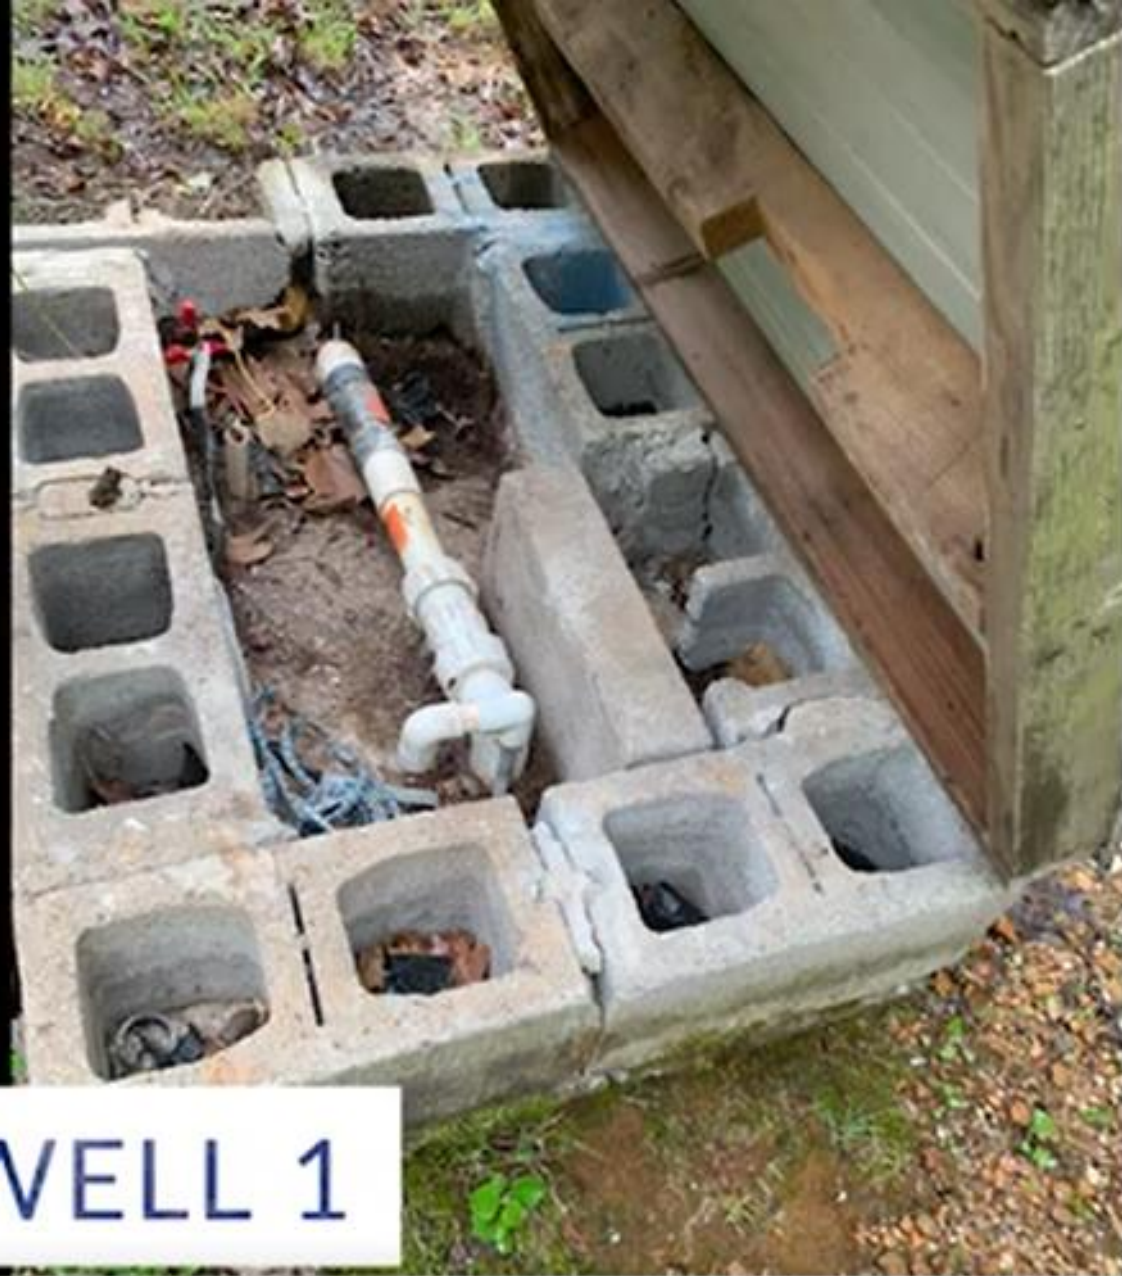
WELL 1

STATUS: DAMAGED STRUCTURE, EXPOSED WIRING

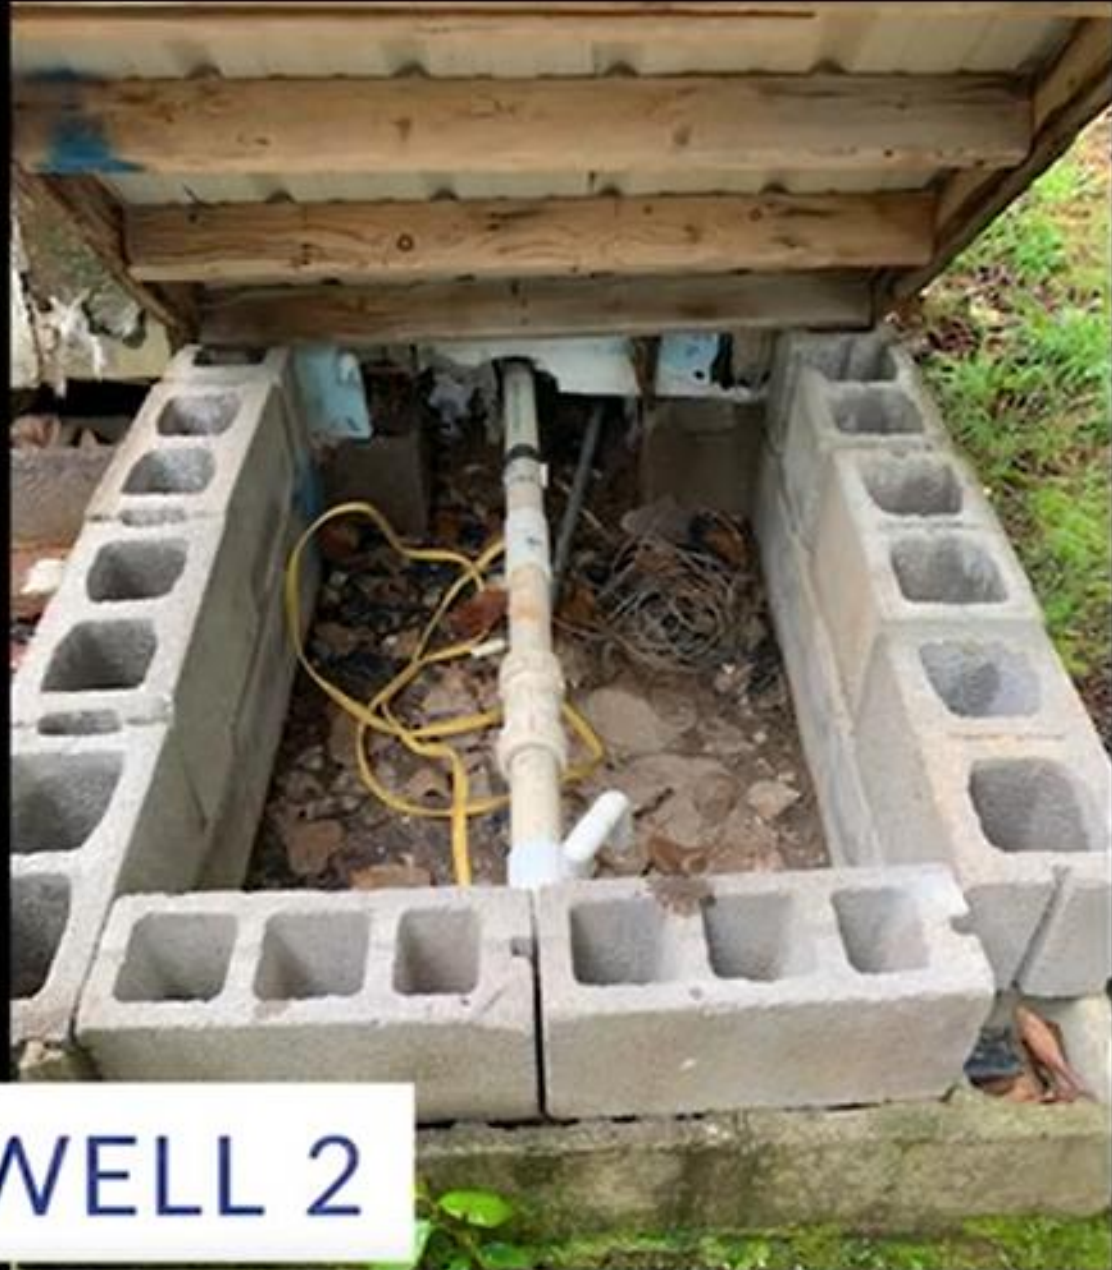
WELL 2

STATUS: DAMAGED STRUCTURE, EXPOSED WIRING

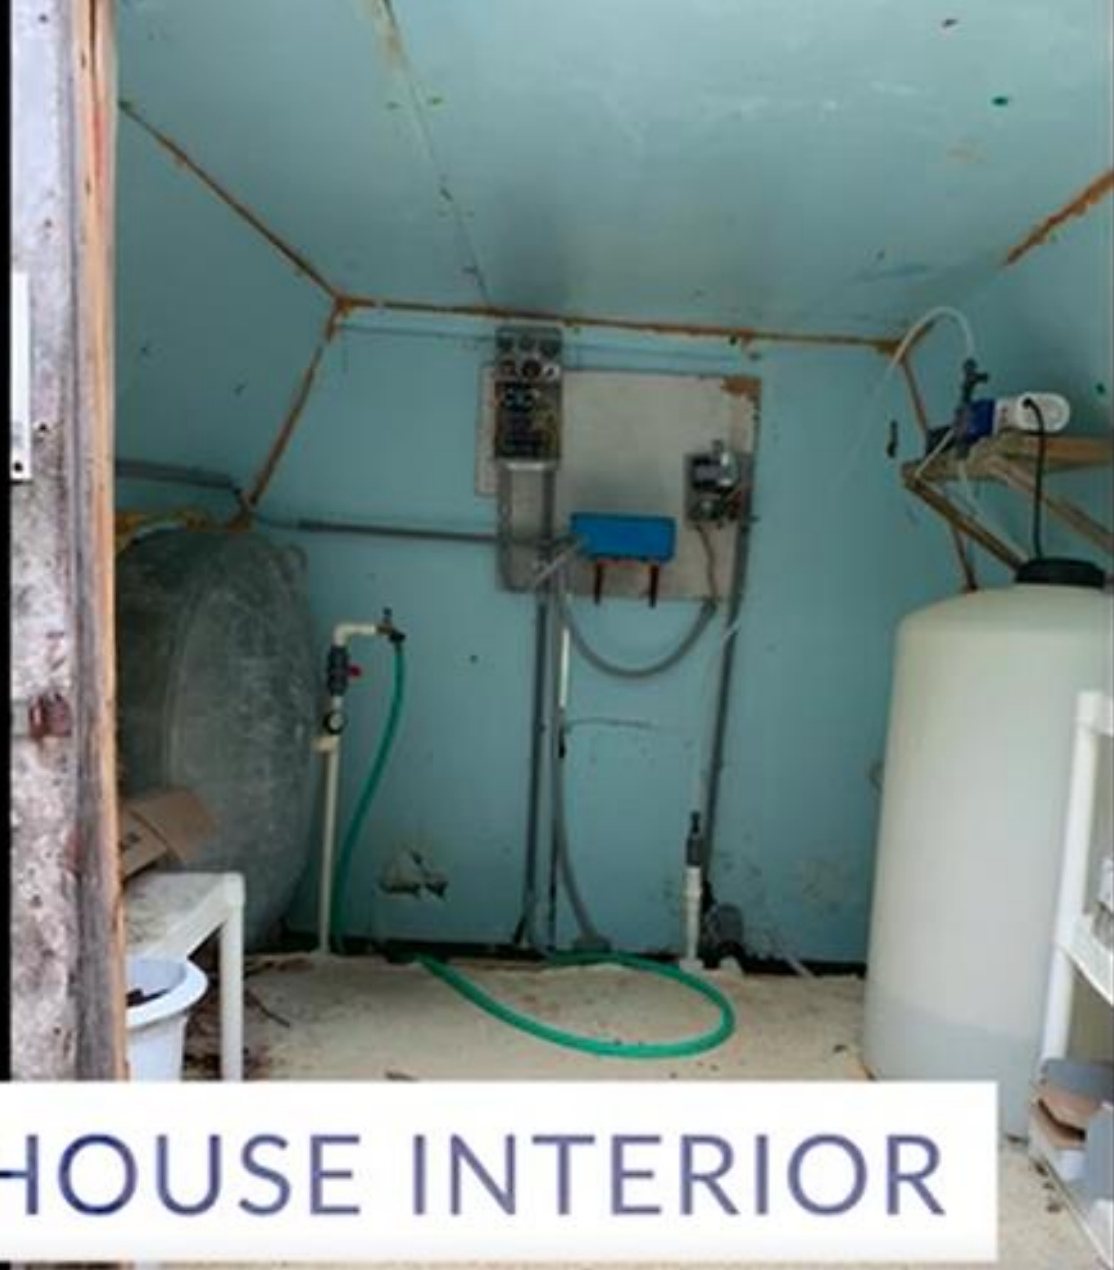
## WELL HOUSE INTERIOR

STATUS: EXPOSED WIRING, IMPROPER INSULATION, CHLORINE AND STORAGE IN SAME ROOM

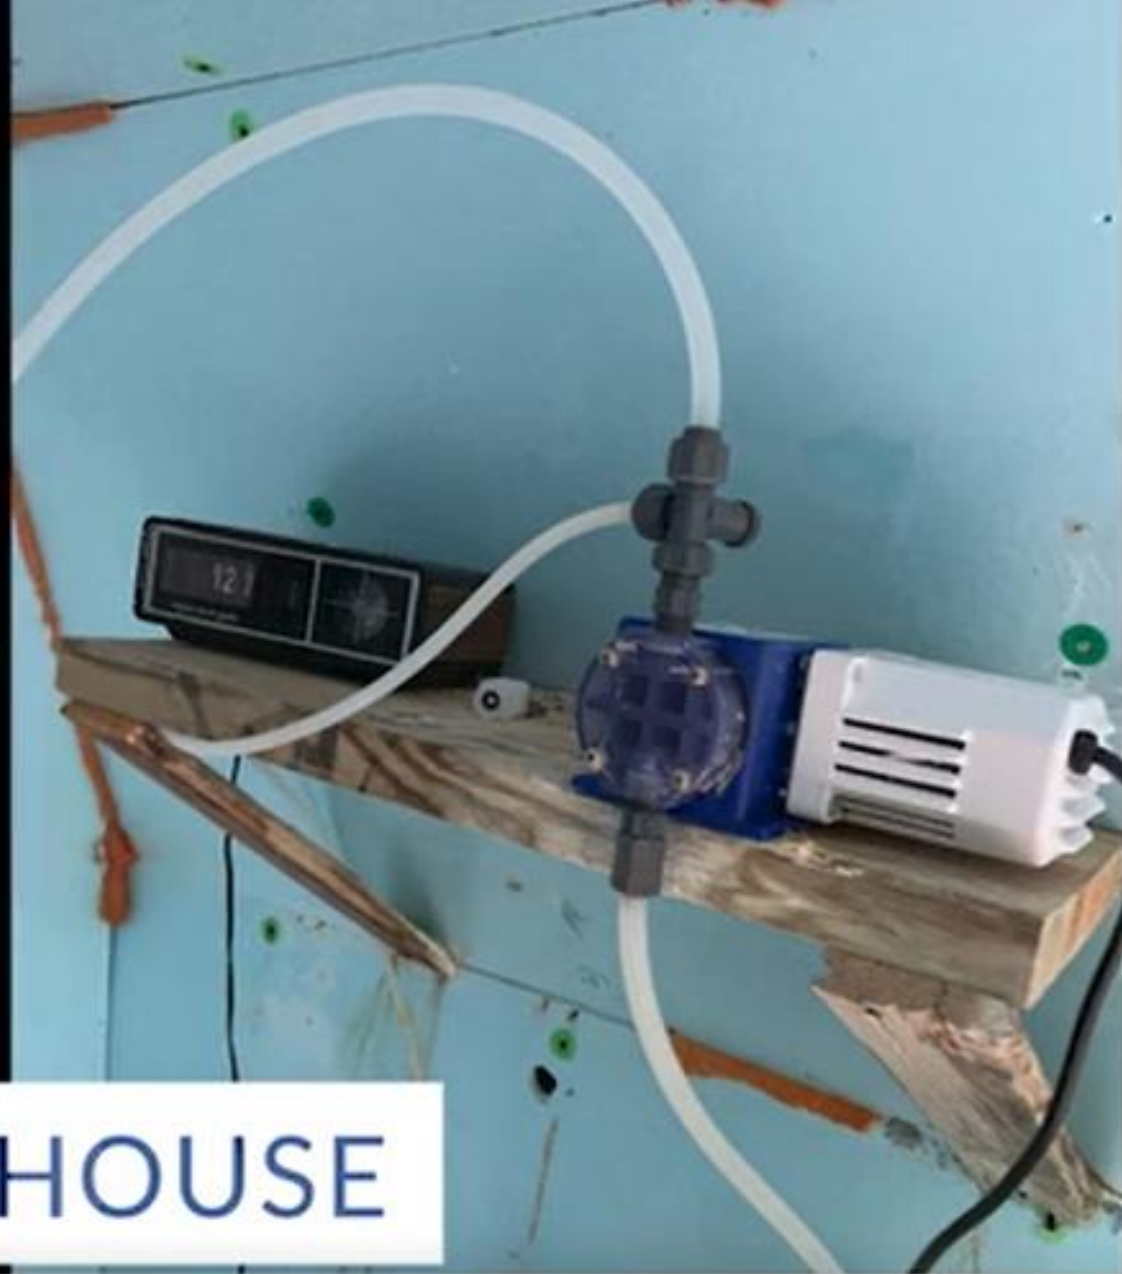
## WELL HOUSE

STATUS: OBSOLETE AND IMPROPERLY INSTALLED DOSING PUMP

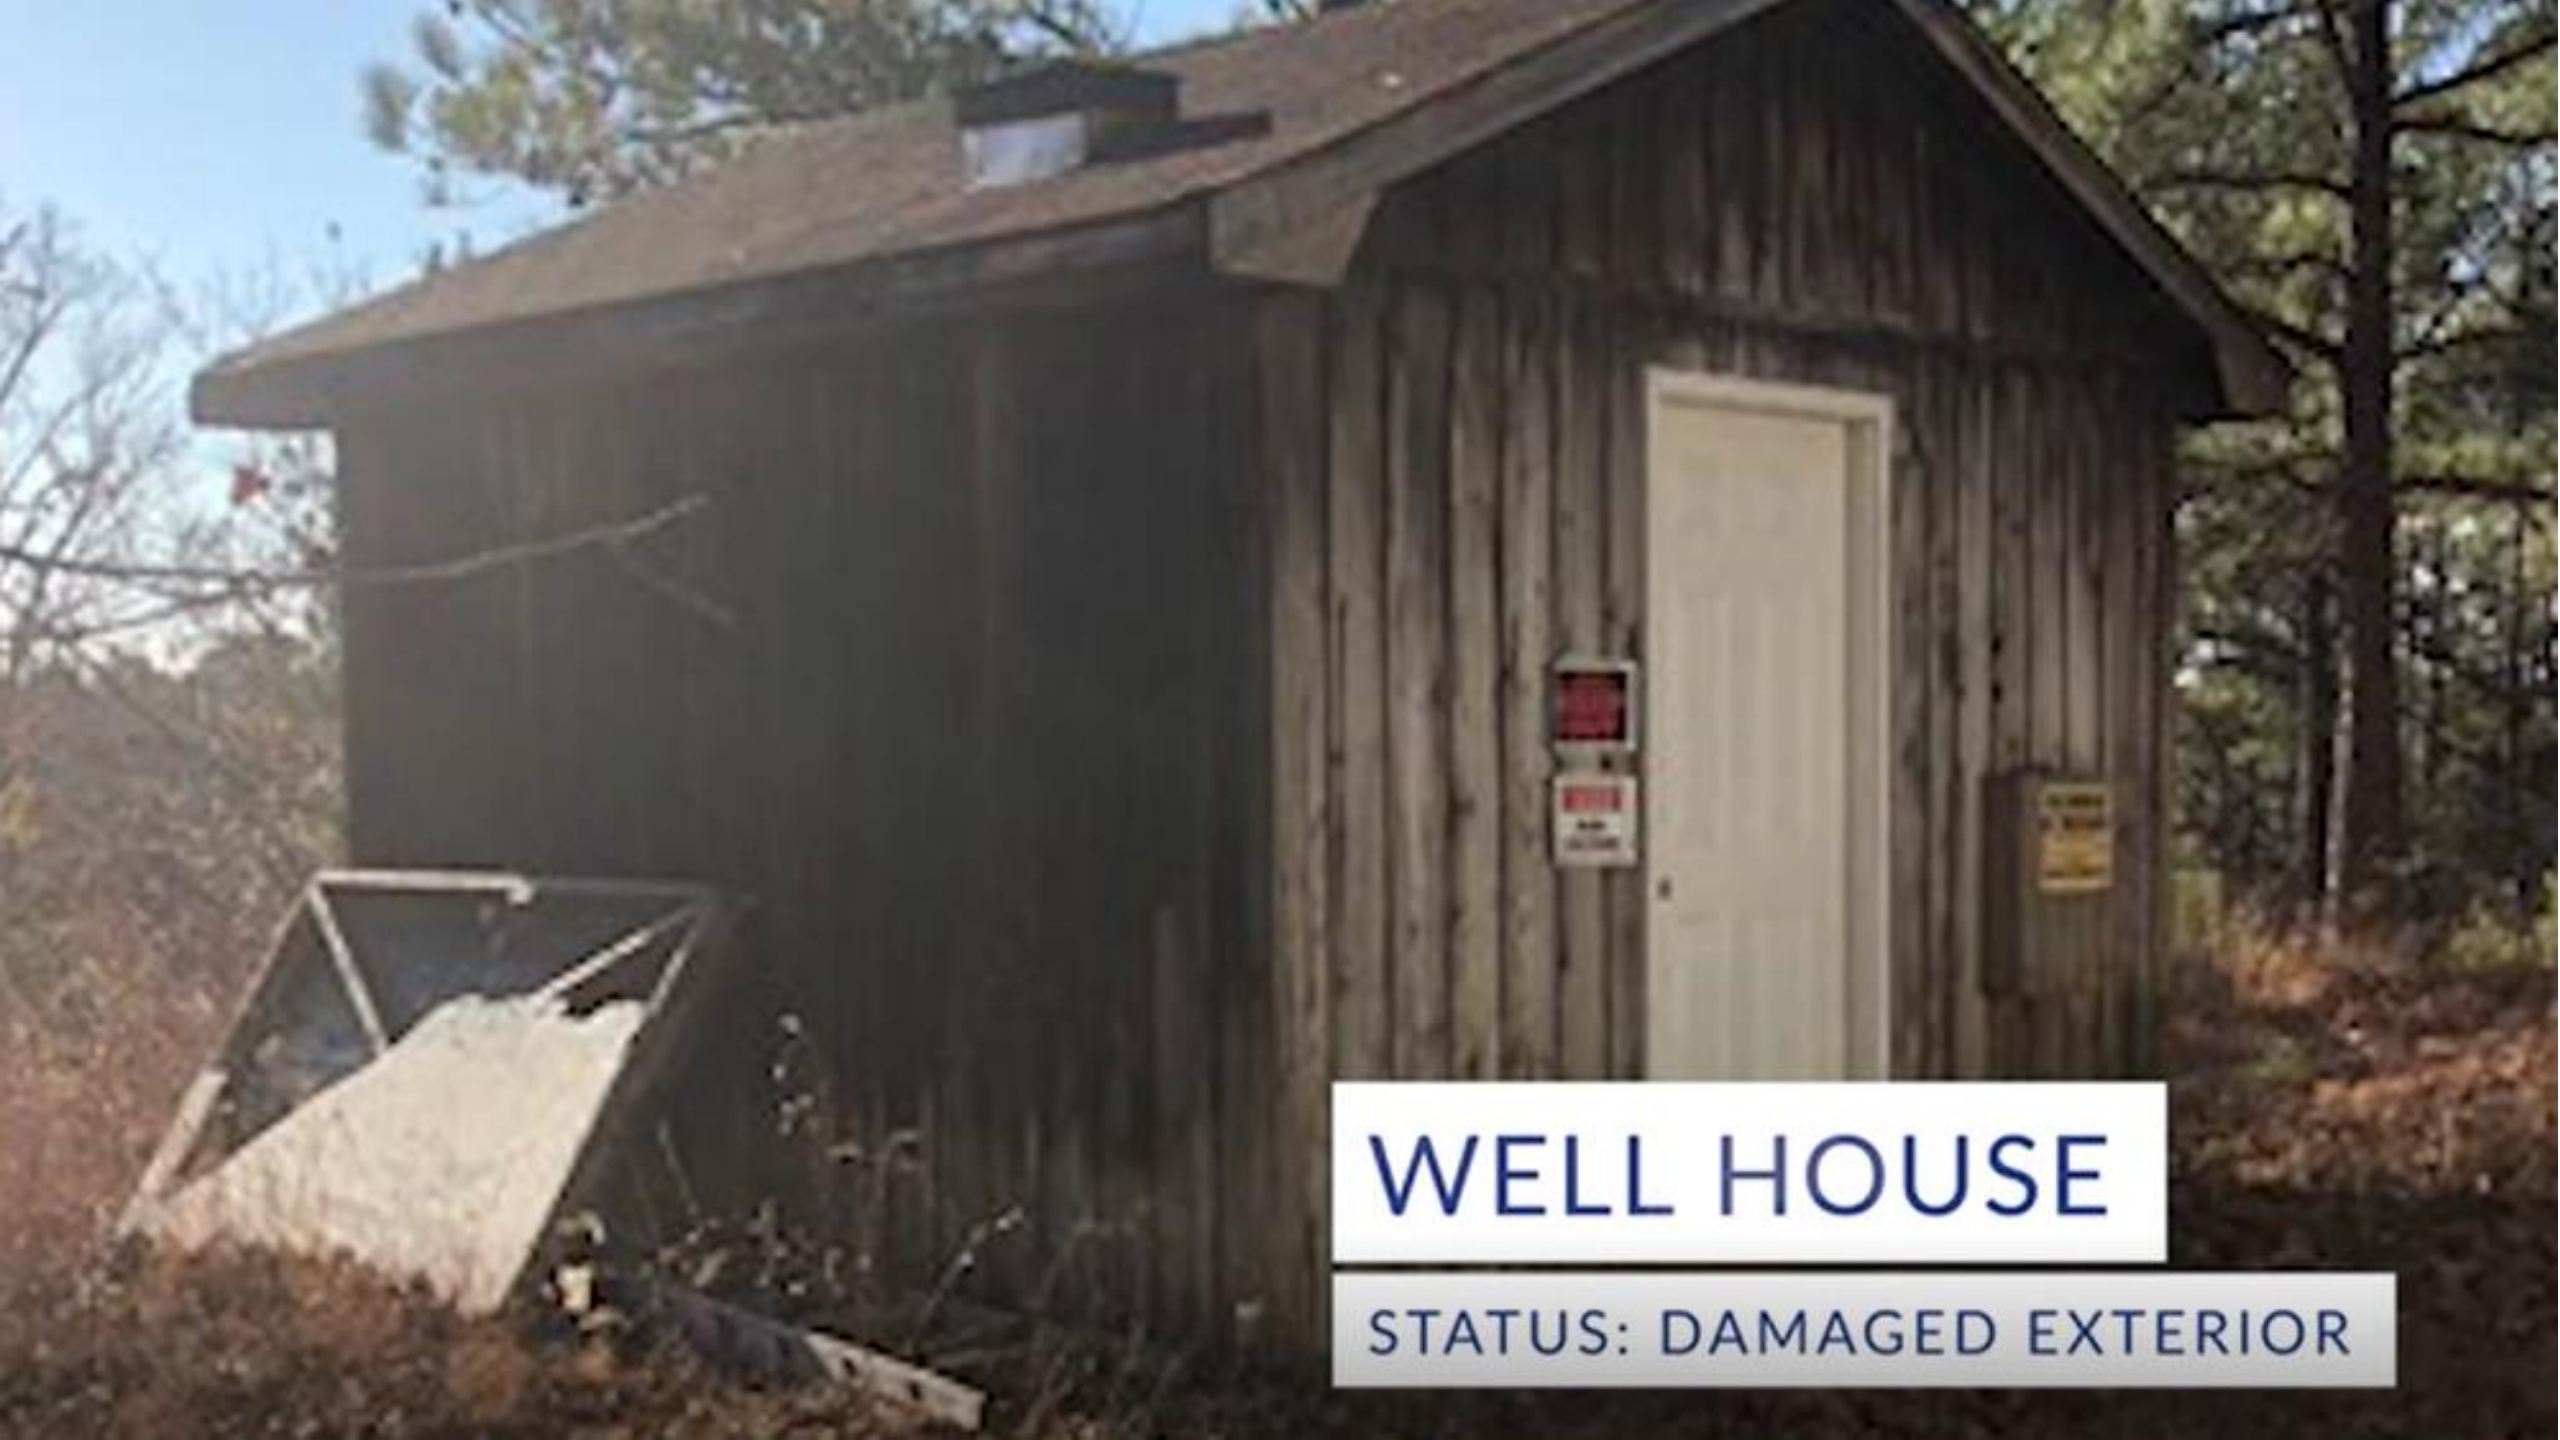
## WELL HOUSE

STATUS: DAMAGED EXTERIOR

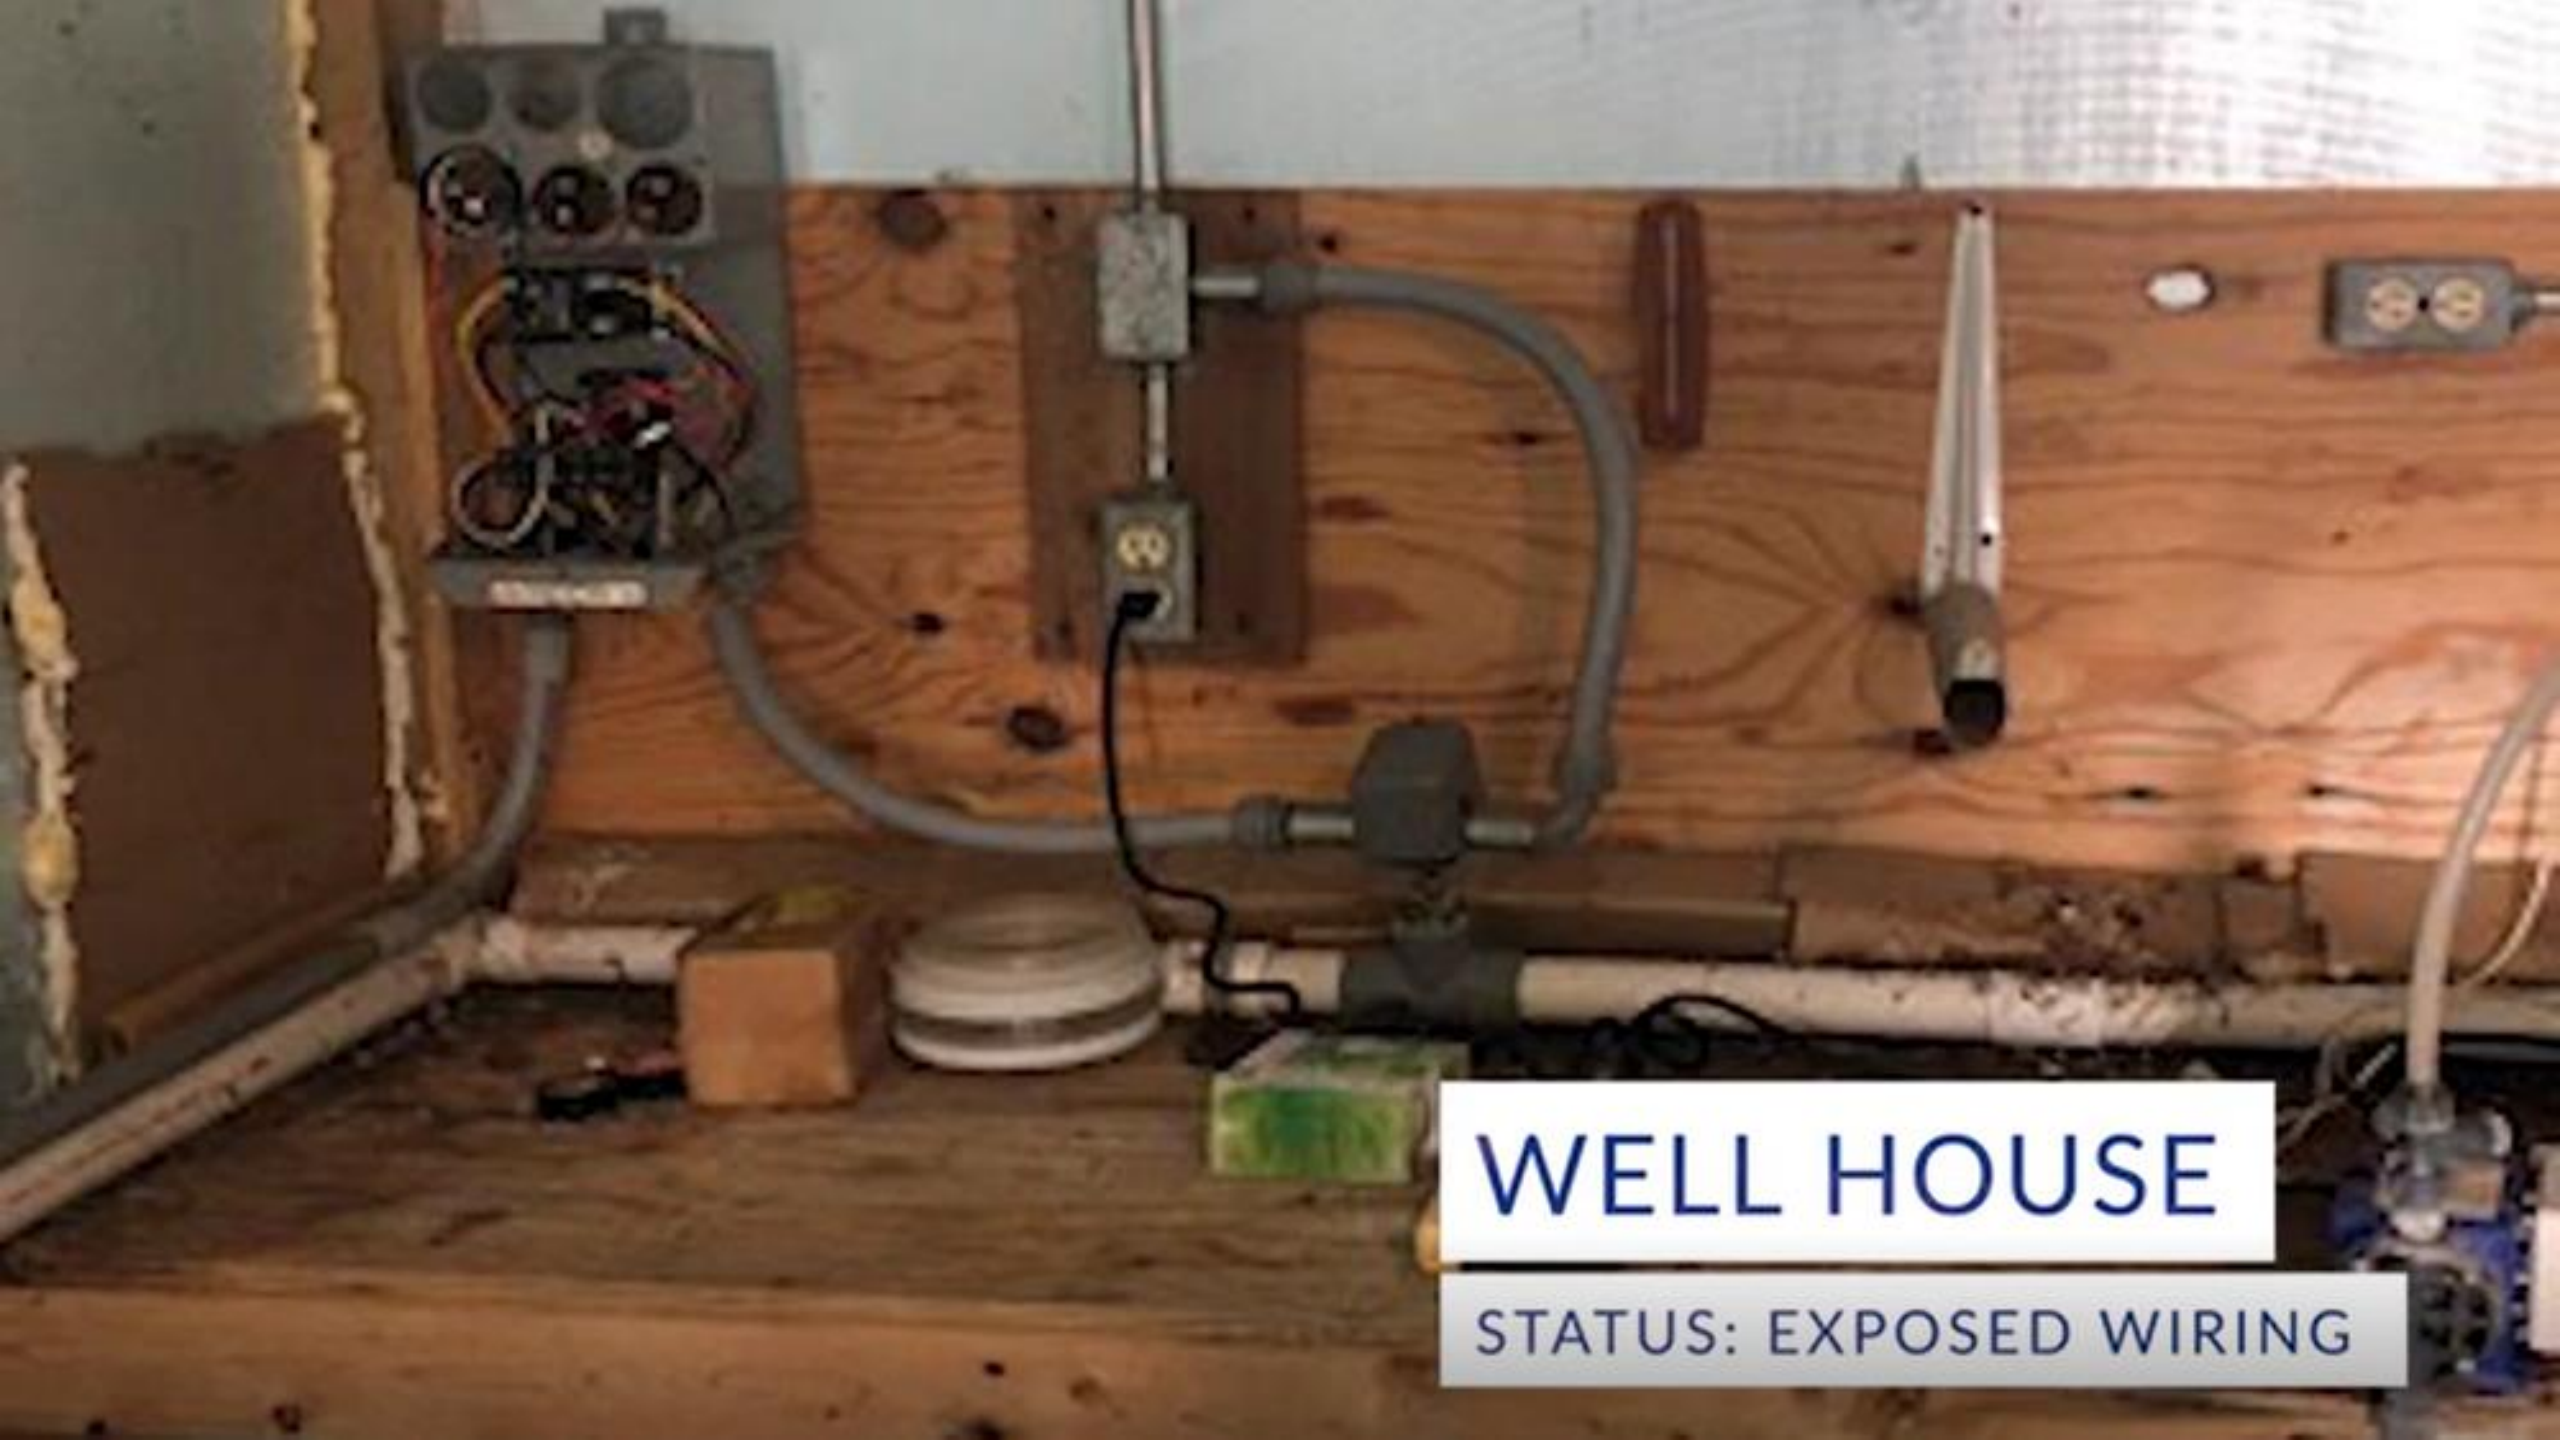
## WELL HOUSE

STATUS: EXPOSED WIRING
