COMMONWEALTH OF KENTUCKY  
BEFORE THE PUBLIC SERVICE COMMISSION

<i>Electronic</i> Application of Bluegrass	)	
Water Utility Operating Company, LLC	)	Case No. 2020-00290
for an Adjustment of Rates and Approval	)	
of Construction	)

**Supplement to Responses  
to Post-Hearing Data Requests**

SUPPLEMENT: Bluegrass attaches hereto a series of stills taken from the video file, *Bluegrass Water UOC\_Before Reel.mp4*, showing the condition of the systems that it acquired before June 30, 2020. The following is an index with the PDF page number of each still, the time counter on the video file, and a description of what is depicted by title or facility and status:

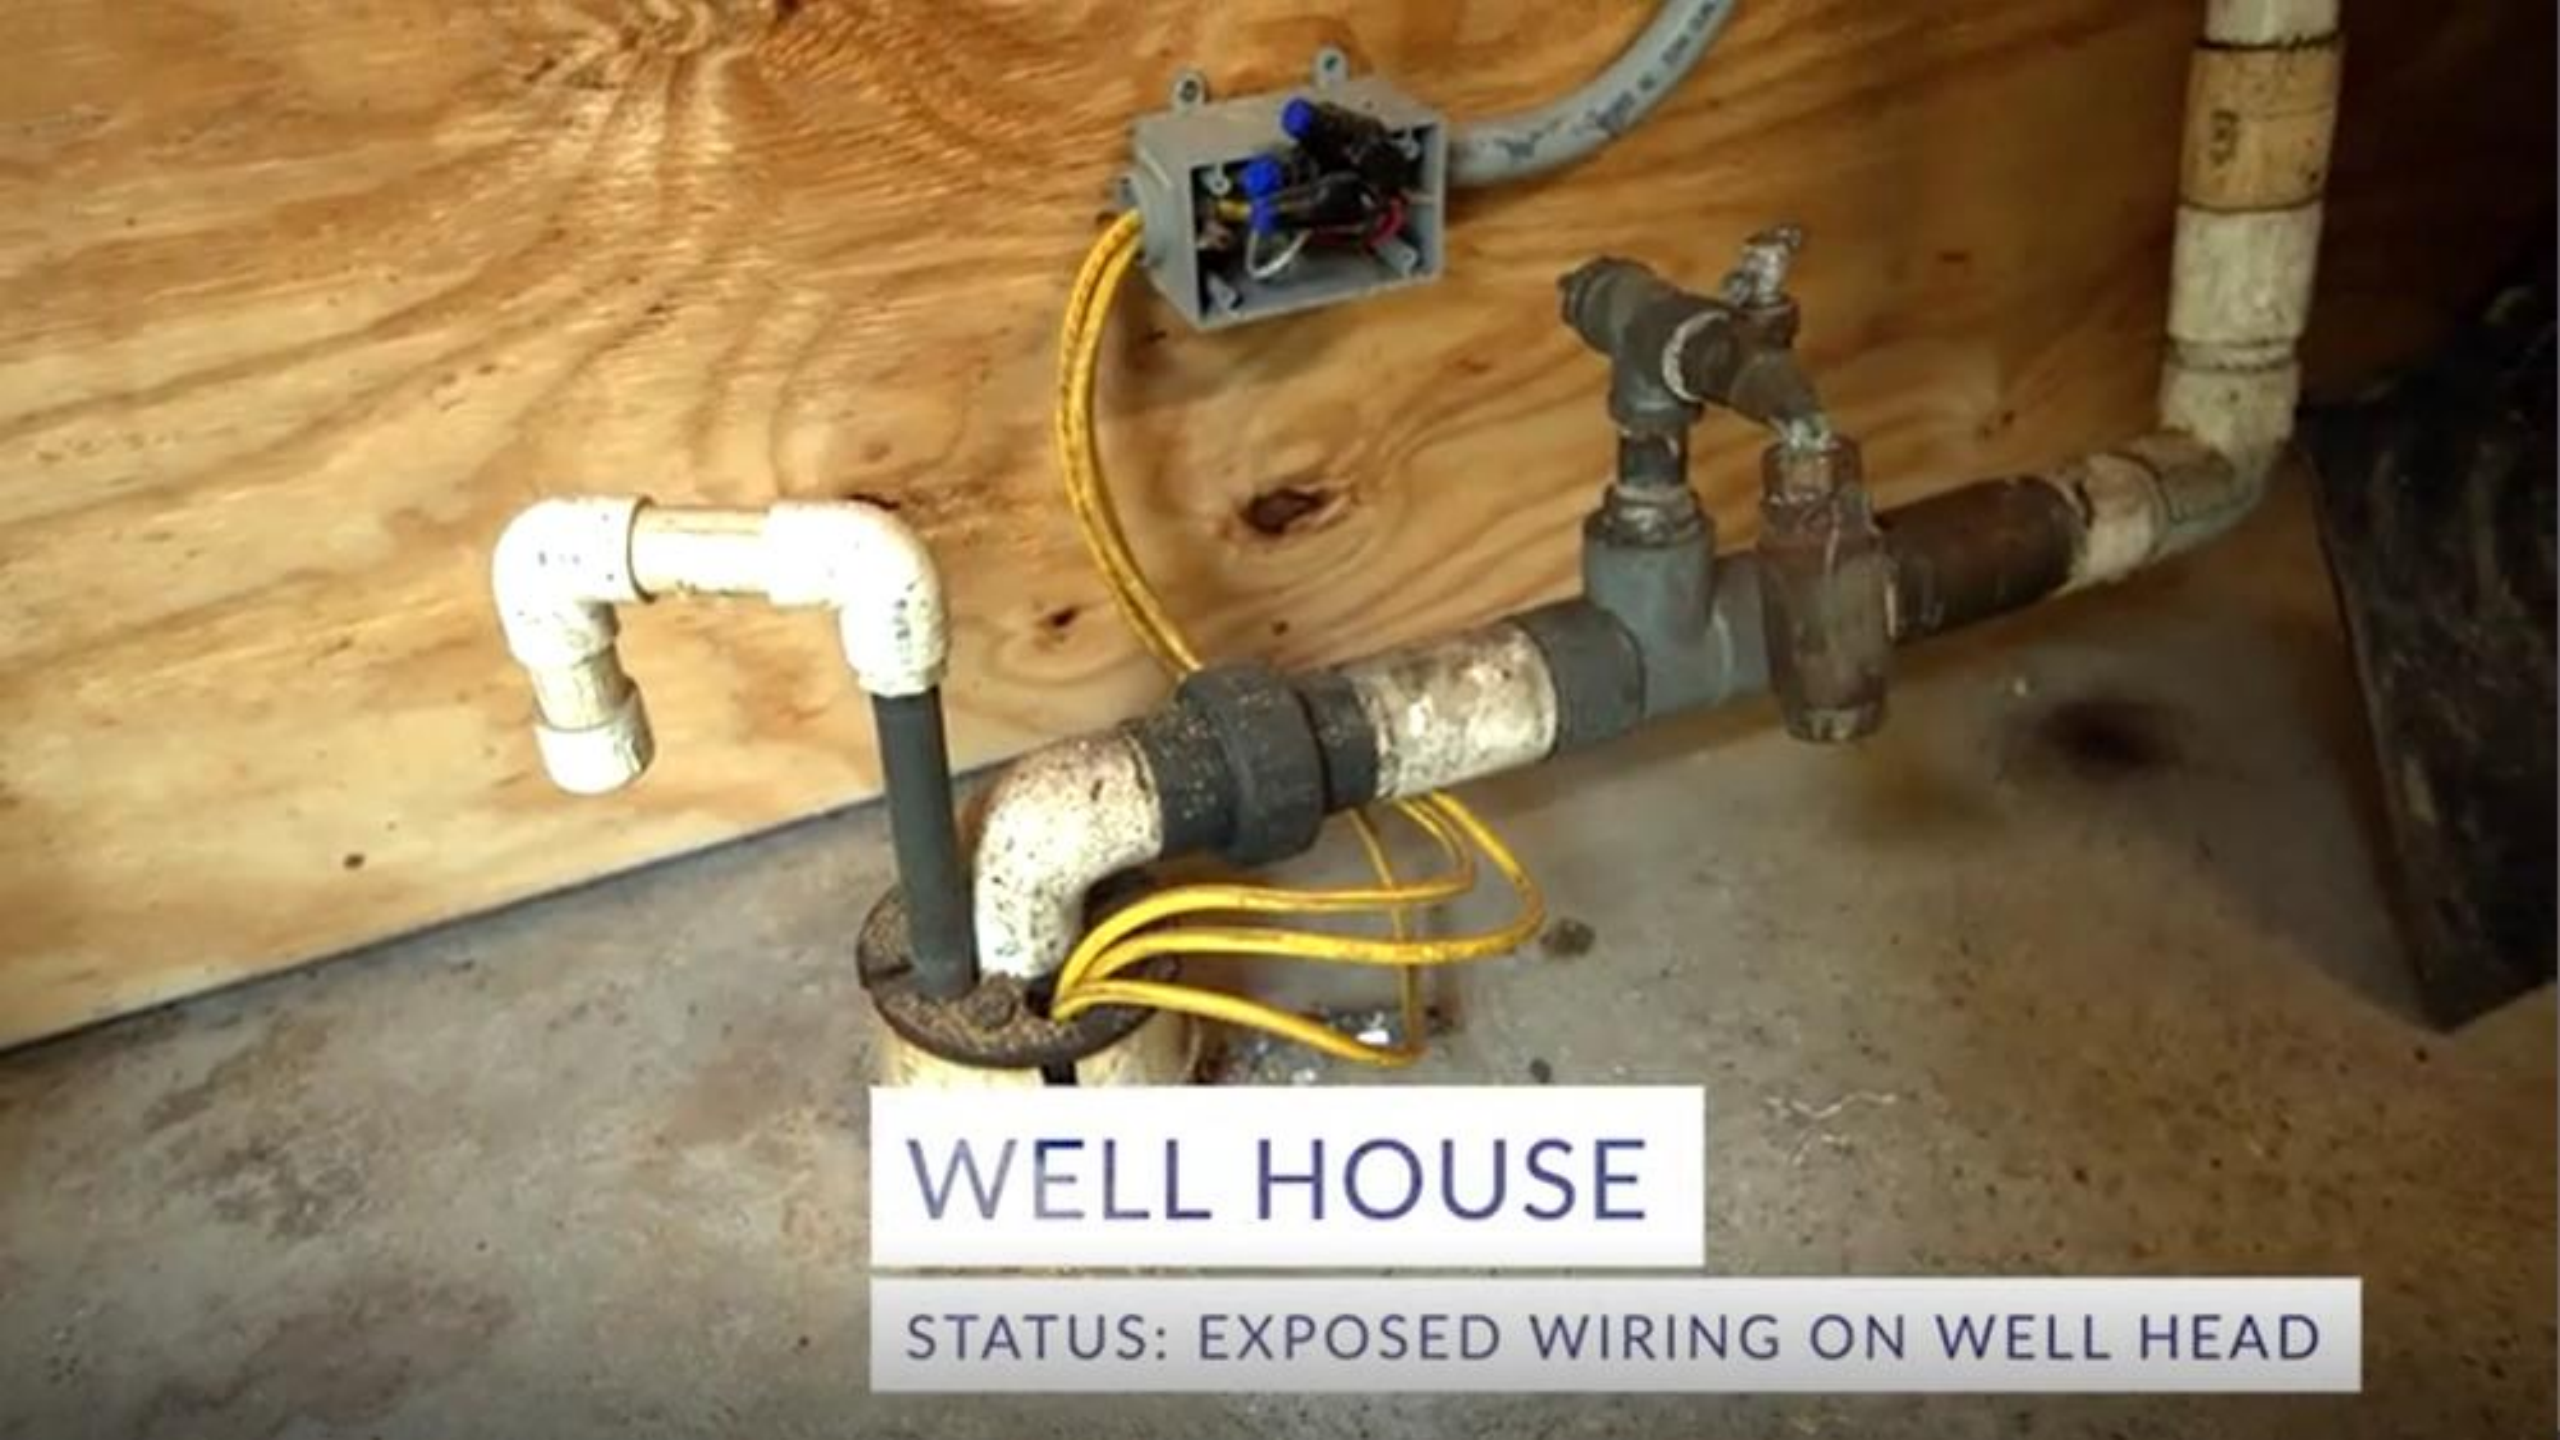
## WELL HOUSE

STATUS: EXPOSED WIRING ON WELL HEAD

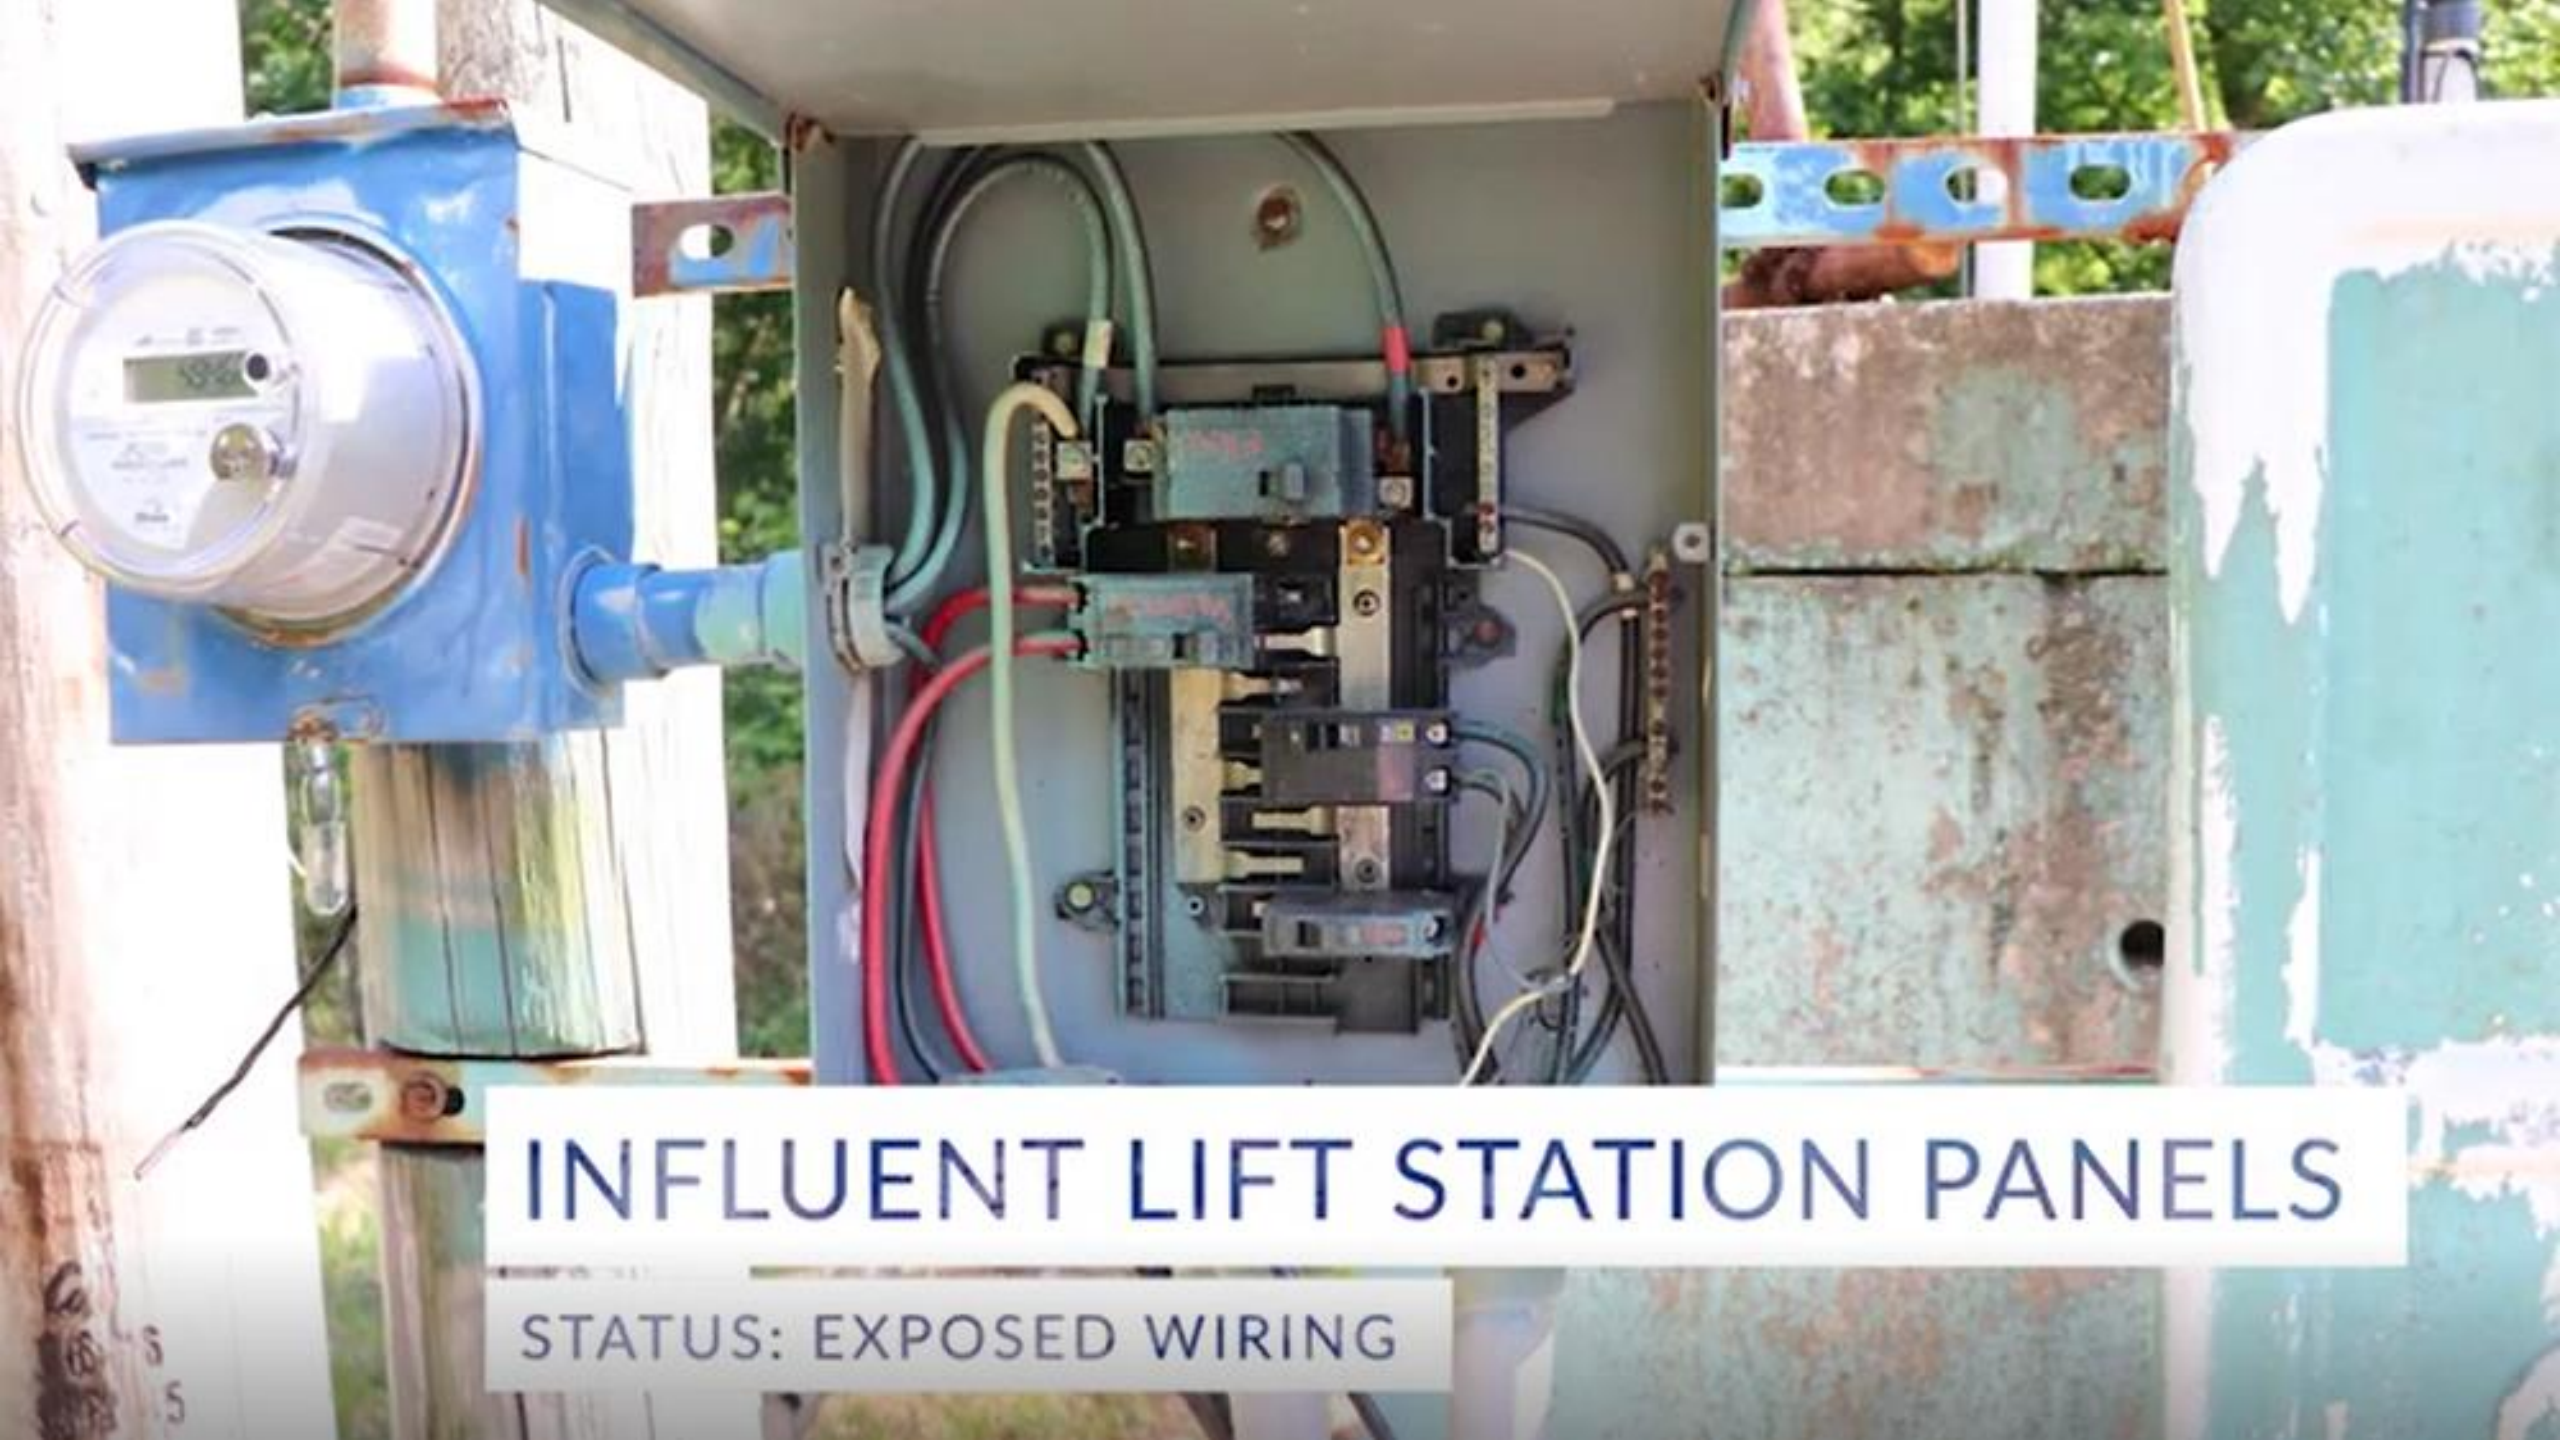
# INFLUENT LIFT STATION PANELS

STATUS: EXPOSED WIRING

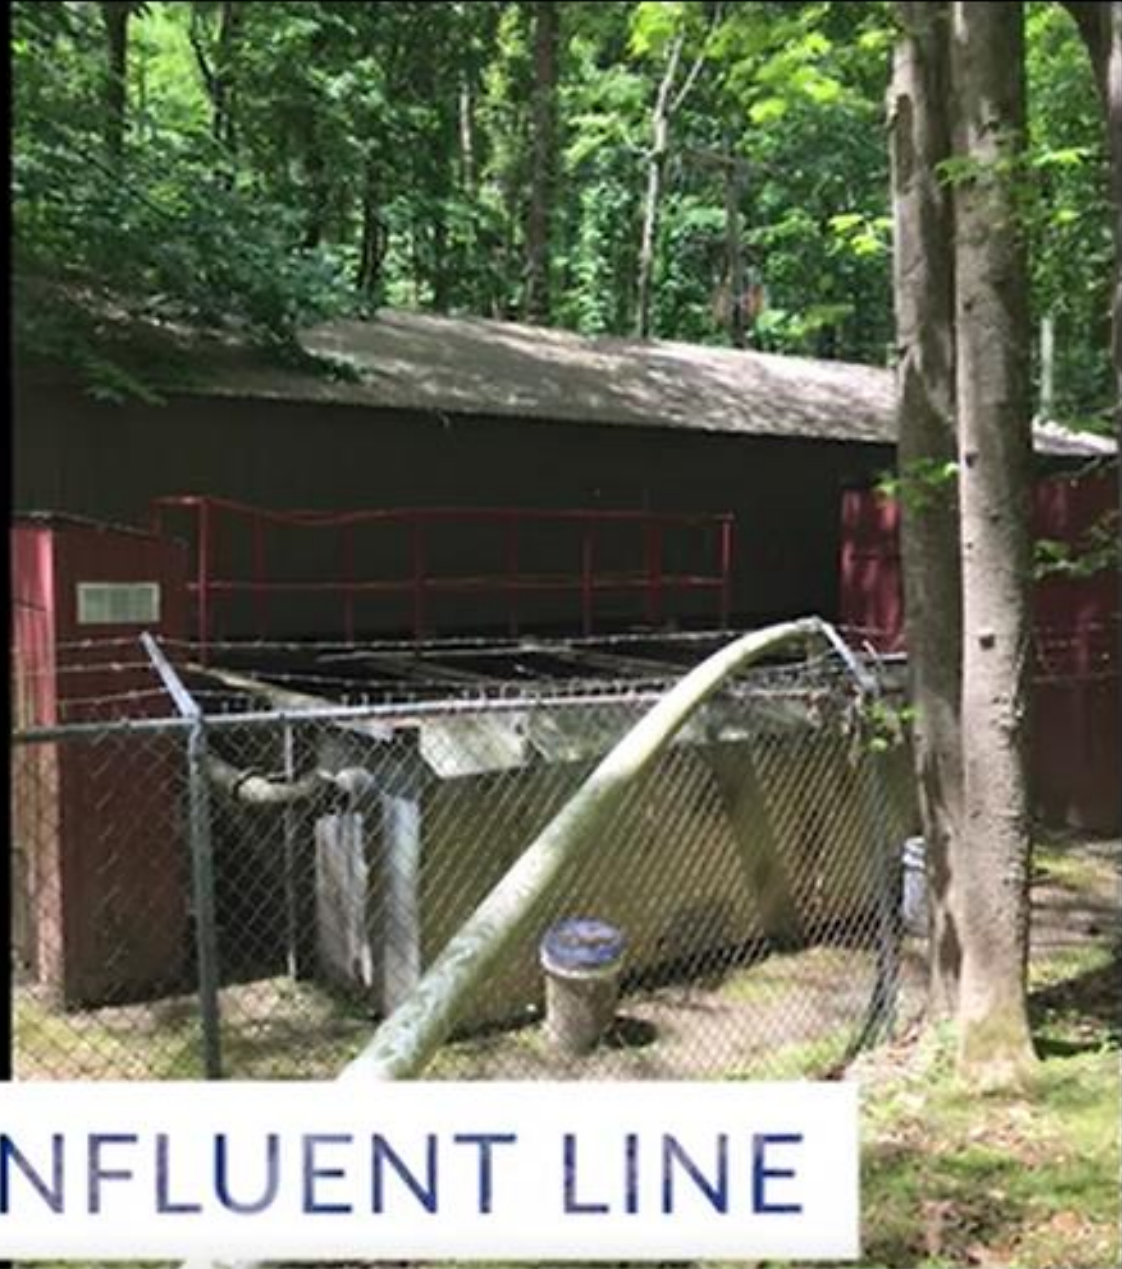
## INFLUENT LINE

STATUS: IMPROPER INSTALLATION AND MATERIALS

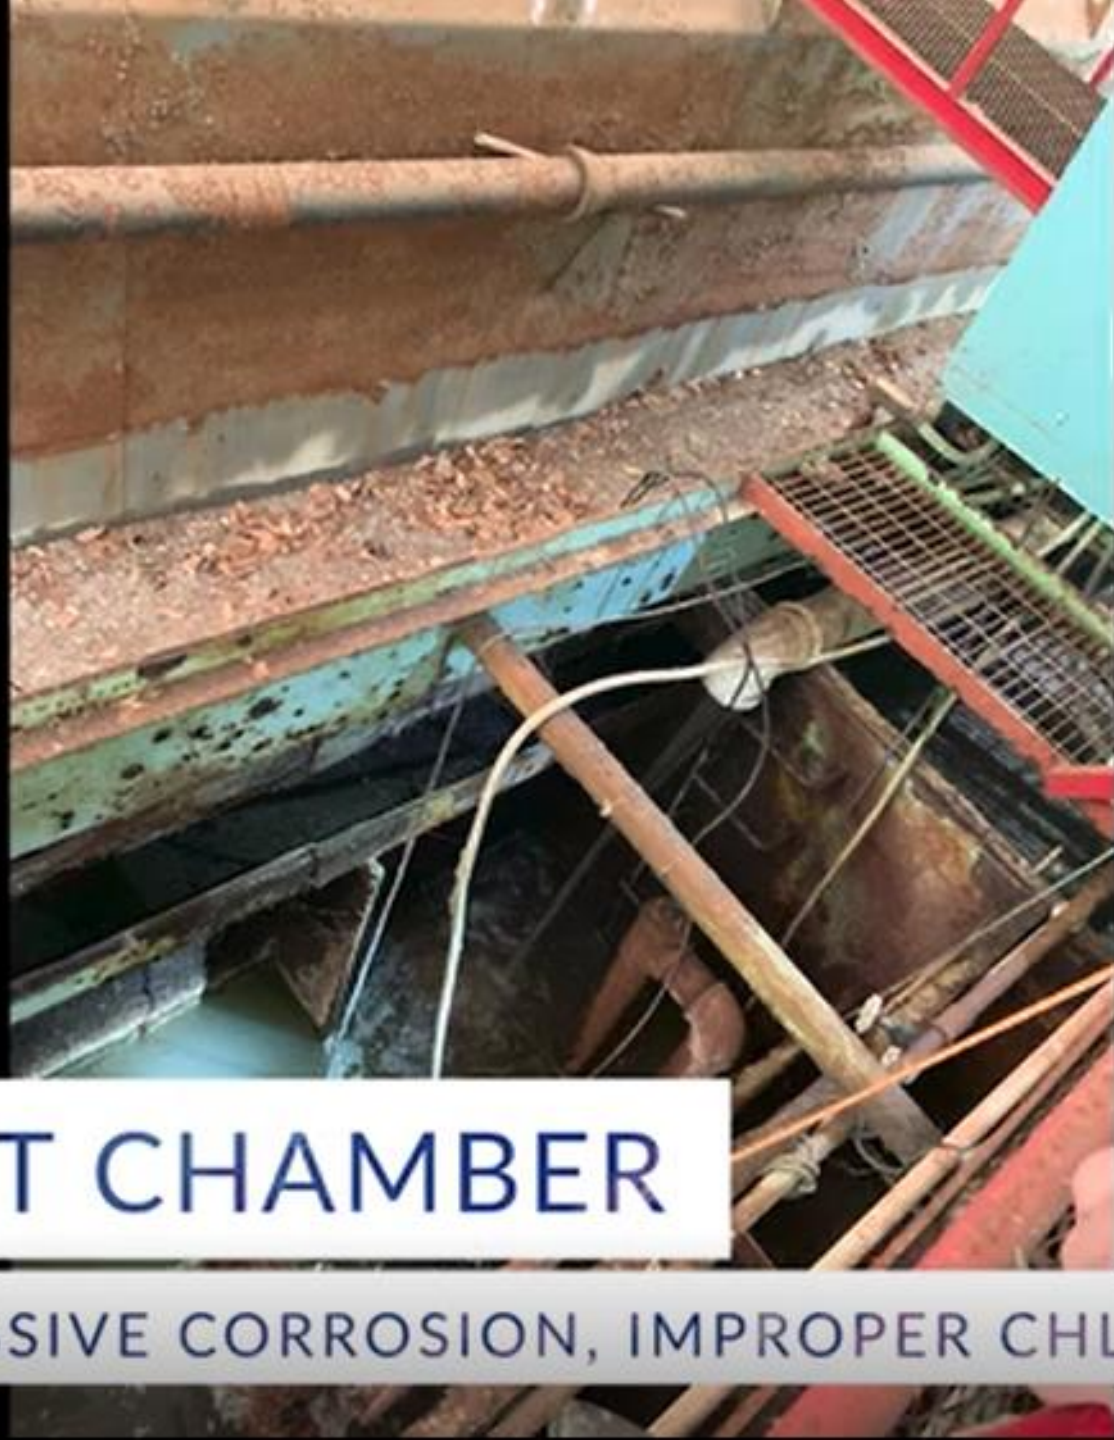
## CONTACT CHAMBER

STATUS: EXCESSIVE CORROSION, IMPROPER CHLORINE DOSING

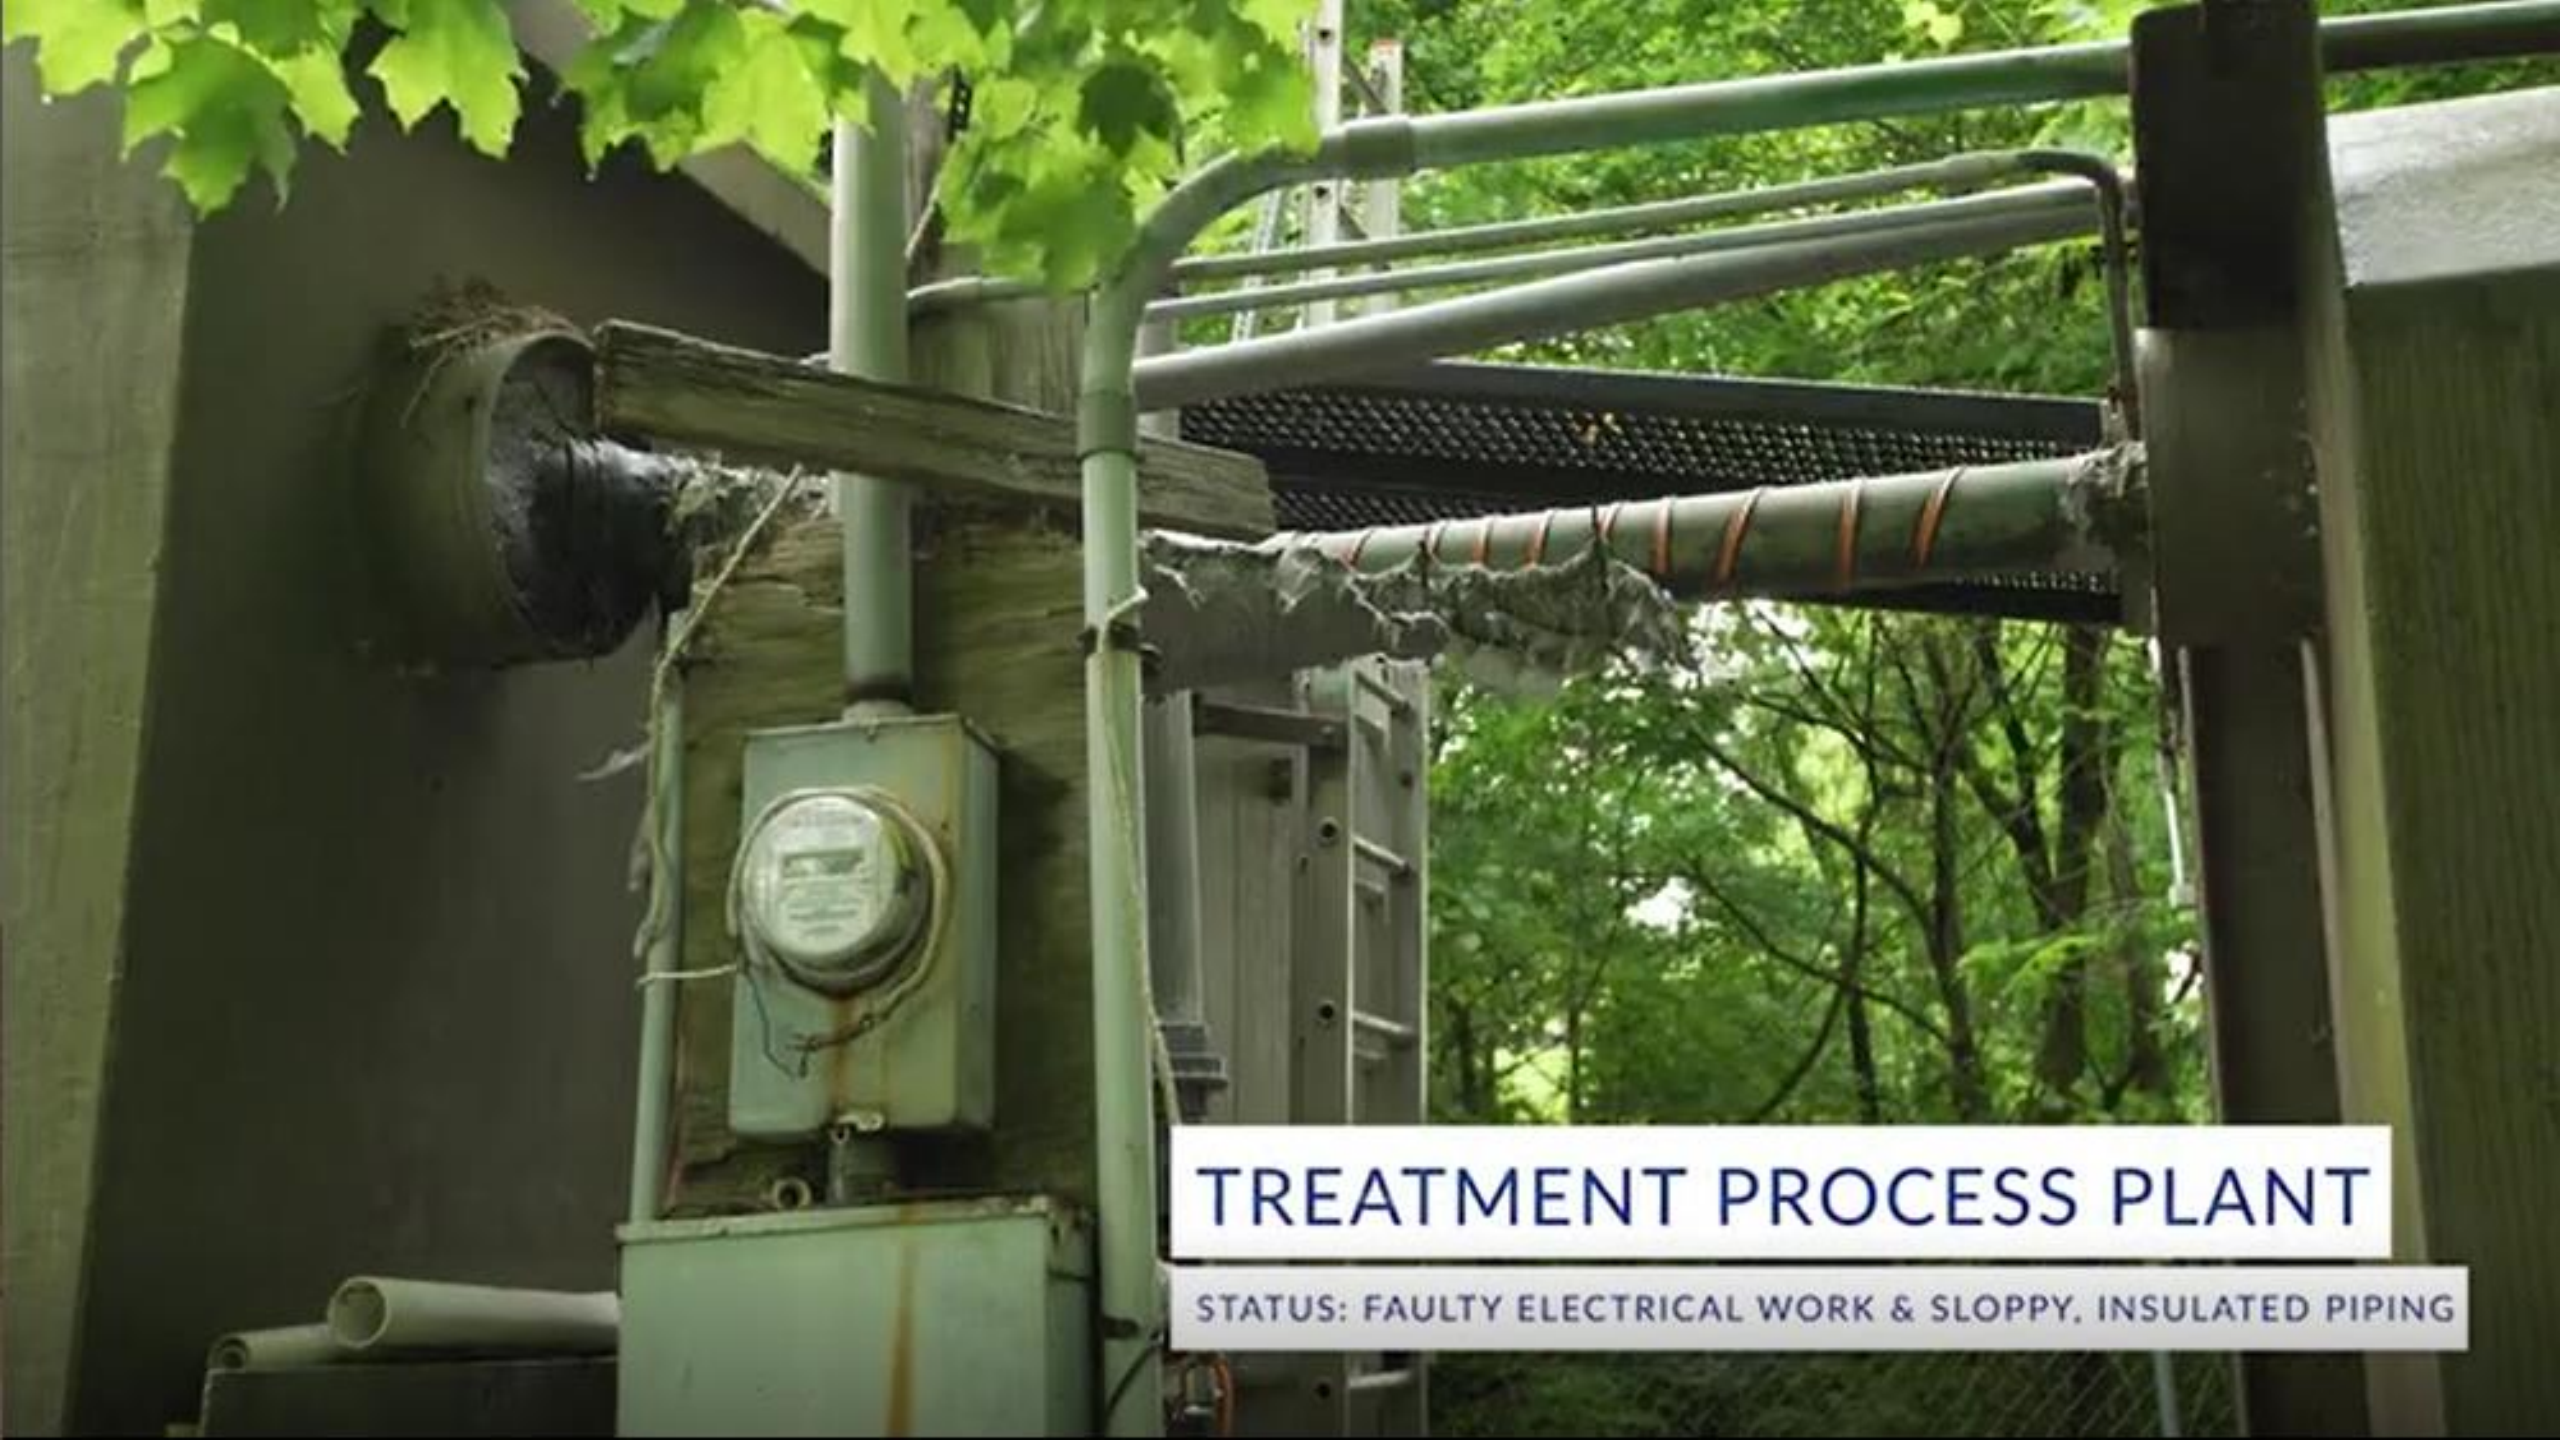
## TREATMENT PROCESS PLANT

STATUS: FAULTY ELECTRICAL WORK & SLOPPY, INSULATED PIPING

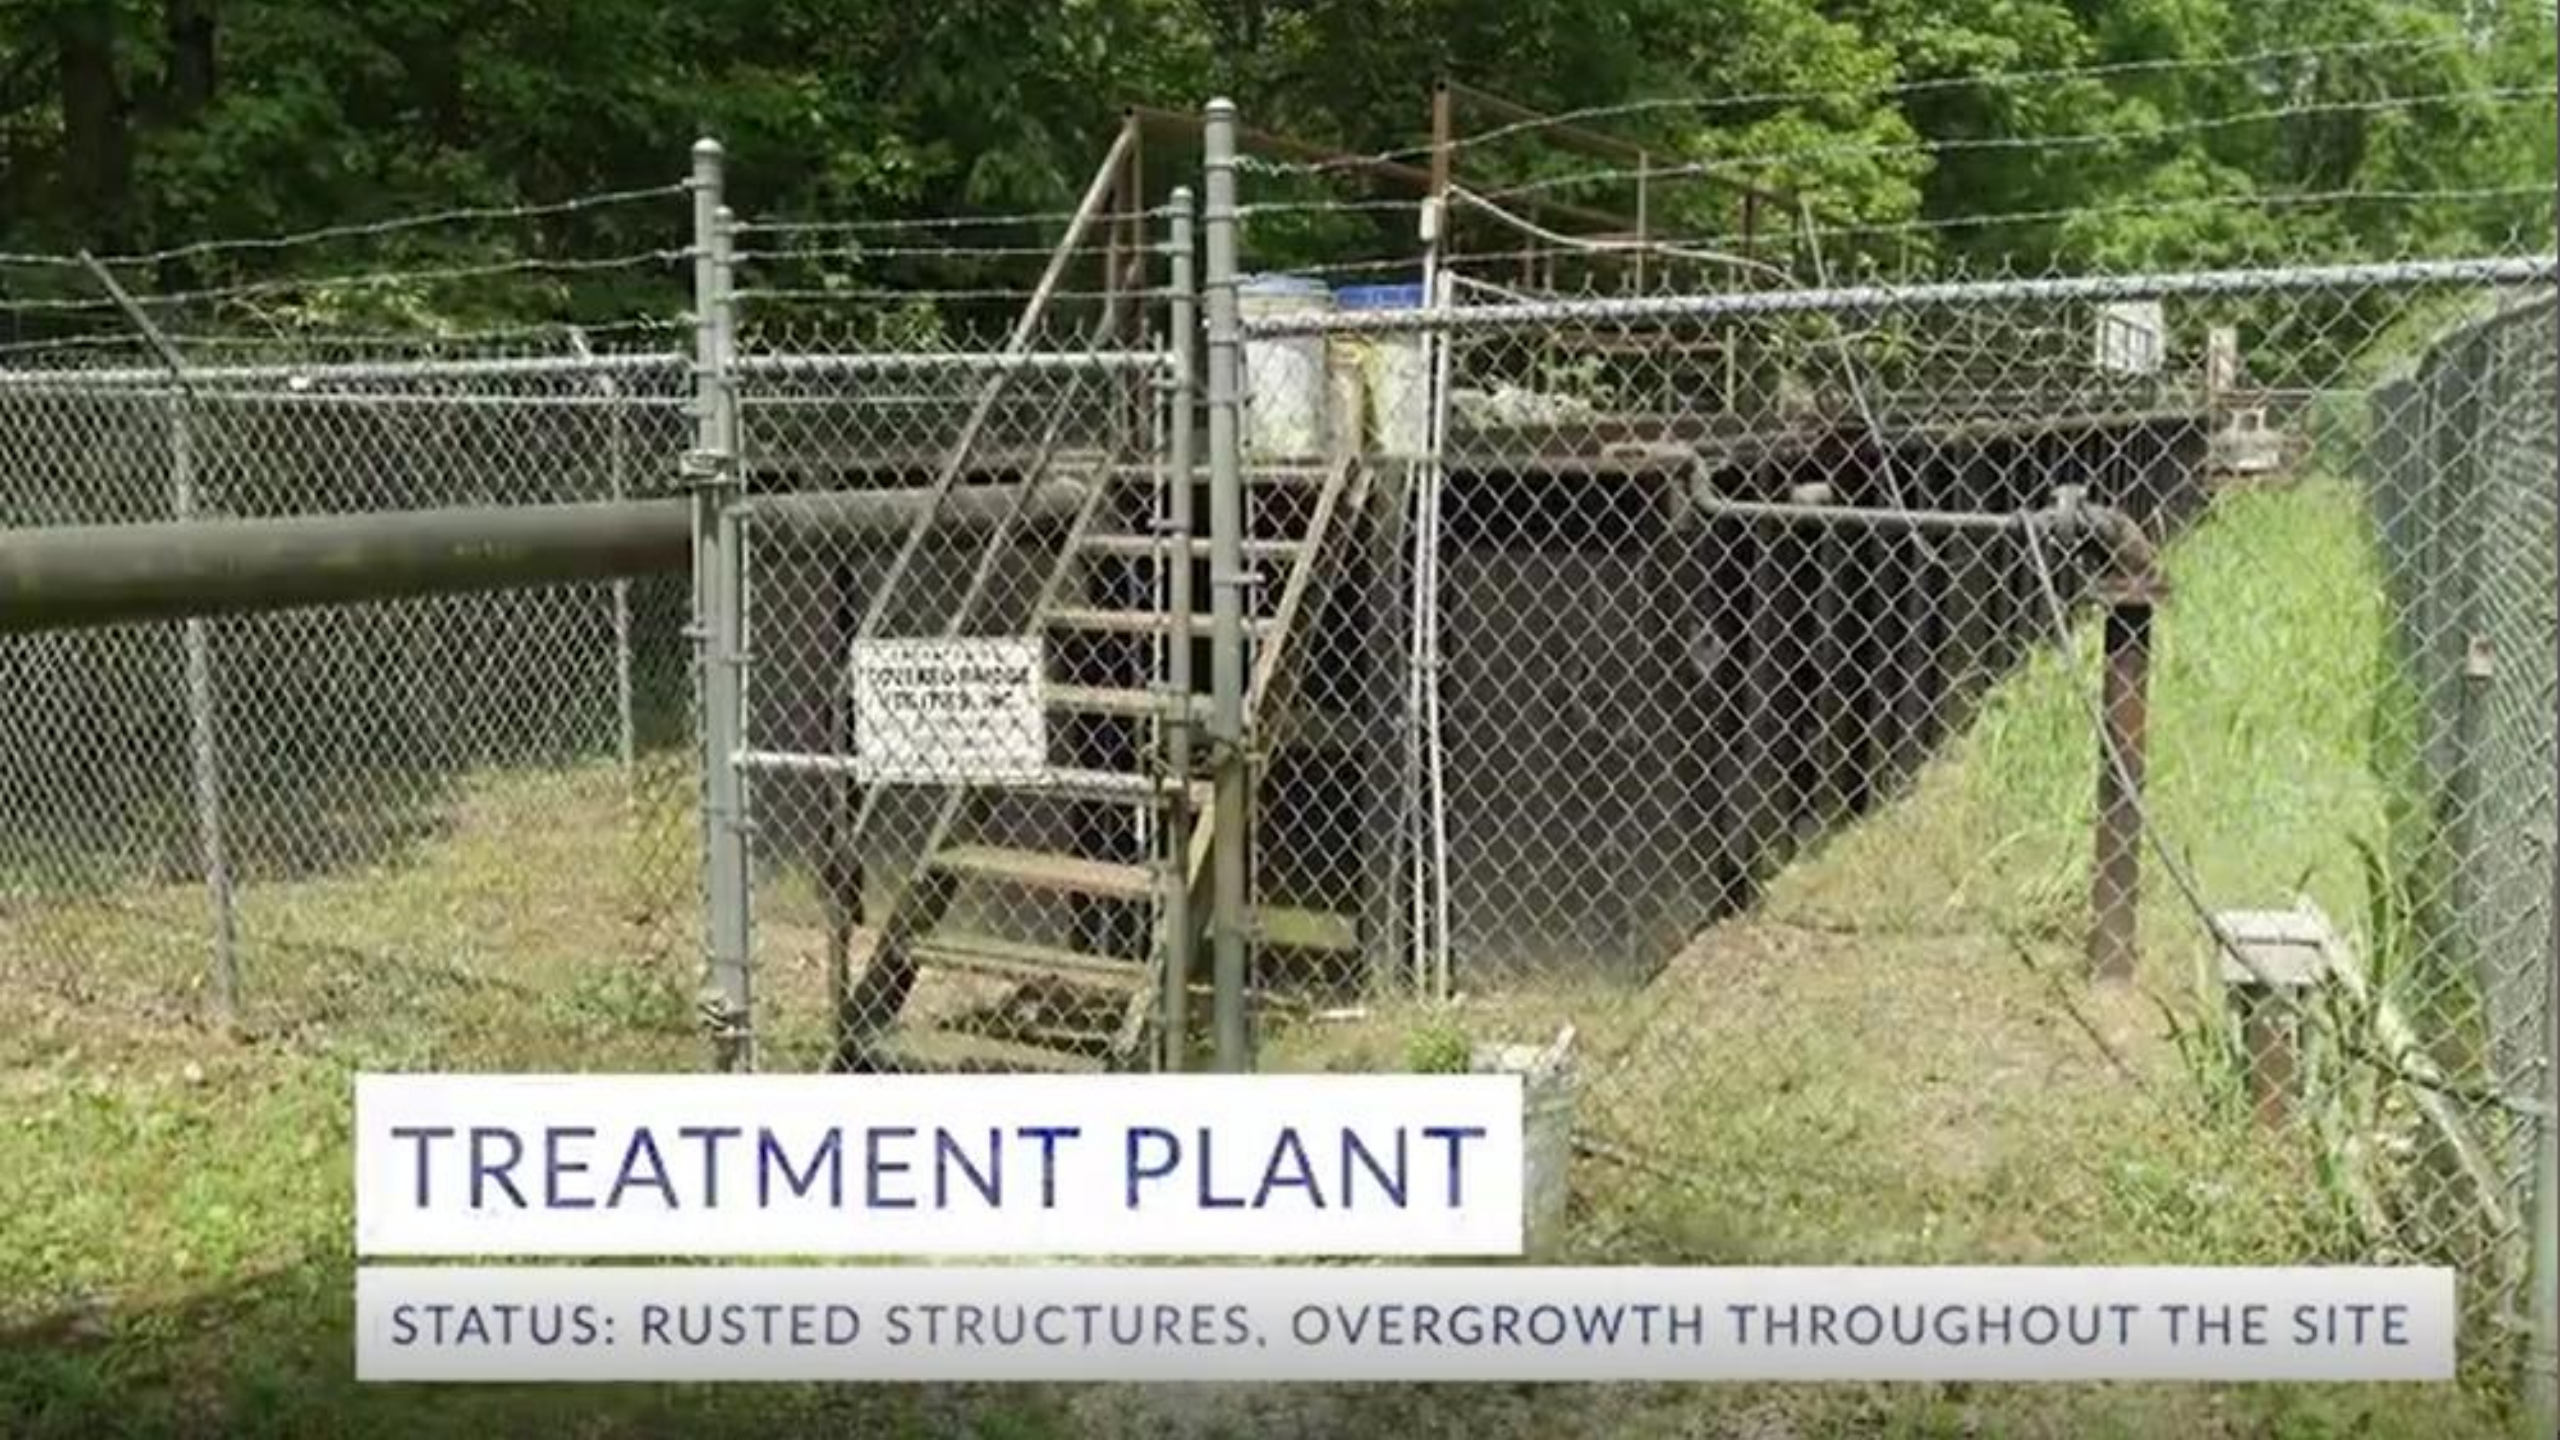
# TREATMENT PLANT

STATUS: RUSTED STRUCTURES, OVERGROWTH THROUGHOUT THE SITE

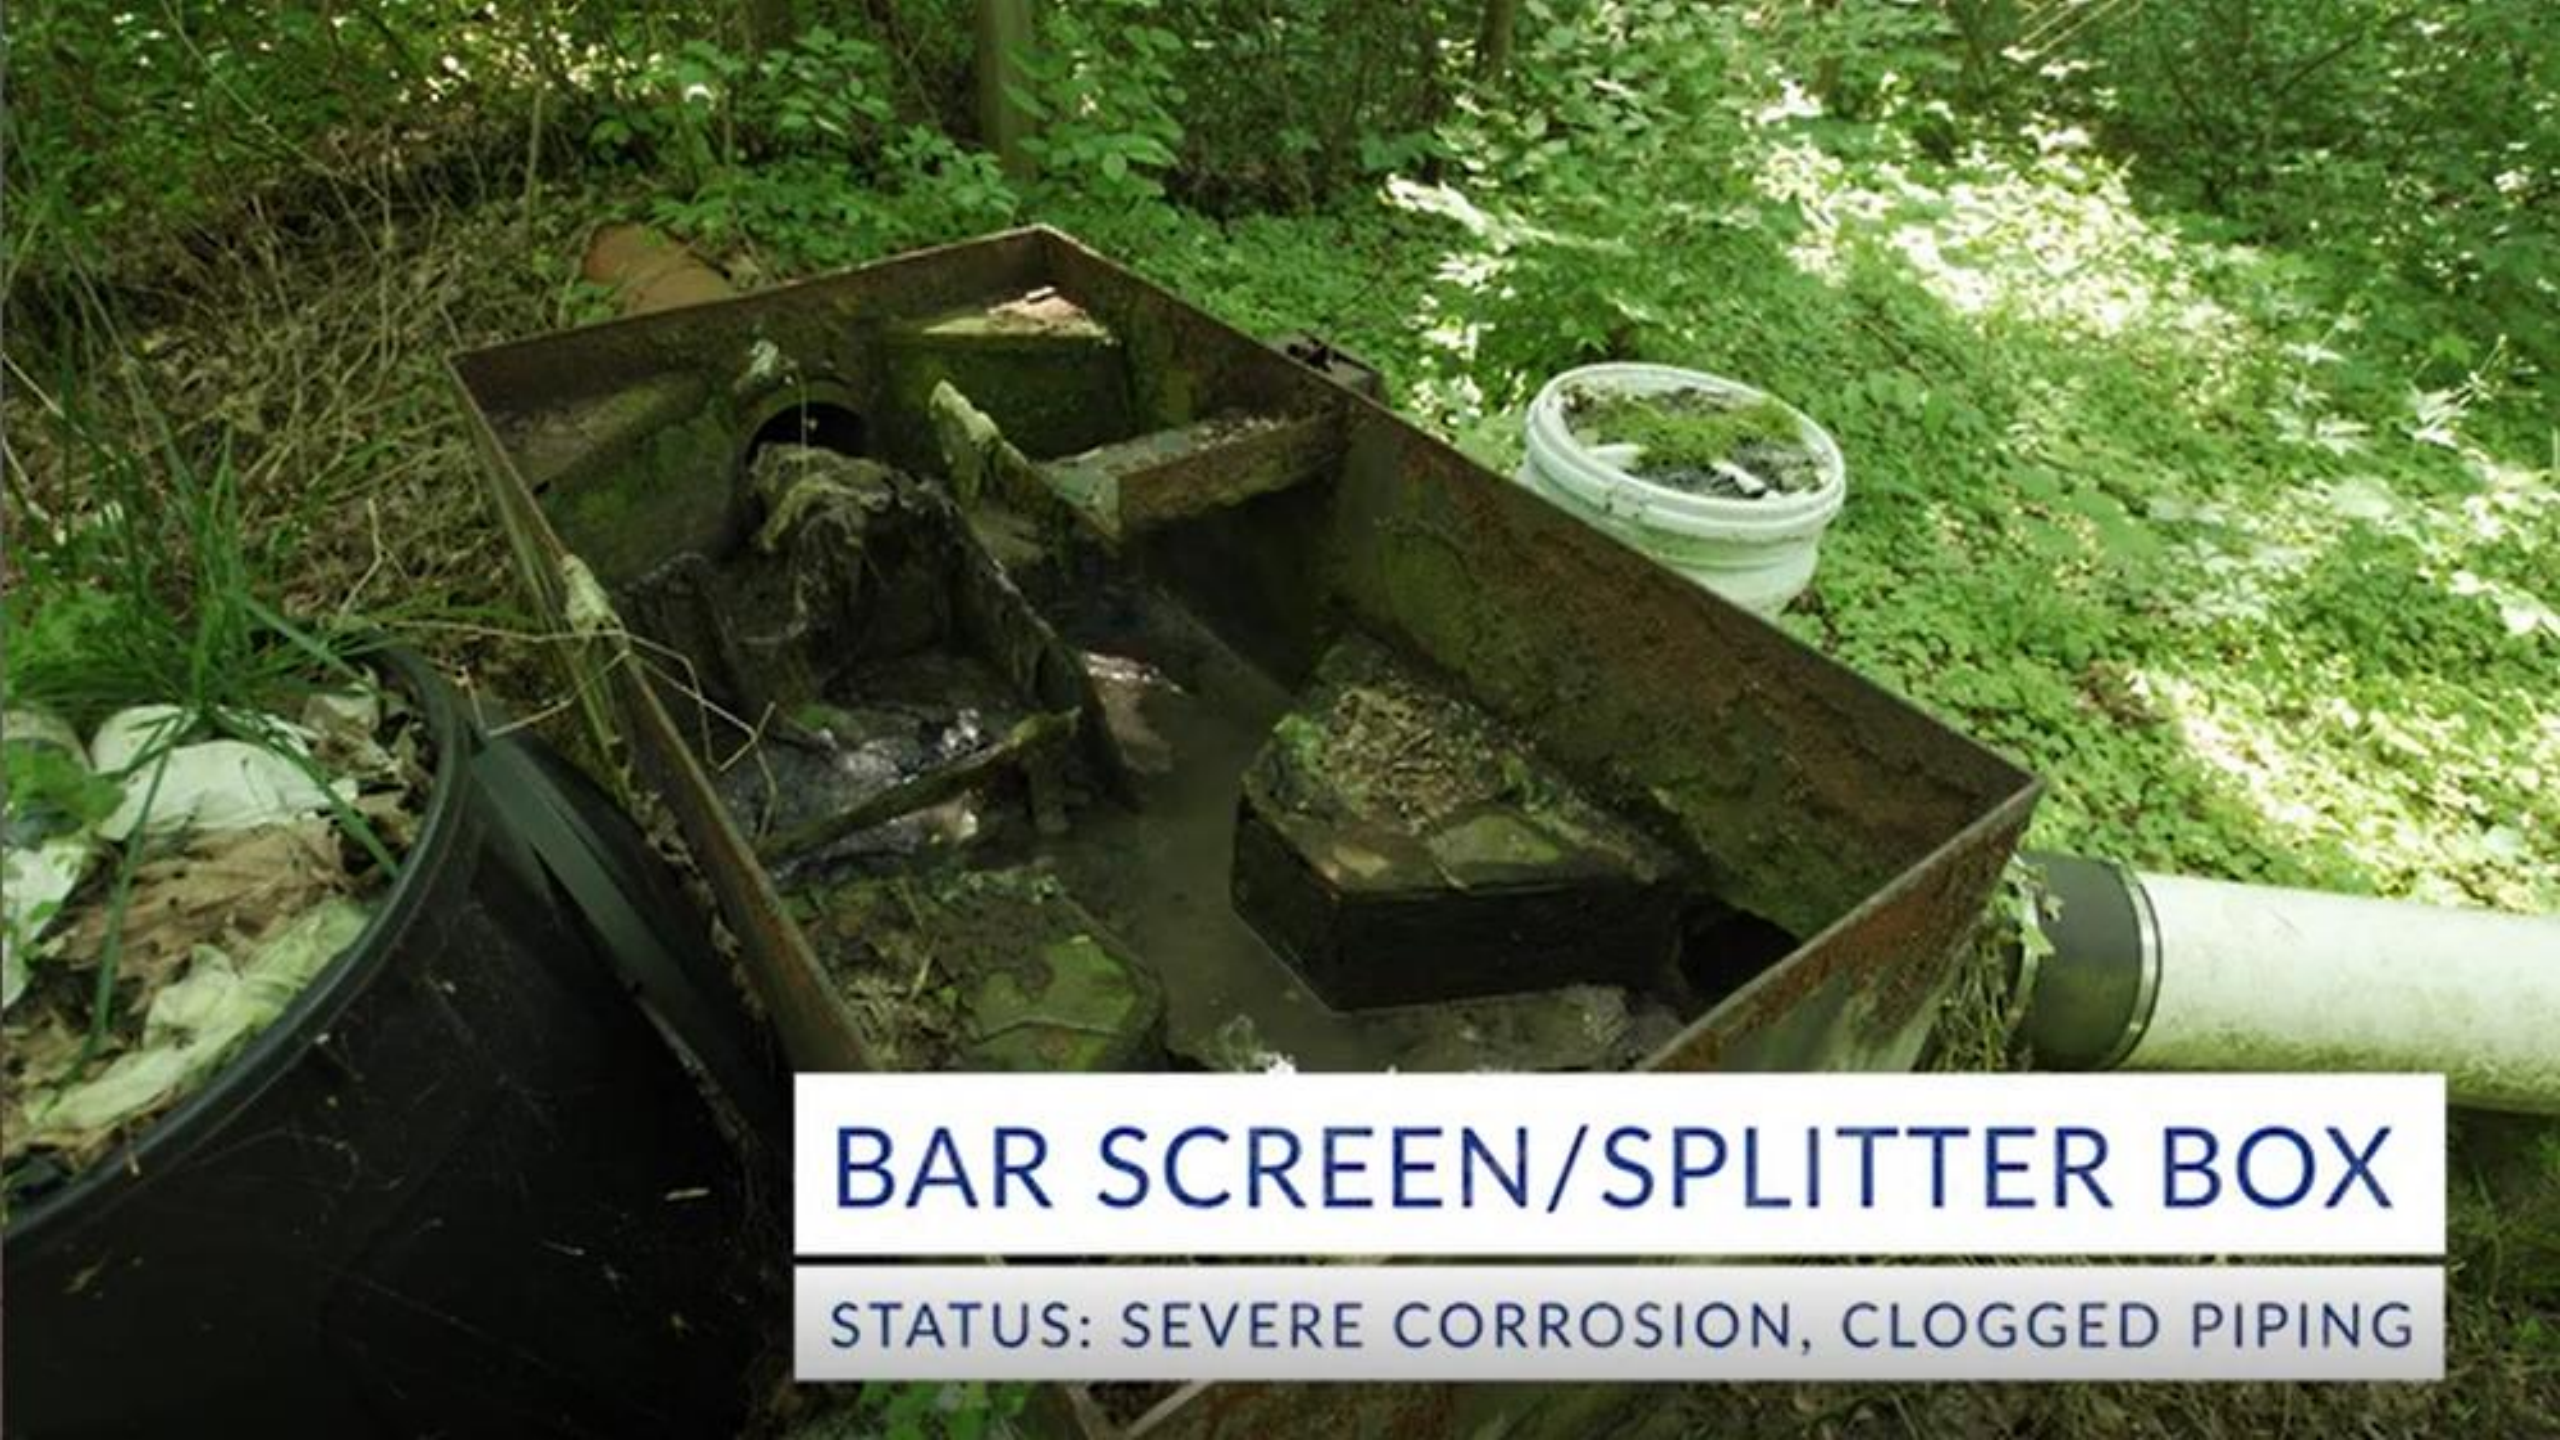
## BAR SCREEN/SPLITTER BOX

STATUS: SEVERE CORROSION, CLOGGED PIPING
