COMMONWEALTH OF KENTUCKY  
BEFORE THE PUBLIC SERVICE COMMISSION

<i>Electronic</i> Application of Bluegrass	)	
Water Utility Operating Company, LLC	)	Case No. 2020-00290
for an Adjustment of Rates and Approval	)	
of Construction	)

**Supplement to Responses  
to Post-Hearing Data Requests**

SUPPLEMENT: Bluegrass attaches hereto a series of stills taken from the video file, *Bluegrass Water UOC\_Before Reel.mp4*, showing the condition of the systems that it acquired before June 30, 2020. The following is an index with the PDF page number of each still, the time counter on the video file, and a description of what is depicted by title or facility and status:

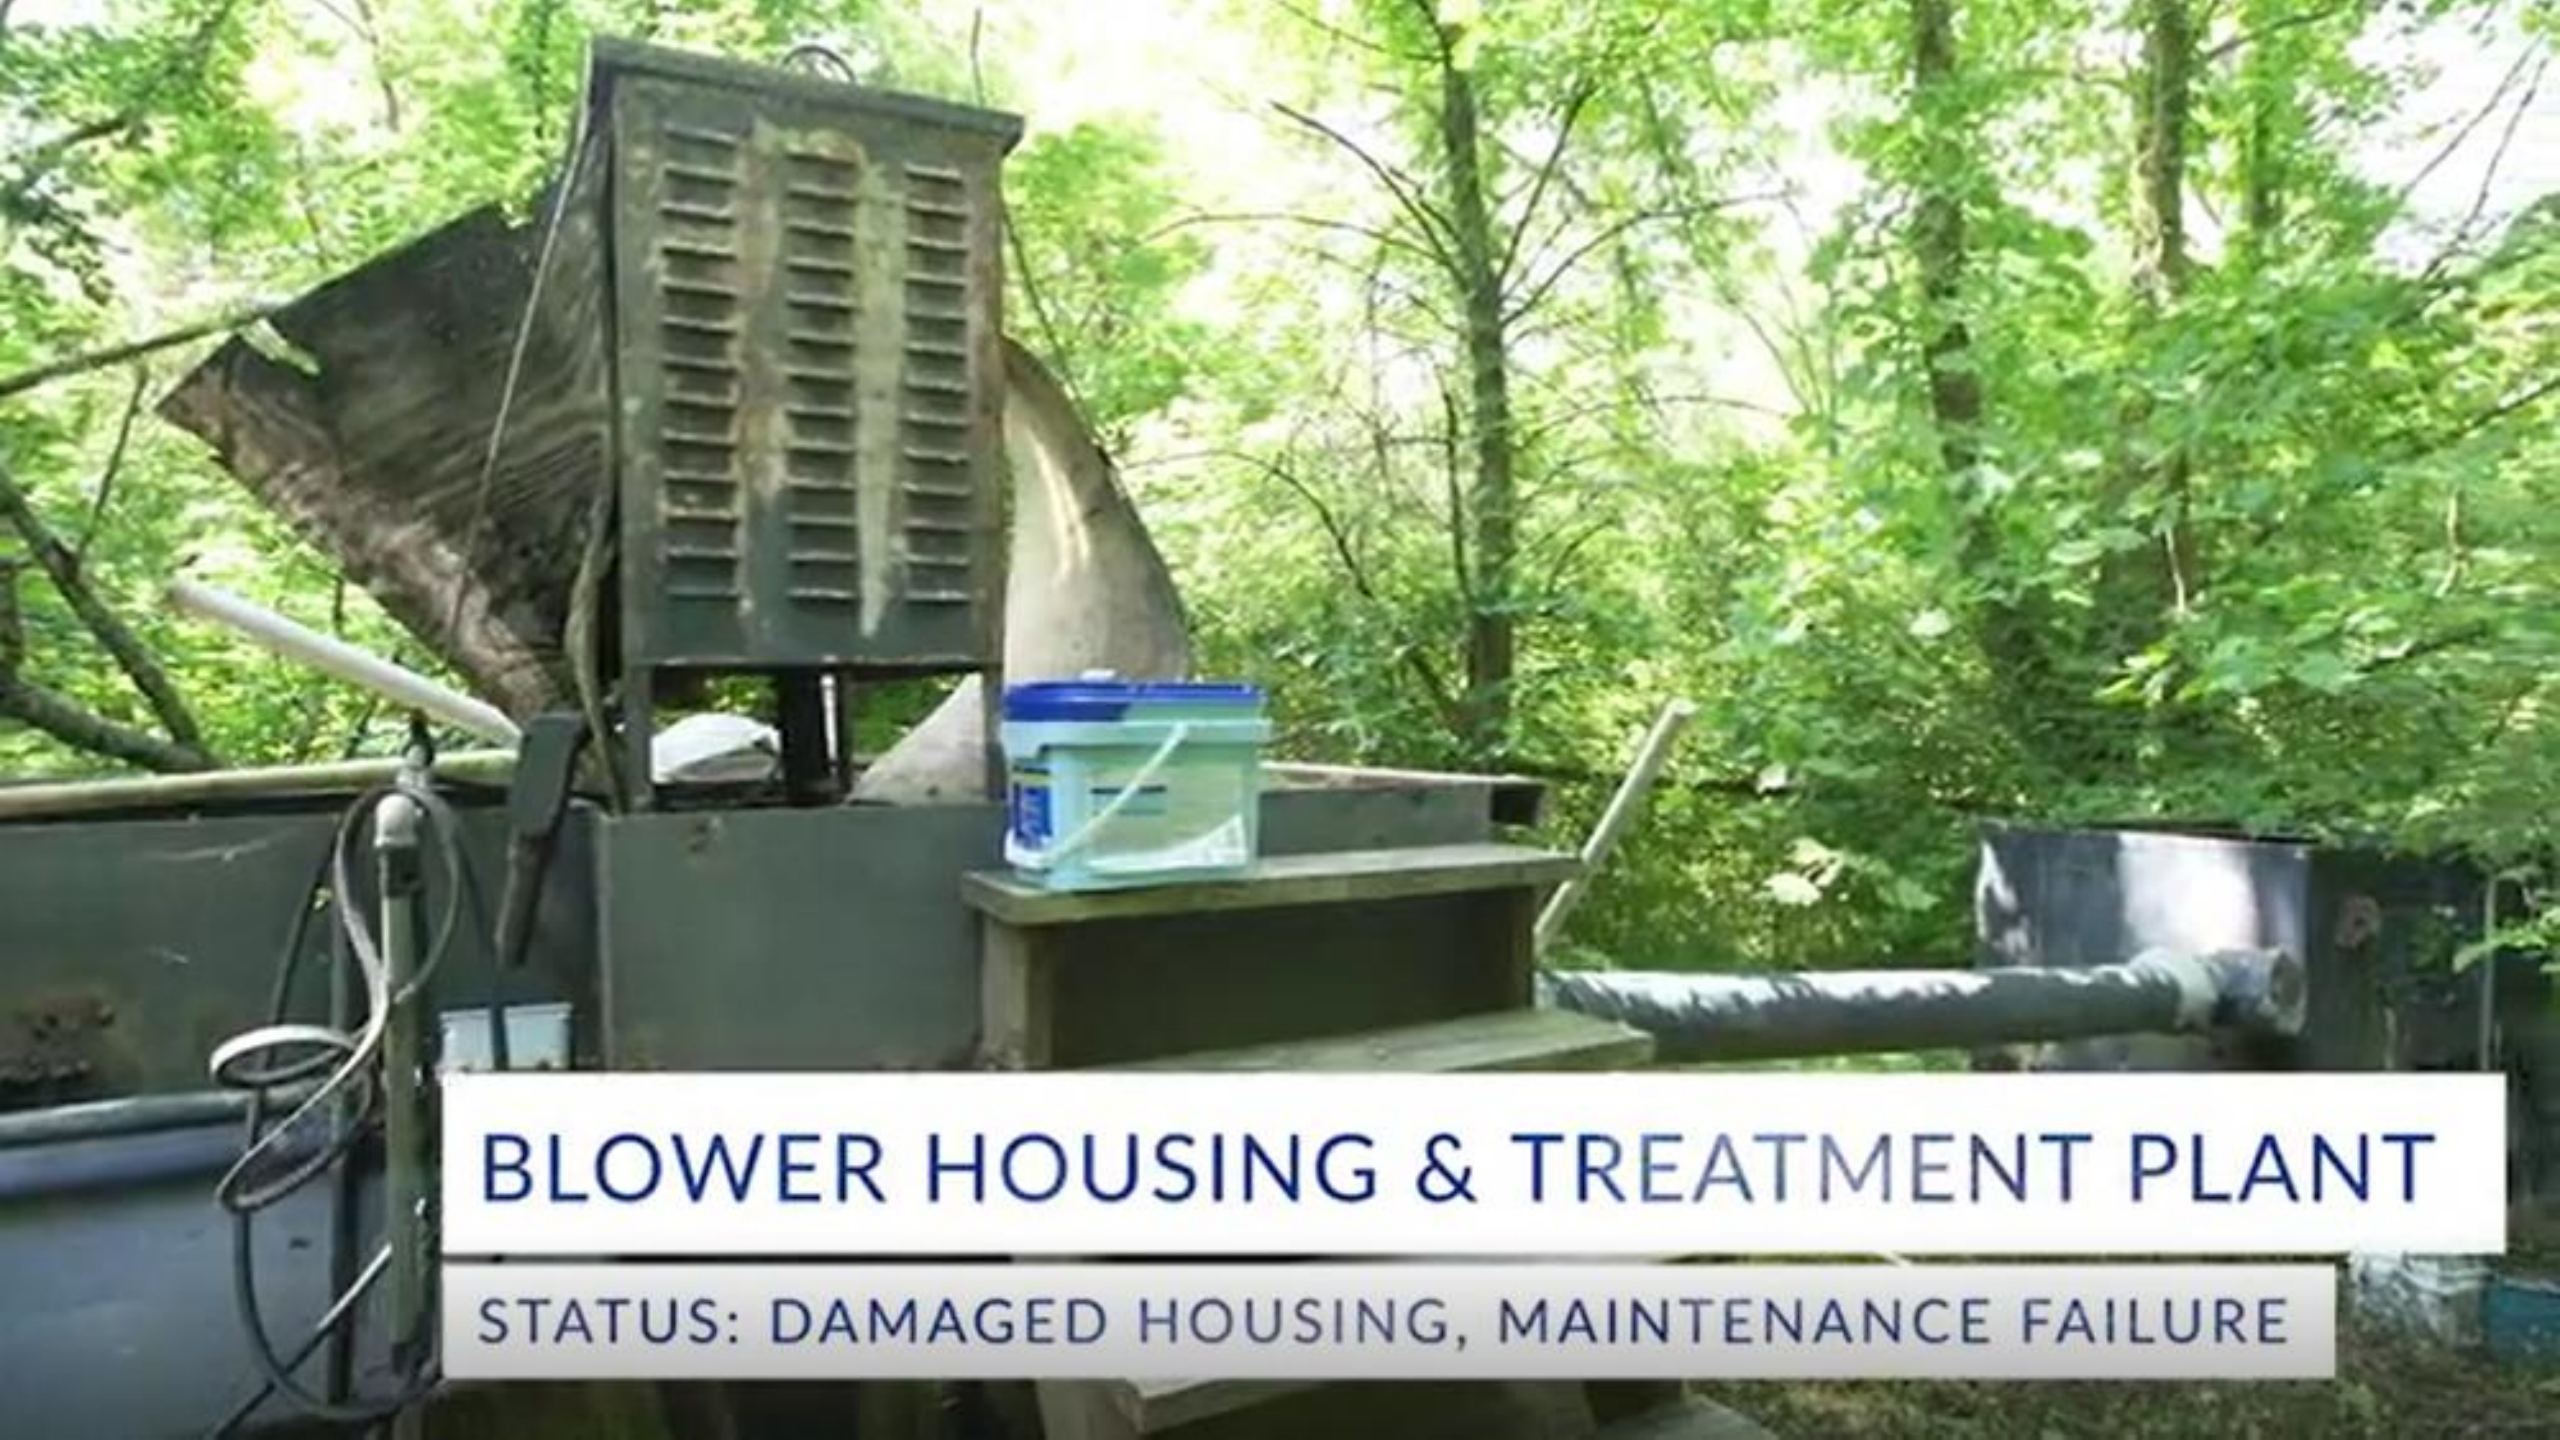
## BLOWER HOUSING & TREATMENT PLANT

STATUS: DAMAGED HOUSING, MAINTENANCE FAILURE

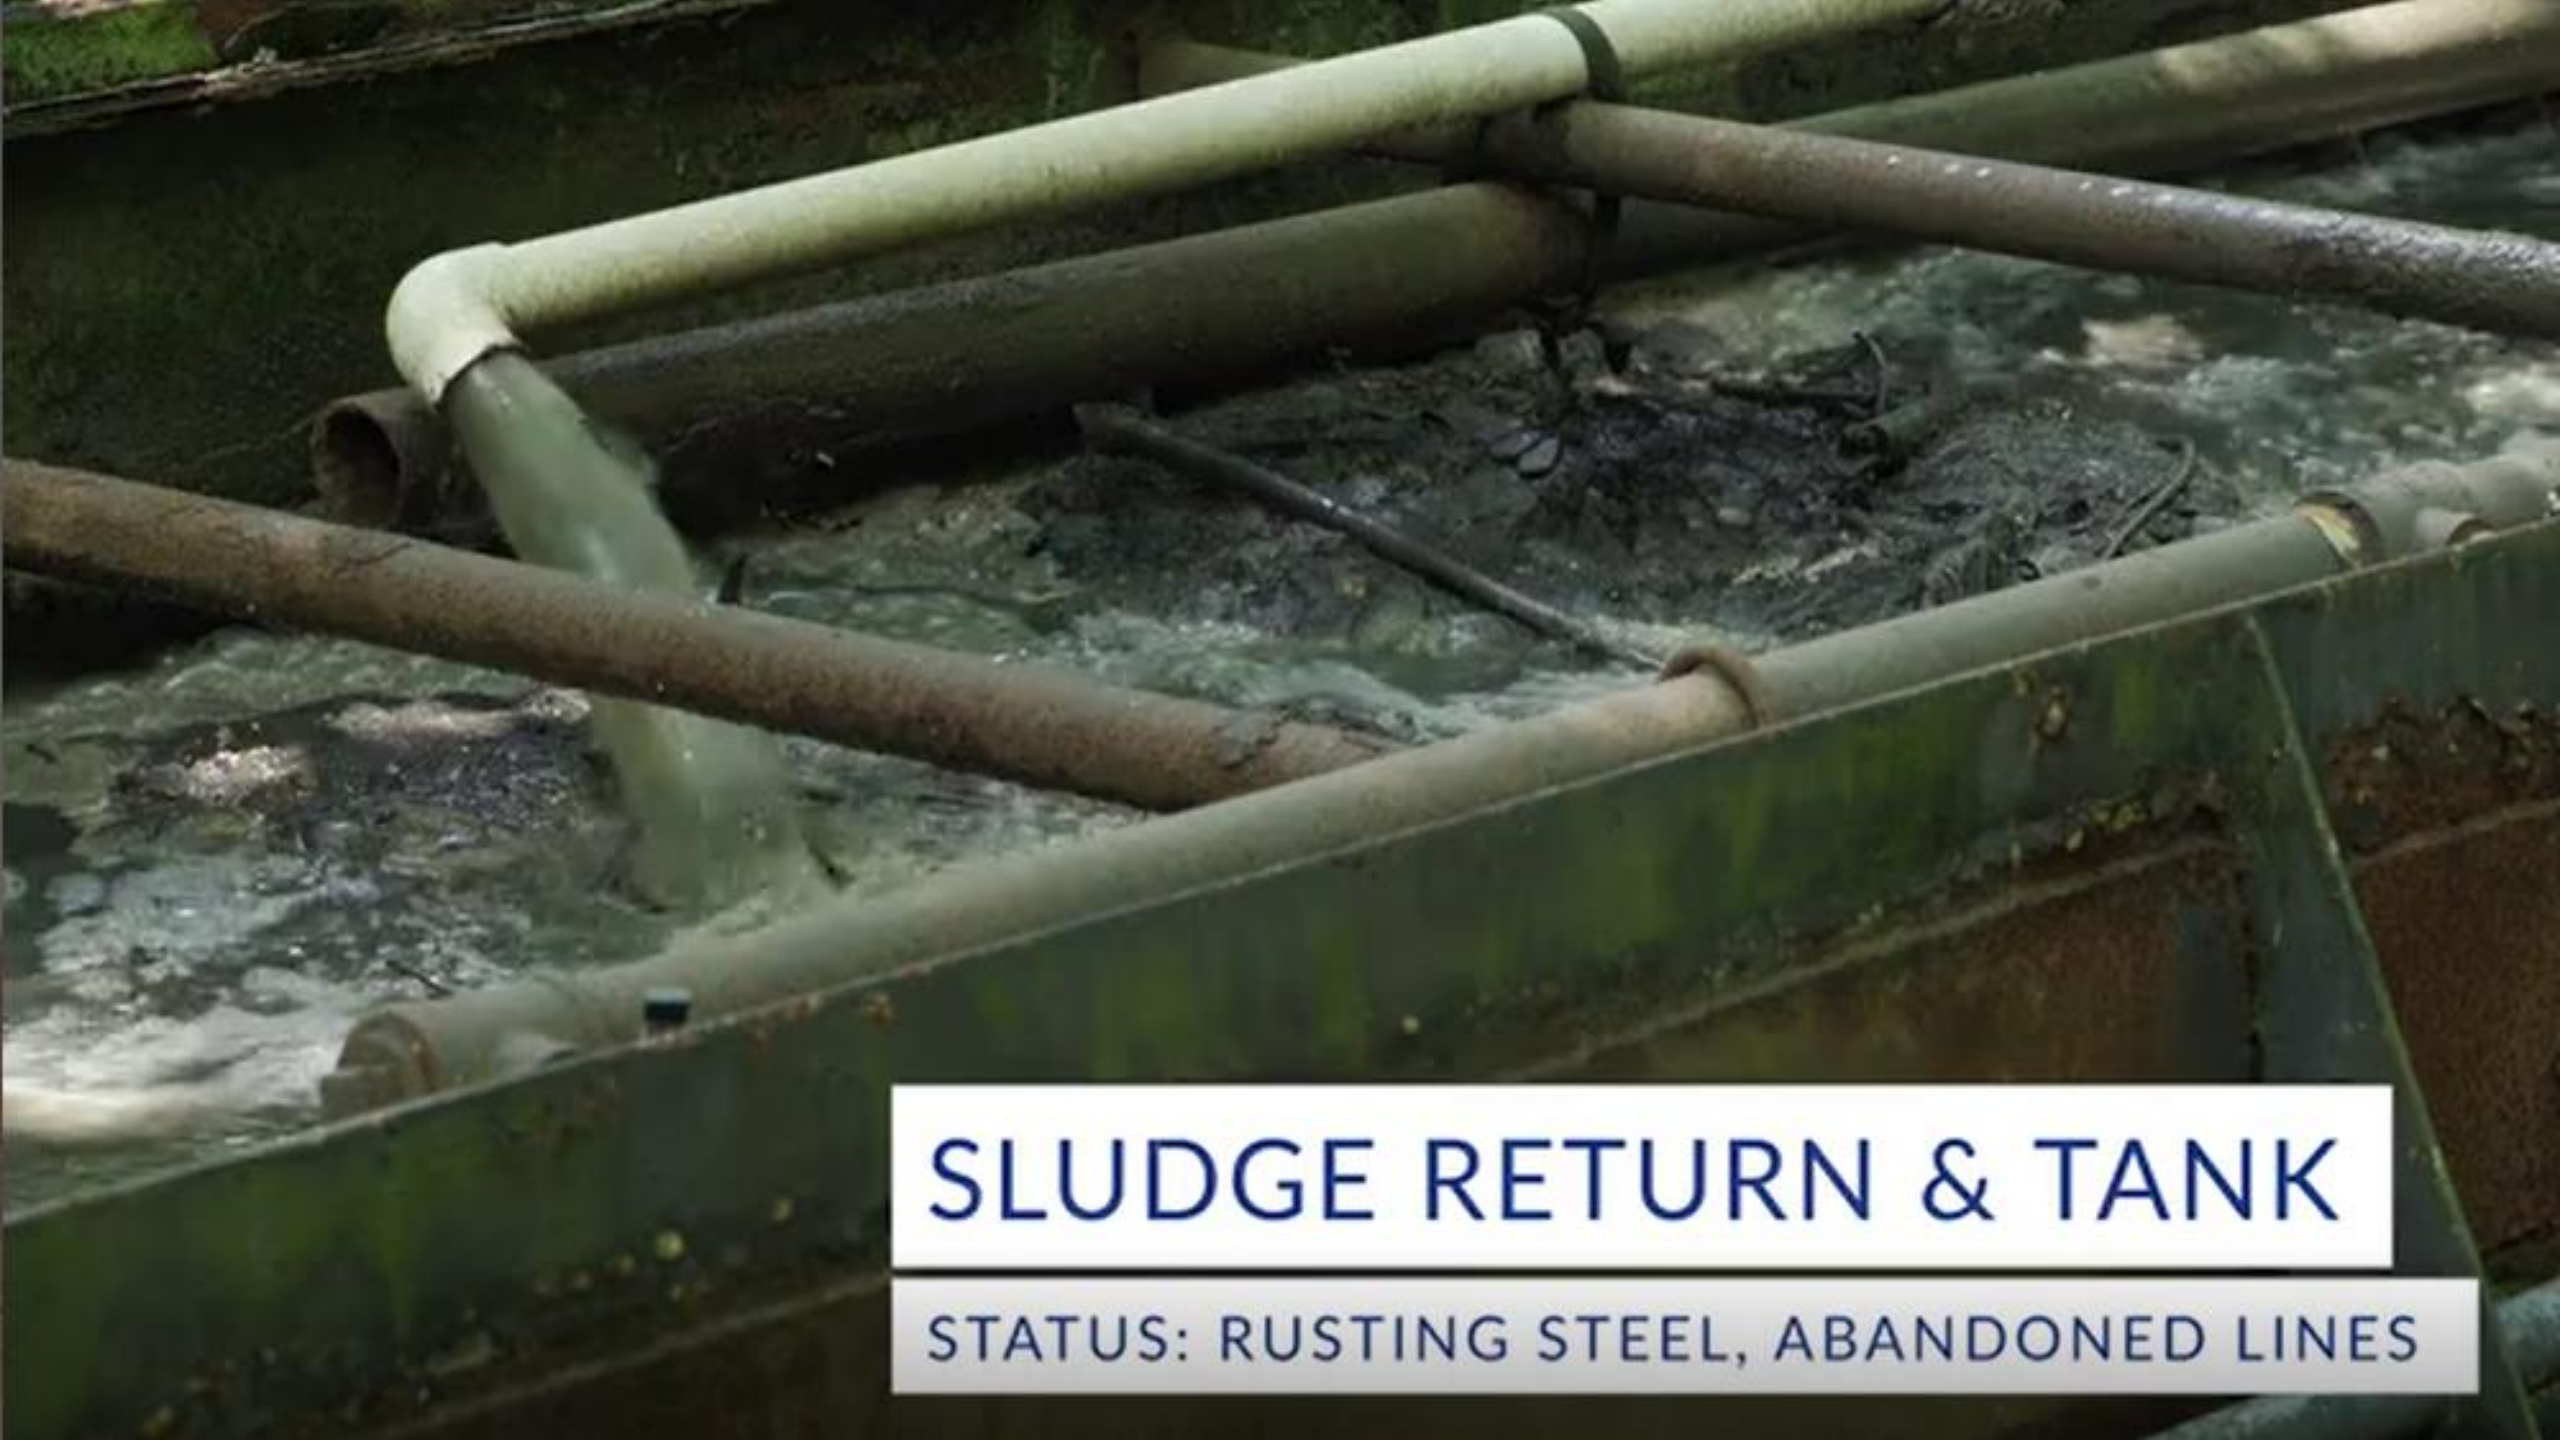
## SLUDGE RETURN & TANK

STATUS: RUSTING STEEL, ABANDONED LINES
