Kentucky Power Company  
KPSC Case No. 2021-00370  
AG/KIUC's First Set of Show Cause Issue Data Requests  
Dated October 16, 2023  
Page 1 of 3

TRK Engineering Services, Inc. was retained by AEP Mitchell Plant to inspect the Unit 2 electrostatic precipitators (Box 3 and Box 4), develop a punch list of mandatory repairs, document needed repairs and make recommendations after evaluating the findings. Work priority was established with the plant during a “kick-off” meeting prior to entering the unit.

The AEP Unit 2 electrostatic precipitator (ESP) system consists of two (2) side-by-side precipitators (ESP 3 & ESP 4) operating in parallel. The precipitators serve an 850 MW boiler. The dual chamber precipitators were designed and manufactured by Wheelabrator (installation circa late 1970s).

**2022 Big Sandy Unit 1 Generator Inspection Report 10/11/2022 to 10/14/2022**

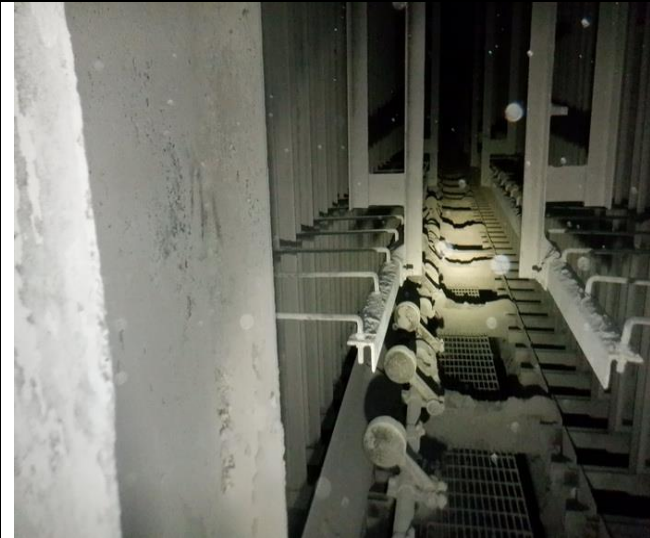
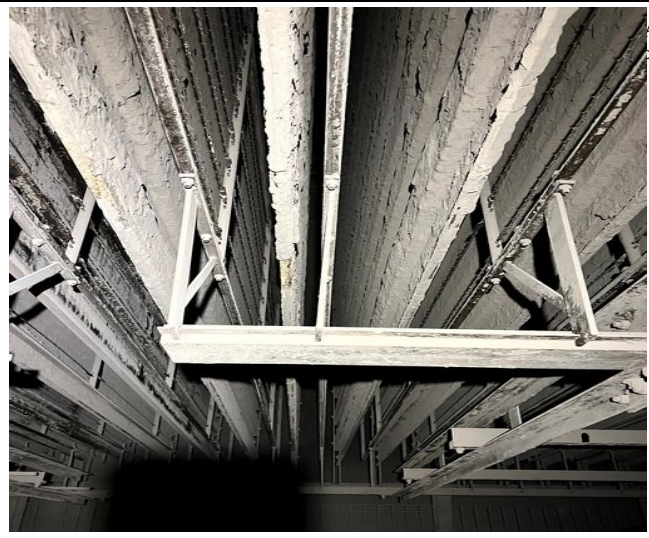
**Above:** General view depicting the hammers and fields. Observe on the right-side picture the high voltage mast is leaning toward the plate.

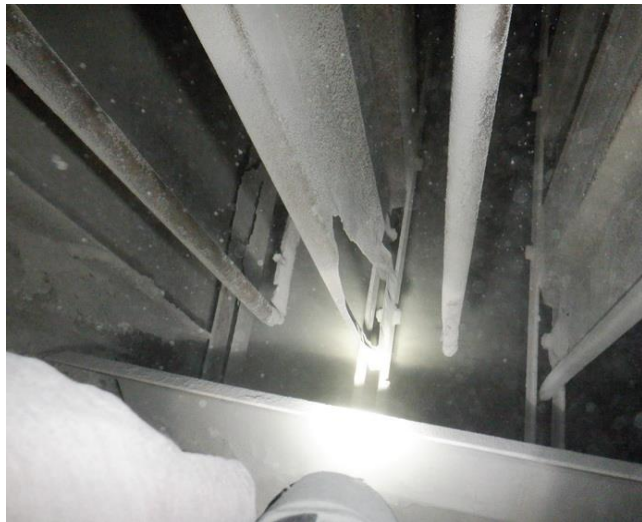
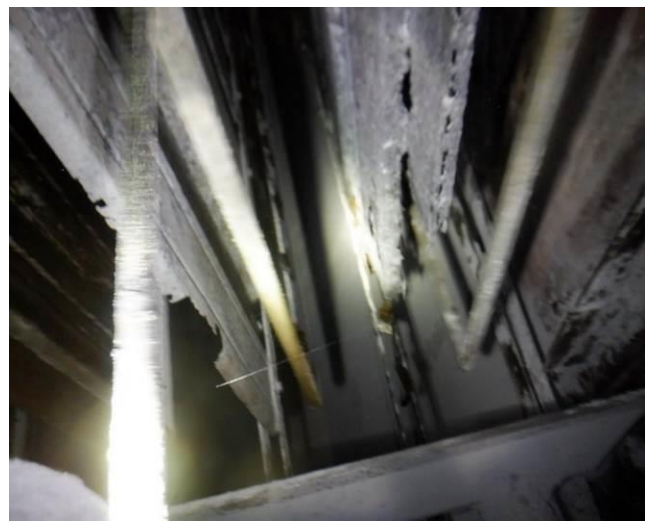
**Below:** A lot of damage was found on the bottom of the collecting plate panels. During this outage the collecting plate panels were stabilized so they would not swing during operation. In the future, a patch plate needs to be installed in these areas.

**Above/Below:** More photographs of fields with damaged collecting plate panels along the bottom of the fields.

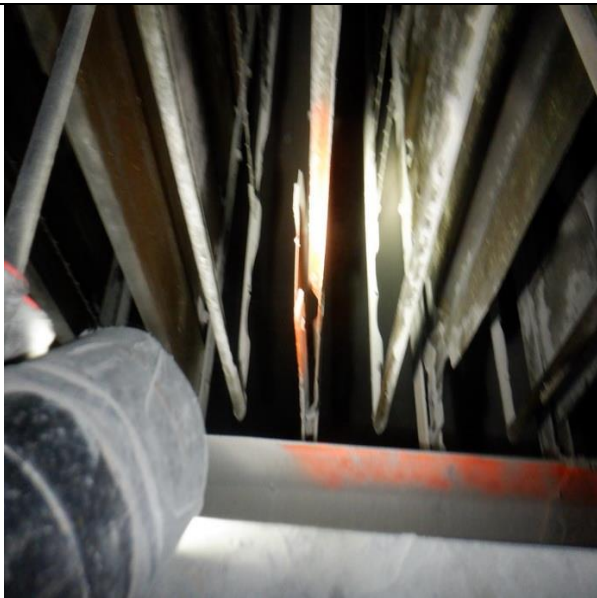
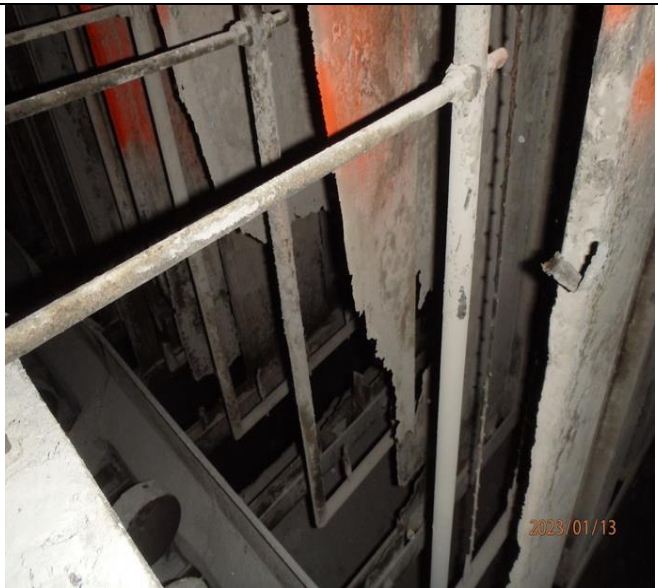
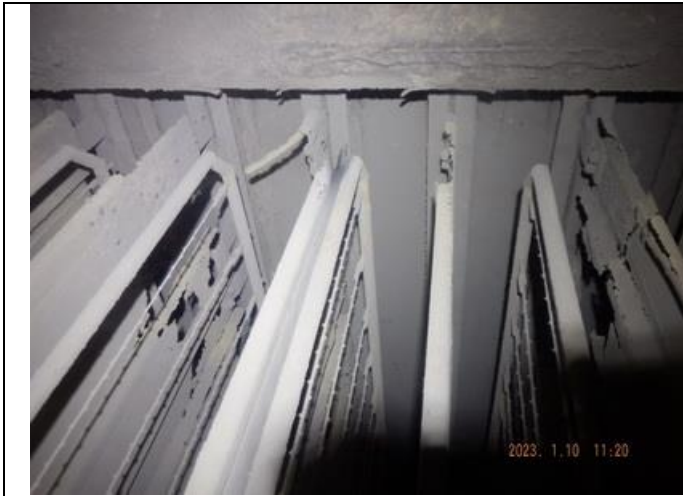
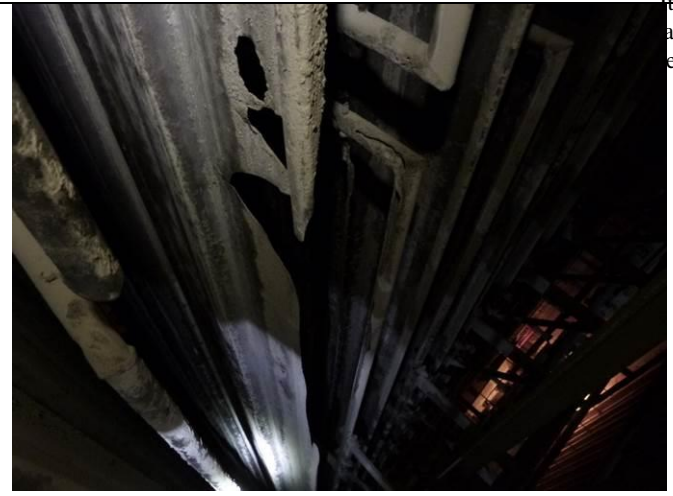
**Above Left:** Collecting plate damage along the hot roof by collecting plates and collecting plate angle, which holds the panels. Also damage along the tops of the panels. It appears as though the hot roof has been repaired in these areas, however the panels need to be stabilized and patch plates need to be installed. None of this was done during this outage.

**Above Right/Bottom:** More photographs of collecting plate panel damage along the tops of the fields. Most of this damage has occurred due to hot roof leaks.

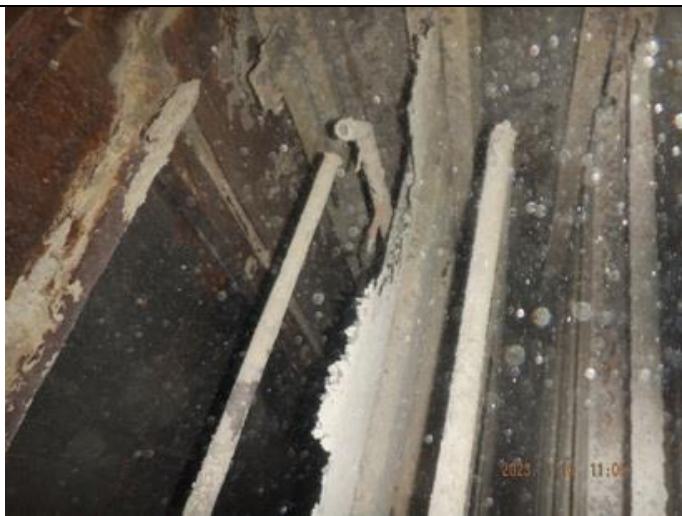
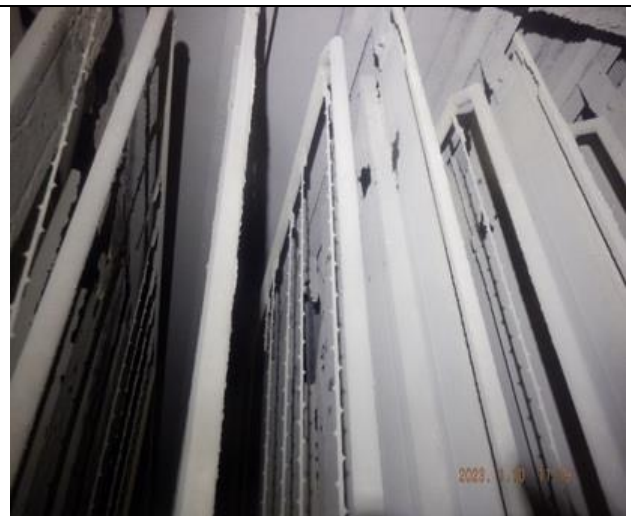
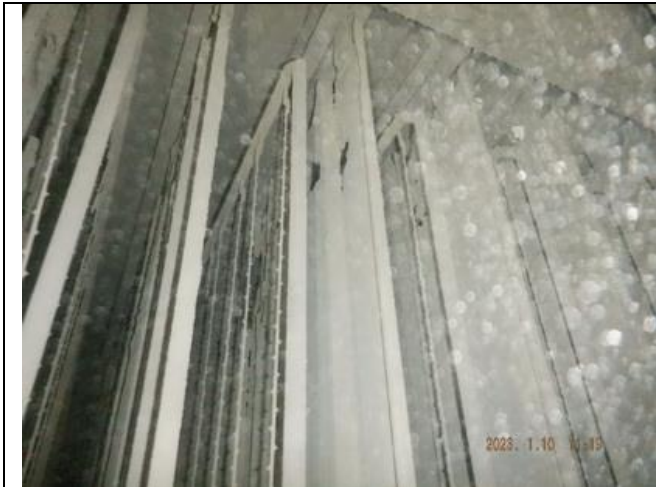
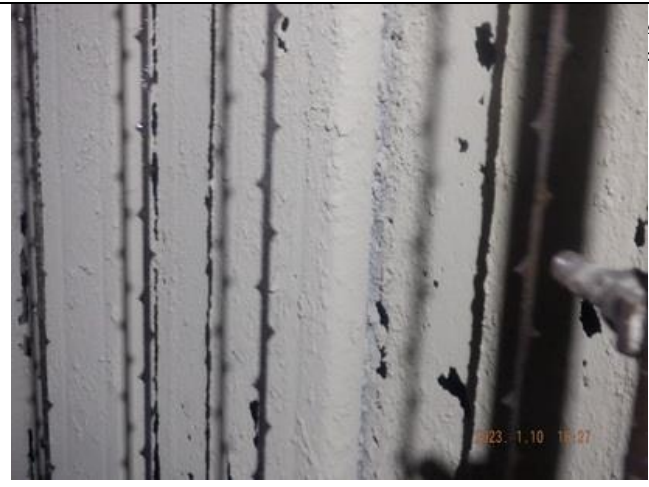
**Above Left:** Another picture of collecting plate damage and holes along the tops of the fields.

**Above Right:** Many of the outside collecting plates against the walls were found with a lot of damage. A few of these were removed during this outage and a few were stabilized using pieces of flat bar to prevent the panels from moving and causing shorts or close clearances.

**Below:** Collecting plate hammer baffles in many locations were found bent toward the high voltage frames. These were causing close electrical clearances and spark damage. Observe the rigid mast pipes. During this outage, when the baffles were found bent, time was spent straightening the baffles to improve the electrical clearance over to the high voltage. Once these areas were repaired and the baffles were pulled back as much as possible, the alignment was checked again. If electrical clearances were not acceptable from the high voltage to the baffle, the bottom of the high voltage would be adjusted to move it away from the hammer baffle.

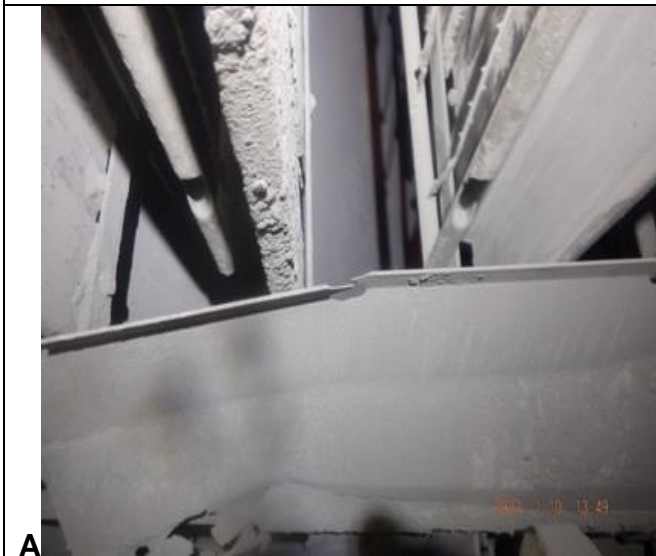
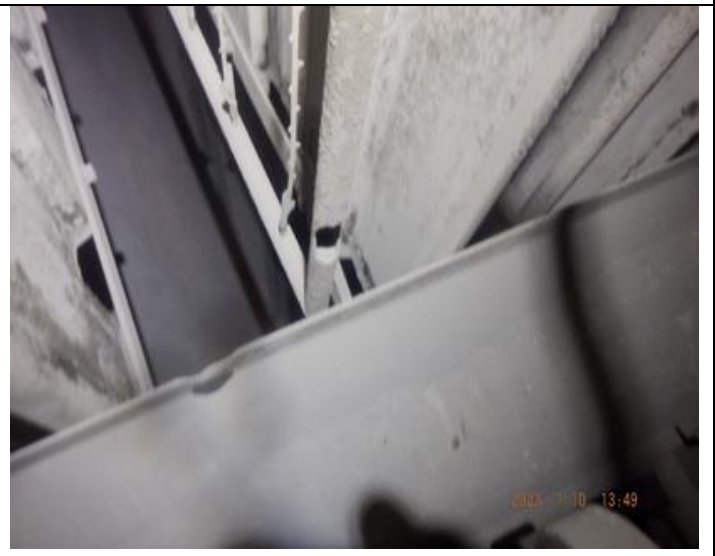
**Above:** More broken collecting plate hammer baffles causing a close electrical clearance.  
**Below Left:** The tabs, which hold the baffles together on the collecting plate hammers, stick out toward the high voltage. This is causing a spark point. When repairs are made in the future, the tabs should be put on the back of the baffle so a sharp point is not sticking out to the high voltage.  
**Below Right:** An example of damage on a collecting plate causing a close electrical clearance; these panels were removed.

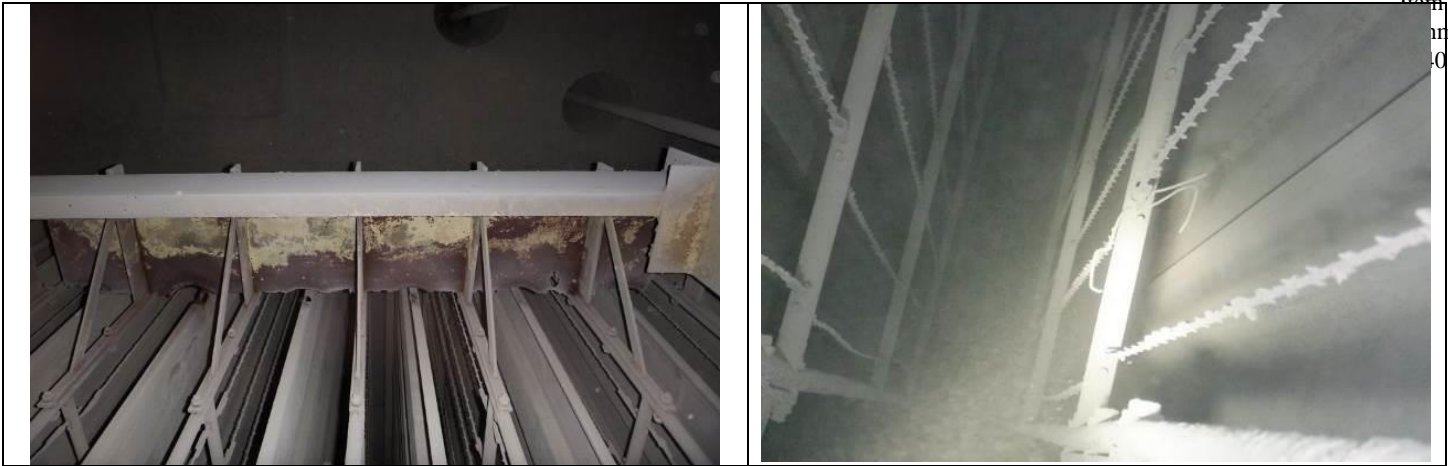
**Above Left:** A piece of a collecting plate panel was found laying on a field. The piece of plate was sitting on the high voltage and touching the collecting plates, grounding out the field.

**Above Right:** More tie wire found in a field causing a close electrical clearance. **Below Left:** A piece of scaffold was found tied between two electrical fields.

**Below Right:** Tie wire holding an alignment bar to the high voltage mast. This was found in many areas of the ESPs. The worst areas, which were loose and would cause a close electrical clearance or a ground, were repaired during this outage. More time needs to be spent making repairs in these areas.

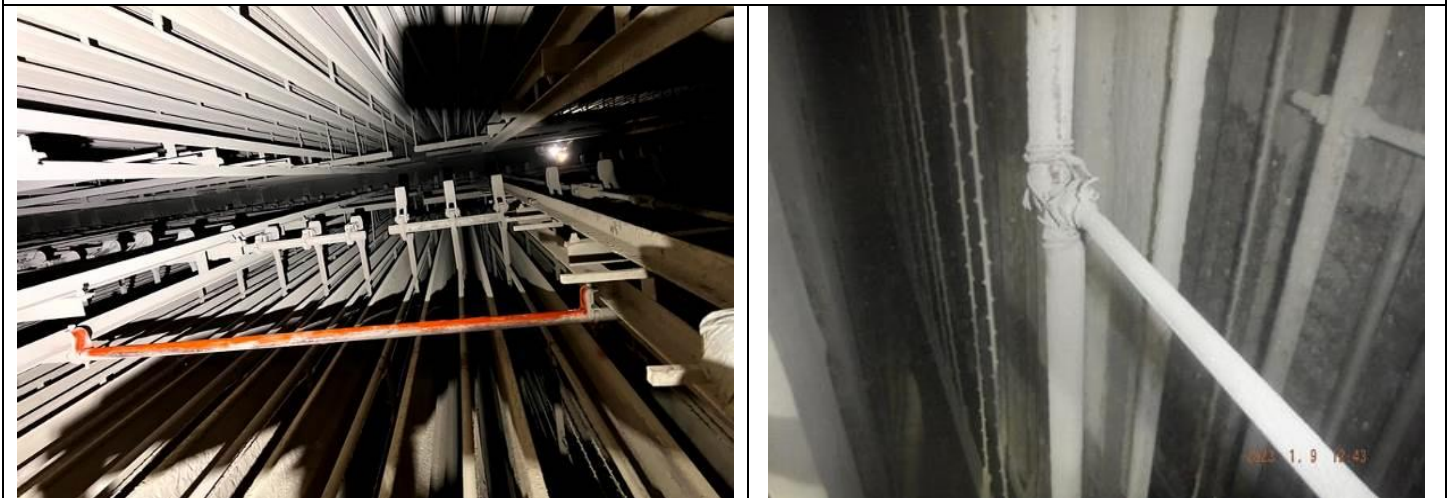
**Above / Below left:** More areas where tie wire was used to hold rigid mast pieces together. The photograph on the left is either causing a close electrical clearance or a ground.  
**Below Right:** Quick repairs on a broken piece of rigid mast. In the future these areas should be replaced with split pieces of pipe and rewelded over the bad areas. The alignment bar can then be properly repaired.

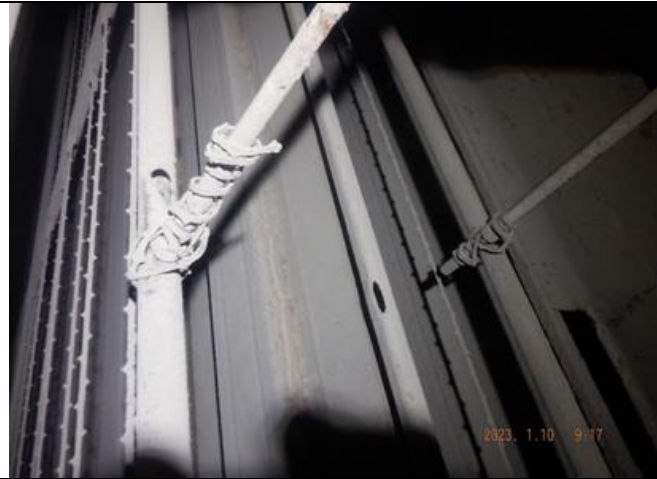
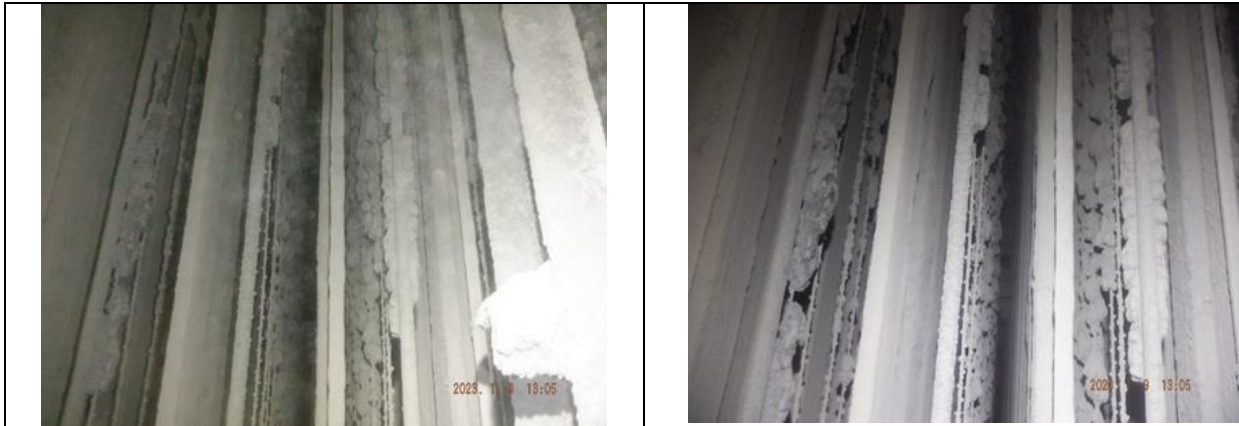
**Above:** Many areas along the tops of the electrical fields were found with dirty wires. This could be due to air in leakage along the tops of the fields, poor rapping, or even low floor. These were not cleaned during this outage.

**Below:** Example of fields with broken wires. These wires are either shorting the fields or causing poor power readings.

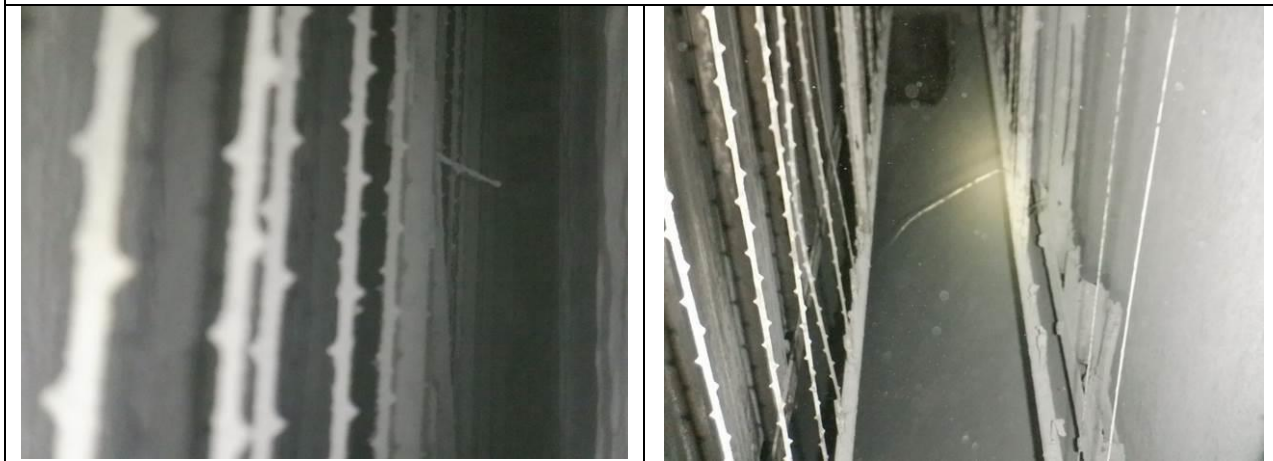
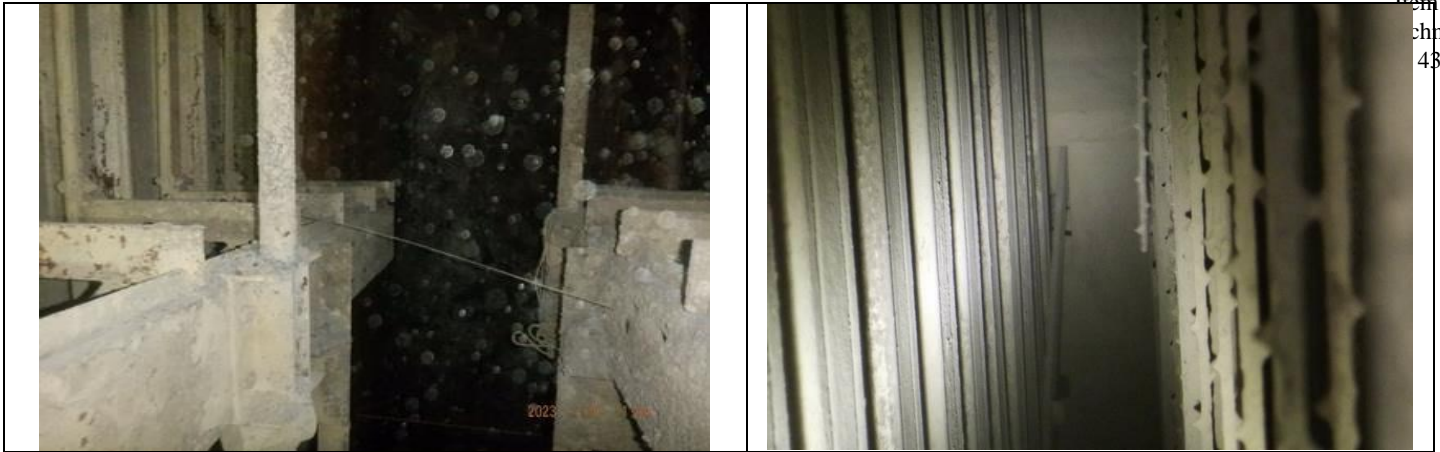
**Above Left:** A broken wire between two fields.

**Above Right:** A broken wire in a higher section of the field. Many areas where broken wires were found were up high and scaffold was required to access them.

**Below Right:** Example of a high voltage support angle knocked from the alignment bar. This was put back in place. This also causes a close electrical clearance or a ground. It is suspected that this occurred from overfilled hoppers.

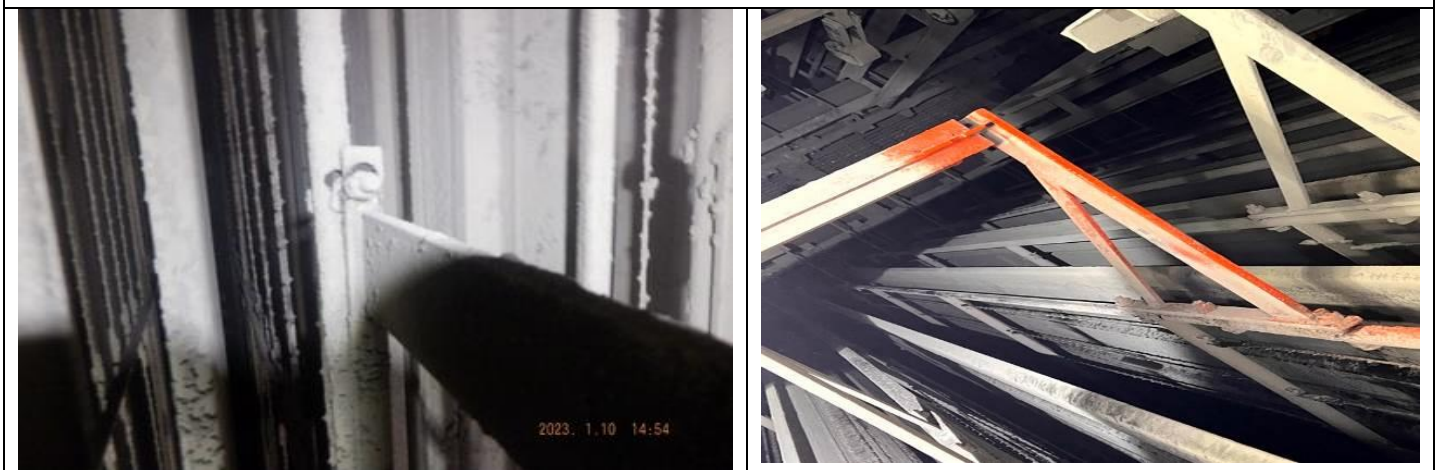
**Above Left:** Another field where the high voltage angles for the rigid masts are out of position. Again, it is suspected that this is occurring from over filled hoppers.

**Below Right:** A corona shield that has fallen off the roof and is shorting out a field.

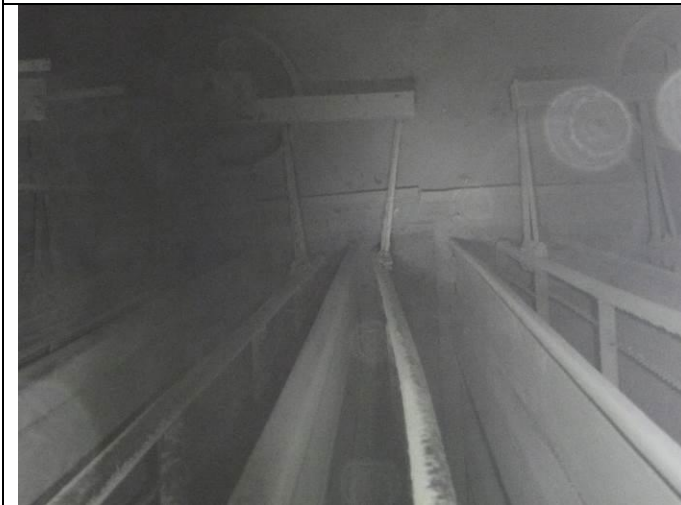
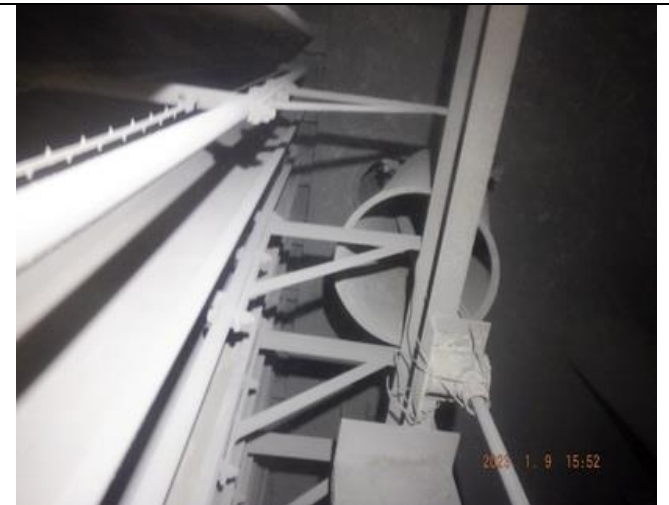
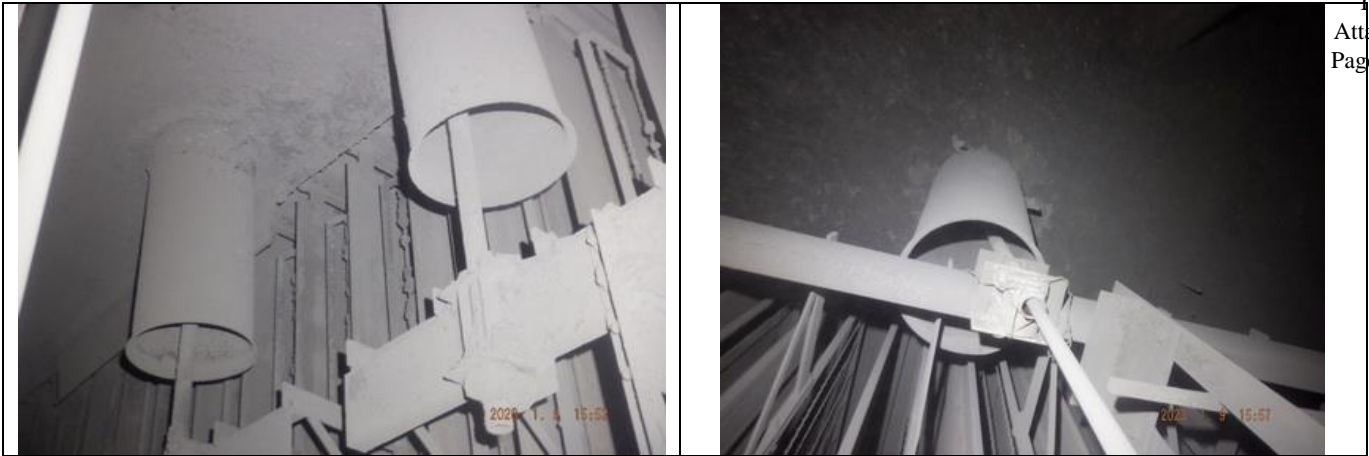
**Above:** More corona shields that had fallen from the hot roof. These issues are occurring due to air in leakage along the roof, which is causing corrosion problems.

**Below Left:** A photograph of the girder box area after a corona shield had been removed.

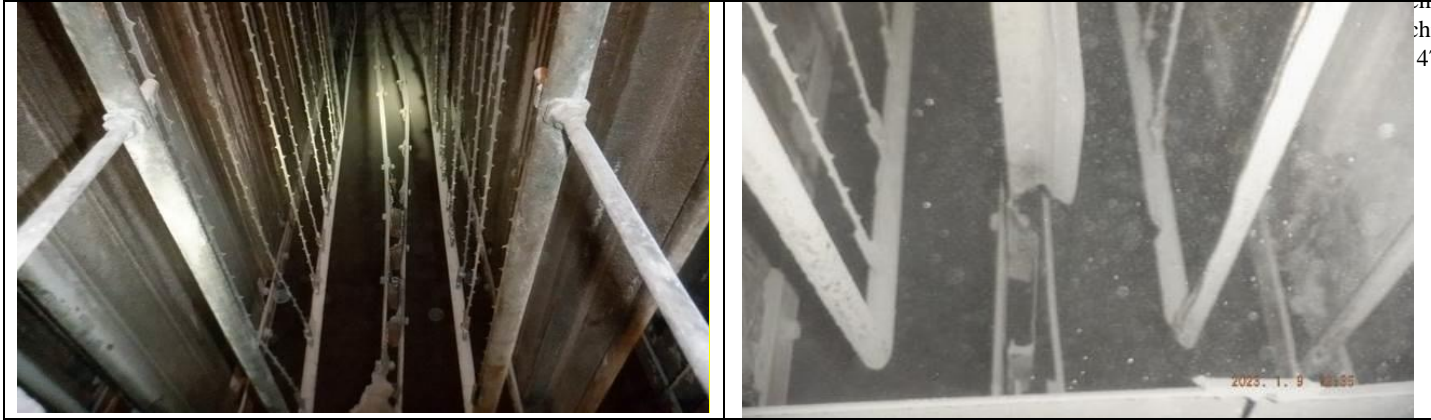
**Above/Below Left:** There were many damaged shock bars identified during this outage. The only repairs the plant typically performs is to change the anvil piece and weld the side piece of the flat bar back to that piece. There were not enough repair anvil pieces to change all of the broken shock bars that were identified. Instead, only the worst areas were replaced with new anvil pieces and repairs were made in all other areas by pulling the broken pieces of the shock bars in and welding them in place. Both of these repairs are temporary. Plans should be made to replace all shock bars starting with the inlet fields and then moving out to the second field. Hoppers will need to be scaffolded in order to do this. This repair effort should be done systematically.

**Bottom Right:** Many problems were identified with the collecting plate hammers. There are a significant amount of hammers missing and worn bearings. There are also two different styles of hammers installed.

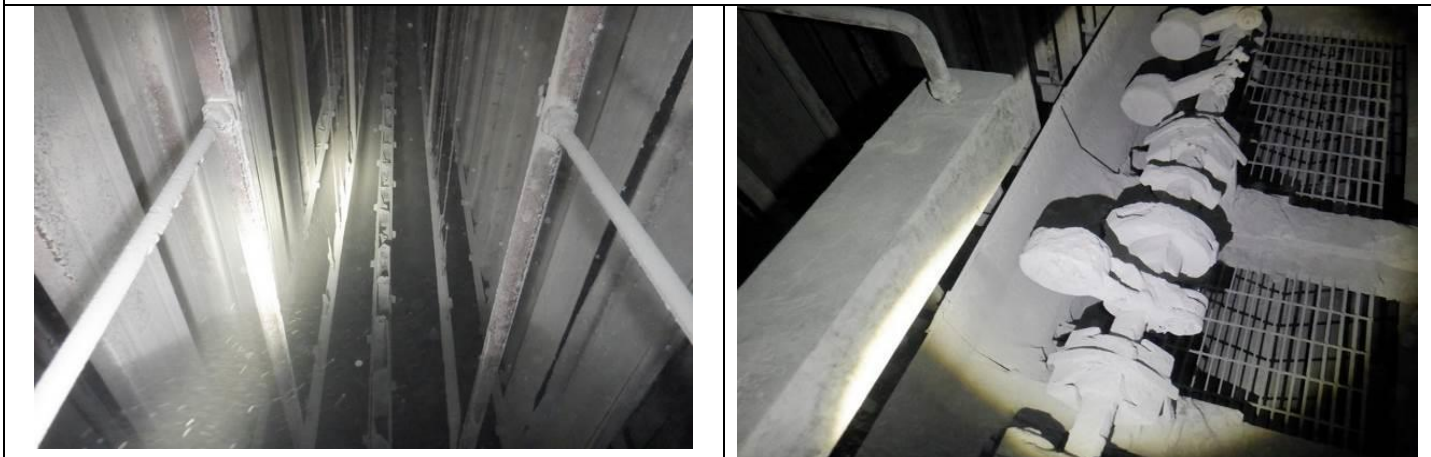
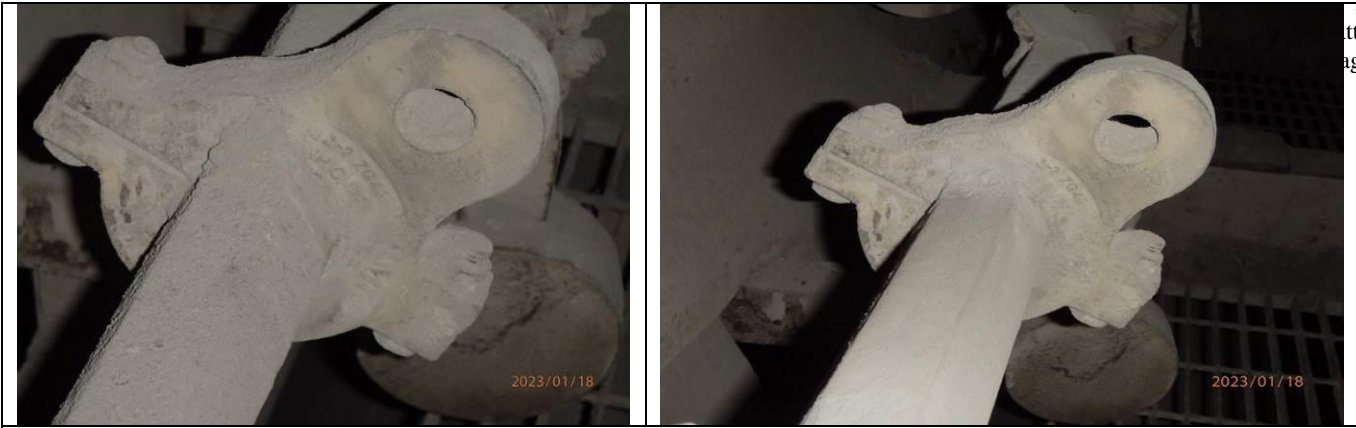
**Above:** Example of missing collecting plate hammers. Plans should be made to replace all missing hammers. The plant should also go back to the old style cast hammer clamps shown above; they allow for more positioning.

**Below Left:** Example of a worn out bearing.

**Below Right:** A photo of the high voltage hammers.

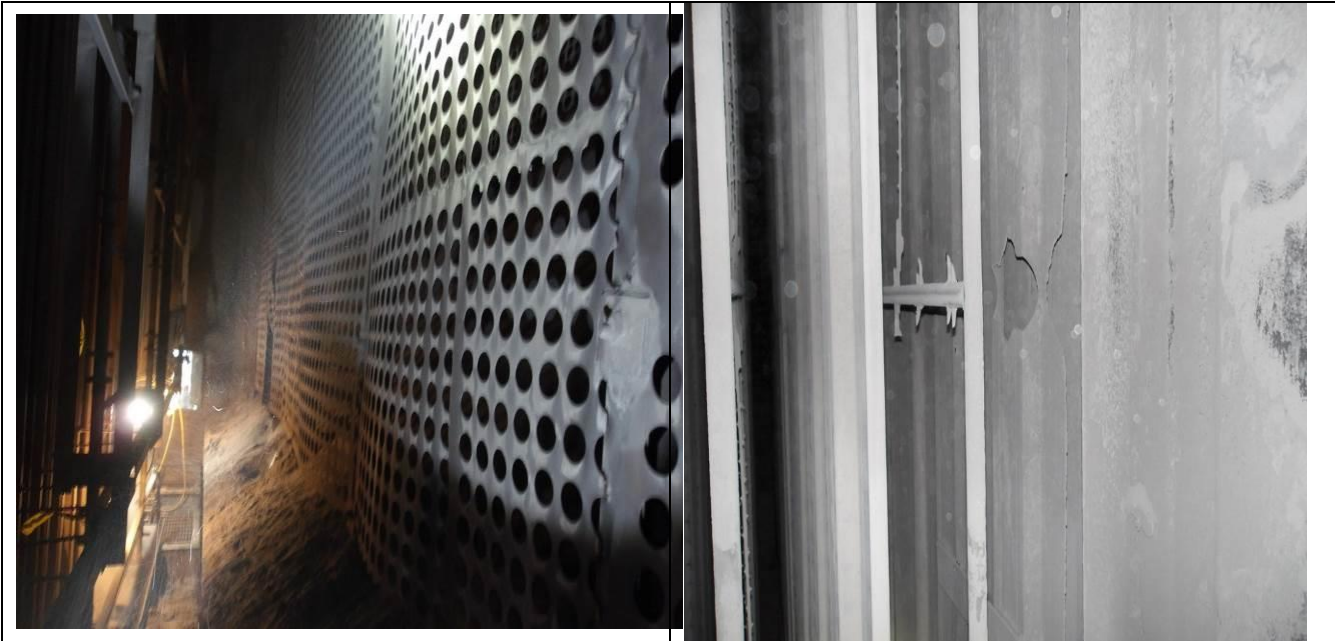
**Top Left:** A view of the perforated plate closest to the fields. No inspections were performed in the inlet duct areas. **Top Right** An example of the holes found in the collecting plates. Electrodes across from these areas were removed in the past but the ends were still sparking over.

**Bottom Left and Right:** Examples of broken collecting plate shock bars causing grounds in the fields.

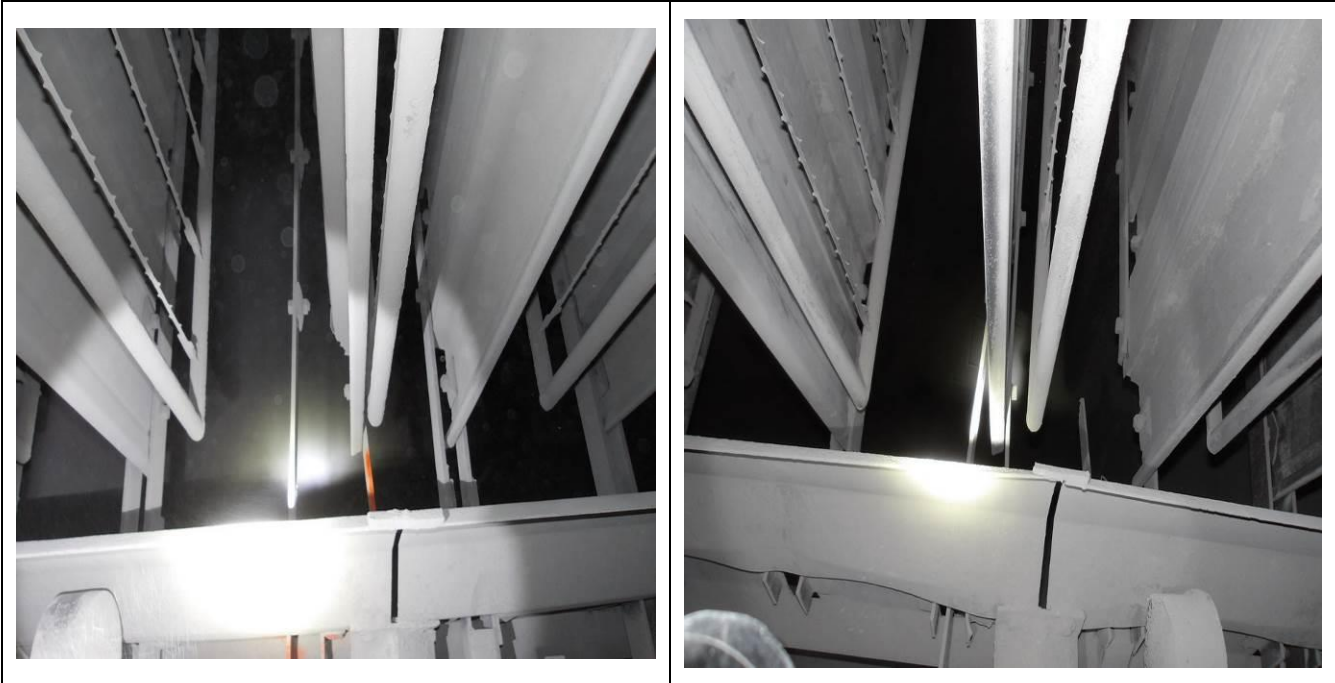
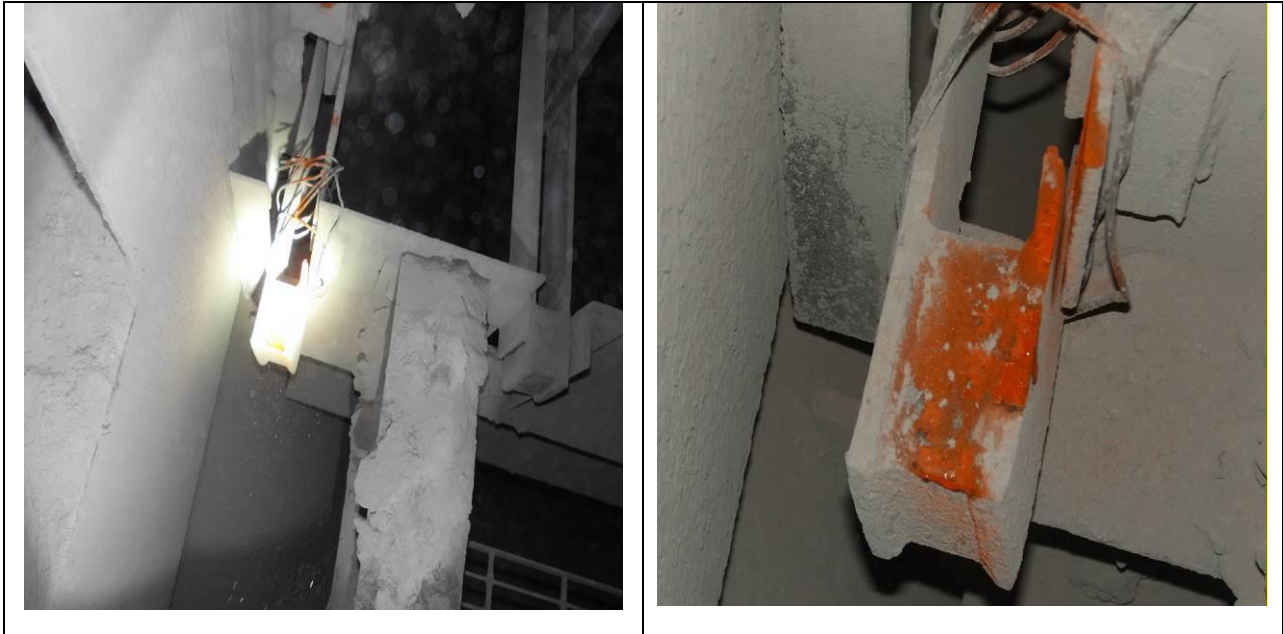
**Top Left and Right:** A photo of tie wire holding collecting plate shock bars together. This is a poor repair. Shock bars need to be either repaired properly or the entire shock bar should be changed. **Bottom Left:** A photo of a shock bar that has come out of the plate guide. **Bottom Right:** More examples of holes found in the collecting plates.

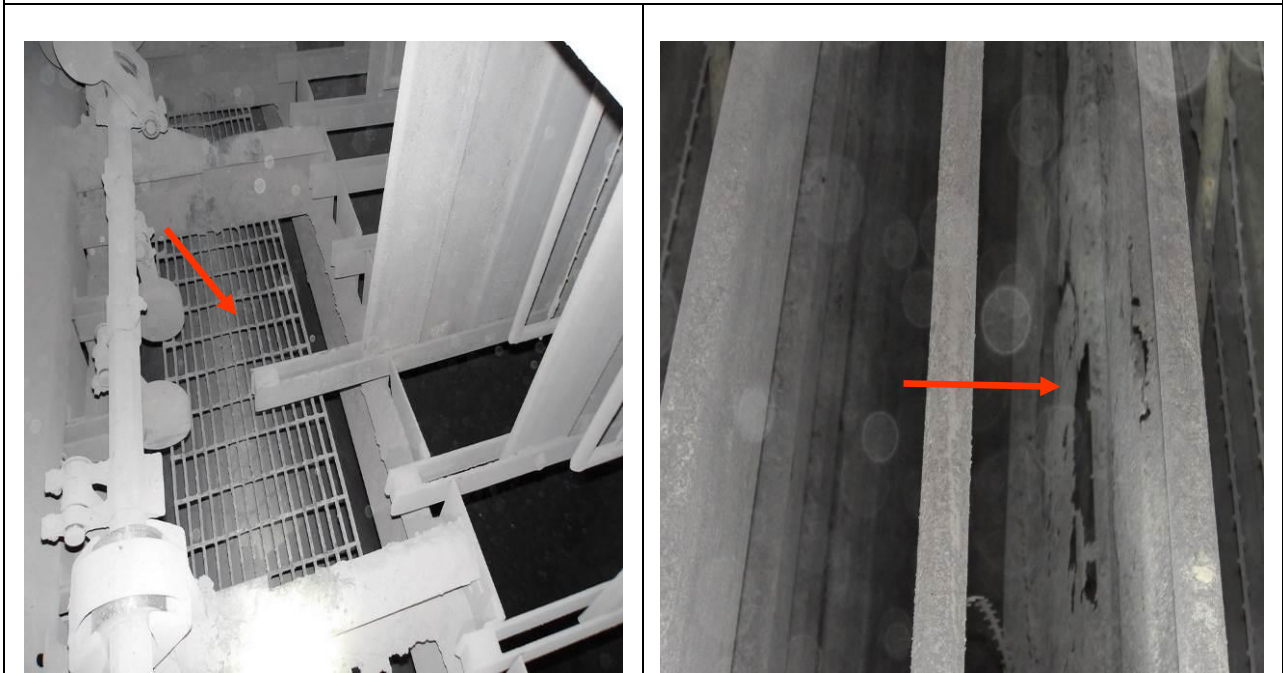
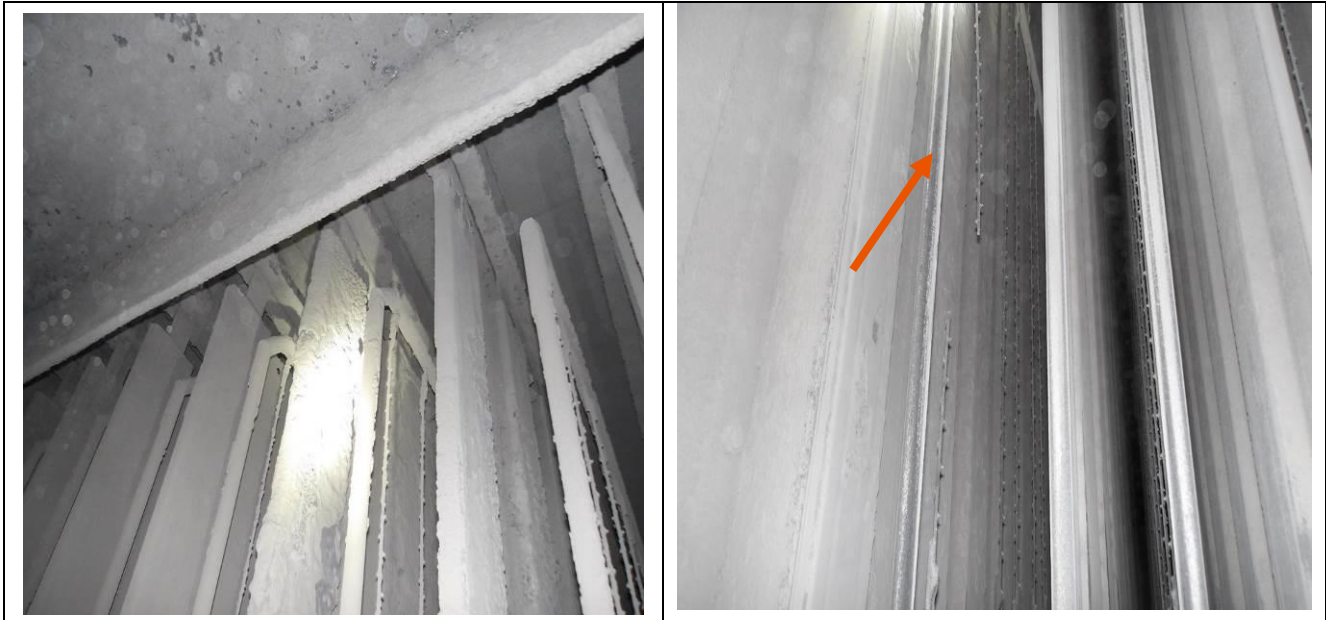
**Top Left:** A general view of the tops of fields. **Top Right and Bottom Left:** Examples of broken wires found and removed through out ESP. **Bottom Right:** Examples of debris found in the ESP from previous outages. This was observed in both Unit 1 and Unit 2.

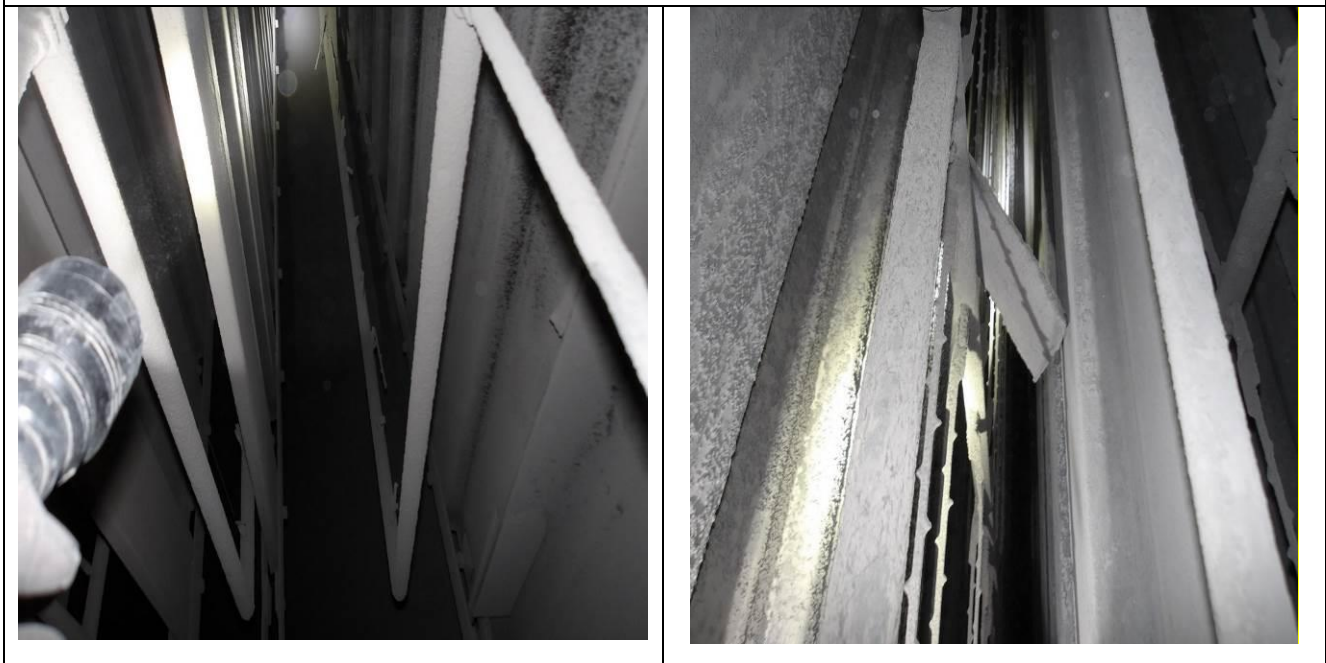
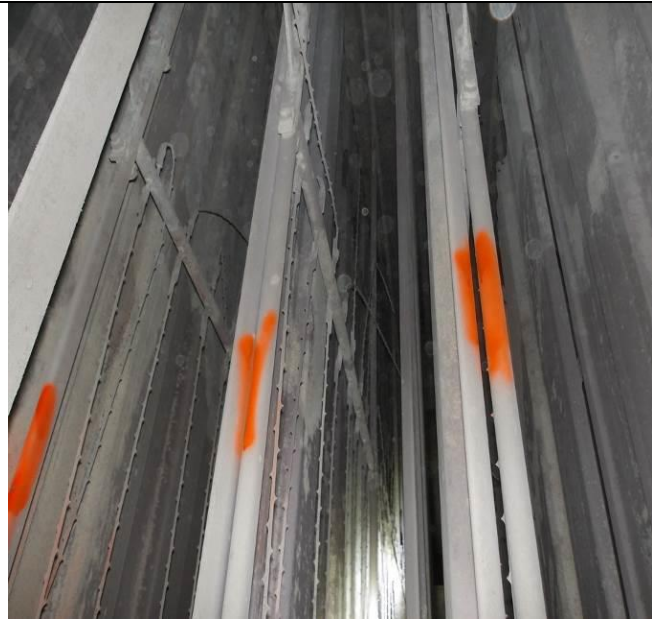
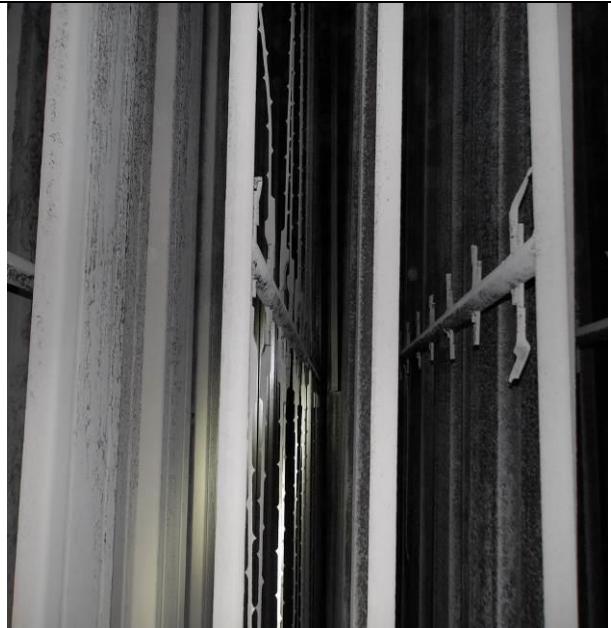
**Top Left and Right:** More examples of broken wires. **Bottom Left and Right:** Examples of broken rigid mast J-bolts that were causing close clearances and spark points.

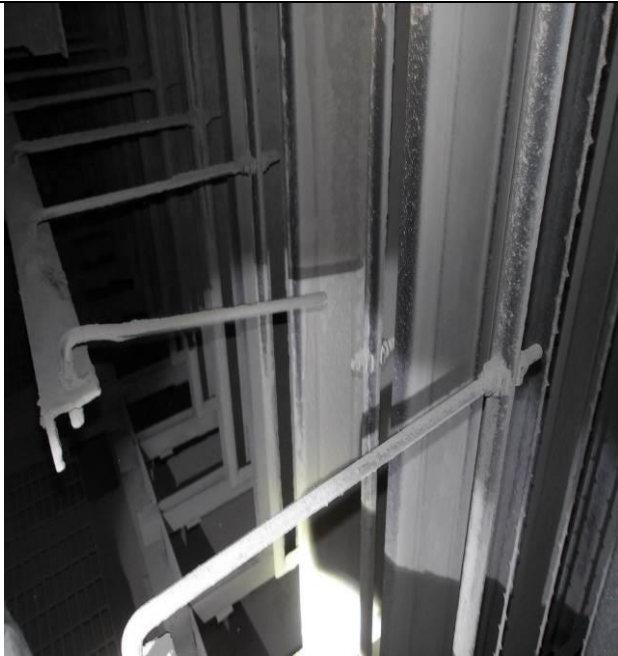
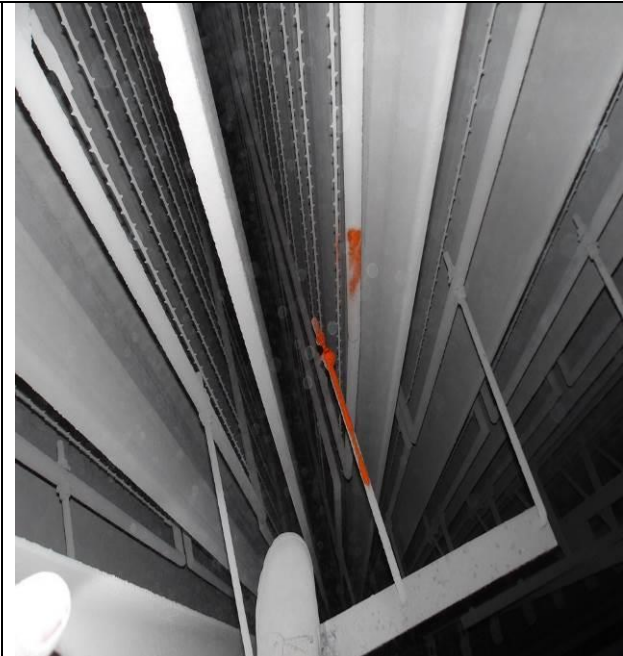
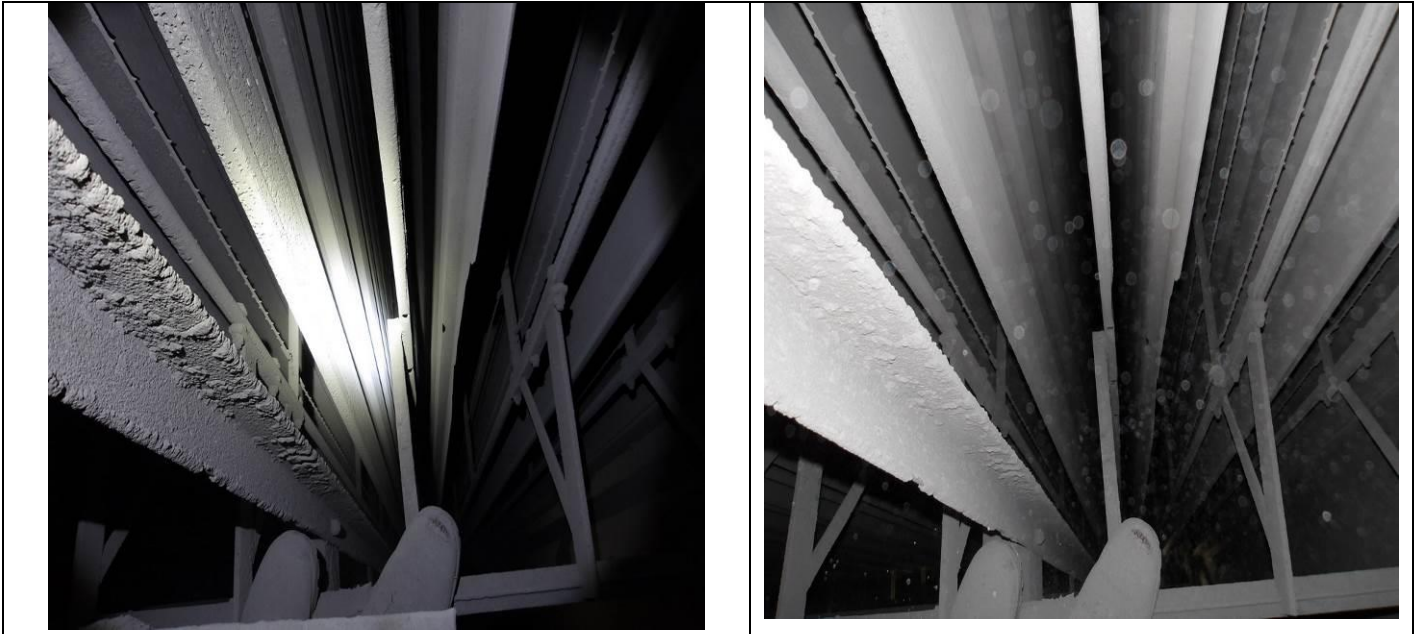
**Top Left and Right:** More examples of broken rigid mast J-bolts. **Bottom Left and Right:** Examples of broken rigid mast pipes. These are normally broken due to spark damage.
