Kentucky Power Company  
KPSC Case No. 2021-00370  
AG/KIUC's First Set of Show Cause Issue Data Requests  
Dated October 16, 2023  
Page 1 of 3

TRK Engineering Services, Inc. was retained by AEP Mitchell Plant to inspect the Unit 2 electrostatic precipitators (Box 3 and Box 4), develop a punch list of mandatory repairs, document needed repairs and make recommendations after evaluating the findings. Work priority was established with the plant during a “kick-off” meeting prior to entering the unit.

The AEP Unit 2 electrostatic precipitator (ESP) system consists of two (2) side-by-side precipitators (ESP 3 & ESP 4) operating in parallel. The precipitators serve an 850 MW boiler. The dual chamber precipitators were designed and manufactured by Wheelabrator (installation circa late 1970s).

**2022 Big Sandy Unit 1 Generator Inspection Report 10/11/2022 to 10/14/2022**

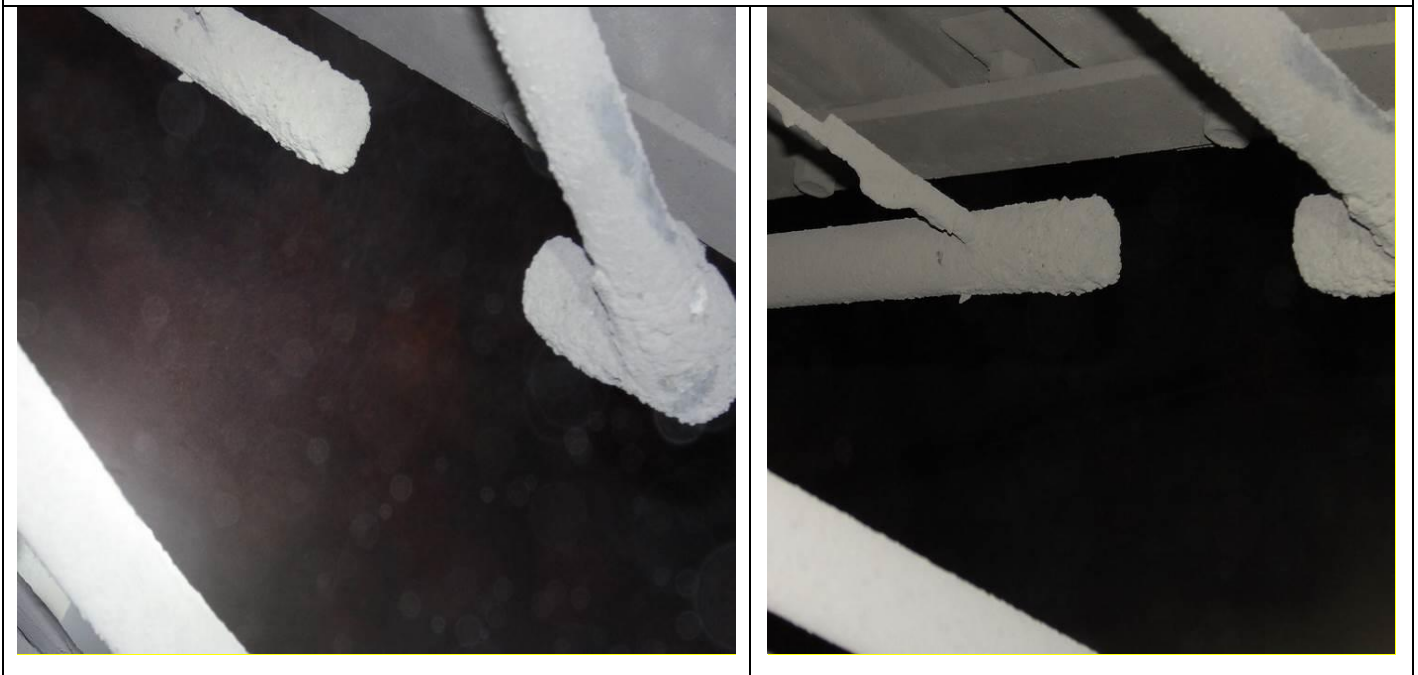
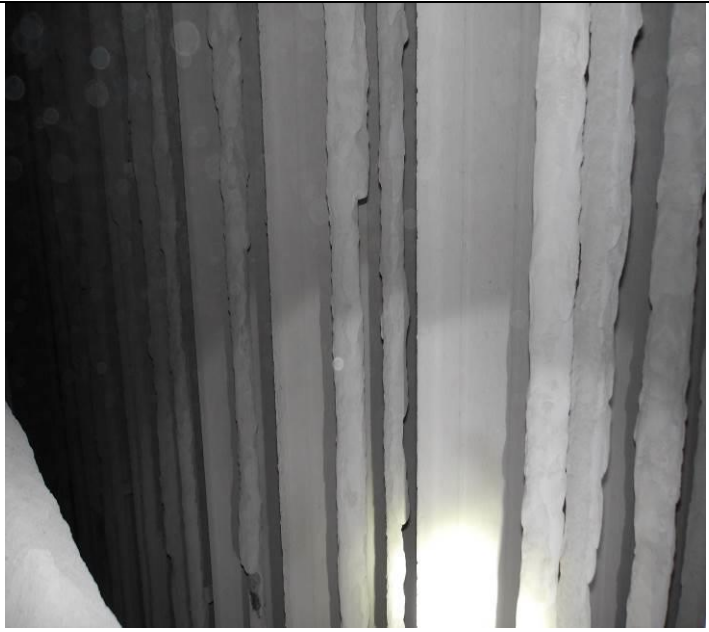
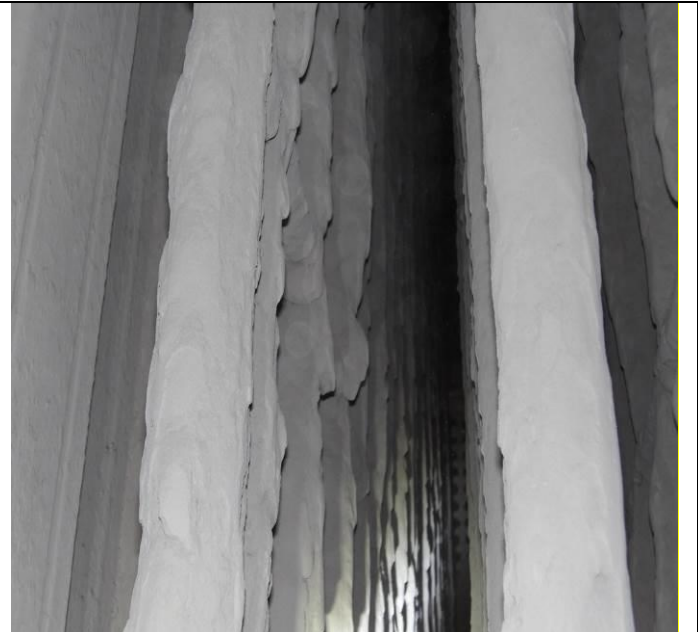
**Top Left and Right and Bottom Left:** Examples of dirty wires where the high voltage rappers were not in operation. **Bottom Right:** An example of a broken collecting plate hammer. Many hammers were found broken, missing or laying on the ground.

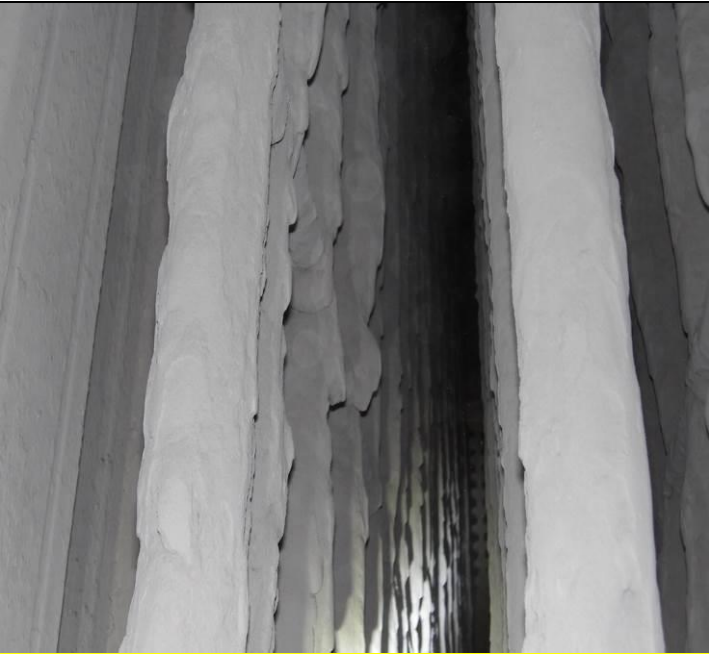
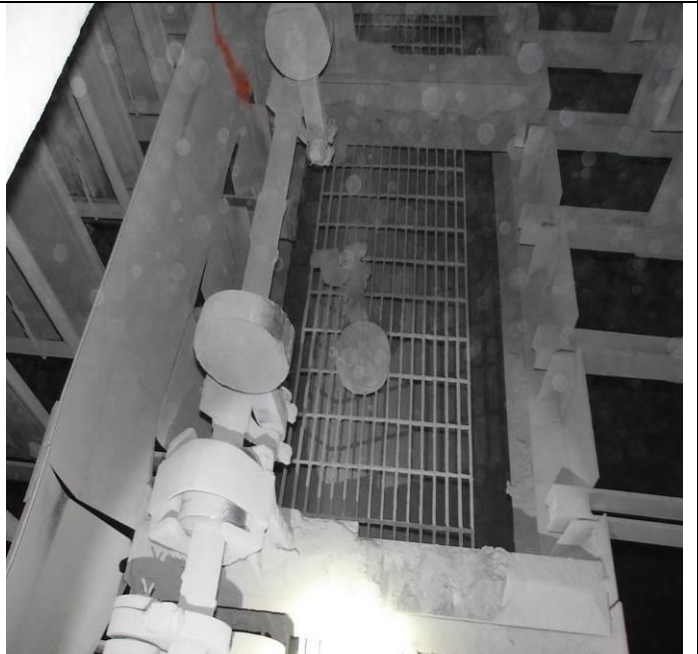
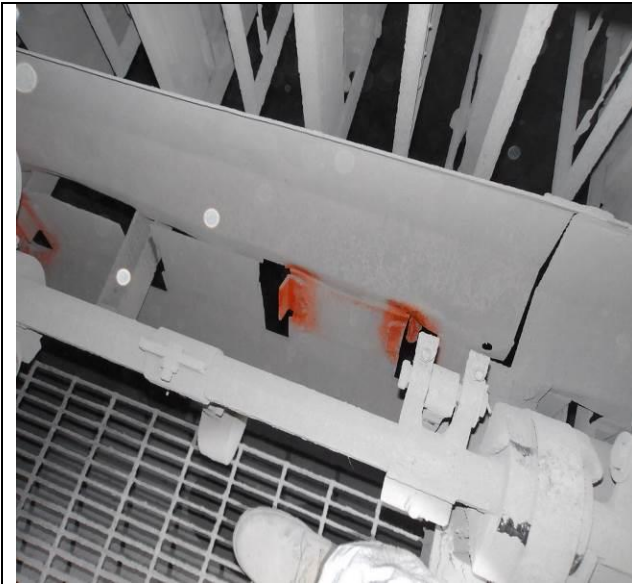
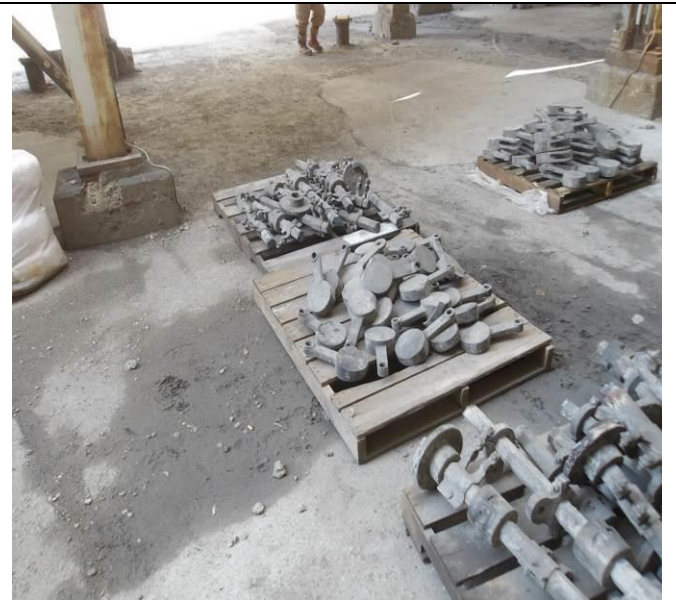
**Top Left:** Another example of missing collecting plate hammers along with broken shock bars in the same area. **Top Right:** A pallet of replacement hammers for the ESPs. A few different hammer bracket styles are being used in the unit. **Bottom Left:** A photo of a broken high voltage rapper rod. This rod was touching the high voltage from the field beside it. **Bottom Right:** A photo of a broken high voltage lifting rod.

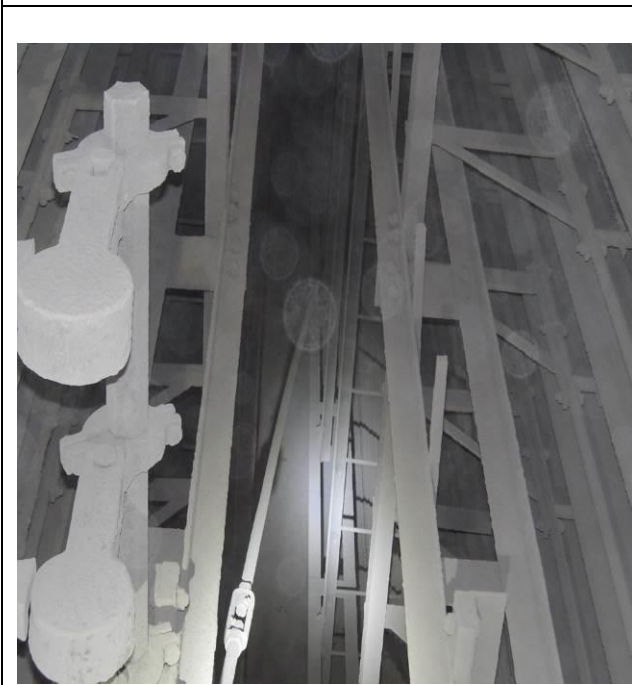
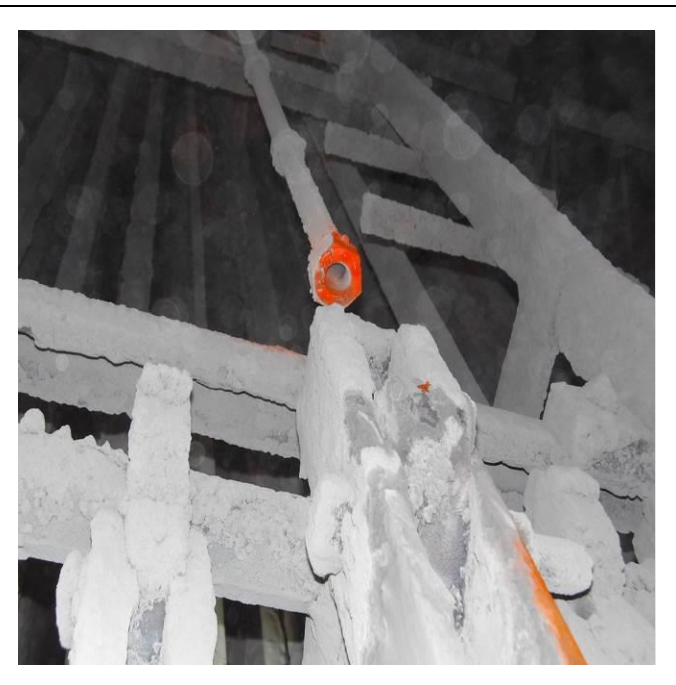
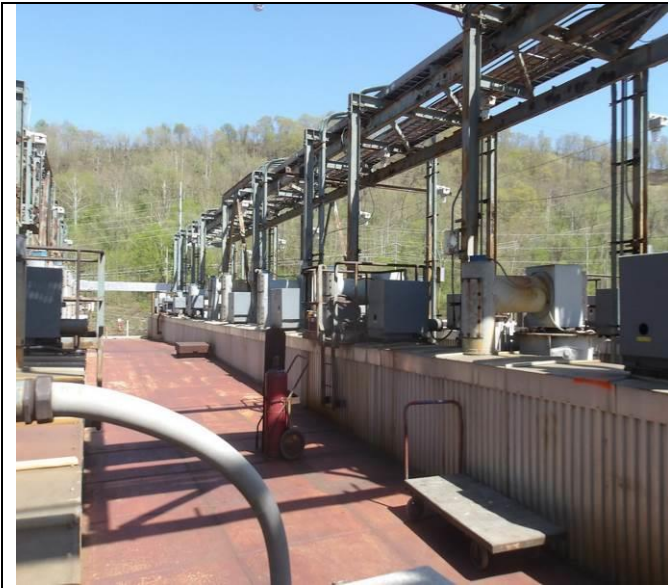
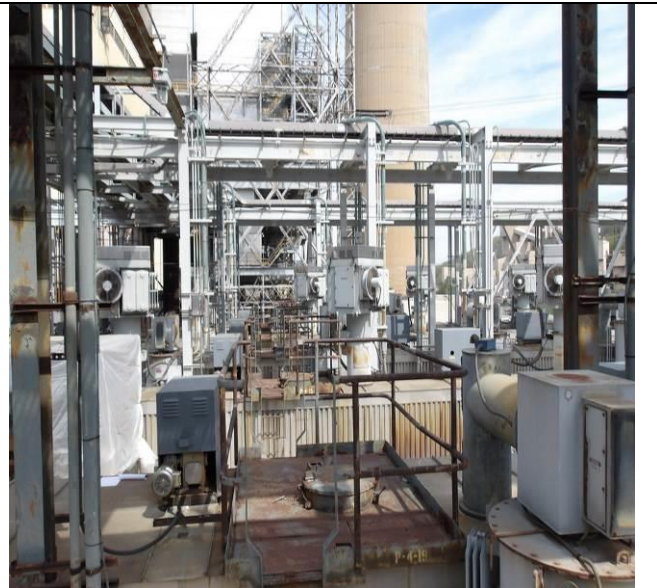
**Top Left and Right:** General views of the rooftop area. **Bottom Left:** A general view of an insulator compartment area. In view is a high voltage lifting rod insulator. **Bottom Right:** A photo of the insulator compartment stiffeners that were added in the past. In many areas, these were located too close to the top plates of the high voltage support insulators. Spark and arc damage was observed on every one that was inspected during this outage.

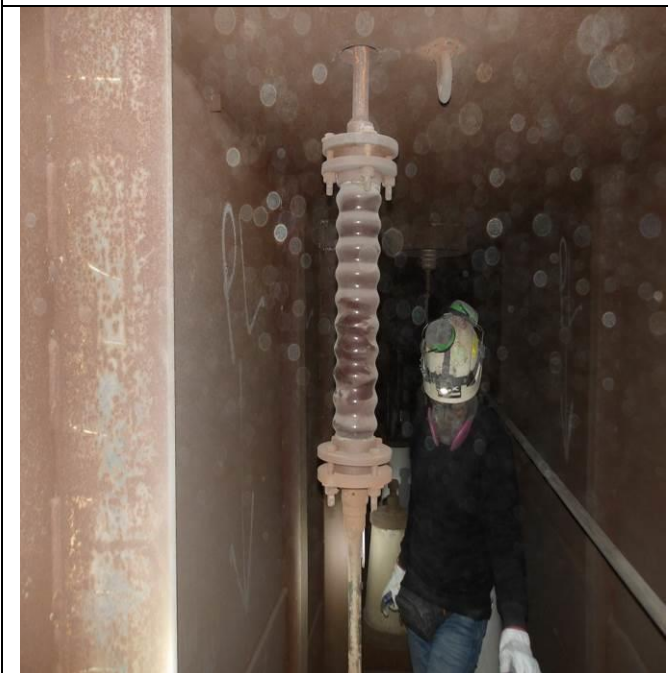
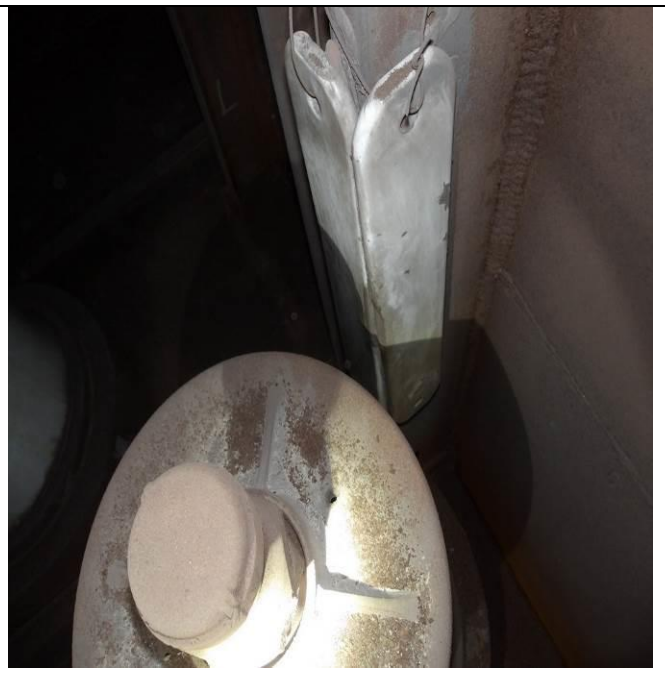
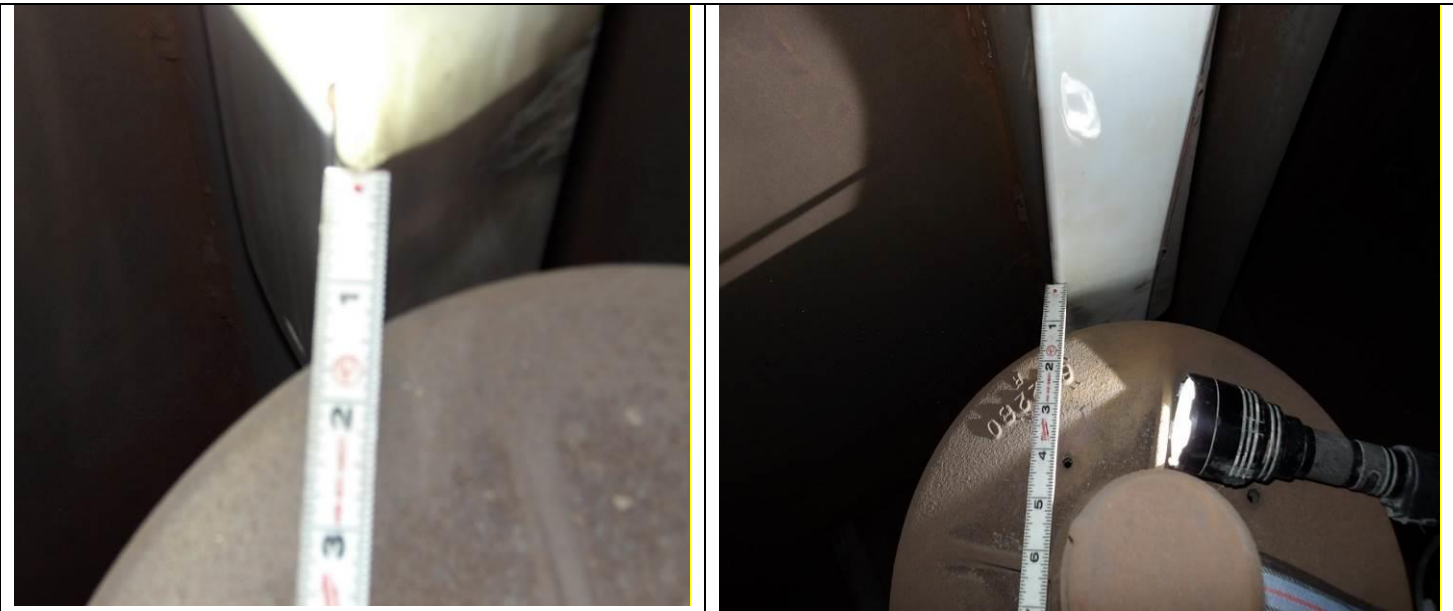
**Top Left and Right:** Documentation of the electrical clearance from the top of the high voltage insulator over to the insulator compartment stiffener. **Bottom Left:** A general view along the tops of fields by the corona shield areas. **Bottom Right:** A photo of the inside of a corona shield and the high voltage support insulator.

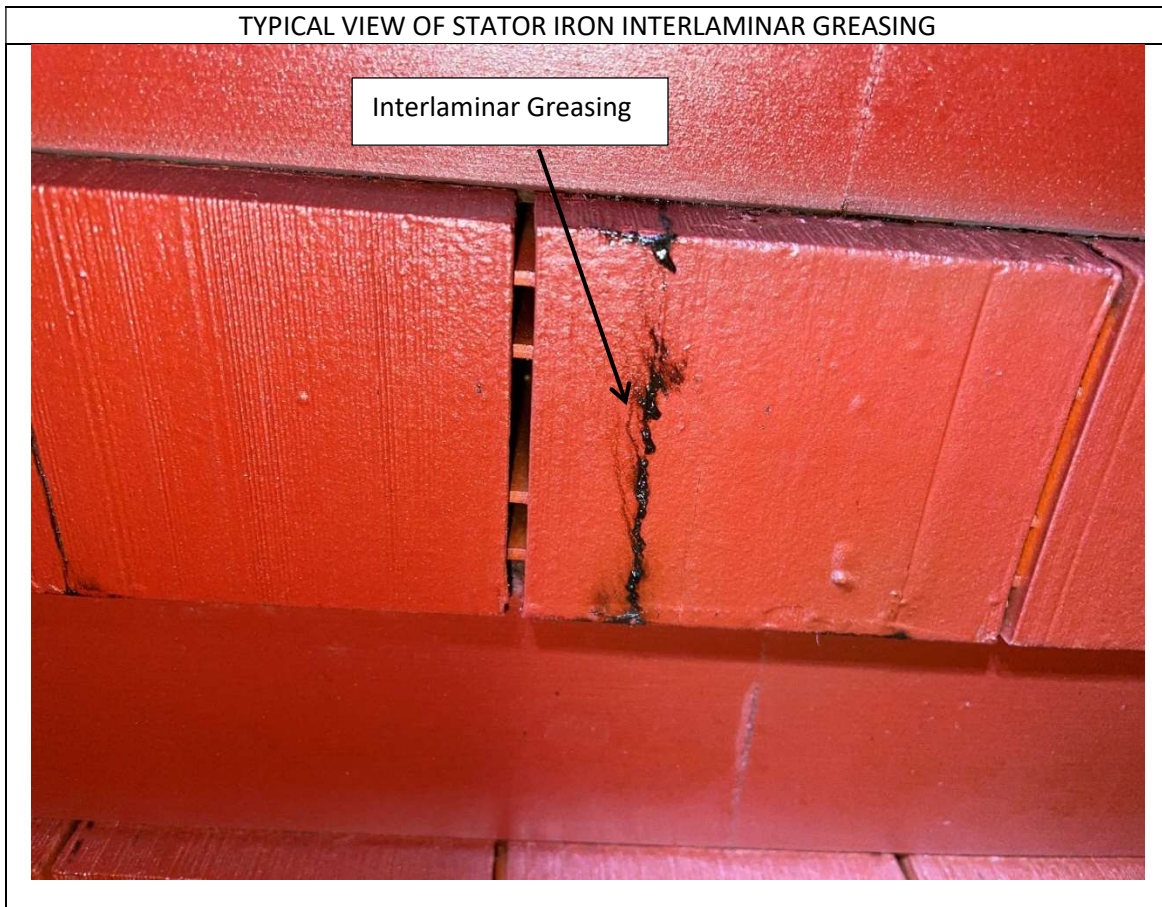
The stator appeared in satisfactory condition considering its age. The stator winding overall was clean with the typical light coating of oil. The stator iron exhibited some interlaminar greasing in sporadic areas which is indicative of core looseness; otherwise, the stator iron appeared generally in good condition with no signs of overheating or mechanical damage. Stator core tightness checks were performed, and it was found that a significant portion of the building and through bolts were hand tight. The core looseness necessitated that a tightening evolution of the building and through bolts was needed and due to the age of the core, a 60% tightness (final torque values of 780ft/lbs building bolts and 450ft/lbs through bolts) was selected to minimize the risk of creating interlaminar iron shorts. Subsequent core loop tests were performed at 80% magnetic flux before and after tightening to ensure that no core damage occurred; it was identified however, there were a few locations that exceeded the 10 degrees Celsius wound core hot spot acceptance criteria. These areas were repaired on a best effort basis by CMS using a combination of wicking resin, mica insertion (where applicable), and acid etching. The final repairs are documented in the attached report in the appendix.

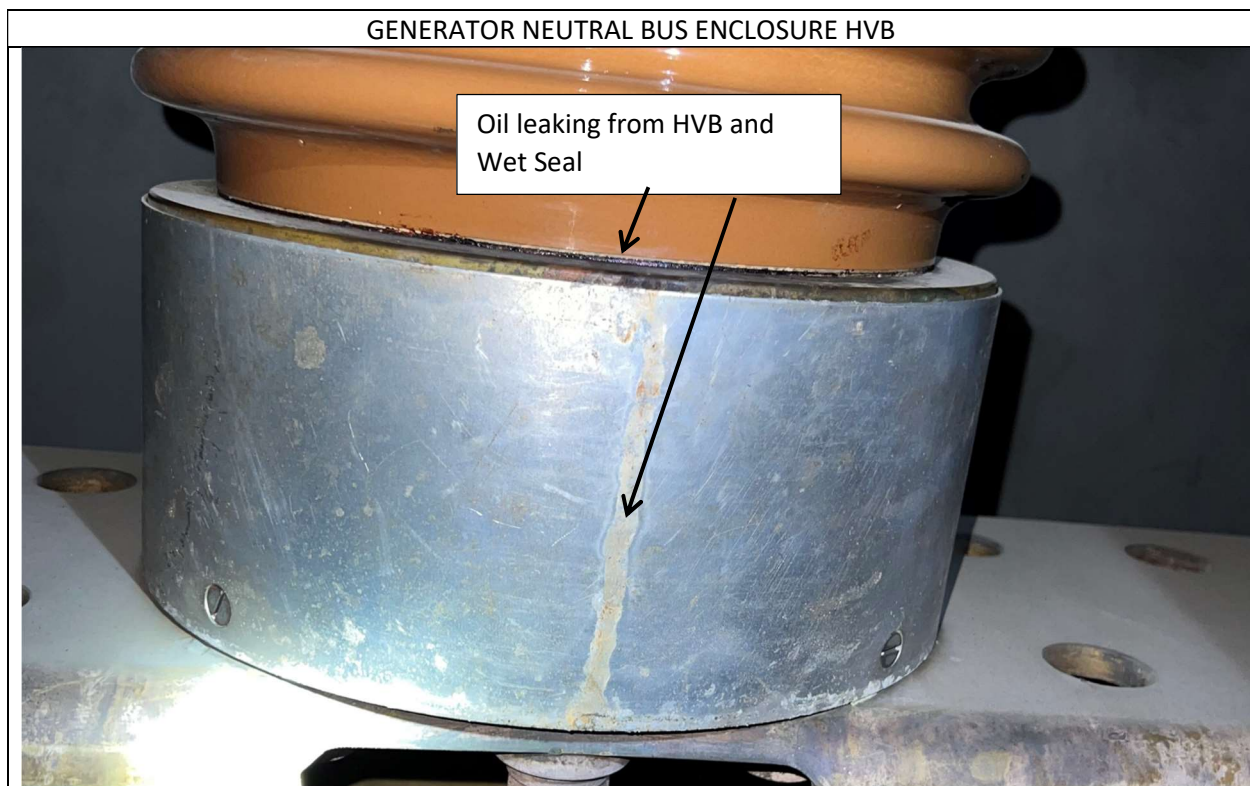
Main generator high voltage bushings (HVB) are original to the unit. Overall, they are in satisfactory condition however, upon closer inspection it appears that these are oil filled and the porcelain to metal flange gaskets are beginning to leak oil. The high voltage bushings along with the current transformers should be replaced when the main generator is rewound.

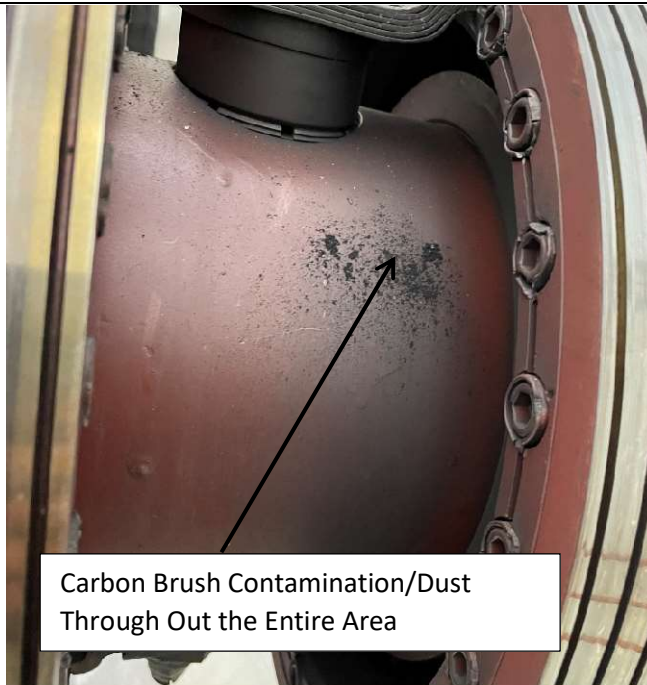
**AS FOUND CONDITION OF COLLECTOR RINGS CONTAMINATED WITH CARBON**

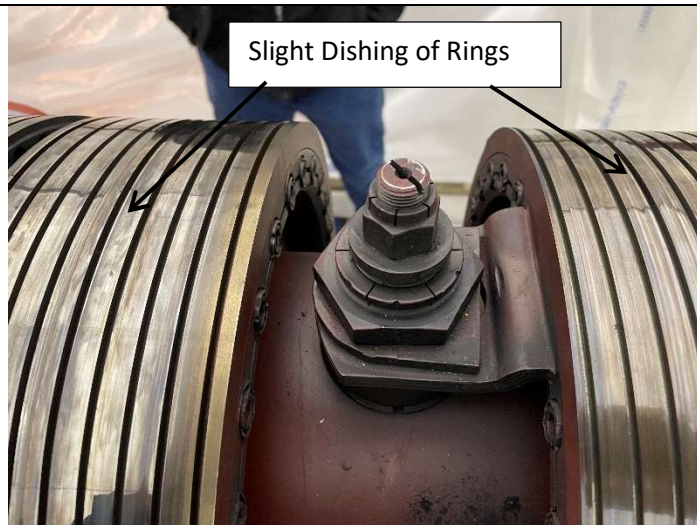
**COLLECTOR RINGS ARE NOT FLAT**

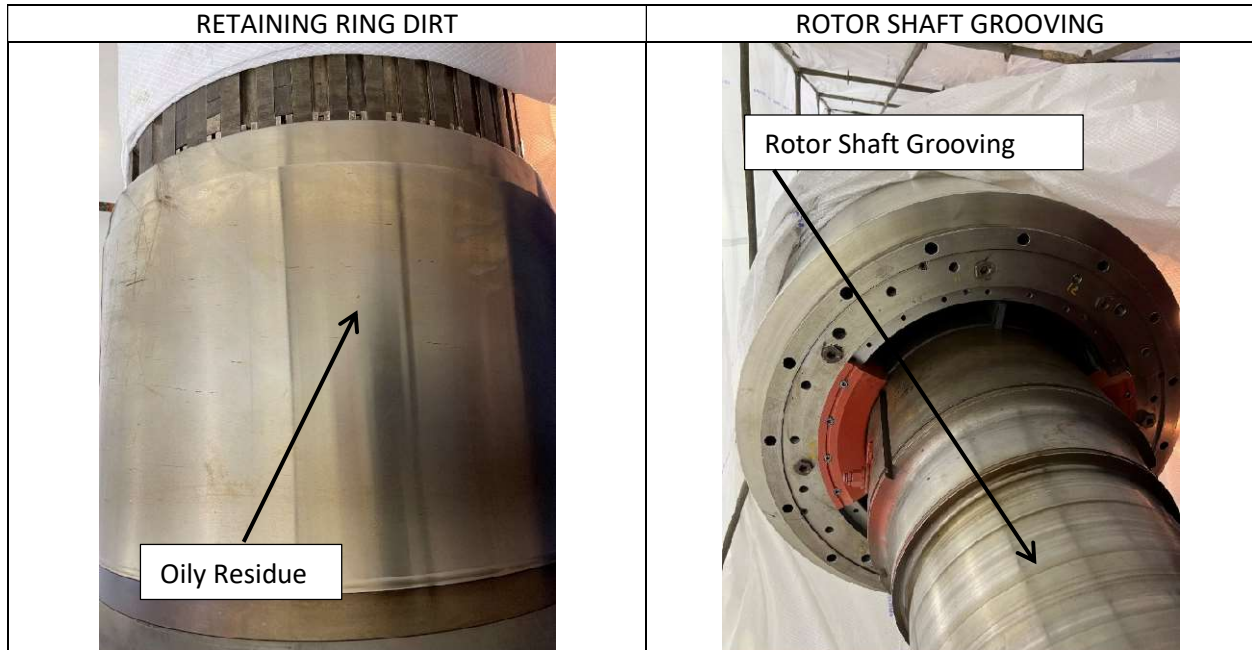
Further visual inspection of the retaining rings found that they were slightly dirty and coated with oil. CMS cleaned the retaining rings to remove the oil that was found. In discussion with the turbine coordinator, the rotor shaft where the journal bearing rides an excessive groove was found. It is believed that at some point in the rotor's history shaft damage occurred subsequent repairs and machining was incomplete. This condition does not affect the rotor's operation as the rotor shaft grooving is in an inconsequential location in relation to the journal bearing and hydrogen shaft seal.

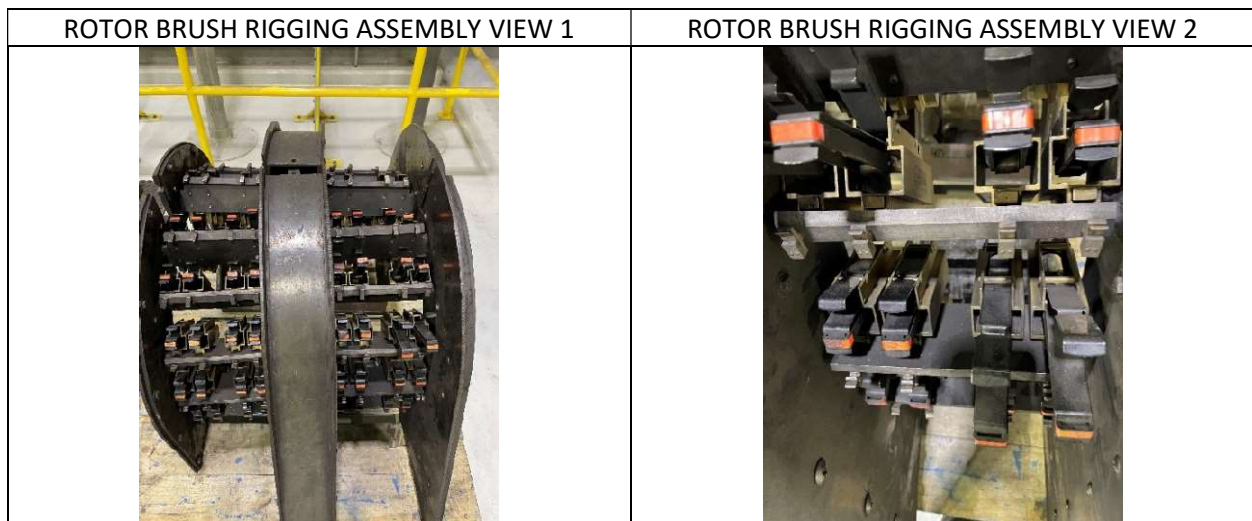
Below are photos of the rotor brush rigging assembly and an example of the carbon brushes that are currently being used by the generator.

All components appeared in very good condition however, a thorough cleaning is needed as there were heavy carbon deposits throughout. Technical brush data can be found in the attachment section of this report.

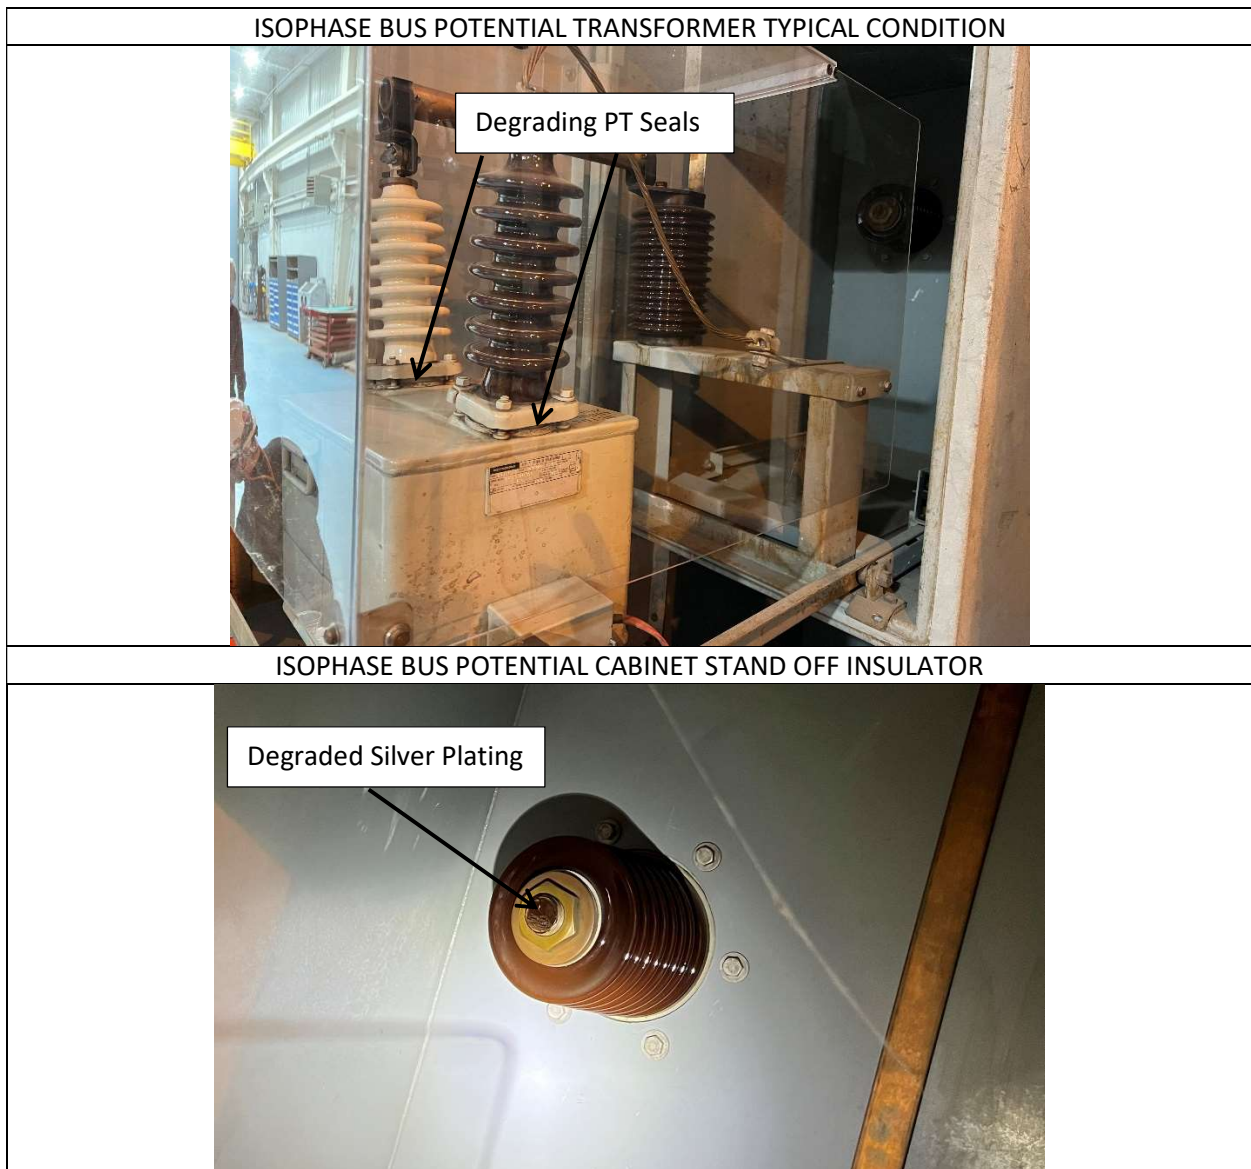
Metering and Regulating Potential transformers are in serviceable condition however, under closer inspection, the rubber seals to the ceramic stand-offs are degrading and are visibly cracking. Frequent inspections are recommended to ensure an oil leak does not develop. It should be noted that one of the six potential transformers has been replaced with an ITEC brand transformer while the remaining five are Westinghouse.

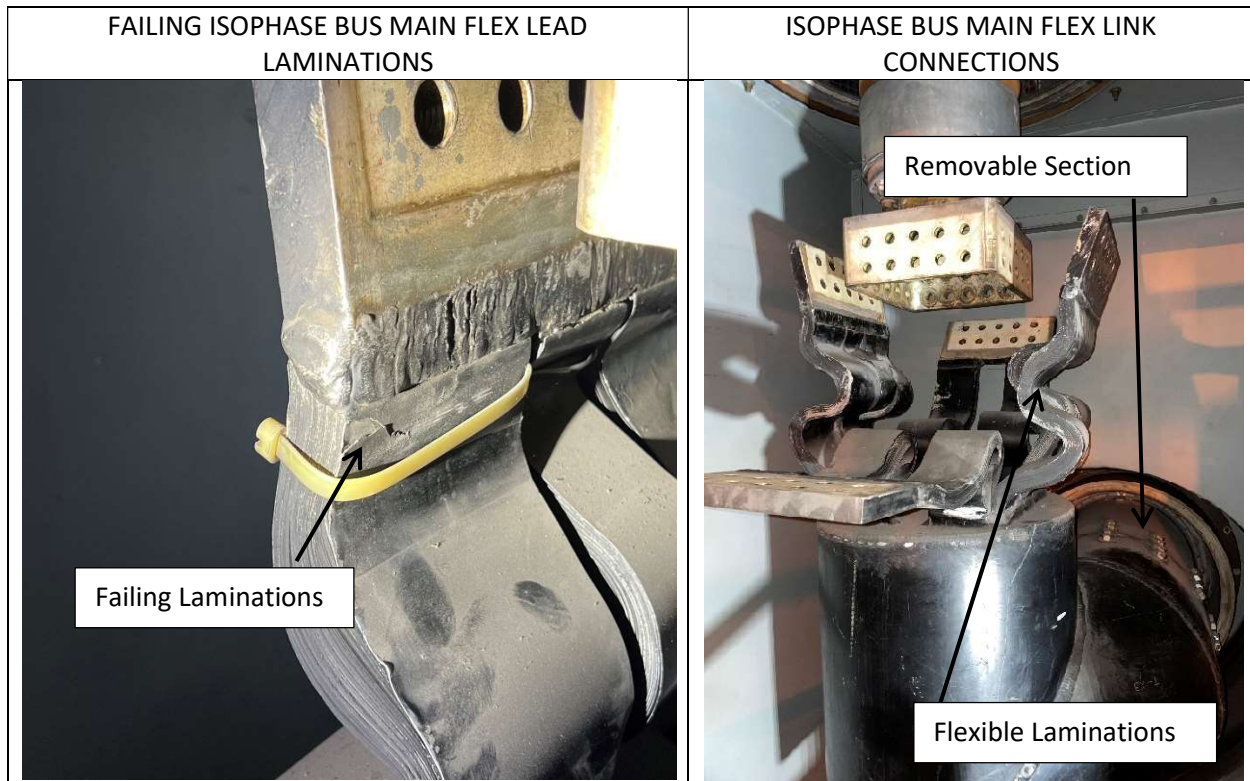
While inspecting the main generator isophase bus flexible links it was noted that the aluminum laminated sheets are cracking and deteriorating. This is evidenced by the zip ties trying to prevent broken sheets to become foreign material which can cause a bus flash over if one is allowed to completely break off. It is recommended that the bus sections be removed during the next main generator rewind and sent to an isophase vendor to remove all the flexible links and install a new solid connection pad so traditional braided links can be installed.
